NC School District/300 Davie County/High School

Central Davie Academy

Campus Assessment Report

March 10, 2017

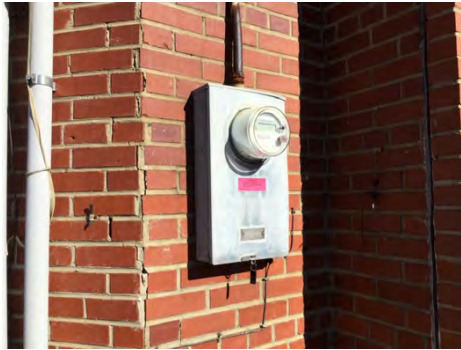
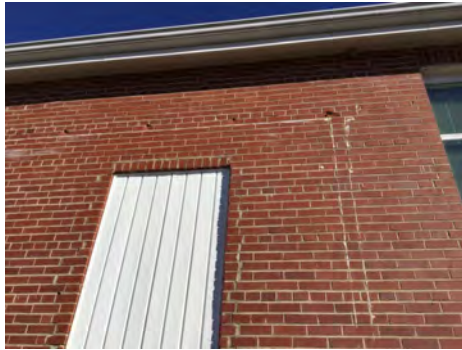
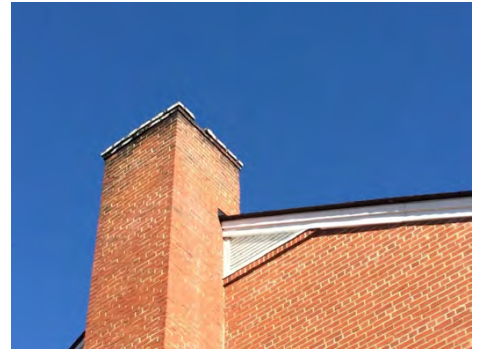
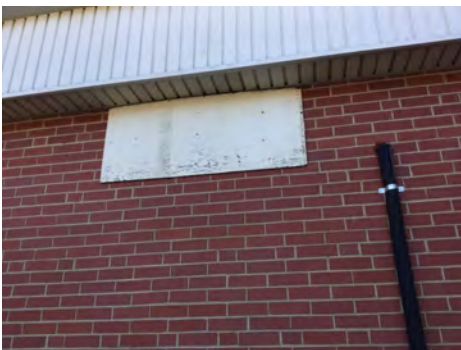
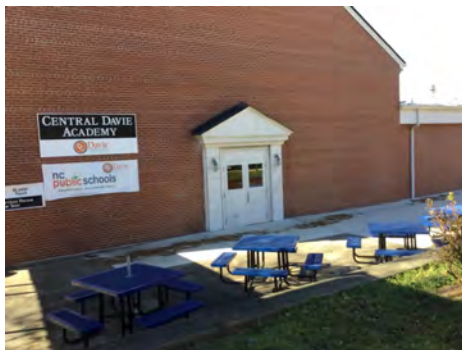
System: B2010 - Exterior Walls

Location: West wall, chimney
Distress: Damaged
Category: Deferred Maintenance
Priority: 3 - Necessary/Not Yet Critical (Years 2-5)
Correction: Point clay brick wall, 2nd floor
Qty: 12.00
Unit of Measure: C.S.F.
Estimate: \$17,170.56
Assessor Name: Eduardo Lopez
Date Created: 02/18/2017

Notes: Some pointing/repair of brick is recommended. Chimney top is deteriorating.

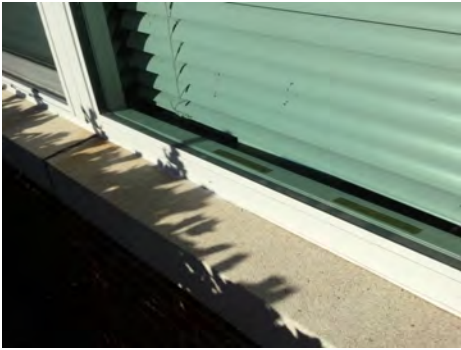
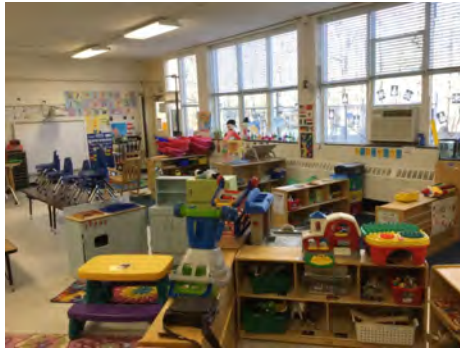
System: B2020 - Exterior Windows

Note: New windows designed with removable panel to readily accommodate new wall mounted heat pumps to be installed summer 2017.

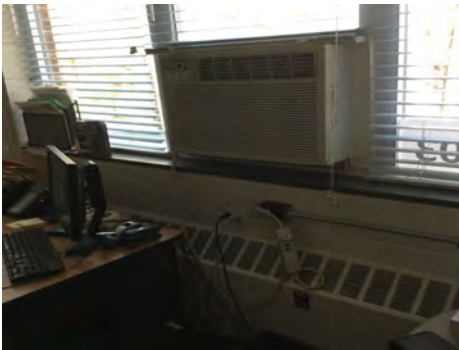
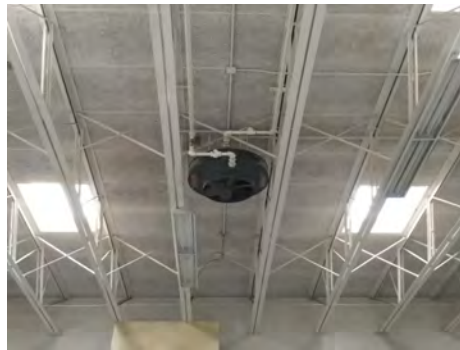
System: D3050 - Terminal & Package Units

Note: Wall mounted heat pumps being installed Summer 2017.

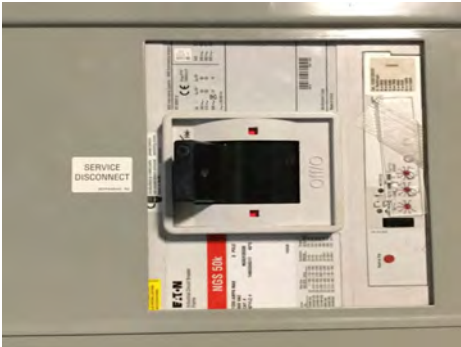
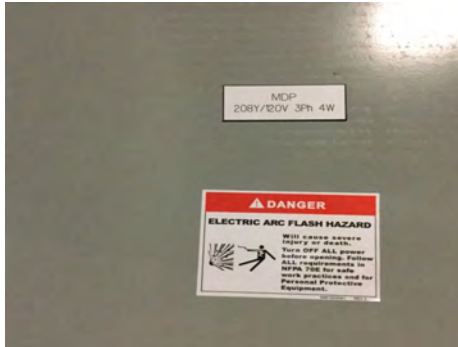
System: D5010 - Electrical Service/Distribution

Note: Upgrades to electric service made to accommodate HVAC change to window mounted heat pumps.
