NC School District/400 Greene County/Elementary School

West Greene Elementary

Campus Assessment Report

March 13, 2017

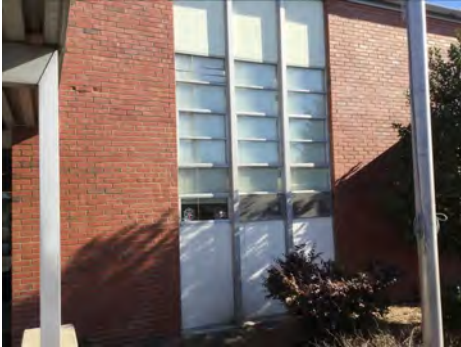
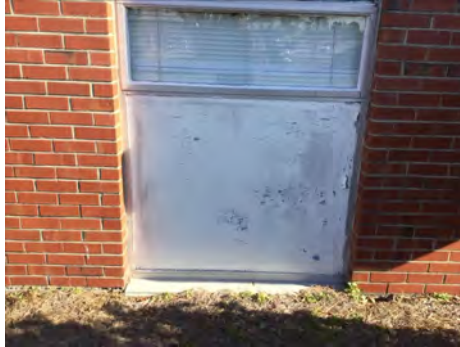
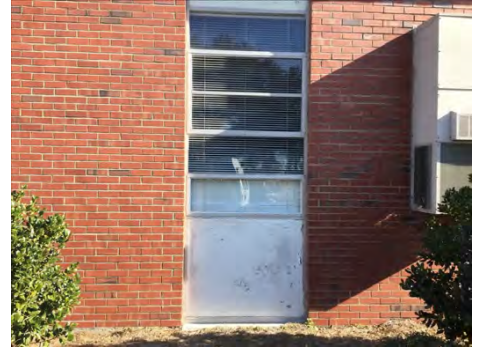
System: B2020 - Exterior Windows

Notes: The aluminum frame, operable, single pane windows are aged, not energy efficient, and should be replaced.

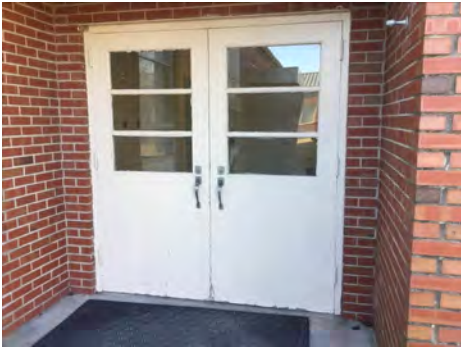
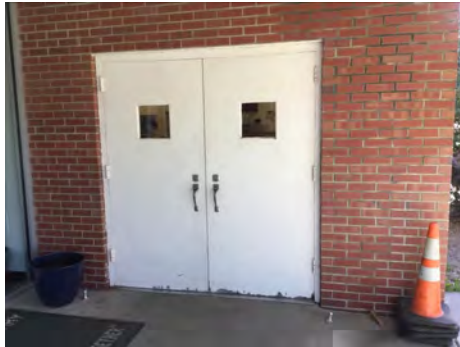
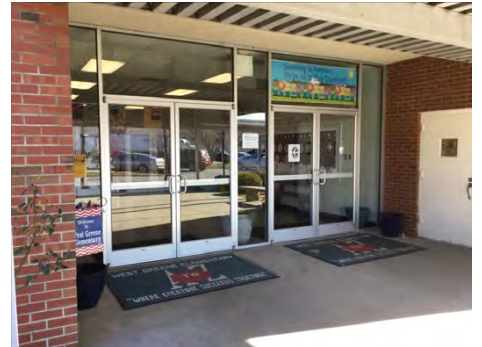
System: B2030 - Exterior Doors

Notes: The original exterior doors are aged and should be replaced.

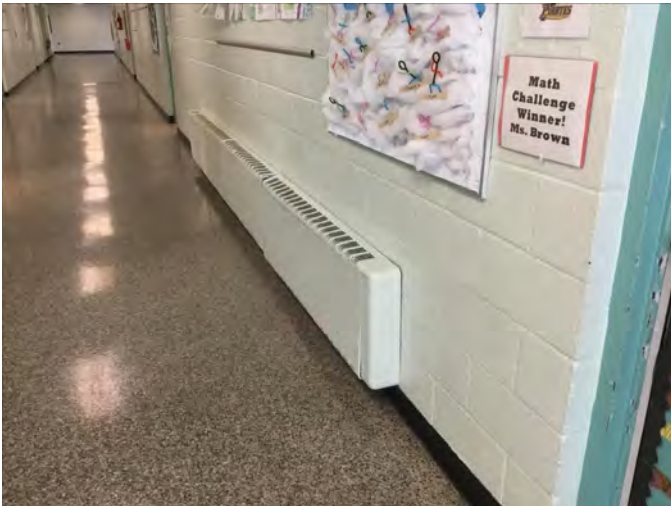
System: D3040 - Distribution Systems

Location: Corridors
Distress: Beyond Service Life
Category: Deferred Maintenance
Priority: 3 - Necessary/Not Yet Critical (Years 2-5)
Correction: Renew System
Qty: 69,949.00
Unit of Measure: S.F.
Estimate: \$463,202.00
Assessor Name: Eduardo Lopez
Date Created: 02/10/2017

Notes: The distribution equipment is inefficient and aging.

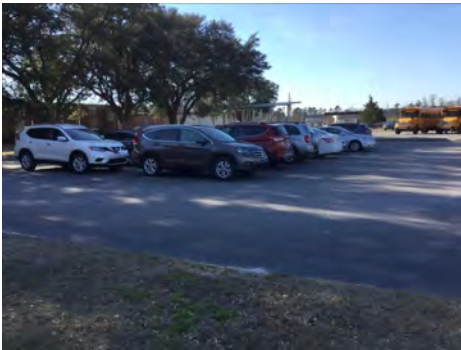
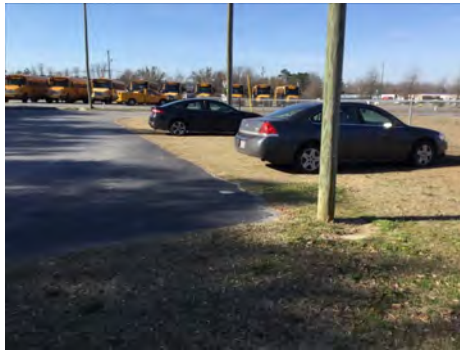
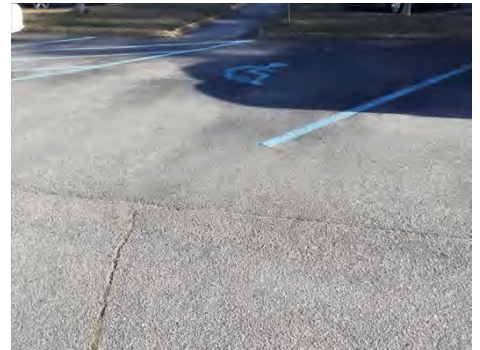
System: G2020 - Parking Lots

Notes: The parking lot is aged, has many road cuts and repairs, and should be re-surfaced and restriped.
