NC School District/400 Greene County/High School

# Greene Central High

## Campus Assessment Report

March 13, 2017

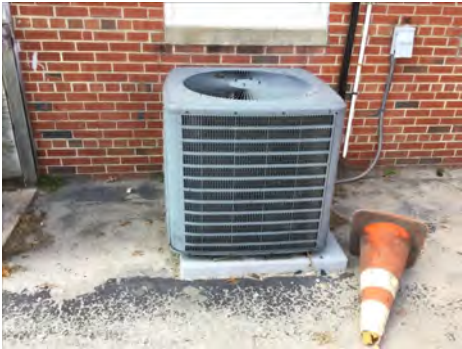
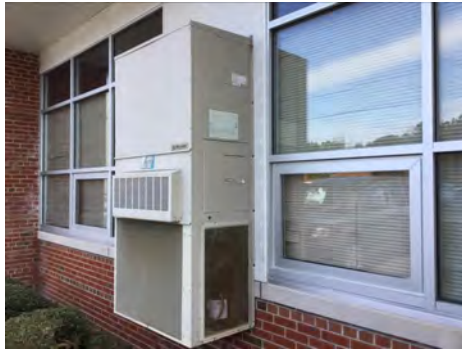
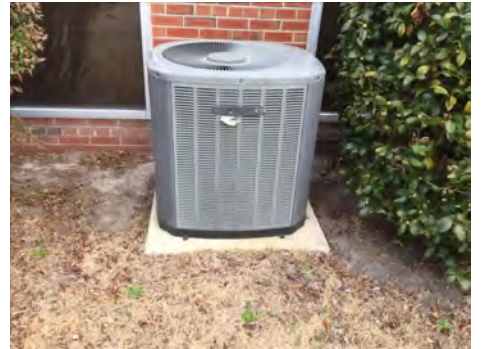
**System:** D3050 - Terminal & Package Units

**Note:** 35 wall mounted units

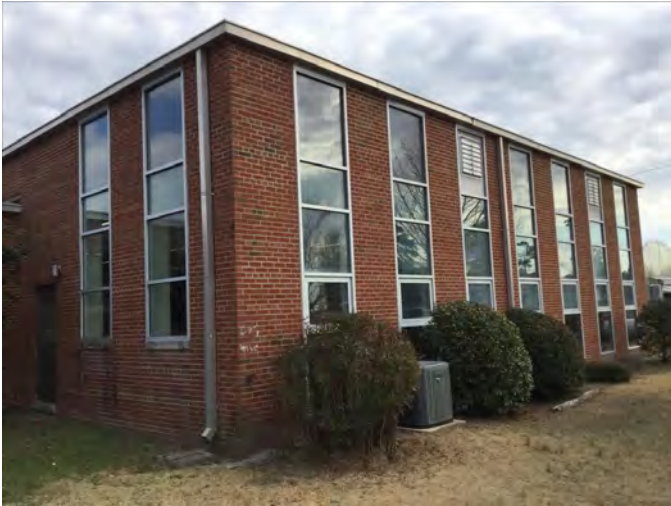
**System: B2020 - Exterior Windows**

**Location:** Exterior  
**Distress:** Damaged  
**Category:** Deferred Maintenance  
**Priority:** 3 - Necessary/Not Yet Critical (Years 2-5)  
**Correction:** Renew System  
**Qty:** 65,472.00  
**Unit of Measure:** S.F.  
**Estimate:** \$939,130.00  
**Assessor Name:** Eduardo Lopez  
**Date Created:** 02/14/2017

**Notes:** The original metal frame, single pane, operable windows are aged, worn, inefficient and should be replaced.

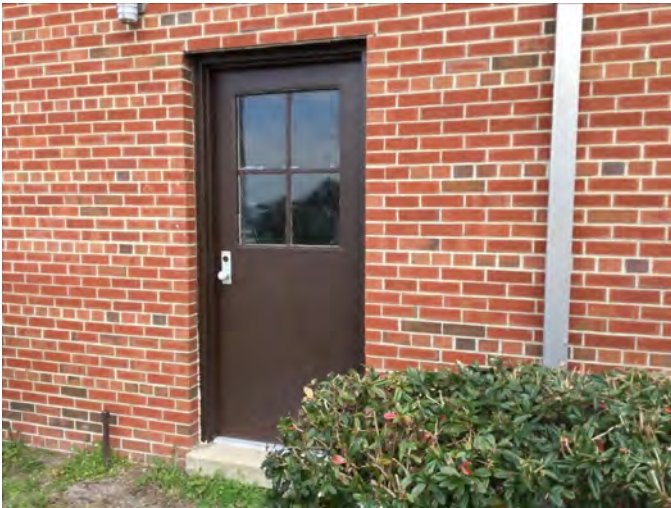
**System: B2030 - Exterior Doors**

**Location:** Exterior  
**Distress:** Beyond Service Life  
**Category:** Deferred Maintenance  
**Priority:** 3 - Necessary/Not Yet Critical (Years 2-5)  
**Correction:** Renew System  
**Qty:** 65,472.00  
**Unit of Measure:** S.F.  
**Estimate:** \$59,056.00  
**Assessor Name:** Eduardo Lopez  
**Date Created:** 02/14/2017

**Notes:** The original metal exterior doors are aged, rusted, damaged and should be replaced with energy efficient doors.

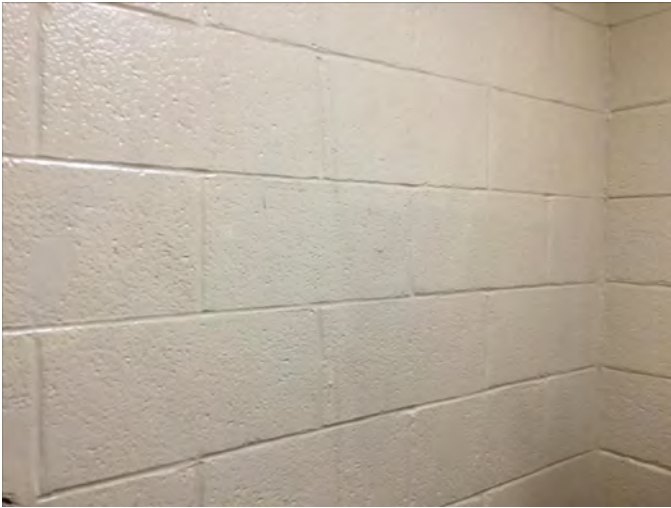
**System: C3010 - Wall Finishes**

**Location:** Interior  
**Distress:** Damaged  
**Category:** Deferred Maintenance  
**Priority:** 3 - Necessary/Not Yet Critical (Years 2-5)  
**Correction:** Renew System  
**Qty:** 65,472.00  
**Unit of Measure:** S.F.  
**Estimate:** \$187,970.00  
**Assessor Name:** Eduardo Lopez  
**Date Created:** 02/14/2017

**Notes:** The office wall paint is damaged, fading, stained, and should be re-painted.

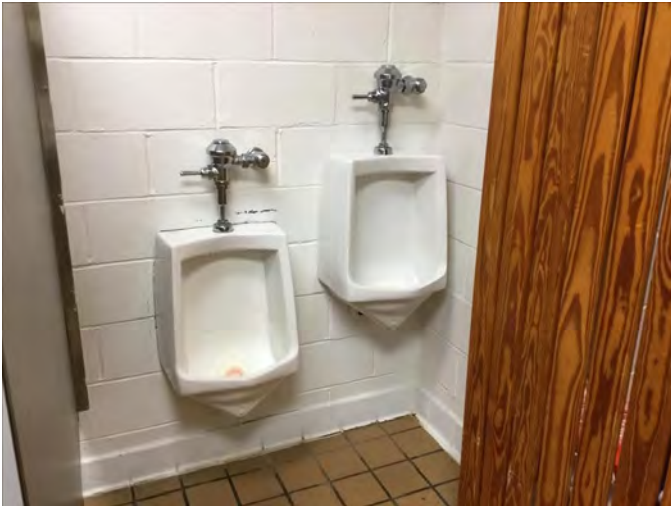
**System: D2010 - Plumbing Fixtures**

**Location:** Restroom  
**Distress:** Inadequate  
**Category:** Accessibility Code Compliance  
**Priority:** 3 - Necessary/Not Yet Critical (Years 2-5)  
**Correction:** Renew System  
**Qty:** 65,472.00  
**Unit of Measure:** S.F.  
**Estimate:** \$649,613.00  
**Assessor Name:** Eduardo Lopez  
**Date Created:** 02/21/2017

**Notes:** Plumbing fixtures are in operational conditions. However, they are aged, not ADA compliant and should be replaced with a low-flow water fixtures.

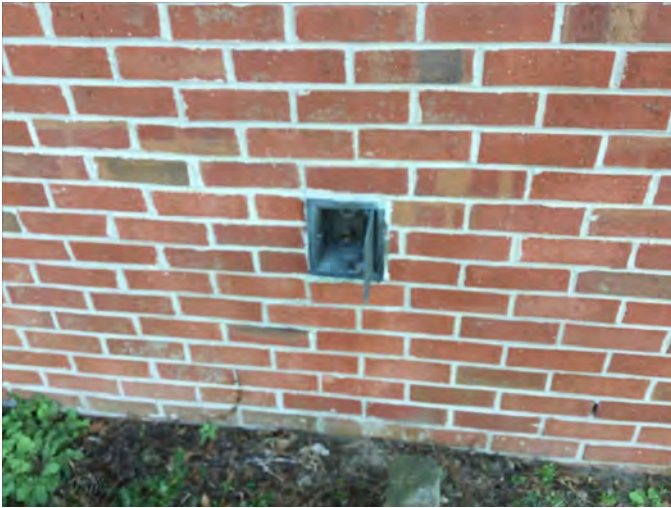
**System: D2020 - Domestic Water Distribution**

**Location:** Throughout the building  
**Distress:** Beyond Service Life  
**Category:** Deferred Maintenance  
**Priority:** 3 - Necessary/Not Yet Critical (Years 2-5)  
**Correction:** Renew System  
**Qty:** 65,472.00  
**Unit of Measure:** S.F.  
**Estimate:** \$120,992.00  
**Assessor Name:** Eduardo Lopez  
**Date Created:** 02/14/2017

**Notes:** There are no reported issues or observed deficiencies with the domestic water piping. Due to the age of the pipe there can be internal pitting corrosion that may be a costly problem that leads to the formation of pinhole leaks and possible water contamination.

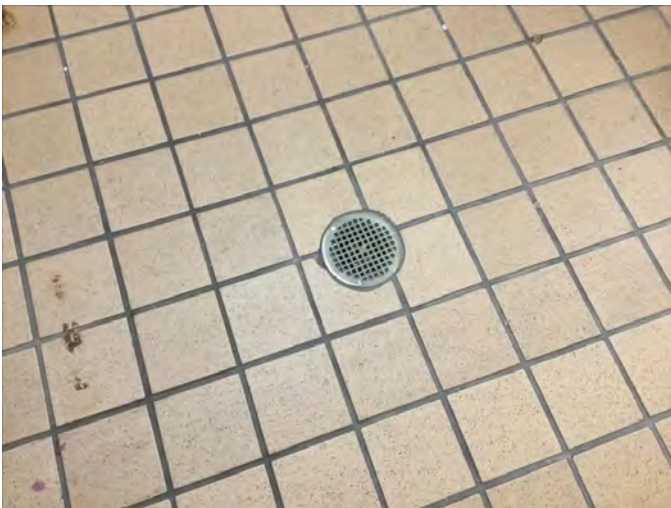
**System: D2030 - Sanitary Waste**

**Location:** Throughout the building  
**Distress:** Beyond Service Life  
**Category:** Deferred Maintenance  
**Priority:** 3 - Necessary/Not Yet Critical (Years 2-5)  
**Correction:** Renew System  
**Qty:** 65,472.00  
**Unit of Measure:** S.F.  
**Estimate:** \$190,131.00  
**Assessor Name:** Eduardo Lopez  
**Date Created:** 02/14/2017

**Notes:** There are no reported issues or observed deficiencies with the sanitary waste piping. The aging sanitary sewer piping is subject to leaks, infiltration, and it can even collapse in the interior walls.

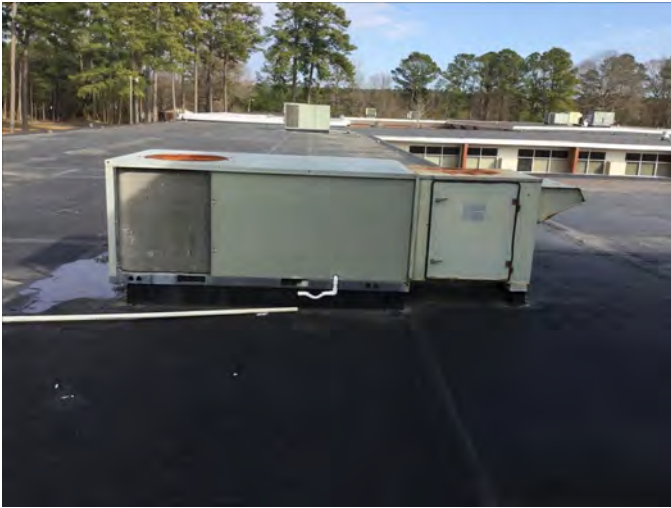
**System: D3050 - Terminal & Package Units**

**Location:** Roof/Ground  
**Distress:** Failing  
**Category:** Deferred Maintenance  
**Priority:** 3 - Necessary/Not Yet Critical (Years 2-5)  
**Correction:** Replace air conditioner, DX, 5 ton  
**Qty:** 10.00  
**Unit of Measure:** Ea.  
**Estimate:** \$169,501.20  
**Assessor Name:** Eduardo Lopez  
**Date Created:** 02/21/2017

**Notes:** Several of the units are beyond their service life and should be replaced.

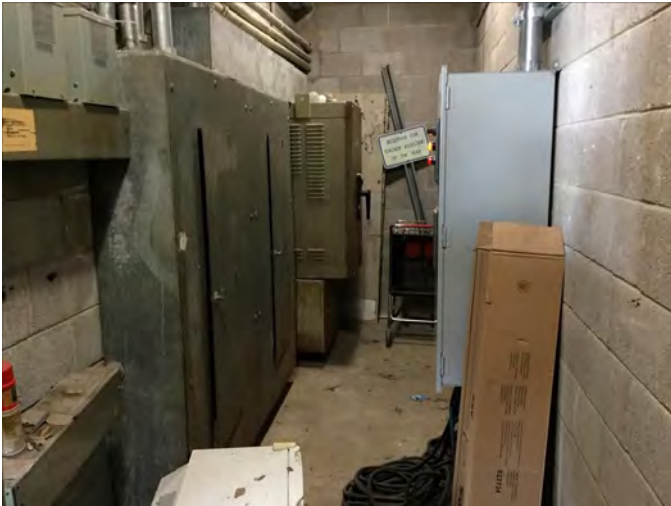
**System: D5010 - Electrical Service/Distribution**

**Location:** Throughout  
**Distress:** Beyond Service Life  
**Category:** Deferred Maintenance  
**Priority:** 3 - Necessary/Not Yet Critical (Years 2-5)  
**Correction:** Renew System  
**Qty:** 65,472.00  
**Unit of Measure:** S.F.  
**Estimate:** \$116,671.00  
**Assessor Name:** Eduardo Lopez  
**Date Created:** 02/14/2017

**Notes:** The original electrical distribution system is operating properly due to an aggressive maintenance program but is aged, in marginal condition, and should be replaced.

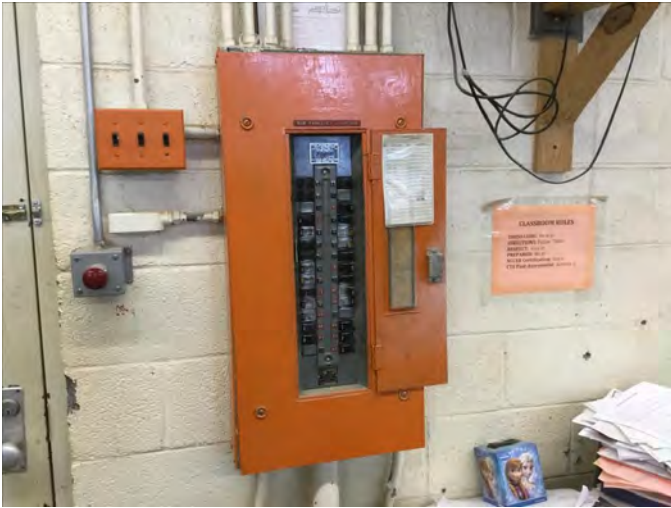
**System: D5020 - Branch Wiring**

**Location:** Throughout the building  
**Distress:** Beyond Service Life  
**Category:** Deferred Maintenance  
**Priority:** 3 - Necessary/Not Yet Critical (Years 2-5)  
**Correction:** Renew System  
**Qty:** 65,472.00  
**Unit of Measure:** S.F.  
**Estimate:** \$334,889.00  
**Assessor Name:** Eduardo Lopez  
**Date Created:** 02/14/2017

**Notes:** The original branch wiring system is operating properly due to an aggressive maintenance program but is aged, in marginal condition, and should be replaced.

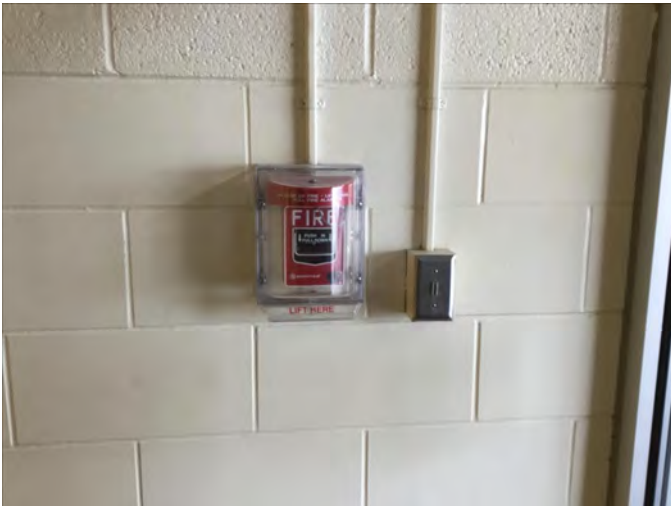
**System: D5030910 - Fire & Alarm Systems**

**Location:** Throughout the building  
**Distress:** Beyond Service Life  
**Category:** Deferred Maintenance  
**Priority:** 3 - Necessary/Not Yet Critical (Years 2-5)  
**Correction:** Renew System  
**Qty:** 65,472.00  
**Unit of Measure:** S.F.  
**Estimate:** \$262,150.00  
**Assessor Name:** Eduardo Lopez  
**Date Created:** 02/14/2017

**Notes:** The original fire alarm system operating as designed, but is beyond its service life and should be replaced.

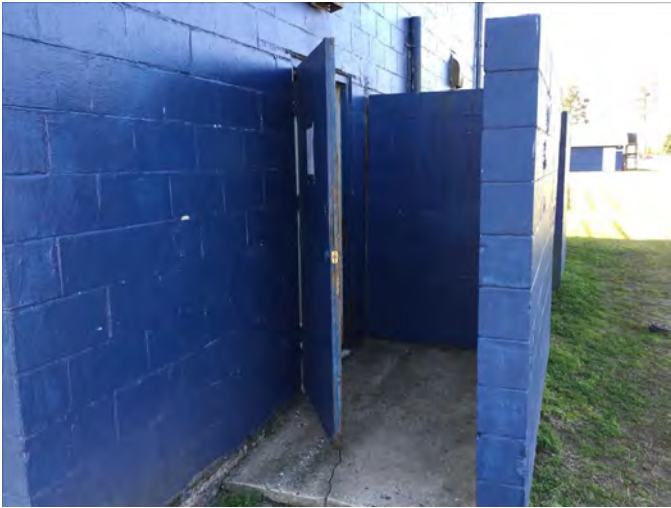
#### System: B2030 - Exterior Doors

**Location:** Restroom  
**Distress:** Beyond Service Life  
**Category:** Deferred Maintenance  
**Priority:** 3 - Necessary/Not Yet Critical (Years 2-5)  
**Correction:** Renew System  
**Qty:** 700.00  
**Unit of Measure:** S.F.  
**Estimate:** \$662.00  
**Assessor Name:** Terence Davis  
**Date Created:** 02/08/2017

**Notes:** The doors are damaged and the hardware is failing.

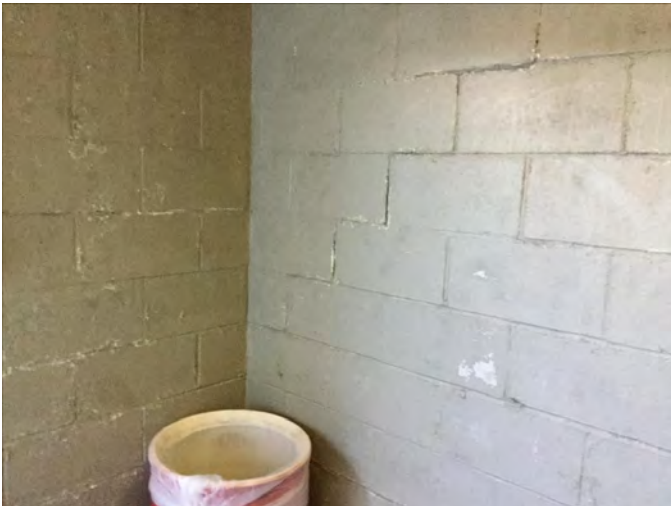
#### System: C3010 - Wall Finishes

**Location:** Interior  
**Distress:** Damaged  
**Category:** Deferred Maintenance  
**Priority:** 3 - Necessary/Not Yet Critical (Years 2-5)  
**Correction:** Renew System  
**Qty:** 700.00  
**Unit of Measure:** S.F.  
**Estimate:** \$2,118.00  
**Assessor Name:** Terence Davis  
**Date Created:** 02/08/2017

**Notes:** The office wall paint is damaged, fading, stained, and should be re-painted.

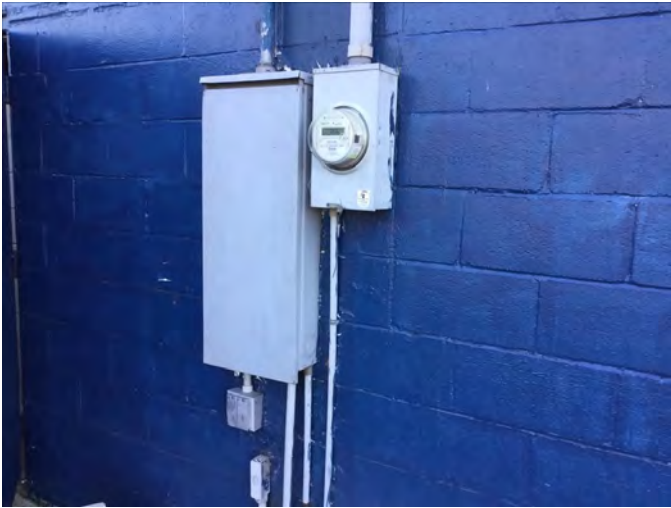
**System: D5010 - Electrical Service/Distribution**

**Location:** Throughout the building  
**Distress:** Beyond Service Life  
**Category:** Deferred Maintenance  
**Priority:** 3 - Necessary/Not Yet Critical (Years 2-5)  
**Correction:** Renew System  
**Qty:** 700.00  
**Unit of Measure:** S.F.  
**Estimate:** \$1,309.00  
**Assessor Name:** Terence Davis  
**Date Created:** 02/08/2017

**Notes:** The original electrical distribution system is operating properly due to an aggressive maintenance program but is aged, in marginal condition, and should be replaced.

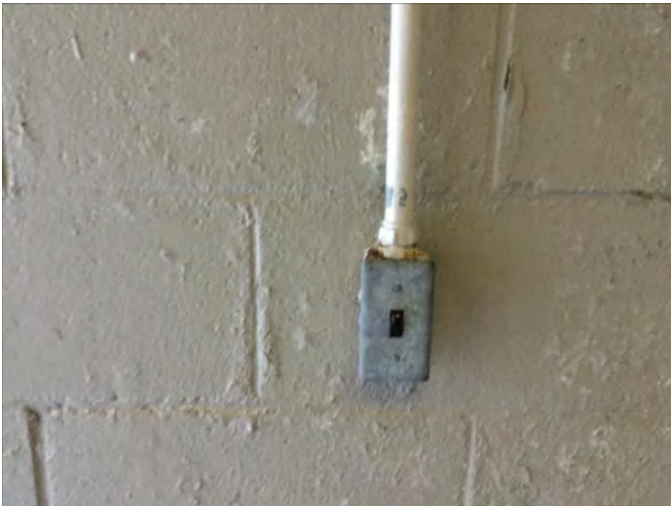
**System: D5020 - Branch Wiring**

**Location:** Throughout the building  
**Distress:** Beyond Service Life  
**Category:** Deferred Maintenance  
**Priority:** 3 - Necessary/Not Yet Critical (Years 2-5)  
**Correction:** Renew System  
**Qty:** 700.00  
**Unit of Measure:** S.F.  
**Estimate:** \$3,750.00  
**Assessor Name:** Terence Davis  
**Date Created:** 02/08/2017

**Notes:** The original branch wiring system is operating properly due to an aggressive maintenance program but is aged, in marginal condition, and should be replaced.

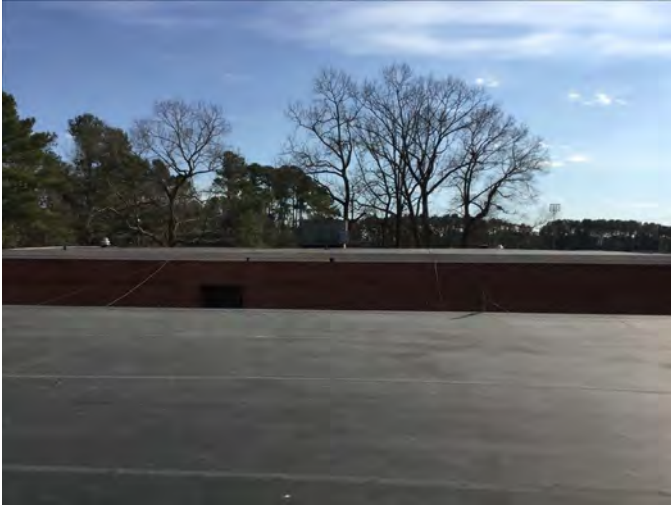
#### **System: B3010120 - Single Ply Membrane**

**Location:** Roof  
**Distress:** Failing  
**Category:** Deferred Maintenance  
**Priority:** 3 - Necessary/Not Yet Critical (Years 2-5)  
**Correction:** Renew System  
**Qty:** 18,118.00  
**Unit of Measure:** S.F.  
**Estimate:** \$189,695.00  
**Assessor Name:** Eduardo Lopez  
**Date Created:** 02/16/2017

**Notes:** The single-ply roof covering is aged, worn and should be replaced.

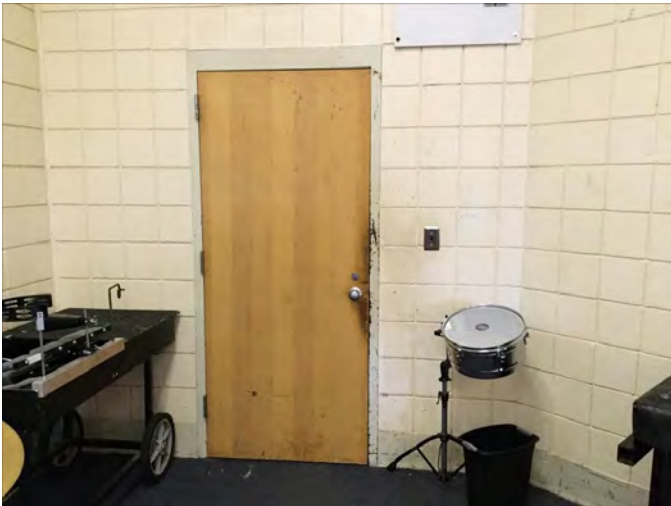
#### **System: C1020 - Interior Doors**

**Location:** Throughout the building  
**Distress:** Failing  
**Category:** Deferred Maintenance  
**Priority:** 3 - Necessary/Not Yet Critical (Years 2-5)  
**Correction:** Renew System  
**Qty:** 18,118.00  
**Unit of Measure:** S.F.  
**Estimate:** \$52,017.00  
**Assessor Name:** Eduardo Lopez  
**Date Created:** 02/16/2017

**Notes:** The original wood interior doors are aged, worn and should be replaced.

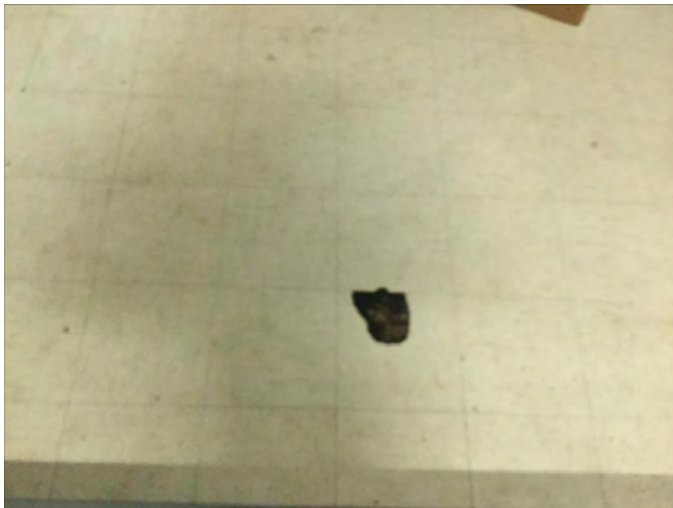
**System: C3020 - Floor Finishes**

**Location:** Throughout the building  
**Distress:** Damaged  
**Category:** Deferred Maintenance  
**Priority:** 3 - Necessary/Not Yet Critical (Years 2-5)  
**Correction:** Replace carpet with pad  
**Qty:** 1.00  
**Unit of Measure:** S.Y.  
**Estimate:** \$7,200.07  
**Assessor Name:** Eduardo Lopez  
**Date Created:** 02/16/2017

**Notes:** The carpet and VCT is damaged and need to be replaced.

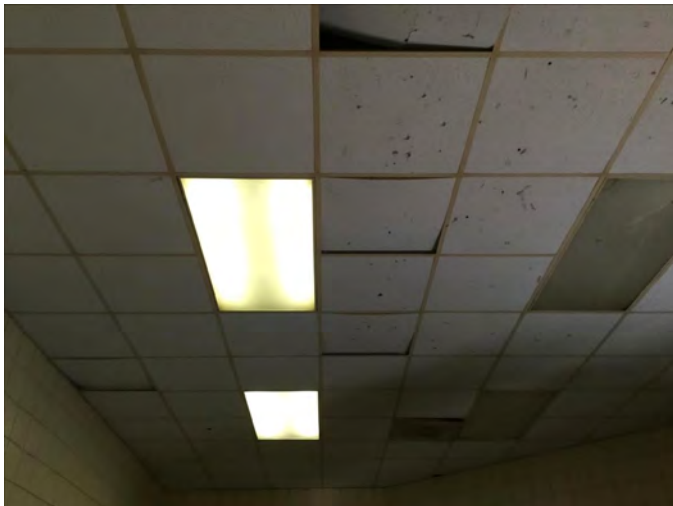
**System: C3030 - Ceiling Finishes**

**Location:** Throughout the building  
**Distress:** Damaged  
**Category:** Deferred Maintenance  
**Priority:** 3 - Necessary/Not Yet Critical (Years 2-5)  
**Correction:** Renew System  
**Qty:** 18,118.00  
**Unit of Measure:** S.F.  
**Estimate:** \$225,207.00  
**Assessor Name:** Eduardo Lopez  
**Date Created:** 02/16/2017

**Notes:** The original ceiling finishes are aged, chipped, stained and should be replaced.

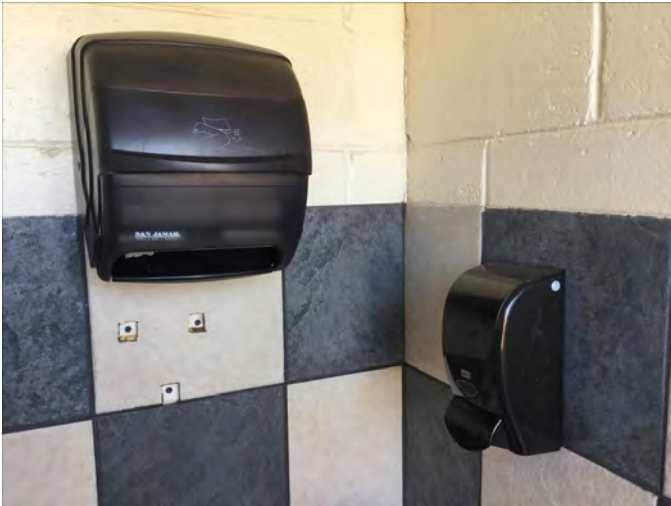
#### System: C1030 - Fittings

**Location:** Interior  
**Distress:** Beyond Service Life  
**Category:** Deferred Maintenance  
**Priority:** 3 - Necessary/Not Yet Critical (Years 2-5)  
**Correction:** Renew System  
**Qty:** 1,100.00  
**Unit of Measure:** S.F.  
**Estimate:** \$10,249.00  
**Assessor Name:** Terence Davis  
**Date Created:** 02/14/2017

**Notes:** The original fittings are aged, and should be replaced

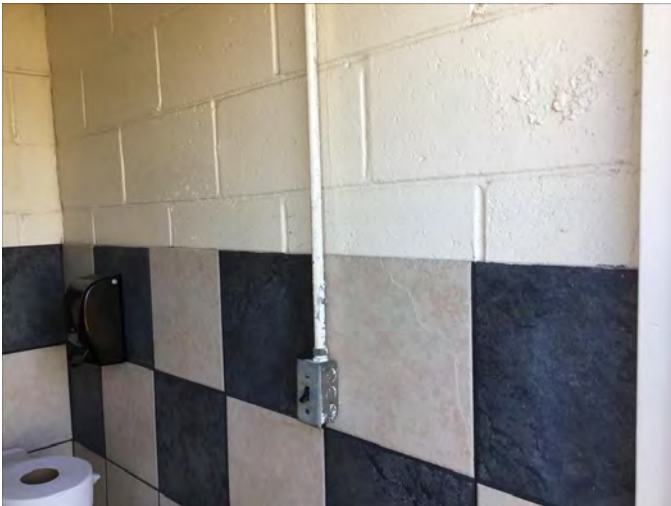
#### System: C3010 - Wall Finishes

**Location:** Interior  
**Distress:** Beyond Service Life  
**Category:** Deferred Maintenance  
**Priority:** 3 - Necessary/Not Yet Critical (Years 2-5)  
**Correction:** Renew System  
**Qty:** 1,100.00  
**Unit of Measure:** S.F.  
**Estimate:** \$9,027.00  
**Assessor Name:** Terence Davis  
**Date Created:** 02/14/2017

**Notes:** The office wall paint is damaged, fading, stained, and should be re-painted.

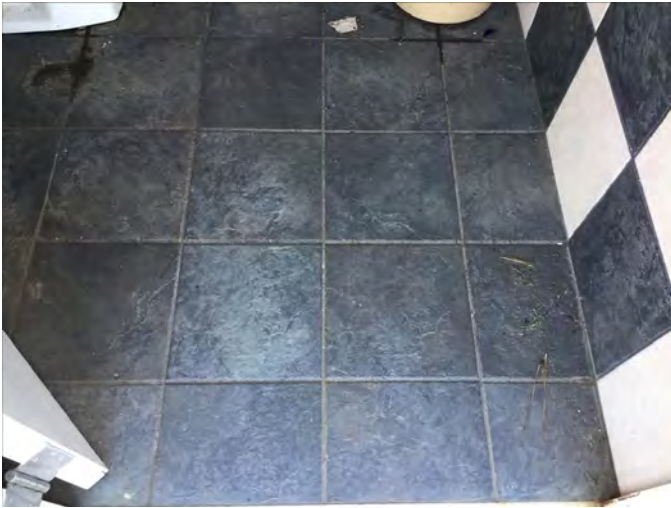
**System: C3020 - Floor Finishes**

**Location:** Throughout the building  
**Distress:** Damaged  
**Category:** Deferred Maintenance  
**Priority:** 3 - Necessary/Not Yet Critical (Years 2-5)  
**Correction:** Renew System  
**Qty:** 1,100.00  
**Unit of Measure:** S.F.  
**Estimate:** \$15,415.00  
**Assessor Name:** Terence Davis  
**Date Created:** 02/14/2017

**Notes:** The flooring is beyond its service life, damaged and it should be replaced.

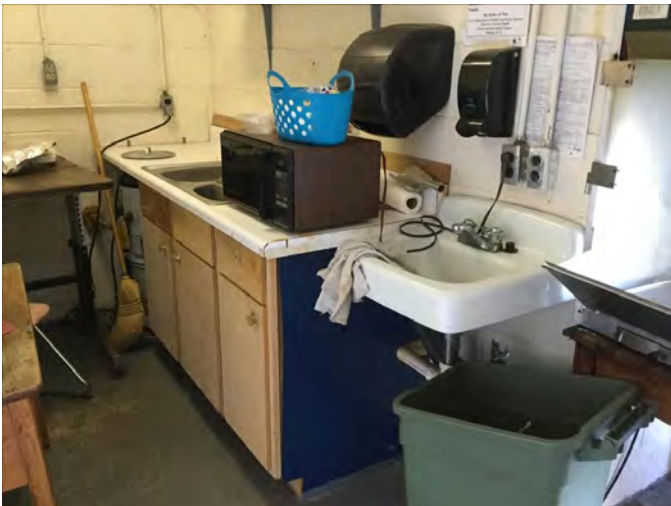
**System: E2010 - Fixed Furnishings**

**Location:** Throughout the building  
**Distress:** Beyond Service Life  
**Category:** Deferred Maintenance  
**Priority:** 3 - Necessary/Not Yet Critical (Years 2-5)  
**Correction:** Renew System  
**Qty:** 1,100.00  
**Unit of Measure:** S.F.  
**Estimate:** \$6,147.00  
**Assessor Name:** Terence Davis  
**Date Created:** 02/14/2017

**Notes:** The fixed furnishings are aged, in marginal condition, and should be replaced.

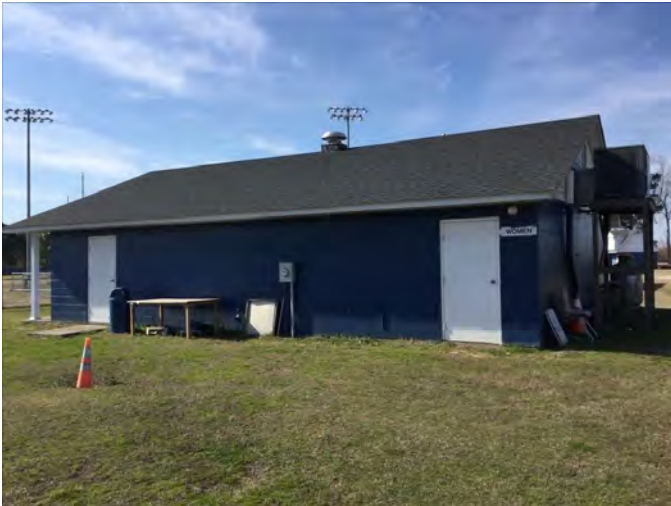
**System: B3010140 - Asphalt Shingles**

**Location:** Roof  
**Distress:** Damaged  
**Category:** Deferred Maintenance  
**Priority:** 3 - Necessary/Not Yet Critical (Years 2-5)  
**Correction:** Renew System  
**Qty:** 1,100.00  
**Unit of Measure:** S.F.  
**Estimate:** \$6,938.00  
**Assessor Name:** Eduardo Lopez  
**Date Created:** 02/14/2017

**Notes:** The asphalt shingle roofing is aged, damaged and should be replaced.

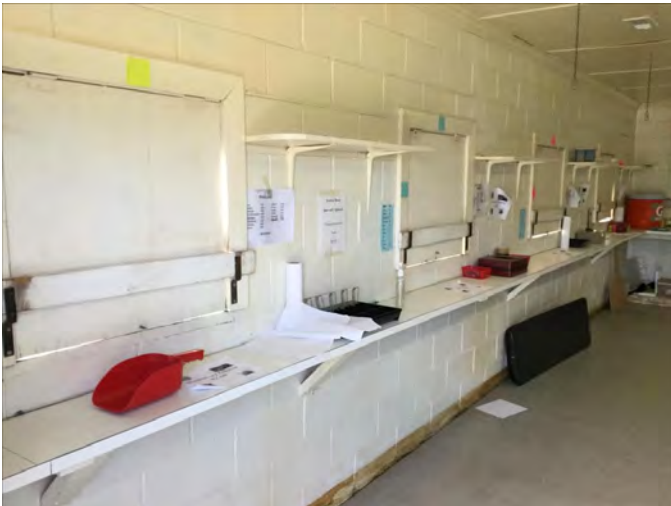
**System: C3010 - Wall Finishes**

**Location:** Interior  
**Distress:** Beyond Service Life  
**Category:** Deferred Maintenance  
**Priority:** 3 - Necessary/Not Yet Critical (Years 2-5)  
**Correction:** Renew System  
**Qty:** 1,100.00  
**Unit of Measure:** S.F.  
**Estimate:** \$9,027.00  
**Assessor Name:** Eduardo Lopez  
**Date Created:** 02/14/2017

**Notes:** The office wall paint is damaged, fading, stained, and should be re-painted.

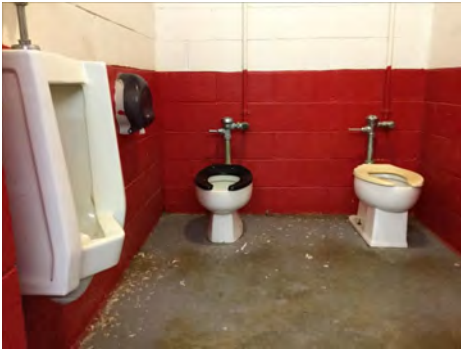
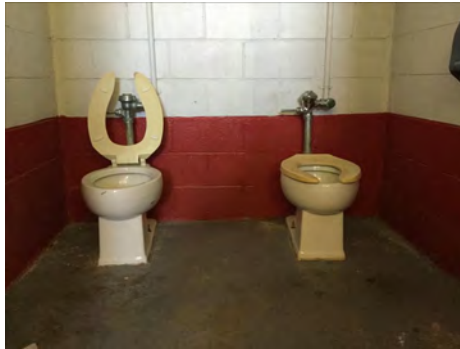
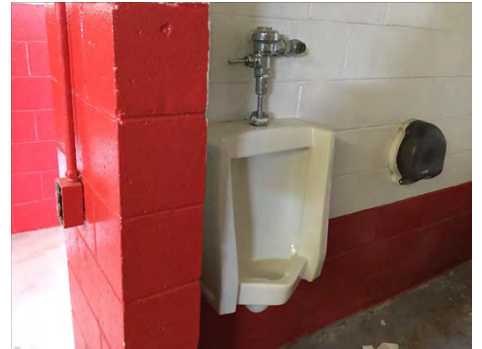
**System:** D2010 - Plumbing Fixtures

**Notes:** Plumbing fixtures are in operational conditions. However, they are aged, not ADA compliant and should be replaced with a low-flow water fixtures.

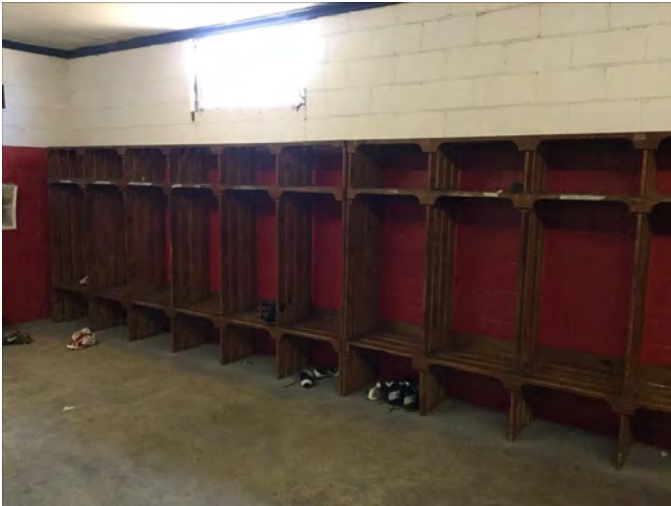
#### System: C1030 - Fittings

**Location:** Locker Room  
**Distress:** Damaged  
**Category:** Deferred Maintenance  
**Priority:** 3 - Necessary/Not Yet Critical (Years 2-5)  
**Correction:** Renew System  
**Qty:** 2,400.00  
**Unit of Measure:** S.F.  
**Estimate:** \$22,361.00  
**Assessor Name:** Eduardo Lopez  
**Date Created:** 02/15/2017

**Notes:** The original fittings are aged, and should be replaced

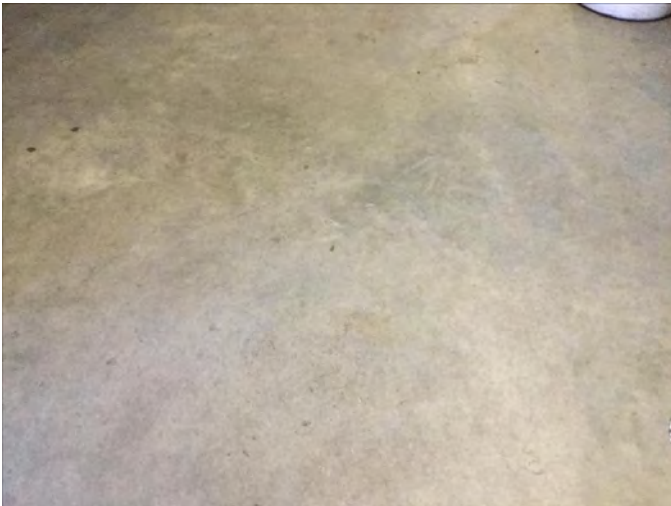
#### System: C3020 - Floor Finishes

**Location:** Interior  
**Distress:** Beyond Service Life  
**Category:** Deferred Maintenance  
**Priority:** 3 - Necessary/Not Yet Critical (Years 2-5)  
**Correction:** Renew System  
**Qty:** 2,400.00  
**Unit of Measure:** S.F.  
**Estimate:** \$33,634.00  
**Assessor Name:** Eduardo Lopez  
**Date Created:** 02/15/2017

**Notes:** The flooring is beyond its service life, damaged and it should be replaced.

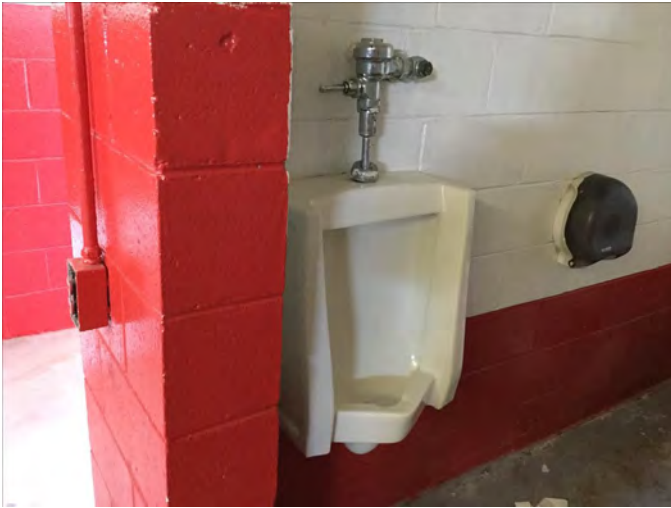
**System: D2010 - Plumbing Fixtures**

**Location:** Restroom  
**Distress:** Beyond Service Life  
**Category:** Deferred Maintenance  
**Priority:** 3 - Necessary/Not Yet Critical (Years 2-5)  
**Correction:** Renew System  
**Qty:** 2,400.00  
**Unit of Measure:** S.F.  
**Estimate:** \$26,347.00  
**Assessor Name:** Eduardo Lopez  
**Date Created:** 02/15/2017

**Notes:** Plumbing fixtures are in operational conditions. However, they are aged, not ADA compliant and should be replaced with a low-flow water fixtures.

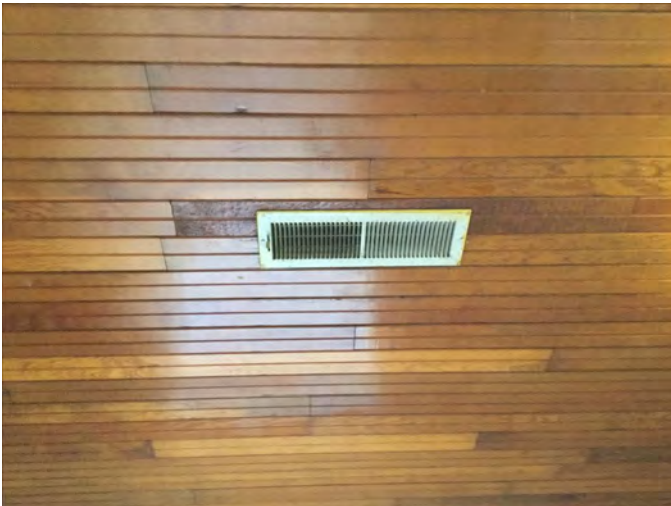
**System: D3040 - Distribution Systems**

**Location:** Throughout the building  
**Distress:** Failing  
**Category:** Deferred Maintenance  
**Priority:** 3 - Necessary/Not Yet Critical (Years 2-5)  
**Correction:** Renew System  
**Qty:** 2,400.00  
**Unit of Measure:** S.F.  
**Estimate:** \$14,124.00  
**Assessor Name:** Eduardo Lopez  
**Date Created:** 02/15/2017

**Notes:** The air distribution system is aged, becoming logistically unsupportable, and should be replaced.

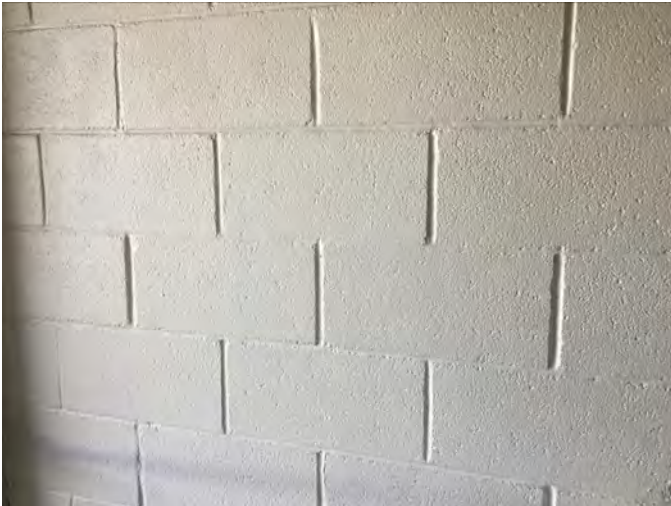
#### System: C3010 - Wall Finishes

**Location:** Interior  
**Distress:** Beyond Service Life  
**Category:** Deferred Maintenance  
**Priority:** 3 - Necessary/Not Yet Critical (Years 2-5)  
**Correction:** Renew System  
**Qty:** 7,500.00  
**Unit of Measure:** S.F.  
**Estimate:** \$22,688.00  
**Assessor Name:** Eduardo Lopez  
**Date Created:** 02/08/2017

**Notes:** The office wall paint is damaged, fading, stained, and should be re-painted.

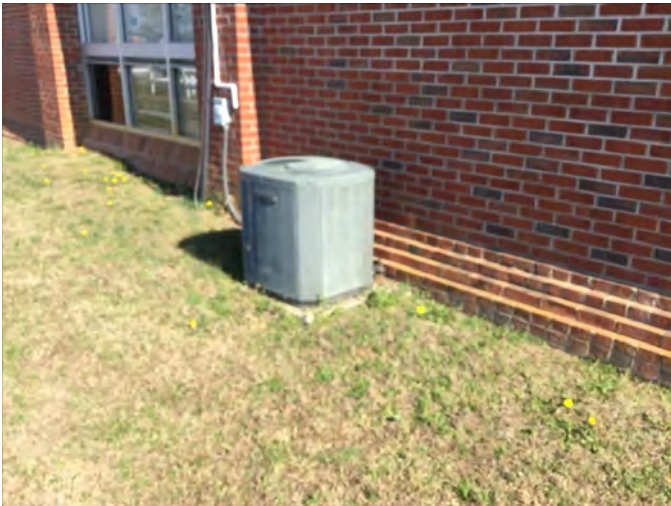
#### System: D3050 - Terminal & Package Units

**Location:** Exterior  
**Distress:** Beyond Service Life  
**Category:** Deferred Maintenance  
**Priority:** 3 - Necessary/Not Yet Critical (Years 2-5)  
**Correction:** Renew System  
**Qty:** 7,500.00  
**Unit of Measure:** S.F.  
**Estimate:** \$161,288.00  
**Assessor Name:** Eduardo Lopez  
**Date Created:** 02/08/2017

**Notes:** The pad mounted DX condensers are aged, rusted, not energy efficient, and should be replaced.

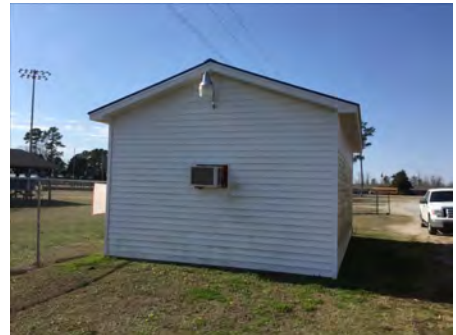
3). East Elevation - Feb 23, 2017

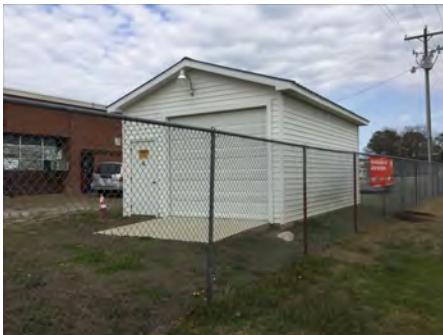
4). South Elevation - Feb 23, 2017
