NC School District/430 Harnett County/Elementary School

Benhaven Elementary

Campus Assessment Report

March 11, 2017

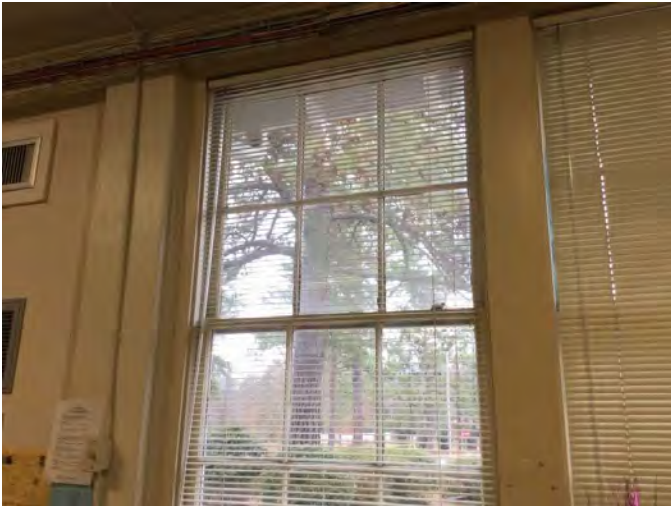
System: B2020 - Exterior Windows

Location: Throughout
Distress: Beyond Service Life
Category: Deferred Maintenance / Energy
Priority: 3 - Necessary/Not Yet Critical (Years 2-5)
Correction: Renew System
Qty: 12,688.00
Unit of Measure: S.F.
Estimate: \$133,567.00
Assessor Name: Terence Davis
Date Created: 12/06/2016

Notes: The wood frame, operable, single pane windows are aged, stuck, not energy efficient, and should be replaced.

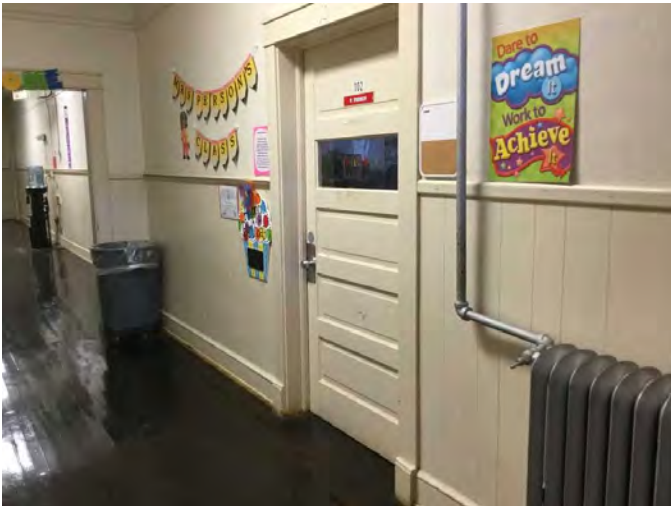
System: C1020 - Interior Doors

Location: Throughout
Distress: Beyond Service Life
Category: Deferred Maintenance
Priority: 3 - Necessary/Not Yet Critical (Years 2-5)
Correction: Renew System
Qty: 12,688.00
Unit of Measure: S.F.
Estimate: \$36,148.00
Assessor Name: Terence Davis
Date Created: 12/06/2016

Notes: The interior doors are aged, failing, hardware is not ADA compliant and should be replaced.

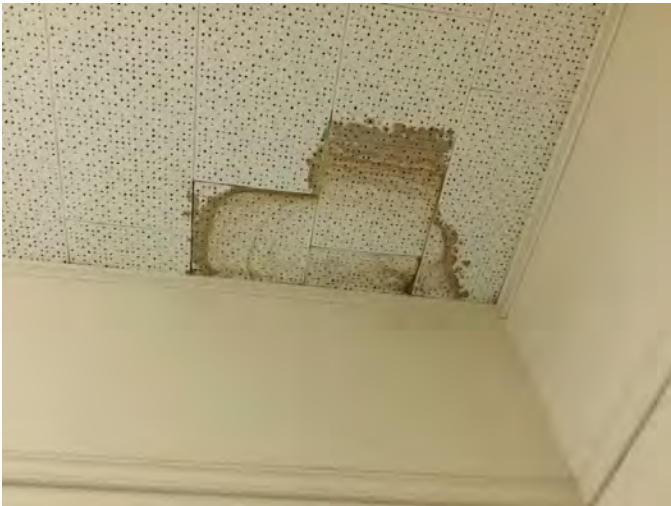
System: C3030 - Ceiling Finishes

Location: Throughout
Distress: Beyond Service Life
Category: Deferred Maintenance
Priority: 3 - Necessary/Not Yet Critical (Years 2-5)
Correction: Renew System
Qty: 12,688.00
Unit of Measure: S.F.
Estimate: \$156,177.00
Assessor Name: Terence Davis
Date Created: 12/06/2016

Notes: The original ceiling finishes are aged, failing and should be replaced.

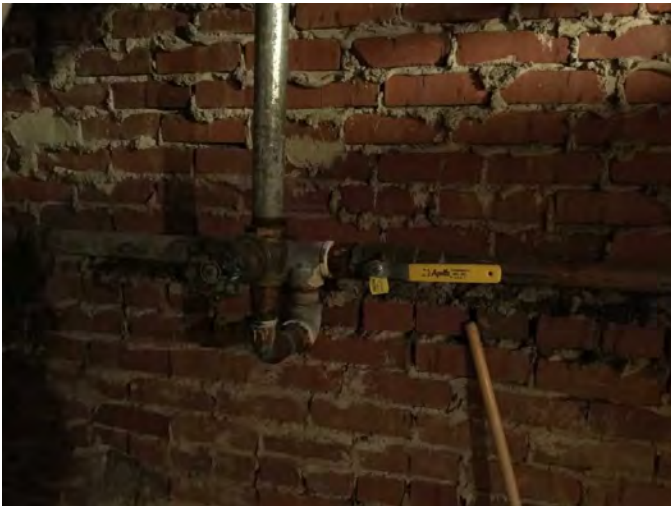
System: D2020 - Domestic Water Distribution

Location: Throughout
Distress: Beyond Service Life
Category: Deferred Maintenance
Priority: 3 - Necessary/Not Yet Critical (Years 2-5)
Correction: Renew System
Qty: 12,688.00
Unit of Measure: S.F.
Estimate: \$13,817.00
Assessor Name: Terence Davis
Date Created: 12/06/2016

Notes: The domestic water distribution system is aged and should be replaced. The school is currently unable to use any domestic water due to health concerns.

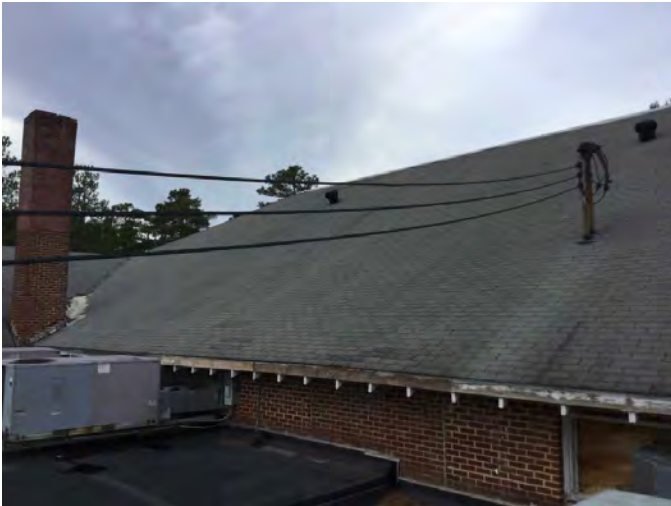
System: D5010 - Electrical Service/Distribution

Location: Throughout
Distress: Beyond Service Life
Category: Deferred Maintenance
Priority: 3 - Necessary/Not Yet Critical (Years 2-5)
Correction: Renew System
Qty: 12,688.00
Unit of Measure: S.F.
Estimate: \$24,145.00
Assessor Name: Terence Davis
Date Created: 12/06/2016

Notes: The electrical distribution system is aged, becoming logistically unsupportable, and should be replaced.

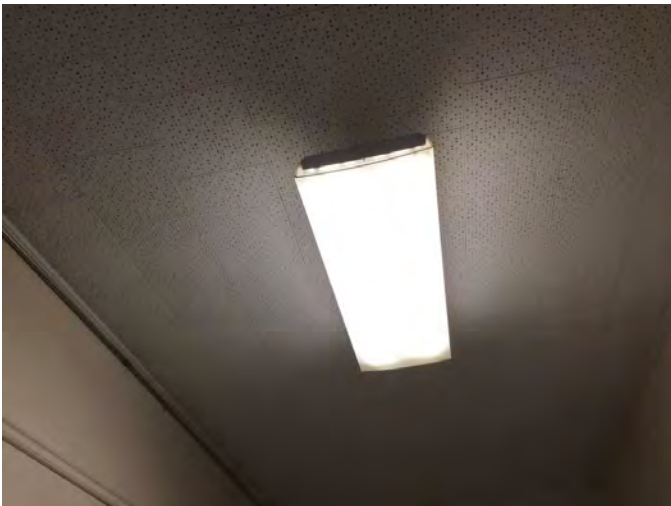
System: D5020 - Lighting

Location: Throughout
Distress: Beyond Service Life
Category: Deferred Maintenance
Priority: 3 - Necessary/Not Yet Critical (Years 2-5)
Correction: Renew System
Qty: 12,688.00
Unit of Measure: S.F.
Estimate: \$169,156.00
Assessor Name: Terence Davis
Date Created: 12/06/2016

Notes: The original lighting system is operating, but is aged, in poor condition, and should be replaced

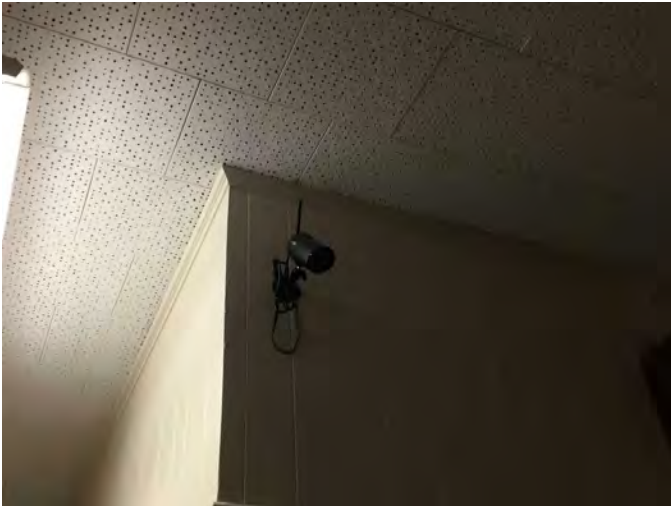
System: D5030810 - Security & Detection Systems

Location: Throughout
Distress: Beyond Service Life
Category: Deferred Maintenance
Priority: 3 - Necessary/Not Yet Critical (Years 2-5)
Correction: Renew System
Qty: 12,688.00
Unit of Measure: S.F.
Estimate: \$26,657.00
Assessor Name: Terence Davis
Date Created: 12/06/2016

Notes: The system is beyond its expected service life and should be scheduled for replacement.
Analog cameras should be upgraded to digital.

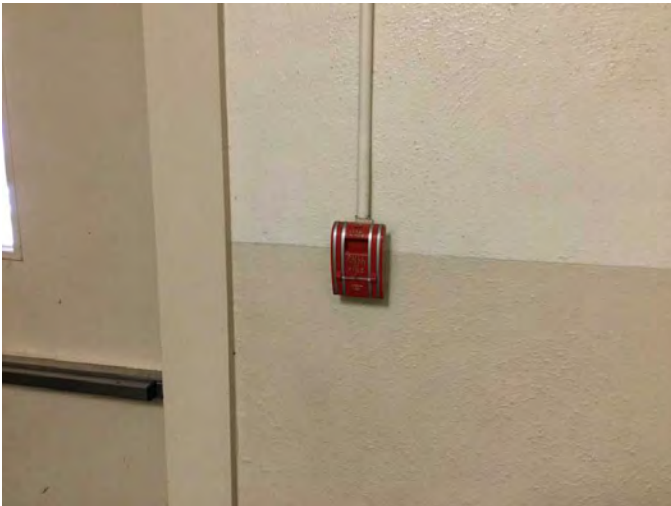
System: D5030910 - Fire Alarm Systems

Location: Throughout
Distress: Beyond Service Life
Category: Deferred Maintenance
Priority: 3 - Necessary/Not Yet Critical (Years 2-5)
Correction: Renew System
Qty: 12,688.00
Unit of Measure: S.F.
Estimate: \$48,291.00
Assessor Name: Terence Davis
Date Created: 12/06/2016

Notes: The system is beyond its expected service life and should be scheduled for replacement.

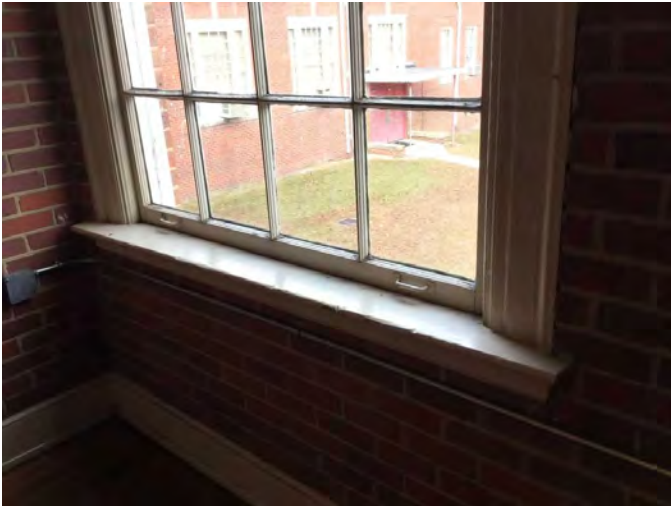
System: B2020 - Exterior Windows

Location: Throughout
Distress: Beyond Service Life
Category: Deferred Maintenance / Energy
Priority: 3 - Necessary/Not Yet Critical (Years 2-5)
Correction: Renew System
Qty: 24,319.00
Unit of Measure: S.F.
Estimate: \$256,006.00
Assessor Name: Terence Davis
Date Created: 12/07/2016

Notes: The wood frame, operable, single pane windows are aged, stuck, not energy efficient, and should be replaced.

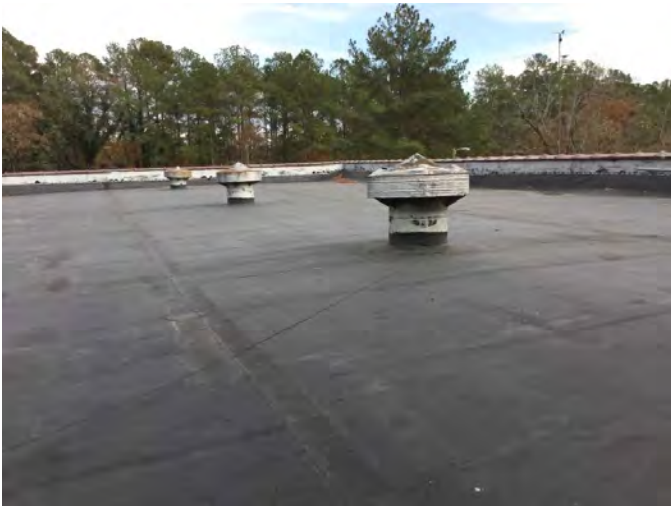
System: B3010120 - Single Ply Membrane

Location: Aud. roof
Distress: Beyond Service Life
Category: Deferred Maintenance
Priority: 3 - Necessary/Not Yet Critical (Years 2-5)
Correction: Renew System
Qty: 8,106.00
Unit of Measure: S.F.
Estimate: \$84,870.00
Assessor Name: Terence Davis
Date Created: 12/09/2016

Notes: The EPDM adhered and ballasted roof coverings are aging, showing signs of failure and should be replaced.

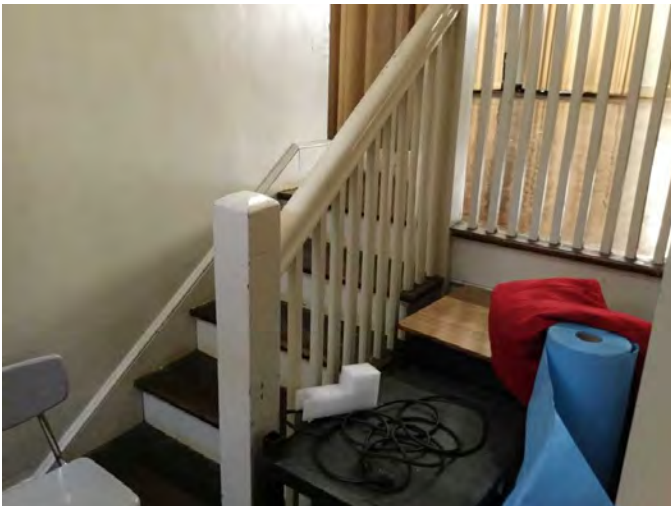
System: C1030 - Fittings

Location: Throughout
Distress: Beyond Service Life
Category: Deferred Maintenance / Accessibility Code Compliance
Priority: 3 - Necessary/Not Yet Critical (Years 2-5)
Correction: Renew System
Qty: 24,319.00
Unit of Measure: S.F.
Estimate: \$265,904.00
Assessor Name: Terence Davis
Date Created: 12/07/2016

Notes: The fittings throughout the building are aged, in marginal condition, handrails and room signage are ADA non-compliance and system should be replaced.

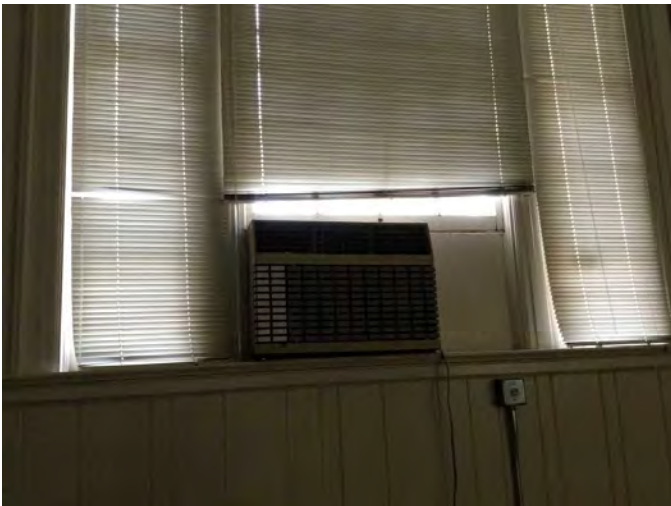
System: D3050 - Terminal & Package Units

Location: Throughout
Distress: Beyond Service Life
Category: Deferred Maintenance / Energy
Priority: 3 - Necessary/Not Yet Critical (Years 2-5)
Correction: Renew System
Qty: 24,319.00
Unit of Measure: S.F.
Estimate: \$226,313.00
Assessor Name: Terence Davis
Date Created: 12/07/2016

Notes: The window mounted DX condensers are aged, rusted, not energy efficient, and should be replaced.

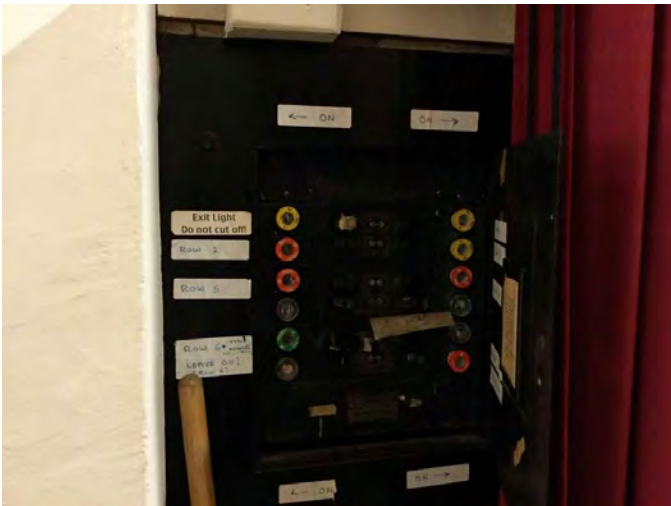
System: D5010 - Electrical Service/Distribution

Location: Throughout
Distress: Beyond Service Life
Category: Deferred Maintenance
Priority: 3 - Necessary/Not Yet Critical (Years 2-5)
Correction: Renew System
Qty: 24,319.00
Unit of Measure: S.F.
Estimate: \$46,279.00
Assessor Name: Terence Davis
Date Created: 12/07/2016

Notes: The original electrical distribution system is operating properly due to an aggressive maintenance program but is aged, in marginal condition, and should be replaced.

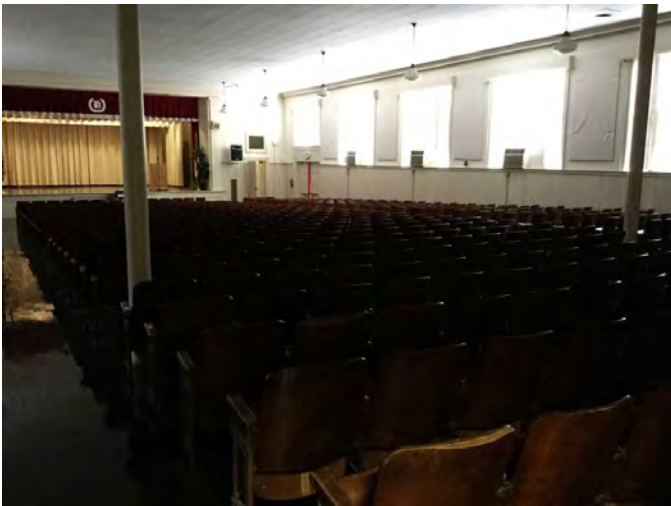
System: E2010 - Fixed Furnishings

Location: Throughout
Distress: Beyond Service Life
Category: Deferred Maintenance
Priority: 3 - Necessary/Not Yet Critical (Years 2-5)
Correction: Renew System
Qty: 24,319.00
Unit of Measure: S.F.
Estimate: \$159,168.00
Assessor Name: Terence Davis
Date Created: 12/07/2016

Notes: The system is beyond its expected service life and should be scheduled for replacement.

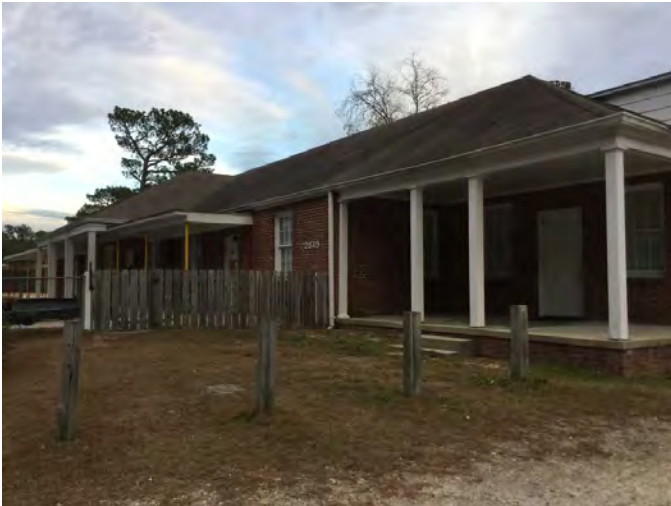
System: B3010140 - Asphalt Shingles

Location: Roof
Distress: Beyond Service Life
Category: Deferred Maintenance
Priority: 3 - Necessary/Not Yet Critical (Years 2-5)
Correction: Renew System
Qty: 4,725.00
Unit of Measure: S.F.
Estimate: \$29,802.00
Assessor Name: Terence Davis
Date Created: 12/09/2016

Notes: The asphalt shingle roofing is aged, damaged and should be replaced.

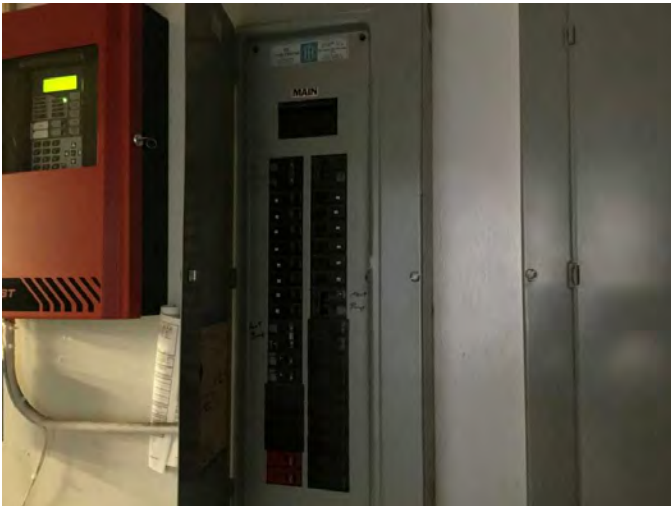
System: D5020 - Branch Wiring

Location: Throughout
Distress: Beyond Service Life
Category: Deferred Maintenance
Priority: 3 - Necessary/Not Yet Critical (Years 2-5)
Correction: Renew System
Qty: 4,725.00
Unit of Measure: S.F.
Estimate: \$27,027.00
Assessor Name: Terence Davis
Date Created: 12/07/2016

Notes: The original branch wiring system is operating, but is aged, in poor condition, and should be replaced.

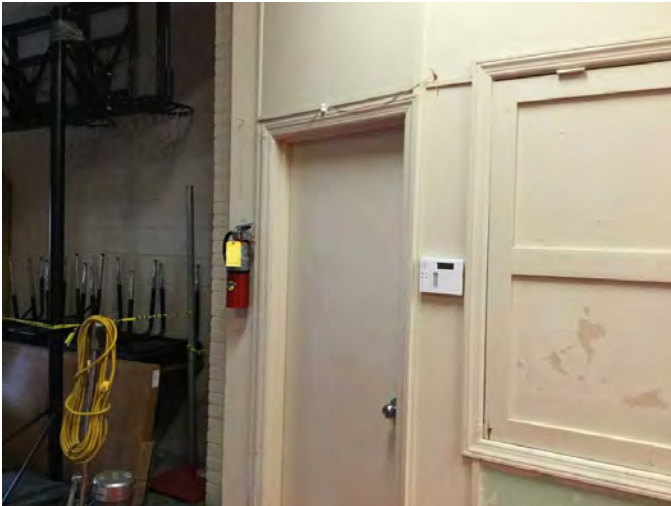
System: C1020 - Interior Doors

Location: Throughout
Distress: Beyond Service Life
Category: Deferred Maintenance / Accessibility Code Compliance
Priority: 3 - Necessary/Not Yet Critical (Years 2-5)
Correction: Renew System
Qty: 20,200.00
Unit of Measure: S.F.
Estimate: \$57,550.00
Assessor Name: Terence Davis
Date Created: 12/07/2016

Notes: The interior doors are aged, failing, hardware is not ADA compliant and should be replaced.

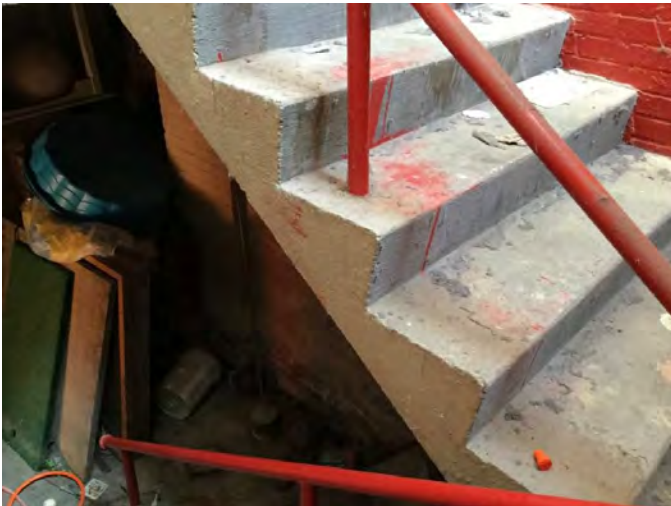
System: C1030 - Fittings

Location: Throughout
Distress: Beyond Service Life
Category: Deferred Maintenance / Accessibility Code Compliance
Priority: 3 - Necessary/Not Yet Critical (Years 2-5)
Correction: Renew System
Qty: 20,200.00
Unit of Measure: S.F.
Estimate: \$220,867.00
Assessor Name: Terence Davis
Date Created: 12/07/2016

Notes: The fittings throughout the building are aged, in marginal condition, not ADA compliant and should be replaced.

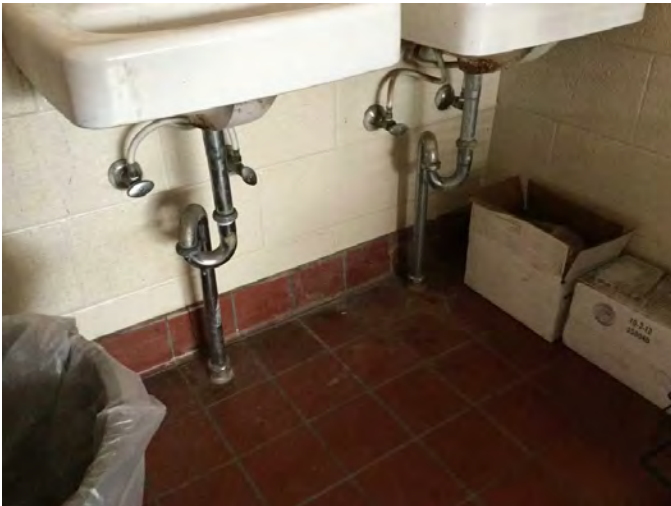
System: D2030 - Sanitary Waste

Location: Throughout
Distress: Beyond Service Life
Category: Deferred Maintenance
Priority: 3 - Necessary/Not Yet Critical (Years 2-5)
Correction: Renew System
Qty: 20,200.00
Unit of Measure: S.F.
Estimate: \$34,885.00
Assessor Name: Terence Davis
Date Created: 12/07/2016

Notes: The sanitary waste system is aged, has reported periodic failures, and should be replaced.

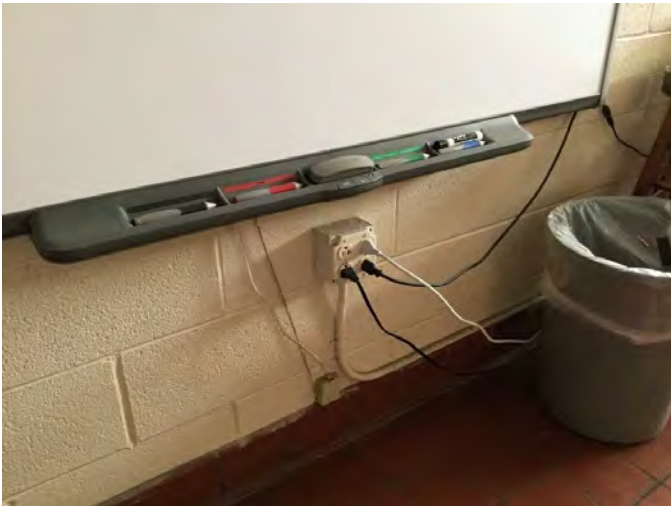
System: D5020 - Branch Wiring

Location: Throughout
Distress: Beyond Service Life
Category: Deferred Maintenance
Priority: 3 - Necessary/Not Yet Critical (Years 2-5)
Correction: Renew System
Qty: 20,200.00
Unit of Measure: S.F.
Estimate: \$115,544.00
Assessor Name: Terence Davis
Date Created: 12/07/2016

Notes: The original branch wiring system is operating, but is aged, in poor condition, and should be replaced.

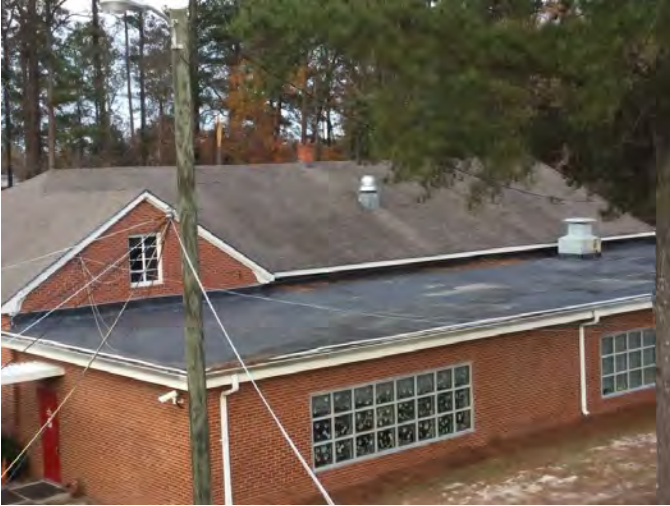
System: B3010120 - Single Ply Membrane

Location: Media roof
Distress: Beyond Service Life
Category: Deferred Maintenance
Priority: 3 - Necessary/Not Yet Critical (Years 2-5)
Correction: Renew System
Qty: 2,000.00
Unit of Measure: S.F.
Estimate: \$20,940.00
Assessor Name: Terence Davis
Date Created: 12/07/2016

Notes: The EPDM adhered and ballasted roof coverings are aging, showing signs of failure and should be replaced.

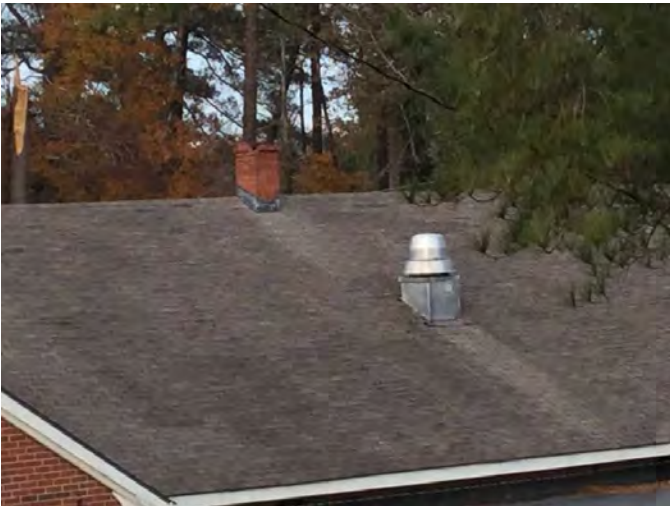
System: B3010140 - Asphalt Shingles

Location: Roof
Distress: Beyond Service Life
Category: Deferred Maintenance
Priority: 3 - Necessary/Not Yet Critical (Years 2-5)
Correction: Renew System
Qty: 4,775.00
Unit of Measure: S.F.
Estimate: \$30,117.00
Assessor Name: Terence Davis
Date Created: 12/07/2016

Notes: The asphalt shingle roofing is aged, damaged and should be replaced.

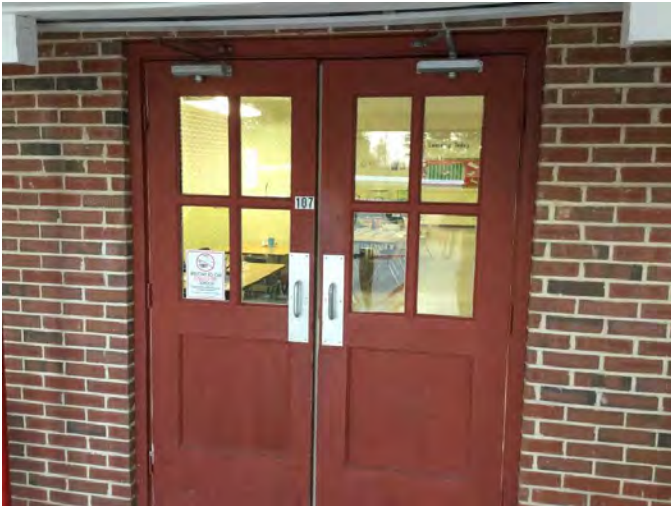
System: B2030 - Exterior Doors

Location: Throughout
Distress: Beyond Service Life
Category: Deferred Maintenance
Priority: 3 - Necessary/Not Yet Critical (Years 2-5)
Correction: Renew System
Qty: 12,688.00
Unit of Measure: S.F.
Estimate: \$14,934.00
Assessor Name: Terence Davis
Date Created: 12/07/2016

Notes: The original exterior doors are aged, rusted, and should be replaced.

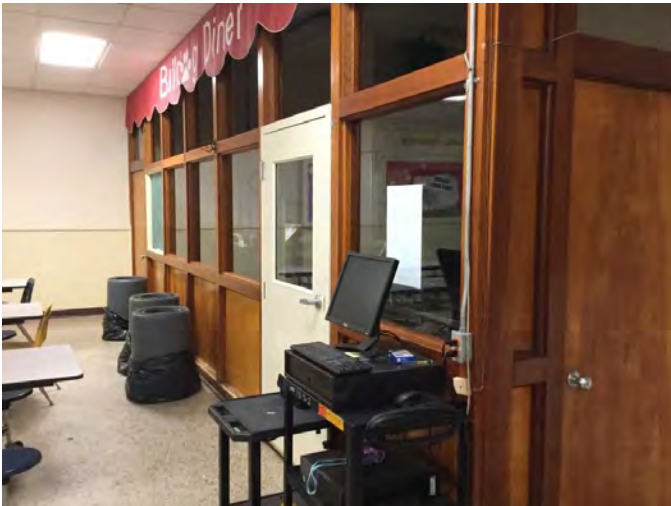
System: C1020 - Interior Doors

Location: Throughout
Distress: Beyond Service Life
Category: Deferred Maintenance
Priority: 3 - Necessary/Not Yet Critical (Years 2-5)
Correction: Renew System
Qty: 12,688.00
Unit of Measure: S.F.
Estimate: \$36,148.00
Assessor Name: Terence Davis
Date Created: 12/07/2016

Notes: The interior doors are aged, failing, hardware is not ADA compliant and should be replaced.

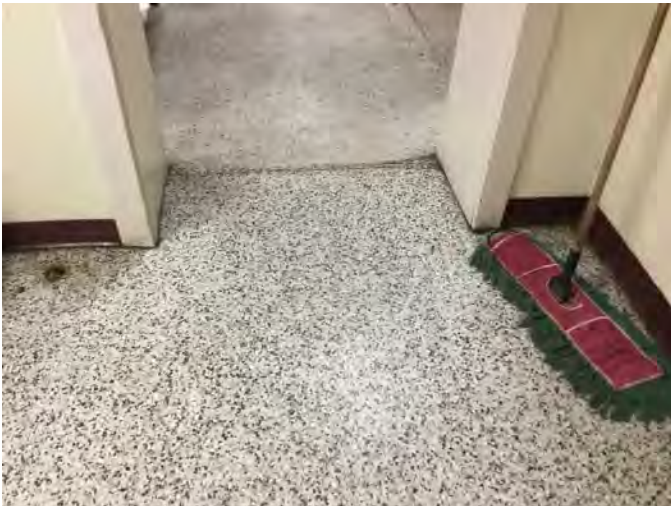
System: C3020 - Floor Finishes

Location: Throughout
Distress: Beyond Service Life
Category: Deferred Maintenance
Priority: 3 - Necessary/Not Yet Critical (Years 2-5)
Correction: Renew System
Qty: 12,688.00
Unit of Measure: S.F.
Estimate: \$161,899.00
Assessor Name: Terence Davis
Date Created: 12/07/2016

Notes: The VCT flooring is aged, cracked, worn, and should be replaced.

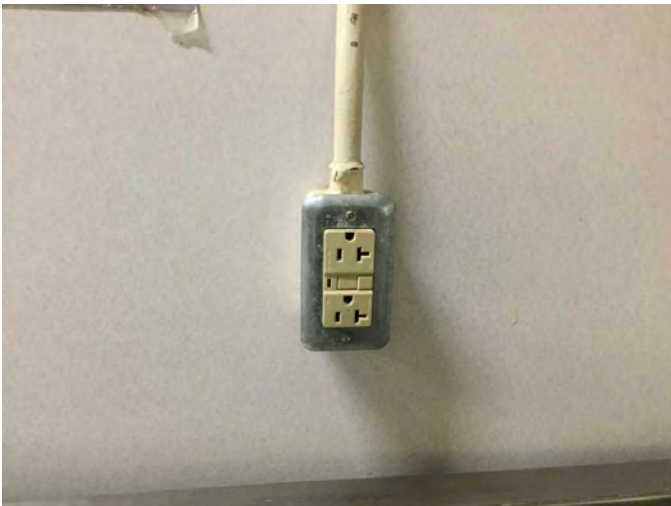
System: D5020 - Branch Wiring

Location: Throughout
Distress: Beyond Service Life
Category: Deferred Maintenance
Priority: 3 - Necessary/Not Yet Critical (Years 2-5)
Correction: Renew System
Qty: 12,688.00
Unit of Measure: S.F.
Estimate: \$72,575.00
Assessor Name: Terence Davis
Date Created: 12/07/2016

Notes: The branch wiring system is operating, but is aged, in poor condition, and should be replaced.

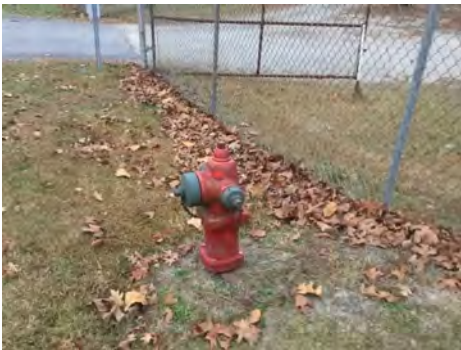
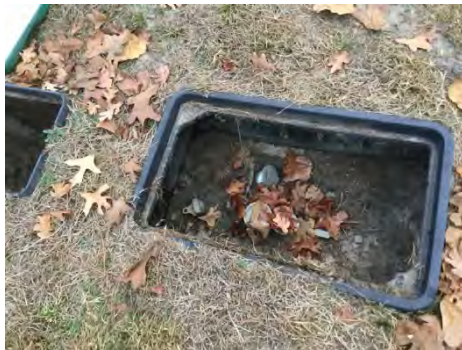
System: G3010 - Water Supply

Notes: The campus is currently unable to use the domestic water system due to health concerns of contaminants. An entire new service should be installed.

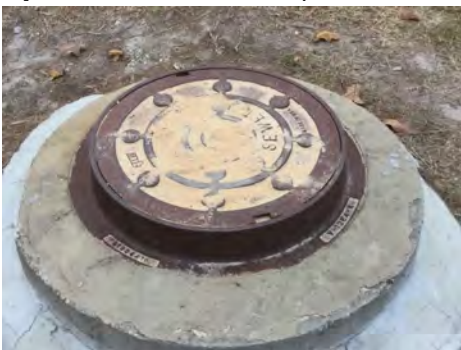
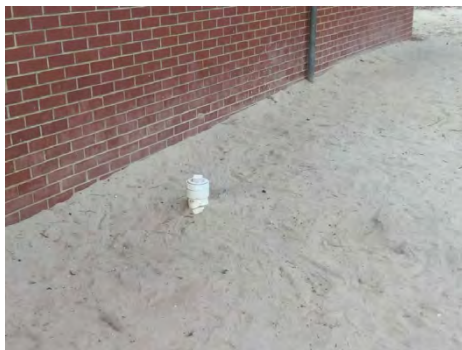
System: G3020 - Sanitary Sewer

Notes: Sanitary sewer system has multiple building feeding into one system and is inadequate for the site.

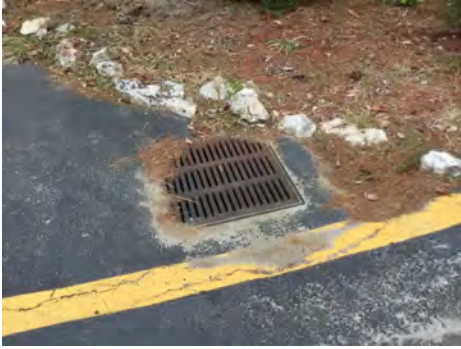
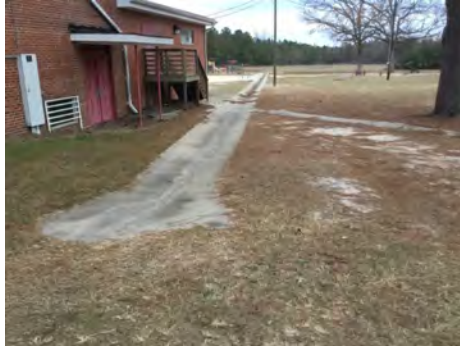
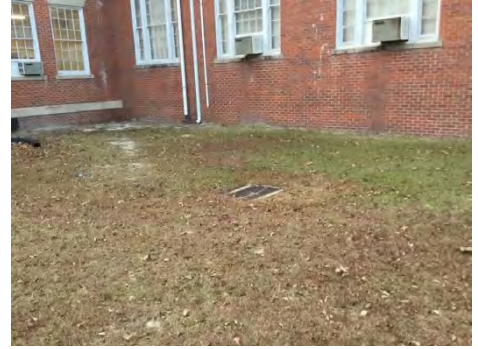
System: G3030 - Storm Sewer

Notes: Storm sewer system is aged, has reported failures and should be replaced.

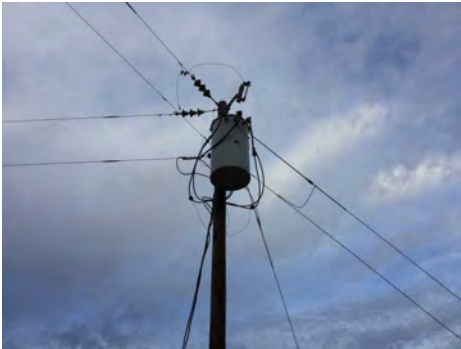
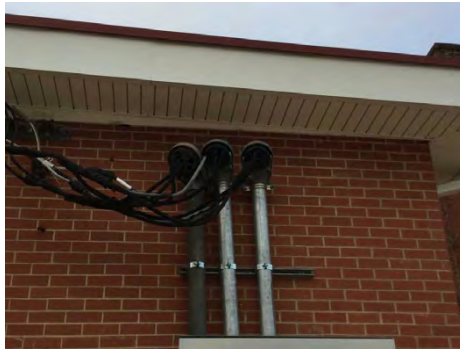
System: G4010 - Electrical Distribution

Notes: Site electrical service is a multitude of ages and operating status and should be replaced as a whole.

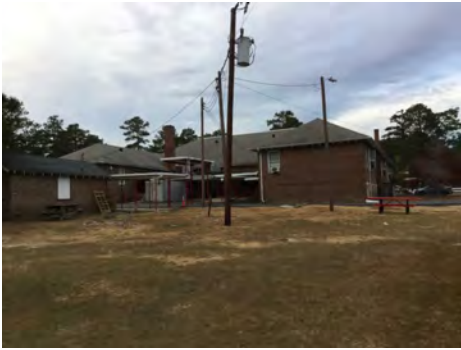
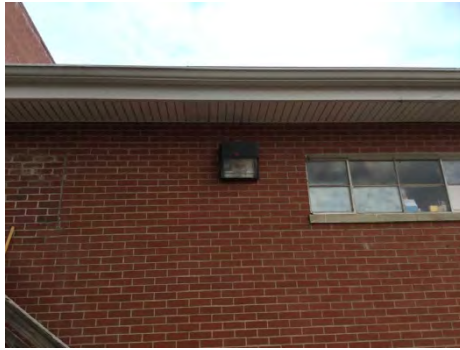
System: G4020 - Site Lighting

Notes: Site lighting is not adequate with reported failures and should be replaced.

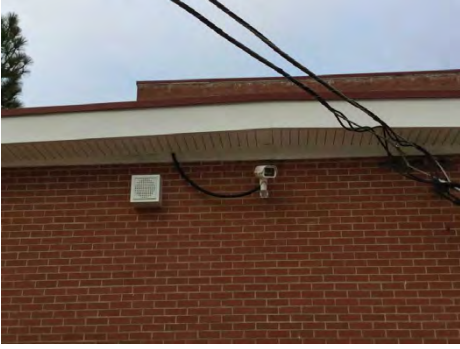
System: G4030 - Site Communications & Security

Notes: Site security system is aged should be replaced with digital system.

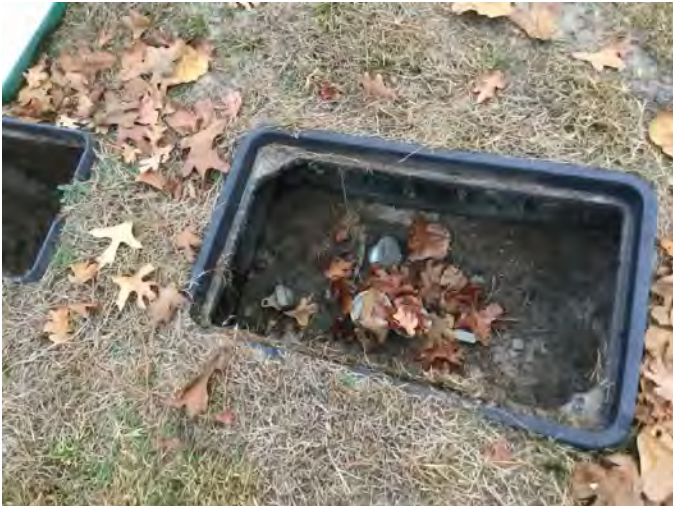
System: G3010 - Water Supply

Location: Campus
Distress: Beyond Service Life
Category: Deferred Maintenance
Priority: 3 - Necessary/Not Yet Critical (Years 2-5)
Correction: Renew System
Qty: 81,395.00
Unit of Measure: S.F.
Estimate: \$209,511.00
Assessor Name: Eduardo Lopez
Date Created: 12/07/2016

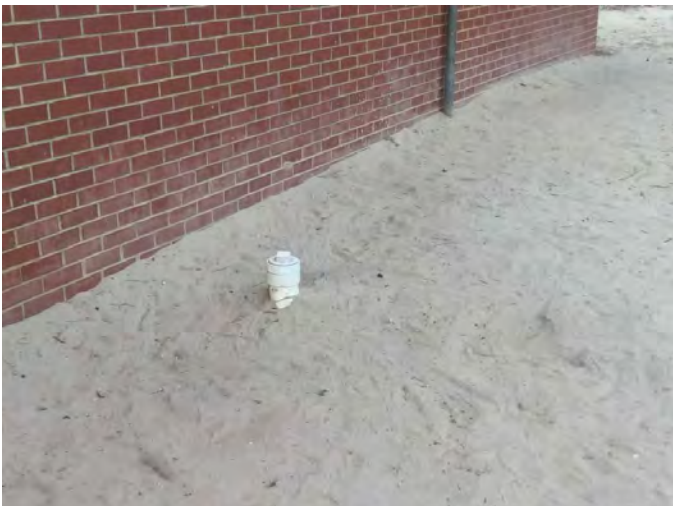
System: G3020 - Sanitary Sewer

Location: Site
Distress: Inadequate
Category: Deferred Maintenance
Priority: 3 - Necessary/Not Yet Critical (Years 2-5)
Correction: Renew System
Qty: 81,395.00
Unit of Measure: S.F.
Estimate: \$129,825.00
Assessor Name: Eduardo Lopez
Date Created: 12/07/2016

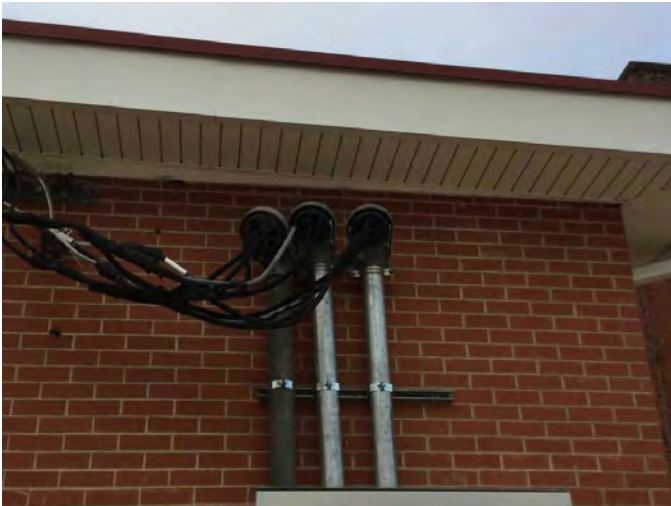
System: G4010 - Electrical Distribution

Location: Site
Distress: Beyond Service Life
Category: Deferred Maintenance
Priority: 3 - Necessary/Not Yet Critical (Years 2-5)
Correction: Renew System
Qty: 81,395.00
Unit of Measure: S.F.
Estimate: \$210,406.00
Assessor Name: Eduardo Lopez
Date Created: 12/07/2016

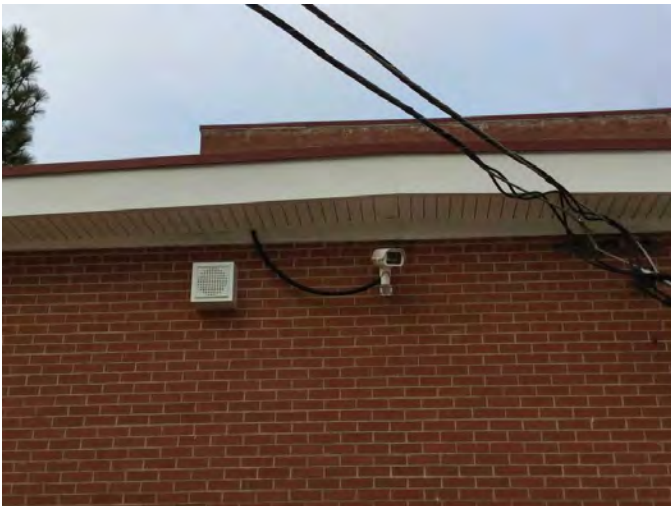
System: G4030 - Site Communications & Security

Location: Site
Distress: Inadequate
Category: Deferred Maintenance / Appearance
Priority: 3 - Necessary/Not Yet Critical (Years 2-5)
Correction: Renew System
Qty: 81,395.00
Unit of Measure: S.F.
Estimate: \$75,209.00
Assessor Name: Eduardo Lopez
Date Created: 12/07/2016
