NC School District/430 Harnett County/Elementary School

Buies Creek Elementary

Campus Assessment Report

March 11, 2017

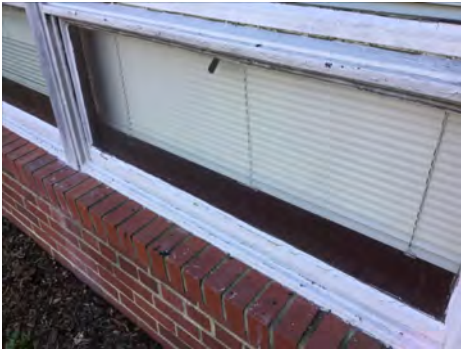
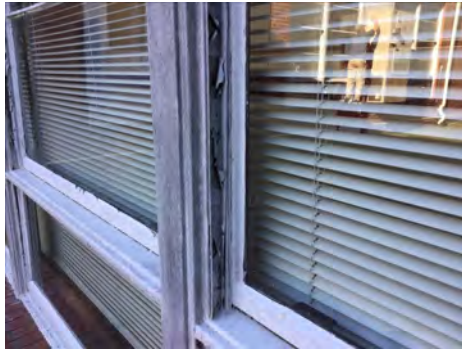
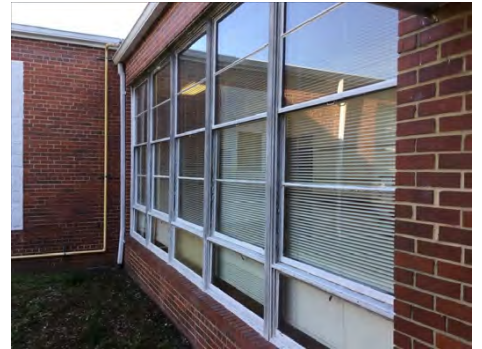
System: B2020 - Exterior Windows

Notes: The aluminum frame, operable, single pane windows are aged, rusted, not energy efficient, and should be replaced.

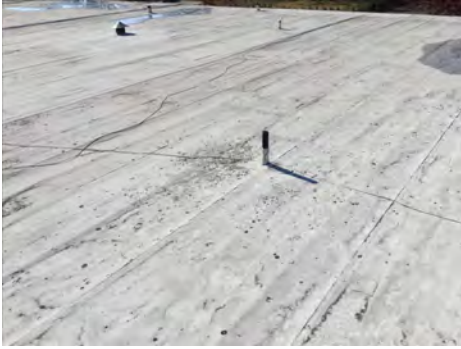
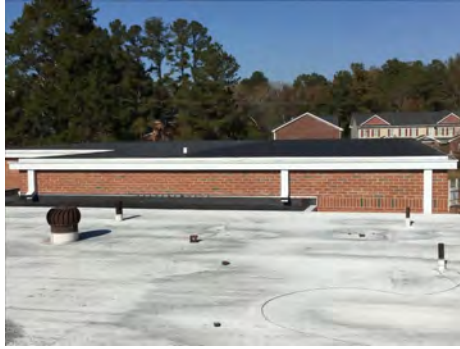
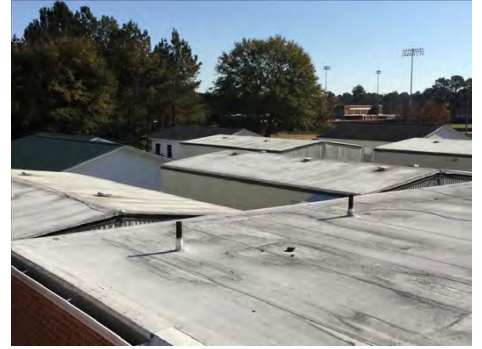
System: B3010120 - Single Ply Membrane

Notes: The EPDM adhered roof coverings are aging, showing signs of failure and should be replaced.

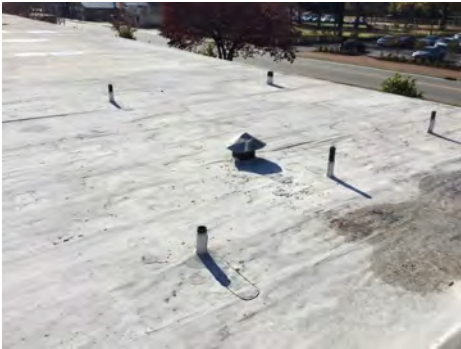
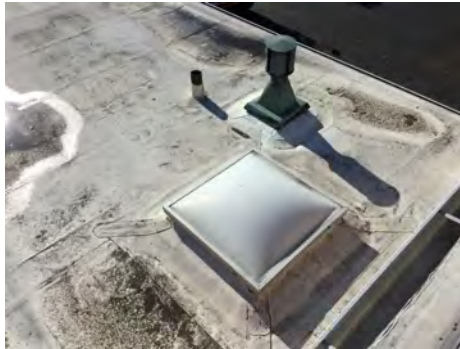
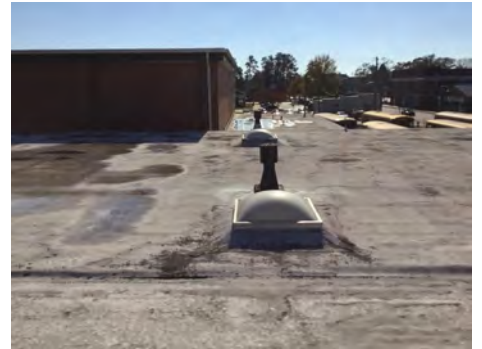
System: B3020 - Roof Openings

Notes: Roof penetrations should be inspected and repaired when the roof is replaced.

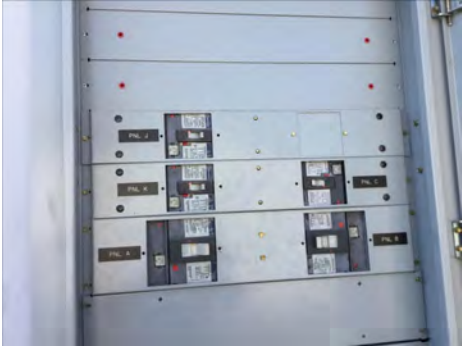
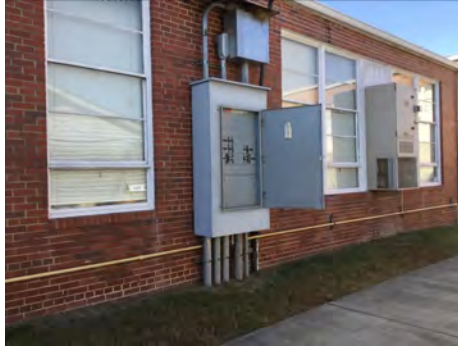
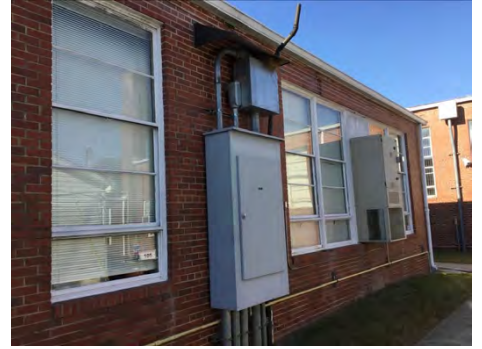
System: D5010 - Electrical Service/Distribution

Notes: The original electrical distribution system is operating properly due to an aggressive maintenance program but is aged, in marginal condition, and should be replaced.

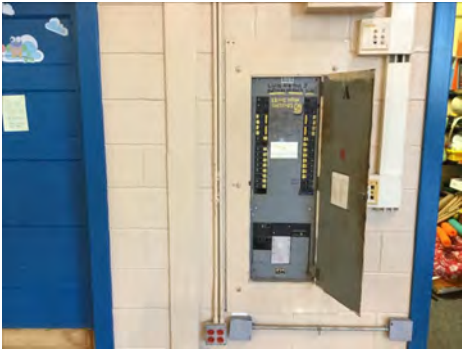
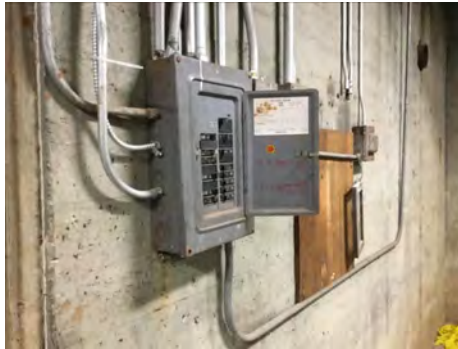
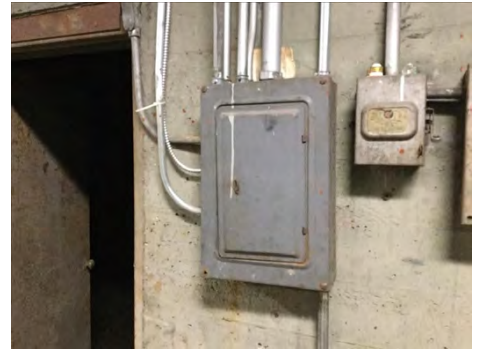
System: D5020 - Branch Wiring

Notes: The original branch wiring system is operating properly due to an aggressive maintenance program but is aged, in marginal condition, and should be replaced.

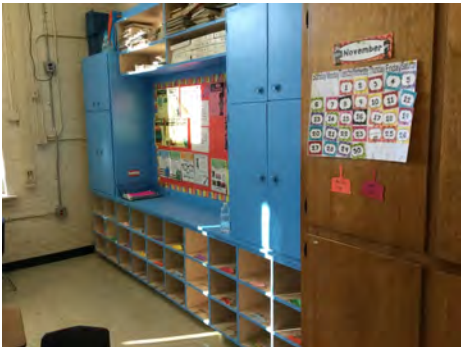
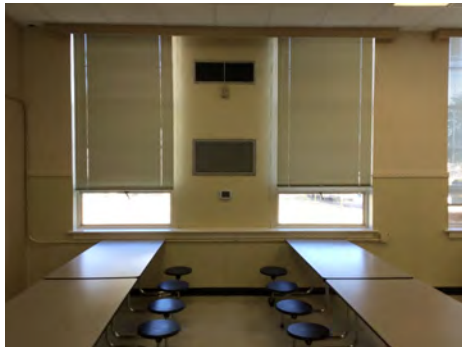
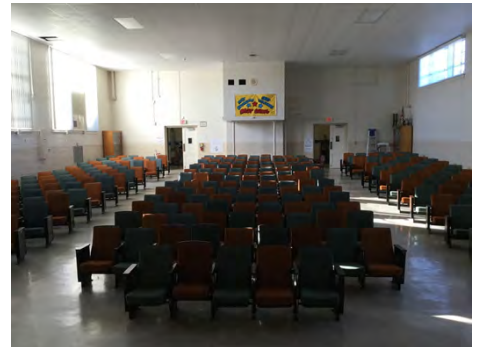
System: E2010 - Fixed Furnishings

Notes: The fixed furnishings are aged, in marginal condition, and should be replaced. The auditorium seating upholstery is stained, wood components are discolored. The wood components require sanding, stain and seal. The upholstery need to be stripped down and re-applied. All new hardware need to be installed. The blinds are damaged and need to be replaced.

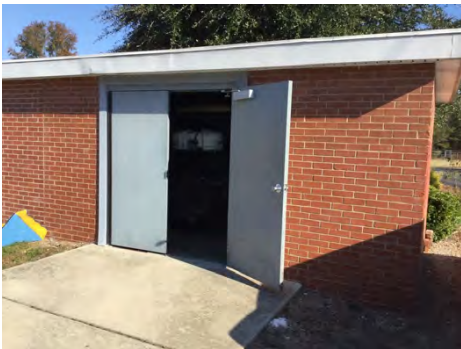
System: B2030 - Exterior Doors

Notes: The original exterior doors are aged, rusted, and should be replaced.

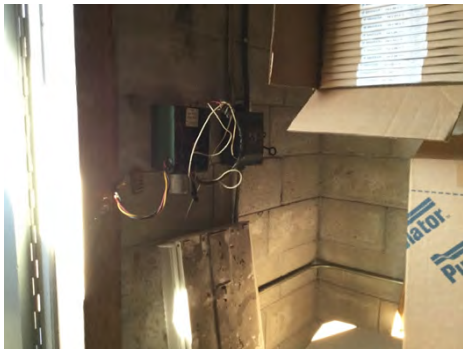
System: D5020 - Branch Wiring

Notes: The electrical wiring is damaged and should be replaced.
