NC School District/430 Harnett County/Elementary School

Coats Elementary

Campus Assessment Report

March 11, 2017

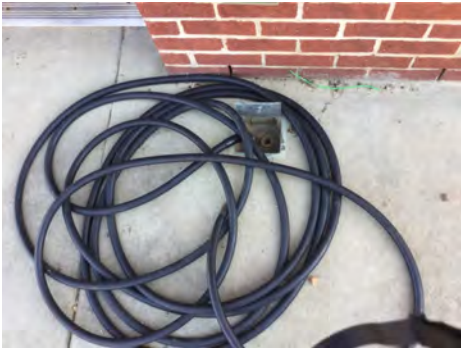
System: D2020 - Domestic Water Distribution

Note: Plumbing consists of one hose connection cast into the slab at the entrance. There is no sewer. Rain drainage is via gutter and downspouts to discharge at grade.
