NC School District/430 Harnett County/Elementary School

Erwin Elementary

Final
Campus Assessment Report

March 11, 2017

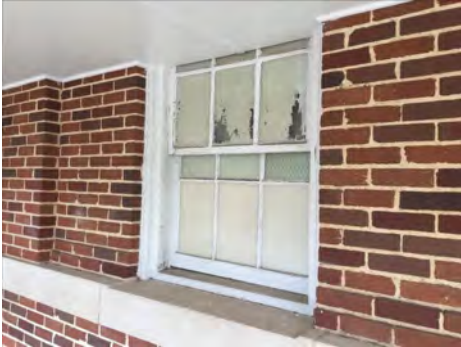
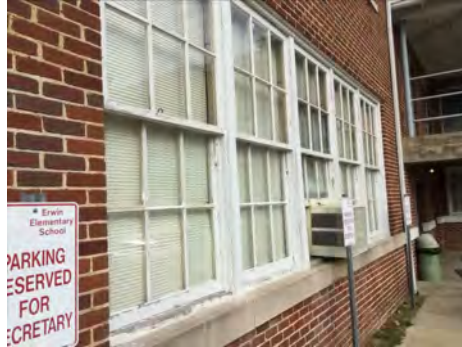
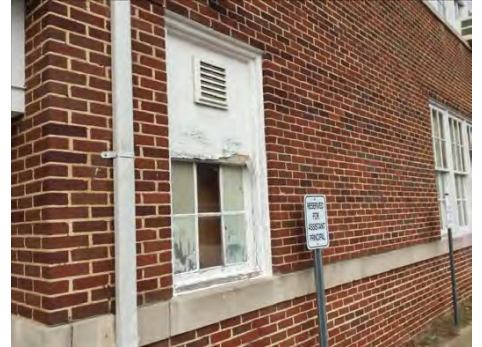
System: B2020 - Exterior Windows

Notes: The aluminum frame, operable, single pane windows are aged, rusted, not energy efficient, and should be replaced.

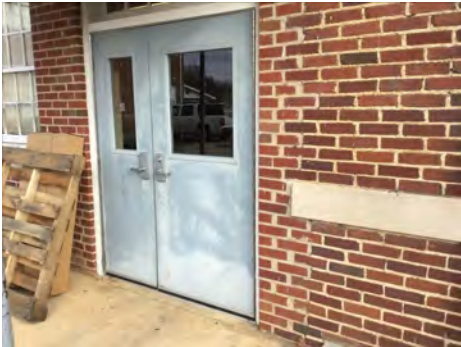
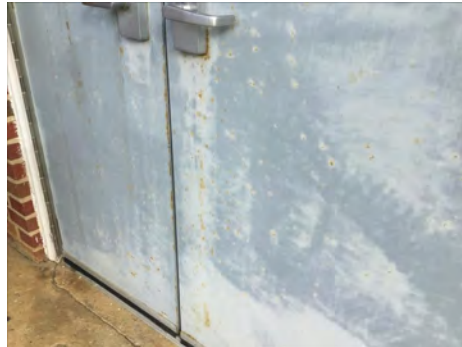
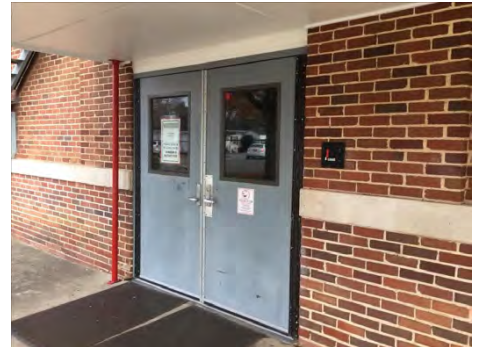
System: B2030 - Exterior Doors

Note: Doors are rusting.

Notes: The original exterior doors are aged, rusted, and should be replaced with new doors that meet all ADA requirements.

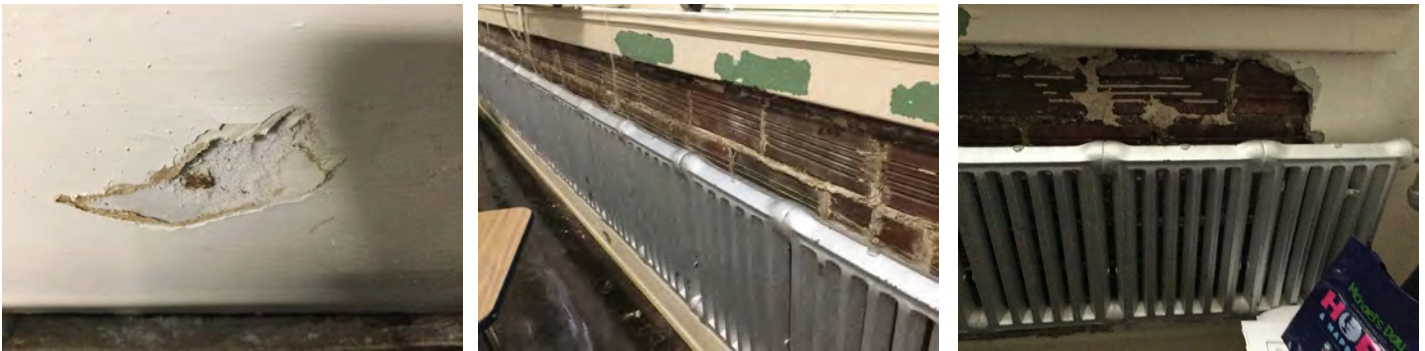
System: C3010 - Wall Finishes

Notes: The paint and plaster is damaged.

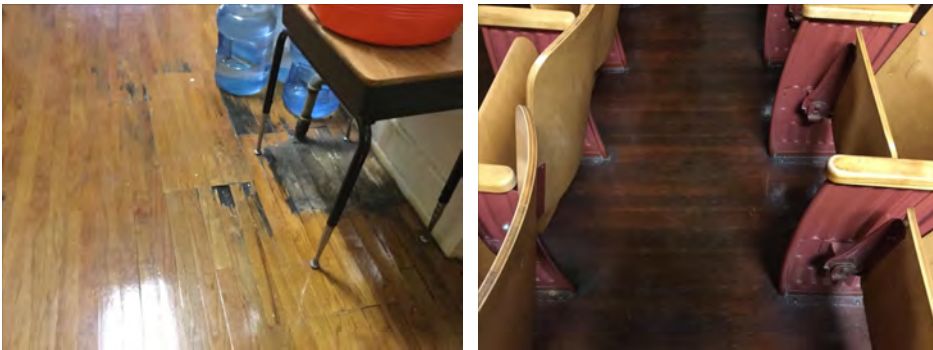
System: C3020 - Floor Finishes

Note: 80% of wood flooring is original. Damage in some areas.

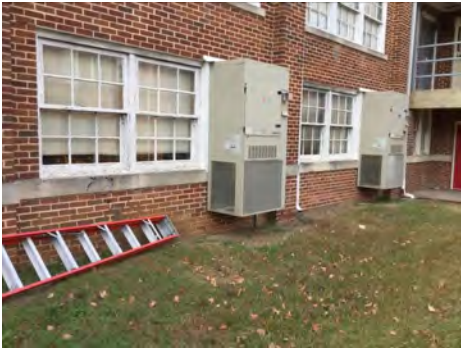
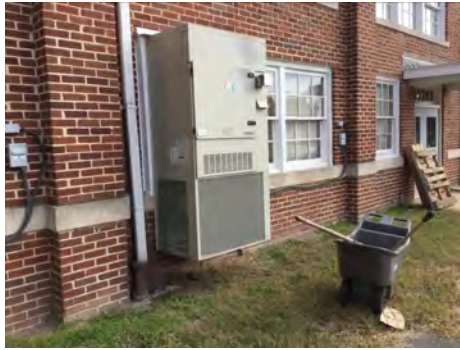
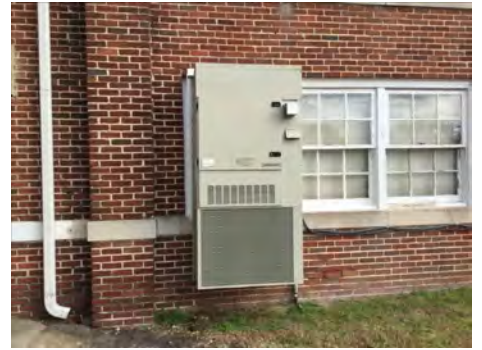
System: D3050 - Terminal & Package Units

Note: There are several window units.

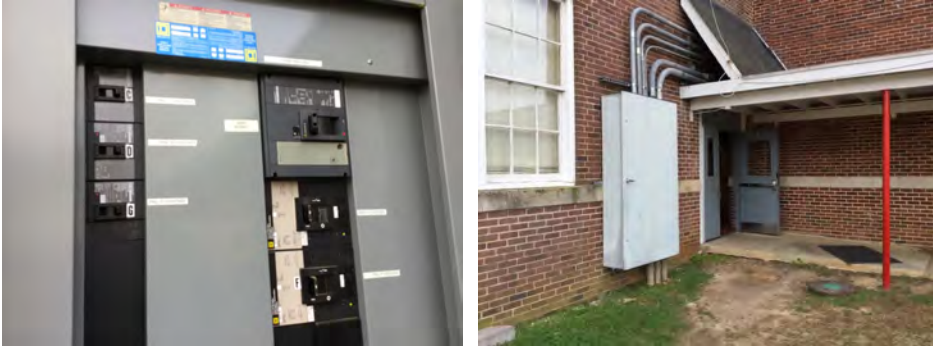
System: D5010 - Electrical Service/Distribution

Note: 40 percent has updated distribution.

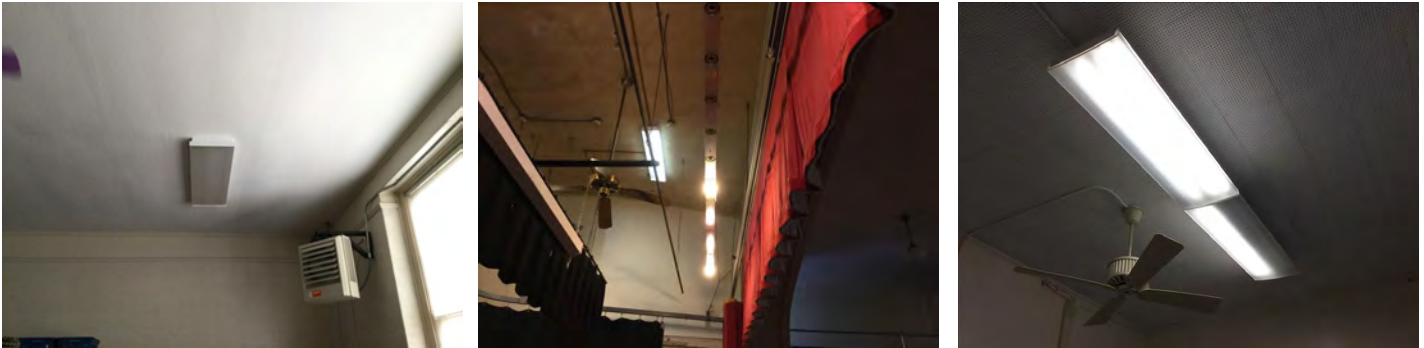
System: D5020 - Lighting

Note: T-8 light fixtures

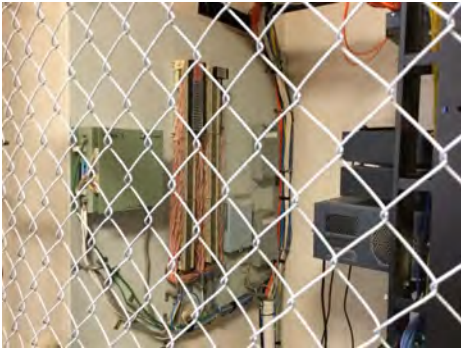
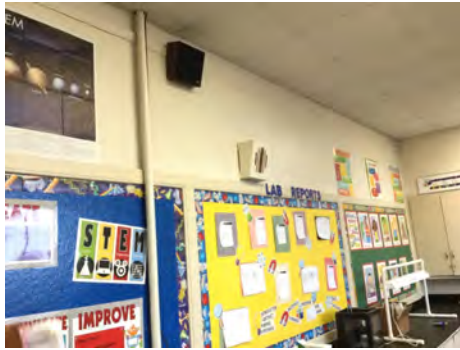
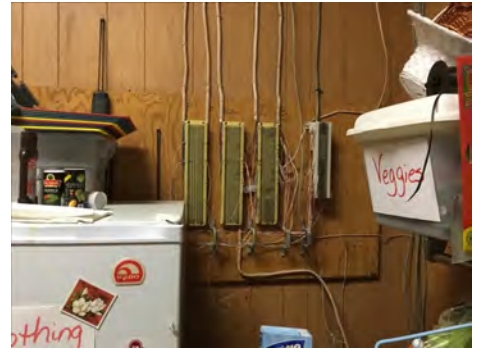
System: D5030920 - Data Communication

Note: Data 2014, phone system aged, pa functions properly, parts are hard to get.

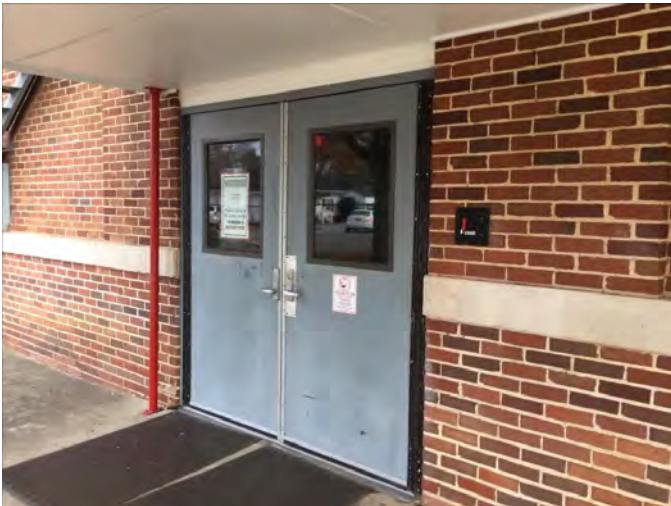
System: B2030 - Exterior Doors

Location: Exterior
Distress: Failing
Category: Deferred Maintenance
Priority: 3 - Necessary/Not Yet Critical (Years 2-5)
Correction: Renew System
Qty: 39,563.00
Unit of Measure: S.F.
Estimate: \$55,705.00
Assessor Name: Eduardo Lopez
Date Created: 12/01/2016

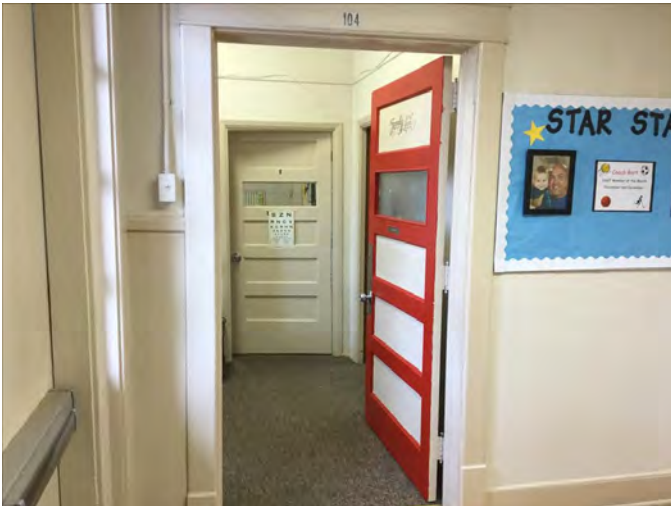
System: C1020 - Interior Doors

Location: Throughout the building
Distress: Inadequate
Category: Deferred Maintenance
Priority: 3 - Necessary/Not Yet Critical (Years 2-5)
Correction: Renew System
Qty: 39,563.00
Unit of Measure: S.F.
Estimate: \$110,104.00
Assessor Name: Eduardo Lopez
Date Created: 12/05/2016

Notes: The interior doors are aged and hardware is not ADA compliant and the doors should be replaced.

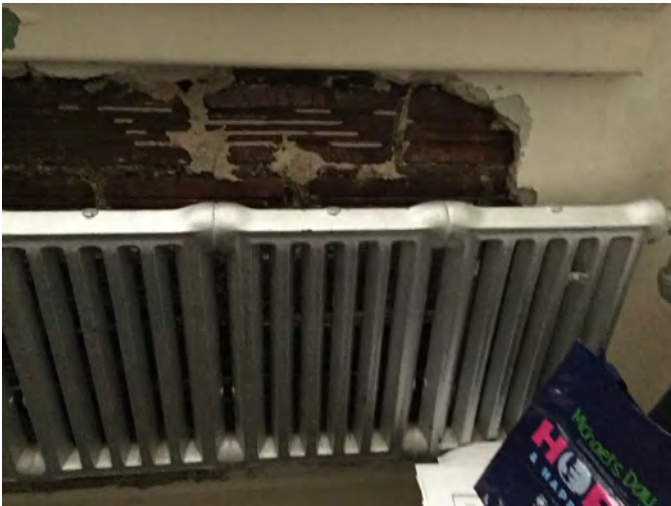
System: C3010 - Wall Finishes

Location: Throughout the building
Distress: Beyond Service Life
Category: Deferred Maintenance
Priority: 3 - Necessary/Not Yet Critical (Years 2-5)
Correction: Renew System
Qty: 39,563.00
Unit of Measure: S.F.
Estimate: \$242,838.00
Assessor Name: Eduardo Lopez
Date Created: 12/09/2016

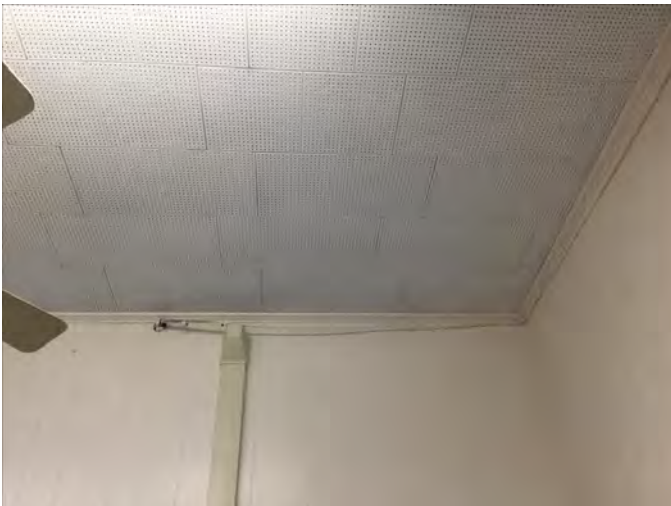
System: C3030 - Ceiling Finishes

Location: Throughout the building
Distress: Damaged
Category: Deferred Maintenance
Priority: 3 - Necessary/Not Yet Critical (Years 2-5)
Correction: Renew System
Qty: 39,563.00
Unit of Measure: S.F.
Estimate: \$477,407.00
Assessor Name: Eduardo Lopez
Date Created: 12/06/2016

Notes: The acoustical ceiling tiles and grid system is aged, tiles stained, grid rusted, and plaster cracking. The ceiling should be replaced.

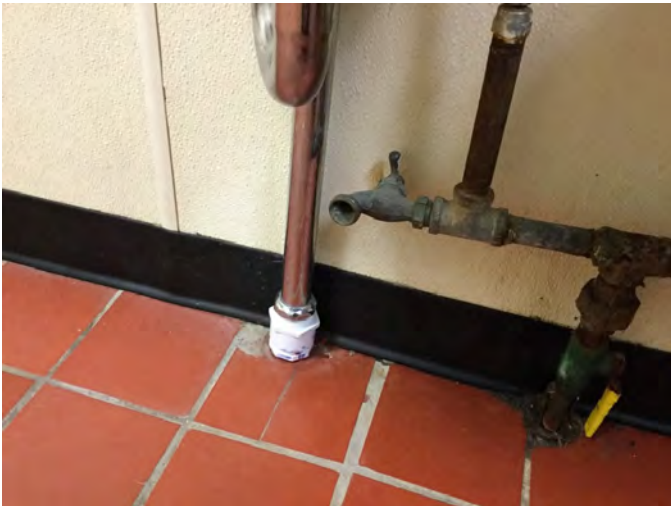
System: D2020 - Domestic Water Distribution

Location: Throughout the building
Distress: Beyond Service Life
Category: Deferred Maintenance
Priority: 3 - Necessary/Not Yet Critical (Years 2-5)
Correction: Renew System
Qty: 39,563.00
Unit of Measure: S.F.
Estimate: \$42,649.00
Assessor Name: Eduardo Lopez
Date Created: 12/06/2016

Notes: There are no reported issues or observed deficiencies with the domestic water piping. Due to the age of the pipe there can be internal pitting corrosion that may be a costly problem that leads to the formation of pinhole leaks and possible water contamination.

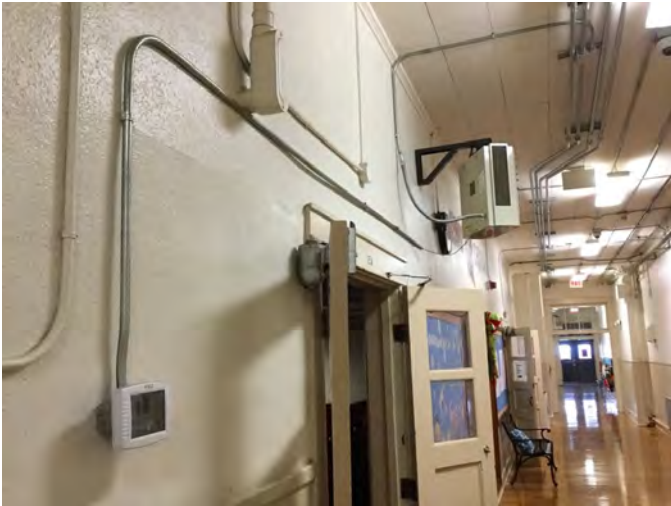
System: D3040 - Distribution Systems

Location: Corridor-Restrooms
Distress: Beyond Service Life
Category: Deferred Maintenance
Priority: 3 - Necessary/Not Yet Critical (Years 2-5)
Correction: Renew System
Qty: 39,563.00
Unit of Measure: S.F.
Estimate: \$267,209.00
Assessor Name: Eduardo Lopez
Date Created: 12/06/2016

Notes: The heaters, exhaust fans at the end of their life cycle and becoming logistically unsupportable and should be replaced with an energy efficient model.

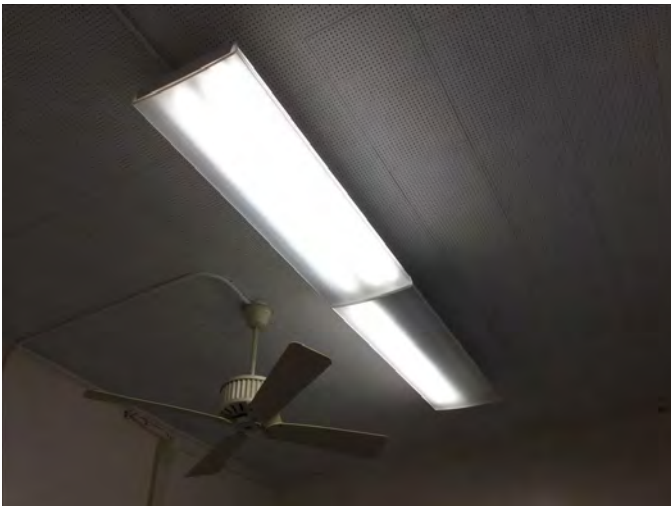
System: D5020 - Lighting

Location: Throughout the building
Distress: Beyond Service Life
Category: Deferred Maintenance
Priority: 3 - Necessary/Not Yet Critical (Years 2-5)
Correction: Renew System
Qty: 39,563.00
Unit of Measure: S.F.
Estimate: \$518,750.00
Assessor Name: Eduardo Lopez
Date Created: 12/06/2016

Notes: The original branch wiring system is operating properly due to an aggressive maintenance program but is aged, in marginal condition, and should be replaced with energy efficient fixtures.

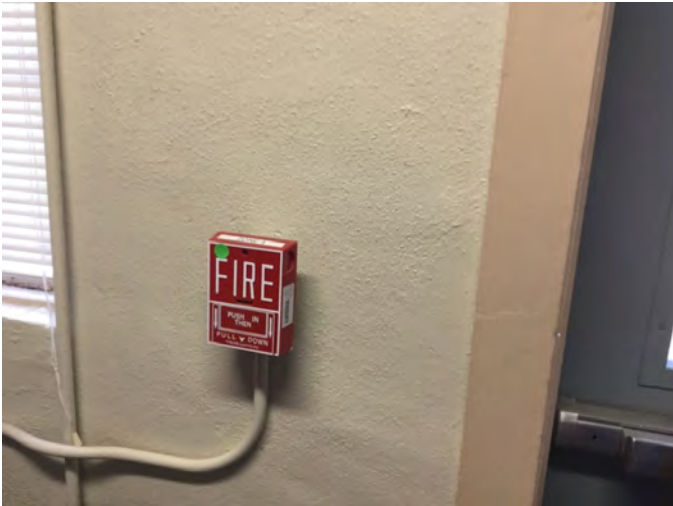
System: D5030910 - Fire Alarm Systems

Location: Throughout the building
Distress: Beyond Service Life
Category: Deferred Maintenance
Priority: 3 - Necessary/Not Yet Critical (Years 2-5)
Correction: Renew System
Qty: 39,563.00
Unit of Measure: S.F.
Estimate: \$147,530.00
Assessor Name: Eduardo Lopez
Date Created: 12/06/2016

Notes: The original fire alarm system operating as designed, but is beyond its service life and should be replaced.

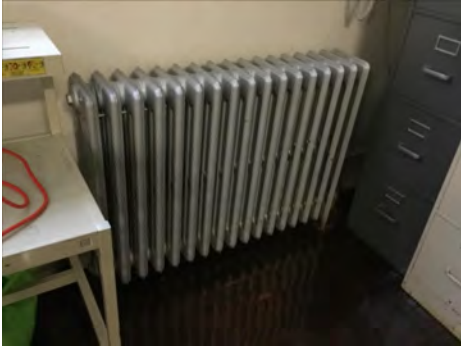
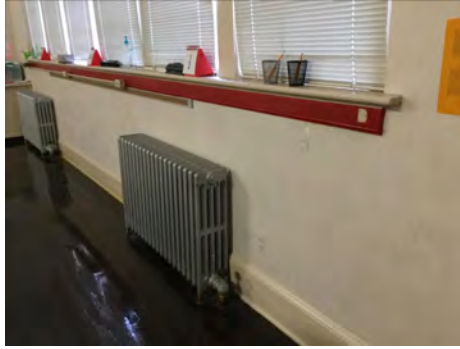
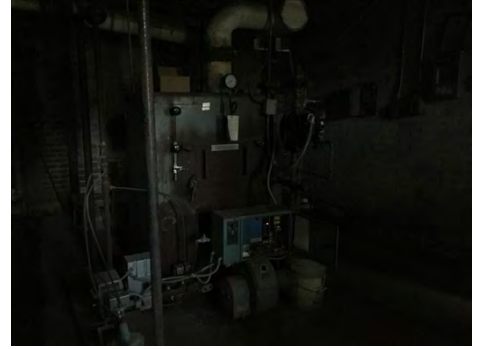
System: D3020 - Heat Generating Systems

Note: Boiler and radiators function.

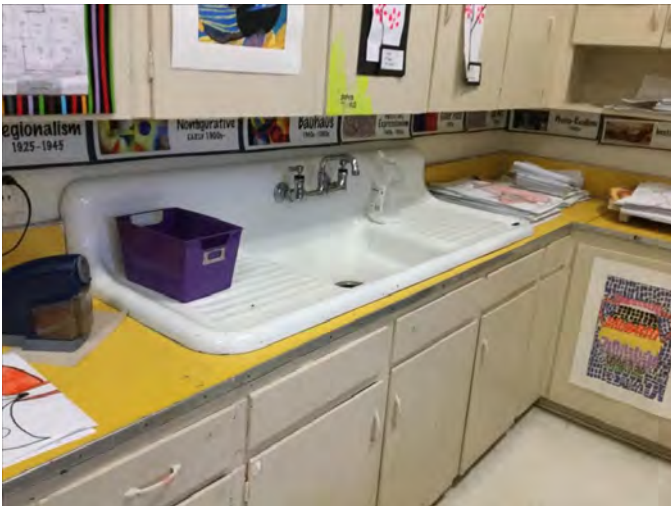
System: D2010 - Plumbing Fixtures

Location: Throughout the building
Distress: Beyond Service Life
Category: Deferred Maintenance
Priority: 3 - Necessary/Not Yet Critical (Years 2-5)
Correction: Renew System
Qty: 9,379.00
Unit of Measure: S.F.
Estimate: \$118,438.00
Assessor Name: Eduardo Lopez
Date Created: 12/06/2016

Notes: Plumbing fixtures are in operational conditions. However, they are aged, not ADA compliant and should be replaced with a low-flow water fixtures.

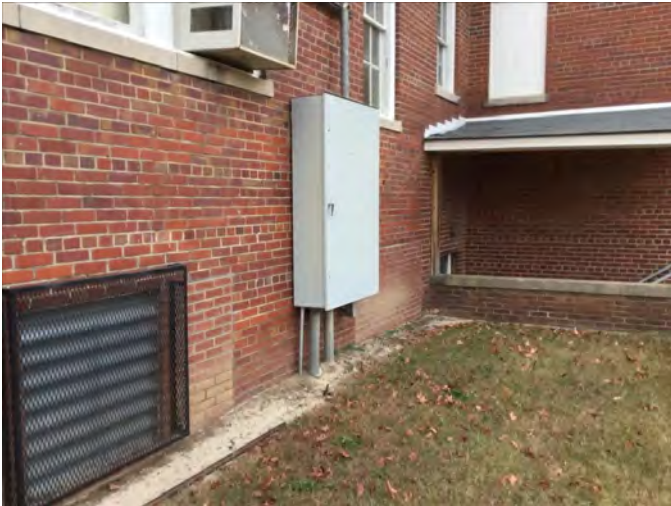
System: D5010 - Electrical Service/Distribution

Location: Exterior
Distress: Beyond Service Life
Category: Deferred Maintenance
Priority: 3 - Necessary/Not Yet Critical (Years 2-5)
Correction: Renew System
Qty: 9,379.00
Unit of Measure: S.F.
Estimate: \$17,436.00
Assessor Name: Eduardo Lopez
Date Created: 12/07/2016

Notes: The electrical distribution system is aged and should be replaced.

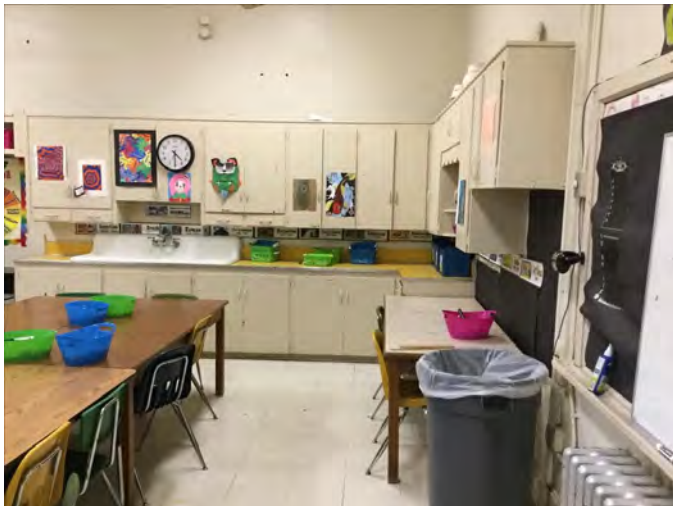
System: E2010 - Fixed Furnishings

Location: Classroom
Distress: Beyond Service Life
Category: Deferred Maintenance
Priority: 3 - Necessary/Not Yet Critical (Years 2-5)
Correction: Renew System
Qty: 9,379.00
Unit of Measure: S.F.
Estimate: \$60,148.00
Assessor Name: Eduardo Lopez
Date Created: 12/06/2016

Notes: The fixed furnishings are aged, in marginal condition, and should be replaced.

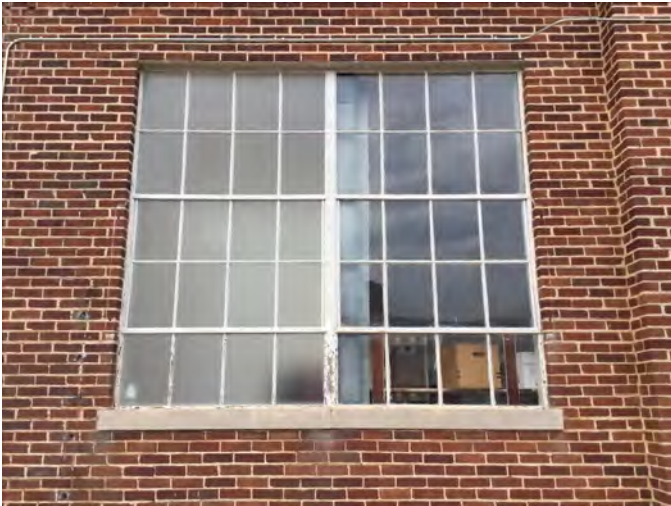
System: B2020 - Exterior Windows

Location: Exterior
Distress: Failing
Category: Deferred Maintenance
Priority: 3 - Necessary/Not Yet Critical (Years 2-5)
Correction: Renew System
Qty: 7,300.00
Unit of Measure: S.F.
Estimate: \$75,402.00
Assessor Name: Eduardo Lopez
Date Created: 12/06/2016

Notes: The original single pane, operable windows are aged, worn, inefficient and should be replaced.

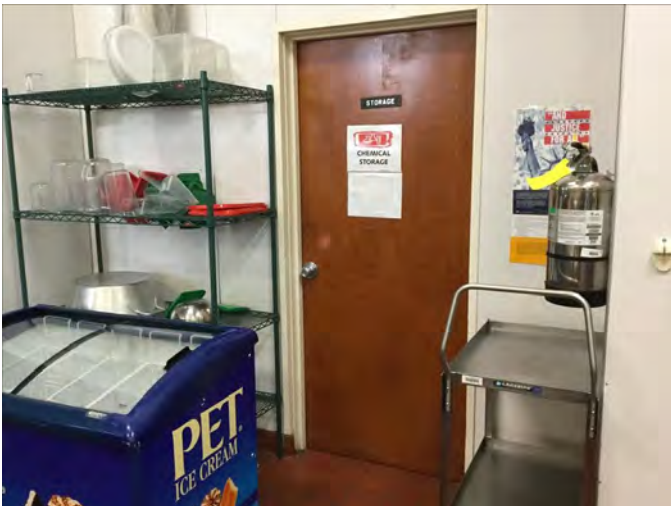
System: C1020 - Interior Doors

Location: Throughout the building
Distress: Beyond Service Life
Category: Deferred Maintenance
Priority: 3 - Necessary/Not Yet Critical (Years 2-5)
Correction: Renew System
Qty: 7,300.00
Unit of Measure: S.F.
Estimate: \$20,316.00
Assessor Name: Eduardo Lopez
Date Created: 12/06/2016

Notes: The interior doors are aged, failing, most hardware is not ADA or code compliant and should be replaced.

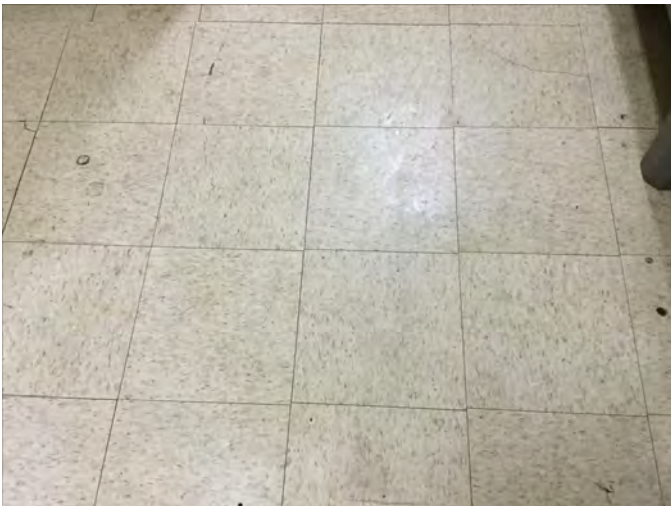
System: C3020 - Floor Finishes

Location: Throughout the building
Distress: Failing
Category: Deferred Maintenance
Priority: 3 - Necessary/Not Yet Critical (Years 2-5)
Correction: Renew System
Qty: 7,300.00
Unit of Measure: S.F.
Estimate: \$91,381.00
Assessor Name: Eduardo Lopez
Date Created: 12/06/2016

Notes: The original floor finishes are aged, failing and should be replaced.

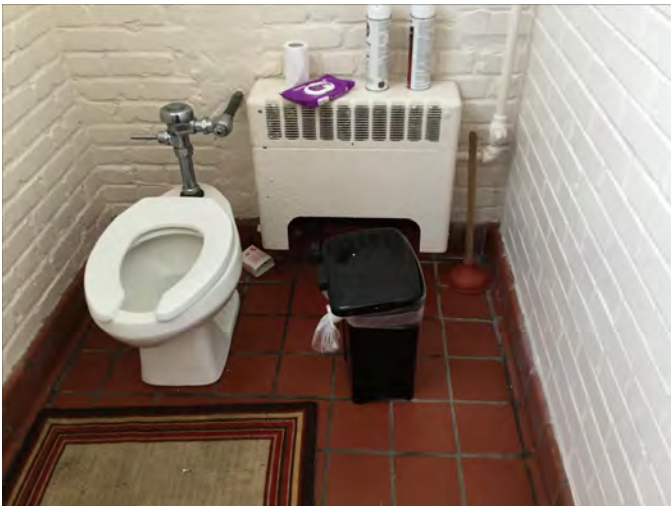
System: D2010 - Plumbing Fixtures

Location: Throughout the building
Distress: Beyond Service Life
Category: Deferred Maintenance
Priority: 3 - Necessary/Not Yet Critical (Years 2-5)
Correction: Renew System
Qty: 7,300.00
Unit of Measure: S.F.
Estimate: \$92,184.00
Assessor Name: Eduardo Lopez
Date Created: 12/06/2016

Notes: Plumbing fixtures are in operational conditions. However, they are aged, not ADA compliant and should be replaced with a low-flow water fixtures.

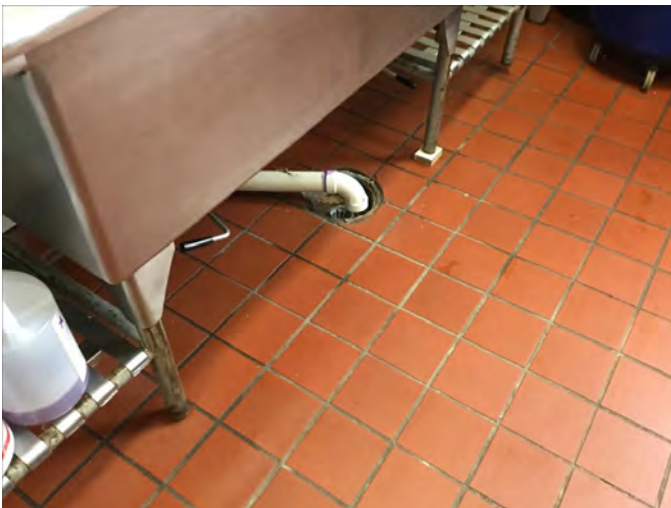
System: D2030 - Sanitary Waste

Location: Throughout the building
Distress: Beyond Service Life
Category: Deferred Maintenance
Priority: 3 - Necessary/Not Yet Critical (Years 2-5)
Correction: Renew System
Qty: 7,300.00
Unit of Measure: S.F.
Estimate: \$12,366.00
Assessor Name: Eduardo Lopez
Date Created: 12/06/2016

Notes: There are no reported issues or observed deficiencies with the sanitary waste piping. The aging sanitary sewer piping is subject to leaks, infiltration, and it can even collapse in the interior walls. The system should be inspected with cameras to ensure that none of these deficiencies exist.

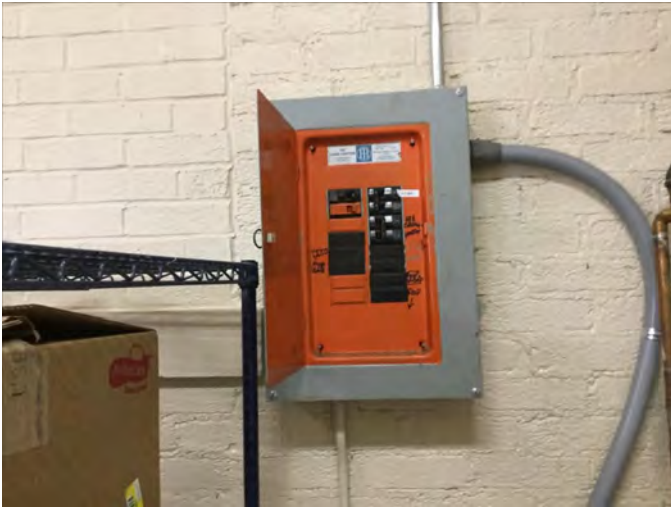
System: D5010 - Electrical Service/Distribution

Location: Throughout the building
Distress: Beyond Service Life
Category: Deferred Maintenance
Priority: 3 - Necessary/Not Yet Critical (Years 2-5)
Correction: Renew System
Qty: 7,300.00
Unit of Measure: S.F.
Estimate: \$13,571.00
Assessor Name: Eduardo Lopez
Date Created: 12/06/2016

Notes: The original branch wiring system is operating properly due to an aggressive maintenance program but is aged, in marginal condition, and should be replaced.

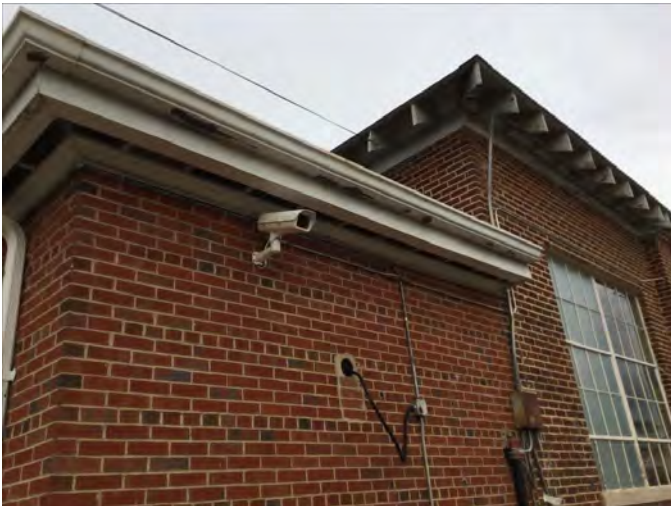
System: D5030810 - Security & Detection Systems

Location: Exterior
Distress: Beyond Service Life
Category: Deferred Maintenance
Priority: 3 - Necessary/Not Yet Critical (Years 2-5)
Correction: Renew System
Qty: 7,300.00
Unit of Measure: S.F.
Estimate: \$15,016.00
Assessor Name: Eduardo Lopez
Date Created: 12/06/2016

Notes: The security system is aged, has poor coverage and camera resolution, and should be replaced.

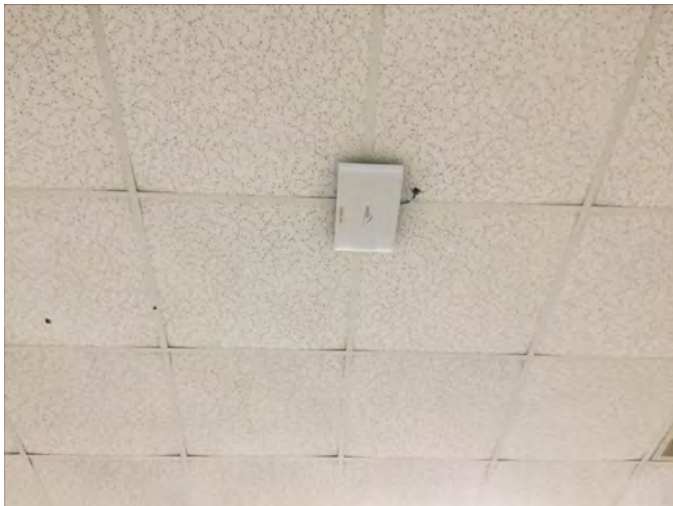
System: D5030920 - Data Communication

Location: Throughout the building
Distress: Beyond Service Life
Category: Deferred Maintenance
Priority: 3 - Necessary/Not Yet Critical (Years 2-5)
Correction: Renew System
Qty: 7,300.00
Unit of Measure: S.F.
Estimate: \$35,332.00
Assessor Name: Eduardo Lopez
Date Created: 12/06/2016

Notes: The original fire alarm system operating as designed, but is beyond its service life and should be replaced.

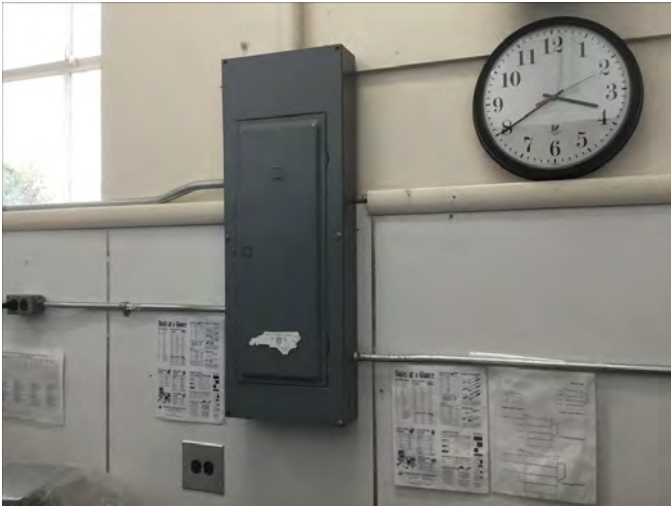
System: D5020 - Branch Wiring

Location: Throughout the building
Distress: Beyond Service Life
Category: Deferred Maintenance
Priority: 4 - Recommended (Years 6-10)
Correction: Renew System
Qty: 7,300.00
Unit of Measure: S.F.
Estimate: \$40,632.00
Assessor Name: Eduardo Lopez
Date Created: 12/06/2016

Notes: The original branch wiring system is operating properly due to an aggressive maintenance program but is aged, in marginal condition, and should be replaced.

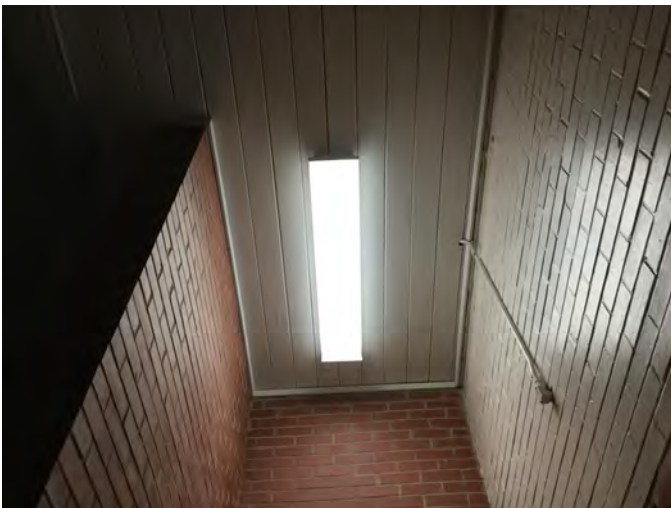
System: D5020 - Lighting

Location: Throughout the building
Distress: Beyond Service Life
Category: Deferred Maintenance
Priority: 4 - Recommended (Years 6-10)
Correction: Renew System
Qty: 7,300.00
Unit of Measure: S.F.
Estimate: \$95,718.00
Assessor Name: Eduardo Lopez
Date Created: 12/06/2016

Notes: The original branch wiring system is operating properly due to an aggressive maintenance program but is aged, in marginal condition, and should be replaced with energy efficient fixtures.

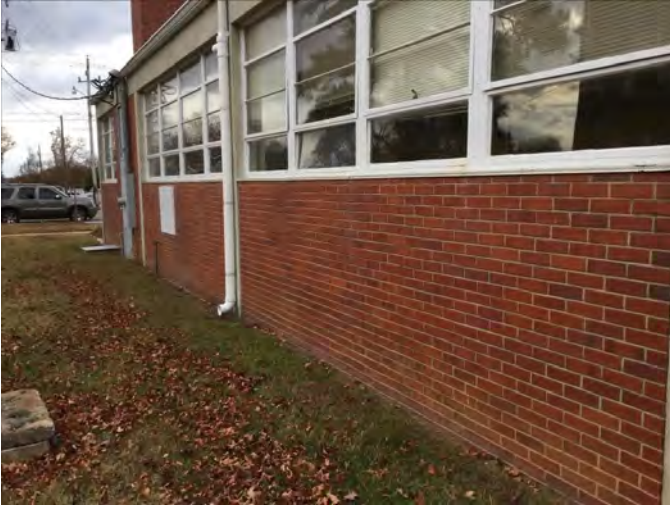
System: B2020 - Exterior Windows

Location: Exterior
Distress: Beyond Service Life
Category: Deferred Maintenance
Priority: 3 - Necessary/Not Yet Critical (Years 2-5)
Correction: Renew System
Qty: 4,818.00
Unit of Measure: S.F.
Estimate: \$49,765.00
Assessor Name: Eduardo Lopez
Date Created: 12/06/2016

Notes: The aluminum frame, operable, single pane windows are aged, rusted, not energy efficient, and should be replaced.

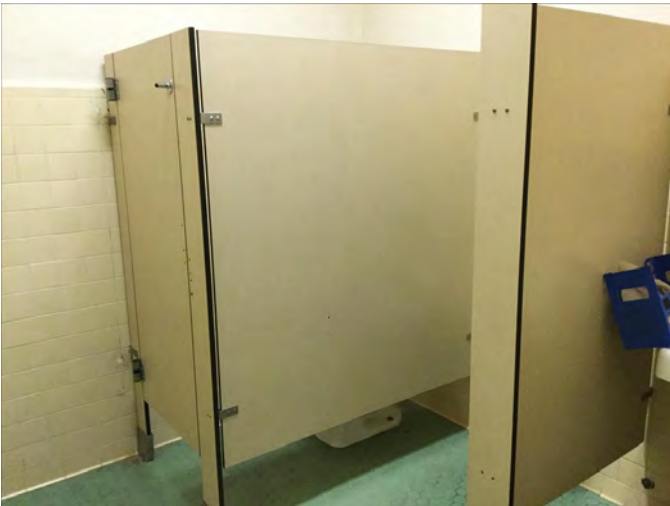
System: C1030 - Fittings

Location: Restroom
Distress: Beyond Service Life
Category: Deferred Maintenance
Priority: 3 - Necessary/Not Yet Critical (Years 2-5)
Correction: Renew System
Qty: 4,818.00
Unit of Measure: S.F.
Estimate: \$51,620.00
Assessor Name: Eduardo Lopez
Date Created: 12/06/2016

Notes: The fittings throughout the building are aged, in marginal condition, handrails and room signage are ADA non-compliance and system should be replaced.

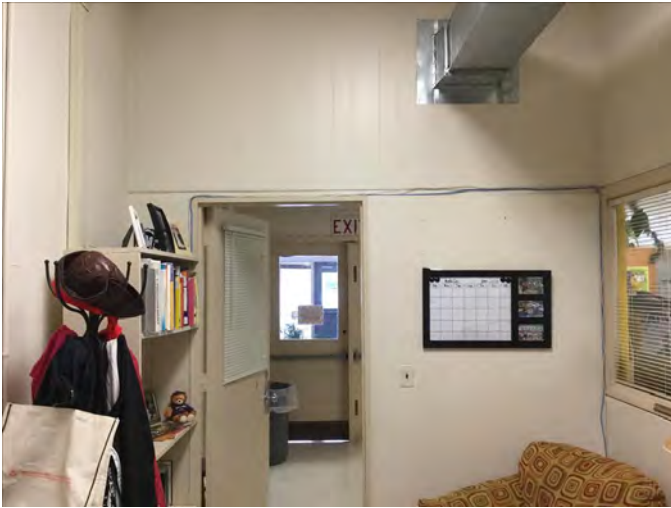
System: C3010 - Wall Finishes

Location: Throughout the building
Distress: Beyond Service Life
Category: Deferred Maintenance
Priority: 3 - Necessary/Not Yet Critical (Years 2-5)
Correction: Renew System
Qty: 4,818.00
Unit of Measure: S.F.
Estimate: \$14,786.00
Assessor Name: Eduardo Lopez
Date Created: 12/06/2016

Notes: The wall finishes are aged, scuffed, fading, stained, and should be re-painted.

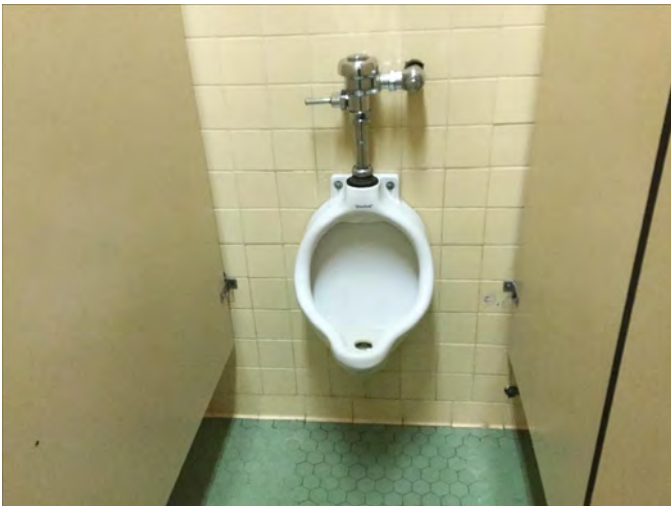
System: D2010 - Plumbing Fixtures

Location: Restroom
Distress: Beyond Service Life
Category: Deferred Maintenance
Priority: 3 - Necessary/Not Yet Critical (Years 2-5)
Correction: Renew System
Qty: 4,818.00
Unit of Measure: S.F.
Estimate: \$60,842.00
Assessor Name: Eduardo Lopez
Date Created: 12/06/2016

Notes: Plumbing fixtures are in operational conditions. However, they are aged, not ADA compliant and should be replaced with a low-flow water fixtures.

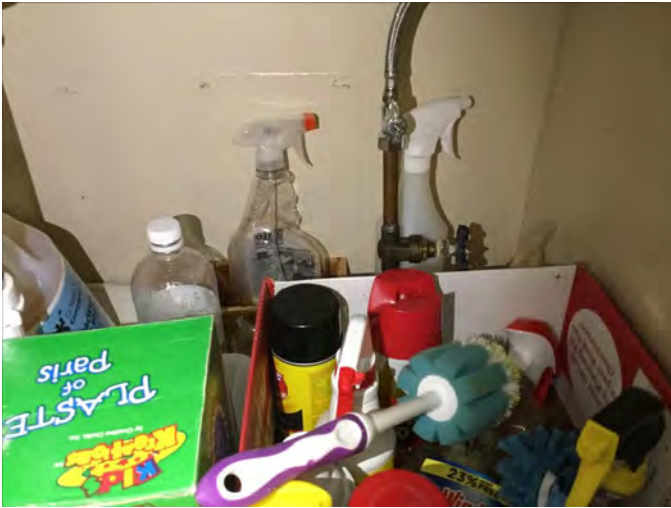
System: D2020 - Domestic Water Distribution

Location: Throughout the building
Distress: Beyond Service Life
Category: Deferred Maintenance
Priority: 3 - Necessary/Not Yet Critical (Years 2-5)
Correction: Renew System
Qty: 4,818.00
Unit of Measure: S.F.
Estimate: \$5,194.00
Assessor Name: Eduardo Lopez
Date Created: 12/06/2016

Notes: The domestic water distribution system is aged and should be replaced.

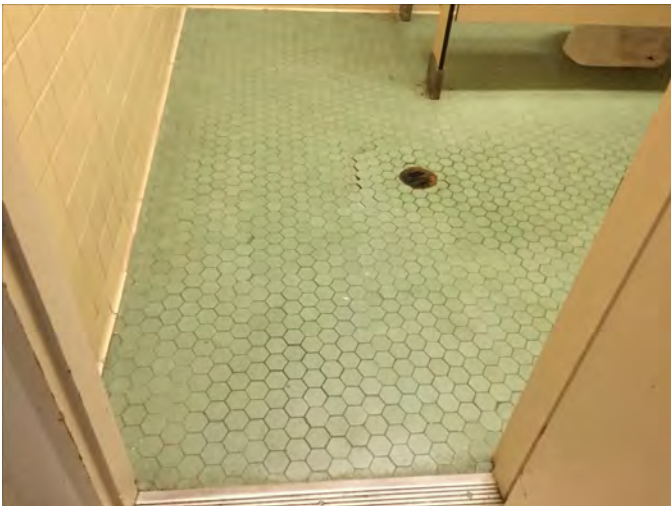
System: D2030 - Sanitary Waste

Location: Throughout the building
Distress: Beyond Service Life
Category: Deferred Maintenance
Priority: 3 - Necessary/Not Yet Critical (Years 2-5)
Correction: Renew System
Qty: 4,818.00
Unit of Measure: S.F.
Estimate: \$8,162.00
Assessor Name: Eduardo Lopez
Date Created: 12/06/2016

Notes: The sanitary waste system is aged, has reported periodic failures, and should be replaced.

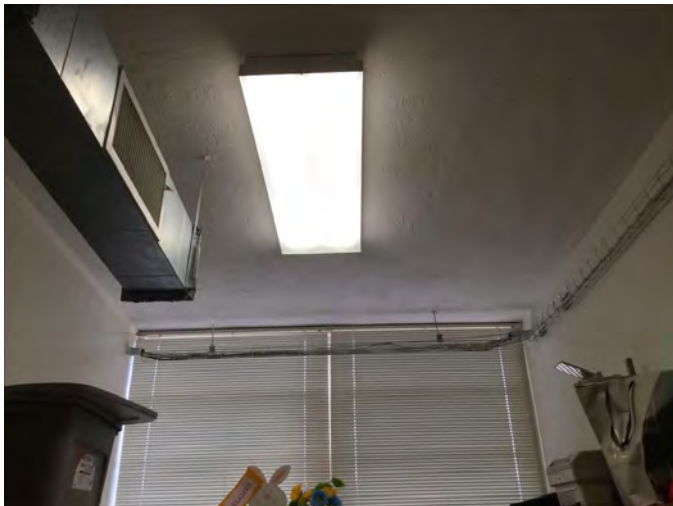
System: D5020 - Lighting

Location: Throughout the building
Distress: Beyond Service Life
Category: Deferred Maintenance
Priority: 3 - Necessary/Not Yet Critical (Years 2-5)
Correction: Renew System
Qty: 4,818.00
Unit of Measure: S.F.
Estimate: \$63,174.00
Assessor Name: Eduardo Lopez
Date Created: 12/06/2016

Notes: The original lighting and branch wiring system is operating, but is aged, in poor condition, and should be replaced.

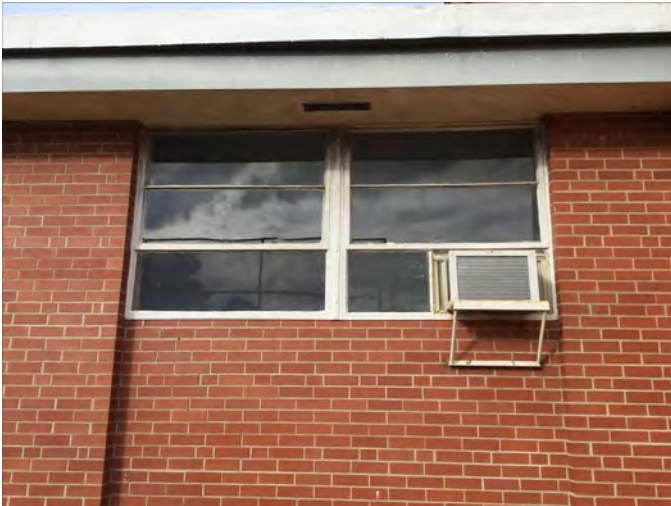
System: B2020 - Exterior Windows

Location: Exterior
Distress: Beyond Service Life
Category: Deferred Maintenance
Priority: 3 - Necessary/Not Yet Critical (Years 2-5)
Correction: Renew System
Qty: 13,087.00
Unit of Measure: S.F.
Estimate: \$135,176.00
Assessor Name: Eduardo Lopez
Date Created: 12/06/2016

Notes: The aluminum frame, operable, single pane windows are aged, rusted, not energy efficient, and should be replaced.

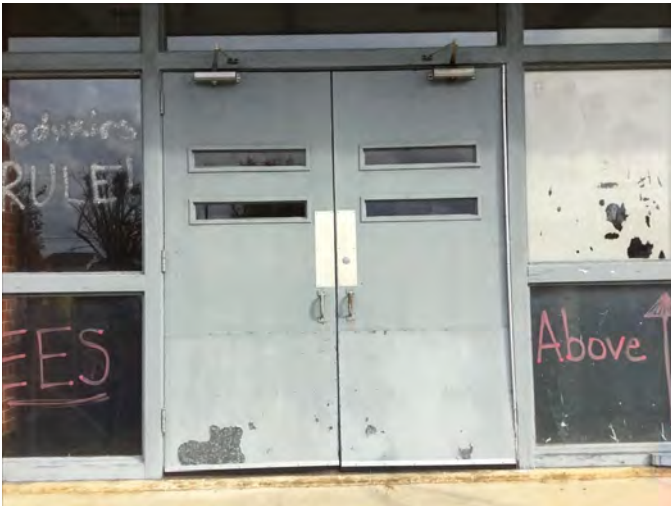
System: B2030 - Exterior Doors

Location: Exterior
Distress: Beyond Service Life
Category: Deferred Maintenance
Priority: 3 - Necessary/Not Yet Critical (Years 2-5)
Correction: Renew System
Qty: 13,087.00
Unit of Measure: S.F.
Estimate: \$14,972.00
Assessor Name: Eduardo Lopez
Date Created: 12/06/2016

Notes: The original exterior doors are aged, rusted, and should be replaced.

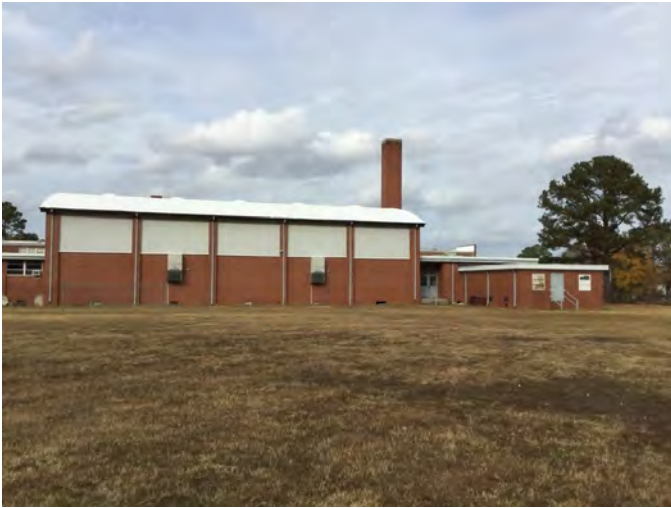
System: B3010120 - Single Ply Membrane

Location: Roof
Distress: Beyond Service Life
Category: Deferred Maintenance
Priority: 3 - Necessary/Not Yet Critical (Years 2-5)
Correction: Renew System
Qty: 13,087.00
Unit of Measure: S.F.
Estimate: \$137,021.00
Assessor Name: Eduardo Lopez
Date Created: 12/09/2016

Notes: The EPDM adhered roof coverings are aging, leaking, and showing signs of failure and should be replaced.

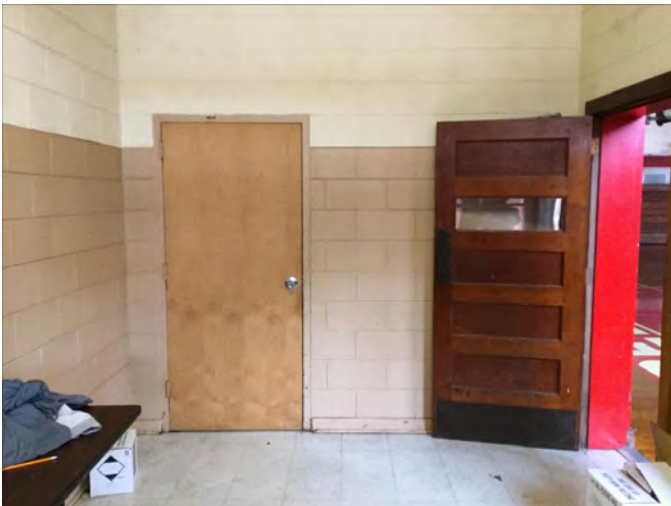
System: C1020 - Interior Doors

Location: Throughout the building
Distress: Beyond Service Life
Category: Deferred Maintenance
Priority: 3 - Necessary/Not Yet Critical (Years 2-5)
Correction: Renew System
Qty: 13,087.00
Unit of Measure: S.F.
Estimate: \$36,421.00
Assessor Name: Eduardo Lopez
Date Created: 12/06/2016

Notes: The interior doors are aged, failing, most hardware is not ADA or code compliant and should be replaced.

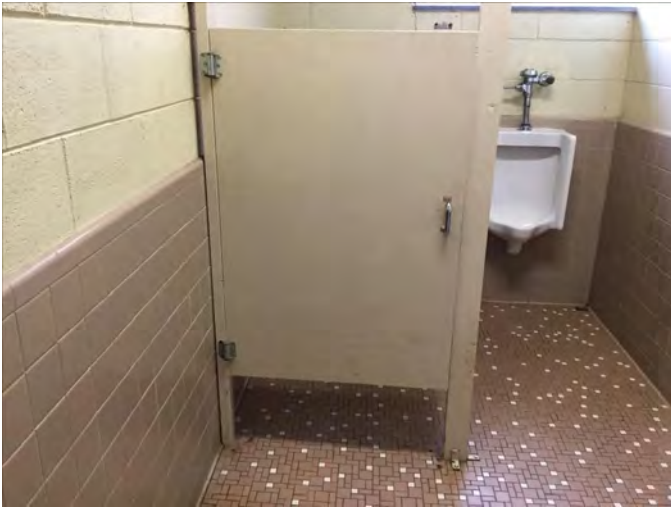
System: C1030 - Fittings

Location: Throughout the building
Distress: Beyond Service Life
Category: Deferred Maintenance
Priority: 3 - Necessary/Not Yet Critical (Years 2-5)
Correction: Renew System
Qty: 13,087.00
Unit of Measure: S.F.
Estimate: \$140,214.00
Assessor Name: Eduardo Lopez
Date Created: 12/06/2016

Notes: The fittings throughout the building are aged, in marginal condition, and should be replaced.

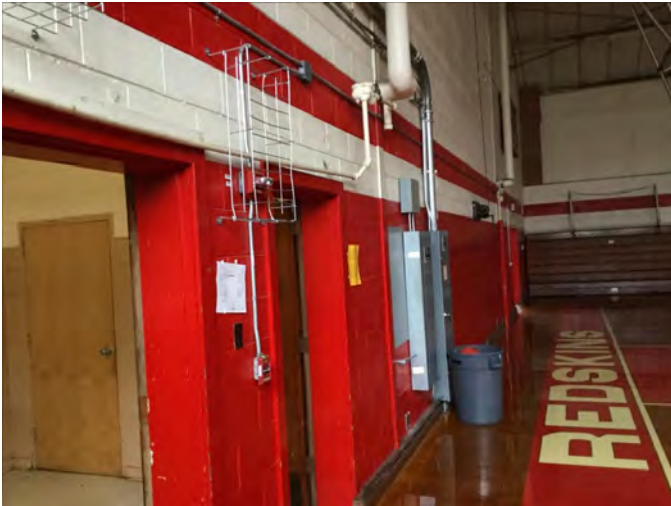
System: C3010 - Wall Finishes

Location: Throughout the building
Distress: Beyond Service Life
Category: Deferred Maintenance
Priority: 3 - Necessary/Not Yet Critical (Years 2-5)
Correction: Renew System
Qty: 13,087.00
Unit of Measure: S.F.
Estimate: \$40,164.00
Assessor Name: Eduardo Lopez
Date Created: 12/06/2016

Notes: The wall finishes are aged, scuffed, fading, stained, and should be re-painted.

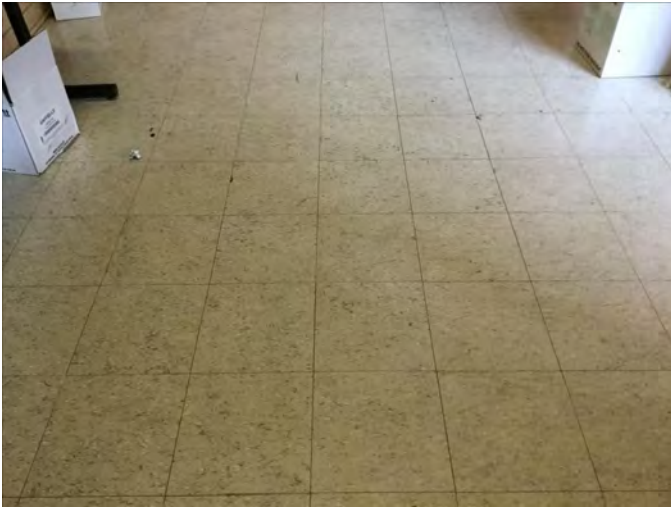
System: C3020 - Floor Finishes

Location: Throughout the building
Distress: Damaged
Category: Deferred Maintenance
Priority: 3 - Necessary/Not Yet Critical (Years 2-5)
Correction: Renew System
Qty: 13,087.00
Unit of Measure: S.F.
Estimate: \$163,823.00
Assessor Name: Eduardo Lopez
Date Created: 12/06/2016

Notes: The original flooring is in poor conditions, with different areas separating from the substrate, and should be replaced.

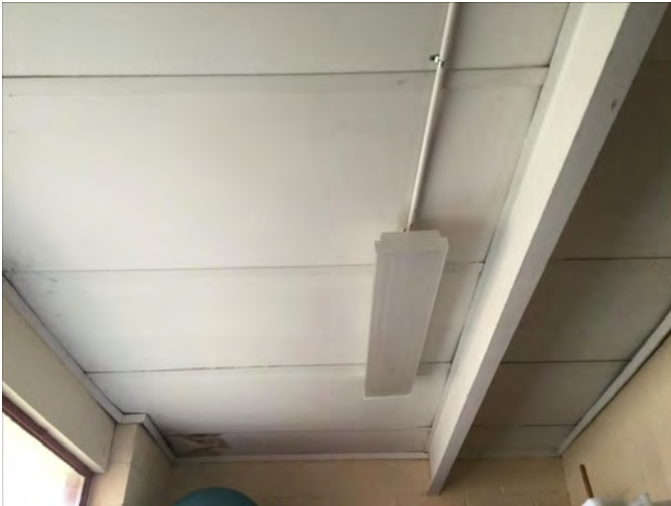
System: C3030 - Ceiling Finishes

Location: Throughout the building
Distress: Damaged
Category: Deferred Maintenance
Priority: 3 - Necessary/Not Yet Critical (Years 2-5)
Correction: Renew System
Qty: 13,087.00
Unit of Measure: S.F.
Estimate: \$157,921.00
Assessor Name: Eduardo Lopez
Date Created: 12/06/2016

Notes: The original ceiling finishes are aged, failing and should be replaced.

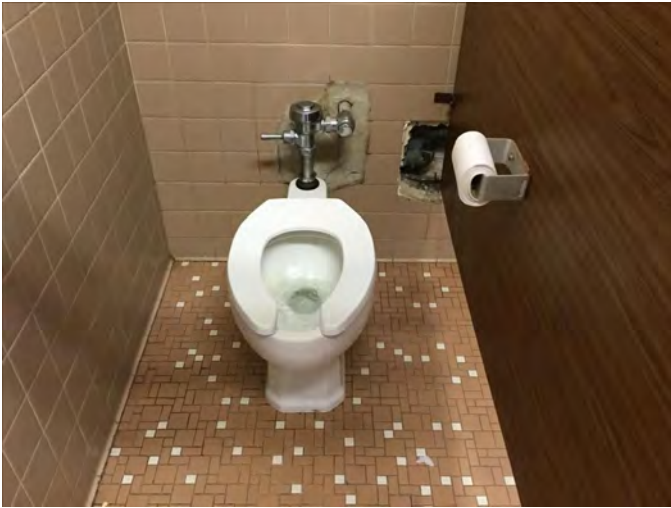
System: D2010 - Plumbing Fixtures

Location: Restroom
Distress: Beyond Service Life
Category: Deferred Maintenance
Priority: 3 - Necessary/Not Yet Critical (Years 2-5)
Correction: Renew System
Qty: 13,087.00
Unit of Measure: S.F.
Estimate: \$165,263.00
Assessor Name: Eduardo Lopez
Date Created: 12/06/2016

Notes: Plumbing fixtures are in operational conditions. However, they are aged, not ADA compliant and should be replaced with a low-flow water fixtures.

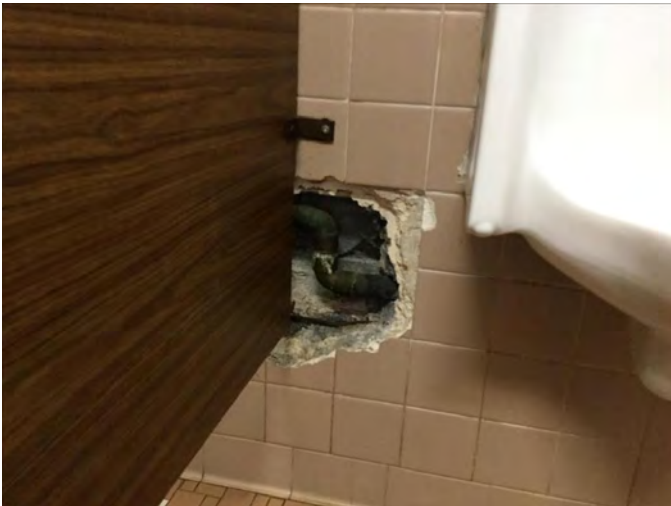
System: D2020 - Domestic Water Distribution

Location: Throughout the building
Distress: Beyond Service Life
Category: Deferred Maintenance
Priority: 3 - Necessary/Not Yet Critical (Years 2-5)
Correction: Renew System
Qty: 13,087.00
Unit of Measure: S.F.
Estimate: \$14,108.00
Assessor Name: Eduardo Lopez
Date Created: 12/06/2016

Notes: The domestic water distribution system is aged and should be replaced.

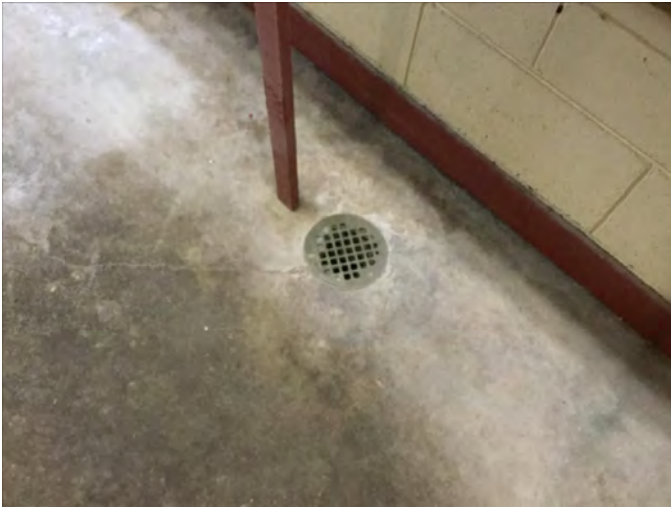
System: D2030 - Sanitary Waste

Location: Throughout the building
Distress: Beyond Service Life
Category: Deferred Maintenance
Priority: 3 - Necessary/Not Yet Critical (Years 2-5)
Correction: Renew System
Qty: 13,087.00
Unit of Measure: S.F.
Estimate: \$22,169.00
Assessor Name: Eduardo Lopez
Date Created: 12/06/2016

Notes: The sanitary waste system is aged and should be replaced.

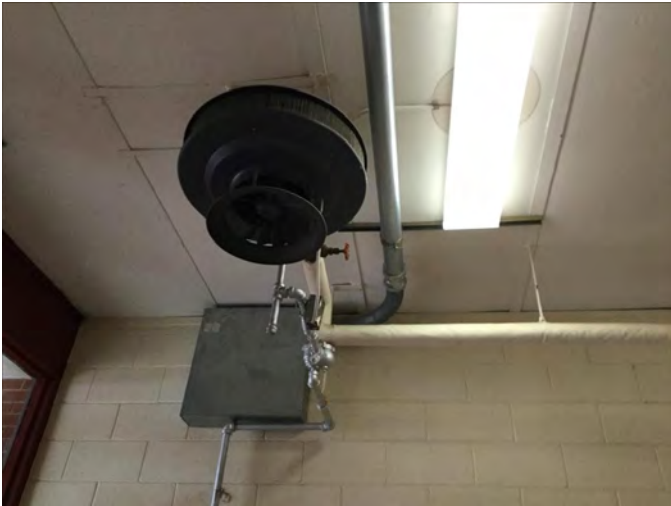
System: D3040 - Distribution Systems

Location: Throughout the building
Distress: Beyond Service Life
Category: Deferred Maintenance
Priority: 3 - Necessary/Not Yet Critical (Years 2-5)
Correction: Renew System
Qty: 13,087.00
Unit of Measure: S.F.
Estimate: \$88,390.00
Assessor Name: Eduardo Lopez
Date Created: 12/06/2016

Notes: The HVAC distribution system is aged and should be replaced.
