NC School District/430 Harnett County/Elementary School

Erwin Elementary

Final
Campus Assessment Report

March 11, 2017

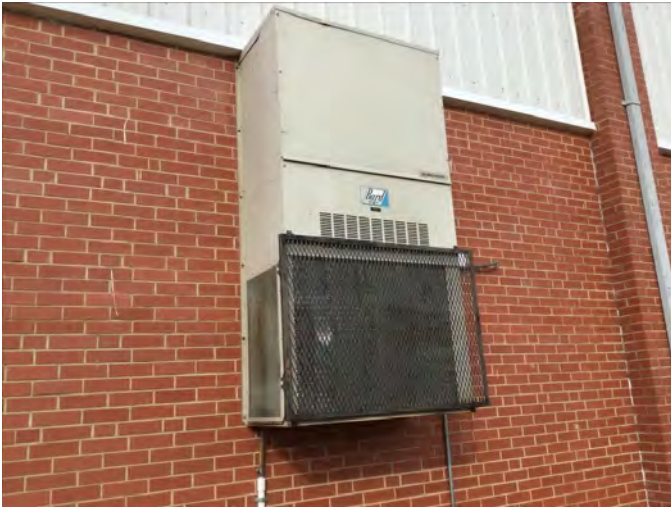
System: D3050 - Terminal & Package Units

Location: Exterior
Distress: Beyond Service Life
Category: Deferred Maintenance
Priority: 3 - Necessary/Not Yet Critical (Years 2-5)
Correction: Renew System
Qty: 13,087.00
Unit of Measure: S.F.
Estimate: \$192,471.00
Assessor Name: Eduardo Lopez
Date Created: 12/06/2016

Notes: The wall mounted Carrier DX condensing unit is aged and should be scheduled for replacement.

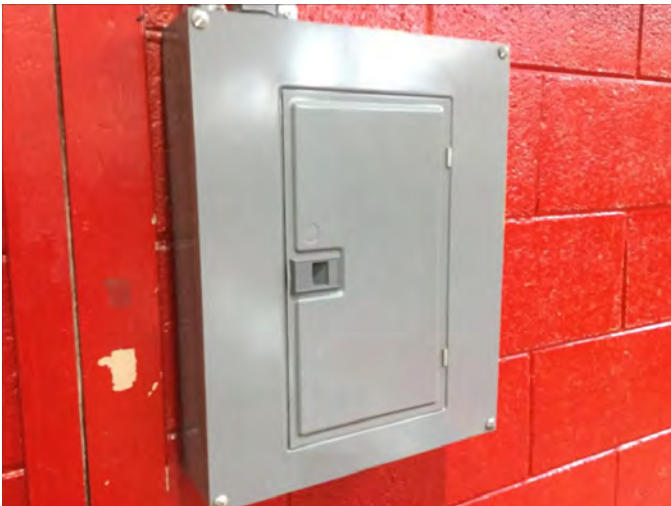
System: D5020 - Branch Wiring

Location: Throughout the building
Distress: Beyond Service Life
Category: Deferred Maintenance
Priority: 3 - Necessary/Not Yet Critical (Years 2-5)
Correction: Renew System
Qty: 13,087.00
Unit of Measure: S.F.
Estimate: \$72,842.00
Assessor Name: Eduardo Lopez
Date Created: 12/06/2016

Notes: The original electrical service is operating, maxed to capacity and should be replaced.

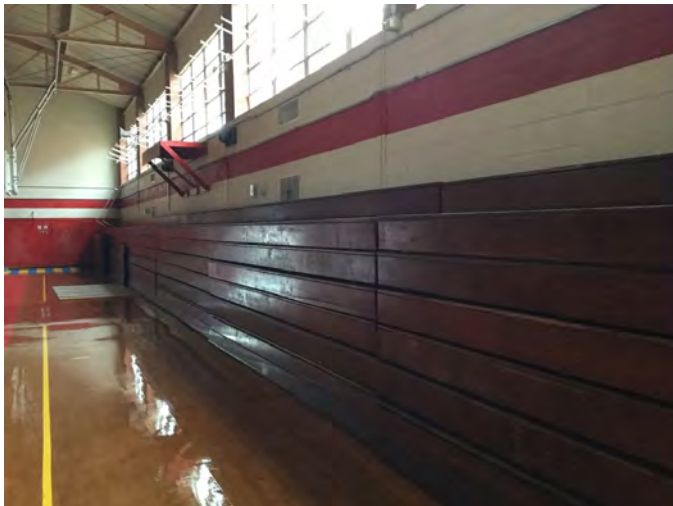
System: E1090 - Other Equipment

Location: Gym
Distress: Beyond Service Life
Category: Deferred Maintenance
Priority: 3 - Necessary/Not Yet Critical (Years 2-5)
Correction: Renew System
Qty: 13,087.00
Unit of Measure: S.F.
Estimate: \$27,352.00
Assessor Name: Eduardo Lopez
Date Created: 12/06/2016

Notes: The athletic, and recreational equipment is aged should be inspected and replaced or repaired as needed.

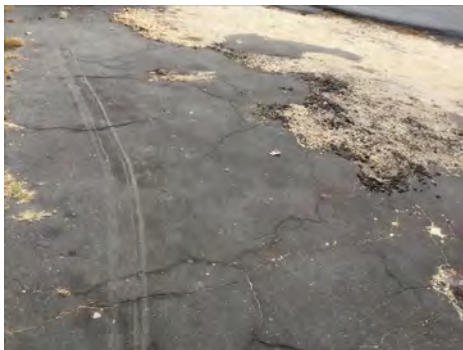
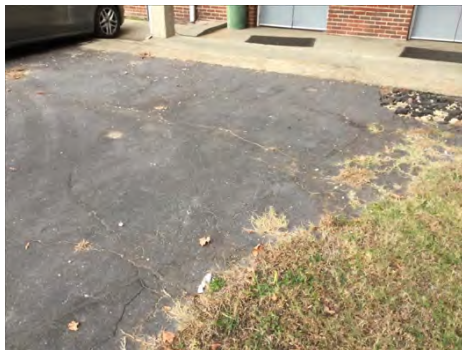
System: G2020 - Parking Lots

Note: No ADA parking.

Notes: The parking lot is aged, has many repairs and potholes, and should be replaced and re-striped. ADA signs height needs to be added per minimum ADA standards.

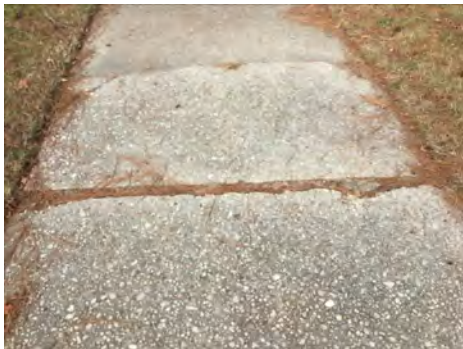
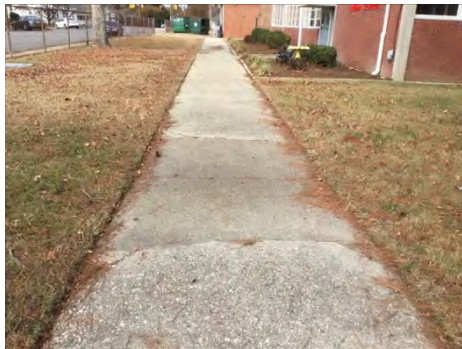
System: G2030 - Pedestrian Paving

Note: Cracks in sidewalks.

Location: Exterior
Distress: Damaged
Category: Safety
Priority: 2 - Potentially Critical (Year 1)
Correction: Renew System
Qty: 74,147.00
Unit of Measure: S.F.
Estimate: \$155,783.00
Assessor Name: Eduardo Lopez
Date Created: 12/07/2016

Notes: Sidewalks are cracking and are a trip hazard.

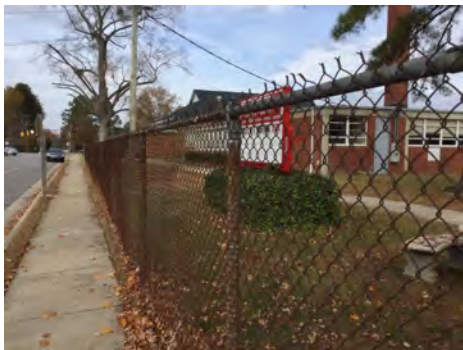
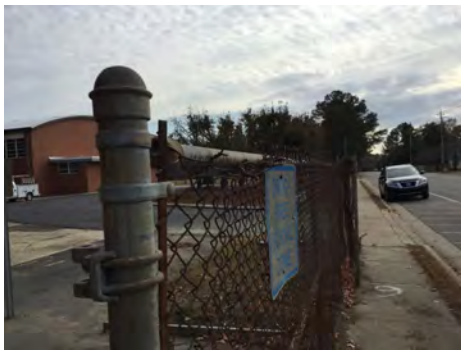
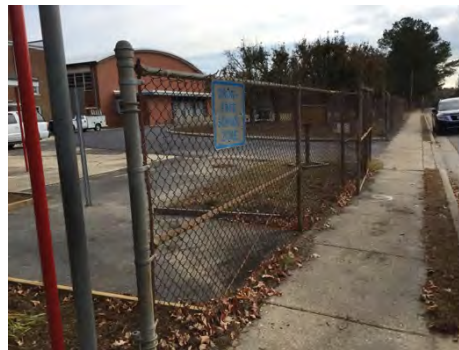
System: G2040105 - Fence & Guardrails

Note: Fence is rusty and damaged.

Notes: The chain link fence is rusty and damaged.

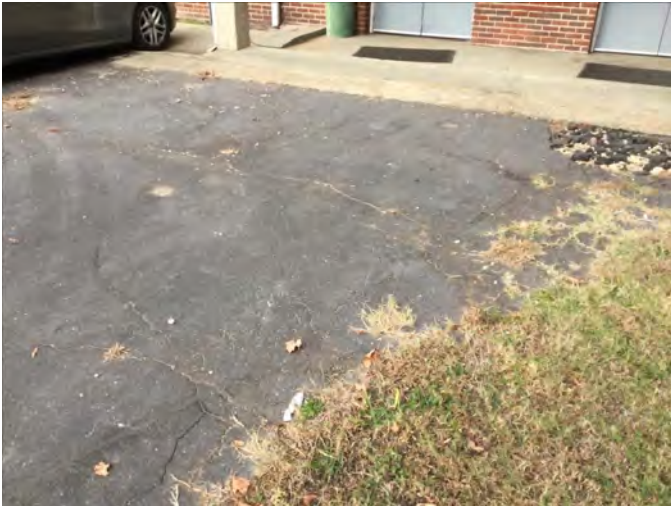
System: G2020 - Parking Lots

Location: Front Entrance
Distress: Beyond Service Life
Category: Deferred Maintenance
Priority: 2 - Potentially Critical (Year 1)
Correction: Renew System
Qty: 74,147.00
Unit of Measure: S.F.
Estimate: \$108,477.00
Assessor Name: Eduardo Lopez
Date Created: 12/07/2016

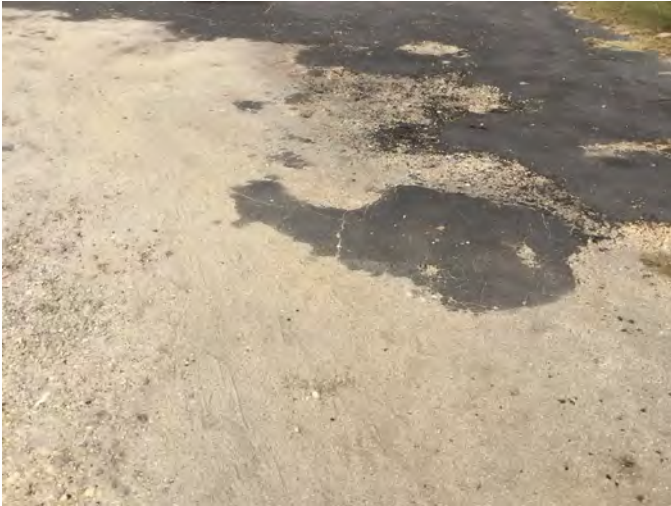
System: G2020 - Parking Lots

Location: Site
Distress: Inadequate
Category: Deferred Maintenance
Priority: 3 - Necessary/Not Yet Critical (Years 2-5)
Correction: Add more parking spaces
Qty: 60.00
Unit of Measure: Ea.
Estimate: \$125,136.00
Assessor Name: Eduardo Lopez
Date Created: 01/25/2017

Notes: The parking lot is not adequate. Add 60 more parking spaces and include ADA signage and striping.

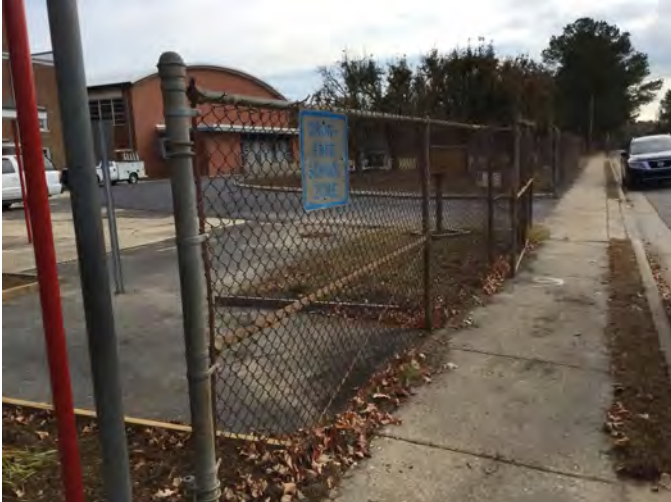
System: G2040105 - Fence & Guardrails

Location: Site
Distress: Beyond Service Life
Category: Deferred Maintenance
Priority: 3 - Necessary/Not Yet Critical (Years 2-5)
Correction: Renew System
Qty: 74,147.00
Unit of Measure: S.F.
Estimate: \$100,321.00
Assessor Name: Eduardo Lopez
Date Created: 12/07/2016

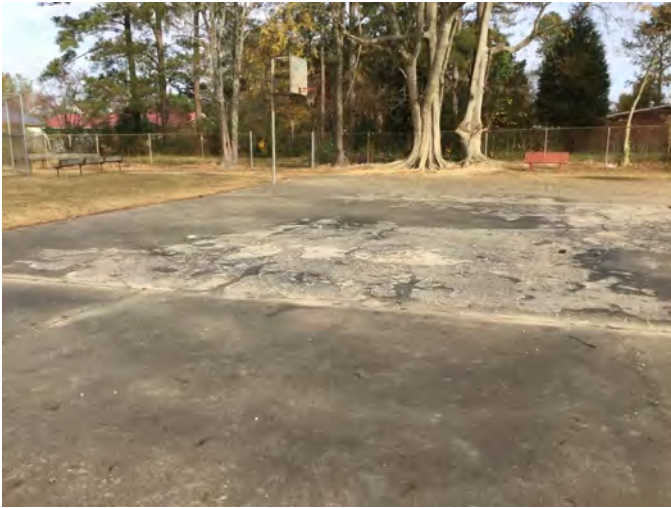
System: G2040950 - Hard Surface Play Area

Location: Site
Distress: Damaged
Category: Safety
Priority: 3 - Necessary/Not Yet Critical (Years 2-5)
Correction: Renew System
Qty: 74,147.00
Unit of Measure: S.F.
Estimate: \$61,171.00
Assessor Name: Eduardo Lopez
Date Created: 12/07/2016

Notes: The outside basketball surface is deteriorating and a trip hazard.

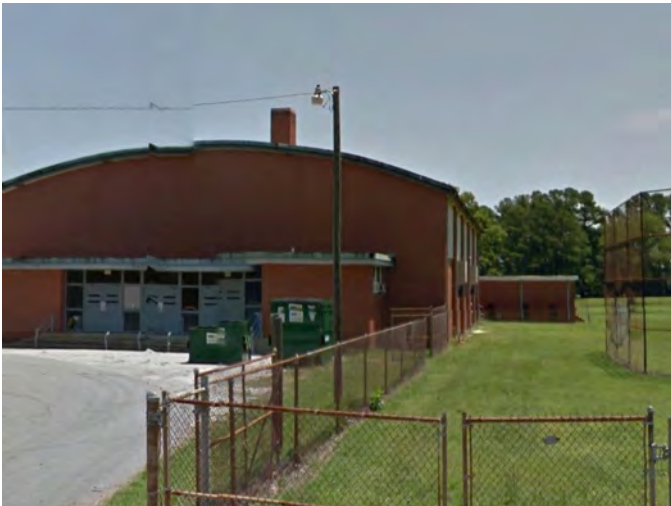
System: G4020110 - Site Lighting

Location: Site
Distress: Inadequate
Category: Safety
Priority: 3 - Necessary/Not Yet Critical (Years 2-5)
Correction: Renew System
Qty: 74,147.00
Unit of Measure: S.F.
Estimate: \$418,412.00
Assessor Name: Eduardo Lopez
Date Created: 01/25/2017

Notes: The lighting is inadequate.
