NC School District/430 Harnett County/Elementary School

# Gentry Primary

## Campus Assessment Report

March 11, 2017

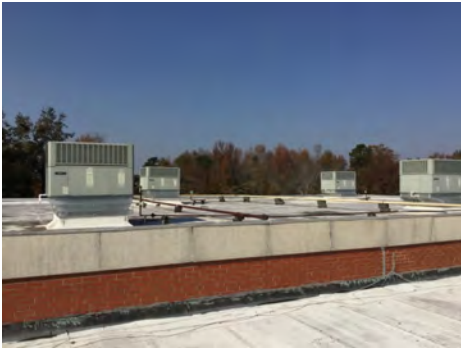
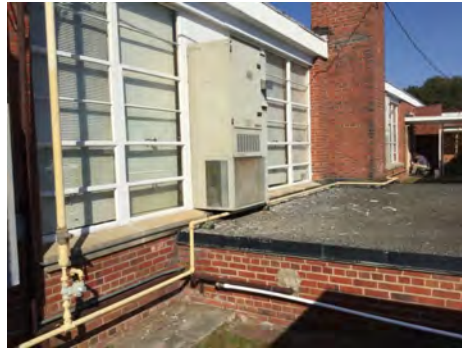
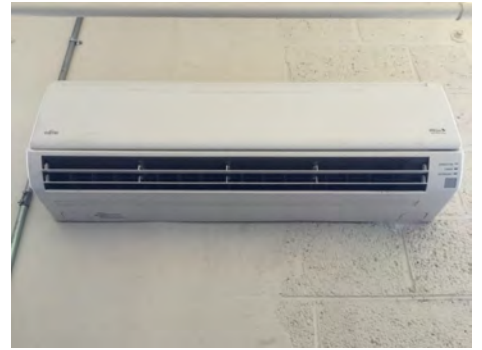
**System:** D3050 - Terminal & Package Units

**Note:** No heat in hallways. Classroom doors opened to condition space.

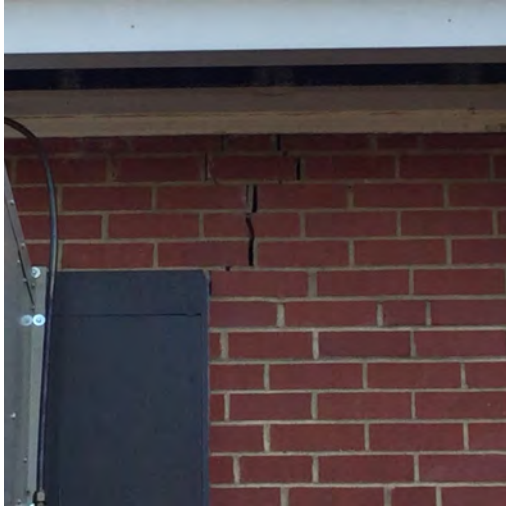
#### **System: B2010 - Exterior Walls**

**Location:** Exterior walls  
**Distress:** Failing  
**Category:** Deferred Maintenance  
**Priority:** 1 - Currently Critical (Immediate)  
**Correction:** Engineering Study-2016-11-15 17:41:59  
**Qty:** 1.00  
**Unit of Measure:** Ea.  
**Estimate:** \$39,600.00  
**Assessor Name:** Eduardo Lopez  
**Date Created:** 12/09/2016

**Notes:** Exterior walls are showing signs of distress with cracked brick and other signs of wall movement. In addition, walls are not well insulated and moisture problems occur at interiors. Soffits are in poor condition - likely due to roof conditions. The inside of exterior walls below BARD HVAC units are particularly moist and support mushroom growth. Rodent problems are possibly attributable to exterior wall conditions. Evaluation by an engineer and/or architect is recommended. Pricing does not include remediation measures..

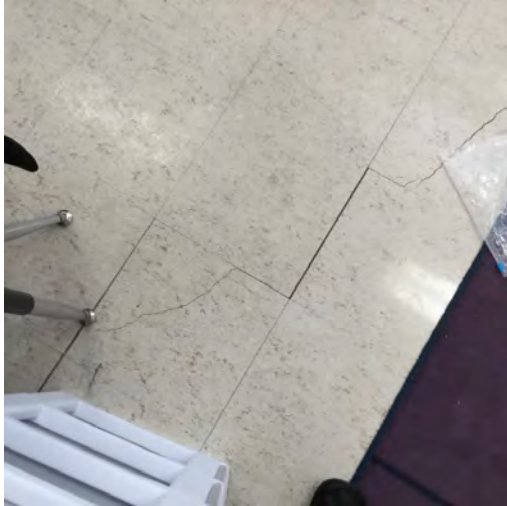
**System: A1010 - Standard Foundations**

**Location:** Foundations  
**Distress:** Failing  
**Category:** Deferred Maintenance  
**Priority:** 2 - Potentially Critical (Year 1)  
**Correction:** Engineering Study  
**Qty:** 1.00  
**Unit of Measure:** Ea.  
**Estimate:** \$10,560.00  
**Assessor Name:** Eduardo Lopez  
**Date Created:** 12/09/2016

**Notes:** Classroom floors are settling, particularly noted in room 8. Some distress in corridor floors noted by cracking in floor tile. Evaluation of foundations by a professional engineer is recommended.

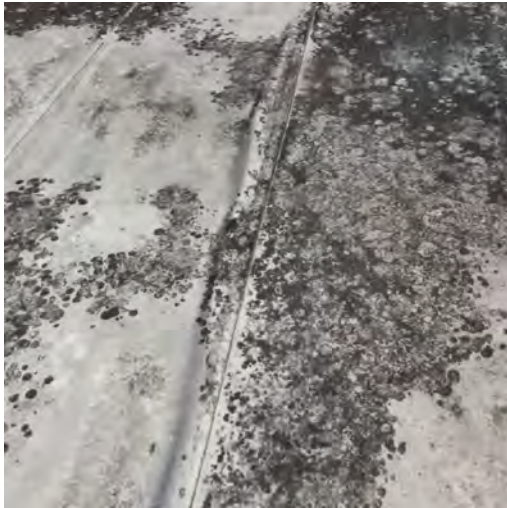
**System: B3010120 - Single Ply Membrane**

**Location:** Roof  
**Distress:** Beyond Service Life  
**Category:** Deferred Maintenance  
**Priority:** 2 - Potentially Critical (Year 1)  
**Correction:** Renew System  
**Qty:** 27,130.00  
**Unit of Measure:** S.F.  
**Estimate:** \$284,051.00  
**Assessor Name:** Eduardo Lopez  
**Date Created:** 12/08/2016

**Notes:** The single ply membrane roof is well beyond its expected life and evidence of leaks was frequently observed at interiors. The low-slope roof deck is not adequate for rain water to drain toward roof drains, creating ponding. System replacement with effective cricket design to prevent ponding is recommended.

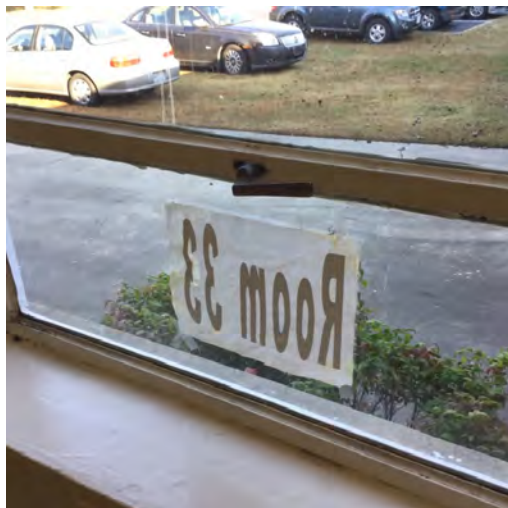
**System: B2020 - Exterior Windows**

**Location:** Throughout the building  
**Distress:** Beyond Service Life  
**Category:** Deferred Maintenance / Energy  
**Priority:** 3 - Necessary/Not Yet Critical (Years 2-5)  
**Correction:** Renew System  
**Qty:** 27,130.00  
**Unit of Measure:** S.F.  
**Estimate:** \$280,226.00  
**Assessor Name:** Eduardo Lopez  
**Date Created:** 12/08/2016

**Notes:** Exterior windows are original and in very poor condition. Operable windows do not operate or secure properly. Many are painted shut. Windows do not open sufficiently to provide emergency egress. Windows sweat in humid weather conditions and are not energy efficient. Windows are unsightly.

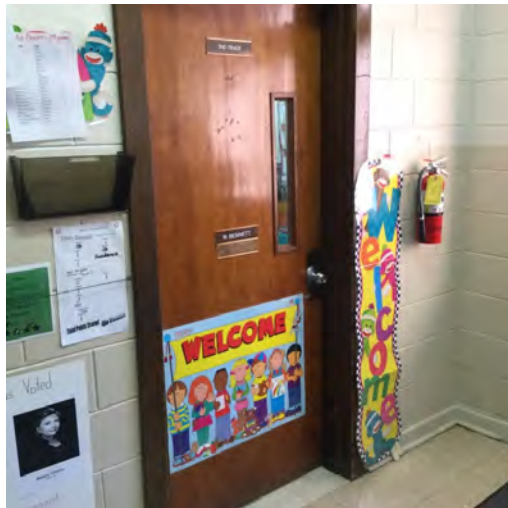
**System: C1020 - Interior Doors**

**Location:** Throughout the building  
**Distress:** Beyond Service Life  
**Category:** Deferred Maintenance  
**Priority:** 3 - Necessary/Not Yet Critical (Years 2-5)  
**Correction:** Renew System  
**Qty:** 27,130.00  
**Unit of Measure:** S.F.  
**Estimate:** \$75,503.00  
**Assessor Name:** Eduardo Lopez  
**Date Created:** 12/08/2016

**Notes:** The interior doors are aged, hardware is not ADA or code compliant and should be replaced.

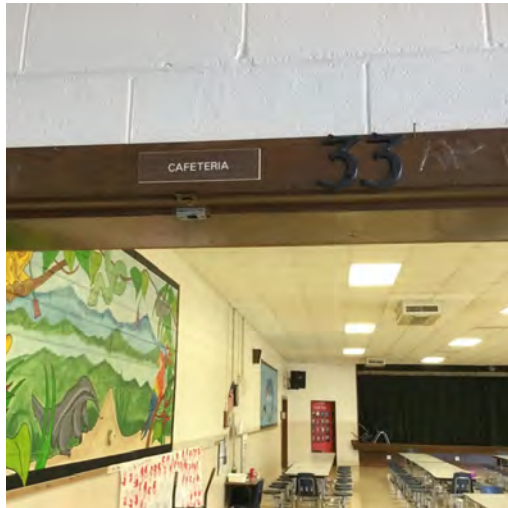
**System: C1030 - Fittings**

**Location:** Throughout the building  
**Distress:** Beyond Service Life  
**Category:** Deferred Maintenance  
**Priority:** 3 - Necessary/Not Yet Critical (Years 2-5)  
**Correction:** Renew System  
**Qty:** 27,130.00  
**Unit of Measure:** S.F.  
**Estimate:** \$290,671.00  
**Assessor Name:** Eduardo Lopez  
**Date Created:** 12/08/2016

**Notes:** Fittings, including interior signage, toilet partitions and accessories are aged, in poor condition and obsolete. System renewal is recommended.

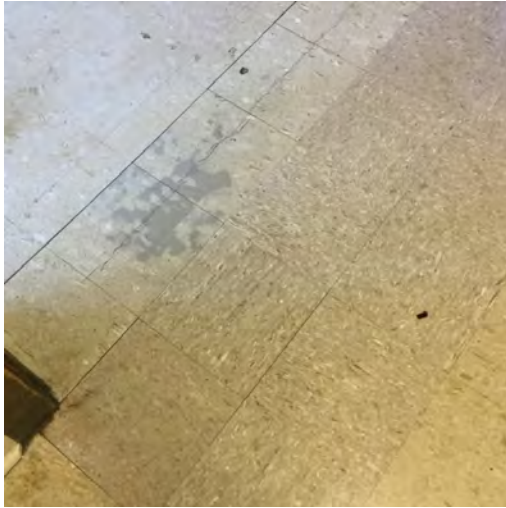
**System: C3020 - Floor Finishes**

**Location:** Throughout the building  
**Distress:** Beyond Service Life  
**Category:** Deferred Maintenance  
**Priority:** 3 - Necessary/Not Yet Critical (Years 2-5)  
**Correction:** Renew System  
**Qty:** 27,130.00  
**Unit of Measure:** S.F.  
**Estimate:** \$339,613.00  
**Assessor Name:** Eduardo Lopez  
**Date Created:** 12/08/2016

**Notes:** Floor finishes, while generally not original, are in aged, poor condition. Some original VAT was observed in the building. System renewal is recommended.

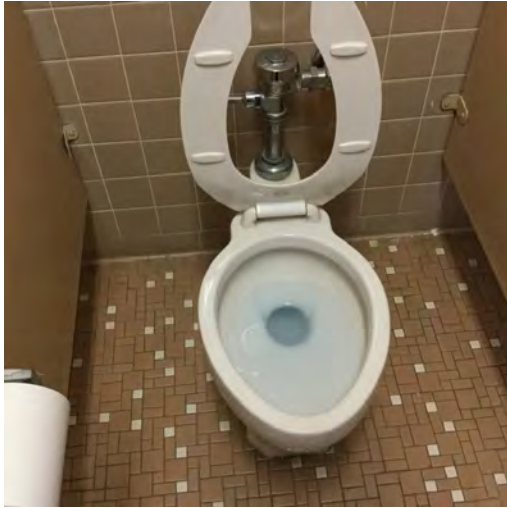
**System: D2010 - Plumbing Fixtures**

**Location:** Throughout the building.  
**Distress:** Beyond Service Life  
**Category:** Deferred Maintenance  
**Priority:** 3 - Necessary/Not Yet Critical (Years 2-5)  
**Correction:** Renew System  
**Qty:** 27,130.00  
**Unit of Measure:** S.F.  
**Estimate:** \$342,598.00  
**Assessor Name:** Eduardo Lopez  
**Date Created:** 12/08/2016

**Notes:** Plumbing fixtures are in operational conditions. However, they are aged, not ADA compliant and should be replaced with a low-flow water fixtures.

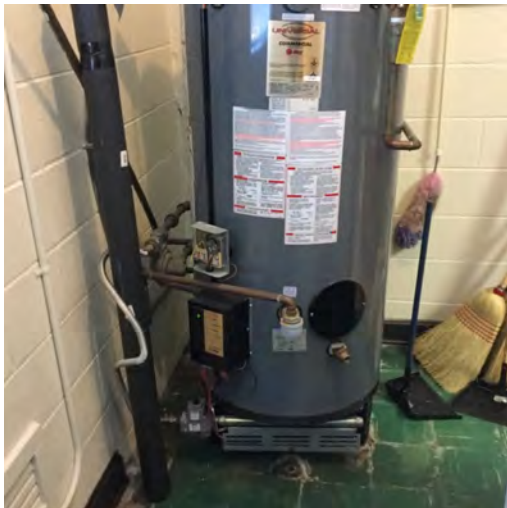
**System: D2020 - Domestic Water Distribution**

**Location:** Throughout the building  
**Distress:** Beyond Service Life  
**Category:** Deferred Maintenance  
**Priority:** 3 - Necessary/Not Yet Critical (Years 2-5)  
**Correction:** Renew System  
**Qty:** 27,130.00  
**Unit of Measure:** S.F.  
**Estimate:** \$29,246.00  
**Assessor Name:** Eduardo Lopez  
**Date Created:** 12/08/2016

**Notes:** Water supply piping is believed to be original and is beyond its expected service life. Hot water is not provided to lavatory sinks throughout the building and is recommended for health and safety. (Photo shows water heater for kitchen.). There are no hose bibs on the exterior of the building, requiring maintenance personnel to thread a hose through an open window to an inside hose connection.

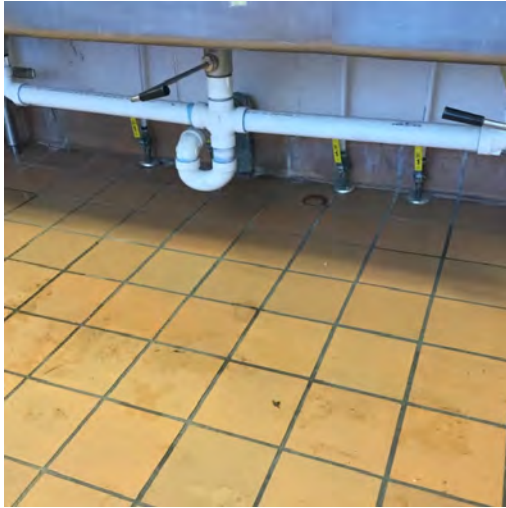
**System: D2030 - Sanitary Waste**

**Location:** Throughout the building  
**Distress:** Beyond Service Life  
**Category:** Deferred Maintenance  
**Priority:** 3 - Necessary/Not Yet Critical (Years 2-5)  
**Correction:** Renew System  
**Qty:** 27,130.00  
**Unit of Measure:** S.F.  
**Estimate:** \$45,958.00  
**Assessor Name:** Eduardo Lopez  
**Date Created:** 12/08/2016

**Notes:** Waster water piping is believed to be original throughout the building, and is beyond its expected useful life. The principal reports that after heavy rains, there is a foul sewer smell in the building. System renewal is recommended.

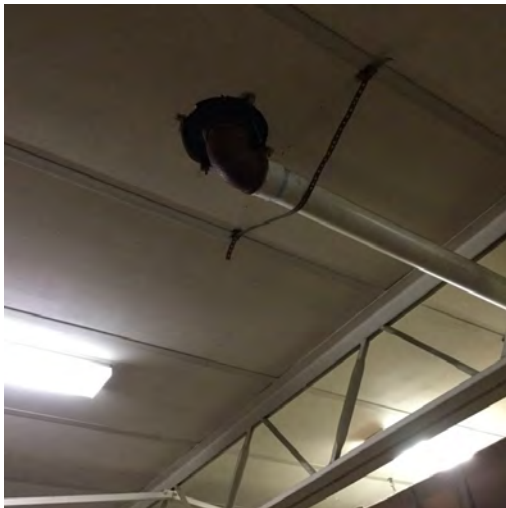
**System: D2040 - Rain Water Drainage**

**Location:** Throughout the building  
**Distress:** Beyond Service Life  
**Category:** Deferred Maintenance  
**Priority:** 3 - Necessary/Not Yet Critical (Years 2-5)  
**Correction:** Renew System  
**Qty:** 27,130.00  
**Unit of Measure:** S.F.  
**Estimate:** \$41,482.00  
**Assessor Name:** Eduardo Lopez  
**Date Created:** 12/08/2016

**Notes:** Rain water drainage has been repaired as needed. Parsons recommends system renewal to ensure the entire system is in good condition.

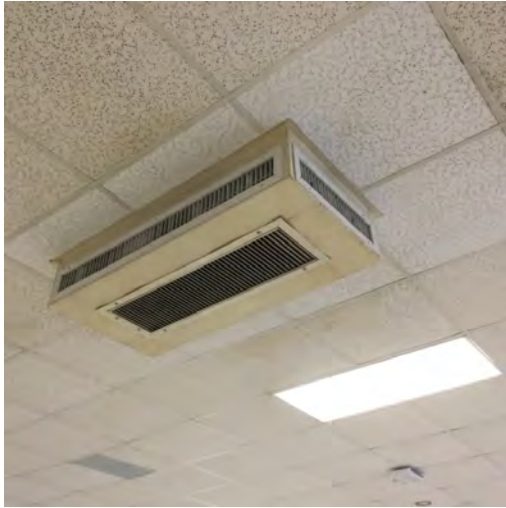
**System: D3040 - Distribution Systems**

**Location:** Throughout the building  
**Distress:** Beyond Service Life  
**Category:** Deferred Maintenance  
**Priority:** 3 - Necessary/Not Yet Critical (Years 2-5)  
**Correction:** Renew System  
**Qty:** 27,130.00  
**Unit of Measure:** S.F.  
**Estimate:** \$183,236.00  
**Assessor Name:** Eduardo Lopez  
**Date Created:** 12/08/2016

**Notes:** The HVAC distribution system is beyond its expected life, and is inadequate. There is no heat/cooling supply to corridors.

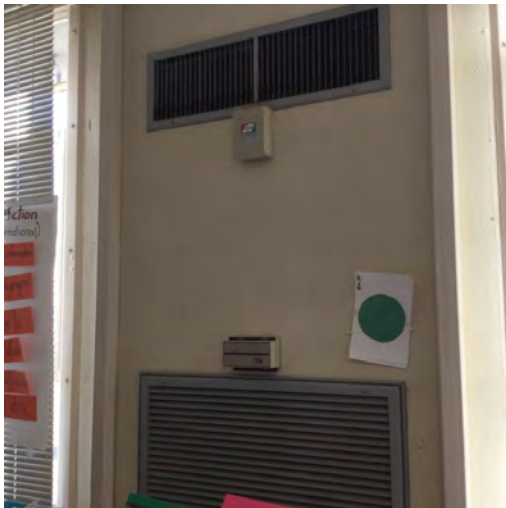
**System: D3060 - Controls & Instrumentation**

**Location:** Throughout the building  
**Distress:** Inadequate  
**Category:** Deferred Maintenance  
**Priority:** 3 - Necessary/Not Yet Critical (Years 2-5)  
**Correction:** Renew System  
**Qty:** 27,130.00  
**Unit of Measure:** S.F.  
**Estimate:** \$74,309.00  
**Assessor Name:** Eduardo Lopez  
**Date Created:** 12/08/2016

**Notes:** HVAC controls and instrumentation are an expired system. System renewal with modern digital devices that can be monitored centrally on a BAS is recommended.

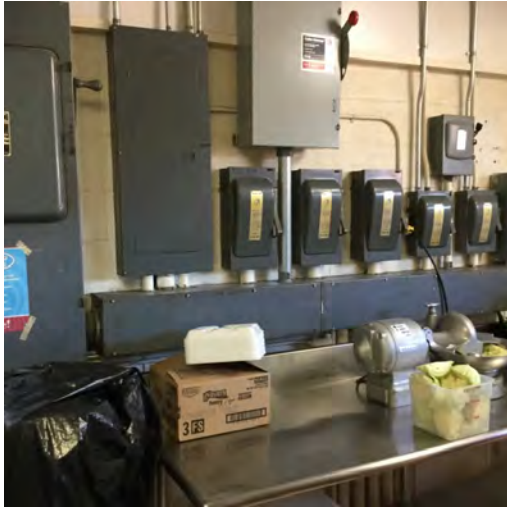
**System: D5010 - Electrical Service/Distribution**

**Location:** Electric distribution room  
**Distress:** Beyond Service Life  
**Category:** Deferred Maintenance  
**Priority:** 3 - Necessary/Not Yet Critical (Years 2-5)  
**Correction:** Renew System  
**Qty:** 27,130.00  
**Unit of Measure:** S.F.  
**Estimate:** \$50,435.00  
**Assessor Name:** Eduardo Lopez  
**Date Created:** 12/08/2016

**Notes:** The original electrical distribution system is operating properly but is aged, in marginal condition, and should be replaced.

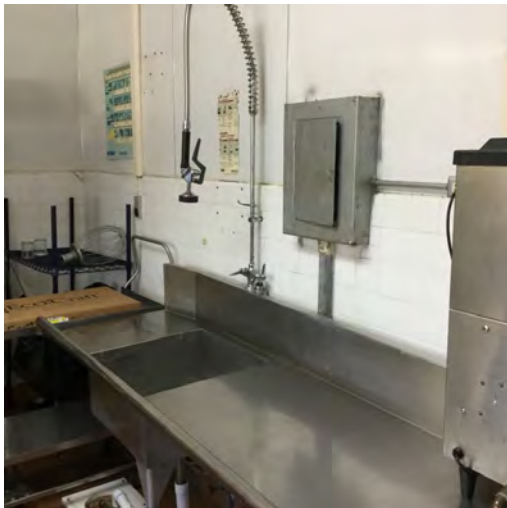
**System: D5020 - Branch Wiring**

**Location:** Throughout the building  
**Distress:** Beyond Service Life  
**Category:** Deferred Maintenance  
**Priority:** 3 - Necessary/Not Yet Critical (Years 2-5)  
**Correction:** Renew System  
**Qty:** 27,130.00  
**Unit of Measure:** S.F.  
**Estimate:** \$151,006.00  
**Assessor Name:** Eduardo Lopez  
**Date Created:** 12/08/2016

**Notes:** Branch wiring, panels, etc. are of varying ages throughout the building. Many outlets are surface mounted in awkward locations. System renewal is recommended.

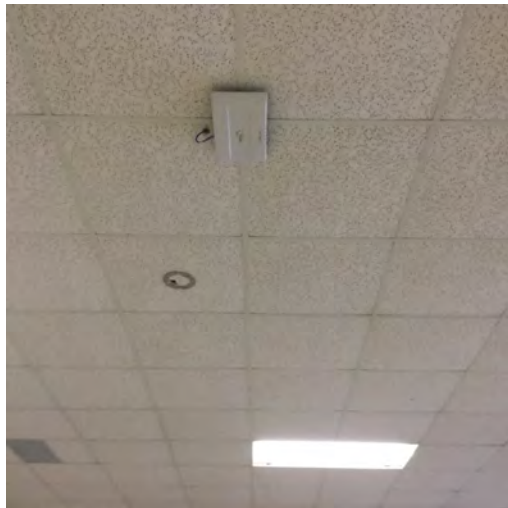
**System: D5030920 - Data Communication**

**Location:** Throughout the building  
**Distress:** Inadequate  
**Category:** Deferred Maintenance  
**Priority:** 3 - Necessary/Not Yet Critical (Years 2-5)  
**Correction:** Renew System  
**Qty:** 27,130.00  
**Unit of Measure:** S.F.  
**Estimate:** \$131,309.00  
**Assessor Name:** Eduardo Lopez  
**Date Created:** 12/08/2016

**Notes:** The principal reports that Wi-Fi coverage is weak at spots throughout the building. System renewal is recommended.

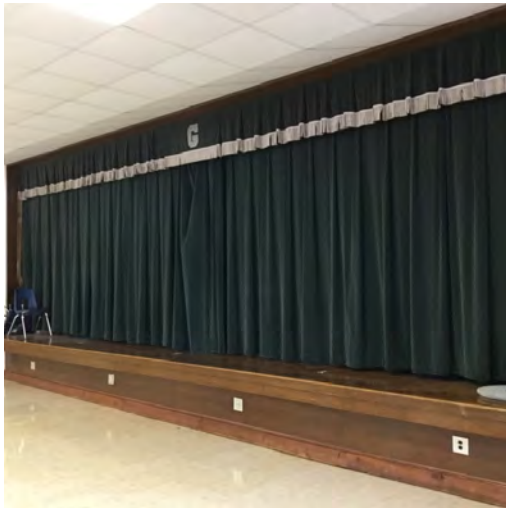
**System: E1020 - Institutional Equipment**

**Location:** Cafeteria stage  
**Distress:** Missing  
**Category:** Deferred Maintenance  
**Priority:** 3 - Necessary/Not Yet Critical (Years 2-5)  
**Correction:** Renew System  
**Qty:** 27,130.00  
**Unit of Measure:** S.F.  
**Estimate:** \$8,953.00  
**Assessor Name:** Eduardo Lopez  
**Date Created:** 12/08/2016

**Notes:** The stage curtain is beyond its expected life and is in poor condition. There is no stage lighting or sound system. System renewal/upgrading is recommended.

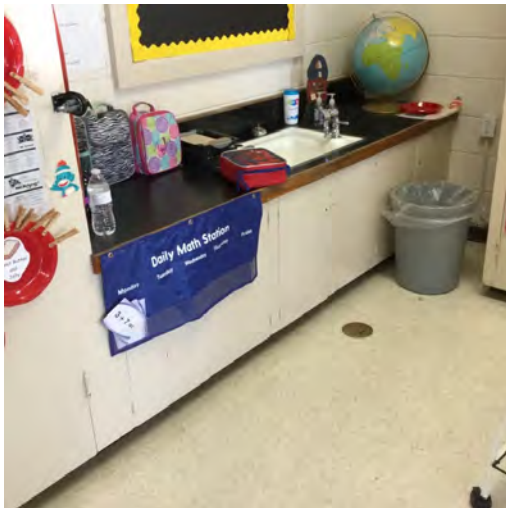
**System: E2010 - Fixed Furnishings**

**Location:** Throughout the building.  
**Distress:** Beyond Service Life  
**Category:** Deferred Maintenance  
**Priority:** 3 - Necessary/Not Yet Critical (Years 2-5)  
**Correction:** Renew System  
**Qty:** 27,130.00  
**Unit of Measure:** S.F.  
**Estimate:** \$173,985.00  
**Assessor Name:** Eduardo Lopez  
**Date Created:** 12/08/2016

**Notes:** Fixed furnishings have exceeded their expected useful life and are in generally poor condition.. System renewal is recommended.

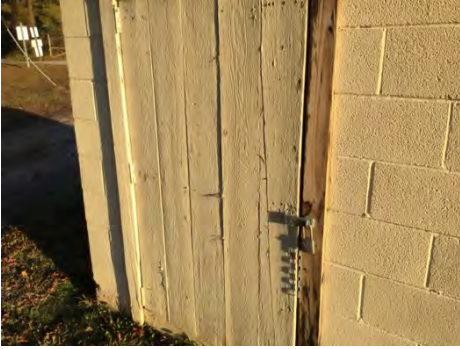
**System:** B2030 - Exterior Doors

**Notes:** The exterior door is in very aged condition, hardware does not function properly, and system replacement is recommended to ensure a secure building.

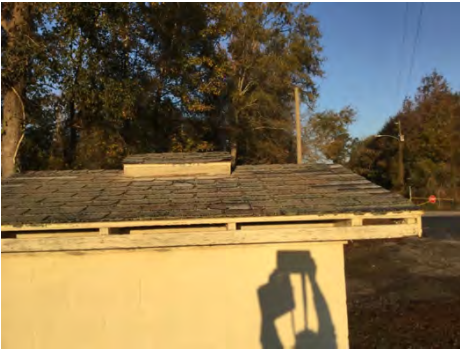
**System:** B3010140 - Asphalt Shingles

**Notes:** Asphalt shingles are in very poor condition with curled edges, broken tile and loss of granules. Replacement is recommended to ensure a waterproof enclosure

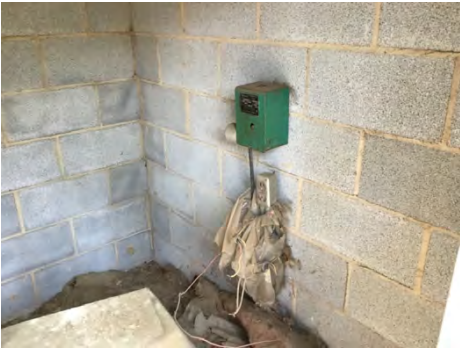
**System:** D5020 - Branch Wiring

**Notes:** The branch wiring system is expired and replacement is recommended.

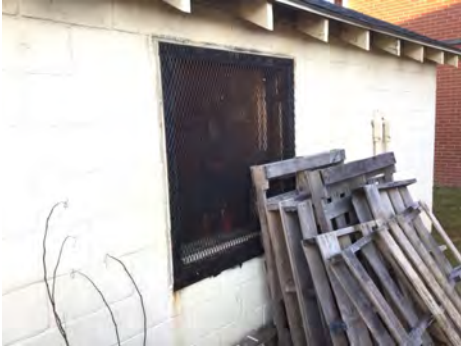
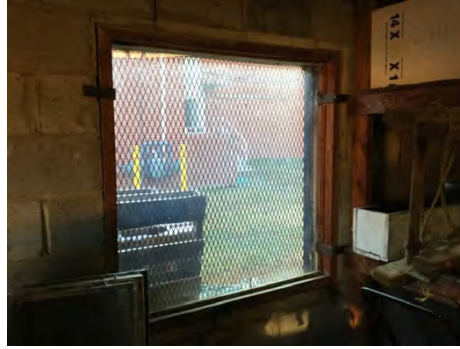
**System:** B2020 - Exterior Windows

**Notes:** The exterior window is original and in poor condition. Replacement is recommended.

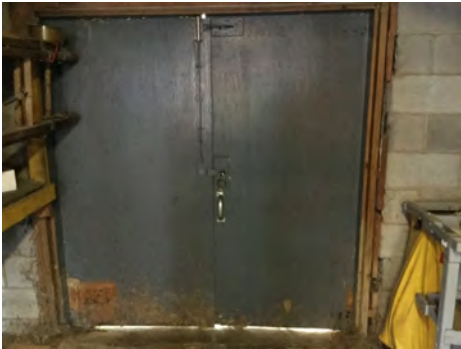
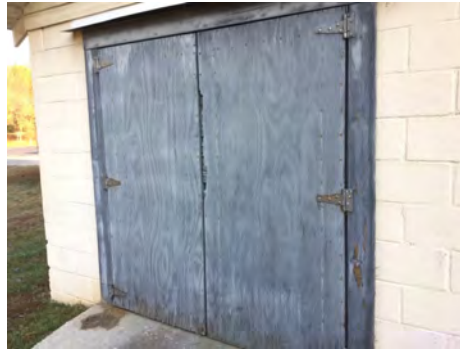
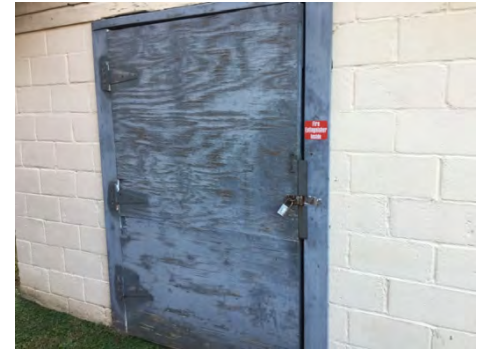
**System:** B2030 - Exterior Doors

**Notes:** Exterior doors are in very poor condition and replacement is recommended to secure the building.

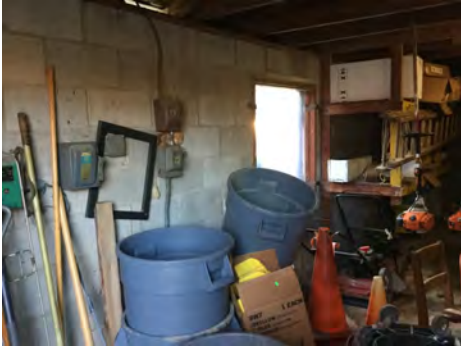
**System:** C1030 - Fittings

**Note:** Storage shelving is performing adequately for its intended purpose. System renewal pushed out.

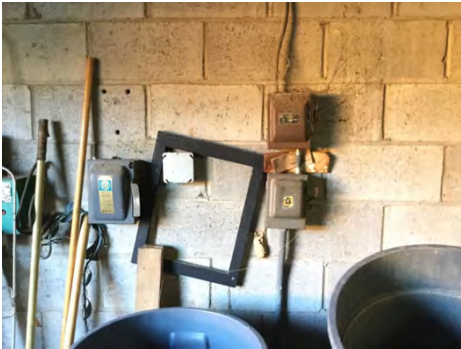
**System:** D5010 - Electrical Service/Distribution

**Notes:** The electric service appears to be original and is expired. System renewal is recommended.

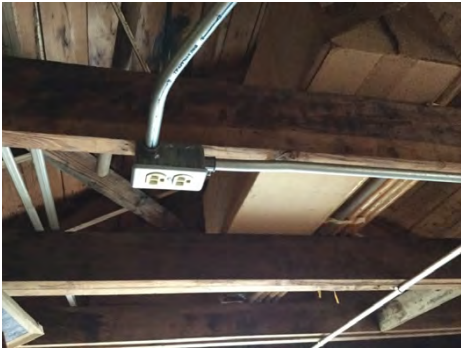
**System:** D5020 - Branch Wiring

**Notes:** Branch wiring is expired. System renewal is recommended.

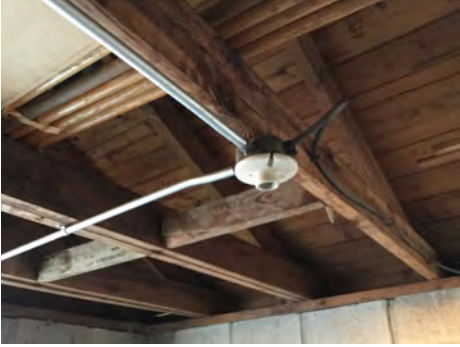
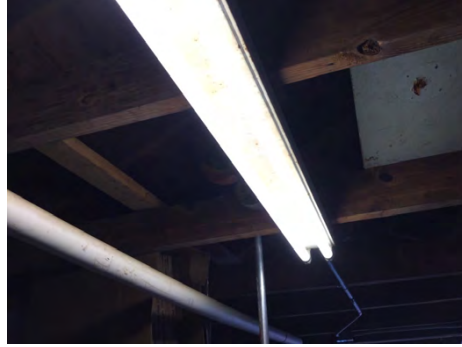
**System:** D5020 - Lighting

**Notes:** Building lighting is not energy efficient. System replacement is recommended.

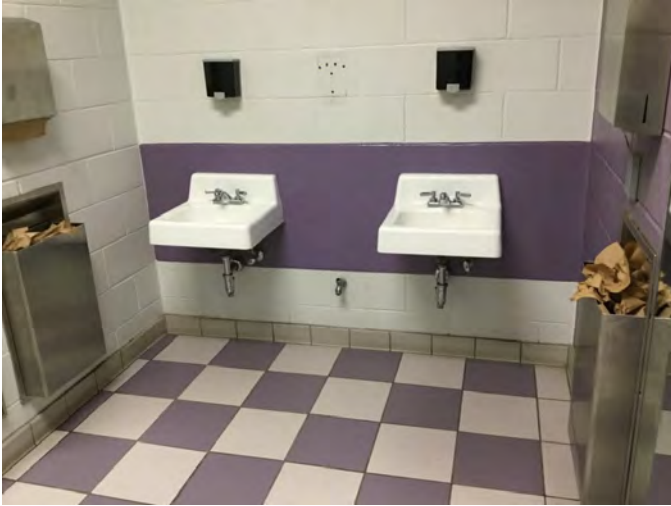
#### System: C3010 - Wall Finishes

**Location:** Throughout the building  
**Distress:** Beyond Service Life  
**Category:** Deferred Maintenance  
**Priority:** 3 - Necessary/Not Yet Critical (Years 2-5)  
**Correction:** Renew System  
**Qty:** 2,970.00  
**Unit of Measure:** S.F.  
**Estimate:** \$9,115.00  
**Assessor Name:** Eduardo Lopez  
**Date Created:** 12/08/2016

**Notes:** Wall finishes are beyond their expected service life.
