NC School District/430 Harnett County/Elementary School

Highland Elementary

Campus Assessment Report

March 11, 2017

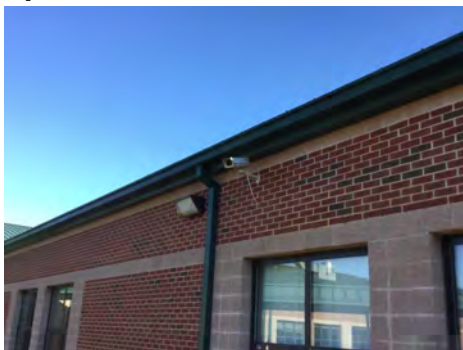
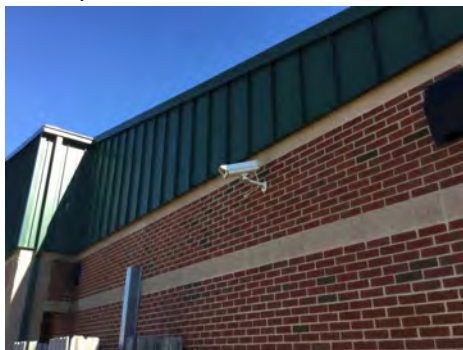
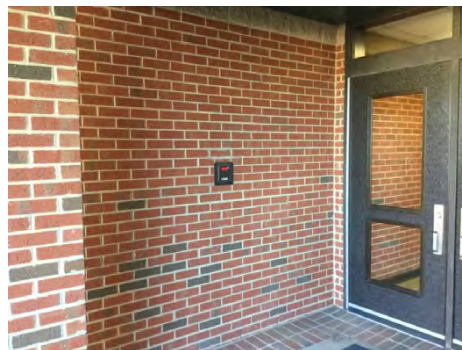
System: G4030 - Site Communications & Security

Notes: Security system is aged, analog cameras should be replaced with digital and key-card access added to exterior doors.
