NC School District/430 Harnett County/Elementary School

North Harnett Primary

Campus Assessment Report

March 11, 2017

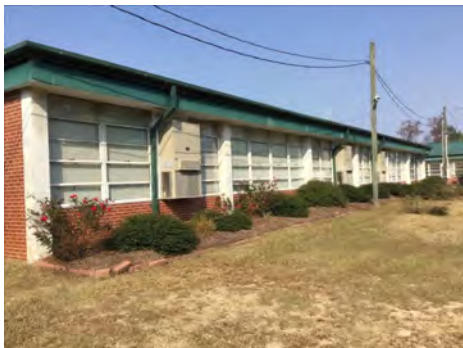
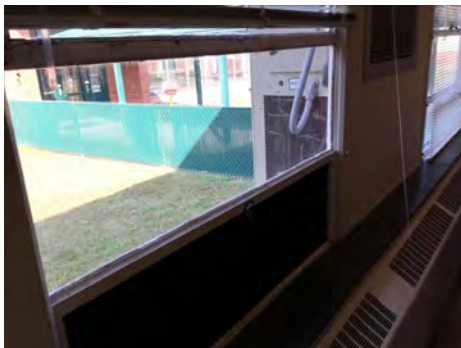
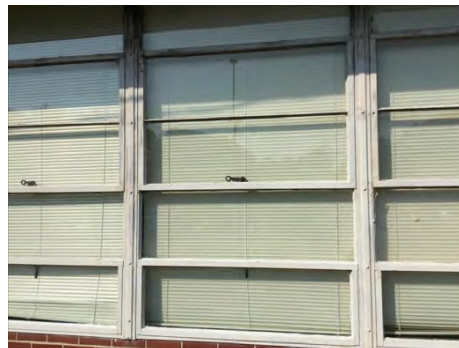
System: B2020 - Exterior Windows

Notes: The aluminum frame, operable, single pane plexi windows are aged, rusted, not energy efficient, and should be replaced.

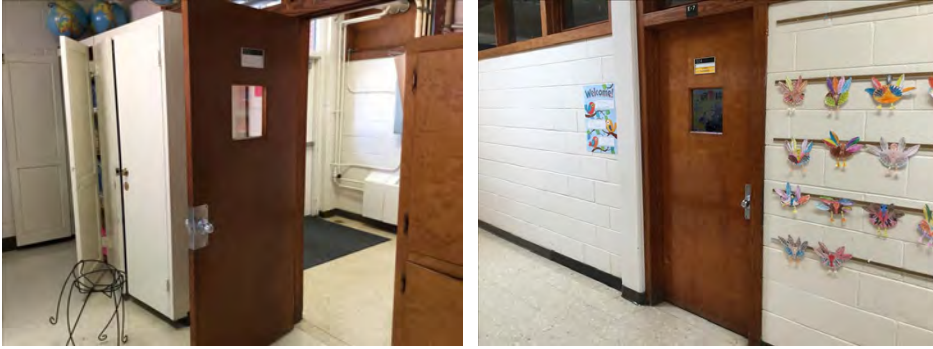
System: C1020 - Interior Doors

Notes: The interior doors are aged, failing, hardware is not ADA compliant and should be replaced.

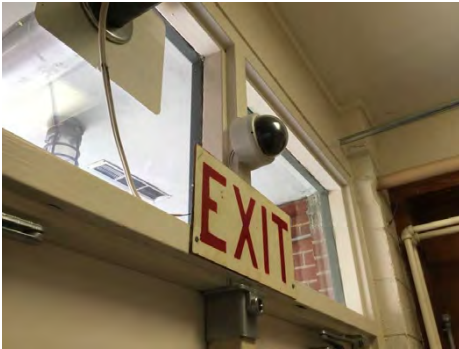
System: C1030 - Fittings

Notes: The fittings throughout the building are aged, in marginal condition, handrails and room signage are ADA non-compliance and system should be replaced.

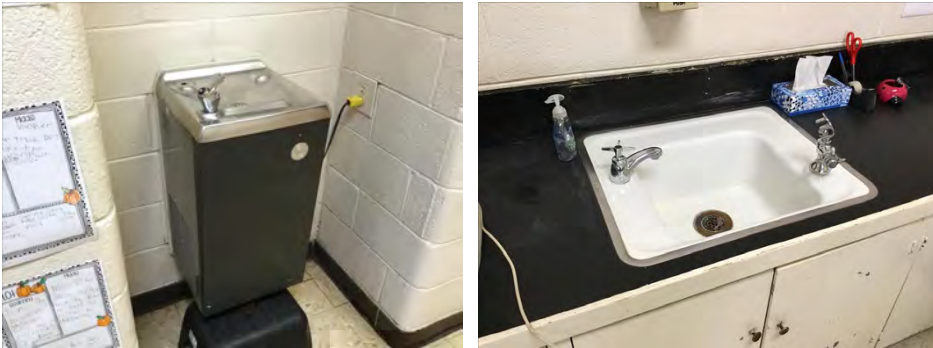
System: D2010 - Plumbing Fixtures

Notes: Plumbing fixtures are in operational conditions. However, they are aged, not ADA compliant and should be replaced with a low-flow water fixtures.

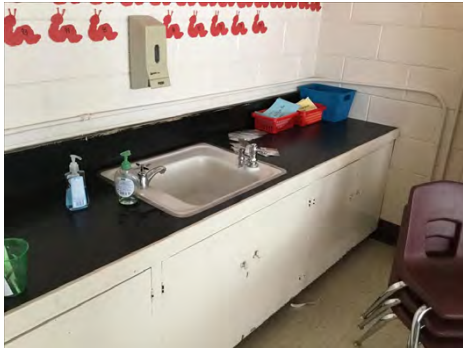
System: D2020 - Domestic Water Distribution

Notes: The domestic water distribution system is aged and should be replaced.

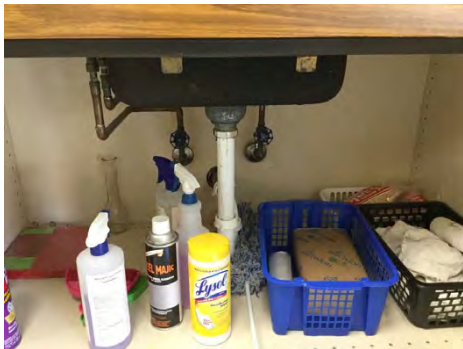
System: D2030 - Sanitary Waste

Notes: The sanitary waste system is aged, has reported periodic failures, and should be replaced.

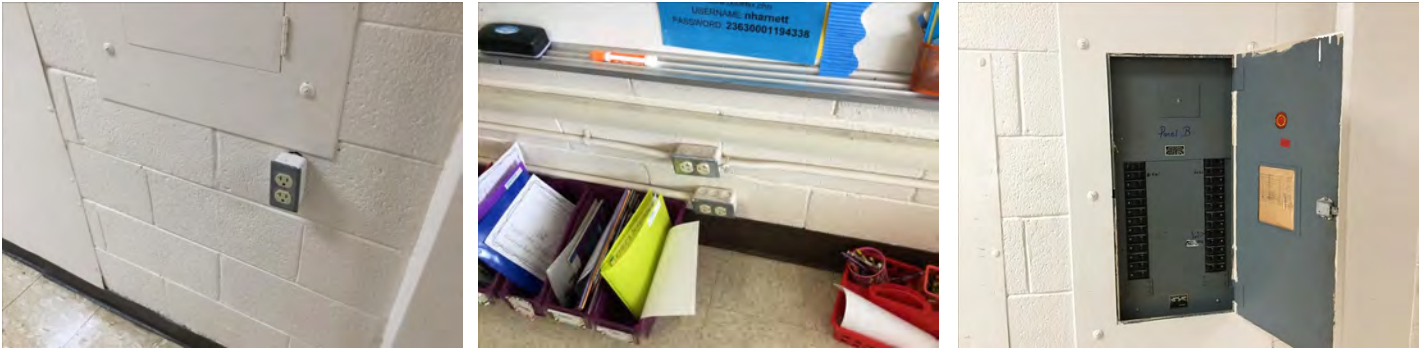
System: D5020 - Branch Wiring

Notes: The original branch wiring system is operating, but is aged, in poor condition, and should be replaced.

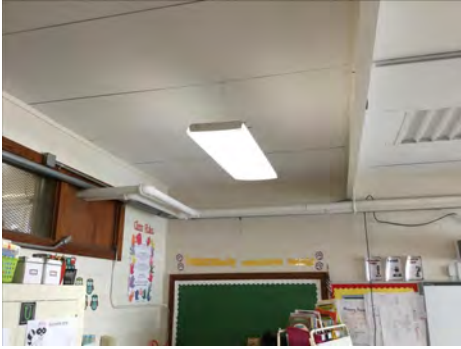
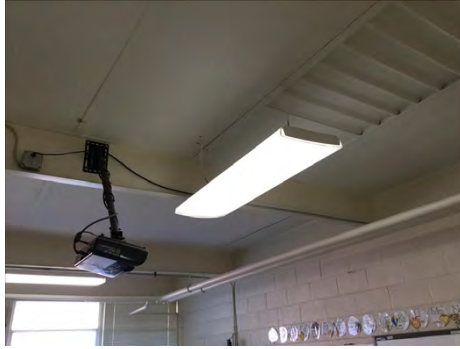
System: D5020 - Lighting

Notes: The lighting system is operating, but is aged, in poor condition, and should be replaced.

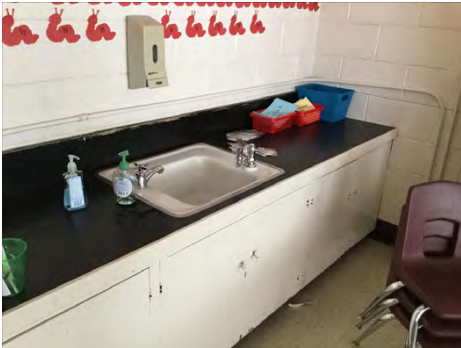
System: E2010 - Fixed Furnishings

Notes: The fixed furnishings are aged, in marginal condition, and should be replaced.

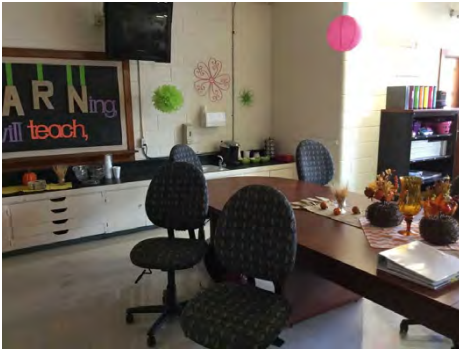
System: E2010 - Fixed Furnishings

Notes: The original fixed furnishings are aged and failing and should be replaced.

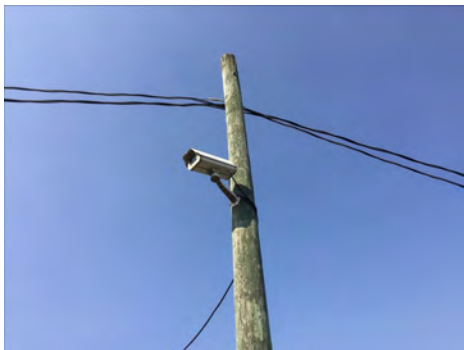
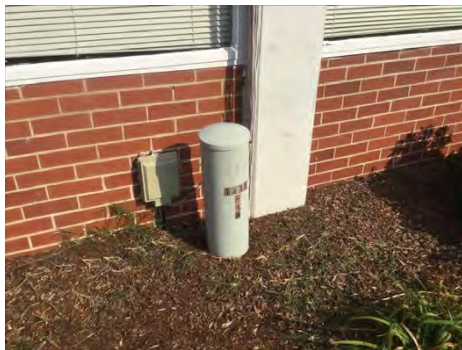
System: G4030 - Site Communications & Security

Notes: Site security cameras are aged and not adequate and should be replaced.
