NC School District/430 Harnett County/Elementary School

Overhills Elementary

Campus Assessment Report

March 11, 2017

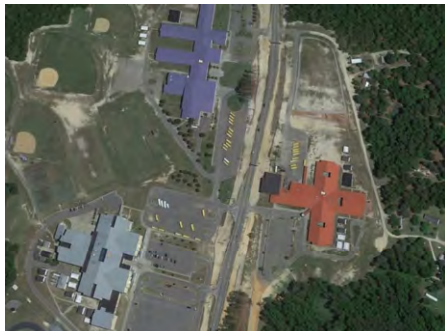
- 1). Aerial Image of Overhills Elementary School - Mar 03, 2017

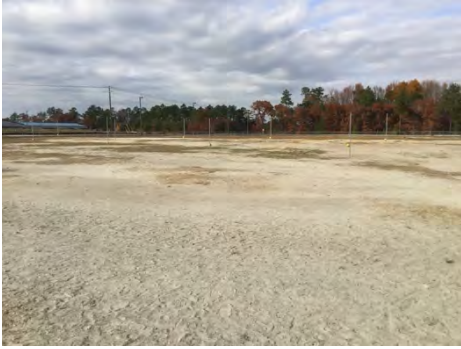
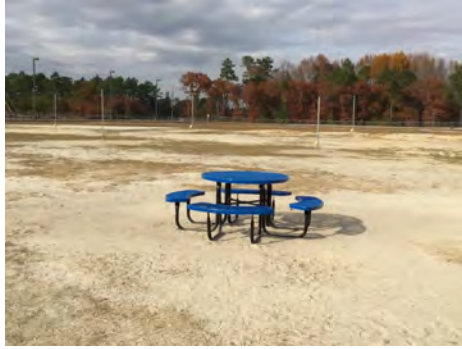
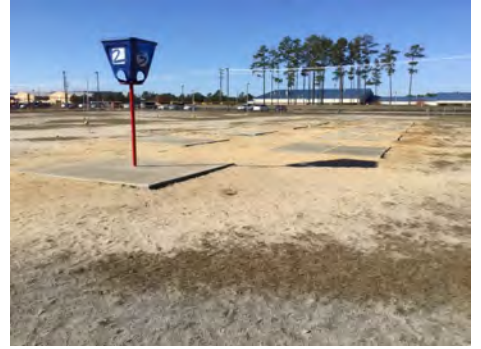
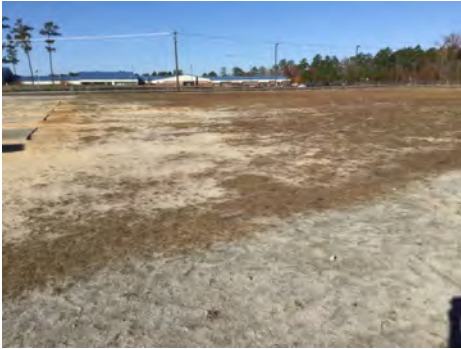
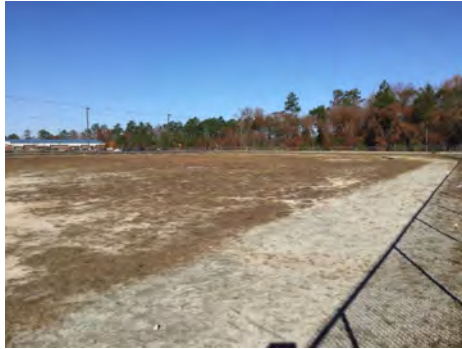
System: G2040950 - Playing Field

Notes: The playing field is in poor conditions, and should be re-sodded to prevent further erosion.
