NC School District/430 Harnett County/High School

Harnett Central High

Campus Assessment Report

March 11, 2017

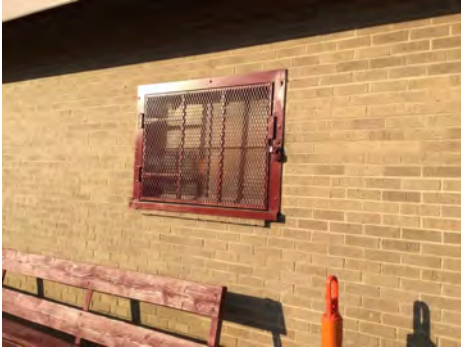
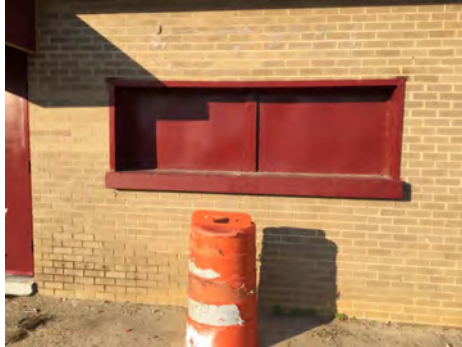
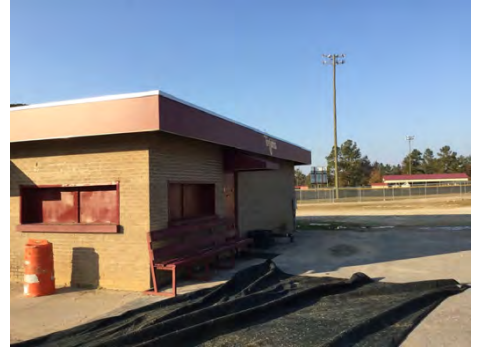
System: B2020 - Exterior Windows

Notes: The single pane windows are aged, not energy efficient, and should be replaced.

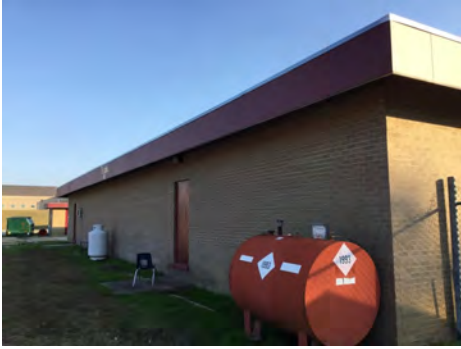
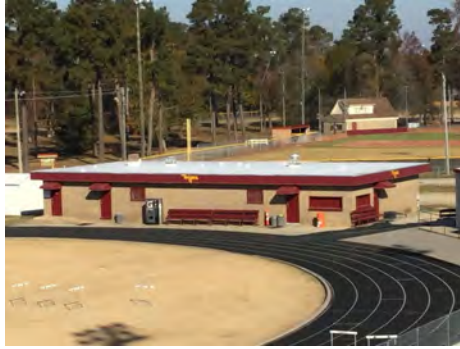
System: B3010120 - Single Ply Membrane

Notes: The roof coverings are aging, showing signs of failure and should be replaced.

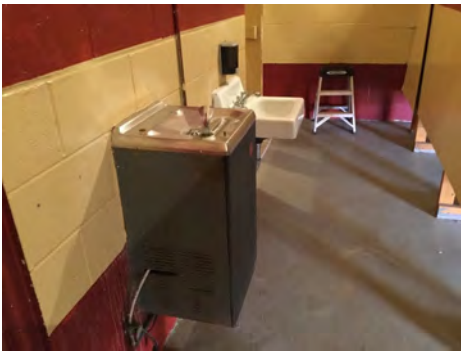
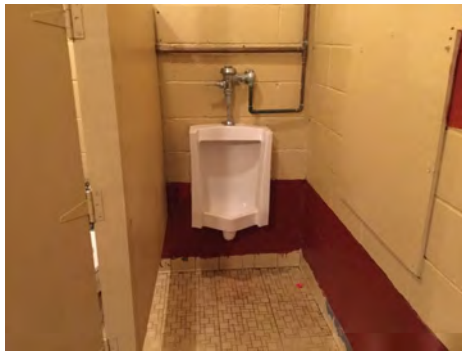
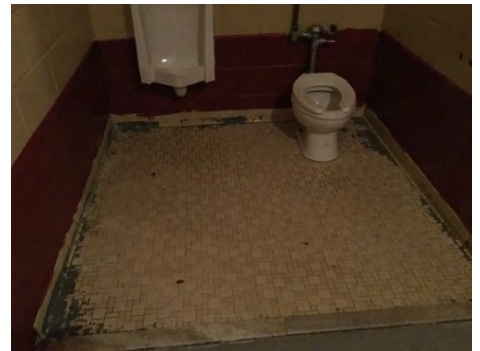
System: D2010 - Plumbing Fixtures

Notes: Plumbing fixtures are in operational conditions. However, they are aged, not ADA compliant and should be replaced with a low-flow water fixtures.

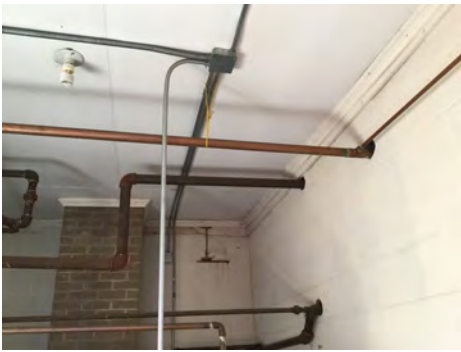
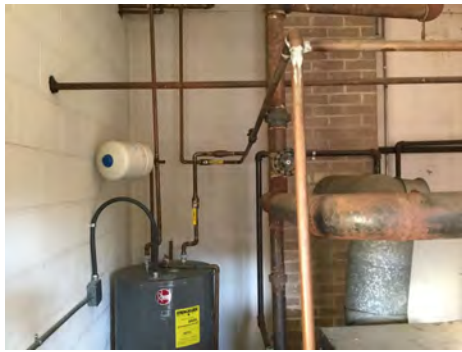
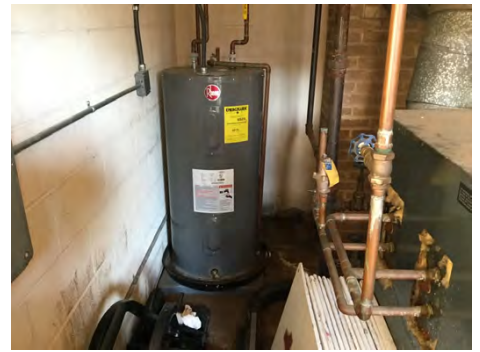
System: D2020 - Domestic Water Distribution

Notes: There are no reported issues or observed deficiencies with the domestic water piping. Due to the age of the pipe there can be internal pitting corrosion that may be a costly problem that leads to the formation of pinhole leaks and possible water contamination.

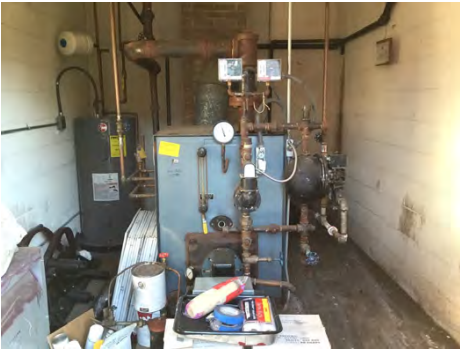
System: D3020 - Heat Generating Systems

Notes: The gas-fired boilers are operating properly and are in fair condition but; are aging, inefficient, becoming logistically unsupportable, and should be replaced with energy efficient models.

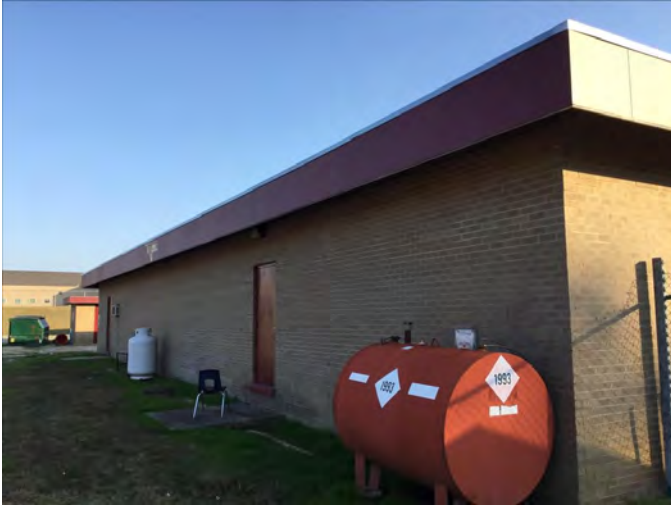
System: B3010120 - Single Ply Membrane

Location: Roof

Distress: Beyond Service Life

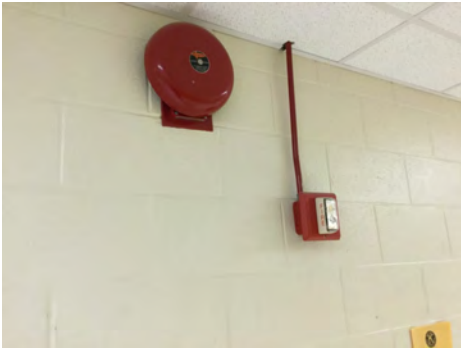
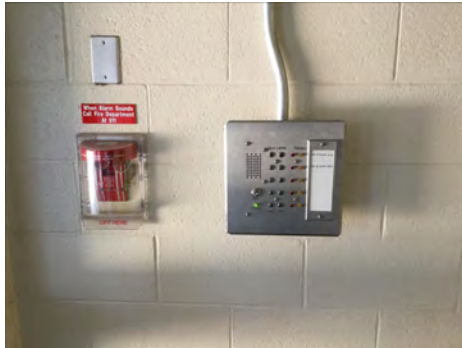
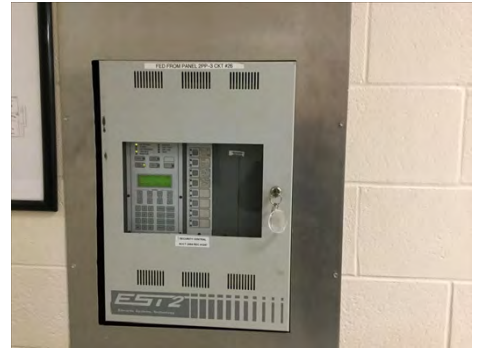
System: D5030910 - Fire & Alarm Systems

Notes: The original fire alarm system is aged, and should be replaced.

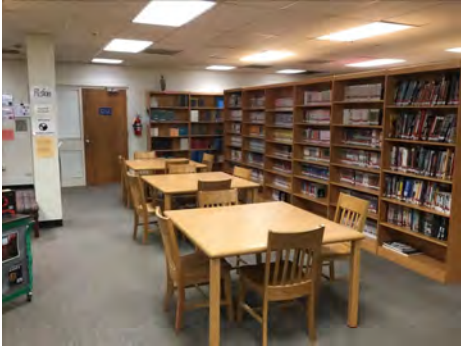
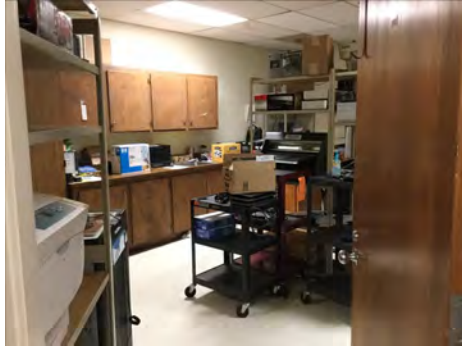
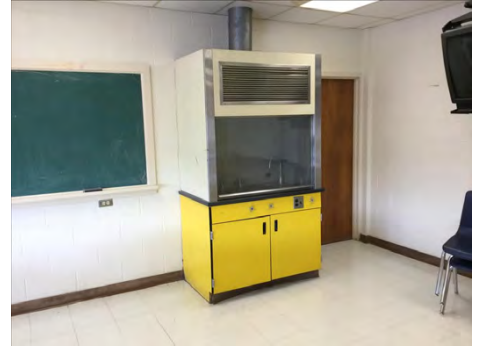
System: E2010 - Fixed Furnishings

Notes: The fixed furnishings are aged, in marginal condition, and should be replaced.

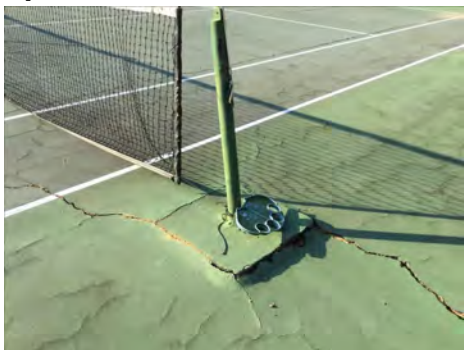
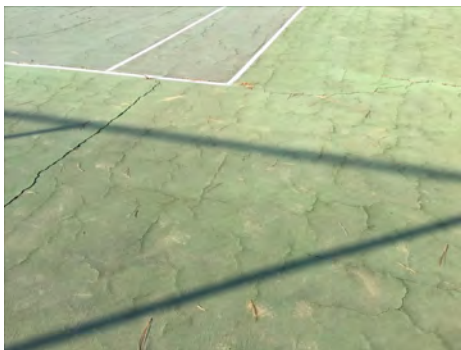
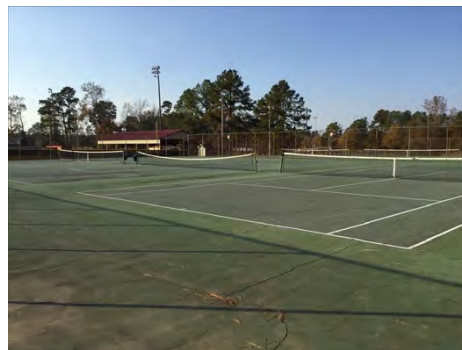
System: G2040950 - Tennis Courts

Location: East of the school
Distress: Damaged
Category: Safety
Priority: 1 - Currently Critical (Immediate)
Correction: Renew System
Qty: 208,181.00
Unit of Measure: S.F.
Estimate: \$412,198.00
Assessor Name: Eduardo Lopez
Date Created: 11/22/2016

Notes: The tennis courts are cracking and unsafe.
