NC School District/430 Harnett County/High School

Western Harnett High

Campus Assessment Report

March 11, 2017

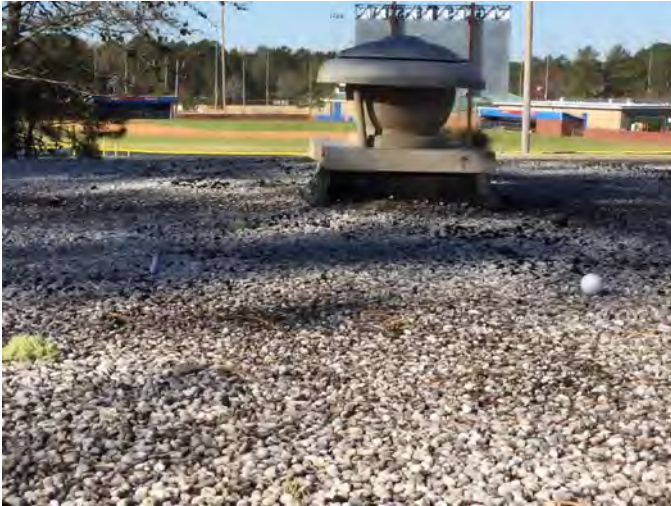
System: B3010105 - Built-Up

Location: Roof
Distress: Beyond Service Life
Category: Deferred Maintenance
Priority: 3 - Necessary/Not Yet Critical (Years 2-5)
Correction: Renew System
Qty: 3,200.00
Unit of Measure: S.F.
Estimate: \$39,523.00
Assessor Name: Eduardo Lopez
Date Created: 12/06/2016

Notes: The Built-up roof covering is in deteriorating conditions and should be scheduled for replacement.

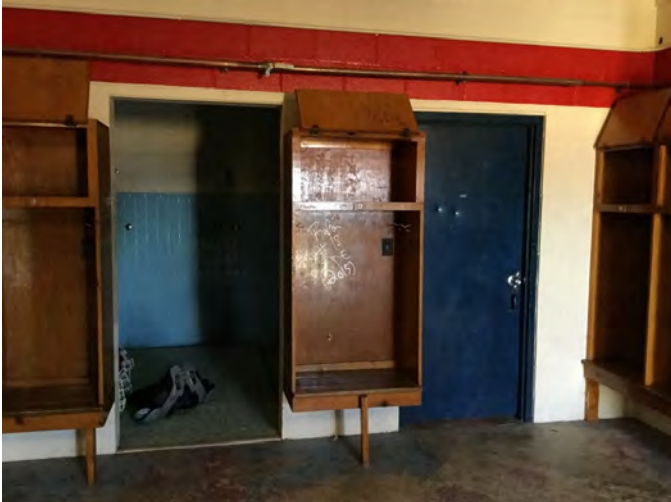
System: C1020 - Interior Doors

Location: Throughout the Building
Distress: Beyond Service Life
Category: Deferred Maintenance / Accessibility Code Compliance
Priority: 3 - Necessary/Not Yet Critical (Years 2-5)
Correction: Renew System
Qty: 3,200.00
Unit of Measure: S.F.
Estimate: \$7,744.00
Assessor Name: Eduardo Lopez
Date Created: 11/23/2016

Notes: The interior doors are aged, failing, hardware is not ADA or code compliant and should be replaced.

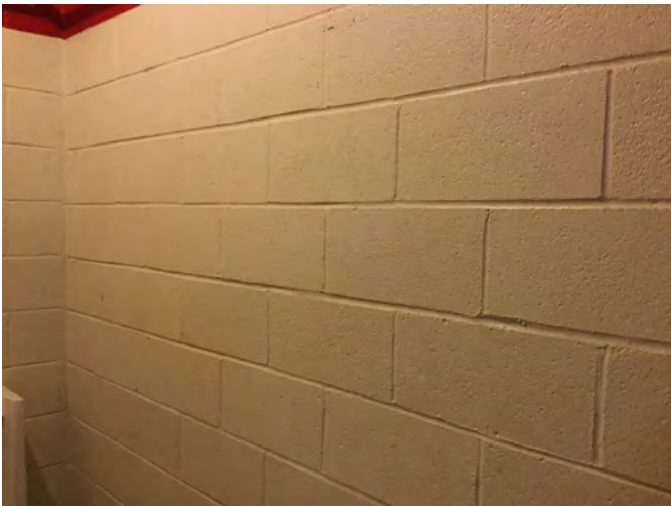
System: C3010 - Wall Finishes

Location: Throughout the Building
Distress: Beyond Service Life
Category: Deferred Maintenance
Priority: 3 - Necessary/Not Yet Critical (Years 2-5)
Correction: Renew System
Qty: 3,200.00
Unit of Measure: S.F.
Estimate: \$26,259.00
Assessor Name: Eduardo Lopez
Date Created: 11/17/2016

Notes: The wall finishes are aged, scuffed, fading, stained and should be repainted.

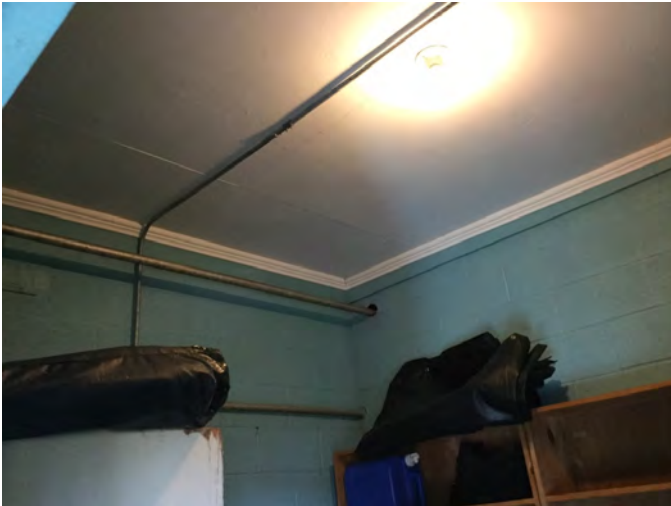
System: C3030 - Ceiling Finishes

Location: Throughout the Building
Distress: Beyond Service Life
Category: Deferred Maintenance
Priority: 3 - Necessary/Not Yet Critical (Years 2-5)
Correction: Renew System
Qty: 3,200.00
Unit of Measure: S.F.
Estimate: \$33,546.00
Assessor Name: Eduardo Lopez
Date Created: 11/23/2016

Notes: The original ceiling finishes are aged, failing and should be replaced.

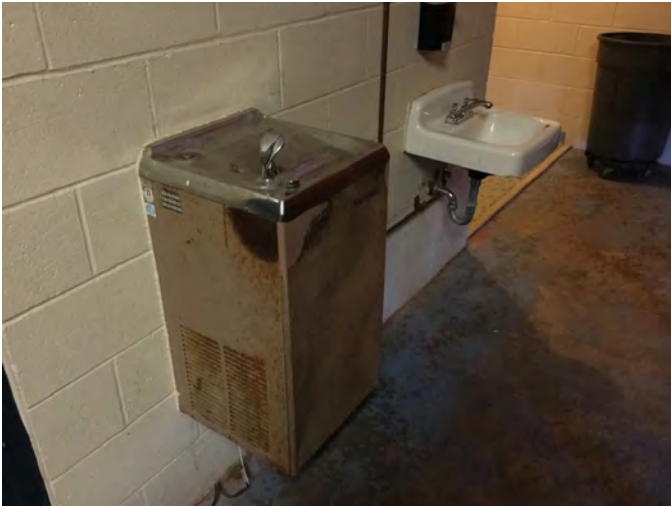
System: D2010 - Plumbing Fixtures

Location: Throughout the Building
Distress: Beyond Service Life
Category: Deferred Maintenance / Accessibility Code Compliance
Priority: 3 - Necessary/Not Yet Critical (Years 2-5)
Correction: Renew System
Qty: 3,200.00
Unit of Measure: S.F.
Estimate: \$35,130.00
Assessor Name: Eduardo Lopez
Date Created: 11/23/2016

Notes: Plumbing fixtures are in operational conditions. However, they are aged, not ADA compliant, and should be scheduled for replacement.

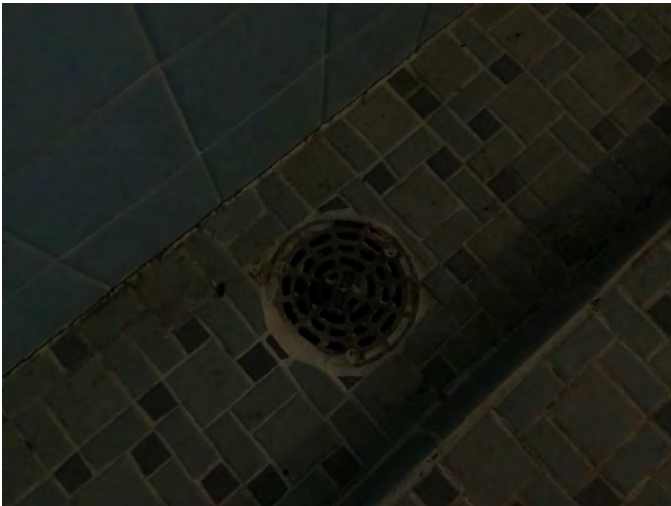
System: D2030 - Sanitary Waste

Location: Throughout the Building
Distress: Beyond Service Life
Category: Deferred Maintenance
Priority: 3 - Necessary/Not Yet Critical (Years 2-5)
Correction: Renew System
Qty: 3,200.00
Unit of Measure: S.F.
Estimate: \$20,909.00
Assessor Name: Eduardo Lopez
Date Created: 11/23/2016

Notes: The sanitary waste system is beyond its expected service life and should be replaced.

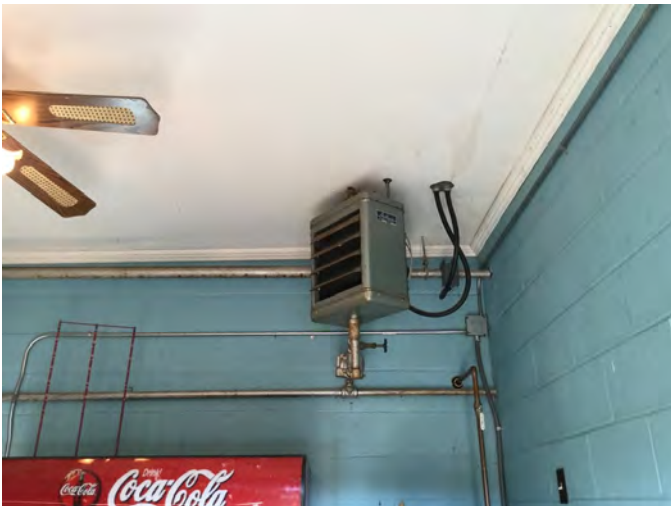
System: D3050 - Terminal & Package Units

Location: Throughout the Building
Distress: Beyond Service Life
Category: Deferred Maintenance
Priority: 3 - Necessary/Not Yet Critical (Years 2-5)
Correction: Renew System
Qty: 3,200.00
Unit of Measure: S.F.
Estimate: \$59,699.00
Assessor Name: Eduardo Lopez
Date Created: 11/17/2016

Notes: Terminal and package units are beyond their expected service life and should be scheduled for replacement.

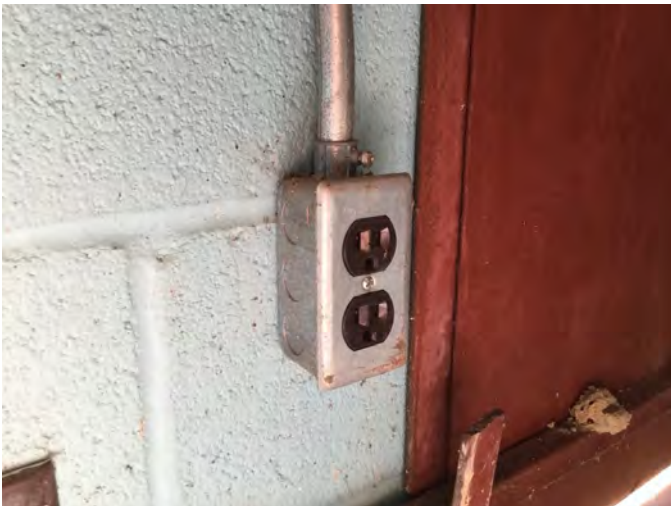
System: D5020 - Branch Wiring

Location: Throughout the Building
Distress: Beyond Service Life
Category: Deferred Maintenance
Priority: 3 - Necessary/Not Yet Critical (Years 2-5)
Correction: Renew System
Qty: 3,200.00
Unit of Measure: S.F.
Estimate: \$8,976.00
Assessor Name: Eduardo Lopez
Date Created: 11/23/2016

Notes: The original branch wiring system is operating but is aged, in marginal condition, and should be replaced.

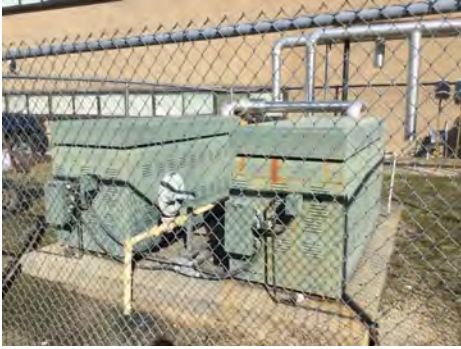
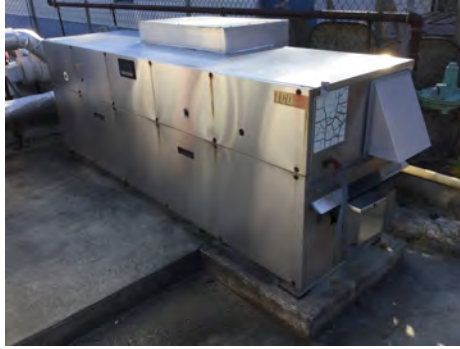
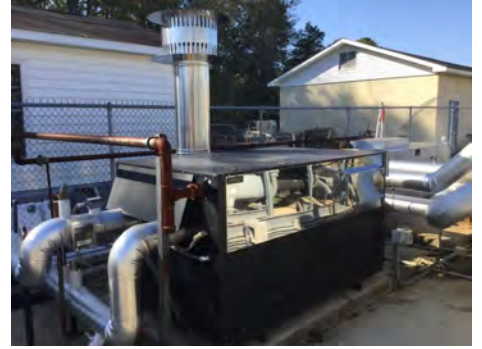
System: D3020 - Heat Generating Systems

Note: (2) Boilers dated 1999 are scheduled for replacement, (2) more boilers dated 2004 and 2009

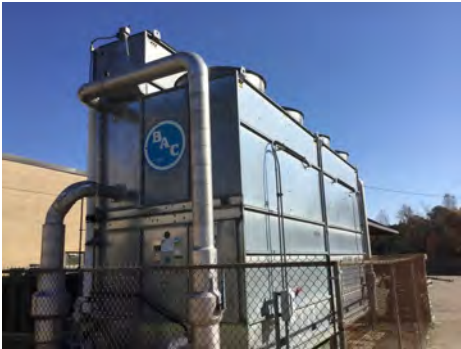
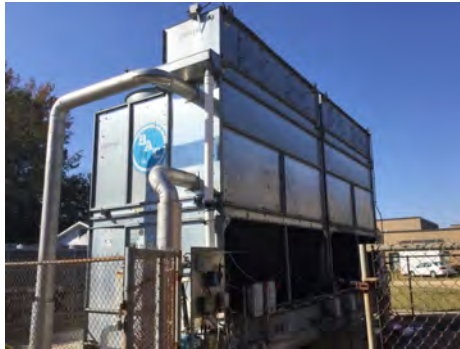
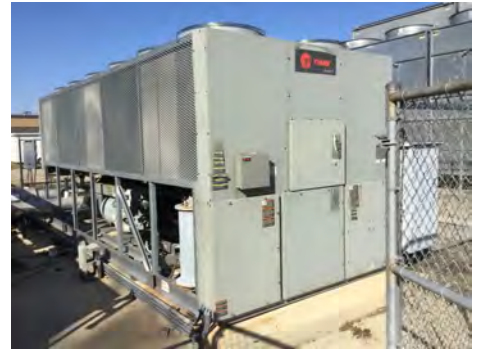
System: D3030 - Cooling Generating Systems

Note: Air cooled chiller was installed around 2009 and Cooling Tower around 2002

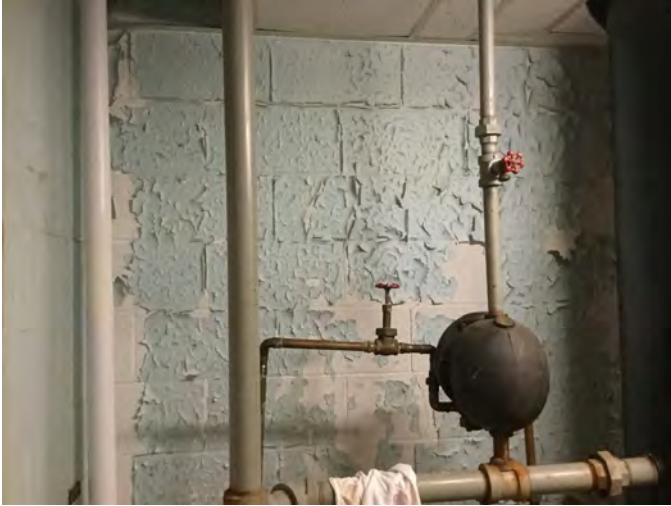
System: C3010 - Wall Finishes

Location: Mech Rm 713 and Storage Rm 711

Distress: Failing

Notes: The wall finishes are aged, peeling and cracking, and should be replaced.

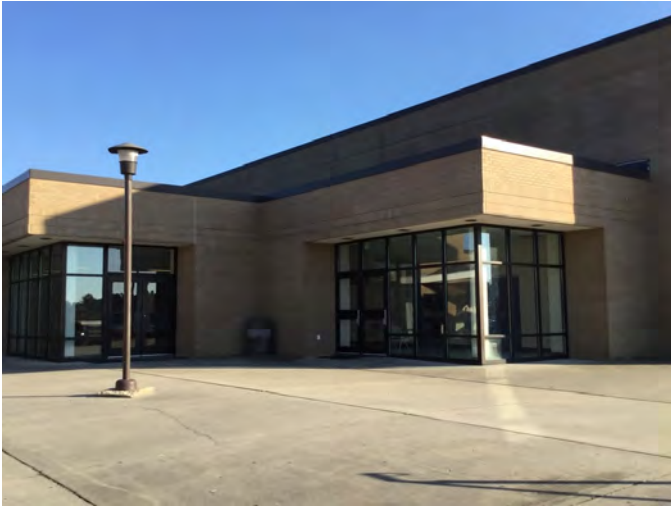
System: B2020 - Exterior Windows

Location: Exterior Walls
Distress: Beyond Service Life
Category: Deferred Maintenance / Energy
Priority: 3 - Necessary/Not Yet Critical (Years 2-5)
Correction: Renew System
Qty: 130,900.00
Unit of Measure: S.F.
Estimate: \$1,840,192.00
Assessor Name: Eduardo Lopez
Date Created: 11/16/2016

Notes: The exterior windows are aged, not energy efficient and should be replaced.

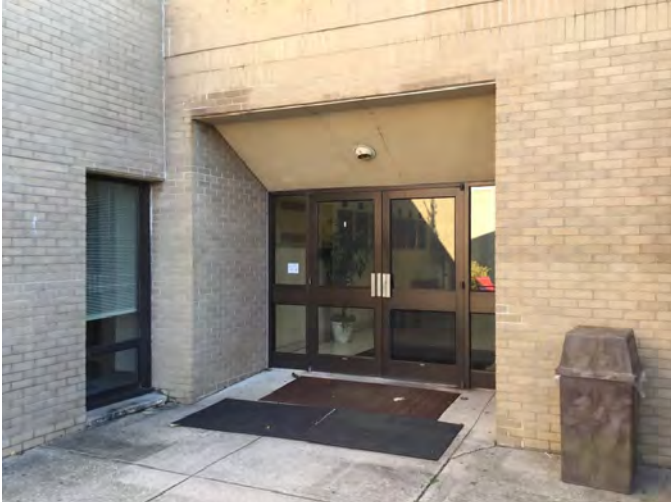
System: B2030 - Exterior Doors

Location: Exterior Walls
Distress: Beyond Service Life
Category: Deferred Maintenance
Priority: 3 - Necessary/Not Yet Critical (Years 2-5)
Correction: Renew System
Qty: 130,900.00
Unit of Measure: S.F.
Estimate: \$116,632.00
Assessor Name: Eduardo Lopez
Date Created: 11/16/2016

Notes: The exterior doors are aged, beyond service life and should be replaced.

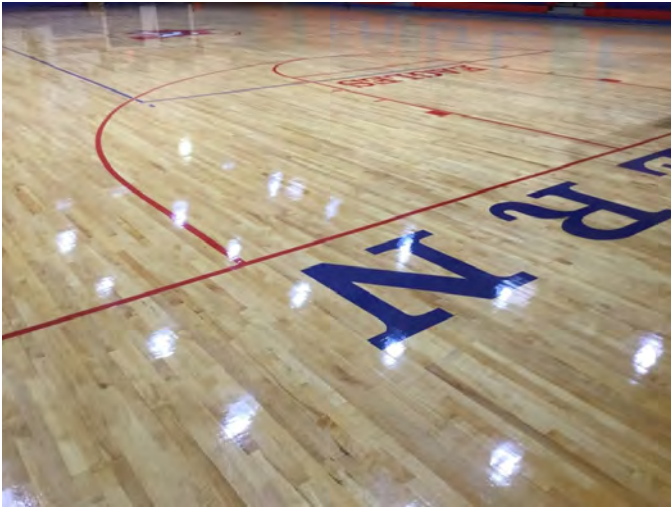
System: C3020 - Floor Finishes

Location: Throughout the Building
Distress: Beyond Service Life
Category: Deferred Maintenance
Priority: 3 - Necessary/Not Yet Critical (Years 2-5)
Correction: Renew System
Qty: 130,900.00
Unit of Measure: S.F.
Estimate: \$1,575,251.00
Assessor Name: Eduardo Lopez
Date Created: 11/16/2016

Notes: The flooring is in poor conditions and should be replaced.

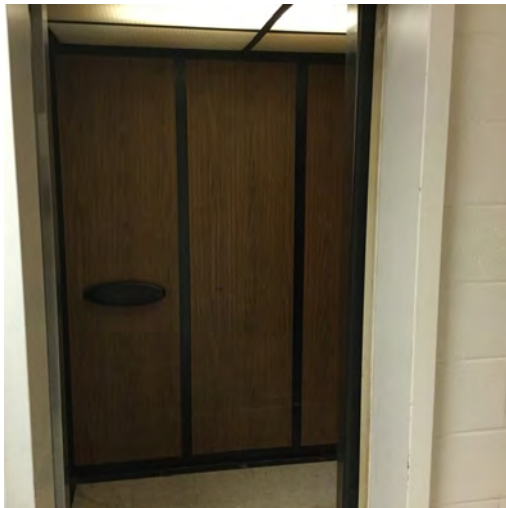
System: D1010 - Elevators and Lifts

Location: Throughout the Building
Distress: Beyond Service Life
Category: Deferred Maintenance / Building Code Compliance
Priority: 3 - Necessary/Not Yet Critical (Years 2-5)
Correction: Renew System
Qty: 130,900.00
Unit of Measure: S.F.
Estimate: \$141,110.00
Assessor Name: Eduardo Lopez
Date Created: 11/16/2016

Notes: The original elevator is operational, but is in poor condition, not ADA and code compliant and should be replaced.

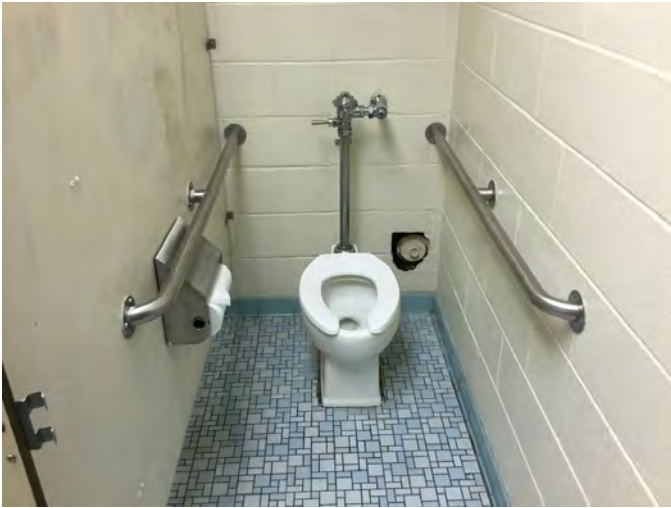
System: D2010 - Plumbing Fixtures

Location: Throughout the Building
Distress: Beyond Service Life
Category: Deferred Maintenance / Accessibility Code Compliance
Priority: 3 - Necessary/Not Yet Critical (Years 2-5)
Correction: Renew System
Qty: 130,900.00
Unit of Measure: S.F.
Estimate: \$1,271,432.00
Assessor Name: Eduardo Lopez
Date Created: 11/16/2016

Notes: Plumbing fixtures are in operational conditions. However, they are aged, not ADA compliant, and should be scheduled for replacement.

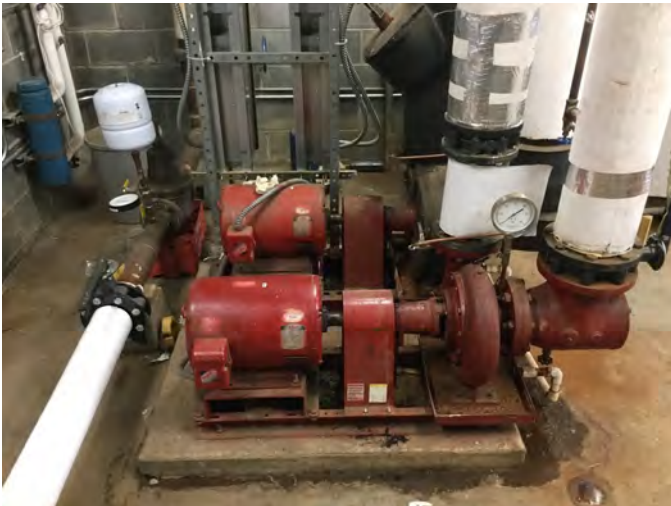
System: D2020 - Domestic Water Distribution

Location: Throughout the Building
Distress: Beyond Service Life
Category: Deferred Maintenance
Priority: 3 - Necessary/Not Yet Critical (Years 2-5)
Correction: Renew System
Qty: 130,900.00
Unit of Measure: S.F.
Estimate: \$236,144.00
Assessor Name: Eduardo Lopez
Date Created: 11/16/2016

Notes: The domestic water distribution system is aged and should be replaced.

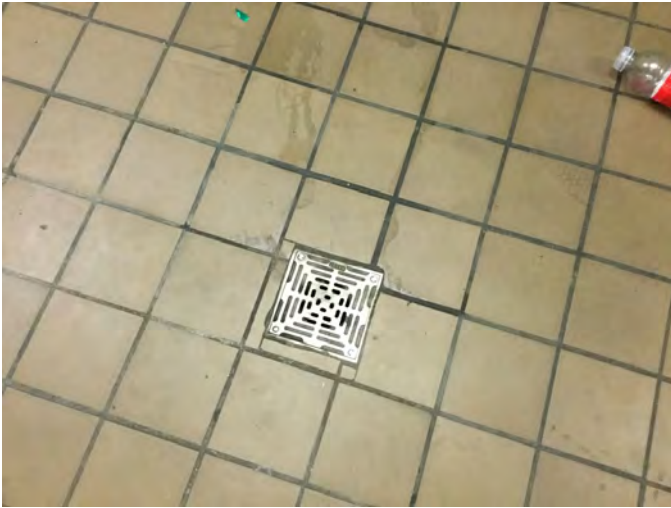
System: D2030 - Sanitary Waste

Location: Throughout the Building
Distress: Beyond Service Life
Category: Deferred Maintenance
Priority: 3 - Necessary/Not Yet Critical (Years 2-5)
Correction: Renew System
Qty: 130,900.00
Unit of Measure: S.F.
Estimate: \$372,934.00
Assessor Name: Eduardo Lopez
Date Created: 11/16/2016

Notes: The sanitary waste system is beyond its expected service life and should be replaced.

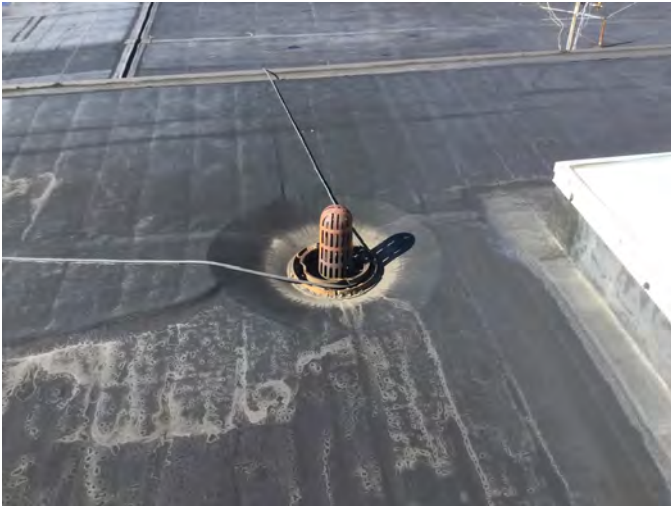
System: D2040 - Rain Water Drainage

Location: Throughout the Building
Distress: Beyond Service Life
Category: Deferred Maintenance
Priority: 3 - Necessary/Not Yet Critical (Years 2-5)
Correction: Renew System
Qty: 130,900.00
Unit of Measure: S.F.
Estimate: \$90,714.00
Assessor Name: Eduardo Lopez
Date Created: 11/16/2016

Notes: The rain water drainage system is aged and should be replaced.

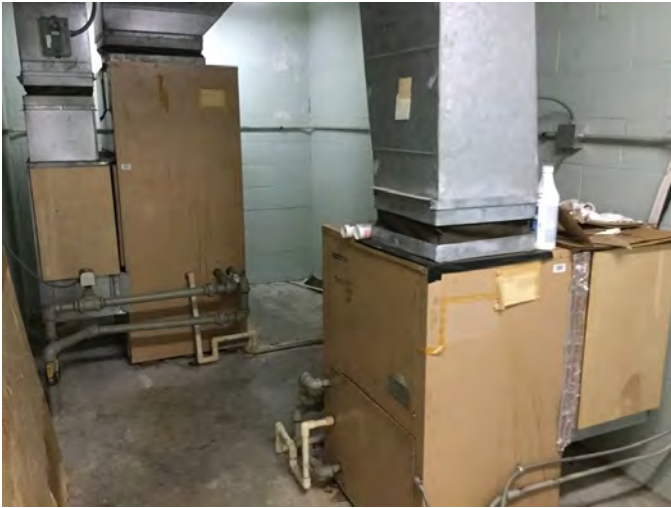
System: D3040 - Distribution Systems

Location: Throughout the Building
Distress: Beyond Service Life
Category: Deferred Maintenance
Priority: 3 - Necessary/Not Yet Critical (Years 2-5)
Correction: Renew System
Qty: 130,900.00
Unit of Measure: S.F.
Estimate: \$1,205,196.00
Assessor Name: Eduardo Lopez
Date Created: 11/16/2016

Notes: Distribution systems are aged, becoming logistically unsupportable, and should be replaced.

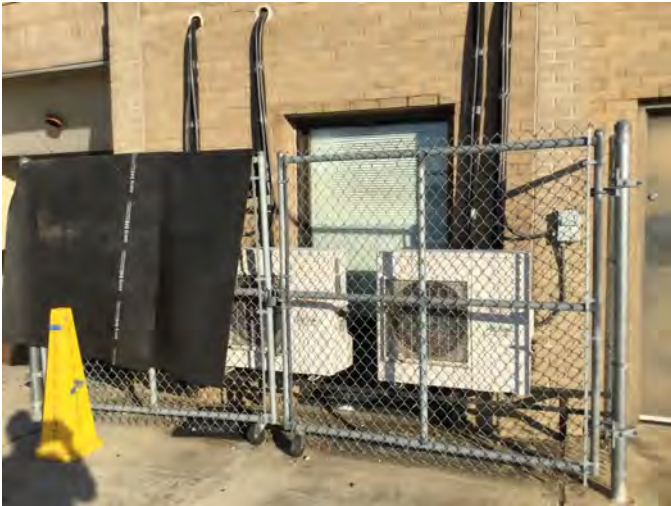
System: D3050 - Terminal & Package Units

Location: Throughout the Building
Distress: Beyond Service Life
Category: Deferred Maintenance
Priority: 3 - Necessary/Not Yet Critical (Years 2-5)
Correction: Renew System
Qty: 130,900.00
Unit of Measure: S.F.
Estimate: \$598,998.00
Assessor Name: Eduardo Lopez
Date Created: 11/16/2016

Notes: Terminal and package units are beyond their expected service life and should be scheduled for replacement.

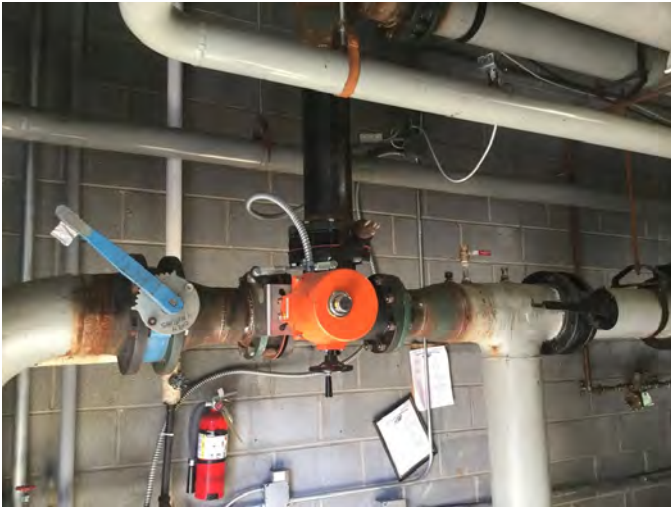
System: D3060 - Controls & Instrumentation

Location: Throughout the Building
Distress: Beyond Service Life
Category: Deferred Maintenance
Priority: 3 - Necessary/Not Yet Critical (Years 2-5)
Correction: Renew System
Qty: 130,900.00
Unit of Measure: S.F.
Estimate: \$381,574.00
Assessor Name: Eduardo Lopez
Date Created: 11/16/2016

Notes: The controls and instrumentation system is in marginal condition and should be schedule for replacement.

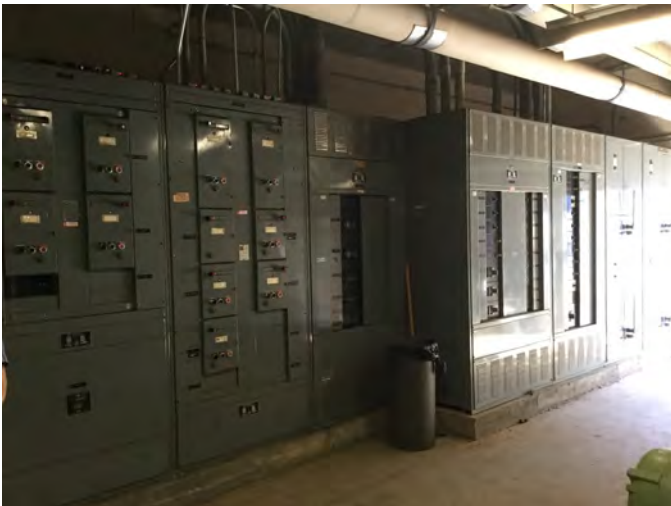
System: D5010 - Electrical Service/Distribution

Location: Throughout the Building
Distress: Beyond Service Life
Category: Deferred Maintenance
Priority: 3 - Necessary/Not Yet Critical (Years 2-5)
Correction: Renew System
Qty: 130,900.00
Unit of Measure: S.F.
Estimate: \$230,384.00
Assessor Name: Eduardo Lopez
Date Created: 11/16/2016

Notes: The original electrical service is operating but is in poor condition and should be replaced.

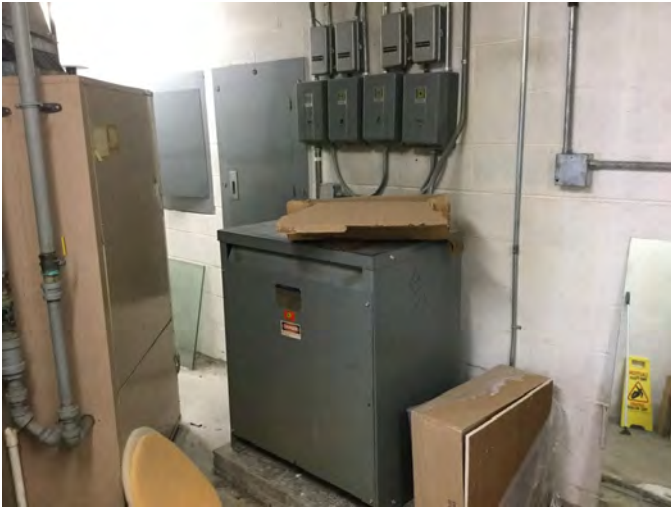
System: D5020 - Branch Wiring

Location: Throughout the Building
Distress: Beyond Service Life
Category: Deferred Maintenance
Priority: 3 - Necessary/Not Yet Critical (Years 2-5)
Correction: Renew System
Qty: 130,900.00
Unit of Measure: S.F.
Estimate: \$655,155.00
Assessor Name: Eduardo Lopez
Date Created: 11/16/2016

Notes: The original branch wiring system is operating but is aged, in marginal condition, and should be replaced.

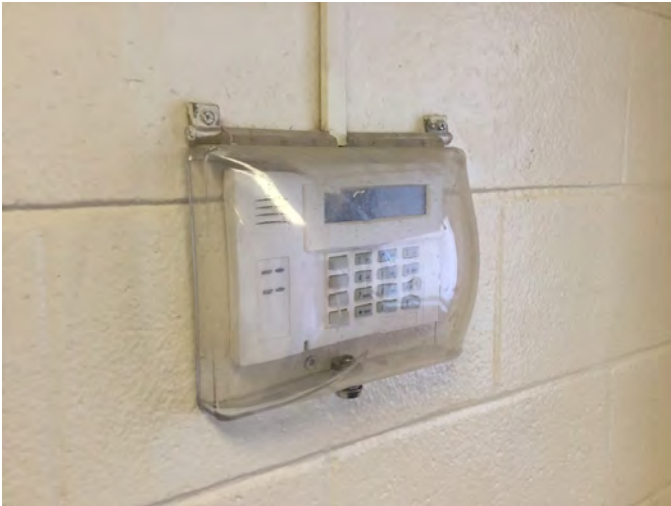
System: D5030810 - Security & Detection Systems

Location: Throughout the Building
Distress: Beyond Service Life
Category: Deferred Maintenance
Priority: 3 - Necessary/Not Yet Critical (Years 2-5)
Correction: Renew System
Qty: 130,900.00
Unit of Measure: S.F.
Estimate: \$283,660.00
Assessor Name: Eduardo Lopez
Date Created: 11/16/2016

Notes: The security & detection system is beyond its expected service life and should be scheduled for replacement.

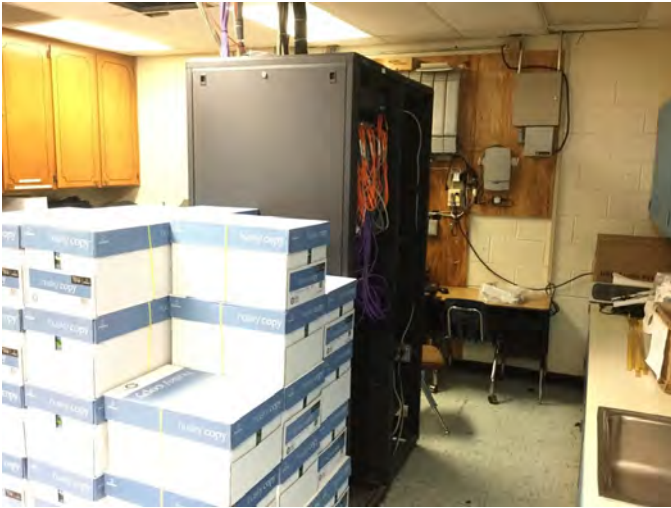
System: D5030920 - Data Communication

Location: Throughout the Building
Distress: Beyond Service Life
Category: Deferred Maintenance
Priority: 3 - Necessary/Not Yet Critical (Years 2-5)
Correction: Renew System
Qty: 130,900.00
Unit of Measure: S.F.
Estimate: \$663,794.00
Assessor Name: Eduardo Lopez
Date Created: 11/16/2016

Notes: The data communication system is beyond its expected service life and should be scheduled for replacement.

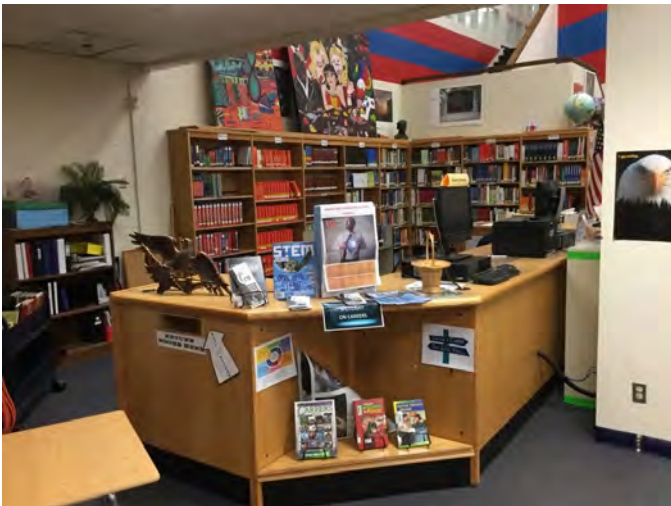
System: E1020 - Institutional Equipment

Location: Throughout the Building
Distress: Beyond Service Life
Category: Deferred Maintenance
Priority: 3 - Necessary/Not Yet Critical (Years 2-5)
Correction: Renew System
Qty: 130,900.00
Unit of Measure: S.F.
Estimate: \$1,877,630.00
Assessor Name: Eduardo Lopez
Date Created: 11/16/2016

Notes: The institutional equipment system is beyond its expected service life and should be scheduled for replacement.

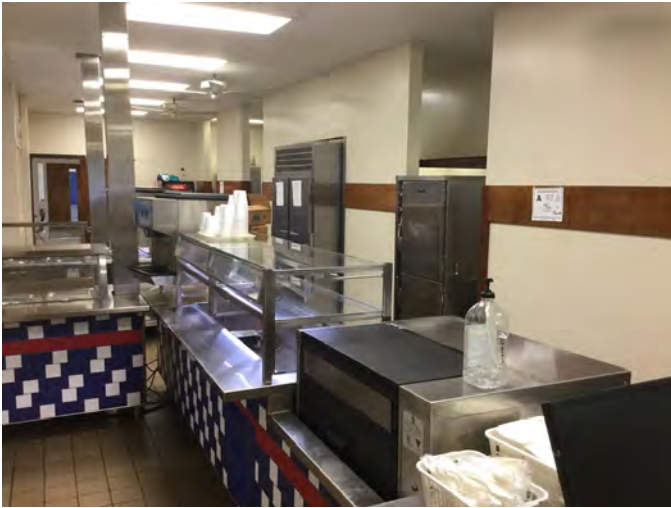
System: E1090 - Other Equipment

Location: Throughout the Building
Distress: Beyond Service Life
Category: Deferred Maintenance
Priority: 3 - Necessary/Not Yet Critical (Years 2-5)
Correction: Renew System
Qty: 130,900.00
Unit of Measure: S.F.
Estimate: \$771,786.00
Assessor Name: Eduardo Lopez
Date Created: 12/07/2016

Notes: The other equipment system is beyond its expected service life and should be scheduled for replacement.

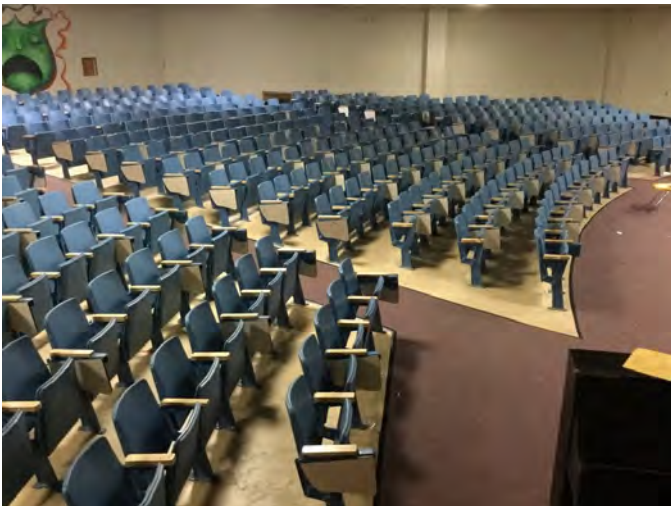
System: E2010 - Fixed Furnishings

Location: Throughout the Building
Distress: Beyond Service Life
Category: Deferred Maintenance
Priority: 3 - Necessary/Not Yet Critical (Years 2-5)
Correction: Renew System
Qty: 130,900.00
Unit of Measure: S.F.
Estimate: \$717,070.00
Assessor Name: Eduardo Lopez
Date Created: 11/16/2016

Notes: The fixed furnishings are aged, in marginal condition, and should be replaced.

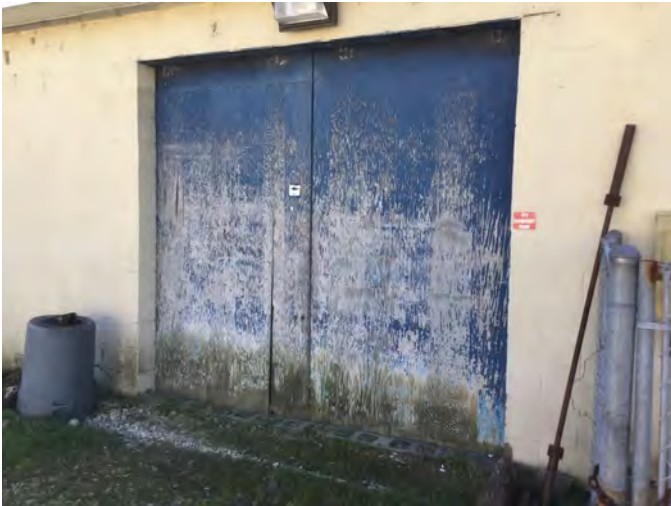
System: B2030 - Exterior Doors

Location: Exterior Walls
Distress: Beyond Service Life
Category: Deferred Maintenance
Priority: 3 - Necessary/Not Yet Critical (Years 2-5)
Correction: Renew System
Qty: 1,821.00
Unit of Measure: S.F.
Estimate: \$17,347.00
Assessor Name: Eduardo Lopez
Date Created: 11/23/2016

Notes: The exterior doors are in poor conditions, aged, and should be replaced.

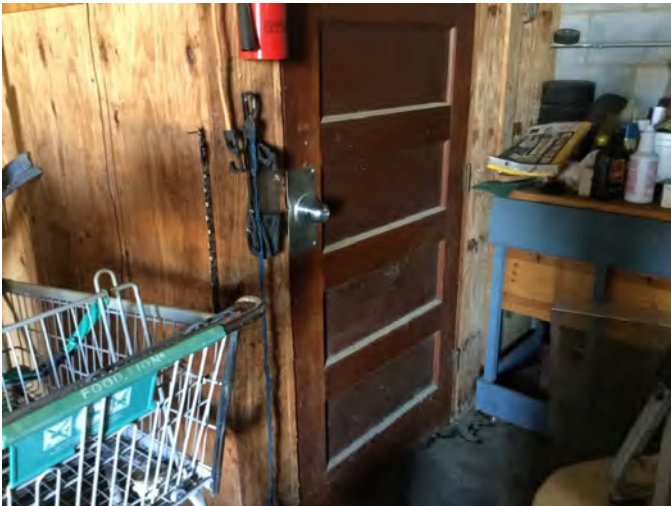
System: C1020 - Interior Doors

Location: Throughout the Building
Distress: Beyond Service Life
Category: Deferred Maintenance / Accessibility Code Compliance
Priority: 3 - Necessary/Not Yet Critical (Years 2-5)
Correction: Renew System
Qty: 1,821.00
Unit of Measure: S.F.
Estimate: \$4,407.00
Assessor Name: Eduardo Lopez
Date Created: 11/23/2016

Notes: The interior doors are aged, failing, hardware is not ADA or code compliant and should be replaced.

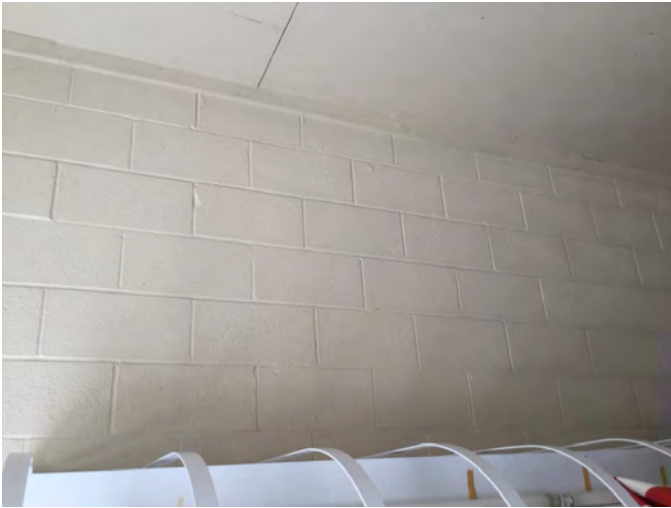
System: C3010 - Wall Finishes

Location: Throughout the Building
Distress: Beyond Service Life
Category: Deferred Maintenance
Priority: 3 - Necessary/Not Yet Critical (Years 2-5)
Correction: Renew System
Qty: 1,821.00
Unit of Measure: S.F.
Estimate: \$10,236.00
Assessor Name: Eduardo Lopez
Date Created: 11/23/2016

Notes: The wall finishes are aged, scuffed, fading, stained and should be replaced.

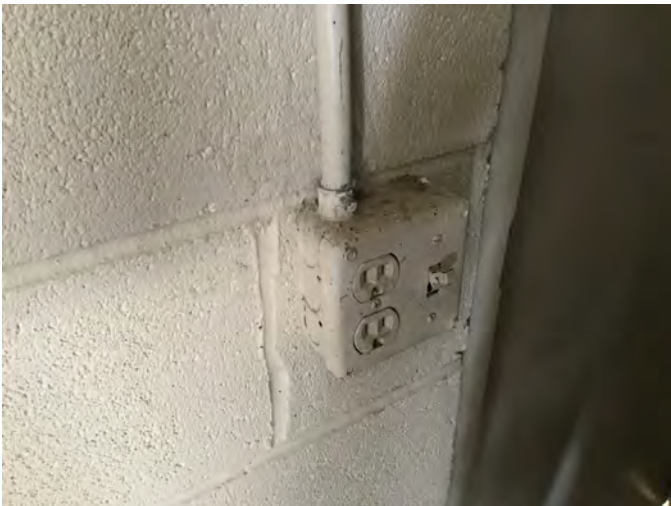
System: D5020 - Branch Wiring

Location: Throughout the Building
Distress: Beyond Service Life
Category: Deferred Maintenance
Priority: 3 - Necessary/Not Yet Critical (Years 2-5)
Correction: Renew System
Qty: 1,821.00
Unit of Measure: S.F.
Estimate: \$7,171.00
Assessor Name: Eduardo Lopez
Date Created: 11/23/2016

Notes: The original branch wiring system is operating but is aged, in marginal condition, and should be replaced.

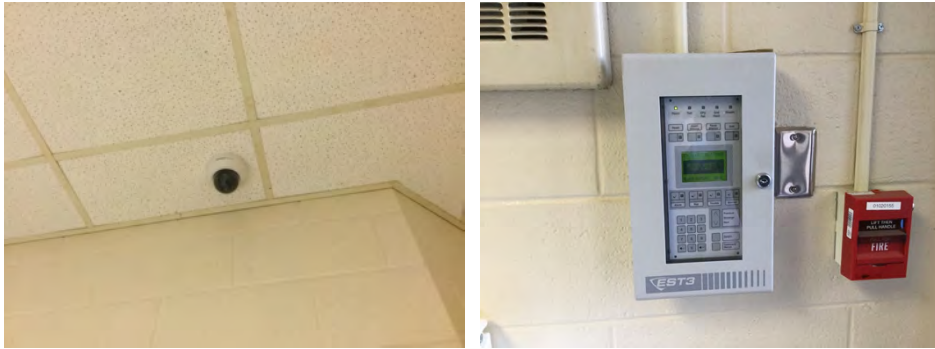
System: D5030810 - Security & Detection Systems

Notes: The security & detection system is beyond its expected service life and should be scheduled for replacement.

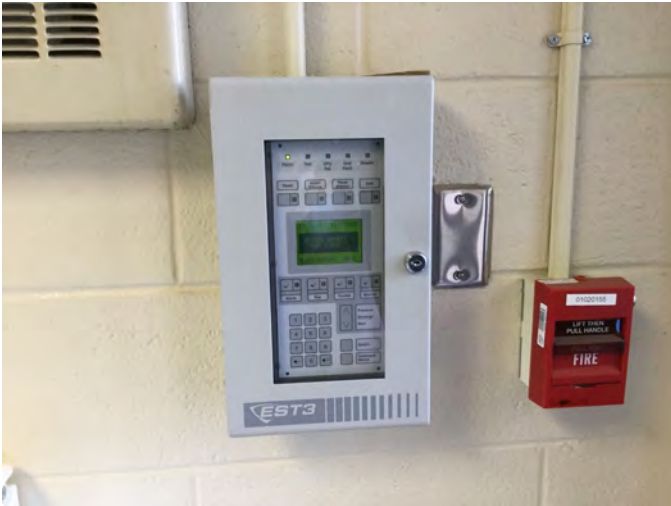
System: D5030810 - Security & Detection Systems

Location: Throughout the Building
Distress: Beyond Service Life
Category: Deferred Maintenance
Priority: 3 - Necessary/Not Yet Critical (Years 2-5)
Correction: Renew System
Qty: 63,917.00
Unit of Measure: S.F.
Estimate: \$138,508.00
Assessor Name: Eduardo Lopez
Date Created: 11/17/2016

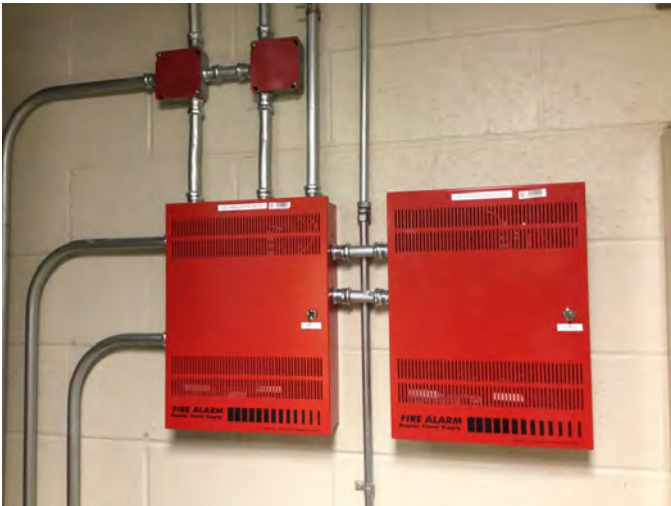
System: D5030910 - Fire Alarm Systems

Location: Throughout the Building
Distress: Beyond Service Life
Category: Deferred Maintenance
Priority: 3 - Necessary/Not Yet Critical (Years 2-5)
Correction: Renew System
Qty: 63,917.00
Unit of Measure: S.F.
Estimate: \$250,299.00
Assessor Name: Eduardo Lopez
Date Created: 11/17/2016

Notes: The fire alarm system is beyond its expected service life and should be scheduled for replacement.

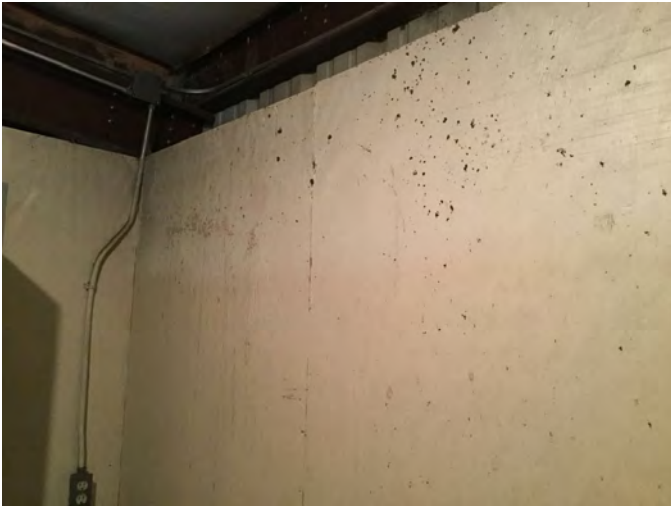
System: C3010 - Wall Finishes

Location: Throughout the Building
Distress: Beyond Service Life
Category: Deferred Maintenance
Priority: 2 - Potentially Critical (Year 1)
Correction: Renew System
Qty: 1,200.00
Unit of Measure: S.F.
Estimate: \$9,847.00
Assessor Name: Eduardo Lopez
Date Created: 11/17/2016

Notes: The wall finishes are aged, scuffed, fading, stained and should be replaced.

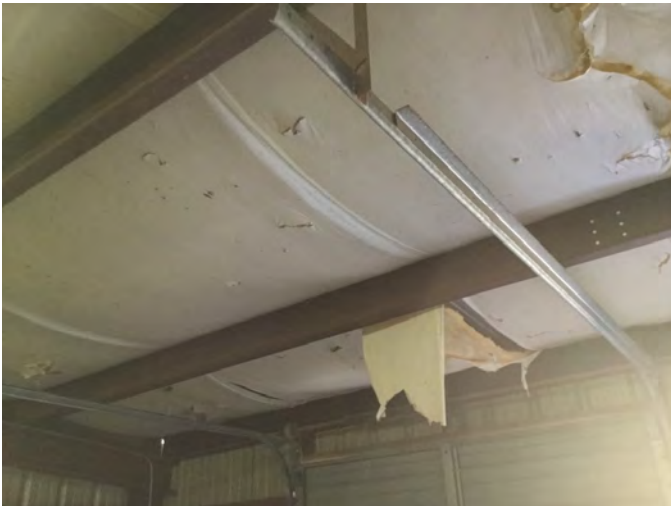
System: C3030 - Ceiling Finishes

Location: Throughout the Building
Distress: Beyond Service Life
Category: Deferred Maintenance
Priority: 2 - Potentially Critical (Year 1)
Correction: Renew System
Qty: 1,200.00
Unit of Measure: S.F.
Estimate: \$12,580.00
Assessor Name: Eduardo Lopez
Date Created: 11/23/2016

Notes: The original ceiling finishes are damaged, failing and should be replaced.

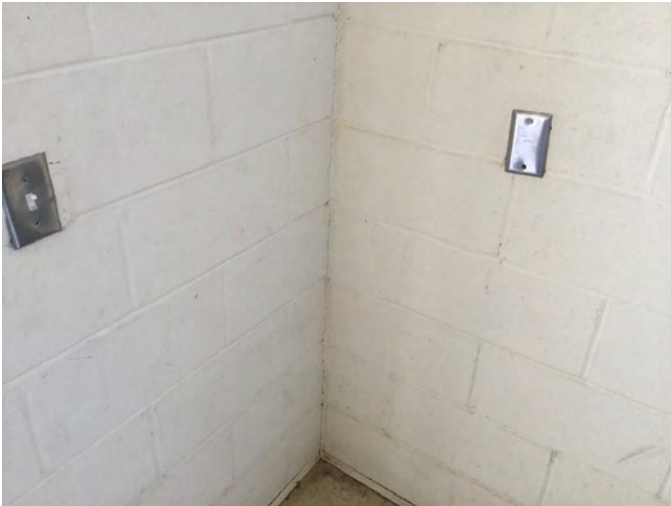
System: C3010 - Wall Finishes

Location: Throughout the Building
Distress: Beyond Service Life
Category: Deferred Maintenance
Priority: 3 - Necessary/Not Yet Critical (Years 2-5)
Correction: Renew System
Qty: 822.00
Unit of Measure: S.F.
Estimate: \$4,620.00
Assessor Name: Eduardo Lopez
Date Created: 11/23/2016

Notes: The wall finishes are aged, scuffed, fading, stained and should be replaced.

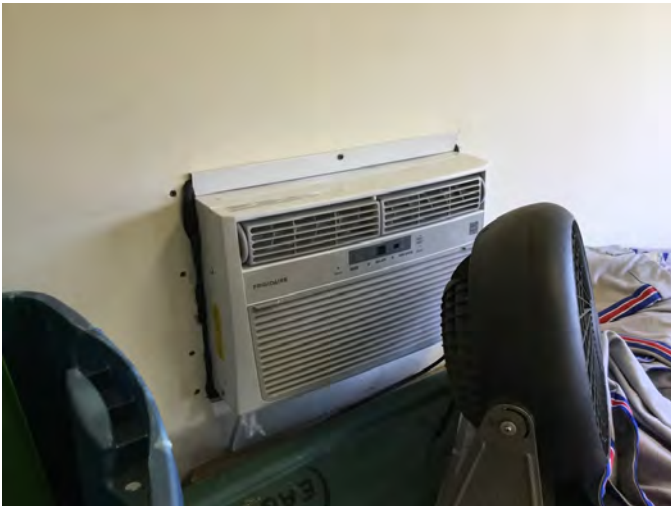
System: D3050 - Terminal & Package Units

Location: Throughout the Building
Distress: Beyond Service Life
Category: Deferred Maintenance
Priority: 3 - Necessary/Not Yet Critical (Years 2-5)
Correction: Renew System
Qty: 822.00
Unit of Measure: S.F.
Estimate: \$31,077.00
Assessor Name: Eduardo Lopez
Date Created: 11/23/2016

Notes: The terminal and package units are beyond their expected service life and should be scheduled for replacement.

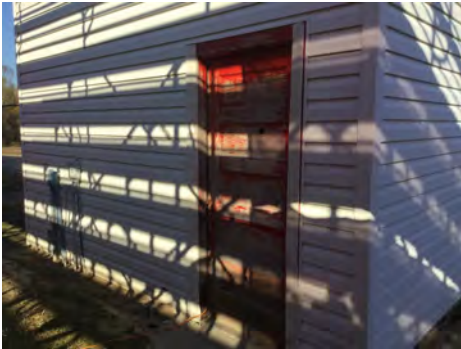
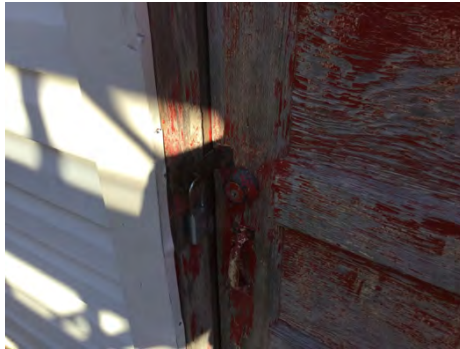
System: B2030 - Exterior Doors

Notes: The exterior doors are aged, in deteriorating conditions, and should be replaced.

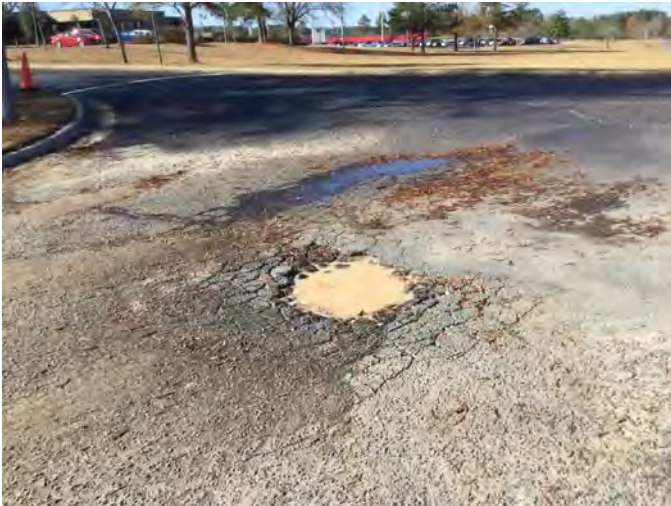
System: G2010 - Roadways

Location: Roadways
Distress: Damaged
Category: Deferred Maintenance / Accessibility Code Compliance
Priority: 2 - Potentially Critical (Year 1)
Correction: Resurface the roadway
Qty: 5.00
Unit of Measure: L.F.
Estimate: \$85,800.00
Assessor Name: Eduardo Lopez
Date Created: 12/07/2016

Notes: The asphalt roadway was re-surfaced last year. However, many locations has potholes and cracks, and should be properly repaired, re-surfaced, and should include a marked path between accessible parking and the sidewalk leading to the main entrance per ADA standards.

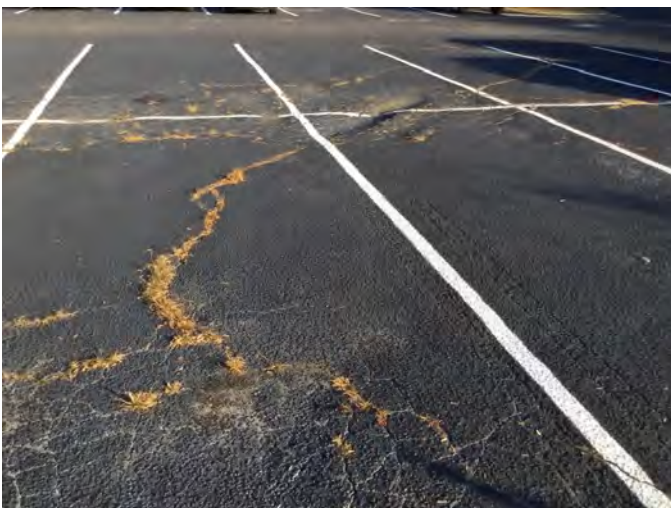
System: G2020 - Parking Lots

Location: Parking Lots
Distress: Failing
Category: Deferred Maintenance / Accessibility Code Compliance
Priority: 2 - Potentially Critical (Year 1)
Correction: Parking lot repair and resurface
Qty: 150.00
Unit of Measure: M.S.F.
Estimate: \$203,664.78
Assessor Name: Eduardo Lopez
Date Created: 12/07/2016

Notes: The parking lot was re-surfaced last year. However, many locations has cracks, more ADA parking spaces are required with access aisle that is currently missing, and should include a van accessible parking space to comply with ADA standards, Re-surface and re-stripe parking spaces were needed.

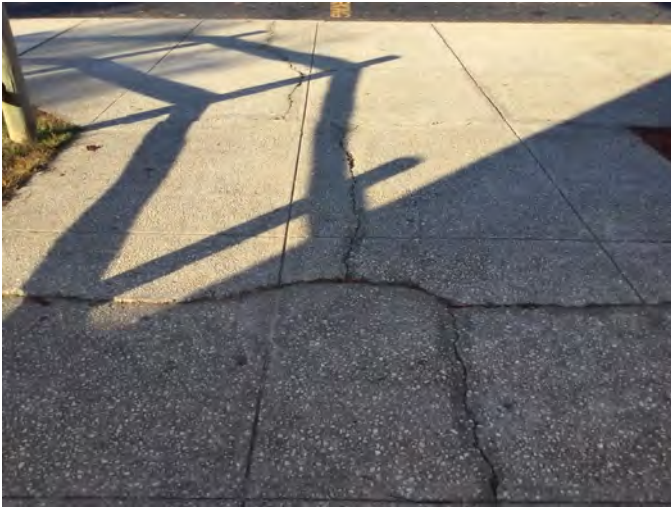
System: G2030 - Pedestrian Paving

Location: Site
Distress: Beyond Service Life
Category: Deferred Maintenance / Accessibility Code Compliance
Priority: 2 - Potentially Critical (Year 1)
Correction: Renew System
Qty: 204,686.00
Unit of Measure: S.F.
Estimate: \$445,806.00
Assessor Name: Eduardo Lopez
Date Created: 12/06/2016

Notes: The pedestrian paving and walkways are aged, showing inclement weather damage and should be replaced to include missing ramps at accessible routes per ADA standards.

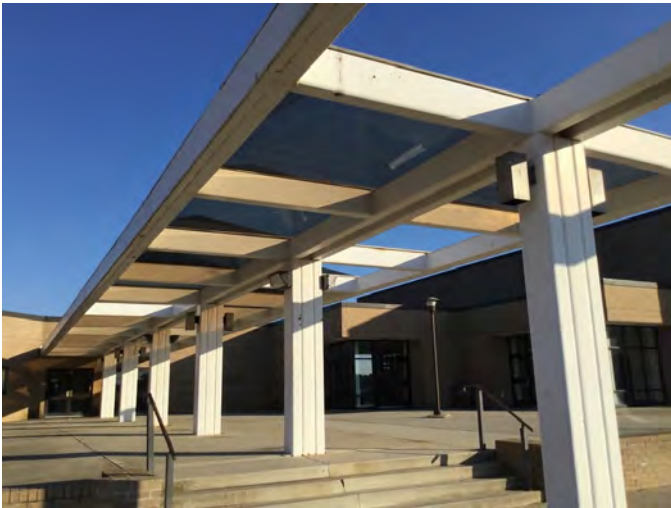
System: G2040950 - Covered Walkways

Location: Northwest Entrance
Distress: Beyond Service Life
Category: Deferred Maintenance / Safety
Priority: 2 - Potentially Critical (Year 1)
Correction: Renew System
Qty: 204,686.00
Unit of Measure: S.F.
Estimate: \$182,375.00
Assessor Name: Eduardo Lopez
Date Created: 12/06/2016

Notes: The covered walkways in in deteriorating conditions, rusted, damaged and with missing acrylic skylights that has been reported to fly away with strong winds. The system is beyond service life and should be replaced.
