NC School District/430 Harnett County/Middle School

Dunn Middle

Campus Assessment Report

March 11, 2017

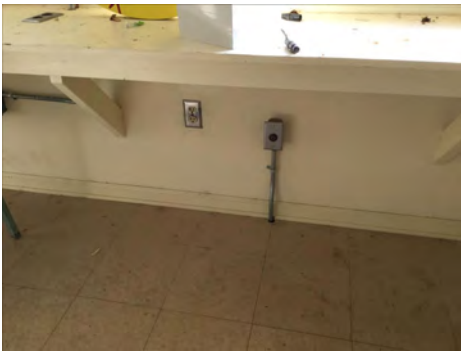
System: D5030920 - Data Communication

Notes: Communication to building is limited, replace system.

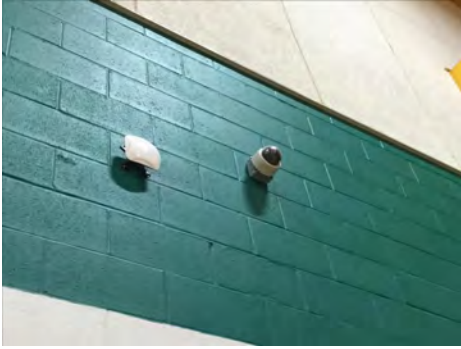
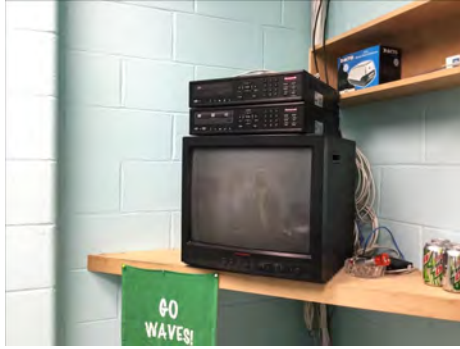
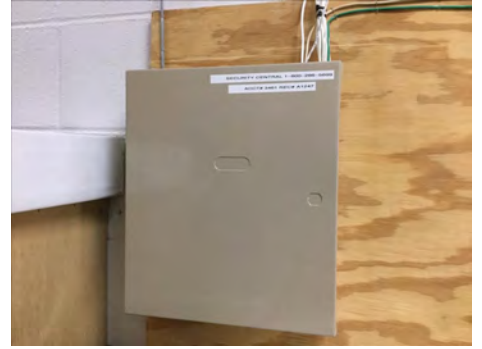
System: D5030810 - Security & Detection Systems

Notes: Security cameras are analog and beginning to fail.
No door alarms or card access for exterior doors. Upgrade system.

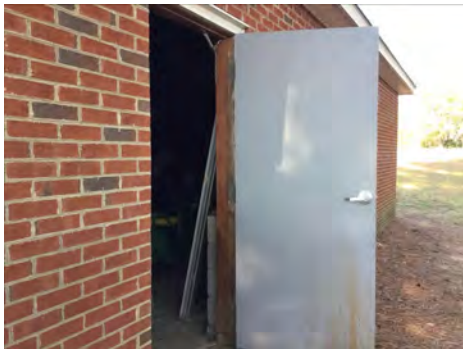
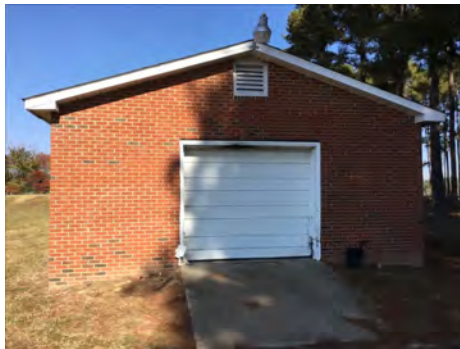
System: B2030 - Exterior Doors

Location: Ext. doors
Distress: Damaged
Category: Deferred Maintenance / Appearance
Priority: 3 - Necessary/Not Yet Critical (Years 2-5)
Correction: Repair aluminum frame and door
Qty: 1.00
Unit of Measure: Ea.
Estimate: \$6,025.35
Assessor Name: Terence Davis
Date Created: 11/23/2016

Notes: Exterior door and roll up door have been damaged by vandalism. Replace
