NC School District/520 Jones County/Middle School

# Jones Middle

## Campus Assessment Report

March 11, 2017

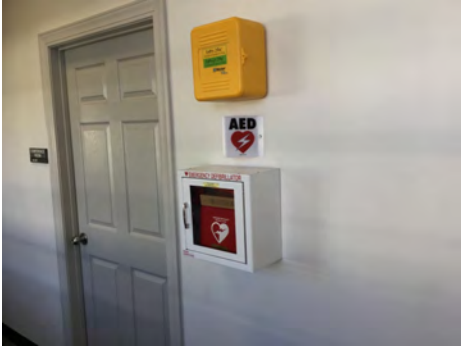
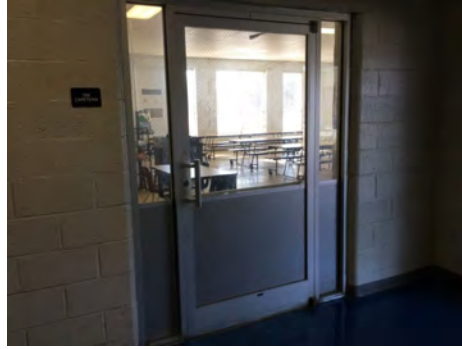
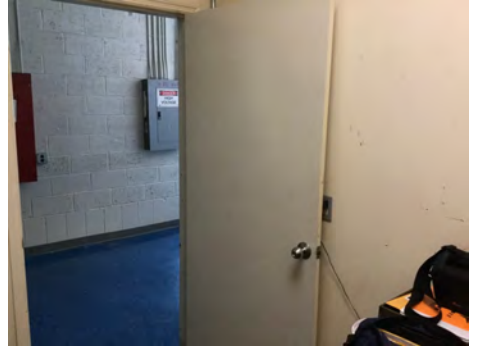
**System:** C1020 - Interior Doors

**Notes:** Interior doors are typically original and beyond their expected useful life. Hardware is not ADA compliant. System renewal is recommended.

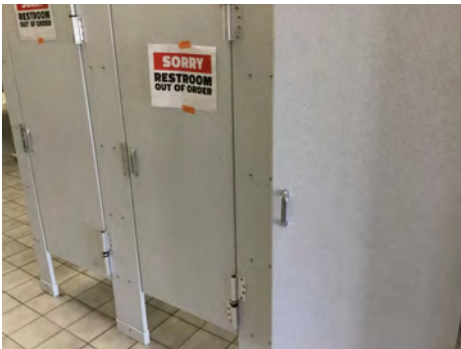
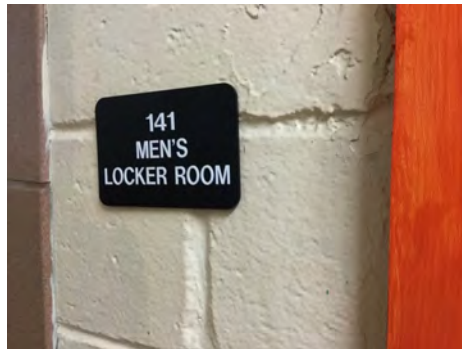
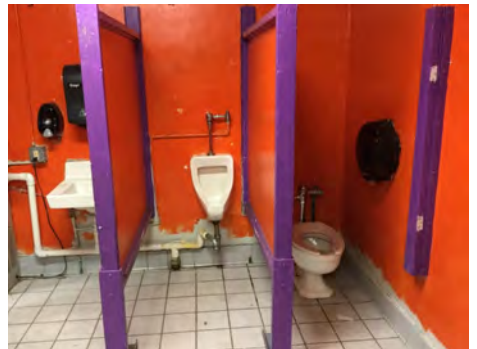
**System:** C1030 - Fittings

**Notes:** Although main gang restrooms have been renovated with new toilet partitions, in general building fittings are expired. Signage is not up to ADA code. Whiteboards are stained. Locker rooms do not have proper fittings. System renewal is recommended.

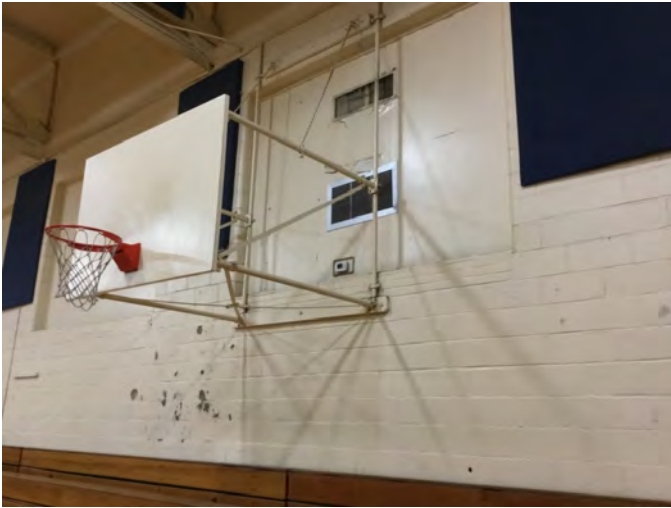
**System: E1020 - Institutional Equipment**

**Location:** Throughout the building  
**Distress:** Beyond Service Life  
**Category:** Deferred Maintenance  
**Priority:** 3 - Necessary/Not Yet Critical (Years 2-5)  
**Correction:** Renew System  
**Qty:** 30,983.00  
**Unit of Measure:** S.F.  
**Estimate:** \$95,768.00  
**Assessor Name:** Ann Buerger Linden  
**Date Created:** 02/17/2017

**Notes:** Institutional equipment as a whole is beyond its expected life. In particular, gym bleachers, backboards, etc. are beyond their expected life.

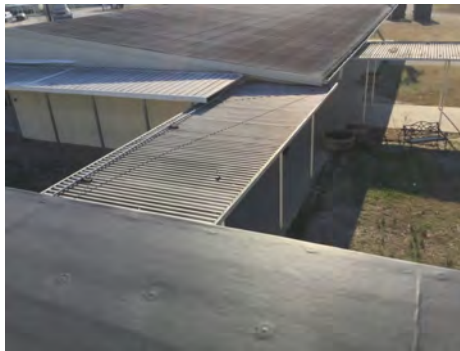
**System:** G2040950 - Covered Walkways

**Note:** Covered walkways do not have any observed deficiencies. Renewal date pushed 5 years.
