NC School District/830 Scotland County/Elementary School

Covington Street Elementary

Campus Assessment Report

March 11, 2017

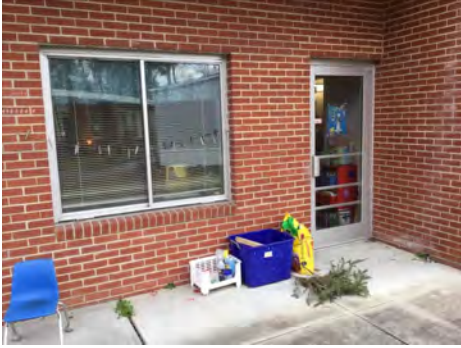
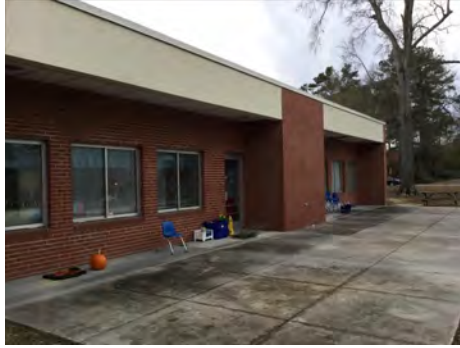
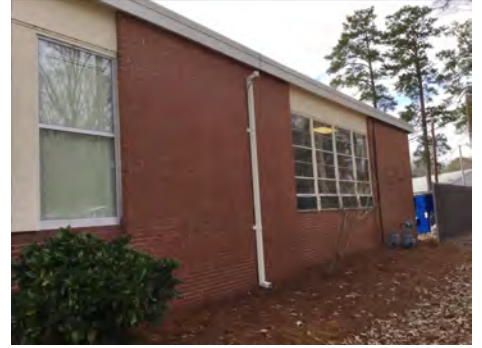
System: B2010 - Exterior Walls

Notes: There are multiple areas where the bricks are missing or there are visible cracks on the exterior walls, a professional engineer should study the problem.

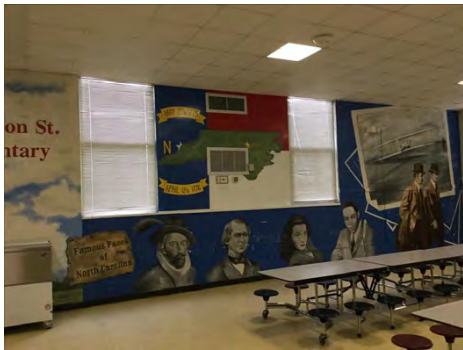
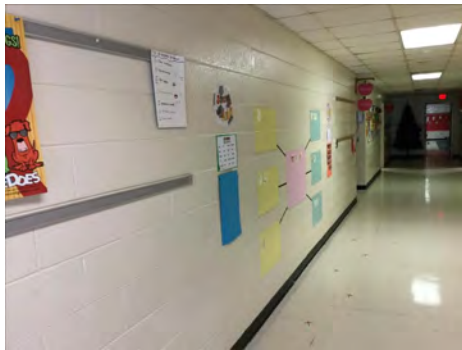
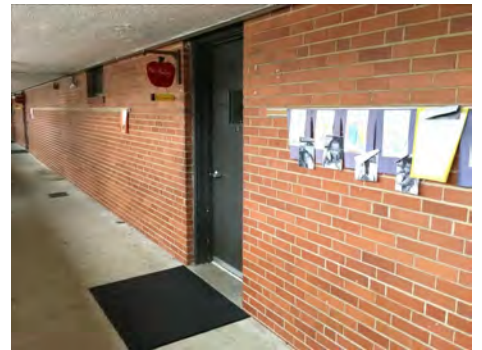
System: C1010 - Partitions

Notes: There are visible cracks on the partition wall which should be studied by a professional engineer.

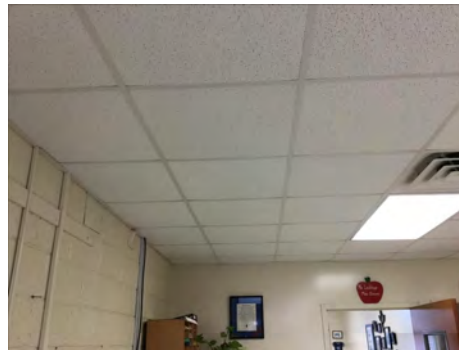
System: C3030 - Ceiling Finishes

Note: The acoustical ceiling tiles are beyond their service life and should be replaced.

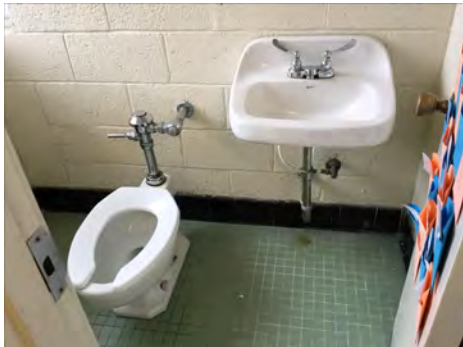
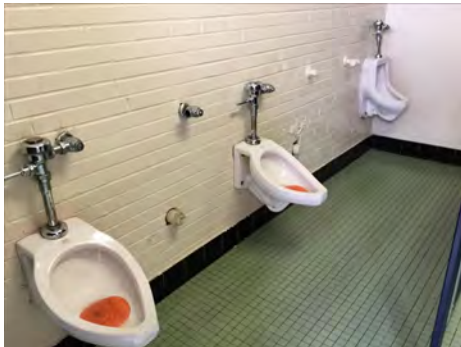
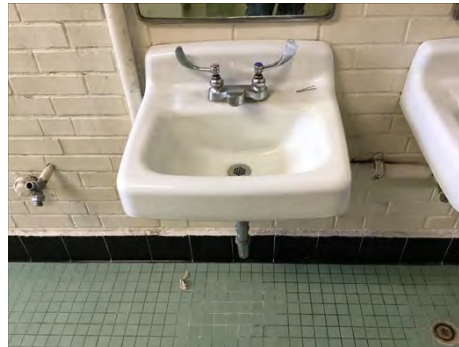
System: D2010 - Plumbing Fixtures

Note: The plumbing fixtures are beyond their service life and should be replaced.

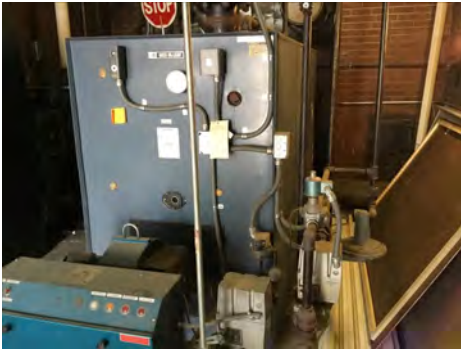
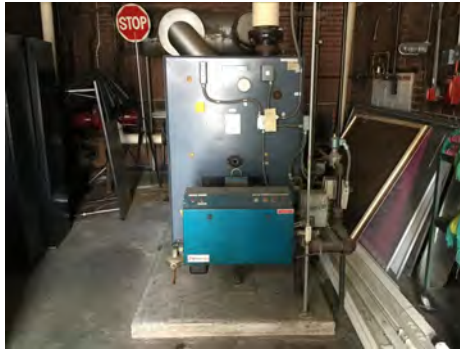
System: D3020 - Heat Generating Systems

Note: The heat generation system is beyond its service life and should be replaced.

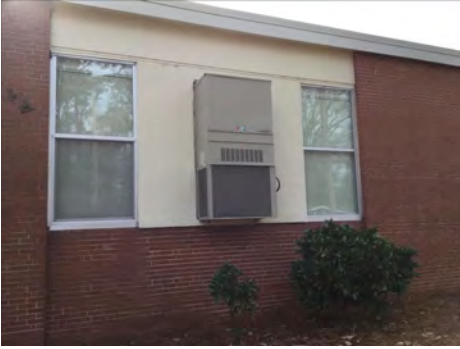
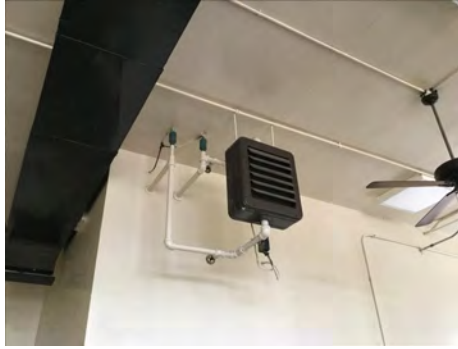
System: D3050 - Terminal & Package Units

Note: The radiating heating system is beyond its service life and should be replaced.

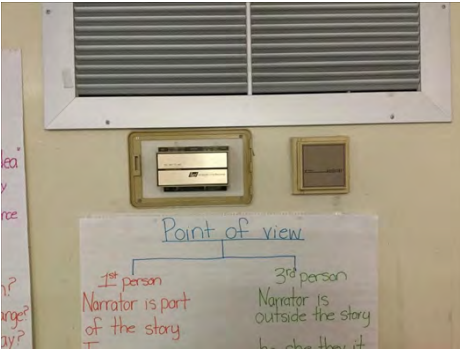
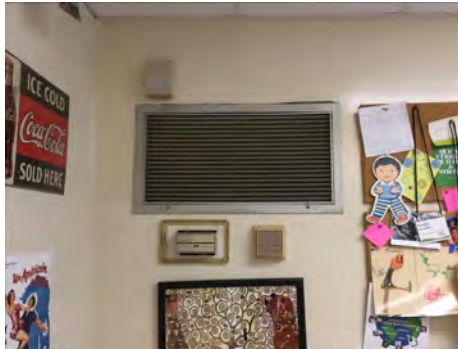
System: D3060 - Controls & Instrumentation

Note: The controls are beyond their service life and should be replaced.

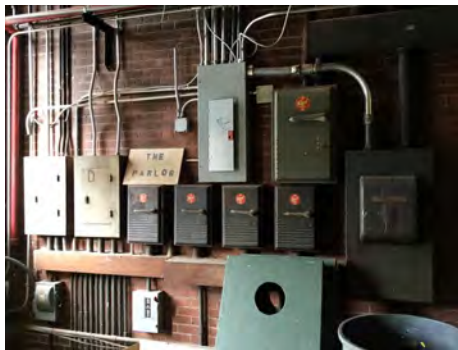
System: D5010 - Electrical Service/Distribution

Note: The electrical service distribution system is beyond its service life and should be replaced.

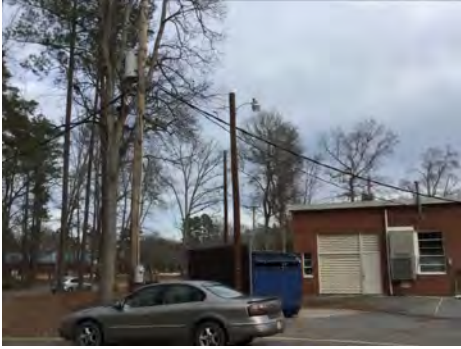
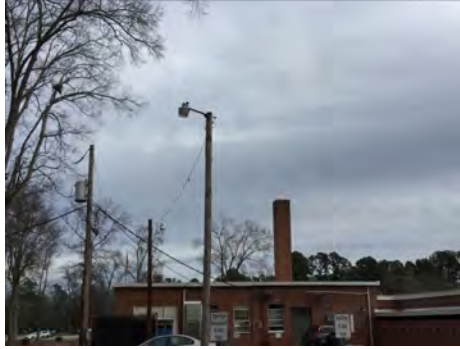
System: G4020 - Site Lighting

Note: The site lighting system is beyond its service life and should be replaced.

Notes: The site lighting system is beyond its service life and should be replaced.
