NC School District/830 Scotland County/Elementary School

I E Johnson Elementary

Campus Assessment Report

March 11, 2017

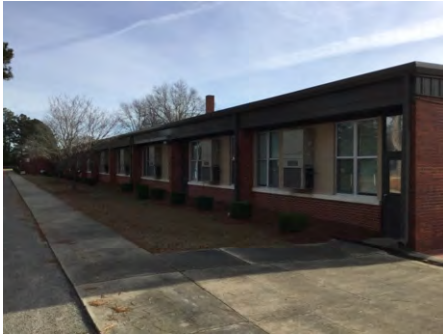
1). Northwest Elevation - Jan 10, 2017

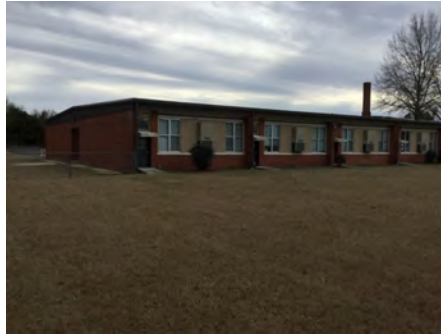
2). Northeast Elevation - Jan 10, 2017

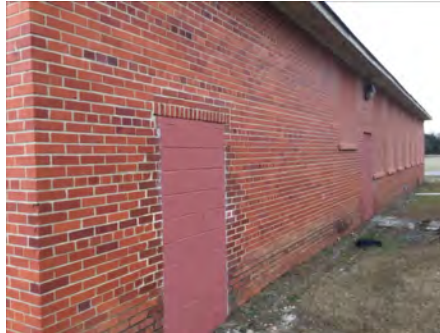
2). East Elevation - Feb 21, 2017

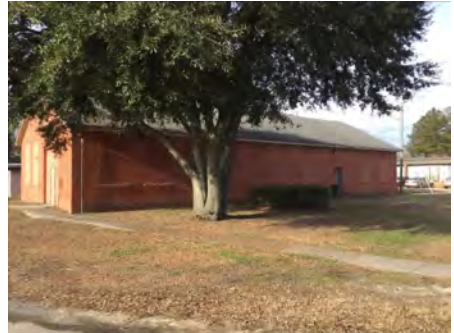
3). West Elevation - Feb 21, 2017

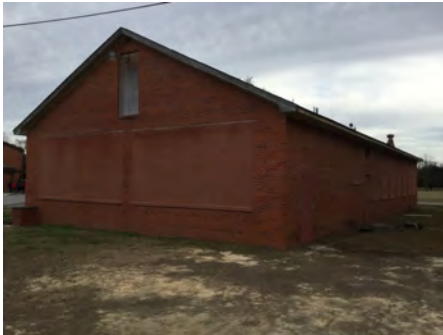
4). Northeast Elevation - Jan 10, 2017
