NC School District/830 Scotland County/Elementary School

North Laurinburg Elementary

Campus Assessment Report

March 11, 2017

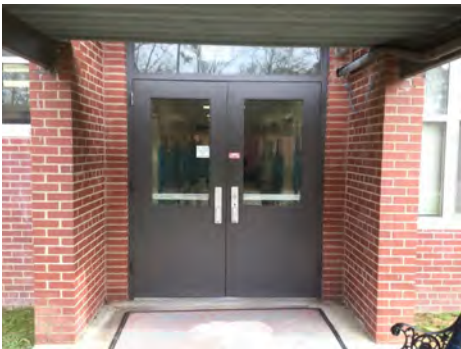
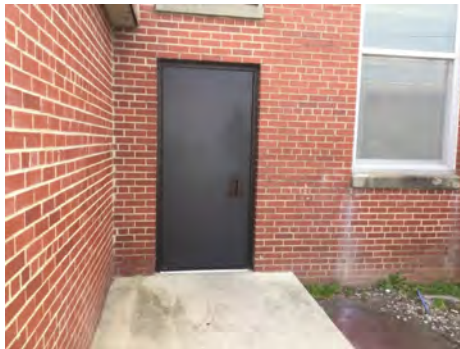
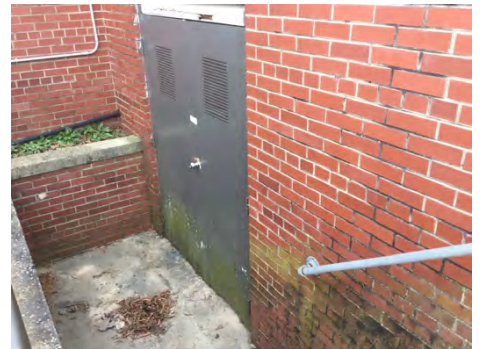
System: B2030 - Exterior Doors

Notes: The original metal exterior doors are aged, rusted, damaged and should be replaced with energy efficient doors

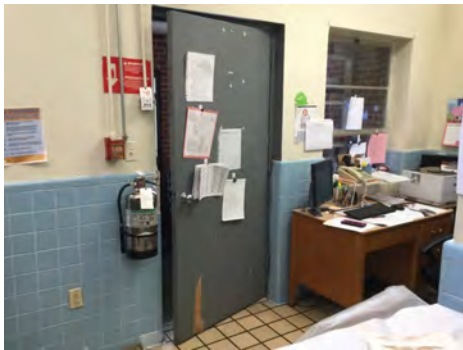
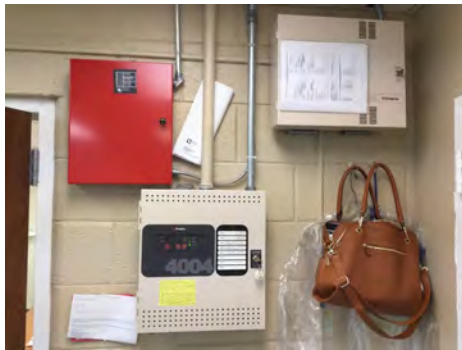
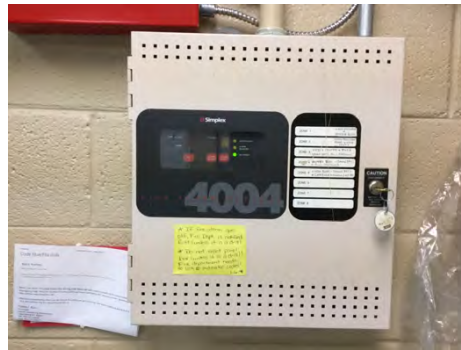
System: D5030910 - Fire Alarm Systems

Notes: The original fire alarm system operating as designed, but is beyond its service life and should be replaced.

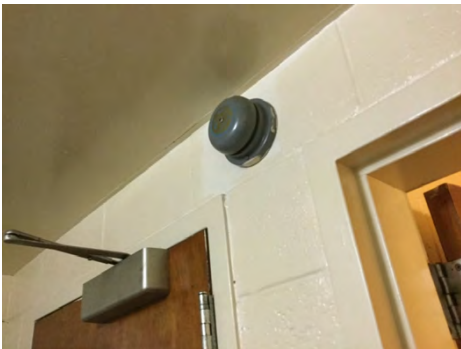
System: D5030910 - Fire Alarm Systems

Notes: The original alarm system is operating but is aged. The system should be inspected and repaired or replaced to ensure that the life safety codes are preserved.

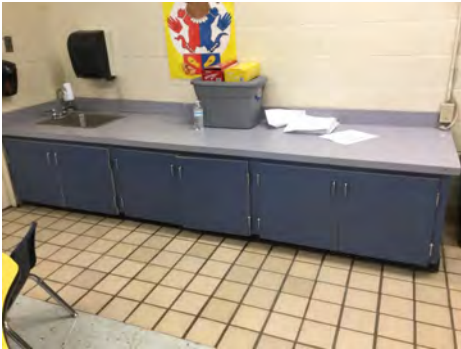
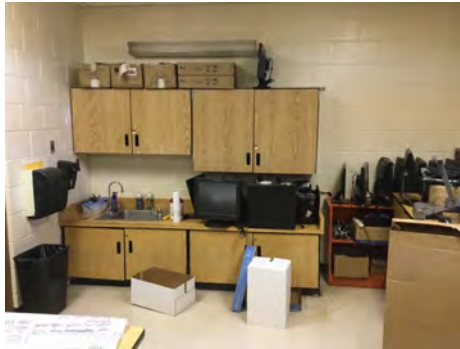
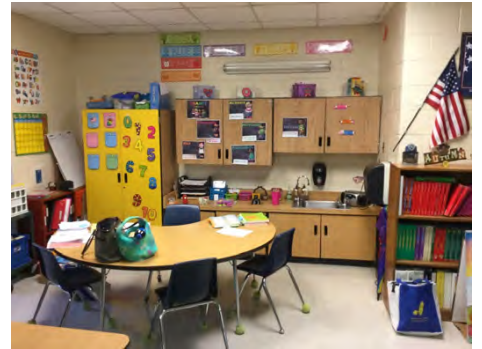
System: E2010 - Fixed Furnishings

Notes: The building casework is aged and worn and should be replaced.

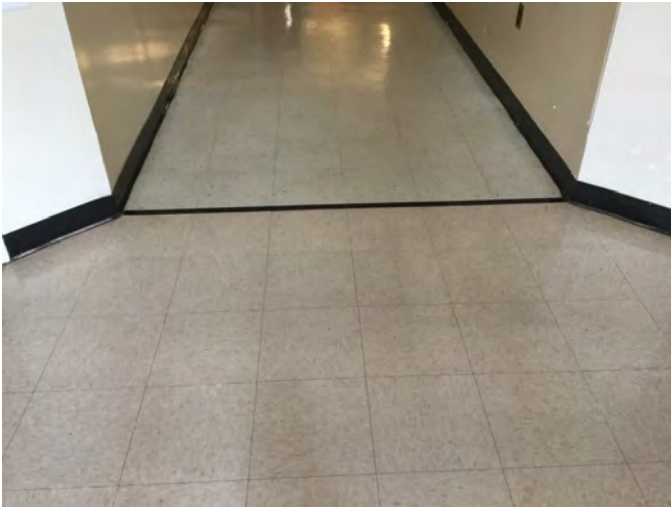
System: C3020 - Floor Finishes

Location: Throughout the building
Distress: Beyond Service Life
Category: Deferred Maintenance
Priority: 3 - Necessary/Not Yet Critical (Years 2-5)
Correction: Renew System
Qty: 16,000.00
Unit of Measure: S.F.
Estimate: \$204,160.00
Assessor Name: Terence Davis
Date Created: 01/04/2017
