Sycamore Lane Elementary

Campus Assessment Report

March 11, 2017

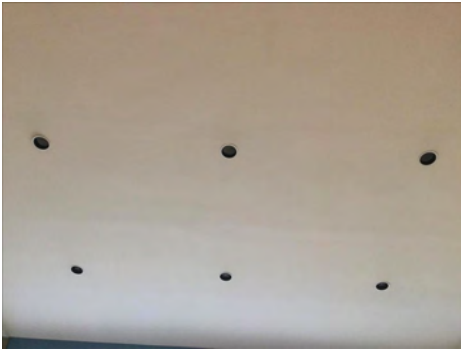
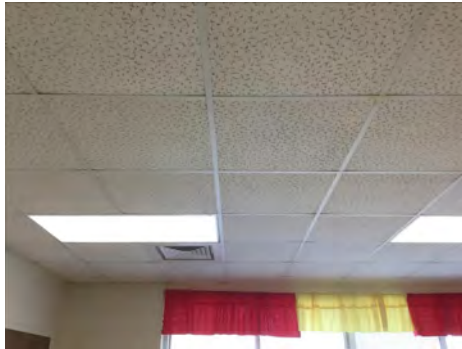
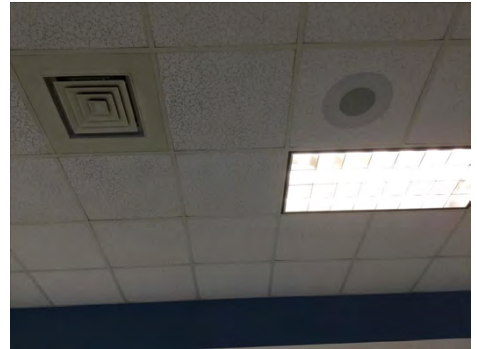
System: C3030 - Ceiling Finishes

Notes: The original ceiling finishes are aged, failing and should be replaced.

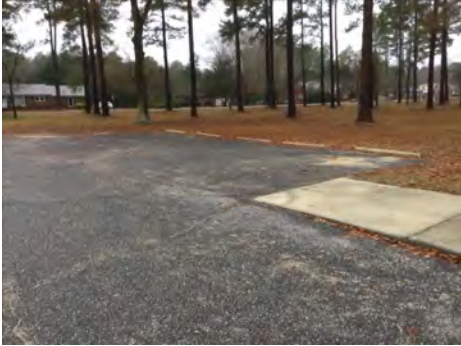
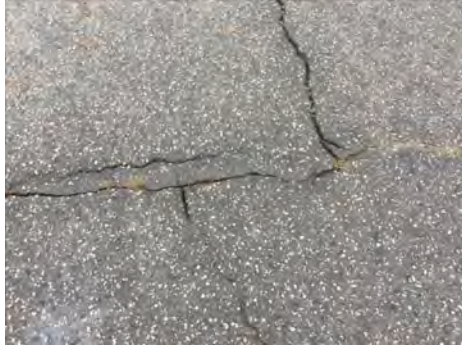
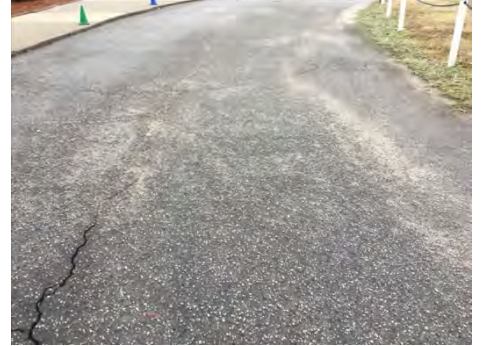
System: G2010 - Roadways

Notes: The asphalt roadways are aged, have many road cuts, significant cracking, and need re-surfacing.

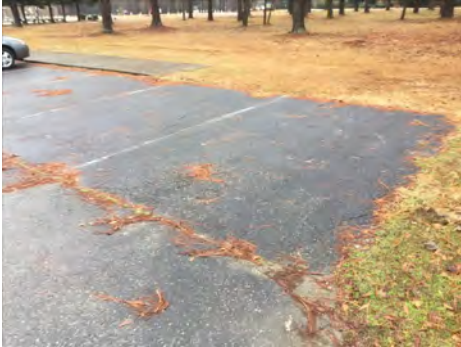
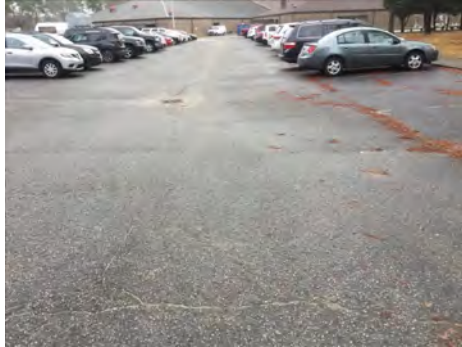
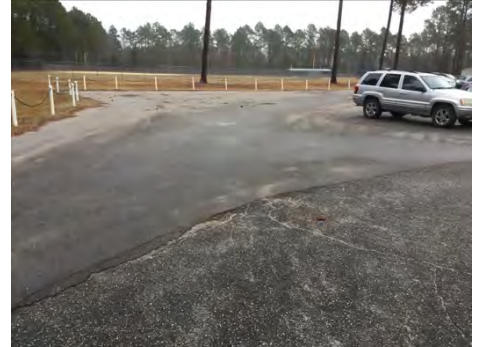
System: G2020 - Parking Lots

Notes: The asphalt parking lots are aged, have cuts and repairs, and should be re-surfaced and re striped.
