NC School District/830 Scotland County/Elementary School

Wagram Elementary

Campus Assessment Report

March 11, 2017

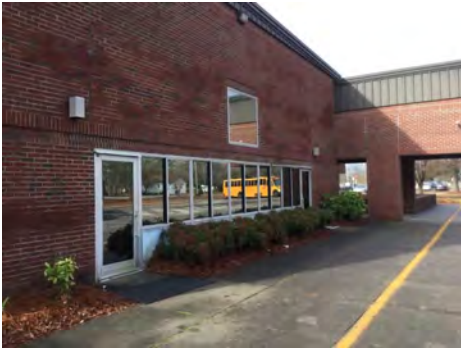
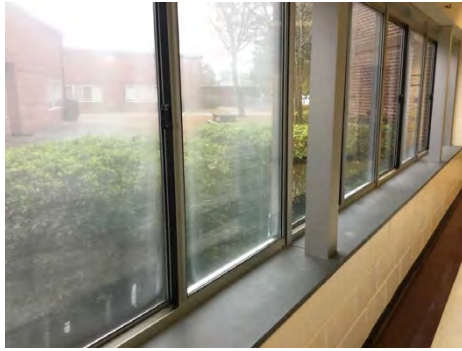
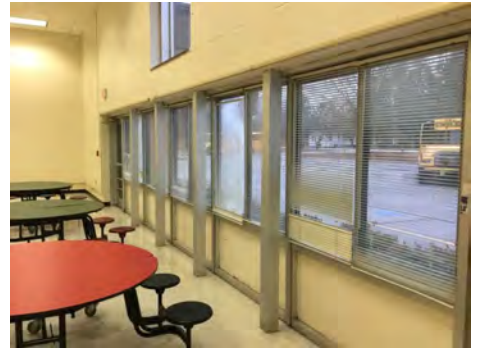
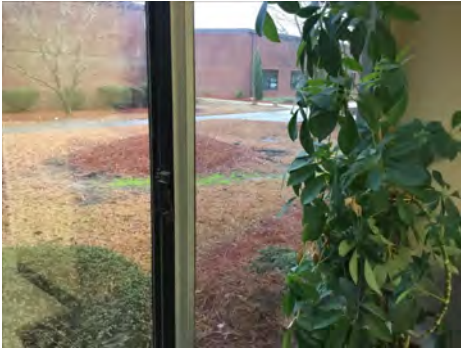
System: B2020 - Exterior Windows

Notes: The aluminum frame, operable, single pane windows are aged, not energy efficient, and should be replaced.

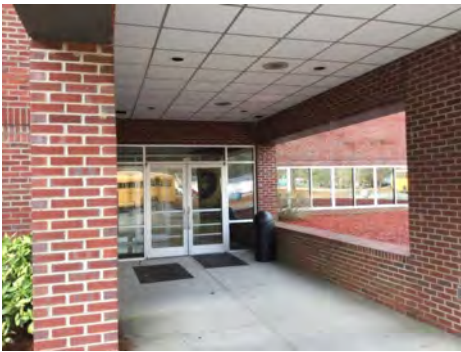
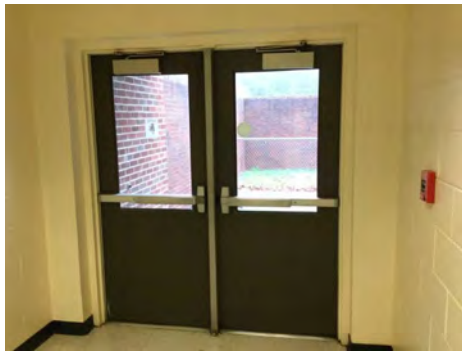
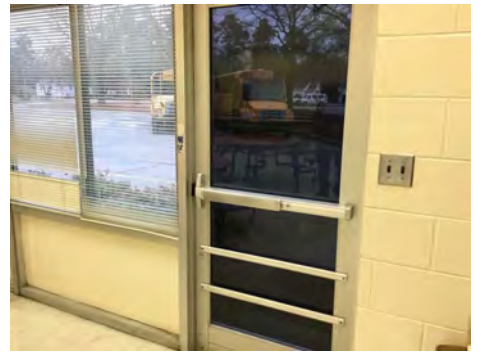
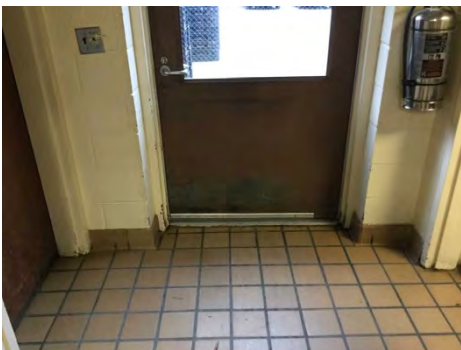
System: B2030 - Exterior Doors

Notes: The original exterior doors are aged, rusted, and should be replaced.

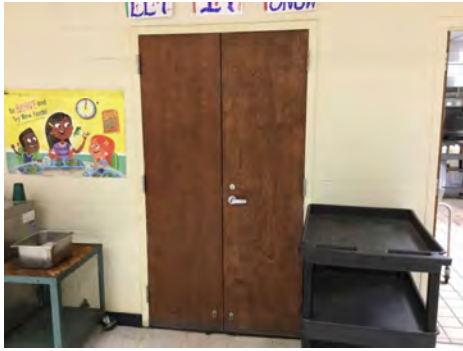
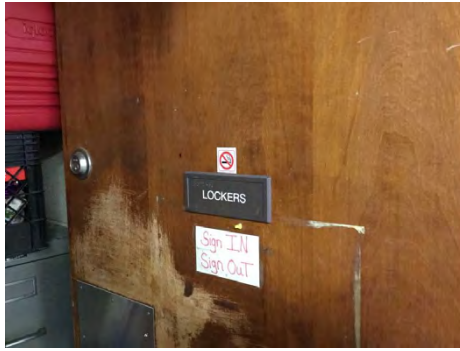
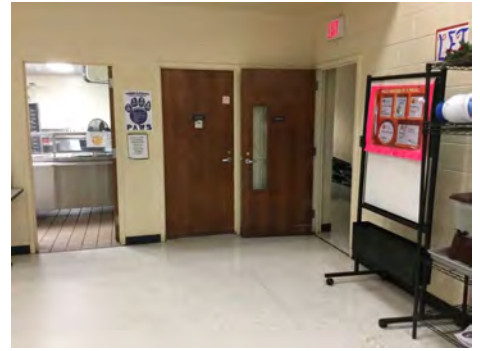
System: C1020 - Interior Doors

Notes: The interior doors are aged and should be replaced

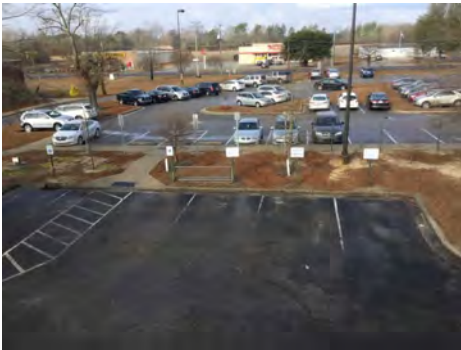
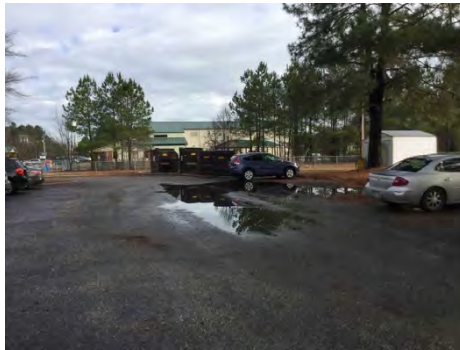
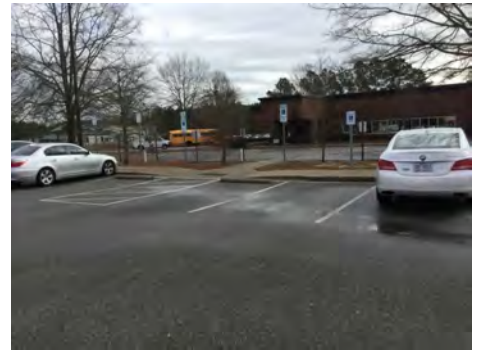
System: G2020 - Parking Lots

Notes: The majority of the parking lot is aged, has many repairs and potholes, and should be re-surfaced.
