NC School District/830 Scotland County/High School

Shaw Academy

Campus Assessment Report

March 11, 2017

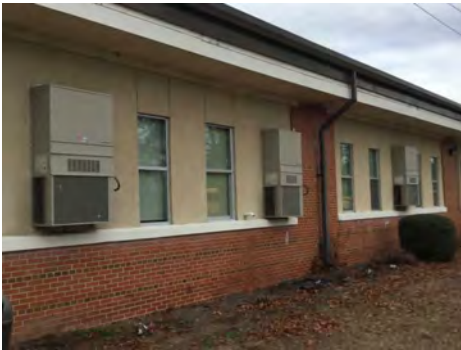
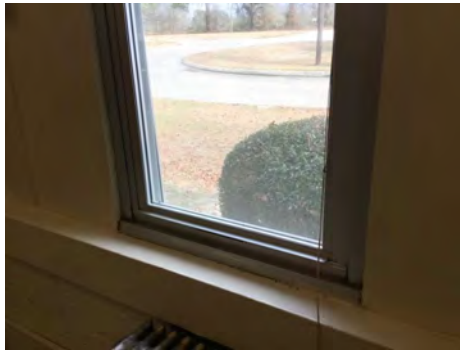
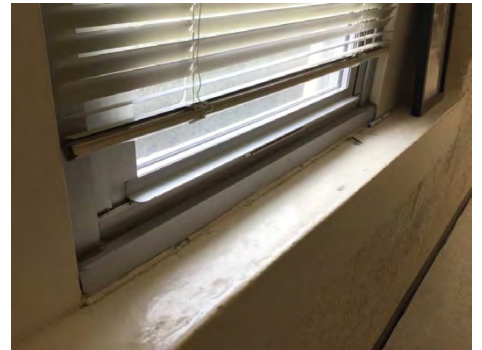
System: B2020 - Exterior Windows

Notes: The aluminum frame, operable, single pane windows are aged, rusted, not energy efficient, and should be replaced.

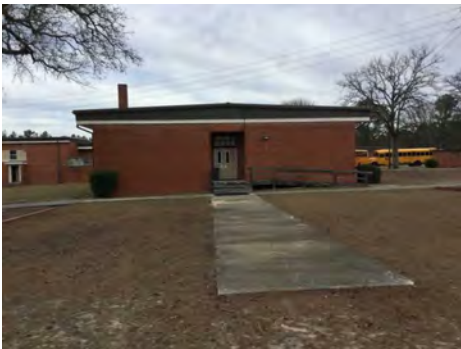
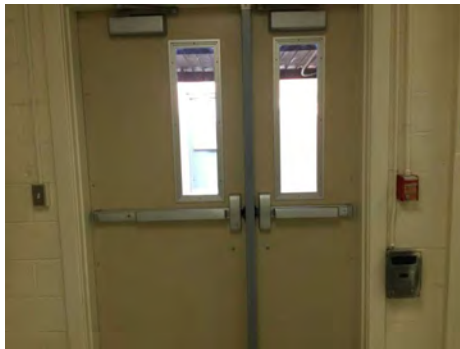
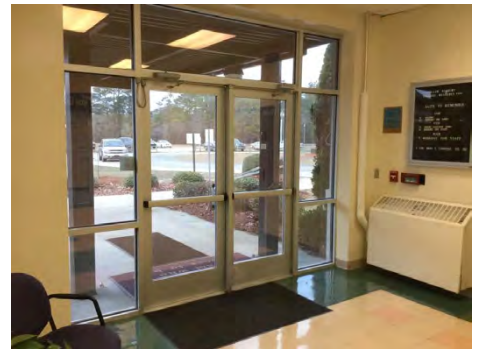
System: B2030 - Exterior Doors

Notes: The original exterior doors are aged, rusted, and should be replaced.

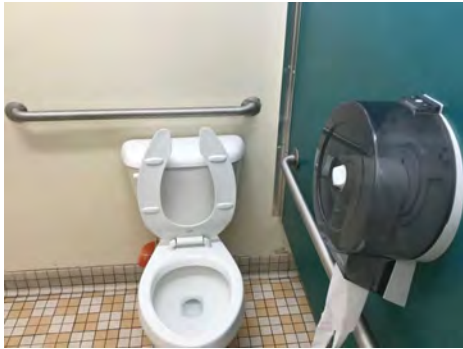
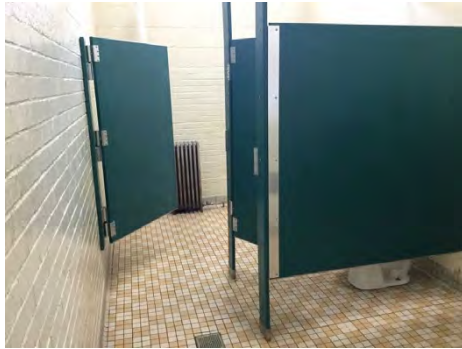
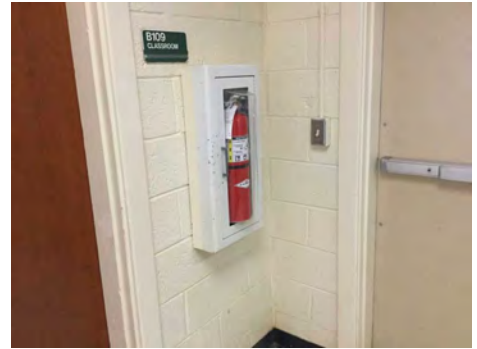
System: C1030 - Fittings

Notes: The fittings throughout the building are aged, in marginal condition, and should be replaced.
Room signage is missing or non-ADA compliant.

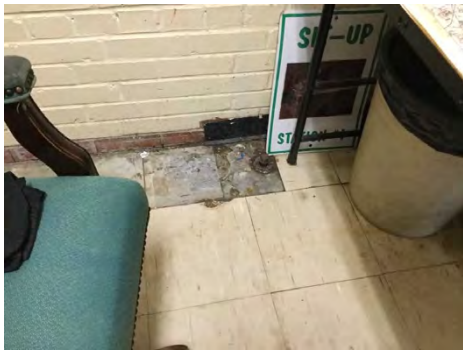
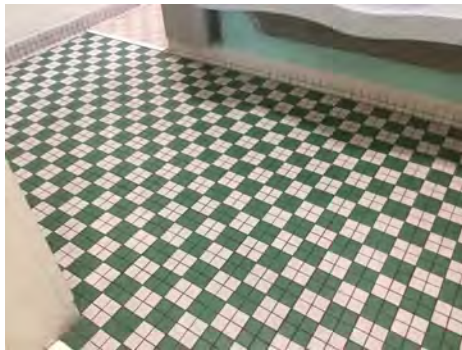
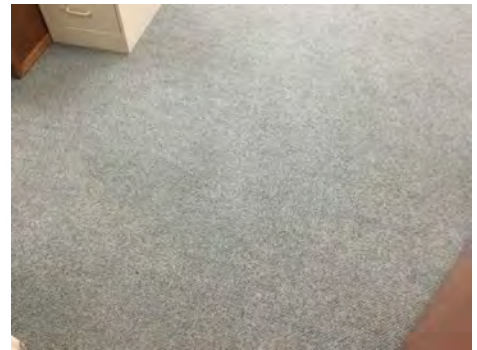
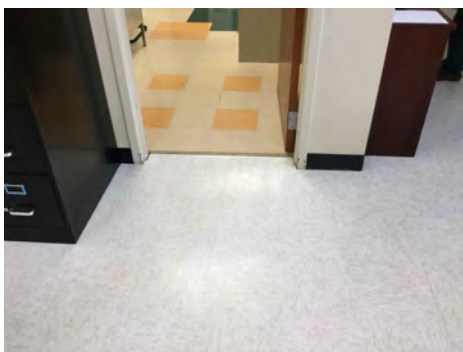
System: C3020 - Floor Finishes

Notes: The VCT flooring is aged, cracked, worn, and should be replaced.
The carpet is also aged, stained, frayed, and should be replace.

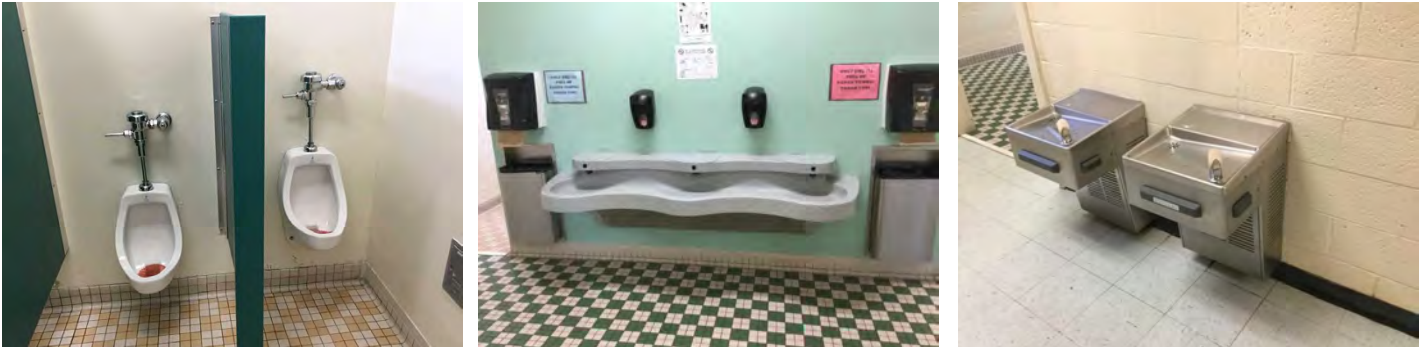
System: D2010 - Plumbing Fixtures

Notes: Plumbing fixtures are in operational conditions. However, they are aged and should be replaced with a low-flow water fixtures.

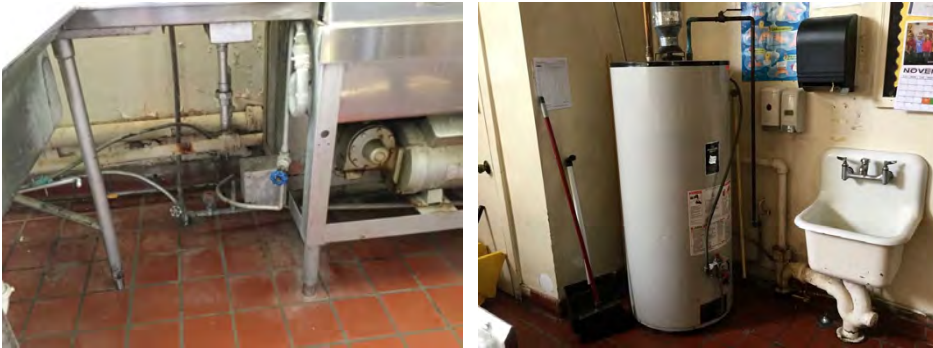
System: D2020 - Domestic Water Distribution

Notes: The domestic water distribution system is aged and should be replaced.

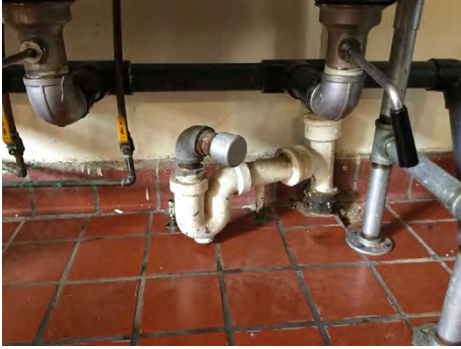
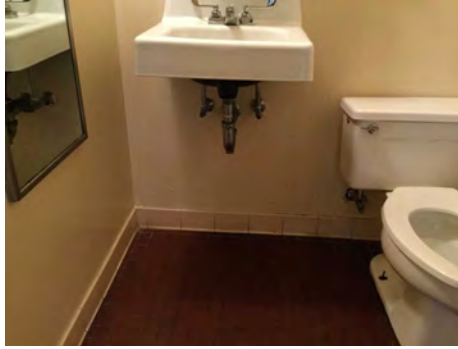
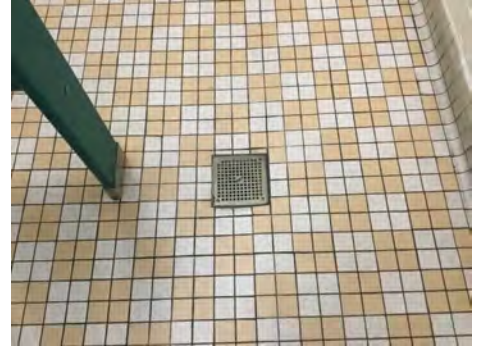
System: D2030 - Sanitary Waste

Notes: The sanitary waste system is aged, has reported periodic failures, and should be replaced.

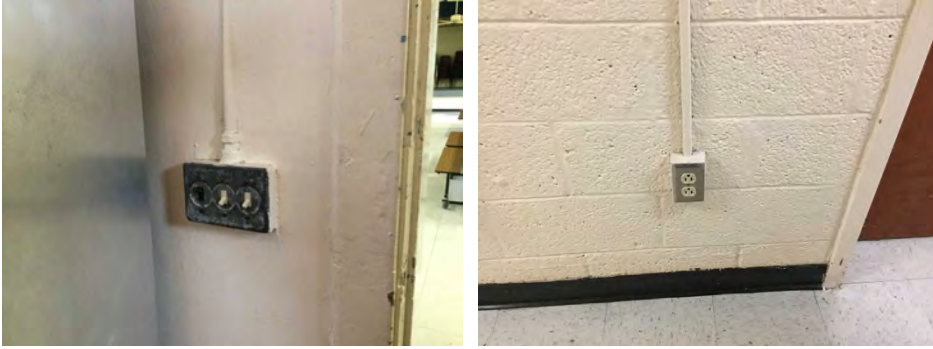
System: D5020 - Branch Wiring

Notes: The original branch wiring system is operating, but is aged, in poor condition, and should be replaced.

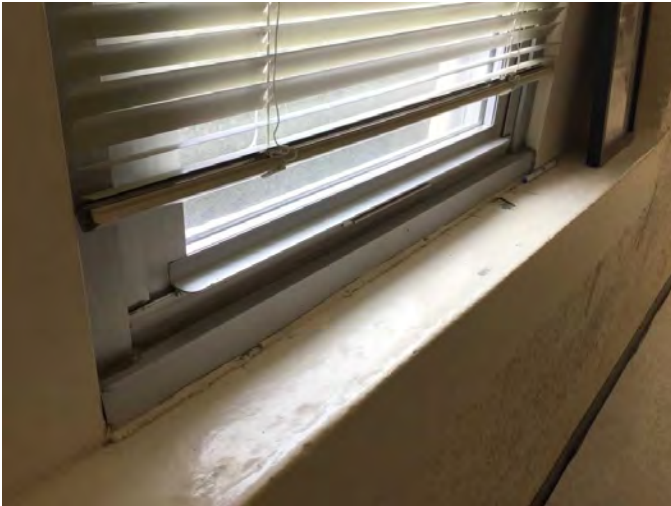
System: B2020 - Exterior Windows

Location: Throughout
Distress: Beyond Service Life
Category: Deferred Maintenance / Energy
Priority: 3 - Necessary/Not Yet Critical (Years 2-5)
Correction: Renew System
Qty: 28,806.00
Unit of Measure: S.F.
Estimate: \$297,537.00
Assessor Name: Terence Davis
Date Created: 12/23/2016

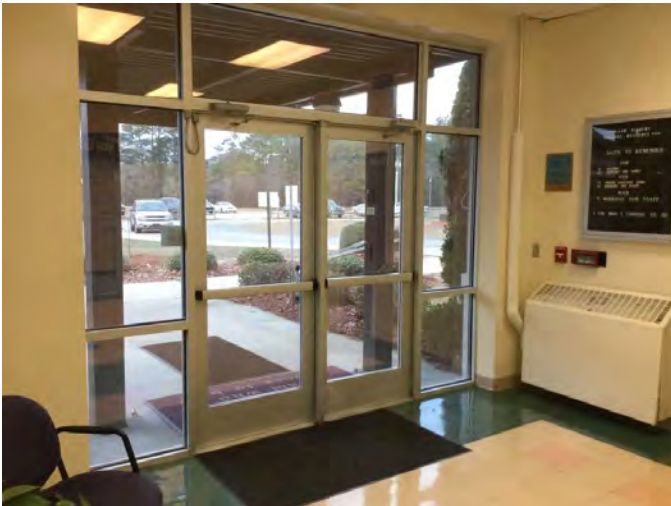
System: B2030 - Exterior Doors

Location: Throughout
Distress: Beyond Service Life
Category: Deferred Maintenance / Appearance
Priority: 3 - Necessary/Not Yet Critical (Years 2-5)
Correction: Renew System
Qty: 28,806.00
Unit of Measure: S.F.
Estimate: \$32,954.00
Assessor Name: Terence Davis
Date Created: 12/23/2016

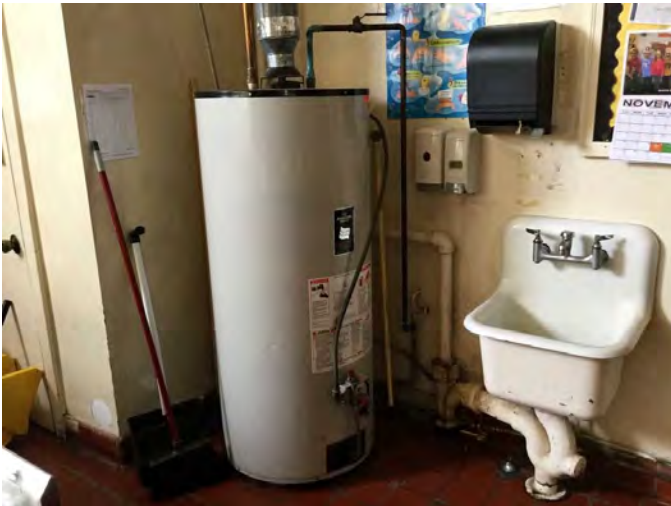
System: D2020 - Domestic Water Distribution

Location: Throughout
Distress: Beyond Service Life
Category: Deferred Maintenance
Priority: 3 - Necessary/Not Yet Critical (Years 2-5)
Correction: Renew System
Qty: 28,806.00
Unit of Measure: S.F.
Estimate: \$31,053.00
Assessor Name: Terence Davis
Date Created: 12/23/2016

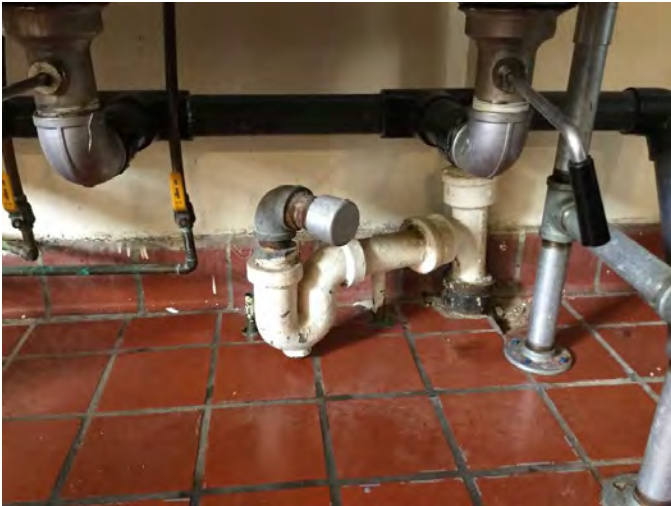
System: D2030 - Sanitary Waste

Location: Throughout
Distress: Beyond Service Life
Category: Deferred Maintenance
Priority: 3 - Necessary/Not Yet Critical (Years 2-5)
Correction: Renew System
Qty: 28,806.00
Unit of Measure: S.F.
Estimate: \$48,797.00
Assessor Name: Terence Davis
Date Created: 12/23/2016

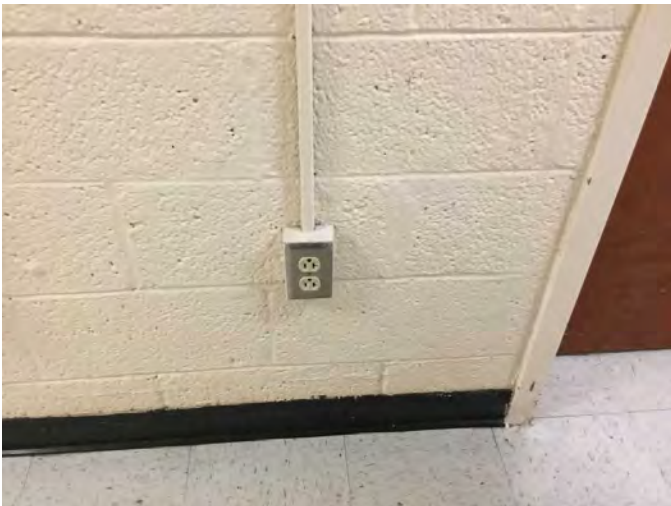
System: D5020 - Branch Wiring

Location: Throughout
Distress: Beyond Service Life
Category: Deferred Maintenance
Priority: 3 - Necessary/Not Yet Critical (Years 2-5)
Correction: Renew System
Qty: 28,806.00
Unit of Measure: S.F.
Estimate: \$160,334.00
Assessor Name: Terence Davis
Date Created: 12/23/2016

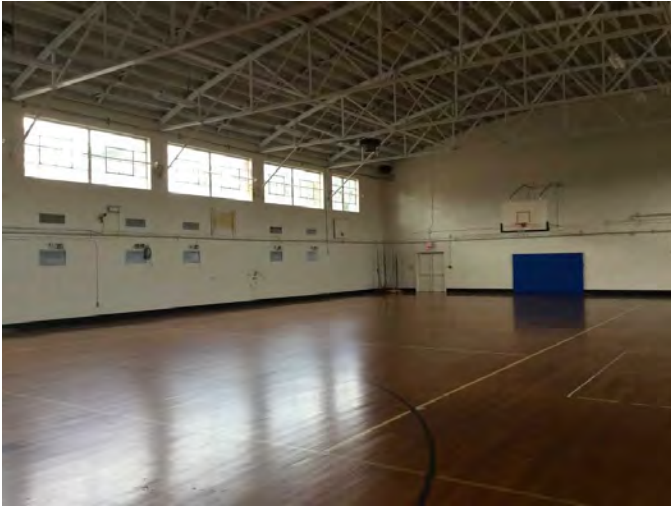
System: B2020 - Exterior Windows

Location: Throughout
Distress: Beyond Service Life
Category: Deferred Maintenance / Energy
Priority: 3 - Necessary/Not Yet Critical (Years 2-5)
Correction: Renew System
Qty: 8,688.00
Unit of Measure: S.F.
Estimate: \$89,738.00
Assessor Name: Terence Davis
Date Created: 12/23/2016

Notes: The aluminum frame, operable, single pane windows are aged, rusted, not energy efficient, and should be replaced.

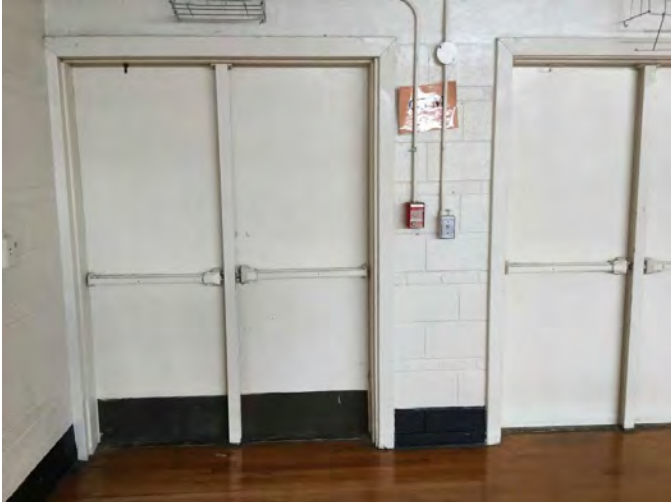
System: B2030 - Exterior Doors

Location: Throughout
Distress: Beyond Service Life
Category: Deferred Maintenance
Priority: 3 - Necessary/Not Yet Critical (Years 2-5)
Correction: Renew System
Qty: 8,688.00
Unit of Measure: S.F.
Estimate: \$9,939.00
Assessor Name: Terence Davis
Date Created: 12/23/2016

Notes: The original exterior doors are aged, rusted, and should be replaced.

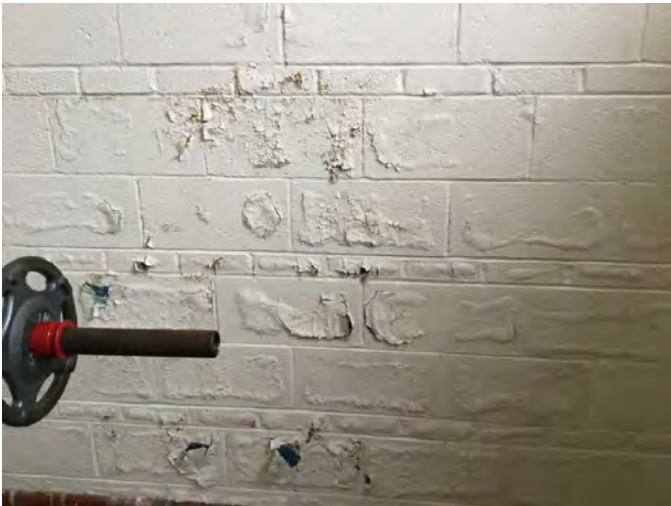
System: C3010 - Wall Finishes

Location: Throughout
Distress: Beyond Service Life
Category: Deferred Maintenance / Appearance
Priority: 3 - Necessary/Not Yet Critical (Years 2-5)
Correction: Renew System
Qty: 8,688.00
Unit of Measure: S.F.
Estimate: \$26,663.00
Assessor Name: Terence Davis
Date Created: 12/23/2016

Notes: The wall finishes are aged, scuffed, fading, stained, and should be replaced.

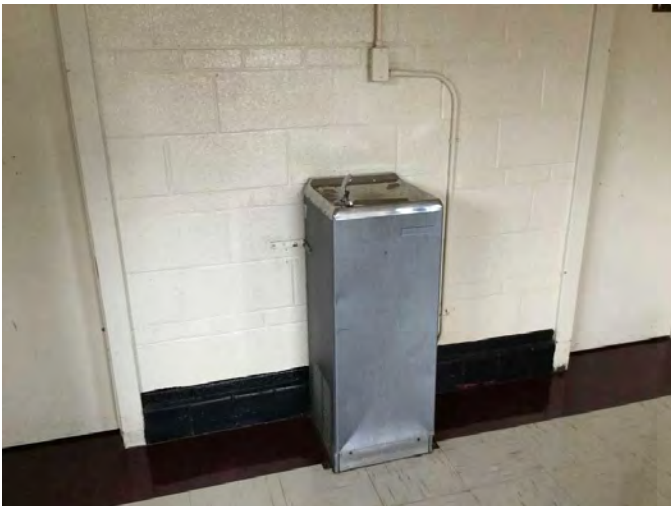
System: D2010 - Plumbing Fixtures

Location: Throughout
Distress: Beyond Service Life
Category: Deferred Maintenance
Priority: 3 - Necessary/Not Yet Critical (Years 2-5)
Correction: Renew System
Qty: 8,688.00
Unit of Measure: S.F.
Estimate: \$109,712.00
Assessor Name: Terence Davis
Date Created: 12/23/2016

Notes: Plumbing fixtures are in operational conditions. However, they are aged, not ADA compliant and should be replaced with a low-flow water fixtures.

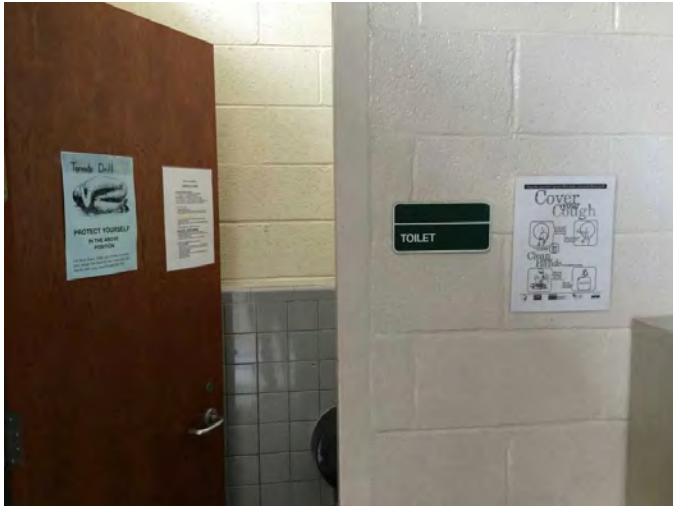
System: C1030 - Fittings

Location: Throughout
Distress: Beyond Service Life
Category: Deferred Maintenance / Accessibility Code Compliance
Priority: 2 - Potentially Critical (Year 1)
Correction: Renew System
Qty: 6,120.00
Unit of Measure: S.F.
Estimate: \$65,570.00
Assessor Name: Terence Davis
Date Created: 01/11/2017

Notes: The fittings throughout the building are aged, in marginal condition, handrails and room signage are ADA non-compliance and system should be replaced.

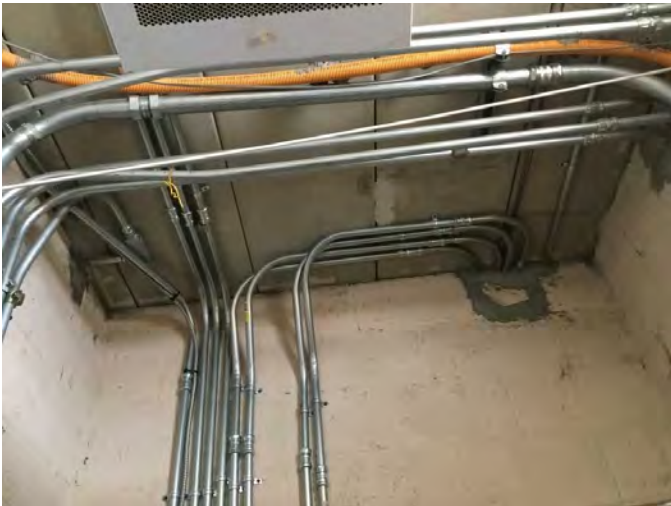
System: D5020 - Branch Wiring

Location: Throughout
Distress: Beyond Service Life
Category: Deferred Maintenance
Priority: 3 - Necessary/Not Yet Critical (Years 2-5)
Correction: Renew System
Qty: 6,120.00
Unit of Measure: S.F.
Estimate: \$34,064.00
Assessor Name: Terence Davis
Date Created: 01/11/2017

Notes: The original branch wiring system is operating, but is aged, in poor condition, and should be replaced.

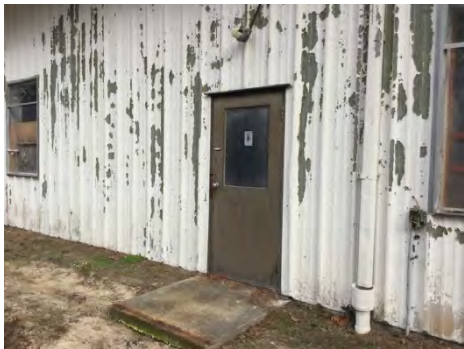
System: B2030 - Exterior Doors

Notes: The original exterior doors are aged, rusted, and should be replaced.

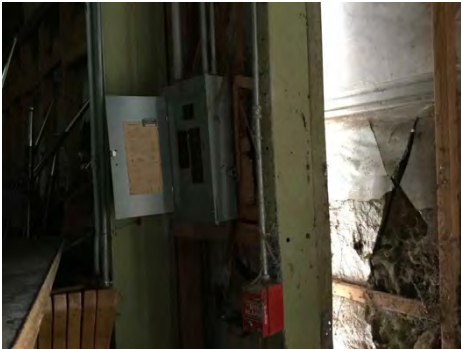
System: D5020 - Branch Wiring

Notes: The original branch wiring system is operating, but is aged, in poor condition, and should be replaced.

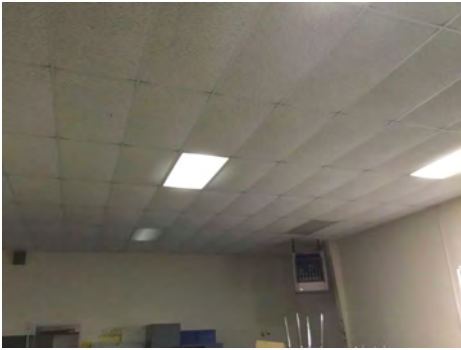
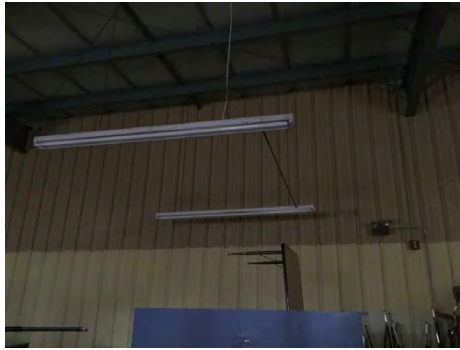
System: D5020 - Lighting

Notes: The original lighting system is operating, but is aged, in poor condition, and should be replaced.

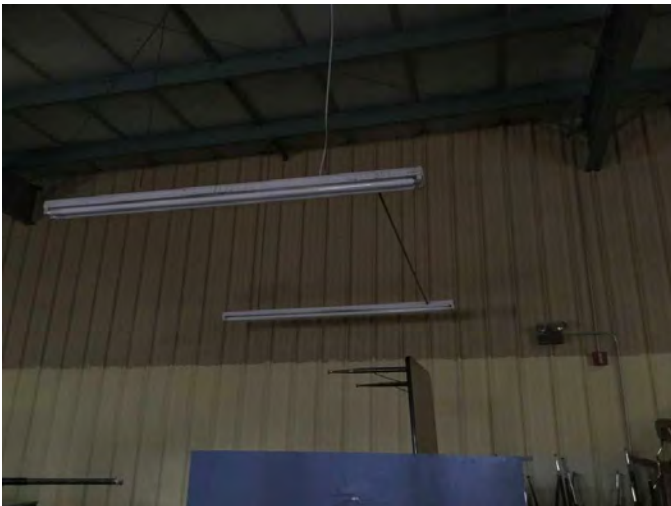
System: D5020 - Lighting

Location: Throughout
Distress: Beyond Service Life
Category: Deferred Maintenance / Energy
Priority: 3 - Necessary/Not Yet Critical (Years 2-5)
Correction: Renew System
Qty: 7,520.00
Unit of Measure: S.F.
Estimate: \$79,246.00
Assessor Name: Terence Davis
Date Created: 01/11/2017

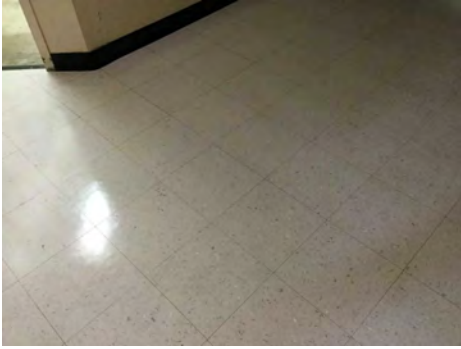
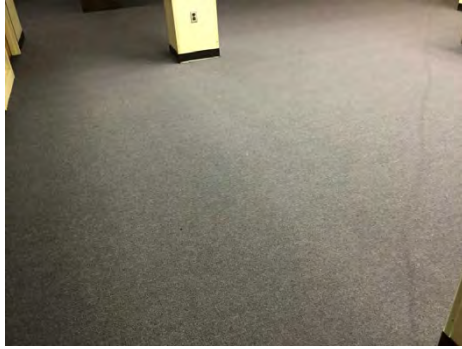
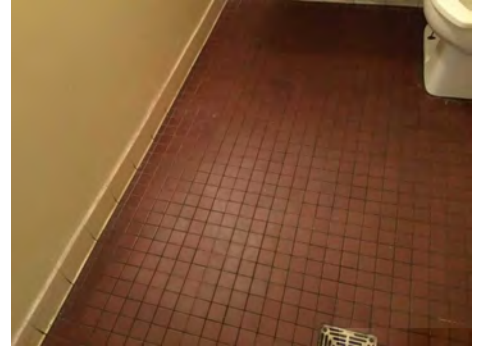
System: C3020 - Floor Finishes

Notes: The carpet is aged, stained, frayed, and should be replaced.

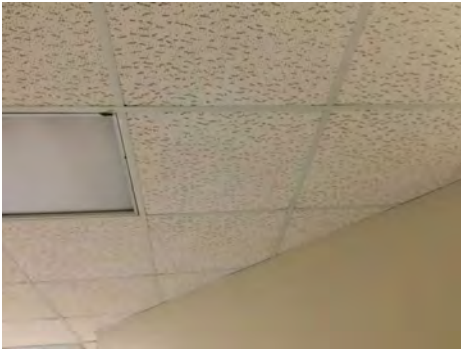
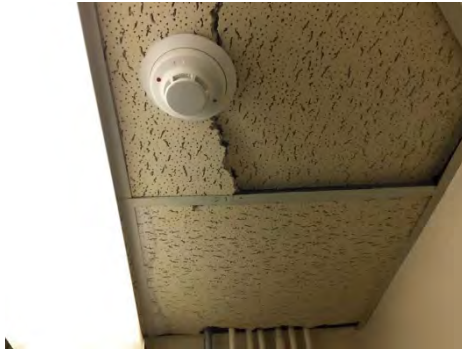
System: C3030 - Ceiling Finishes

Notes: The original ceiling finishes are aged, failing and should be replaced.

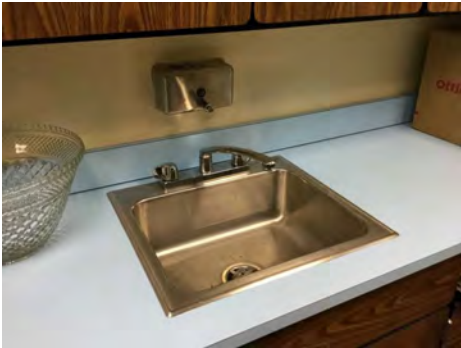
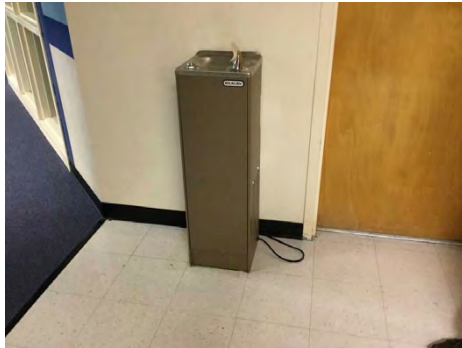
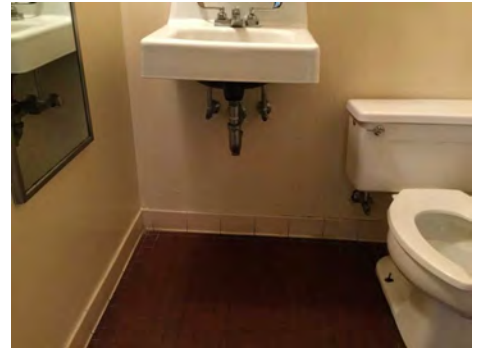
System: D2010 - Plumbing Fixtures

Notes: Plumbing fixtures are in operational conditions. However, they are aged, not ADA compliant and should be replaced with a low-flow water fixtures.

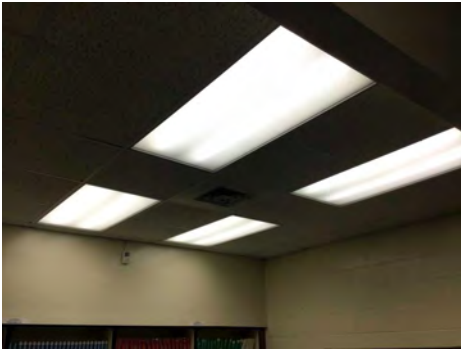
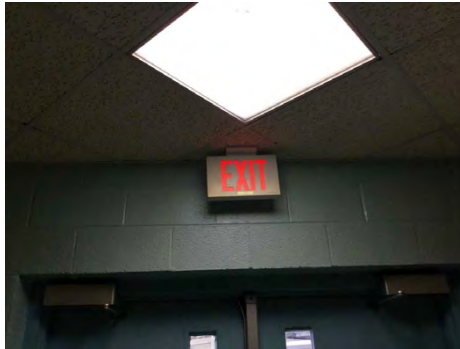
System: D5020 - Lighting

Notes: The original lighting system is operating, but is aged, in poor condition, and should be replaced with energy savings models.

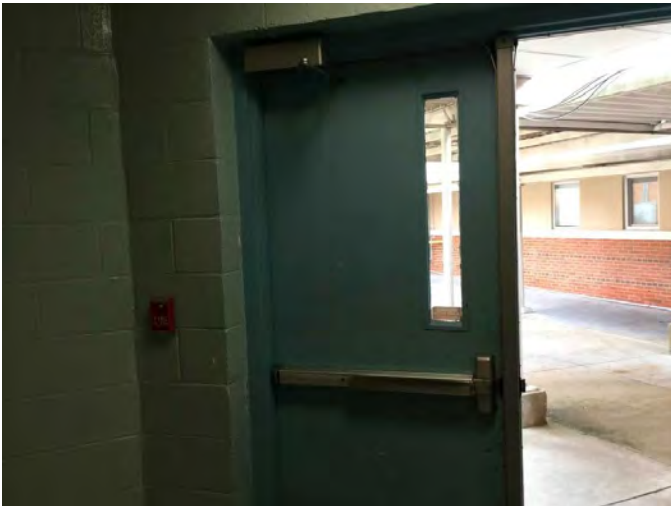
System: B2030 - Exterior Doors

Location: Throughout
Distress: Beyond Service Life
Category: Deferred Maintenance
Priority: 3 - Necessary/Not Yet Critical (Years 2-5)
Correction: Renew System
Qty: 3,762.00
Unit of Measure: S.F.
Estimate: \$4,304.00
Assessor Name: Terence Davis
Date Created: 01/11/2017

Notes: The original exterior doors are aged, rusted, and should be replaced.

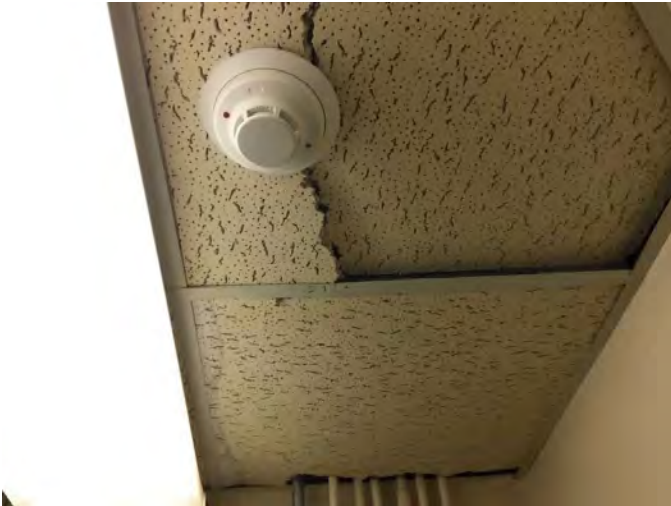
System: C3030 - Ceiling Finishes

Location: Throughout
Distress: Beyond Service Life
Category: Deferred Maintenance / Appearance
Priority: 3 - Necessary/Not Yet Critical (Years 2-5)
Correction: Renew System
Qty: 3,762.00
Unit of Measure: S.F.
Estimate: \$45,396.00
Assessor Name: Terence Davis
Date Created: 01/11/2017

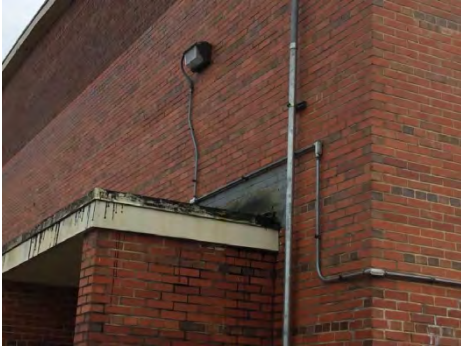
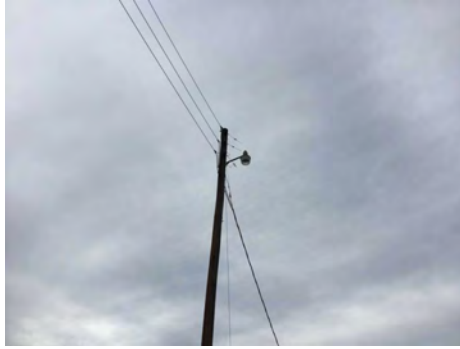
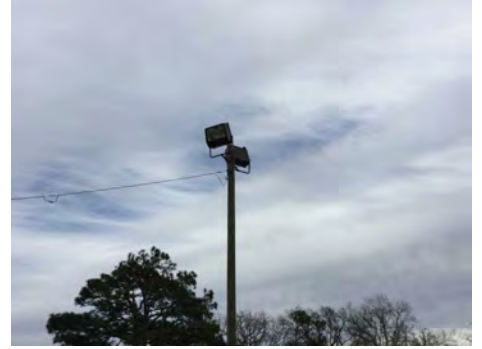
System: G4020 - Site Lighting

Notes: Site Lighting is aged and does not adequately cover all areas and should be replaced.

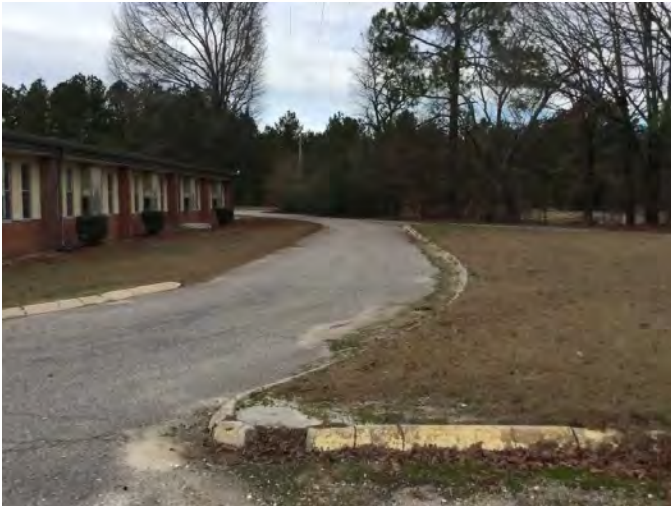
System: G2010 - Roadways

Location: Site
Distress: Beyond Service Life
Category: Deferred Maintenance / Building Code Compliance
Priority: 3 - Necessary/Not Yet Critical (Years 2-5)
Correction: Renew System
Qty: 54,896.00
Unit of Measure: S.F.
Estimate: \$230,069.00
Assessor Name: Eduardo Lopez
Date Created: 01/11/2017

Notes: The asphaltic roadway is aged, has many road cuts and repairs, and should be re-surfaced. Provide Fire lane markings per Local Code requirements.

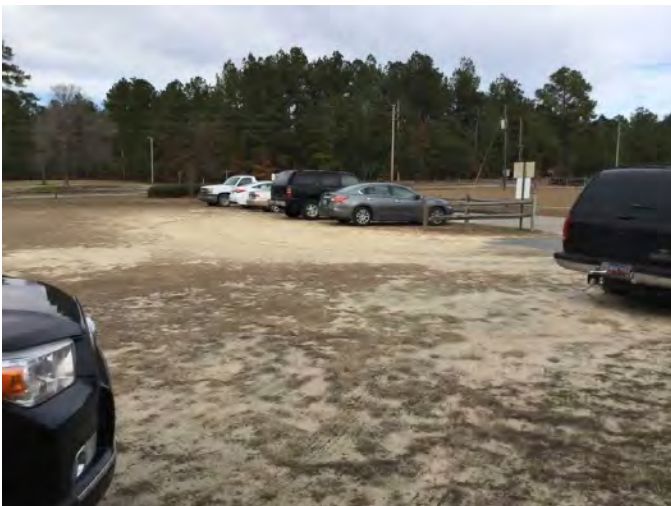
System: G2020 - Parking Lots

Location: Parking
Distress: Beyond Service Life
Category: Deferred Maintenance / Accessibility Code Compliance
Priority: 3 - Necessary/Not Yet Critical (Years 2-5)
Correction: Renew System
Qty: 54,896.00
Unit of Measure: S.F.
Estimate: \$80,313.00
Assessor Name: Eduardo Lopez
Date Created: 01/11/2017

Notes: The parking lot is aged, has many repairs and potholes, and should be replaced and re-striped. ADA signs height needs to be adjusted per minimum ADA standards.

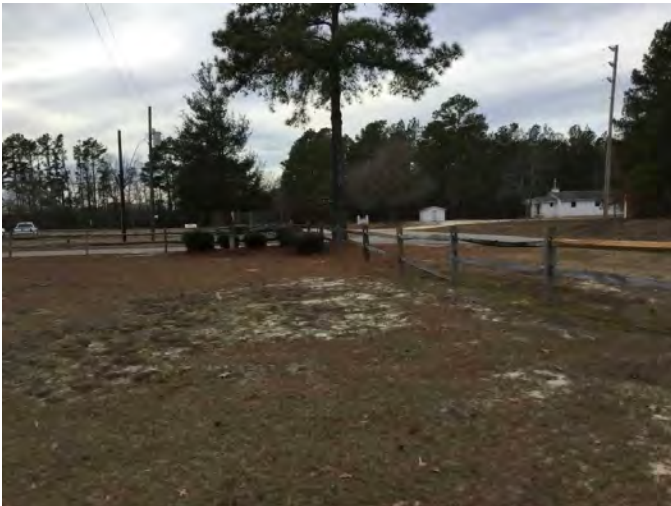
System: G2040105 - Fence & Guardrails

Location: Parking/roadways
Distress: Beyond Service Life
Category: Deferred Maintenance / Appearance
Priority: 3 - Necessary/Not Yet Critical (Years 2-5)
Correction: Renew System
Qty: 54,896.00
Unit of Measure: S.F.
Estimate: \$74,274.00
Assessor Name: Eduardo Lopez
Date Created: 01/11/2017

Notes: The fence and guardrails are failing, beyond expected life, and not longer an effective barrier and should be scheduled for replacement.

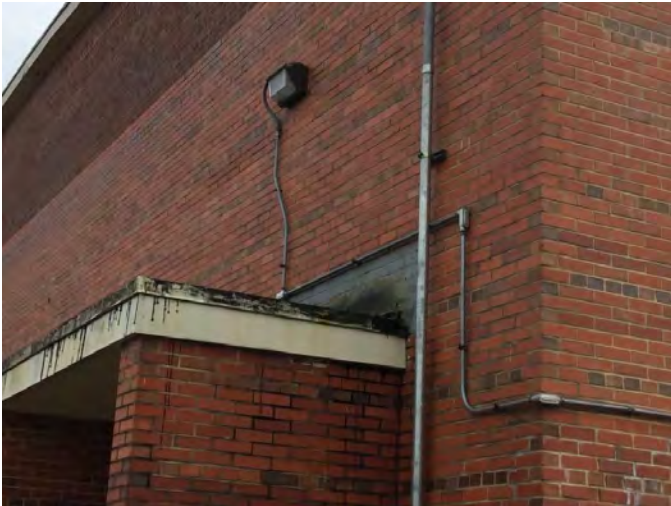
System: G4020 - Site Lighting

Location: Entire site
Distress: Inadequate
Category: Deferred Maintenance / Energy
Priority: 3 - Necessary/Not Yet Critical (Years 2-5)
Correction: Renew System
Qty: 54,896.00
Unit of Measure: S.F.
Estimate: \$88,767.00
Assessor Name: Eduardo Lopez
Date Created: 01/11/2017
