NC School District/995 Yancey County/Elementary School

Micaville Elementary

Campus Assessment Report

March 11, 2017

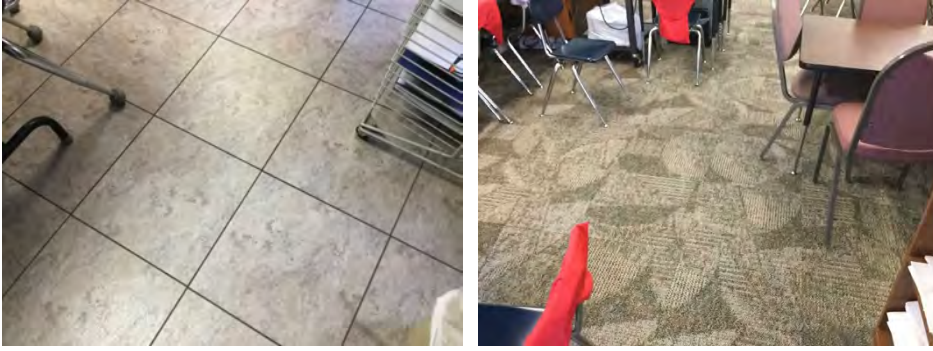
System: C3020 - Floor Finishes

Notes: The carpet is aged, stained, frayed, and should be replaced.

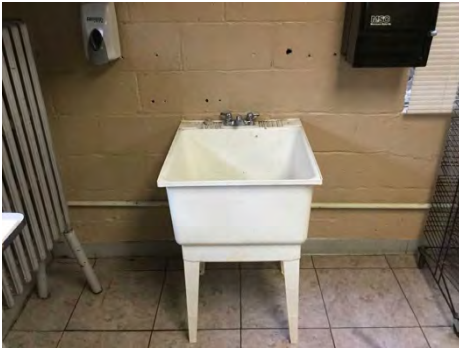
System: D2010 - Plumbing Fixtures

Notes: Plumbing fixtures are in operational conditions. However, they are aged, not ADA compliant and should be replaced with a low-flow water fixtures.

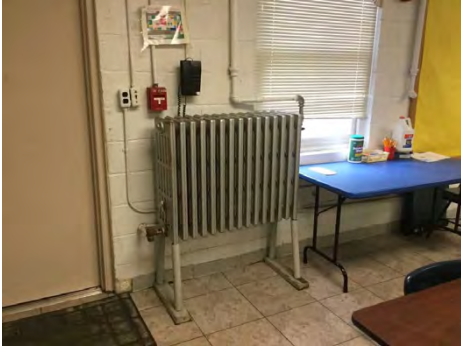
System: D3040 - Distribution Systems

Notes: The radiators units are aged, becoming logistically unsupportable, and should be replaced.

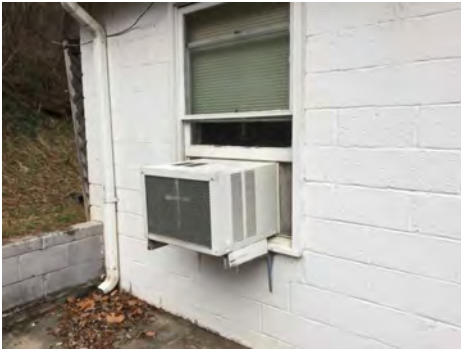
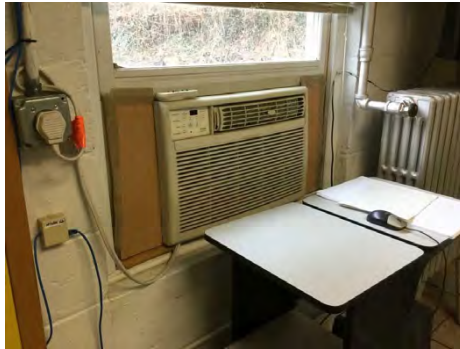
System: D3050 - Terminal & Package Units

Notes: The window mounted DX condensers are aged, rusted, not energy efficient, and should be replaced.

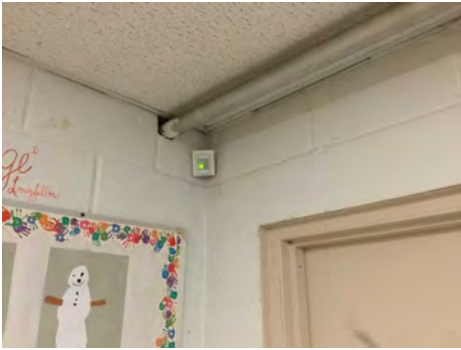
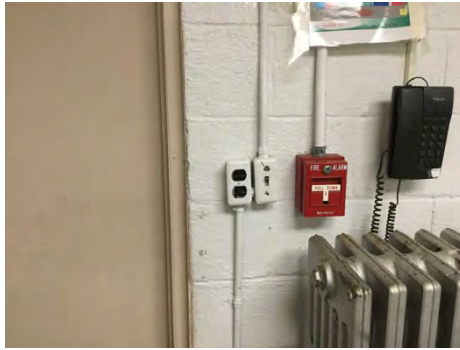
System: D5020 - Branch Wiring

Notes: The original branch wiring system is operating, but is aged, in poor condition, and should be replaced.

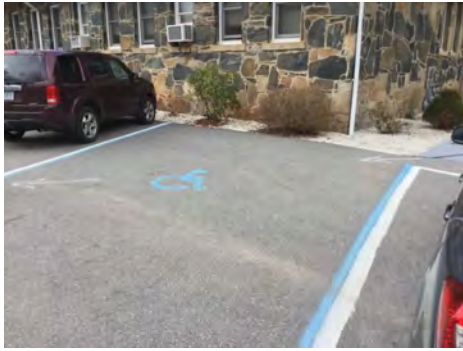
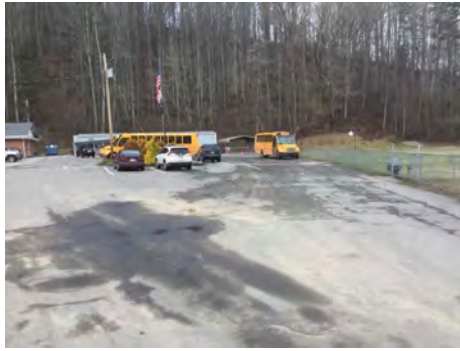
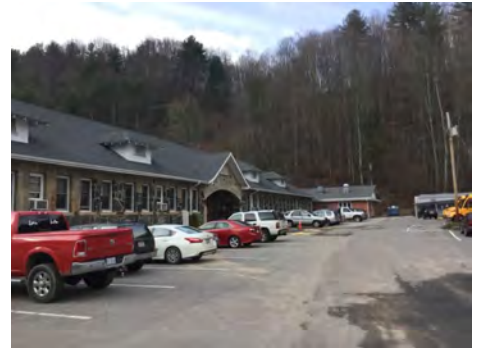
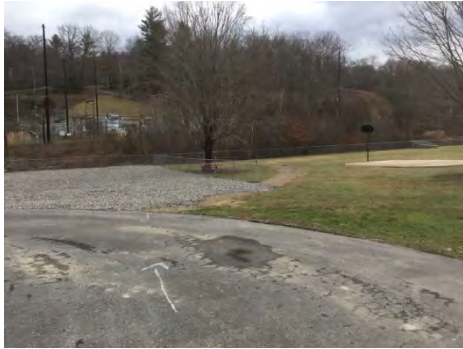
System: G2020 - Parking Lots

Location: Parking
Distress: Failing
Category: Deferred Maintenance / Accessibility Code Compliance
Priority: 2 - Potentially Critical (Year 1)
Correction: Renew System
Qty: 24,414.00
Unit of Measure: S.F.
Estimate: \$35,718.00
Assessor Name: Eduardo Lopez
Date Created: 01/27/2017

Notes: The parking lot is aged, has many repairs and potholes, and should be replaced and re-striped. ADA signs height needs to be adjusted per minimum ADA standards.

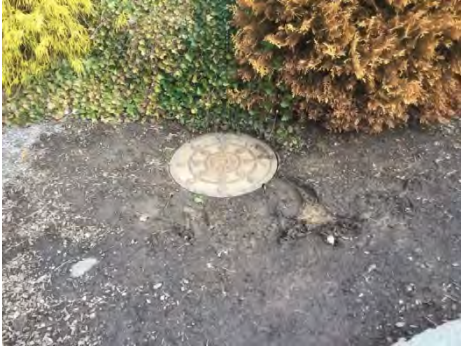
System: G3020 - Sanitary Sewer

Location: Septic
Distress: Failing
Category: Deferred Maintenance / Environmental
Priority: 1 - Currently Critical (Immediate)
Correction: Renew System
Qty: 24,414.00
Unit of Measure: S.F.
Estimate: \$38,940.00
Assessor Name: Eduardo Lopez
Date Created: 01/27/2017

Notes: The sanitary waste system requires daily pump-out, is aged, and should be replaced.
