NC School District/995 Yancey County/Elementary School

South Toe Elementary

Campus Assessment Report

March 11, 2017

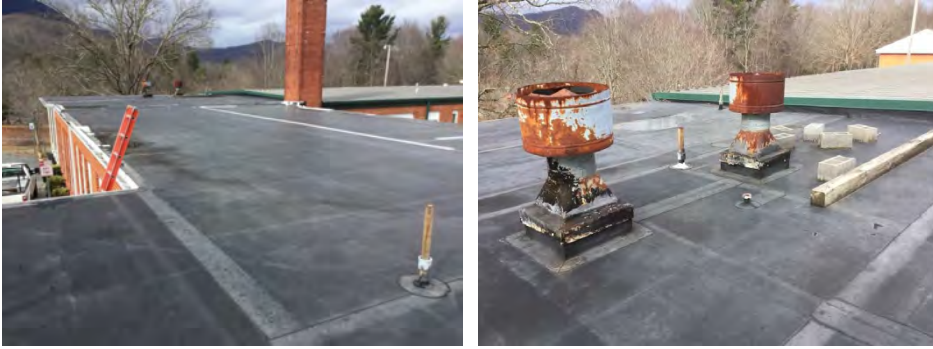
System: B3010120 - Single Ply Membrane

Location: Cafeteria
Distress: Failing
Category: Deferred Maintenance
Priority: 3 - Necessary/Not Yet Critical (Years 2-5)
Correction: Renew System
Qty: 4,560.00
Unit of Measure: S.F.
Estimate: \$47,743.00
Assessor Name: Terence Davis
Date Created: 01/30/2017

Notes: The EPDM adhered roof coverings are aging, showing signs of failure and should be replaced.

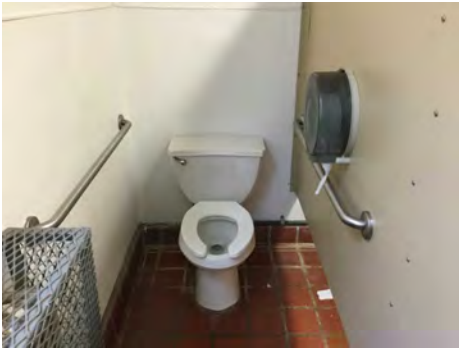
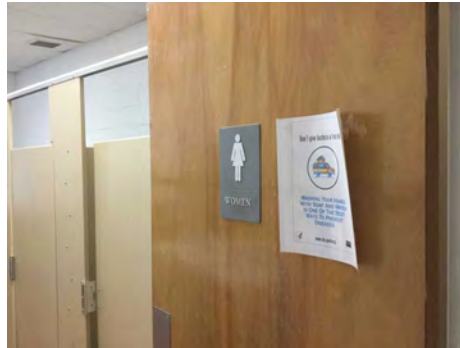
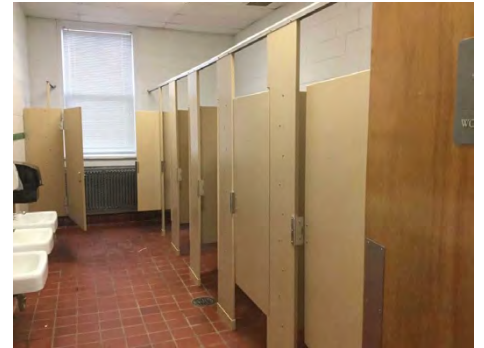
System: C1030 - Fittings

Notes: The fittings throughout the building are aged, in marginal condition, handrails and room signage are ADA non-compliance and system should be replaced.

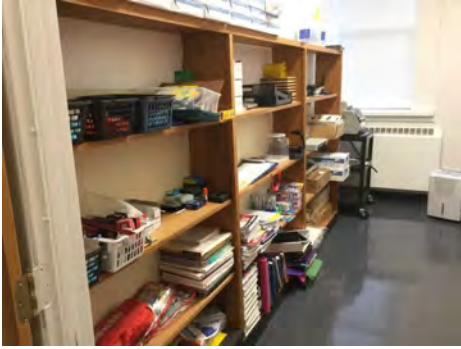
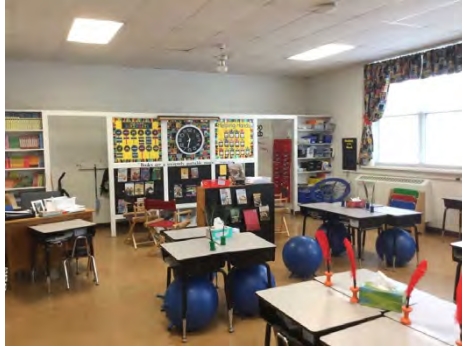
System: E2010 - Fixed Furnishings

Notes: The fixed furnishings are aged, in marginal condition, and should be replaced.

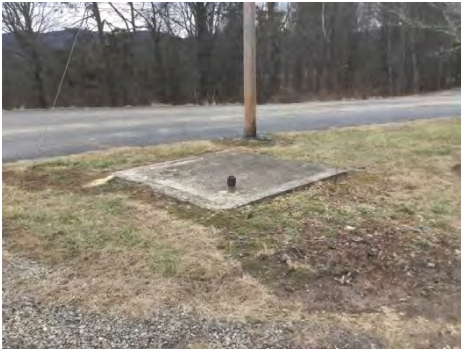
System: G3060 - Fuel Distribution

Notes: The fuel distribution system is aged, becoming logistically unsupportable, and should be replaced.

Location: Boiler Exterior
Distress: Failing
Category: Deferred Maintenance / Safety
Priority: 3 - Necessary/Not Yet Critical (Years 2-5)
Correction: Renew System
Qty: 22,744.00
Unit of Measure: S.F.
Estimate: \$24,518.00
Assessor Name: Eduardo Lopez
Date Created: 01/30/2017
