NC School District/995 Yancey County/High School

Mountain Heritage High

Campus Assessment Report

March 12, 2017

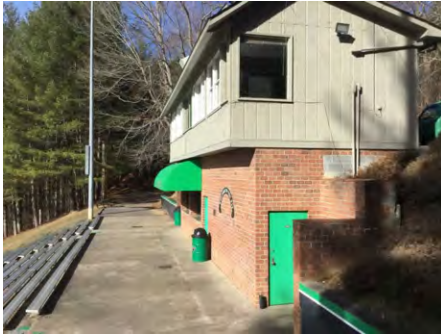
1). Southwest Elevation - Feb 01, 2017

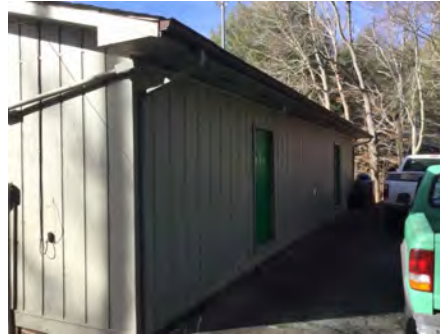
2). East Elevation - Feb 01, 2017
