NC School District/995 Yancey County/Middle School

Cane River Middle

Campus Assessment Report

March 11, 2017

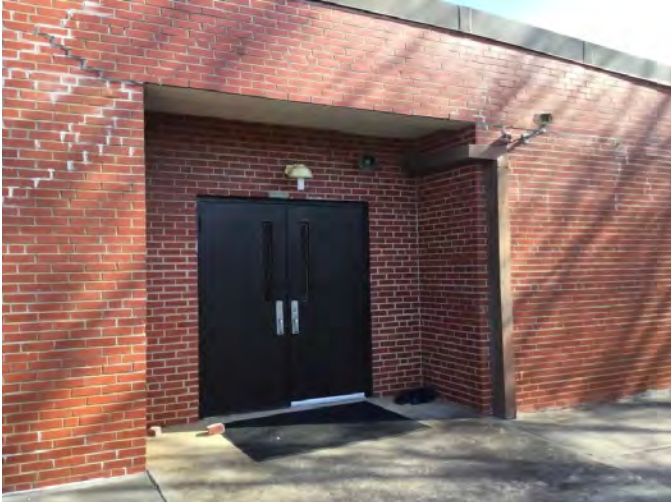
System: B2030 - Exterior Doors

Location: Throughout
Distress: Beyond Service Life
Category: Deferred Maintenance / Appearance
Priority: 3 - Necessary/Not Yet Critical (Years 2-5)
Correction: Renew System
Qty: 44,433.00
Unit of Measure: S.F.
Estimate: \$50,831.00
Assessor Name: Terence Davis
Date Created: 02/01/2017

Notes: The original exterior doors are aged, rusted, and should be replaced.

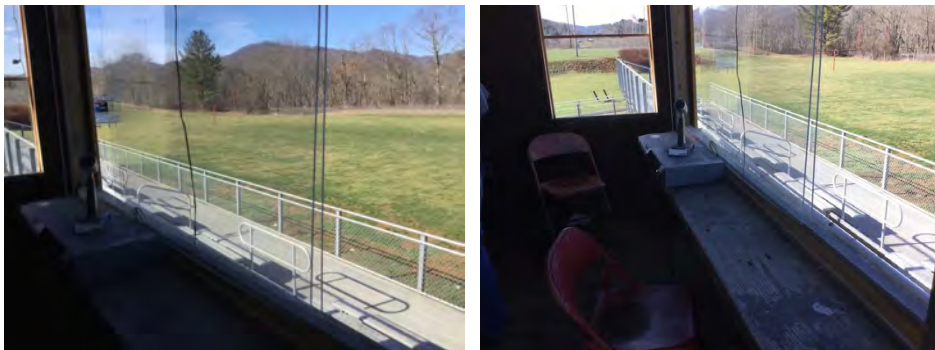
System: B2020 - Exterior Windows

Notes: The plexi-glass, single pane windows are aged, warped, not energy efficient, and should be replaced.

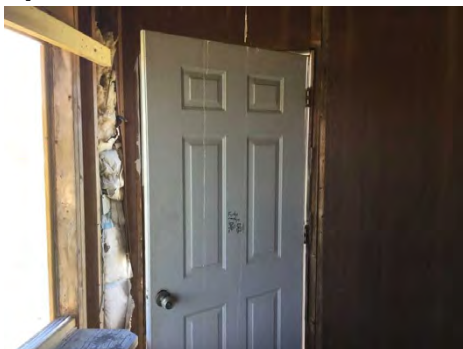
System: B2030 - Exterior Doors

Notes: The original exterior doors are aged, damaged, and should be replaced.

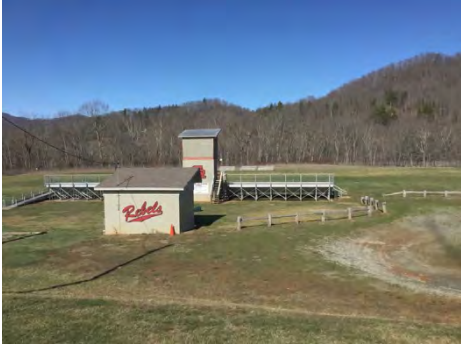
System: B3010140 - Asphalt Shingles

Notes: The asphalt shingle roofing is aged, damaged and should be replaced.

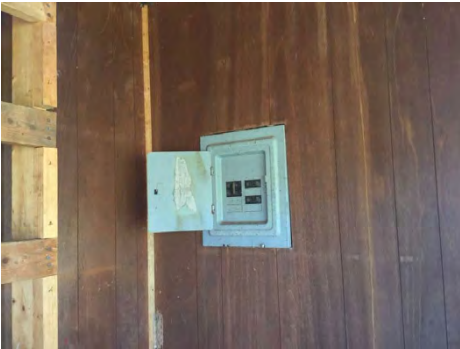
System: D5010 - Electrical Service/Distribution

Notes: The original electrical service is operating but is in poor condition and should be replaced.

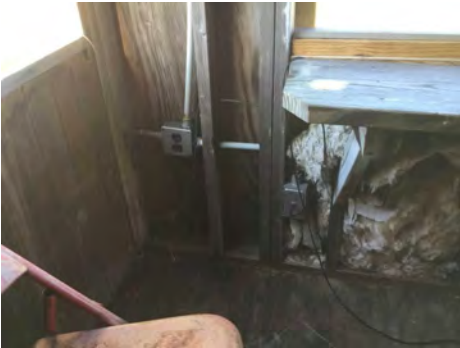
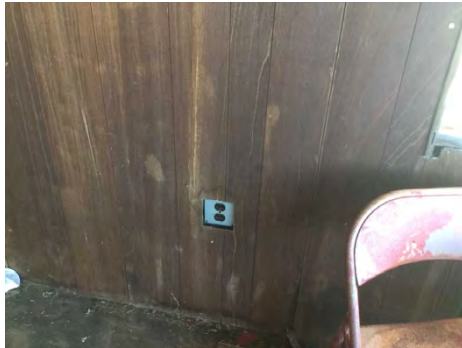
System: D5020 - Branch Wiring

Notes: The original branch wiring system is operating, but is aged, in poor condition, and should be replaced.

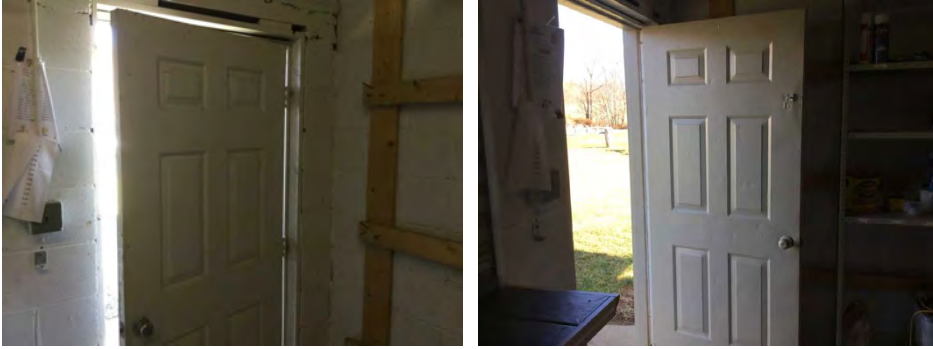
System: B2030 - Exterior Doors

Notes: The original exterior doors are aged, damaged, and should be replaced.

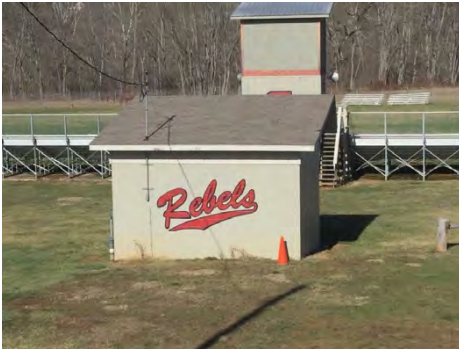
System: B3010140 - Asphalt Shingles

Notes: The asphalt shingle roofing is aged, damaged and should be replaced.

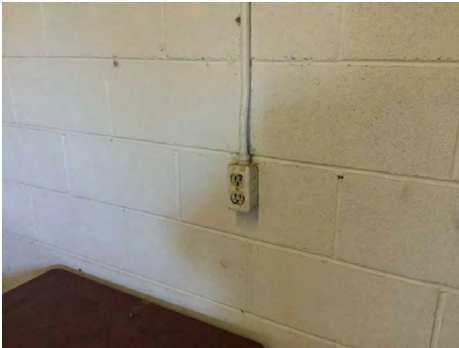
System: C3010 - Wall Finishes

Notes: The wall paint is damaged, fading, stained, and should be re-painted.

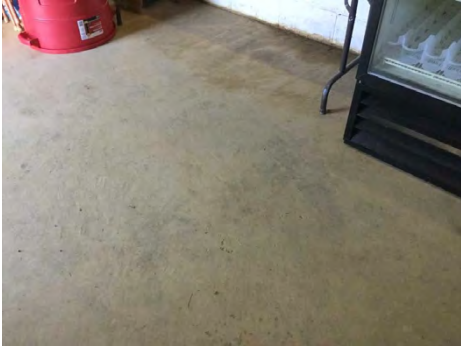
System: C3020 - Floor Finishes

Notes: The original floor finish is worn and no longer effective for protection and should be replaced.

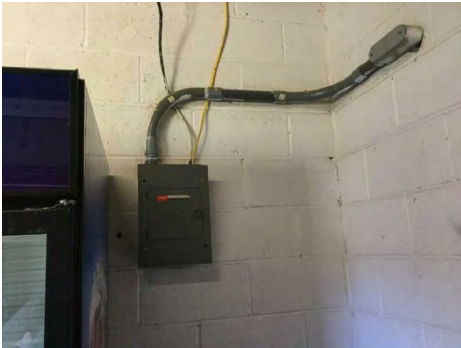
System: D5010 - Electrical Service/Distribution

Notes: The original electrical service is operating but is in poor condition and should be replaced.

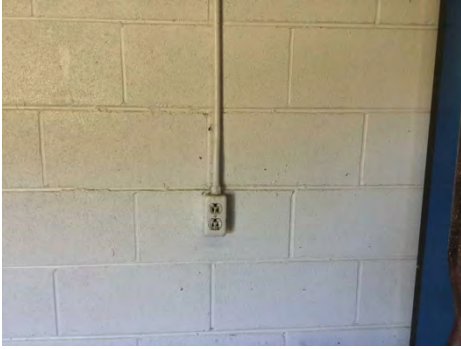
System: D5020 - Branch Wiring

Notes: The original branch wiring system is operating, but is aged, in poor condition, and should be replaced.

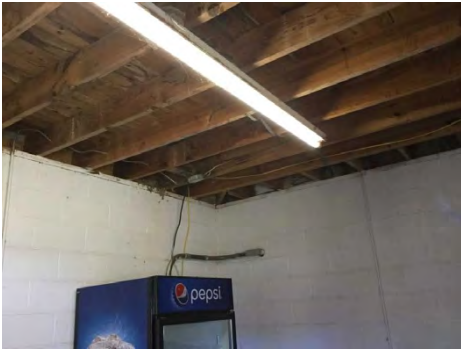
System: D5020 - Lighting

Notes: The original lighting system is operating, but is aged, in poor condition, and should be replaced.

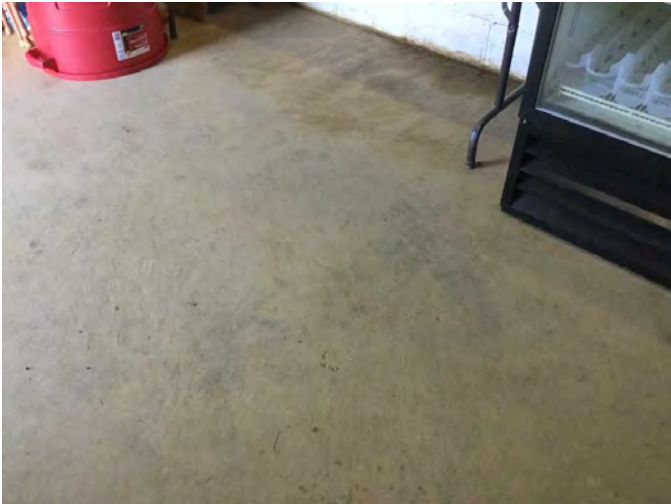
System: C3020 - Floor Finishes

Location: Throughout
Distress: Failing
Category: Deferred Maintenance / Appearance
Priority: 3 - Necessary/Not Yet Critical (Years 2-5)
Correction: Renew System
Qty: 250.00
Unit of Measure: S.F.
Estimate: \$3,504.00
Assessor Name: Eduardo Lopez
Date Created: 02/01/2017

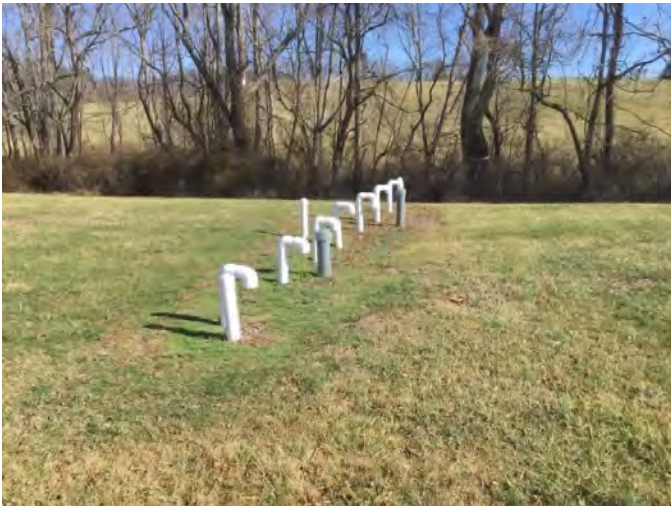
System: G3020 - Sanitary Sewer

Location: Septic
Distress: Beyond Service Life
Category: Deferred Maintenance
Priority: 3 - Necessary/Not Yet Critical (Years 2-5)
Correction: Renew System
Qty: 54,577.00
Unit of Measure: S.F.
Estimate: \$91,253.00
Assessor Name: Matt Mahaffey
Date Created: 02/01/2017

Notes: The sanitary sewer system is aged, has reported periodic failures, and should be replaced.

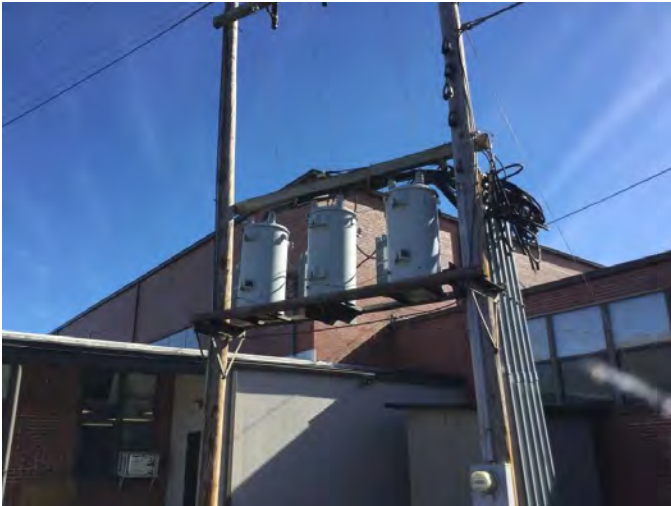
System: G4010 - Electrical Distribution

Location: Throughout
Distress: Beyond Service Life
Category: Deferred Maintenance
Priority: 3 - Necessary/Not Yet Critical (Years 2-5)
Correction: Renew System
Qty: 54,577.00
Unit of Measure: S.F.
Estimate: \$155,490.00
Assessor Name: Matt Mahaffey
Date Created: 02/01/2017

Notes: The original electrical distribution system is operating properly due to an aggressive maintenance program but is aged, in marginal condition, and should be replaced.
