NC School District/995 Yancey County/Middle School

East Yancey Middle

Campus Assessment Report

March 11, 2017

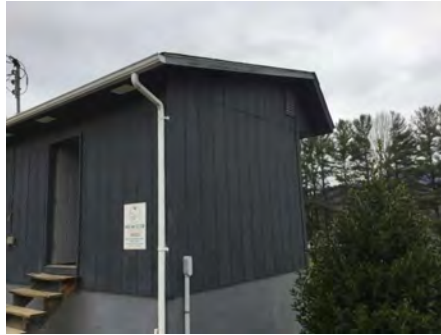
2). East Elevation - Feb 02, 2017

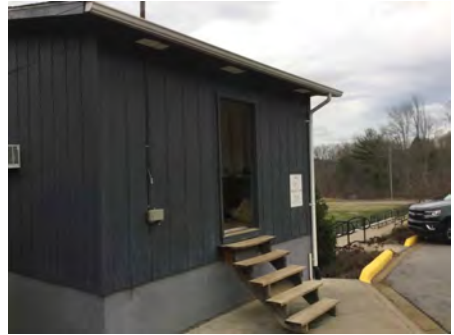
3). South Elevation - Feb 02, 2017
