NC School District/040 Anson County/High School

Anson High

Campus Assessment Report

March 10, 2017

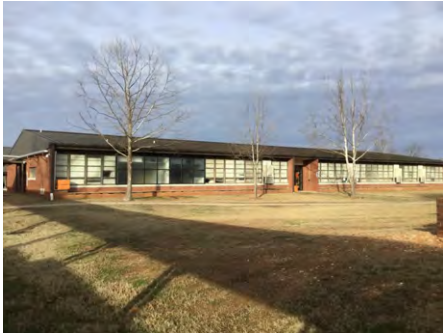
1). East Elevation - Feb 12, 2017

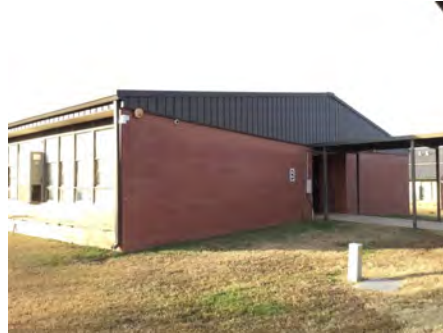
2). North Elevation - Feb 12, 2017

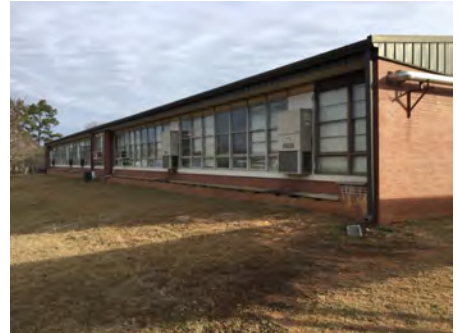
3). West Elevation - Feb 12, 2017

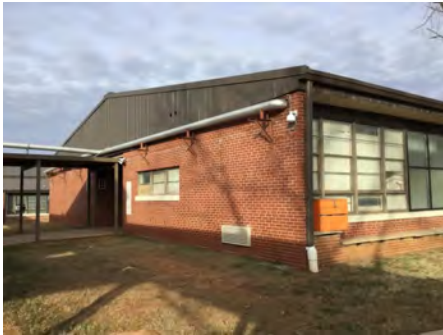
4). South Elevation - Feb 12, 2017

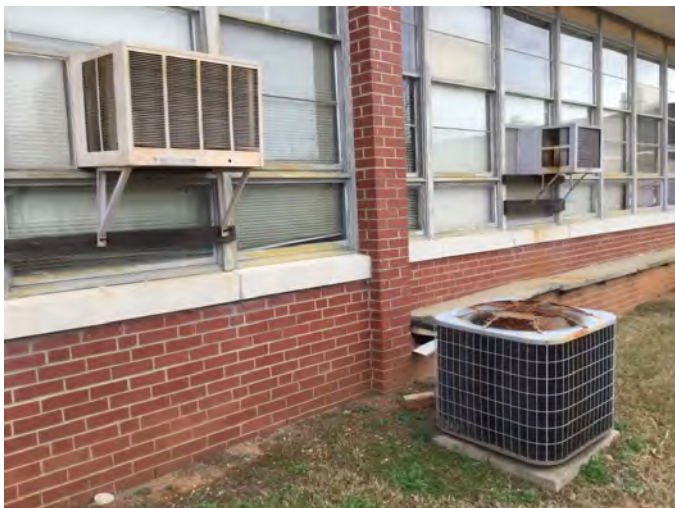
System: B2020 - Exterior Windows

Location: Exterior Walls
Distress: Beyond Service Life
Category: Deferred Maintenance
Priority: 3 - Necessary/Not Yet Critical (Years 2-5)
Correction: Renew System
Qty: 12,158.00
Unit of Measure: S.F.
Estimate: \$206,893.00
Assessor Name: Eduardo Lopez
Date Created: 01/04/2017

Notes: The exterior windows are aged, rusted, not energy efficient and should be replaced.

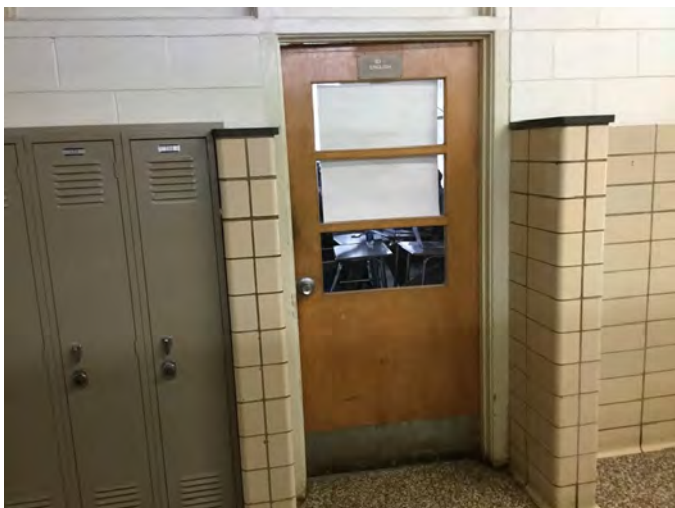
System: C1020 - Interior Doors

Location: Throughout the Building
Distress: Beyond Service Life
Category: Deferred Maintenance
Priority: 3 - Necessary/Not Yet Critical (Years 2-5)
Correction: Renew System
Qty: 12,158.00
Unit of Measure: S.F.
Estimate: \$39,319.00
Assessor Name: Eduardo Lopez
Date Created: 01/04/2017

Notes: The interior doors are aged, failing, most hardware is not ADA or code compliant and should be replaced.

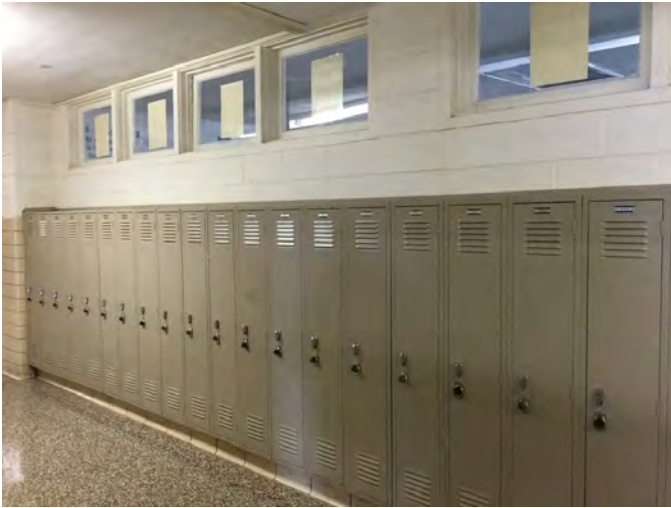
System: C1030 - Fittings

Location: Throughout the Building
Distress: Beyond Service Life
Category: Deferred Maintenance
Priority: 3 - Necessary/Not Yet Critical (Years 2-5)
Correction: Renew System
Qty: 12,158.00
Unit of Measure: S.F.
Estimate: \$24,207.00
Assessor Name: Eduardo Lopez
Date Created: 01/04/2017

Notes: The fittings throughout the building are aged, in marginal condition, handrails and room signage are not ADA compliant and should be replaced.

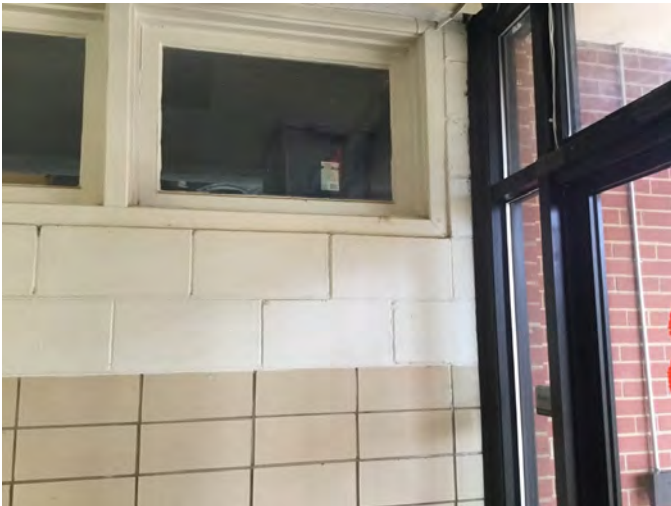
System: C3010 - Wall Finishes

Location: Throughout the Building
Distress: Beyond Service Life
Category: Deferred Maintenance
Priority: 3 - Necessary/Not Yet Critical (Years 2-5)
Correction: Renew System
Qty: 12,158.00
Unit of Measure: S.F.
Estimate: \$41,459.00
Assessor Name: Eduardo Lopez
Date Created: 01/04/2017

Notes: The wall finishes are aged, scuffed, fading, stained and should be replaced.

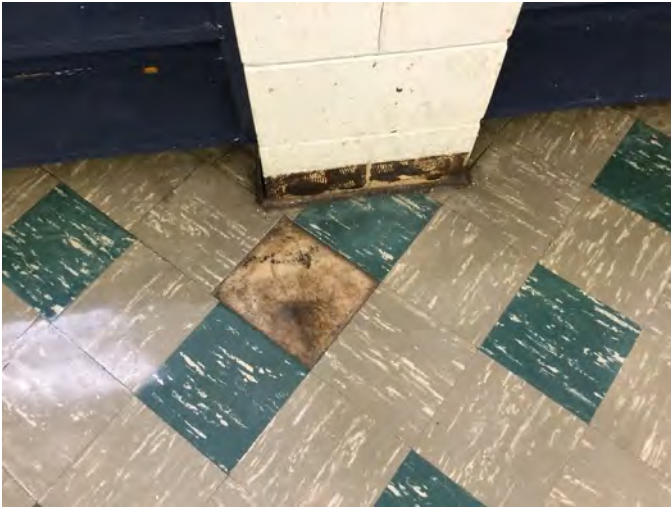
System: C3020 - Floor Finishes

Location: Throughout the Building
Distress: Beyond Service Life
Category: Deferred Maintenance
Priority: 3 - Necessary/Not Yet Critical (Years 2-5)
Correction: Renew System
Qty: 12,158.00
Unit of Measure: S.F.
Estimate: \$177,203.00
Assessor Name: Eduardo Lopez
Date Created: 01/04/2017

Notes: The original flooring is in poor conditions and should be replaced.

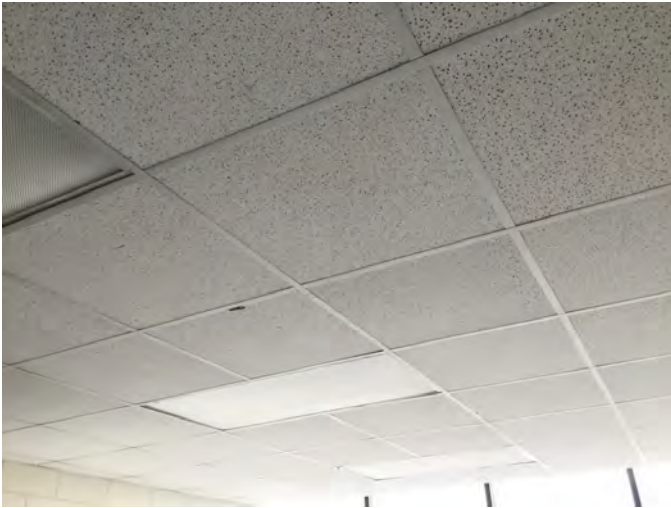
System: C3030 - Ceiling Finishes

Location: Throughout the Building
Distress: Beyond Service Life
Category: Deferred Maintenance
Priority: 3 - Necessary/Not Yet Critical (Years 2-5)
Correction: Renew System
Qty: 12,158.00
Unit of Measure: S.F.
Estimate: \$171,051.00
Assessor Name: Eduardo Lopez
Date Created: 01/04/2017

Notes: The original ceiling finishes are aged, failing and should be replaced.

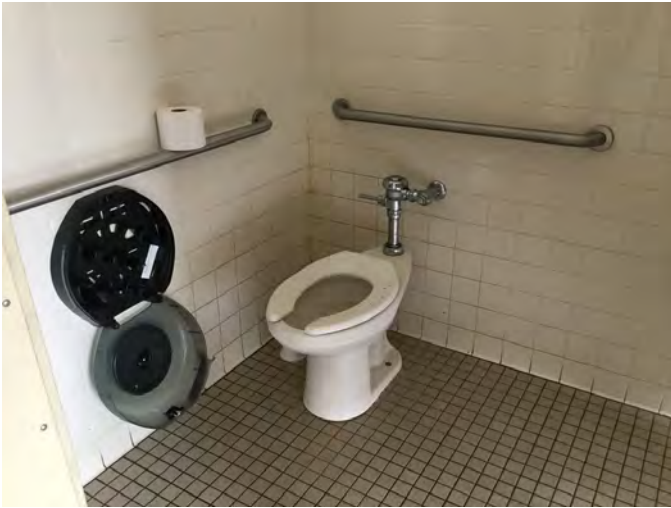
System: D2010 - Plumbing Fixtures

Location: Throughout the Building
Distress: Beyond Service Life
Category: Deferred Maintenance
Priority: 3 - Necessary/Not Yet Critical (Years 2-5)
Correction: Renew System
Qty: 12,158.00
Unit of Measure: S.F.
Estimate: \$143,233.00
Assessor Name: Eduardo Lopez
Date Created: 01/04/2017

Notes: Plumbing fixtures are in operational conditions. However, they are aged, not ADA compliant, and should be scheduled for replacement.

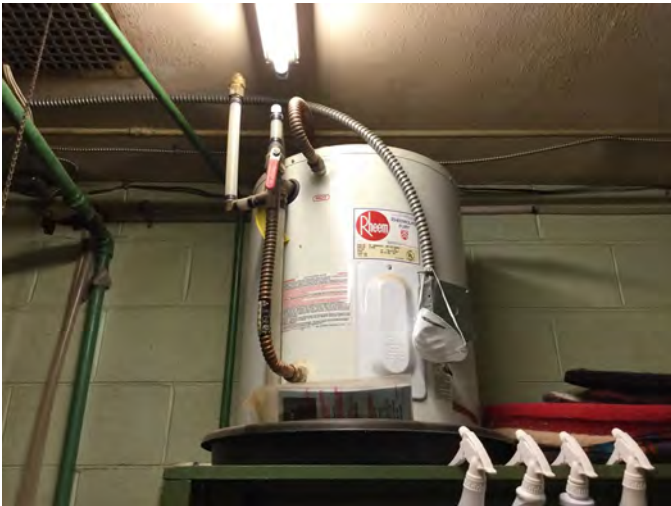
System: D2020 - Domestic Water Distribution

Location: Throughout the Building
Distress: Beyond Service Life
Category: Deferred Maintenance
Priority: 3 - Necessary/Not Yet Critical (Years 2-5)
Correction: Renew System
Qty: 12,158.00
Unit of Measure: S.F.
Estimate: \$26,614.00
Assessor Name: Eduardo Lopez
Date Created: 01/04/2017

Notes: The domestic water distribution system is aged and should be replaced.

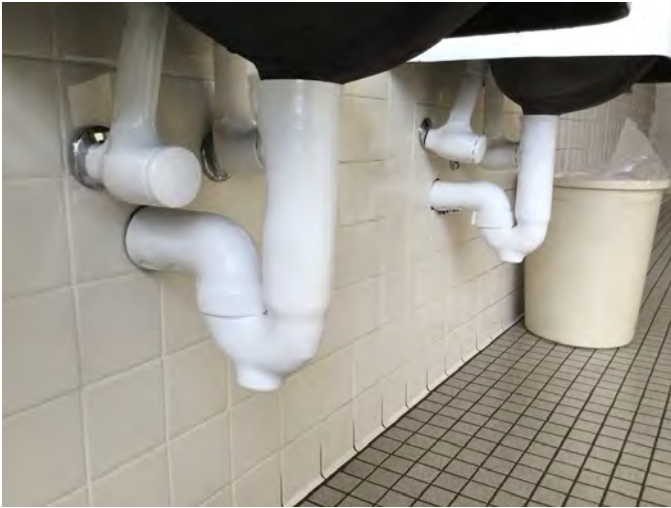
System: D2030 - Sanitary Waste

Location: Throughout the Building
Distress: Beyond Service Life
Category: Deferred Maintenance
Priority: 3 - Necessary/Not Yet Critical (Years 2-5)
Correction: Renew System
Qty: 12,158.00
Unit of Measure: S.F.
Estimate: \$41,994.00
Assessor Name: Eduardo Lopez
Date Created: 01/04/2017

Notes: The sanitary waste system is beyond its expected service life and should be replaced.

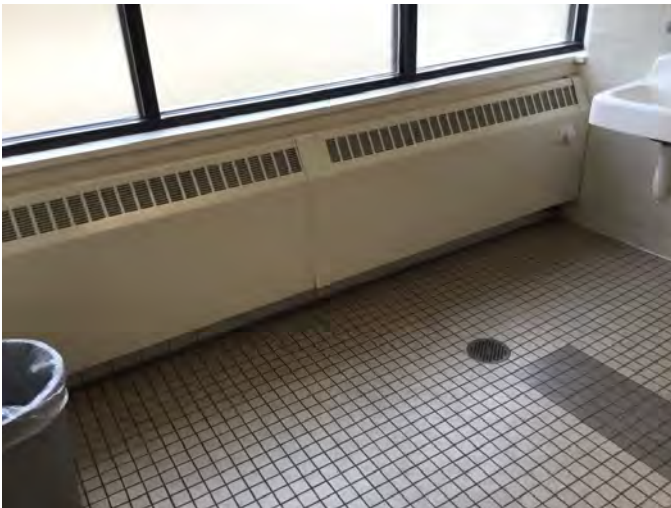
System: D3040 - Distribution Systems

Location: Throughout the Building
Distress: Beyond Service Life
Category: Deferred Maintenance
Priority: 3 - Necessary/Not Yet Critical (Years 2-5)
Correction: Renew System
Qty: 12,158.00
Unit of Measure: S.F.
Estimate: \$135,610.00
Assessor Name: Eduardo Lopez
Date Created: 01/04/2017

Notes: Distribution systems are aged, becoming logistically unsupportable, and should be replaced.

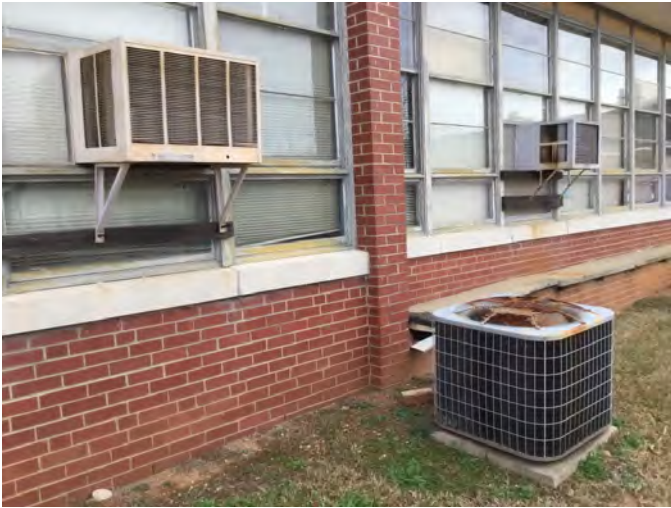
System: D3050 - Terminal & Package Units

Location: Throughout the Building
Distress: Beyond Service Life
Category: Deferred Maintenance
Priority: 3 - Necessary/Not Yet Critical (Years 2-5)
Correction: Renew System
Qty: 12,158.00
Unit of Measure: S.F.
Estimate: \$296,096.00
Assessor Name: Eduardo Lopez
Date Created: 01/04/2017

Notes: Terminal and package units are beyond their expected service life and should be scheduled for replacement.

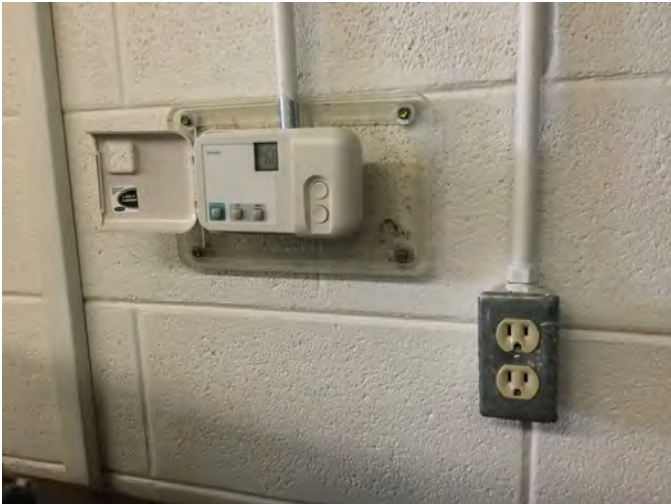
System: D3060 - Controls & Instrumentation

Location: Throughout the Building
Distress: Beyond Service Life
Category: Deferred Maintenance
Priority: 3 - Necessary/Not Yet Critical (Years 2-5)
Correction: Renew System
Qty: 12,158.00
Unit of Measure: S.F.
Estimate: \$42,930.00
Assessor Name: Eduardo Lopez
Date Created: 01/04/2017

Notes: The controls and instrumentation system is in marginal condition and should be schedule for replacement.

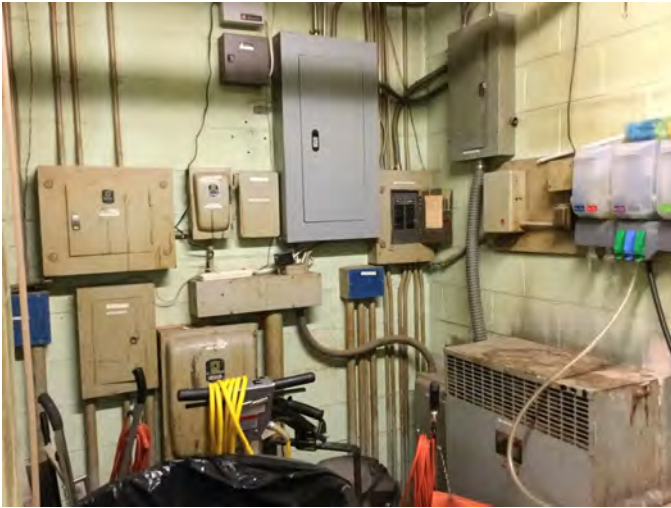
System: D5010 - Electrical Service/Distribution

Location: Throughout the Building
Distress: Beyond Service Life
Category: Deferred Maintenance
Priority: 3 - Necessary/Not Yet Critical (Years 2-5)
Correction: Renew System
Qty: 12,158.00
Unit of Measure: S.F.
Estimate: \$25,811.00
Assessor Name: Eduardo Lopez
Date Created: 01/04/2017

Notes: The original electrical service is operating but is in poor condition and should be replaced.

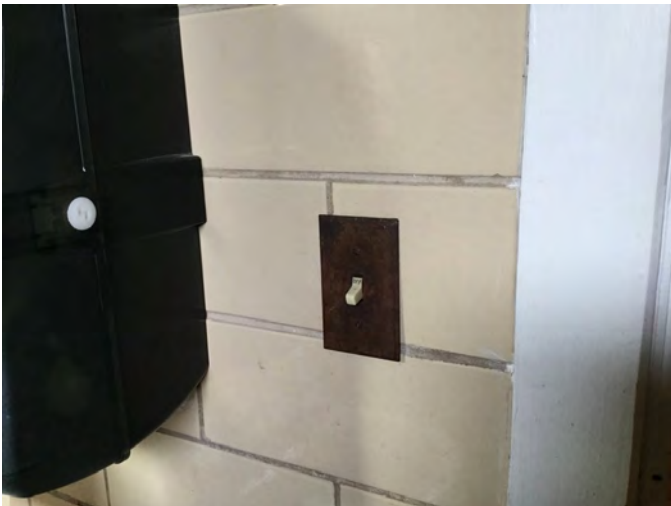
System: D5020 - Branch Wiring

Location: Throughout the Building
Distress: Beyond Service Life
Category: Deferred Maintenance
Priority: 3 - Necessary/Not Yet Critical (Years 2-5)
Correction: Renew System
Qty: 12,158.00
Unit of Measure: S.F.
Estimate: \$73,556.00
Assessor Name: Eduardo Lopez
Date Created: 01/04/2017

Notes: The original branch wiring system is operating but is aged, in marginal condition, and should be replaced.

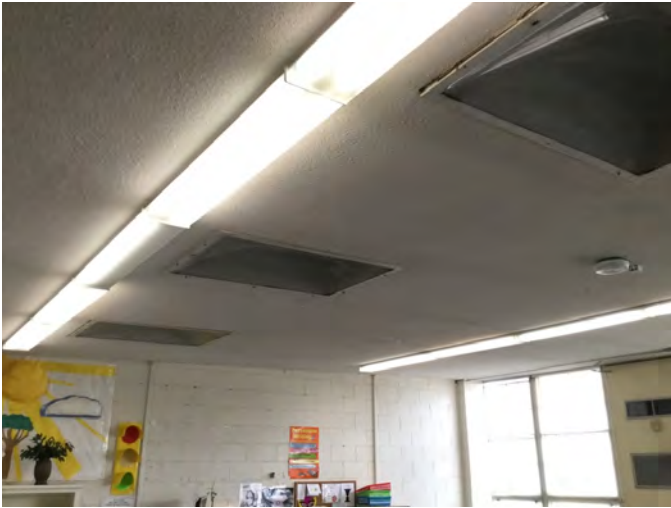
System: D5020 - Lighting

Location: Throughout the Building
Distress: Beyond Service Life
Category: Deferred Maintenance
Priority: 3 - Necessary/Not Yet Critical (Years 2-5)
Correction: Renew System
Qty: 12,158.00
Unit of Measure: S.F.
Estimate: \$172,522.00
Assessor Name: Eduardo Lopez
Date Created: 01/04/2017

Notes: The original lighting system is operating but is aged, in marginal condition, and should be replaced.

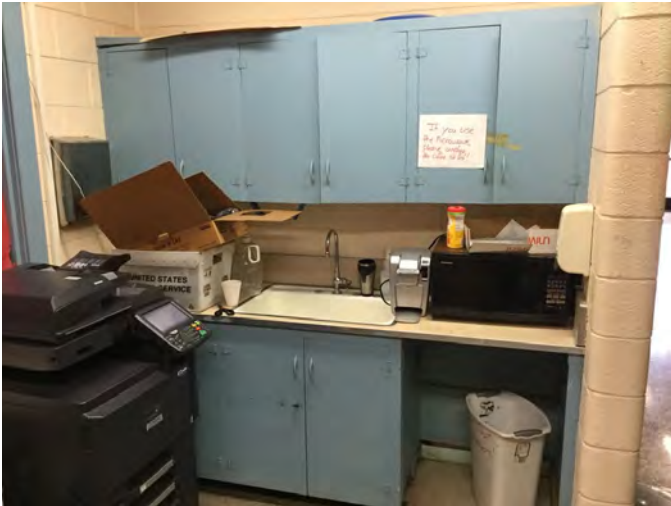
System: E2010 - Fixed Furnishings

Location: Throughout the Building
Distress: Beyond Service Life
Category: Deferred Maintenance
Priority: 3 - Necessary/Not Yet Critical (Years 2-5)
Correction: Renew System
Qty: 12,158.00
Unit of Measure: S.F.
Estimate: \$80,644.00
Assessor Name: Eduardo Lopez
Date Created: 01/04/2017

Notes: The fixed furnishings are aged, in marginal condition, and should be replaced.

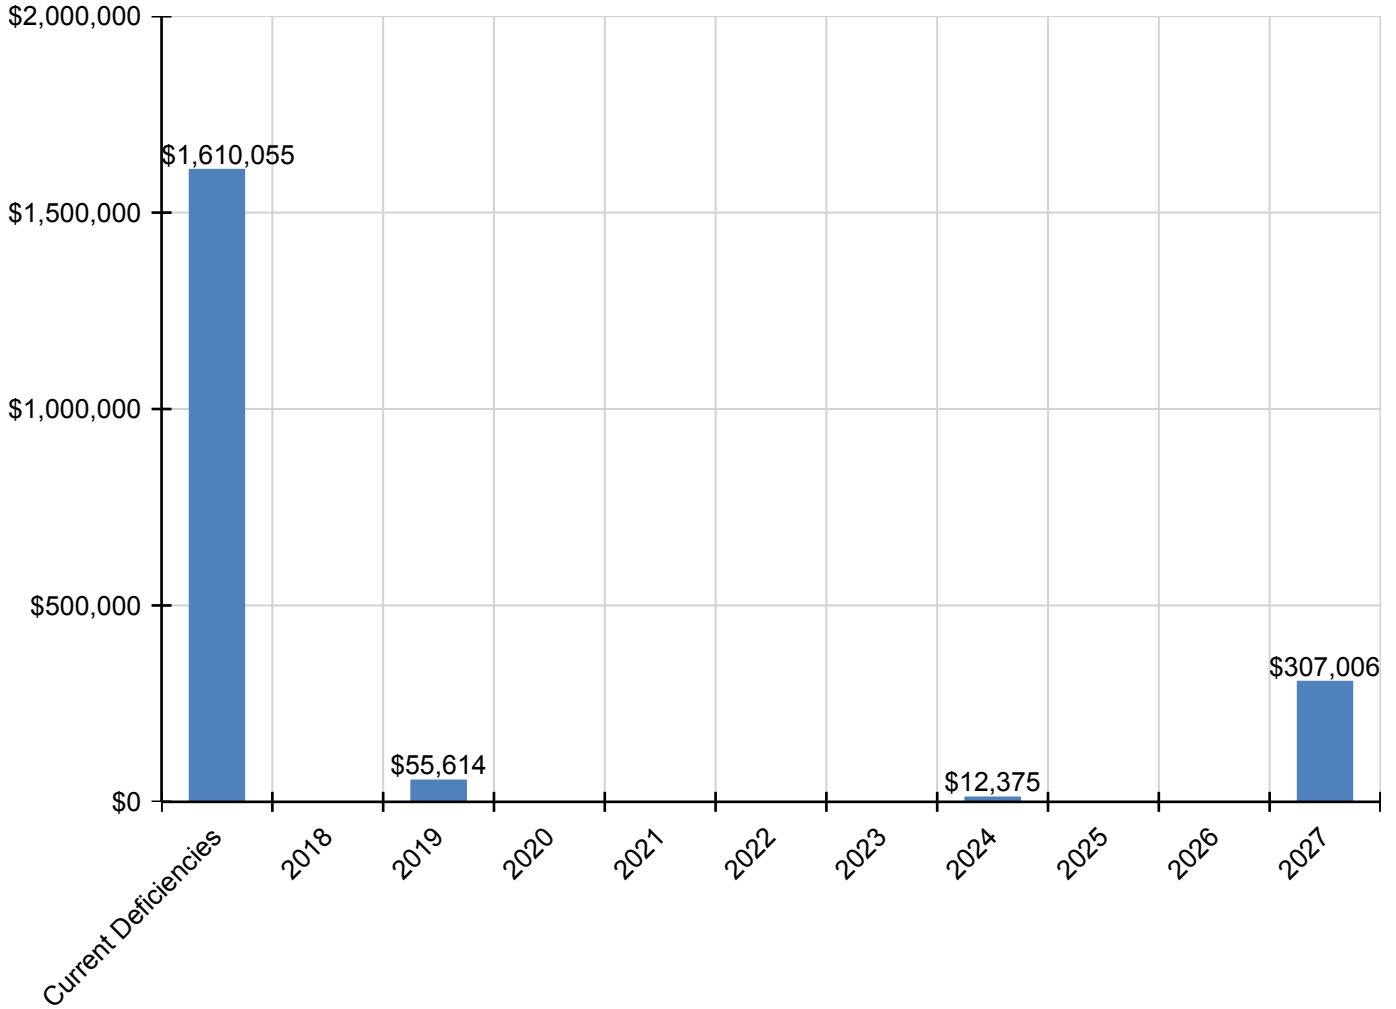
Forecasted Capital Renewal Requirement

The following chart shows the current building deficiencies and forecasting capital renewal or sustainment requirements over the next ten years.

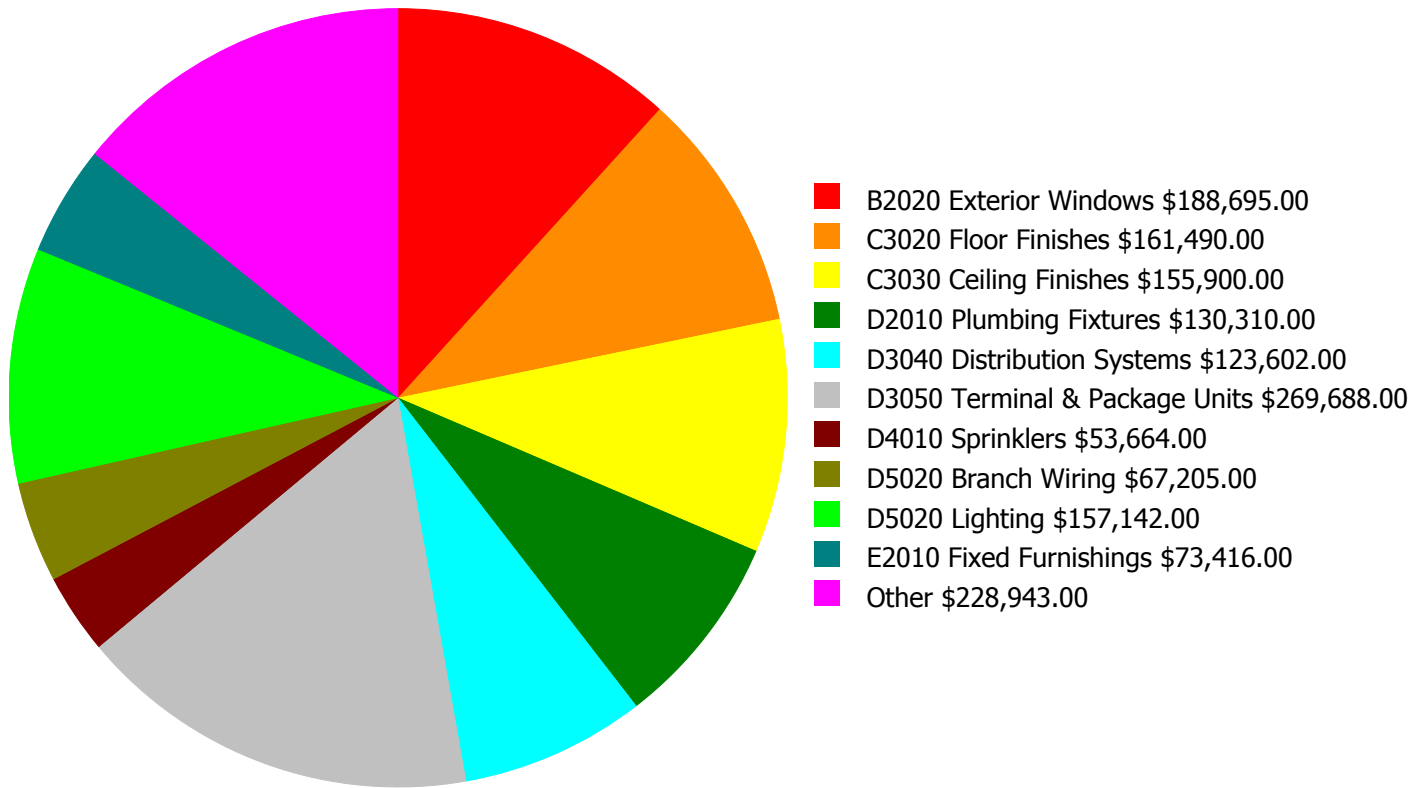
Deficiency Summary by System

Current deficiencies included assemblies that have reached or exceeded their design life or components of the assemblies that are in need of repair. Assemblies that have reached their design life are identified as current deficiencies and assigned the distress 'Beyond Useful Life'. The following chart lists all current deficiencies associated with this facility.

Budget Estimate Total: \$1,610,055.00

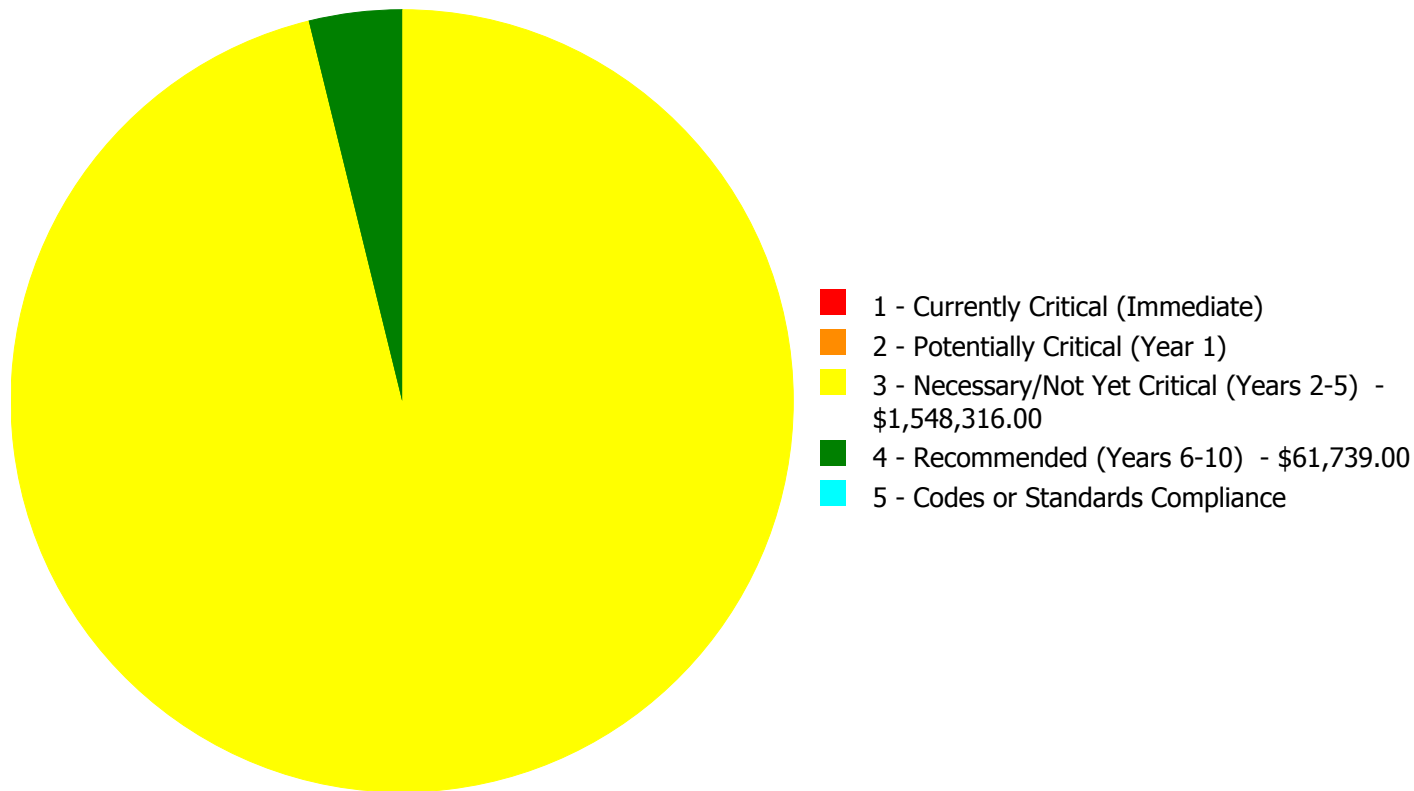
Deficiency Summary by Priority

The following chart shows the total repair costs broken down by priority. Assessors assigned deficiencies within eCOMET to one of the following priority categories:

Budget Estimate Total: \$1,610,055.00

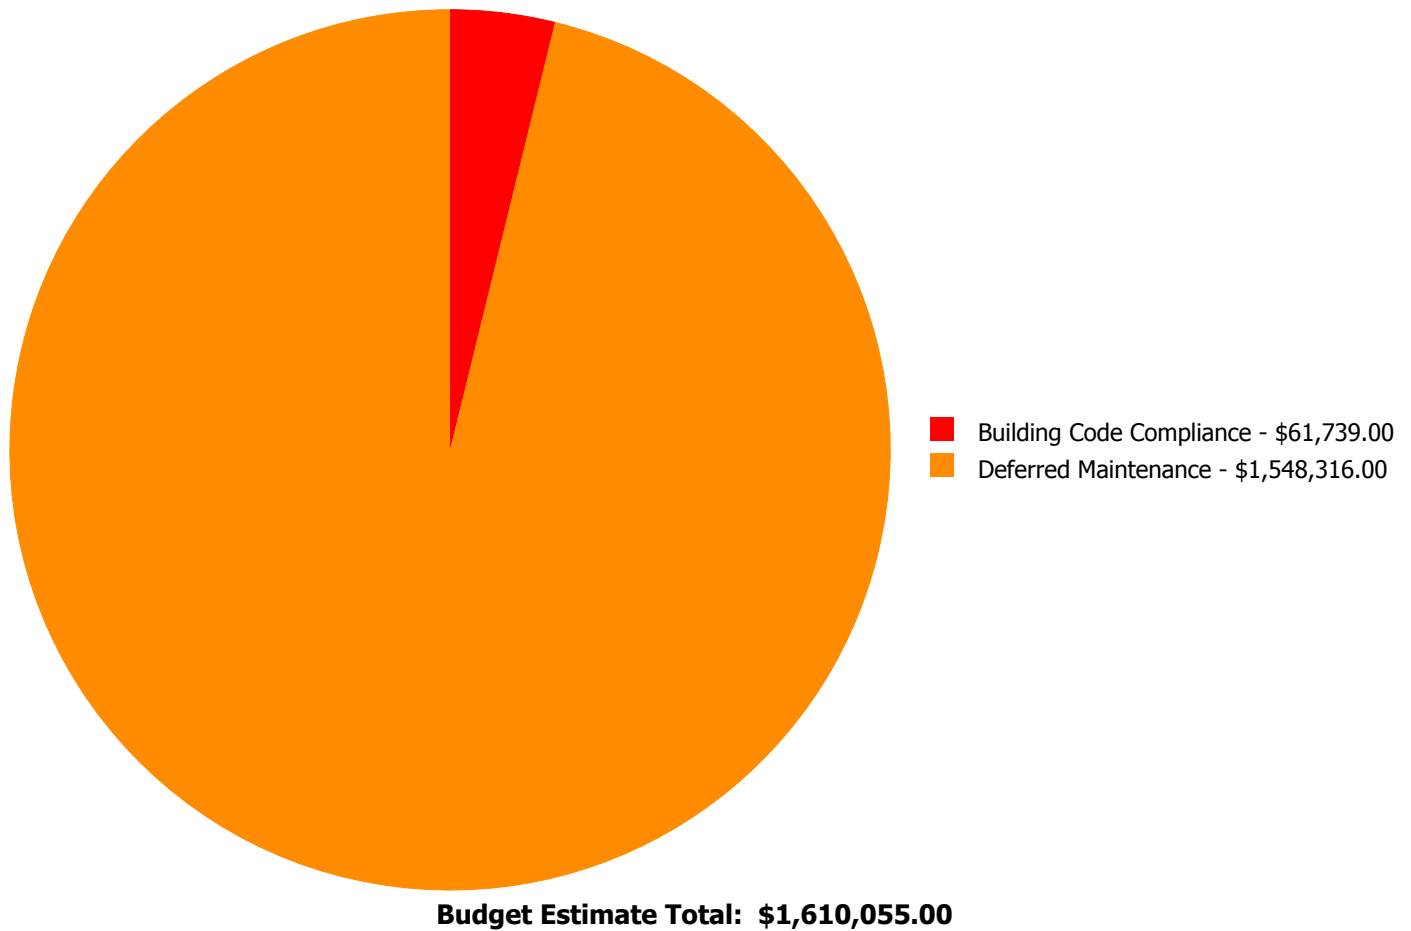
Deficiency Summary by Category

The following chart shows the total repair costs broken down by deficiency categories. Assessors assigned deficiencies to one of the following categories:

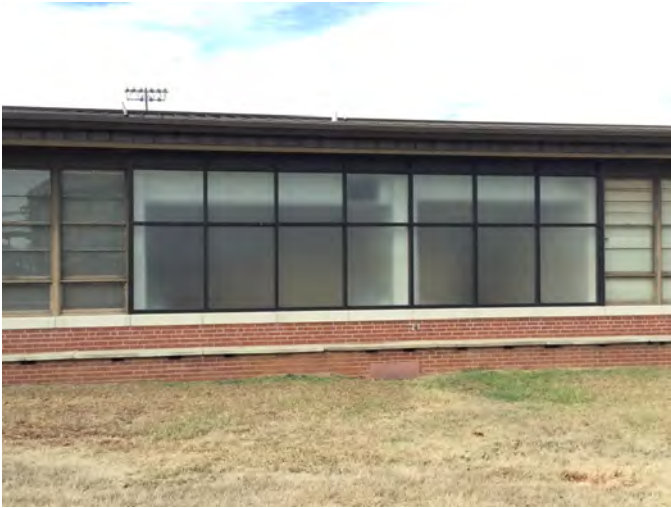
System: B2020 - Exterior Windows

Location: Exterior Walls
Distress: Beyond Service Life
Category: Deferred Maintenance
Priority: 3 - Necessary/Not Yet Critical (Years 2-5)
Correction: Renew System
Qty: 11,293.00
Unit of Measure: S.F.
Estimate: \$188,695.00
Assessor Name: Eduardo Lopez
Date Created: 01/04/2017

Notes: The exterior windows are aged, rusted, not energy efficient and should be replaced.

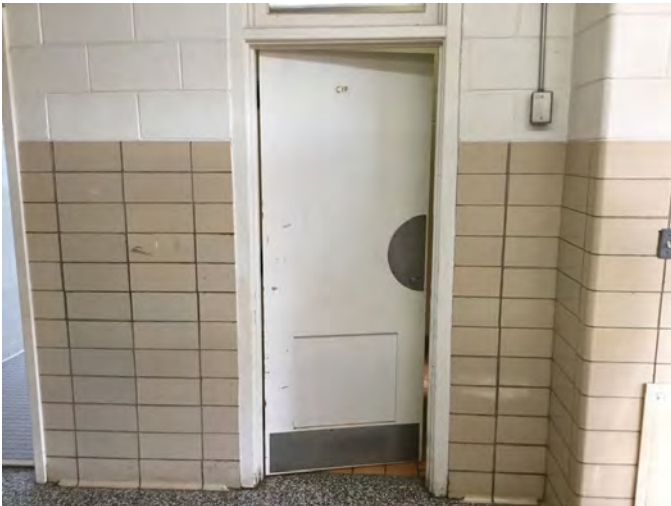
System: C1020 - Interior Doors

Location: Throughout the Building
Distress: Beyond Service Life
Category: Deferred Maintenance
Priority: 3 - Necessary/Not Yet Critical (Years 2-5)
Correction: Renew System
Qty: 11,293.00
Unit of Measure: S.F.
Estimate: \$36,025.00
Assessor Name: Eduardo Lopez
Date Created: 01/04/2017

Notes: The interior doors are aged, failing, most hardware is not ADA or code compliant and should be replaced.

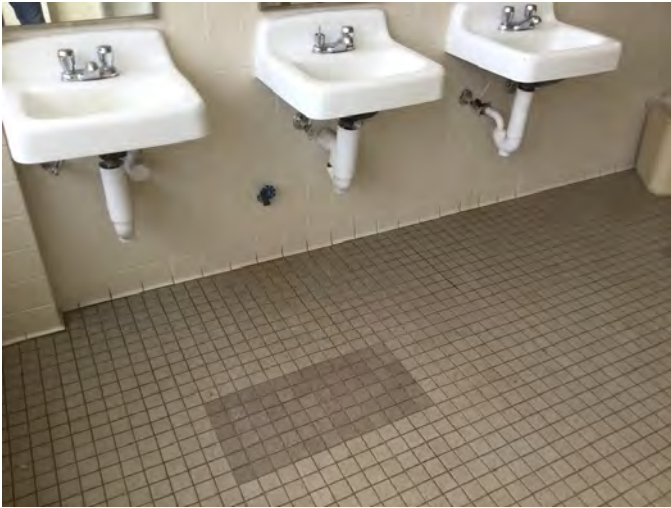
System: C3020 - Floor Finishes

Location: Throughout the Building
Distress: Beyond Service Life
Category: Deferred Maintenance
Priority: 3 - Necessary/Not Yet Critical (Years 2-5)
Correction: Renew System
Qty: 11,293.00
Unit of Measure: S.F.
Estimate: \$161,490.00
Assessor Name: Eduardo Lopez
Date Created: 01/04/2017

Notes: The original flooring is in poor conditions and should be replaced.

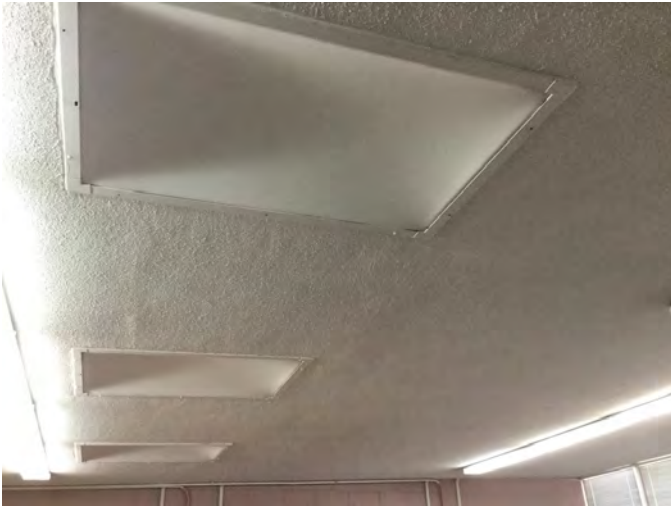
System: C3030 - Ceiling Finishes

Location: Throughout the Building
Distress: Beyond Service Life
Category: Deferred Maintenance
Priority: 3 - Necessary/Not Yet Critical (Years 2-5)
Correction: Renew System
Qty: 11,293.00
Unit of Measure: S.F.
Estimate: \$155,900.00
Assessor Name: Eduardo Lopez
Date Created: 01/04/2017

Notes: The original ceiling finishes are aged, failing and should be replaced.

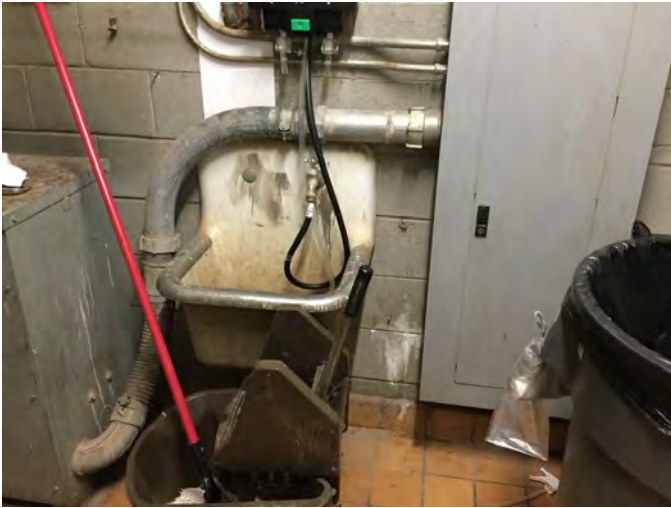
System: D2010 - Plumbing Fixtures

Location: Throughout the Building
Distress: Beyond Service Life
Category: Deferred Maintenance
Priority: 3 - Necessary/Not Yet Critical (Years 2-5)
Correction: Renew System
Qty: 11,293.00
Unit of Measure: S.F.
Estimate: \$130,310.00
Assessor Name: Eduardo Lopez
Date Created: 01/04/2017

Notes: Plumbing fixtures are in operational conditions. However, they are aged, not ADA compliant, and should be scheduled for replacement.

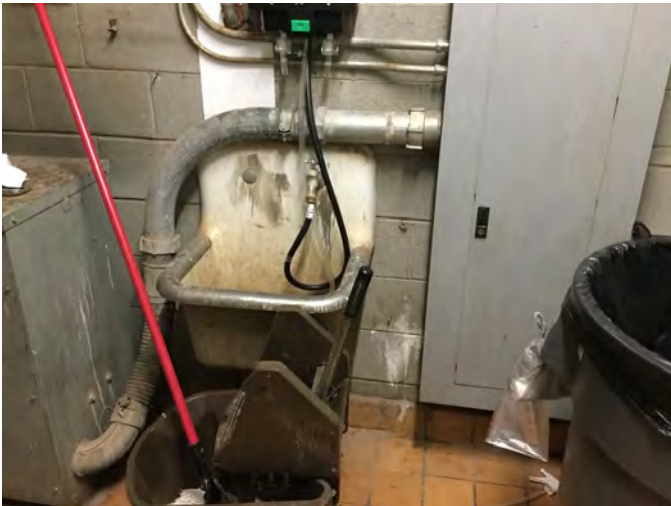
System: D2020 - Domestic Water Distribution

Location: Throughout the Building
Distress: Beyond Service Life
Category: Deferred Maintenance
Priority: 3 - Necessary/Not Yet Critical (Years 2-5)
Correction: Renew System
Qty: 11,293.00
Unit of Measure: S.F.
Estimate: \$24,223.00
Assessor Name: Eduardo Lopez
Date Created: 01/04/2017

Notes: The domestic water distribution system is aged and should be replaced.

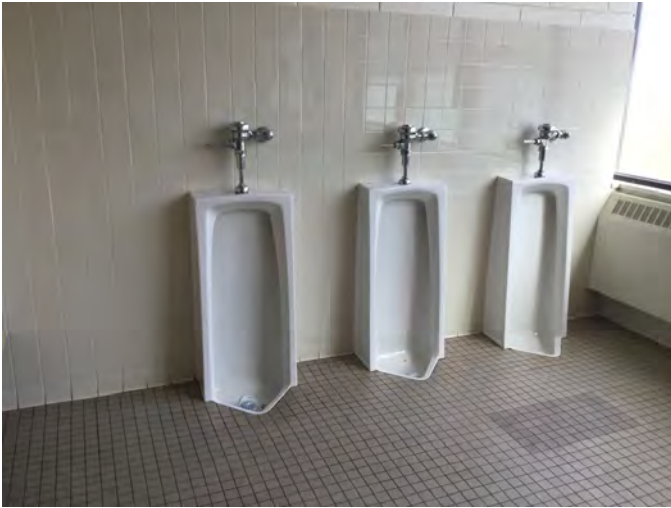
System: D2030 - Sanitary Waste

Location: Throughout the Building
Distress: Beyond Service Life
Category: Deferred Maintenance
Priority: 3 - Necessary/Not Yet Critical (Years 2-5)
Correction: Renew System
Qty: 11,293.00
Unit of Measure: S.F.
Estimate: \$38,261.00
Assessor Name: Eduardo Lopez
Date Created: 01/04/2017

Notes: The sanitary waste system is beyond its expected service life and should be replaced.

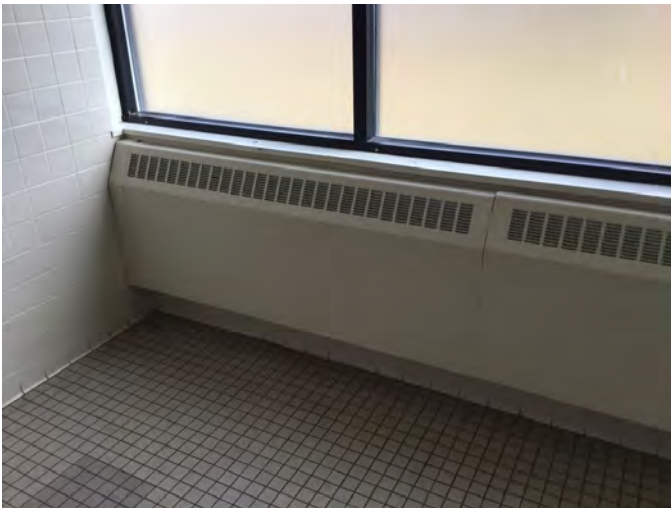
System: D3040 - Distribution Systems

Location: Throughout the Building
Distress: Beyond Service Life
Category: Deferred Maintenance
Priority: 3 - Necessary/Not Yet Critical (Years 2-5)
Correction: Renew System
Qty: 11,293.00
Unit of Measure: S.F.
Estimate: \$123,602.00
Assessor Name: Eduardo Lopez
Date Created: 01/04/2017

Notes: Distribution systems are aged, becoming logistically unsupportable, and should be replaced.

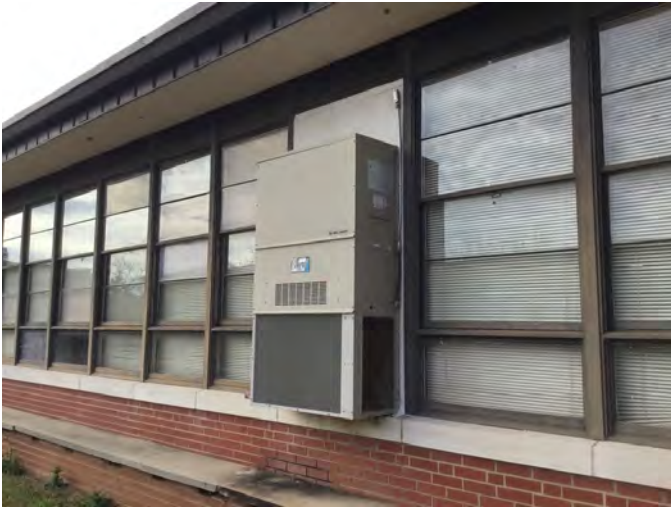
System: D3050 - Terminal & Package Units

Location: Throughout the Building
Distress: Beyond Service Life
Category: Deferred Maintenance
Priority: 3 - Necessary/Not Yet Critical (Years 2-5)
Correction: Renew System
Qty: 11,293.00
Unit of Measure: S.F.
Estimate: \$269,688.00
Assessor Name: Eduardo Lopez
Date Created: 01/04/2017

Notes: Terminal and package units are beyond their expected service life and should be scheduled for replacement.

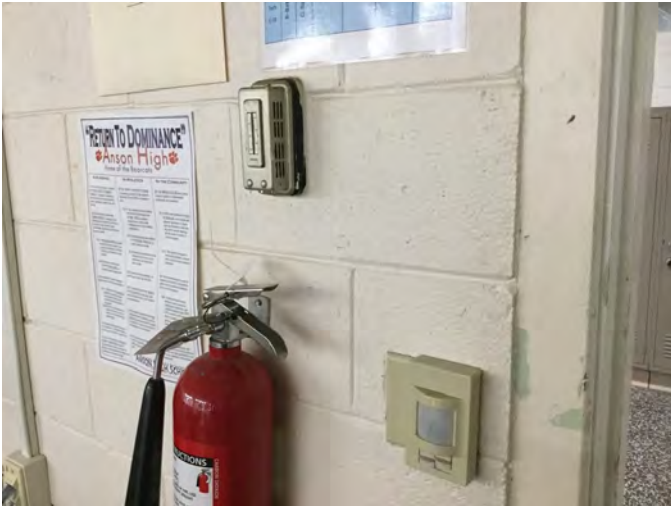
System: D3060 - Controls & Instrumentation

Location: Throughout the Building
Distress: Beyond Service Life
Category: Deferred Maintenance
Priority: 3 - Necessary/Not Yet Critical (Years 2-5)
Correction: Renew System
Qty: 11,293.00
Unit of Measure: S.F.
Estimate: \$39,130.00
Assessor Name: Eduardo Lopez
Date Created: 01/04/2017

Notes: The controls and instrumentation system is in marginal condition and should be schedule for replacement.

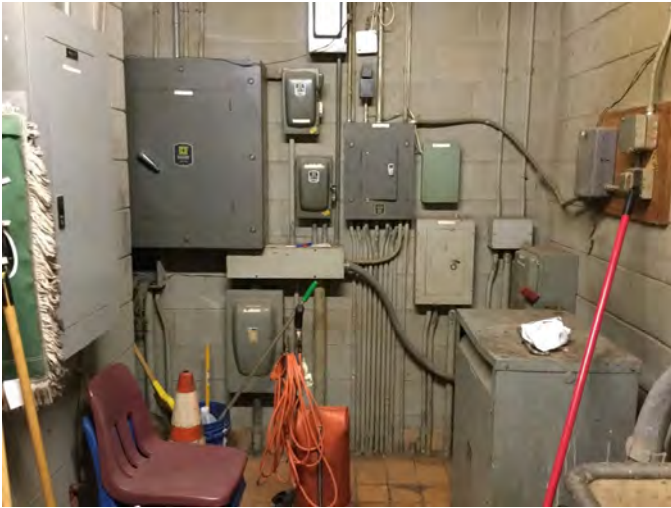
System: D5010 - Electrical Service/Distribution

Location: Throughout the Building
Distress: Beyond Service Life
Category: Deferred Maintenance
Priority: 3 - Necessary/Not Yet Critical (Years 2-5)
Correction: Renew System
Qty: 11,293.00
Unit of Measure: S.F.
Estimate: \$23,602.00
Assessor Name: Eduardo Lopez
Date Created: 01/04/2017

Notes: The original electrical service is operating but is in poor condition and should be replaced.

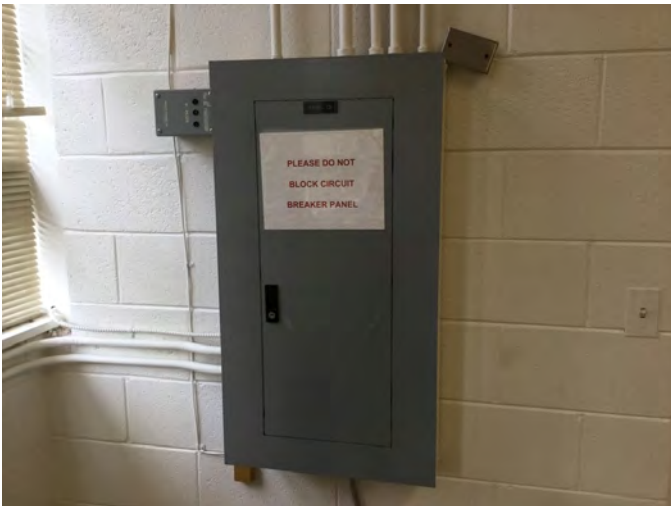
System: D5020 - Branch Wiring

Location: Throughout the Building
Distress: Beyond Service Life
Category: Deferred Maintenance
Priority: 3 - Necessary/Not Yet Critical (Years 2-5)
Correction: Renew System
Qty: 11,293.00
Unit of Measure: S.F.
Estimate: \$67,205.00
Assessor Name: Eduardo Lopez
Date Created: 01/04/2017

Notes: The original branch wiring system is operating but is aged, in marginal condition, and should be replaced.

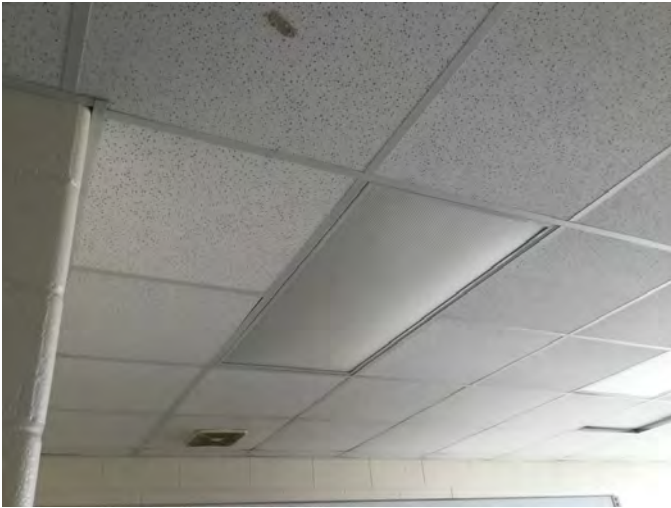
System: D5020 - Lighting

Location: Throughout the Building
Distress: Beyond Service Life
Category: Deferred Maintenance
Priority: 3 - Necessary/Not Yet Critical (Years 2-5)
Correction: Renew System
Qty: 11,293.00
Unit of Measure: S.F.
Estimate: \$157,142.00
Assessor Name: Eduardo Lopez
Date Created: 01/04/2017

Notes: The original lighting system is operating but is aged, in marginal condition, and should be replaced.

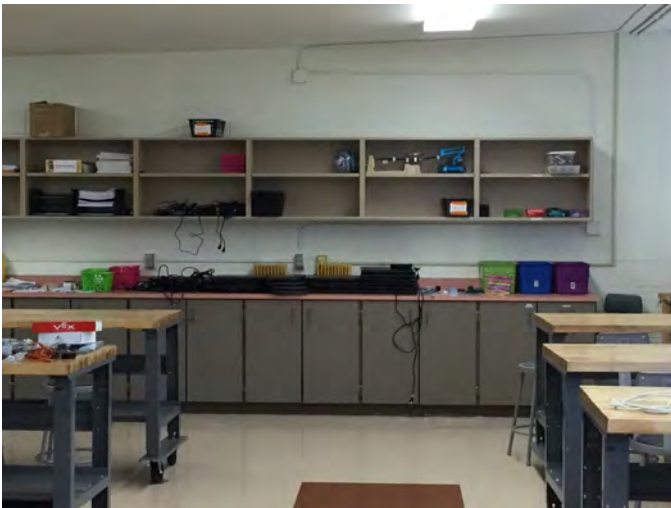
System: E2010 - Fixed Furnishings

Location: Throughout the Building
Distress: Beyond Service Life
Category: Deferred Maintenance
Priority: 3 - Necessary/Not Yet Critical (Years 2-5)
Correction: Renew System
Qty: 11,293.00
Unit of Measure: S.F.
Estimate: \$73,416.00
Assessor Name: Eduardo Lopez
Date Created: 01/04/2017

Notes: The fixed furnishings are aged, in marginal condition, and should be replaced.

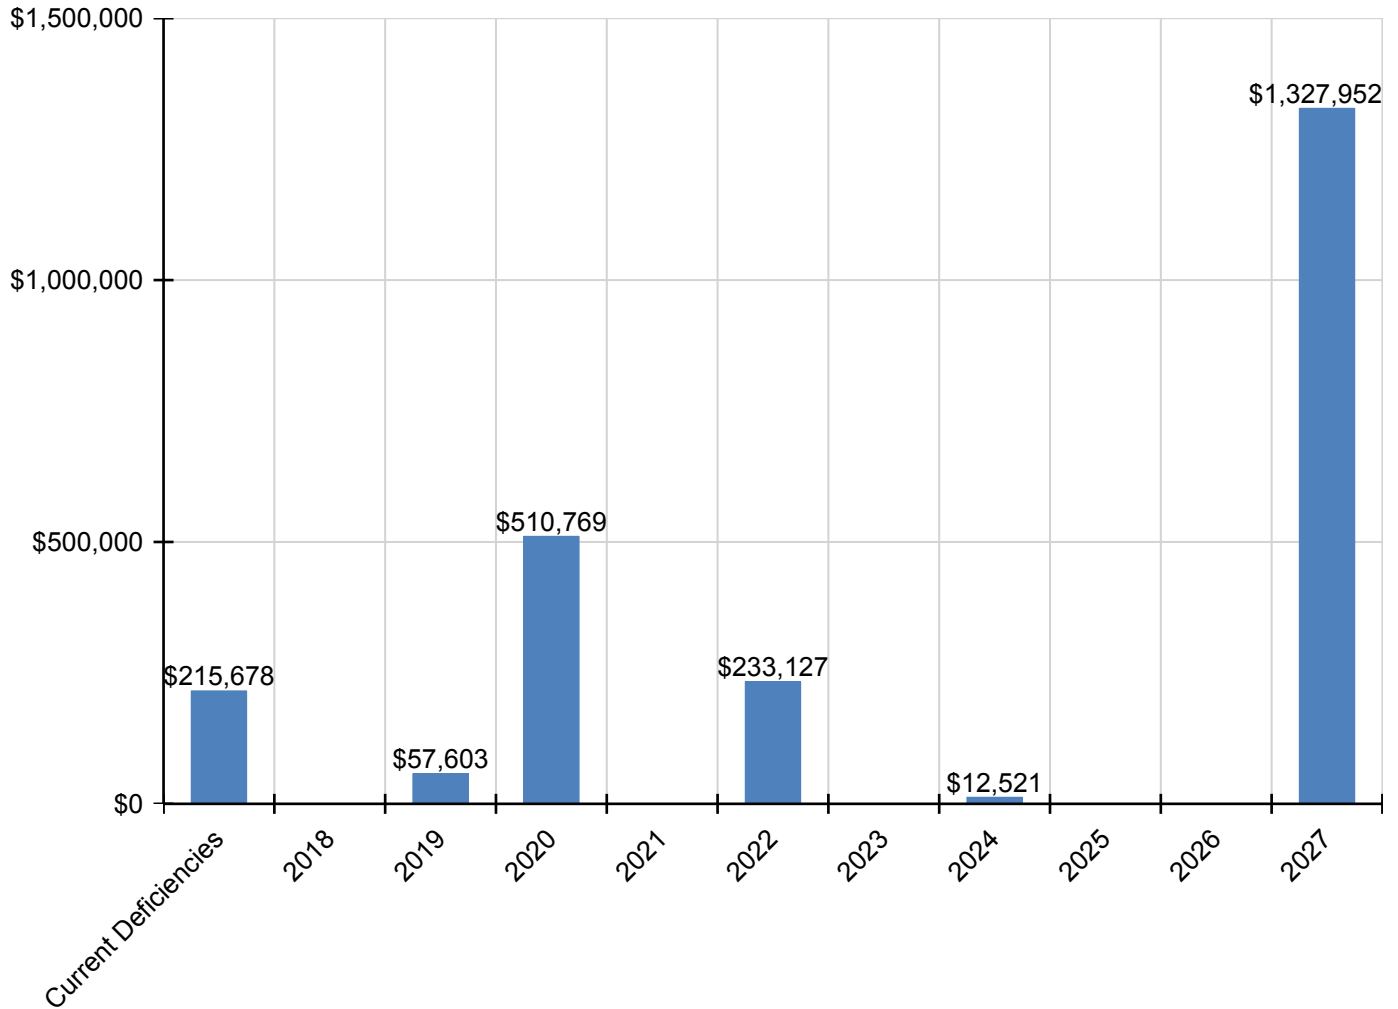
Forecasted Capital Renewal Requirement

The following chart shows the current building deficiencies and forecasting capital renewal or sustainment requirements over the next ten years.

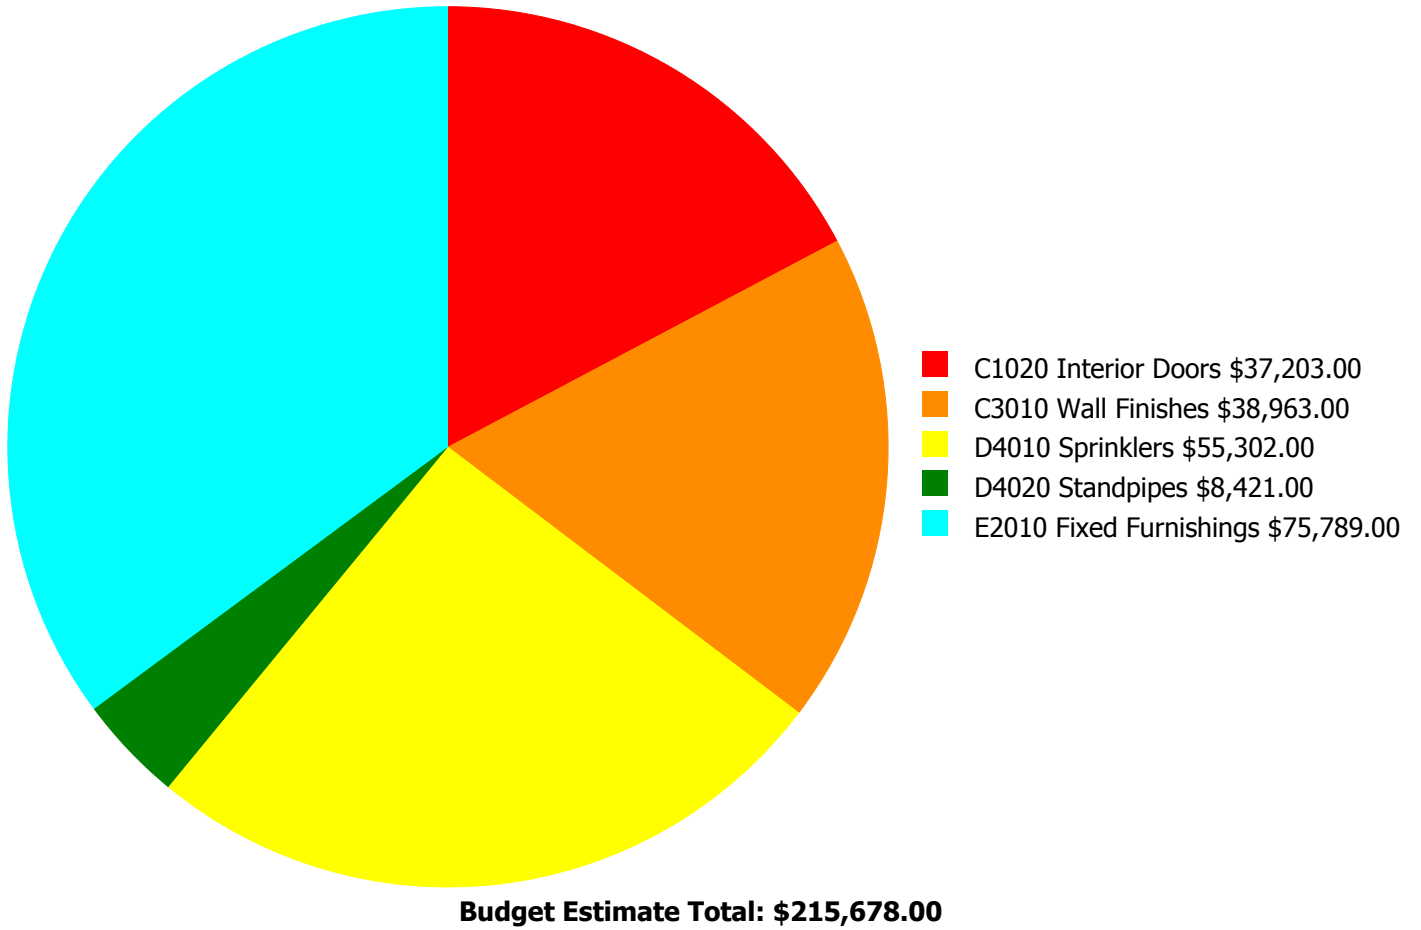
Deficiency Summary by System

Current deficiencies included assemblies that have reached or exceeded their design life or components of the assemblies that are in need of repair. Assemblies that have reached their design life are identified as current deficiencies and assigned the distress 'Beyond Useful Life'. The following chart lists all current deficiencies associated with this facility.
