NC School District/040 Anson County/High School

Anson High

Campus Assessment Report

March 10, 2017

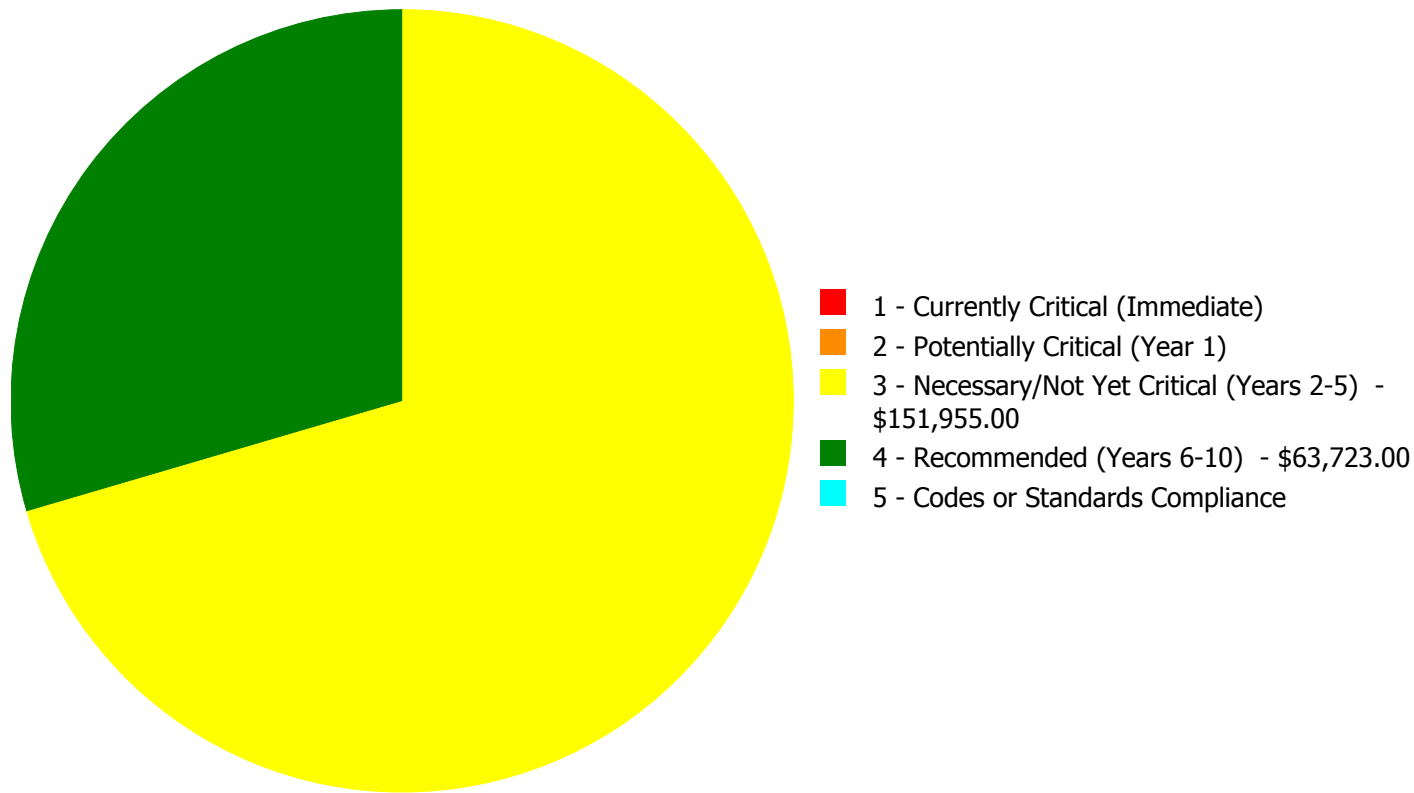
Deficiency Summary by Priority

The following chart shows the total repair costs broken down by priority. Assessors assigned deficiencies within eCOMET to one of the following priority categories:

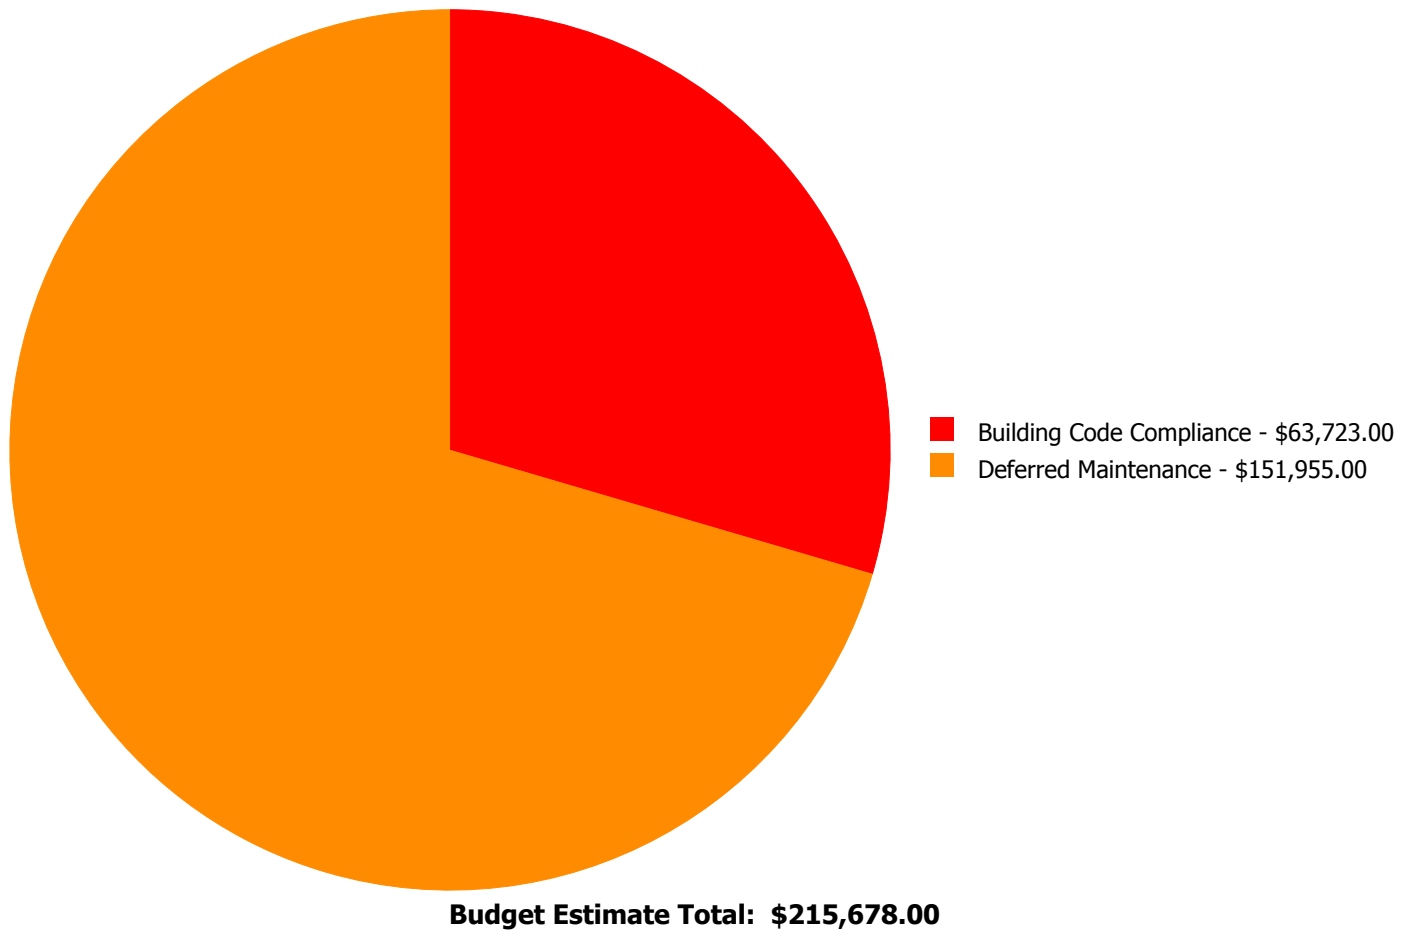
Deficiency Summary by Category

The following chart shows the total repair costs broken down by deficiency categories. Assessors assigned deficiencies to one of the following categories:

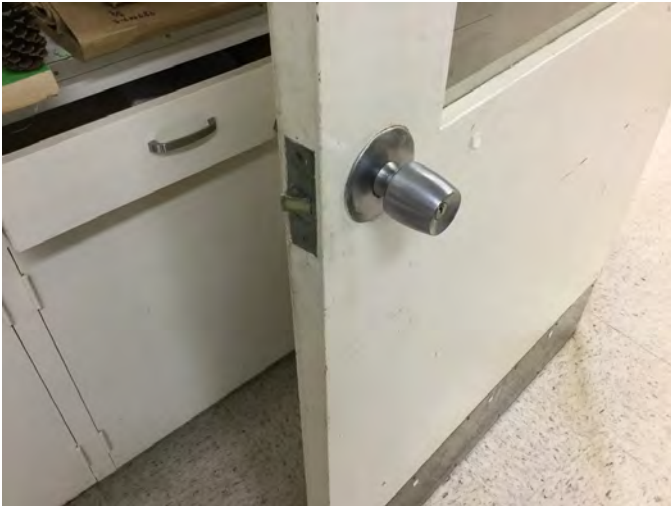
System: C1020 - Interior Doors

Location: Throughout the Building
Distress: Beyond Service Life
Category: Deferred Maintenance
Priority: 3 - Necessary/Not Yet Critical (Years 2-5)
Correction: Renew System
Qty: 11,426.00
Unit of Measure: S.F.
Estimate: \$37,203.00
Assessor Name: Eduardo Lopez
Date Created: 01/04/2017

Notes: The interior doors are aged, failing, most hardware is not ADA or code compliant and should be replaced.

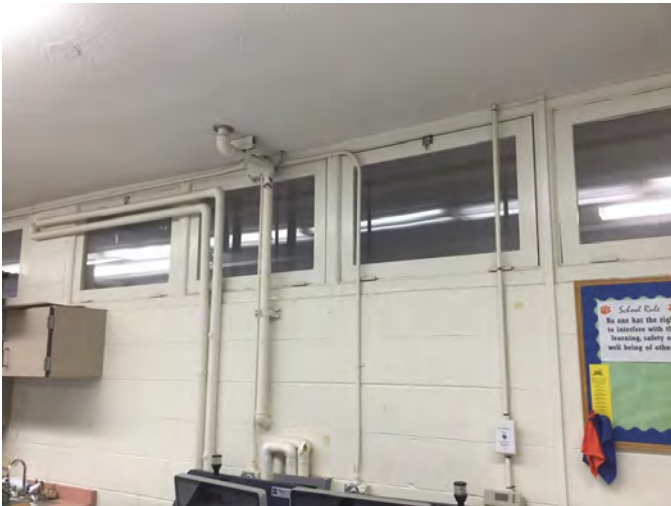
System: C3010 - Wall Finishes

Location: Throughout the Building
Distress: Beyond Service Life
Category: Deferred Maintenance
Priority: 3 - Necessary/Not Yet Critical (Years 2-5)
Correction: Renew System
Qty: 11,426.00
Unit of Measure: S.F.
Estimate: \$38,963.00
Assessor Name: Eduardo Lopez
Date Created: 01/04/2017

Notes: The wall finishes are aged, scuffed, fading, stained and should be replaced.

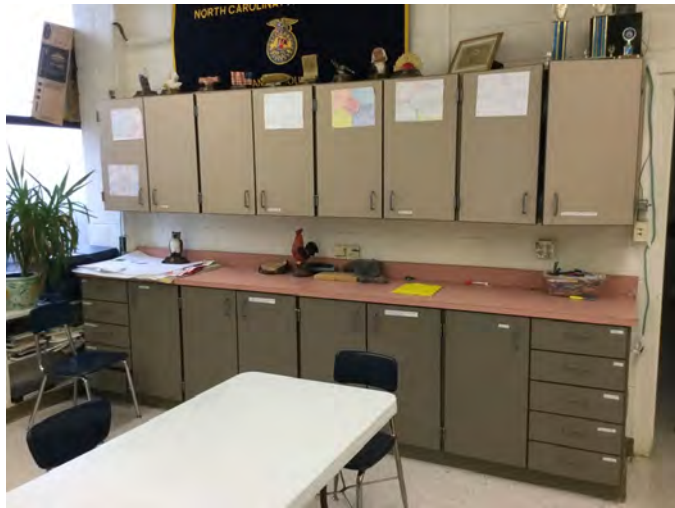
System: E2010 - Fixed Furnishings

Location: Throughout the Building
Distress: Beyond Service Life
Category: Deferred Maintenance
Priority: 3 - Necessary/Not Yet Critical (Years 2-5)
Correction: Renew System
Qty: 11,426.00
Unit of Measure: S.F.
Estimate: \$75,789.00
Assessor Name: Eduardo Lopez
Date Created: 01/04/2017

Notes: The fixed furnishings are aged, in marginal condition, and should be replaced.

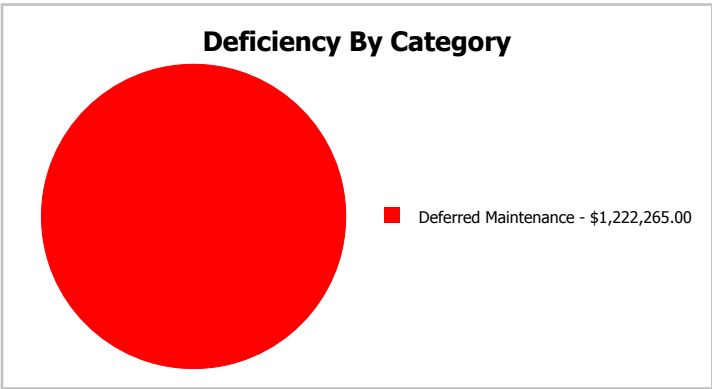
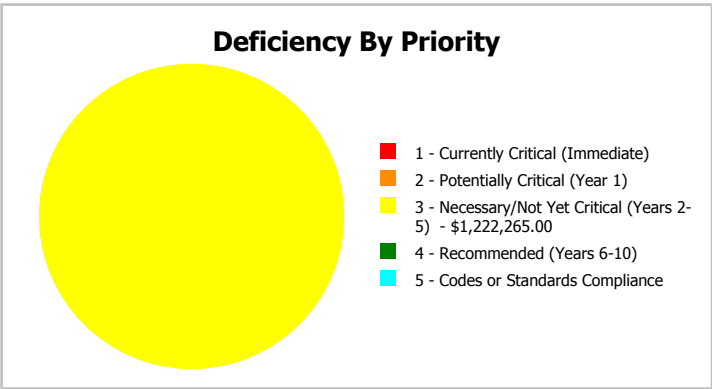
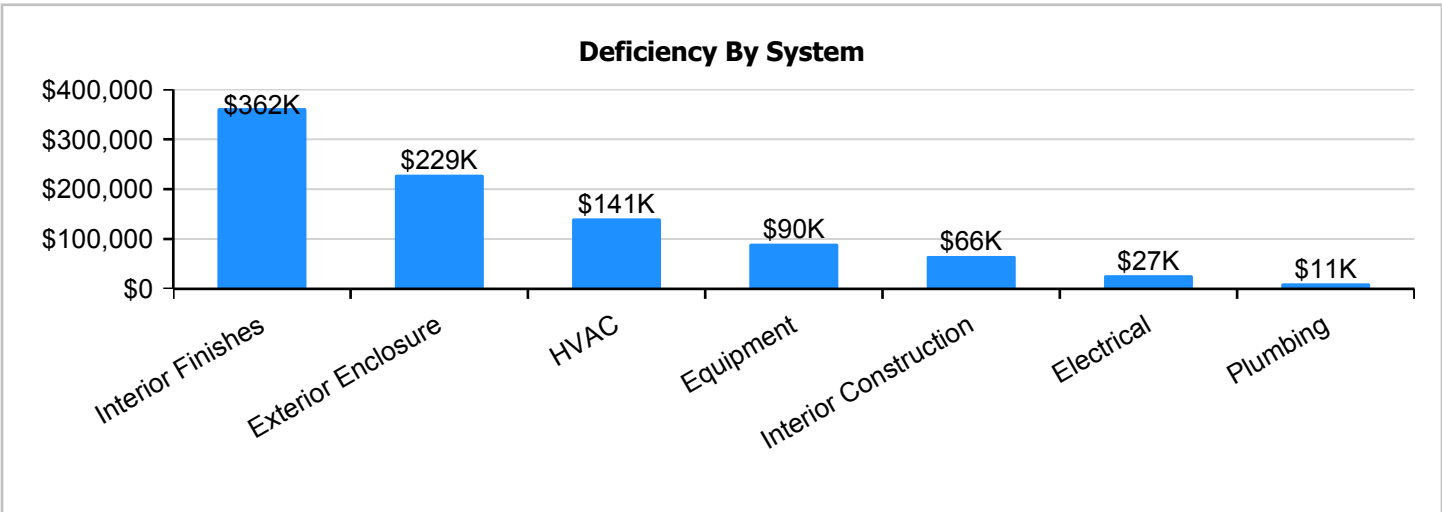
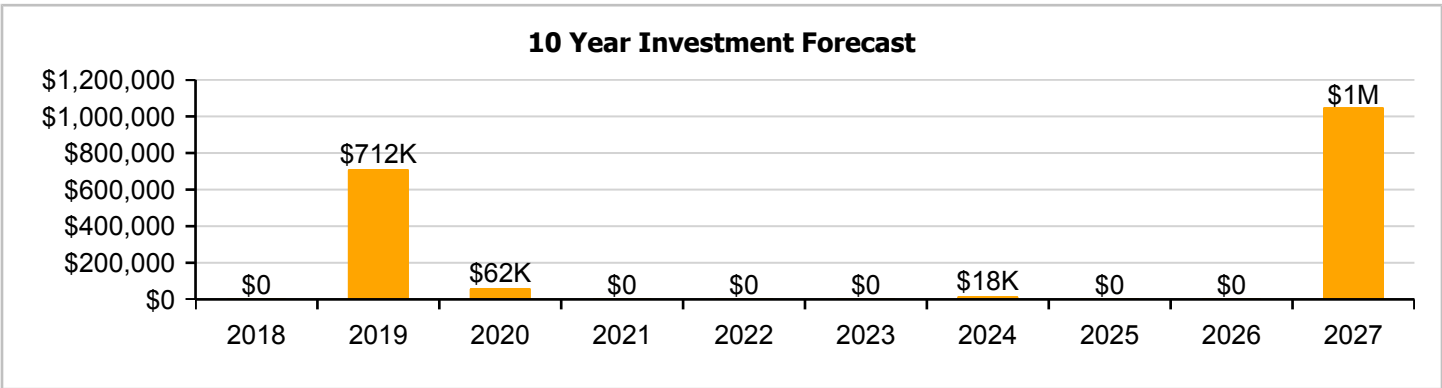
Dashboard Summary

Function:	HS -High School	Gross Area:	16,704
Year Built:	1960	Last Renovation:	
Repair Cost:	\$1,222,265	Replacement Value:	\$3,438,186
FCI:	35.55 %	RSLI%:	24.74 %

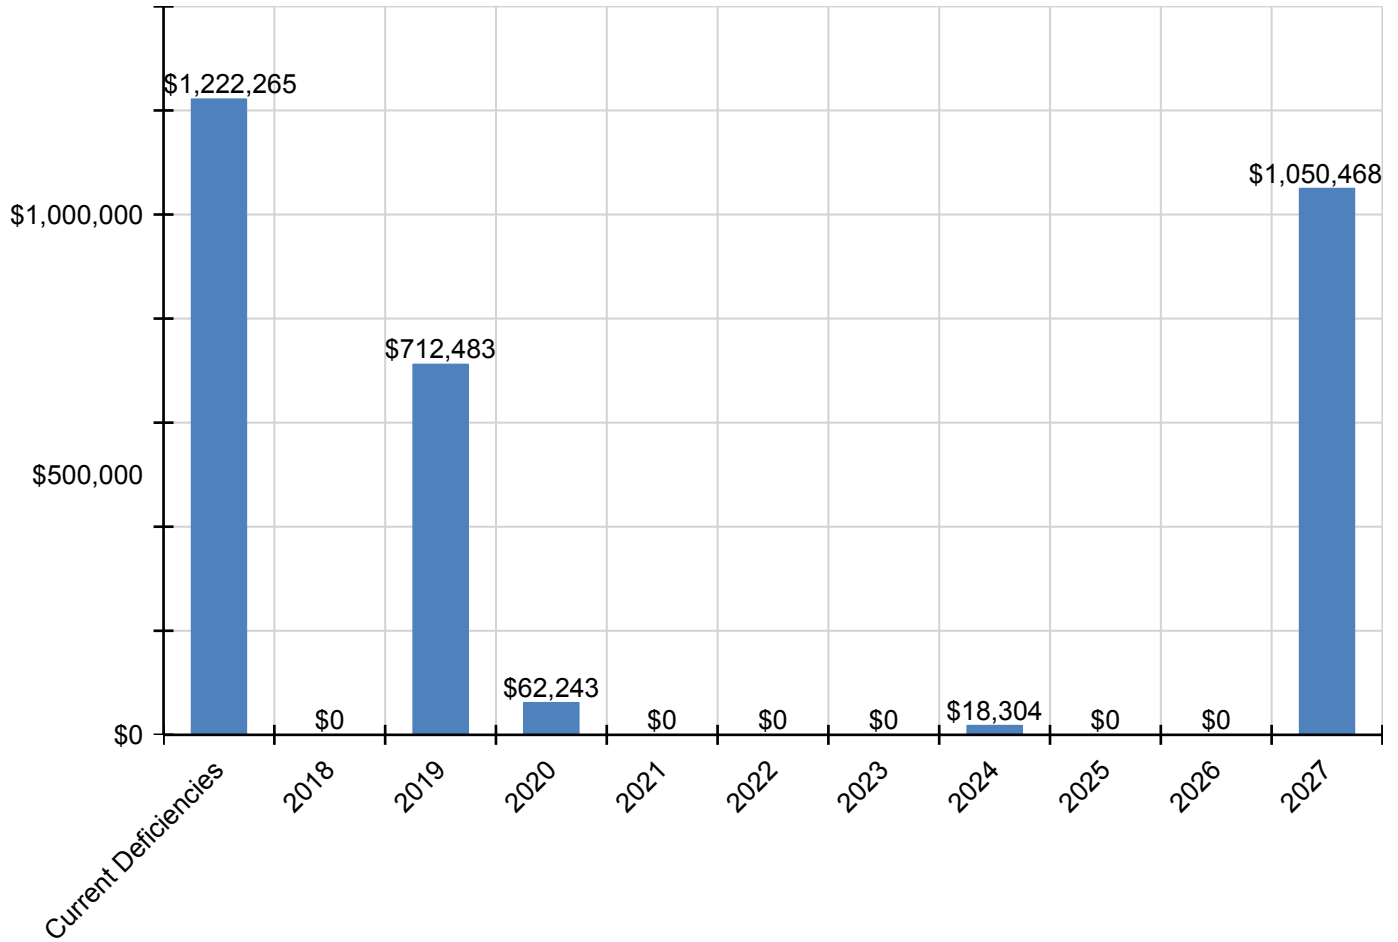
Forecasted Capital Renewal Requirement

The following chart shows the current building deficiencies and forecasting capital renewal or sustainment requirements over the next ten years.

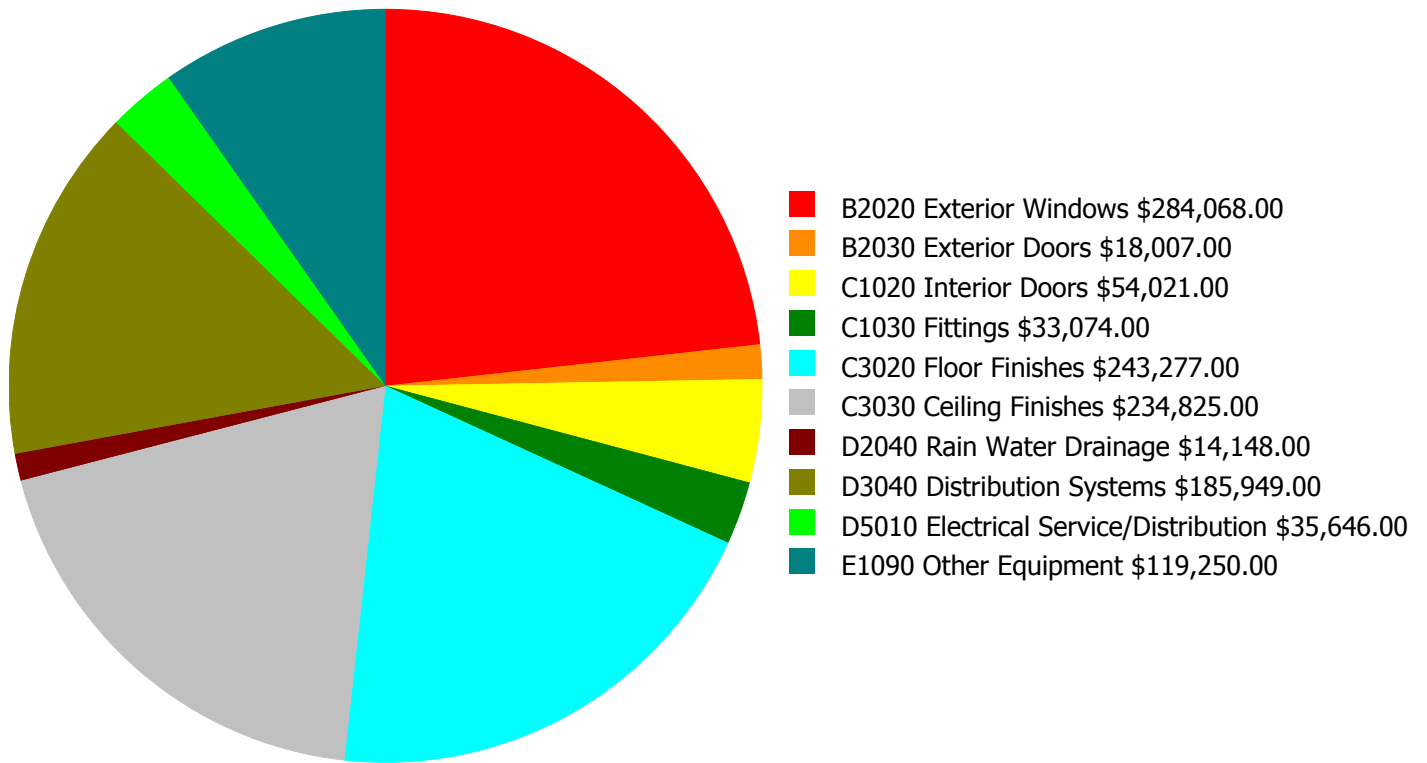
Deficiency Summary by System

Current deficiencies included assemblies that have reached or exceeded their design life or components of the assemblies that are in need of repair. Assemblies that have reached their design life are identified as current deficiencies and assigned the distress 'Beyond Useful Life'. The following chart lists all current deficiencies associated with this facility.

Budget Estimate Total: \$1,222,265.00

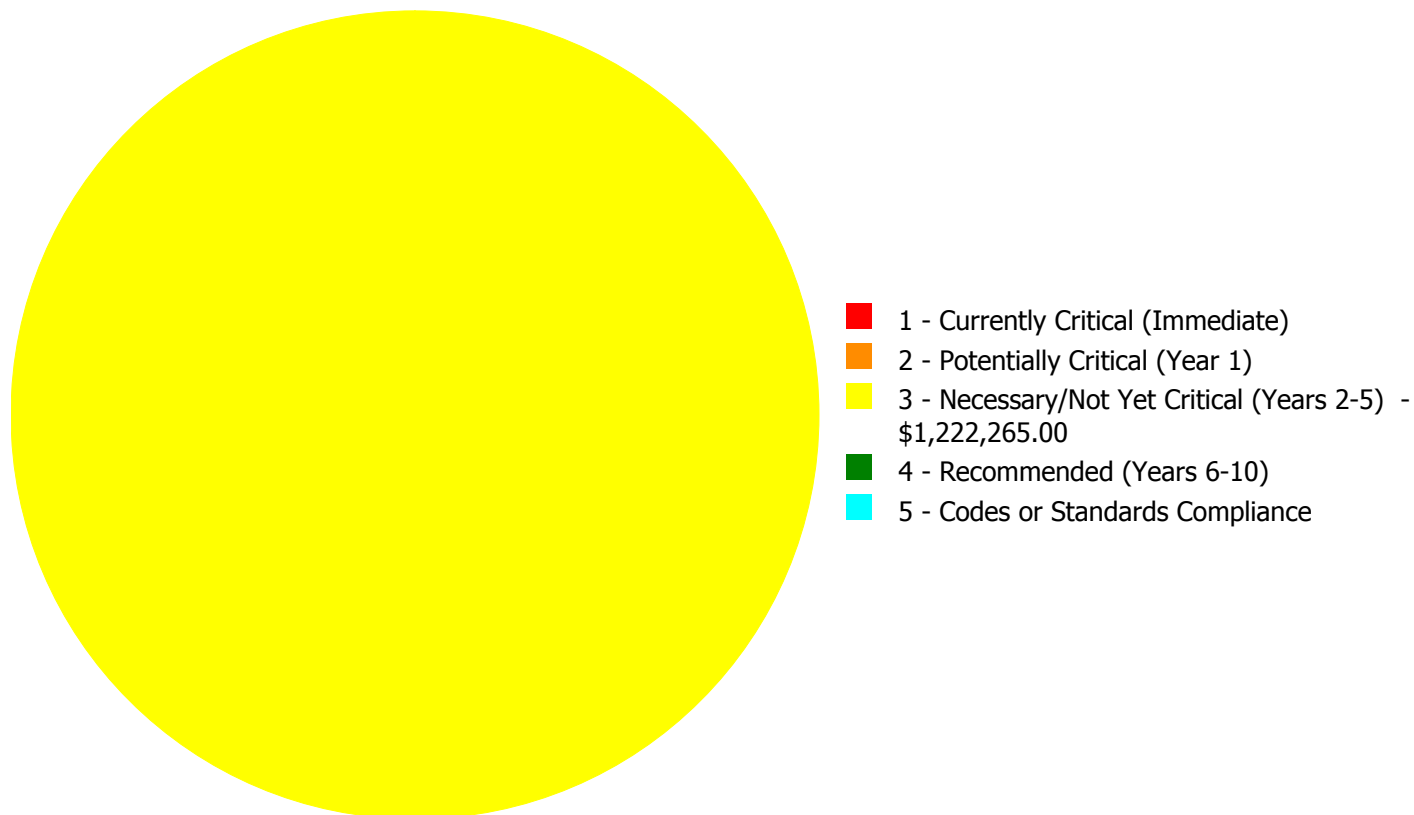
Deficiency Summary by Priority

The following chart shows the total repair costs broken down by priority. Assessors assigned deficiencies within eCOMET to one of the following priority categories:

Budget Estimate Total: \$1,222,265.00

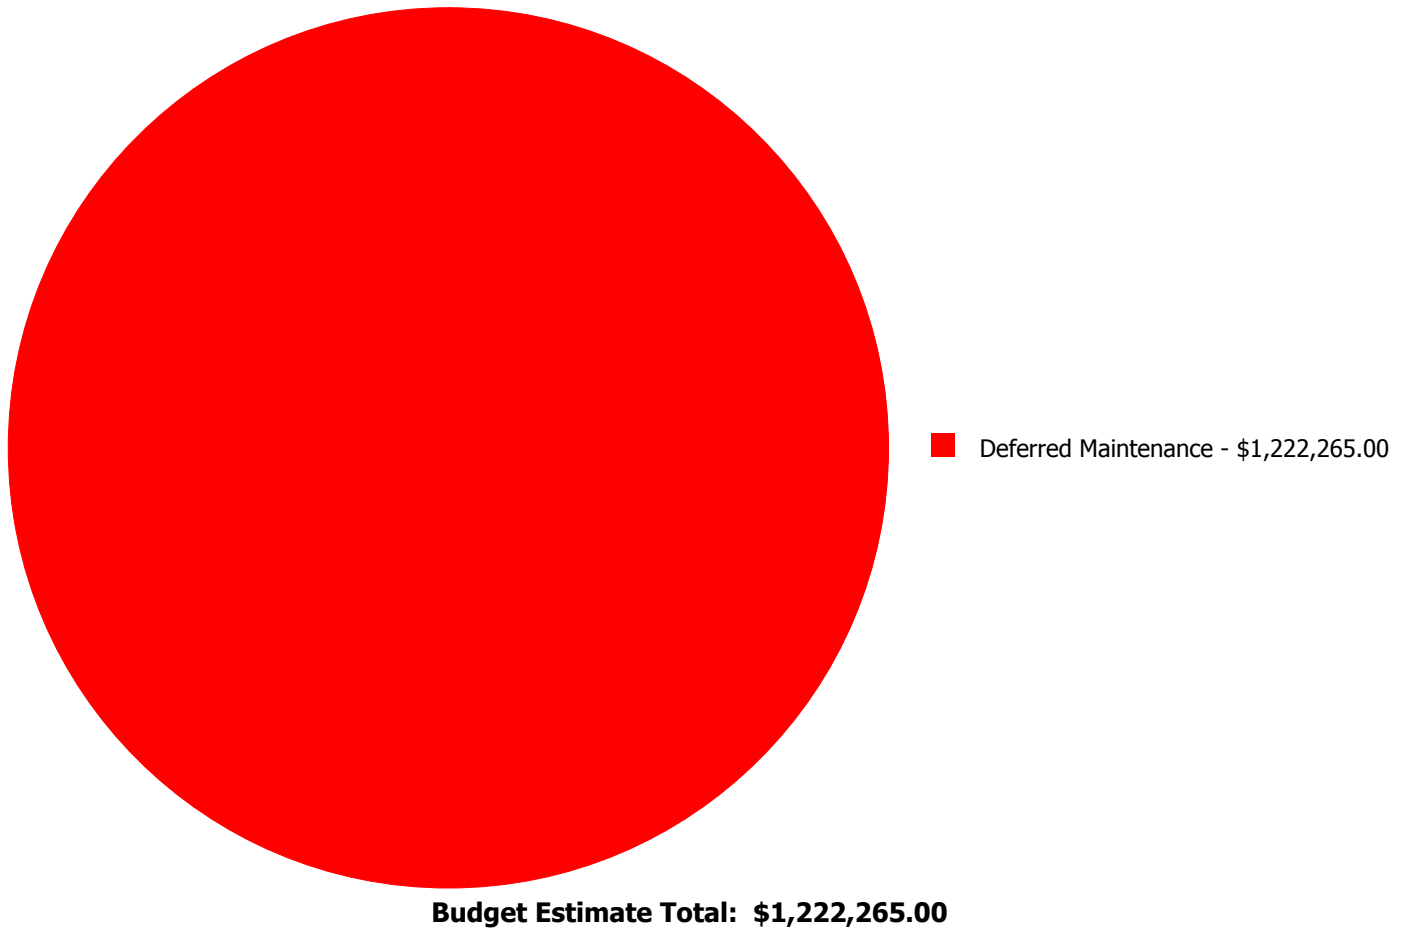
Deficiency Summary by Category

The following chart shows the total repair costs broken down by deficiency categories. Assessors assigned deficiencies to one of the following categories:

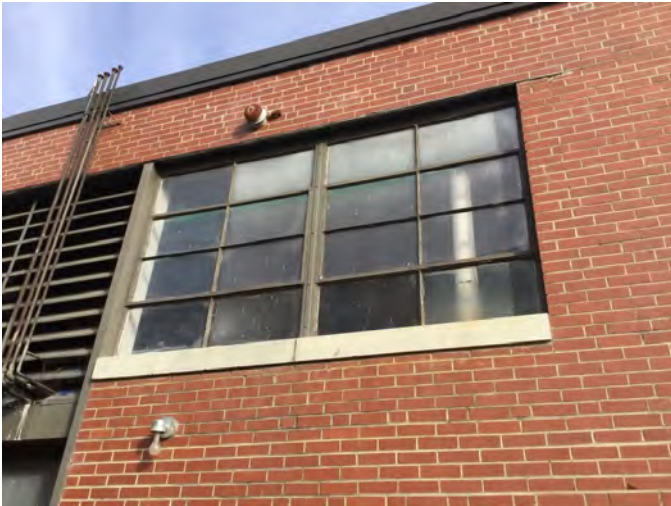
System: B2020 - Exterior Windows

Location: Exterior Walls
Distress: Beyond Service Life
Category: Deferred Maintenance
Priority: 3 - Necessary/Not Yet Critical (Years 2-5)
Correction: Renew System
Qty: 16,704.00
Unit of Measure: S.F.
Estimate: \$284,068.00
Assessor Name: Eduardo Lopez
Date Created: 01/04/2017

Notes: The exterior windows are aged, rusted, not energy efficient and should be replaced.

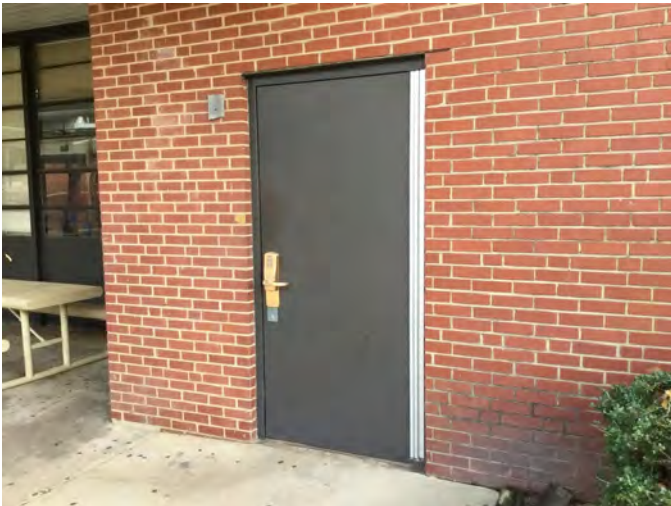
System: B2030 - Exterior Doors

Location: Exterior Walls
Distress: Beyond Service Life
Category: Deferred Maintenance
Priority: 3 - Necessary/Not Yet Critical (Years 2-5)
Correction: Renew System
Qty: 16,704.00
Unit of Measure: S.F.
Estimate: \$18,007.00
Assessor Name: Eduardo Lopez
Date Created: 01/04/2017

Notes: The exterior doors are aged, rusted and should be replaced.

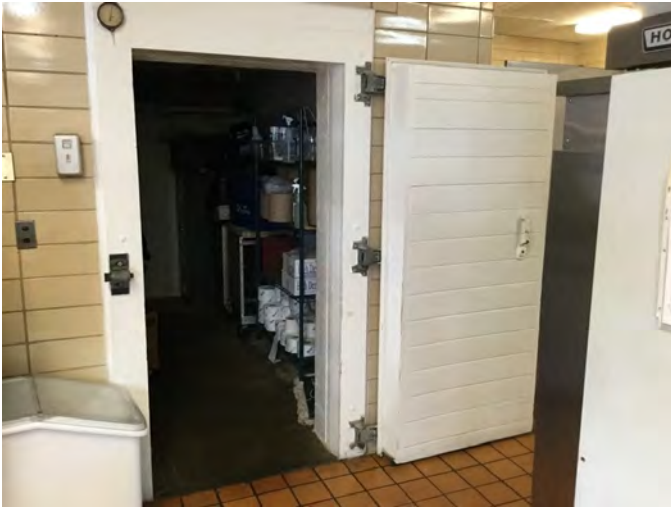
System: C1020 - Interior Doors

Location: Throughout the Building
Distress: Beyond Service Life
Category: Deferred Maintenance
Priority: 3 - Necessary/Not Yet Critical (Years 2-5)
Correction: Renew System
Qty: 16,704.00
Unit of Measure: S.F.
Estimate: \$54,021.00
Assessor Name: Eduardo Lopez
Date Created: 01/04/2017

Notes: The interior doors are aged, failing, most hardware is not ADA or code compliant and should be replaced.

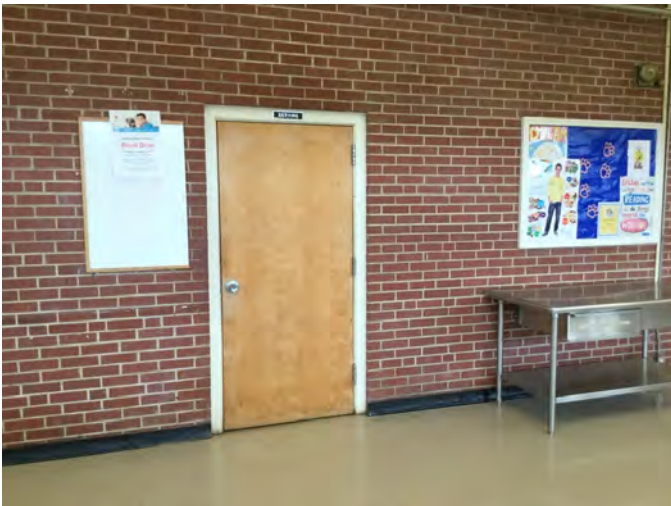
System: C1030 - Fittings

Location: Throughout the Building
Distress: Beyond Service Life
Category: Deferred Maintenance
Priority: 3 - Necessary/Not Yet Critical (Years 2-5)
Correction: Renew System
Qty: 16,704.00
Unit of Measure: S.F.
Estimate: \$33,074.00
Assessor Name: Eduardo Lopez
Date Created: 01/04/2017

Notes: The fittings throughout the building are aged, in marginal condition, handrails and room signage are not ADA compliant and should be replaced.

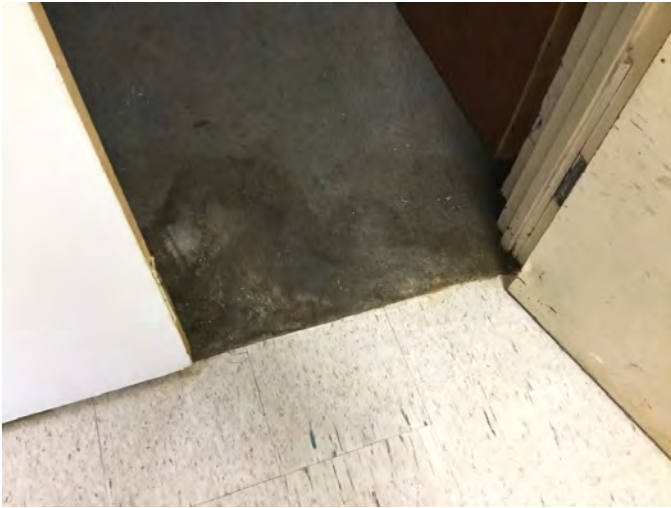
System: C3020 - Floor Finishes

Location: Throughout the Building
Distress: Beyond Service Life
Category: Deferred Maintenance
Priority: 3 - Necessary/Not Yet Critical (Years 2-5)
Correction: Renew System
Qty: 16,704.00
Unit of Measure: S.F.
Estimate: \$243,277.00
Assessor Name: Eduardo Lopez
Date Created: 01/04/2017

Notes: The original flooring is in poor conditions and should be replaced.

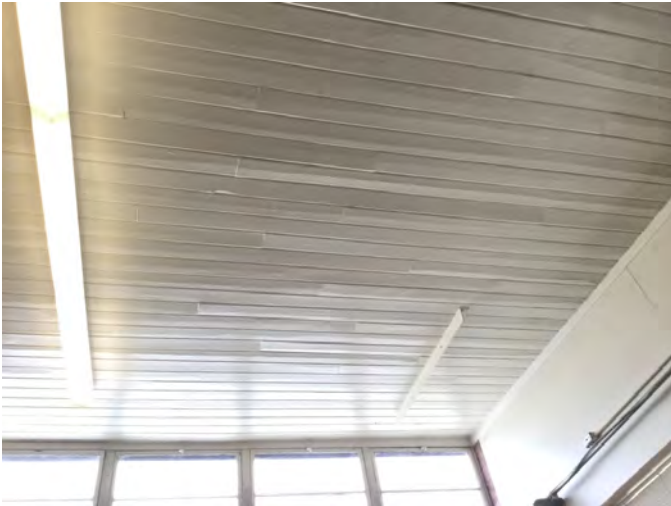
System: C3030 - Ceiling Finishes

Location: Throughout the Building
Distress: Beyond Service Life
Category: Deferred Maintenance
Priority: 3 - Necessary/Not Yet Critical (Years 2-5)
Correction: Renew System
Qty: 16,704.00
Unit of Measure: S.F.
Estimate: \$234,825.00
Assessor Name: Eduardo Lopez
Date Created: 01/04/2017

Notes: The original ceiling finishes are aged, failing and should be replaced.

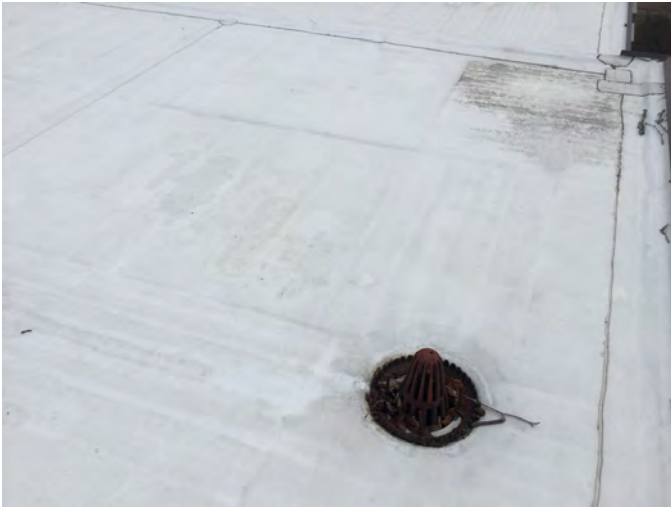
System: D2040 - Rain Water Drainage

Location: Throughout the Building
Distress: Beyond Service Life
Category: Deferred Maintenance
Priority: 3 - Necessary/Not Yet Critical (Years 2-5)
Correction: Renew System
Qty: 16,704.00
Unit of Measure: S.F.
Estimate: \$14,148.00
Assessor Name: Eduardo Lopez
Date Created: 01/04/2017

Notes: The rain water drainage system is aged and should be replaced.

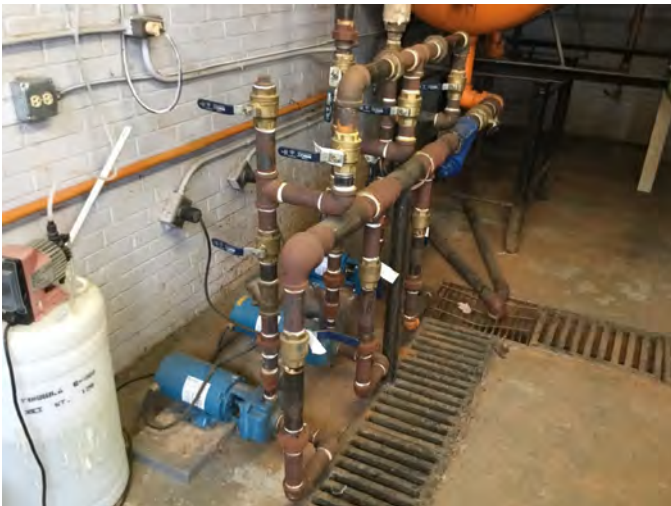
System: D3040 - Distribution Systems

Location: Throughout the Building
Distress: Beyond Service Life
Category: Deferred Maintenance
Priority: 3 - Necessary/Not Yet Critical (Years 2-5)
Correction: Renew System
Qty: 16,704.00
Unit of Measure: S.F.
Estimate: \$185,949.00
Assessor Name: Eduardo Lopez
Date Created: 01/04/2017

Notes: Distribution systems are aged, becoming logistically unsupportable, and should be replaced.

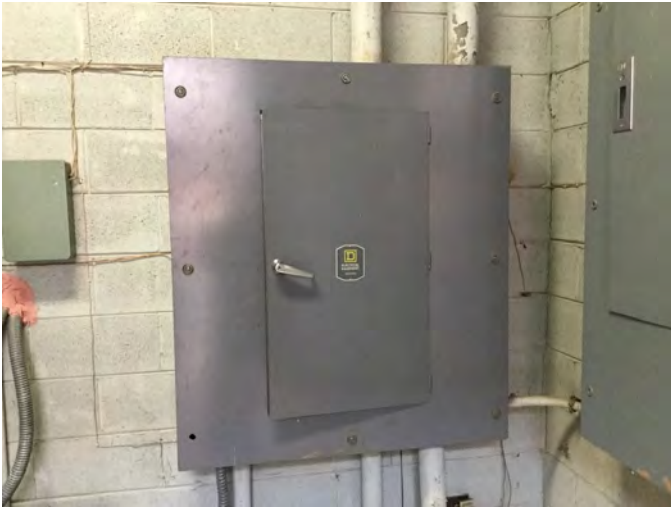
System: D5010 - Electrical Service/Distribution

Location: Throughout the Building
Distress: Beyond Service Life
Category: Deferred Maintenance
Priority: 3 - Necessary/Not Yet Critical (Years 2-5)
Correction: Renew System
Qty: 16,704.00
Unit of Measure: S.F.
Estimate: \$35,646.00
Assessor Name: Eduardo Lopez
Date Created: 01/04/2017

Notes: The original electrical service is operating but is in poor condition and should be replaced.

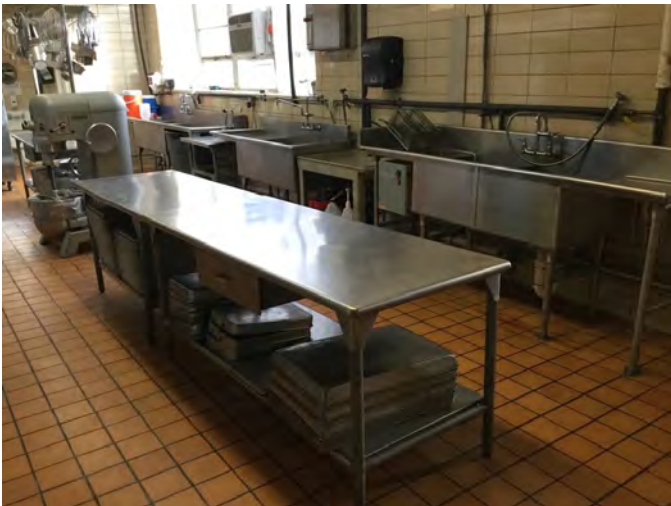
System: E1090 - Other Equipment

Location: Throughout the Building
Distress: Beyond Service Life
Category: Deferred Maintenance
Priority: 3 - Necessary/Not Yet Critical (Years 2-5)
Correction: Renew System
Qty: 16,704.00
Unit of Measure: S.F.
Estimate: \$119,250.00
Assessor Name: Eduardo Lopez
Date Created: 01/04/2017

Notes: The other equipment is in deteriorating conditions and should be replaced.

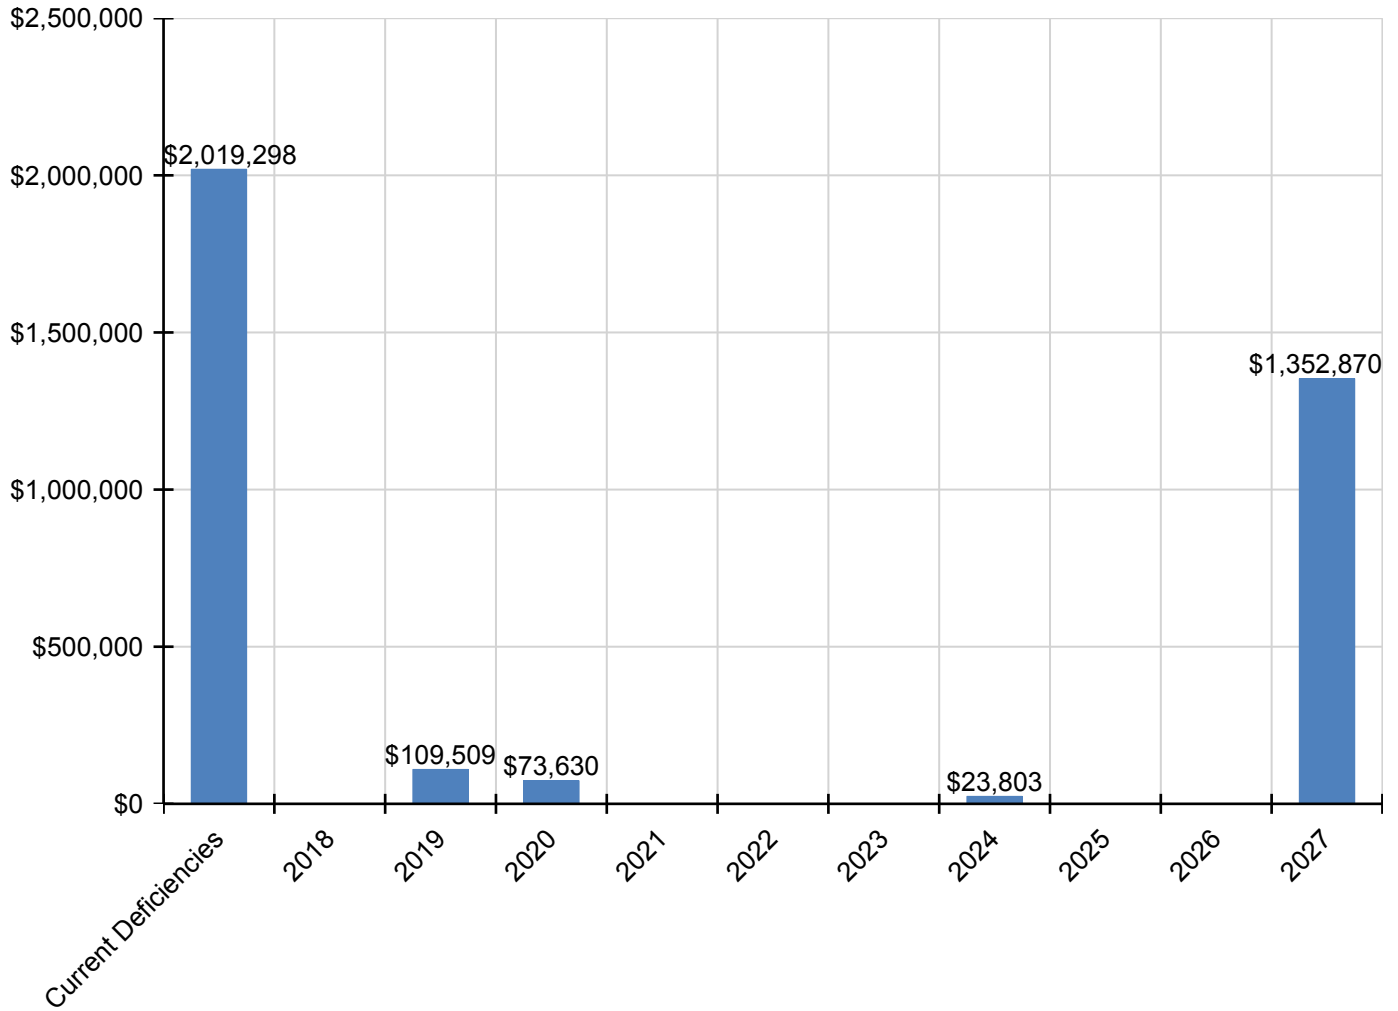
Forecasted Capital Renewal Requirement

The following chart shows the current building deficiencies and forecasting capital renewal or sustainment requirements over the next ten years.

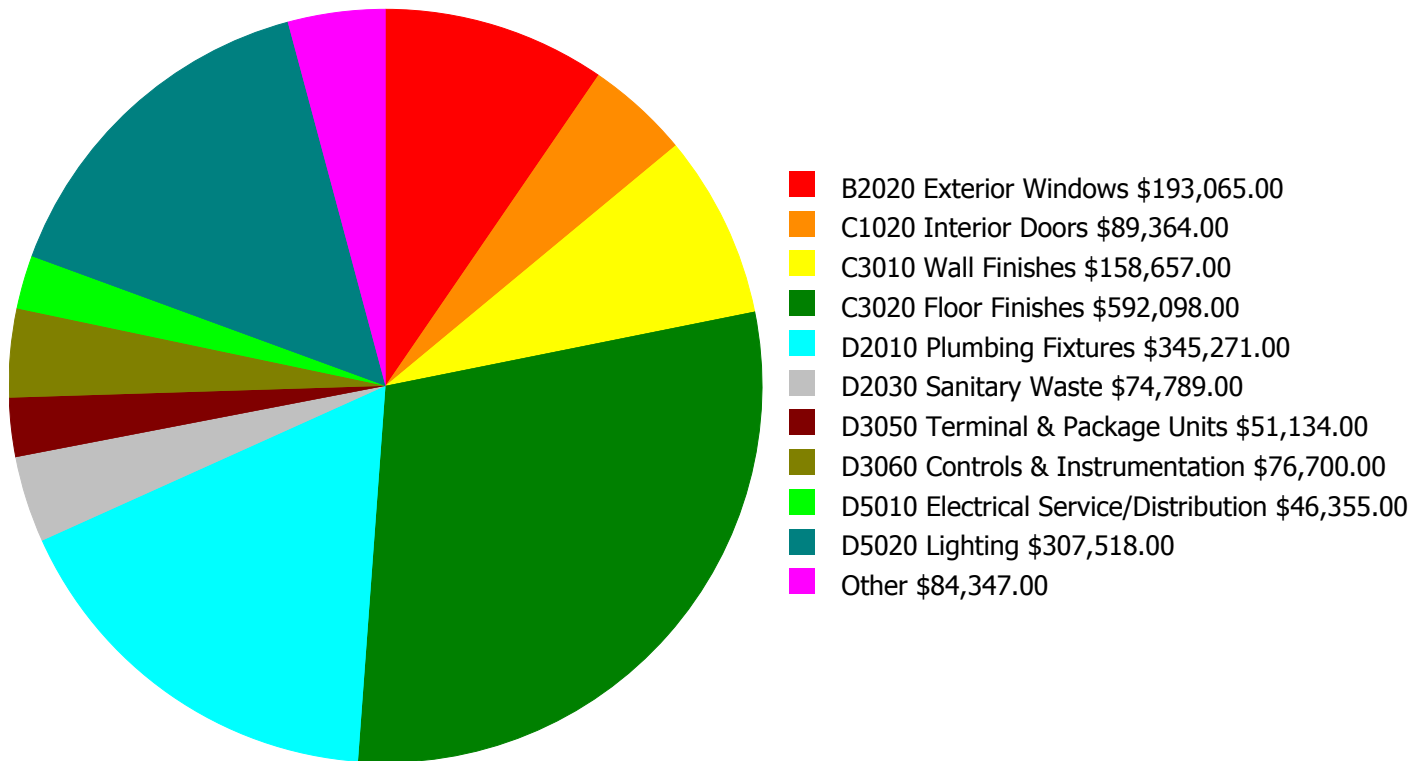
Deficiency Summary by System

Current deficiencies included assemblies that have reached or exceeded their design life or components of the assemblies that are in need of repair. Assemblies that have reached their design life are identified as current deficiencies and assigned the distress 'Beyond Useful Life'. The following chart lists all current deficiencies associated with this facility.

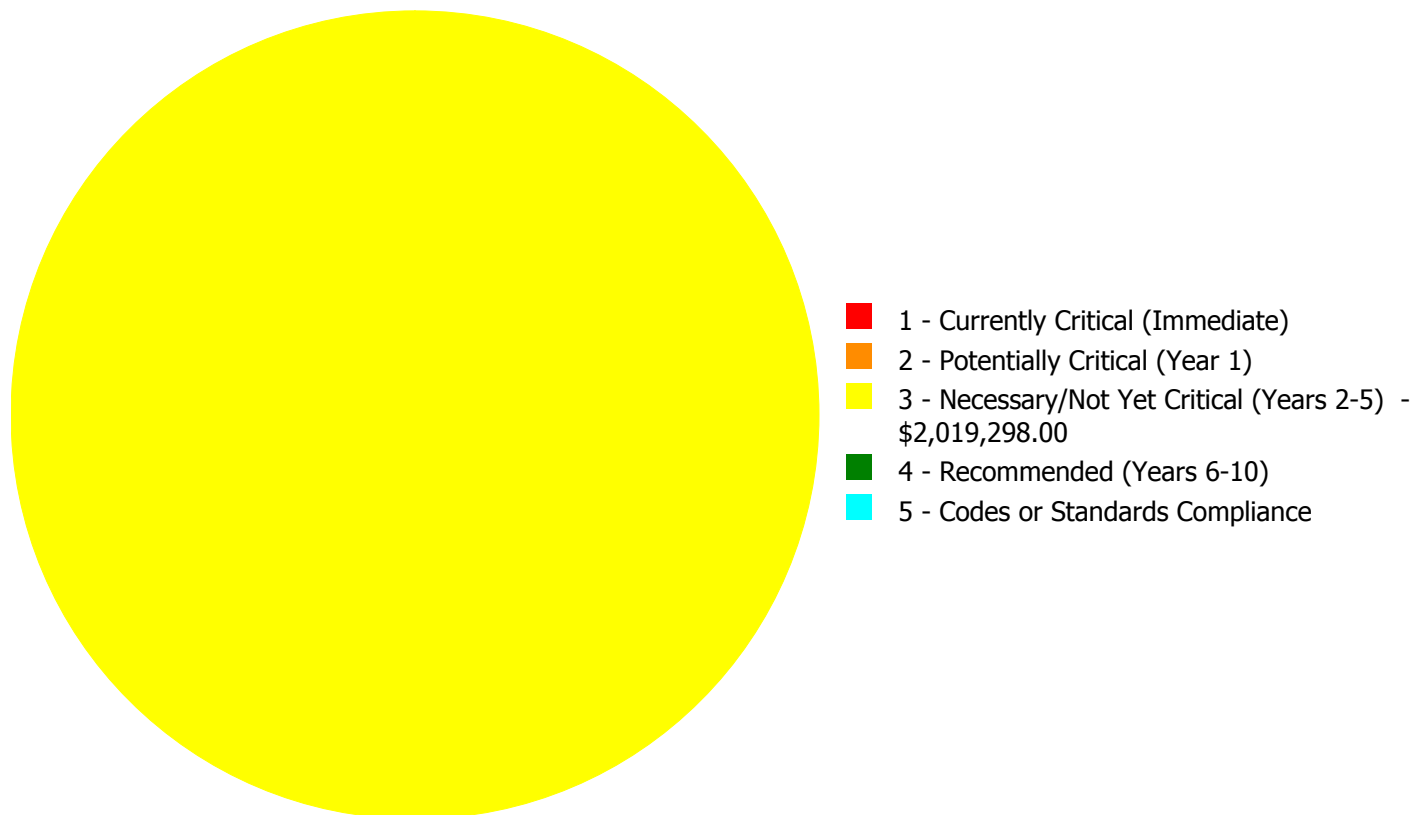
Deficiency Summary by Priority

The following chart shows the total repair costs broken down by priority. Assessors assigned deficiencies within eCOMET to one of the following priority categories:

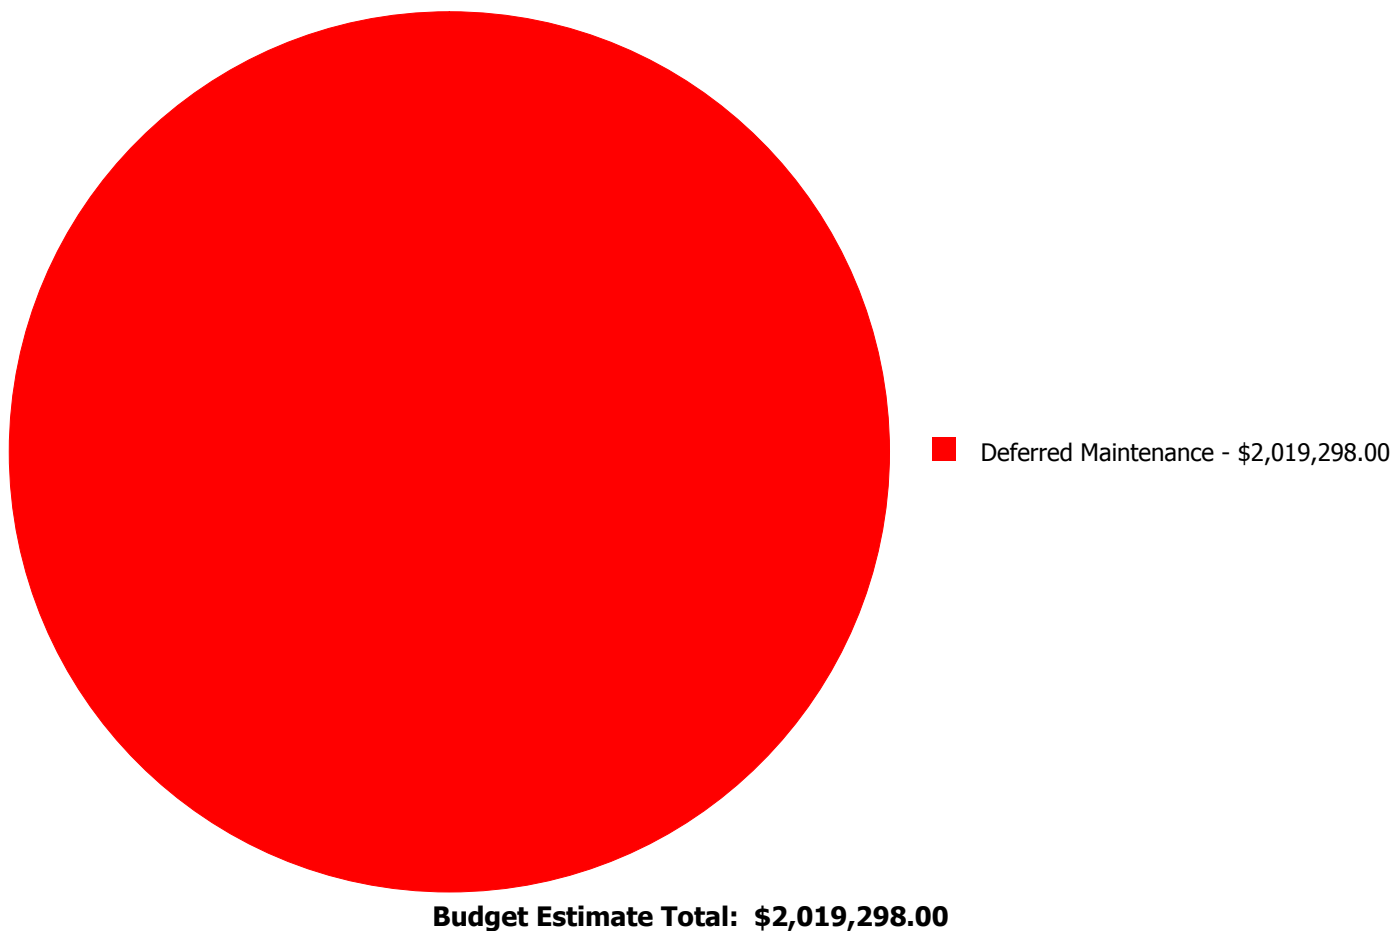
Deficiency Summary by Category

The following chart shows the total repair costs broken down by deficiency categories. Assessors assigned deficiencies to one of the following categories:

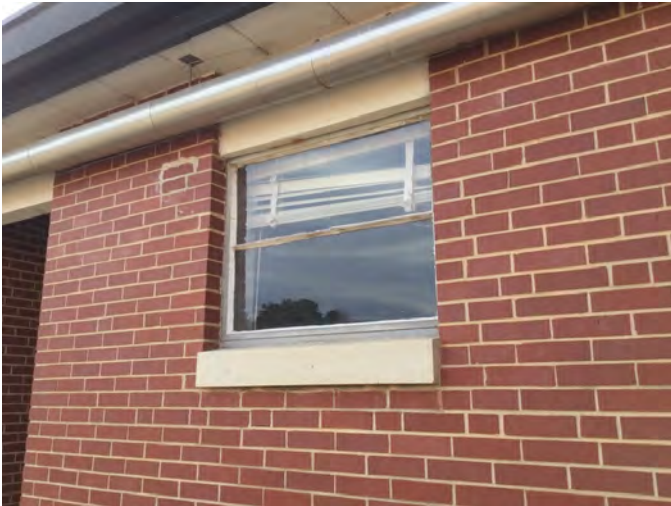
System: B2020 - Exterior Windows

Location: Exterior Walls
Distress: Beyond Service Life
Category: Deferred Maintenance
Priority: 3 - Necessary/Not Yet Critical (Years 2-5)
Correction: Renew System
Qty: 21,722.00
Unit of Measure: S.F.
Estimate: \$193,065.00
Assessor Name: Eduardo Lopez
Date Created: 02/16/2017

Notes: The exterior windows are aged, rusted, not energy efficient and should be replaced.

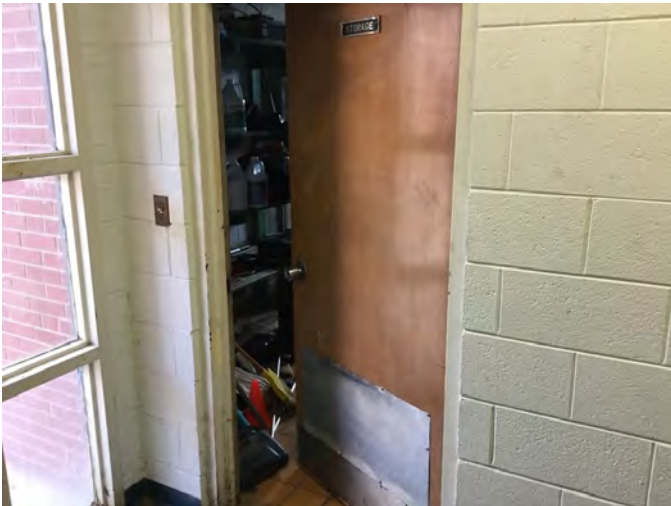
System: C1020 - Interior Doors

Location: Throughout the Building
Distress: Beyond Service Life
Category: Deferred Maintenance
Priority: 3 - Necessary/Not Yet Critical (Years 2-5)
Correction: Renew System
Qty: 21,722.00
Unit of Measure: S.F.
Estimate: \$89,364.00
Assessor Name: Eduardo Lopez
Date Created: 02/16/2017

Notes: The interior doors are aged, failing, most hardware is not ADA or code compliant and should be replaced.

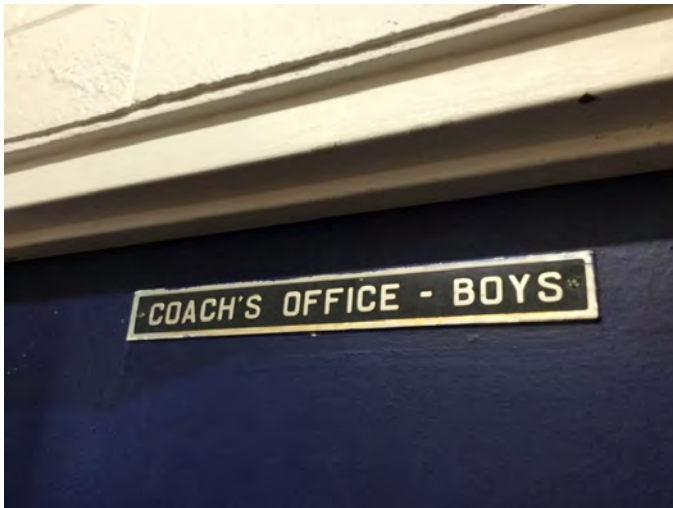
System: C1030 - Fittings

Location: Throughout the Building
Distress: Beyond Service Life
Category: Deferred Maintenance
Priority: 3 - Necessary/Not Yet Critical (Years 2-5)
Correction: Renew System
Qty: 21,722.00
Unit of Measure: S.F.
Estimate: \$43,010.00
Assessor Name: Eduardo Lopez
Date Created: 02/16/2017

Notes: The fittings throughout the building are aged, in marginal condition, handrails and room signage are not ADA compliant and should be replaced.

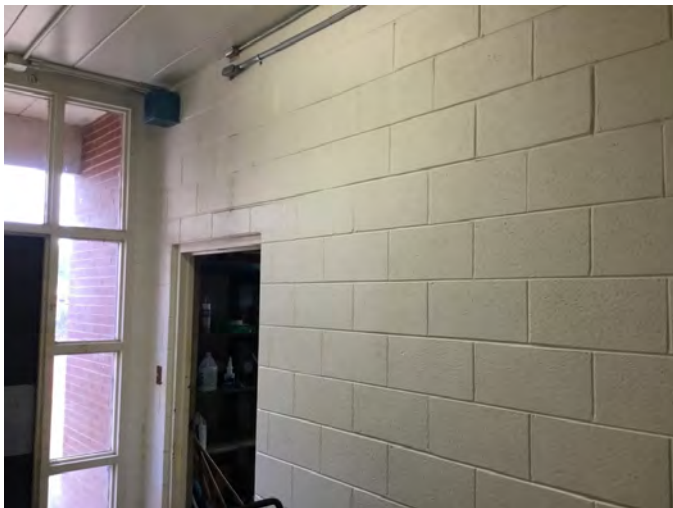
System: C3010 - Wall Finishes

Location: Throughout the Building
Distress: Beyond Service Life
Category: Deferred Maintenance
Priority: 3 - Necessary/Not Yet Critical (Years 2-5)
Correction: Renew System
Qty: 21,722.00
Unit of Measure: S.F.
Estimate: \$158,657.00
Assessor Name: Eduardo Lopez
Date Created: 02/16/2017

Notes: The wall finishes are aged, scuffed, fading, stained and should be replaced.

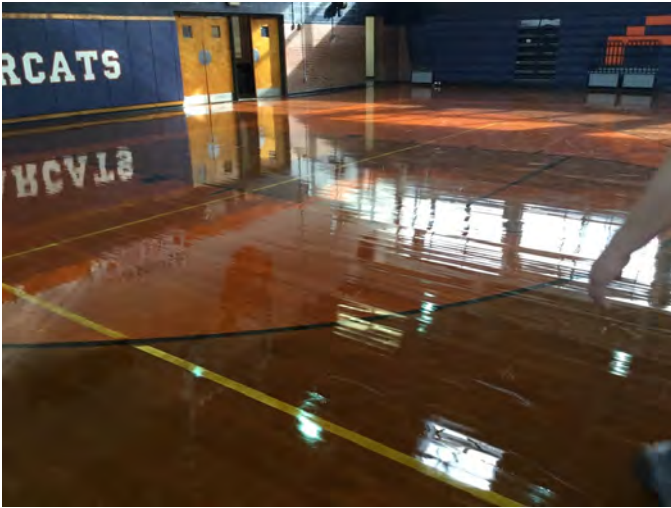
System: C3020 - Floor Finishes

Location: Throughout the Building
Distress: Beyond Service Life
Category: Deferred Maintenance
Priority: 3 - Necessary/Not Yet Critical (Years 2-5)
Correction: Renew System
Qty: 21,722.00
Unit of Measure: S.F.
Estimate: \$592,098.00
Assessor Name: Eduardo Lopez
Date Created: 02/16/2017

Notes: The original flooring is in poor conditions and should be replaced.
