NC School District/040 Anson County/High School

Anson High

Campus Assessment Report

March 10, 2017

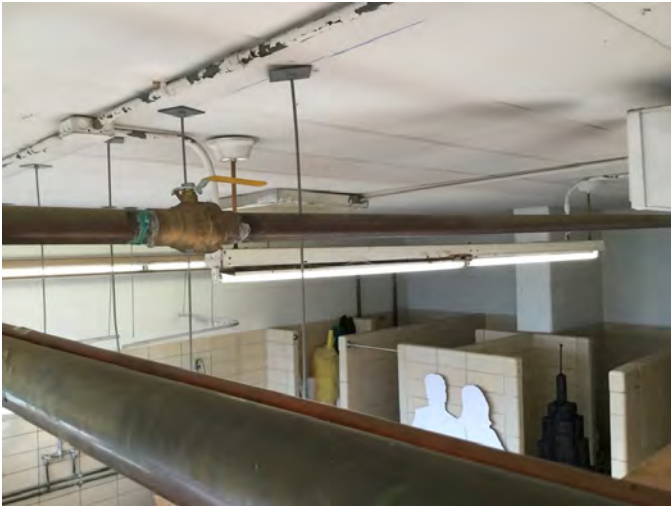
System: C3030 - Ceiling Finishes

Location: Throughout the Building
Distress: Beyond Service Life
Category: Deferred Maintenance
Priority: 3 - Necessary/Not Yet Critical (Years 2-5)
Correction: Renew System
Qty: 21,722.00
Unit of Measure: S.F.
Estimate: \$41,337.00
Assessor Name: Eduardo Lopez
Date Created: 02/16/2017

Notes: The original ceiling finishes are aged, failing and should be replaced.

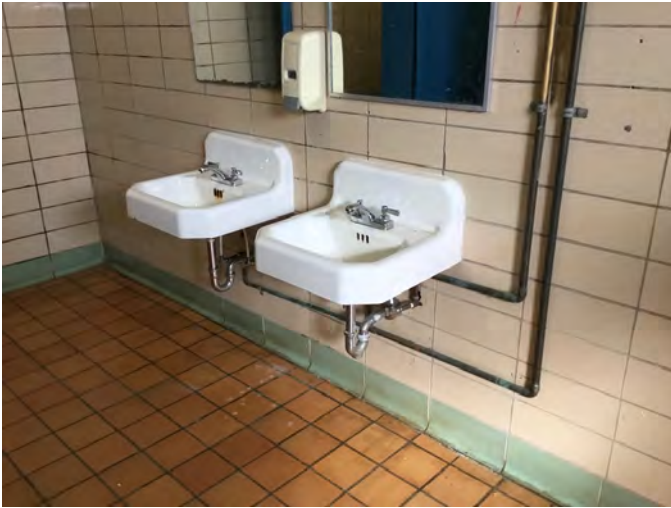
System: D2010 - Plumbing Fixtures

Location: Throughout the Building
Distress: Beyond Service Life
Category: Deferred Maintenance
Priority: 3 - Necessary/Not Yet Critical (Years 2-5)
Correction: Renew System
Qty: 21,722.00
Unit of Measure: S.F.
Estimate: \$345,271.00
Assessor Name: Eduardo Lopez
Date Created: 02/16/2017

Notes: Plumbing fixtures are in operational conditions. However, they are aged, not ADA compliant, and should be scheduled for replacement.

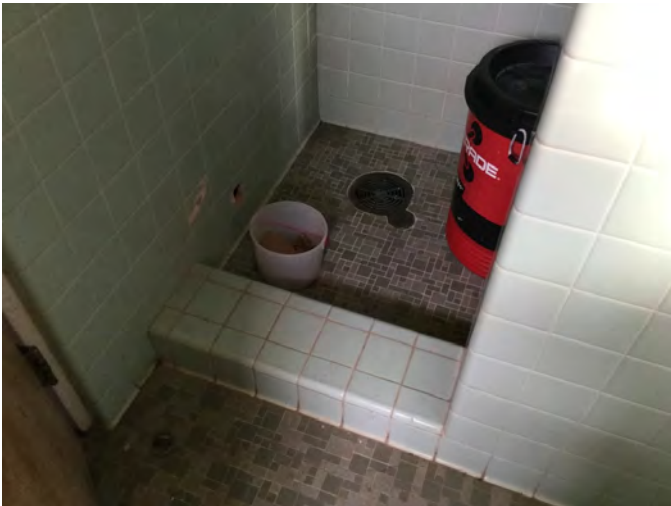
System: D2030 - Sanitary Waste

Location: Throughout the Building
Distress: Beyond Service Life
Category: Deferred Maintenance
Priority: 3 - Necessary/Not Yet Critical (Years 2-5)
Correction: Renew System
Qty: 21,722.00
Unit of Measure: S.F.
Estimate: \$74,789.00
Assessor Name: Eduardo Lopez
Date Created: 02/16/2017

Notes: The sanitary waste system is beyond its expected service life and should be replaced.

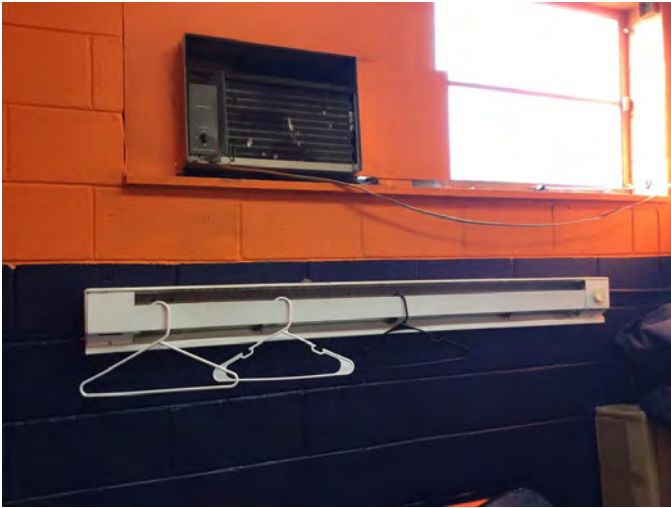
System: D3050 - Terminal & Package Units

Location: Throughout the Building
Distress: Beyond Service Life
Category: Deferred Maintenance
Priority: 3 - Necessary/Not Yet Critical (Years 2-5)
Correction: Renew System
Qty: 21,722.00
Unit of Measure: S.F.
Estimate: \$51,134.00
Assessor Name: Eduardo Lopez
Date Created: 02/16/2017

Notes: Terminal and package units are beyond their expected service life and should be scheduled for replacement.

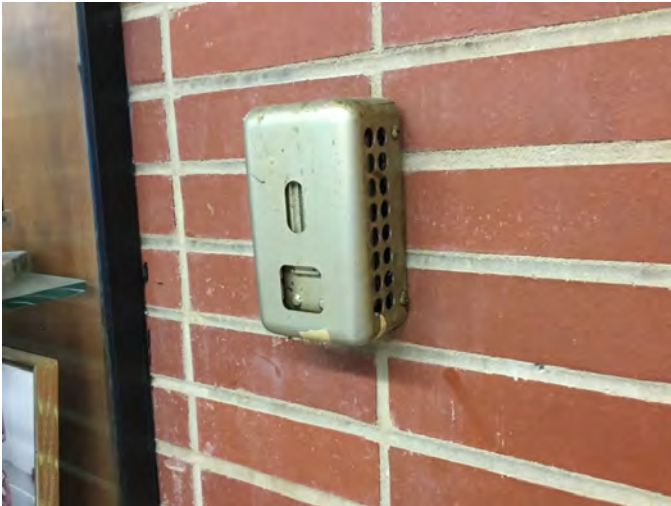
System: D3060 - Controls & Instrumentation

Location: Throughout the Building
Distress: Beyond Service Life
Category: Deferred Maintenance
Priority: 3 - Necessary/Not Yet Critical (Years 2-5)
Correction: Renew System
Qty: 21,722.00
Unit of Measure: S.F.
Estimate: \$76,700.00
Assessor Name: Eduardo Lopez
Date Created: 02/16/2017

Notes: The controls and instrumentation system is in marginal condition and should be schedule for replacement.

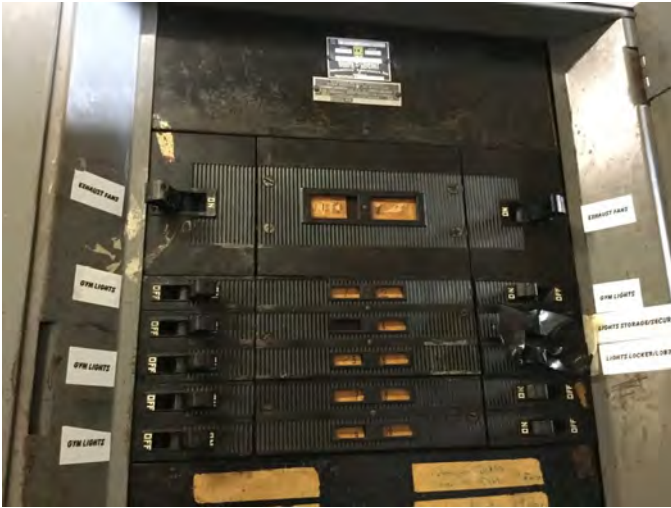
System: D5010 - Electrical Service/Distribution

Location: Throughout the Building
Distress: Beyond Service Life
Category: Deferred Maintenance
Priority: 3 - Necessary/Not Yet Critical (Years 2-5)
Correction: Renew System
Qty: 21,722.00
Unit of Measure: S.F.
Estimate: \$46,355.00
Assessor Name: Eduardo Lopez
Date Created: 02/16/2017

Notes: The original electrical service is operating but is in poor condition and should be replaced.

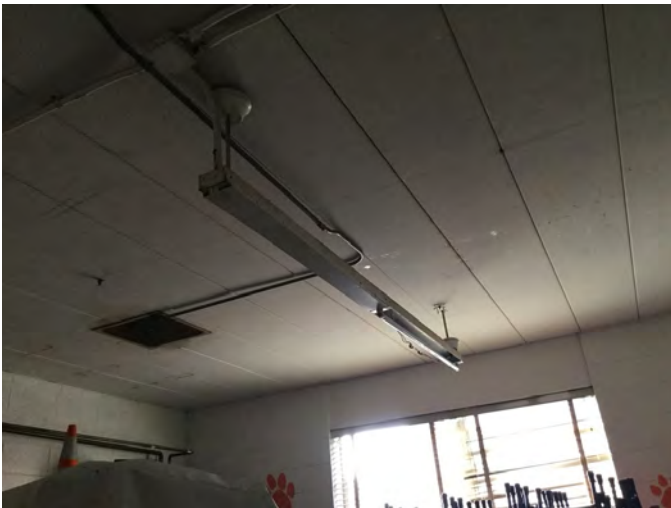
System: D5020 - Lighting

Location: Throughout the Building
Distress: Beyond Service Life
Category: Deferred Maintenance
Priority: 3 - Necessary/Not Yet Critical (Years 2-5)
Correction: Renew System
Qty: 21,722.00
Unit of Measure: S.F.
Estimate: \$307,518.00
Assessor Name: Eduardo Lopez
Date Created: 02/16/2017

Notes: The original lighting system is operating but is aged, in marginal condition, and should be replaced.

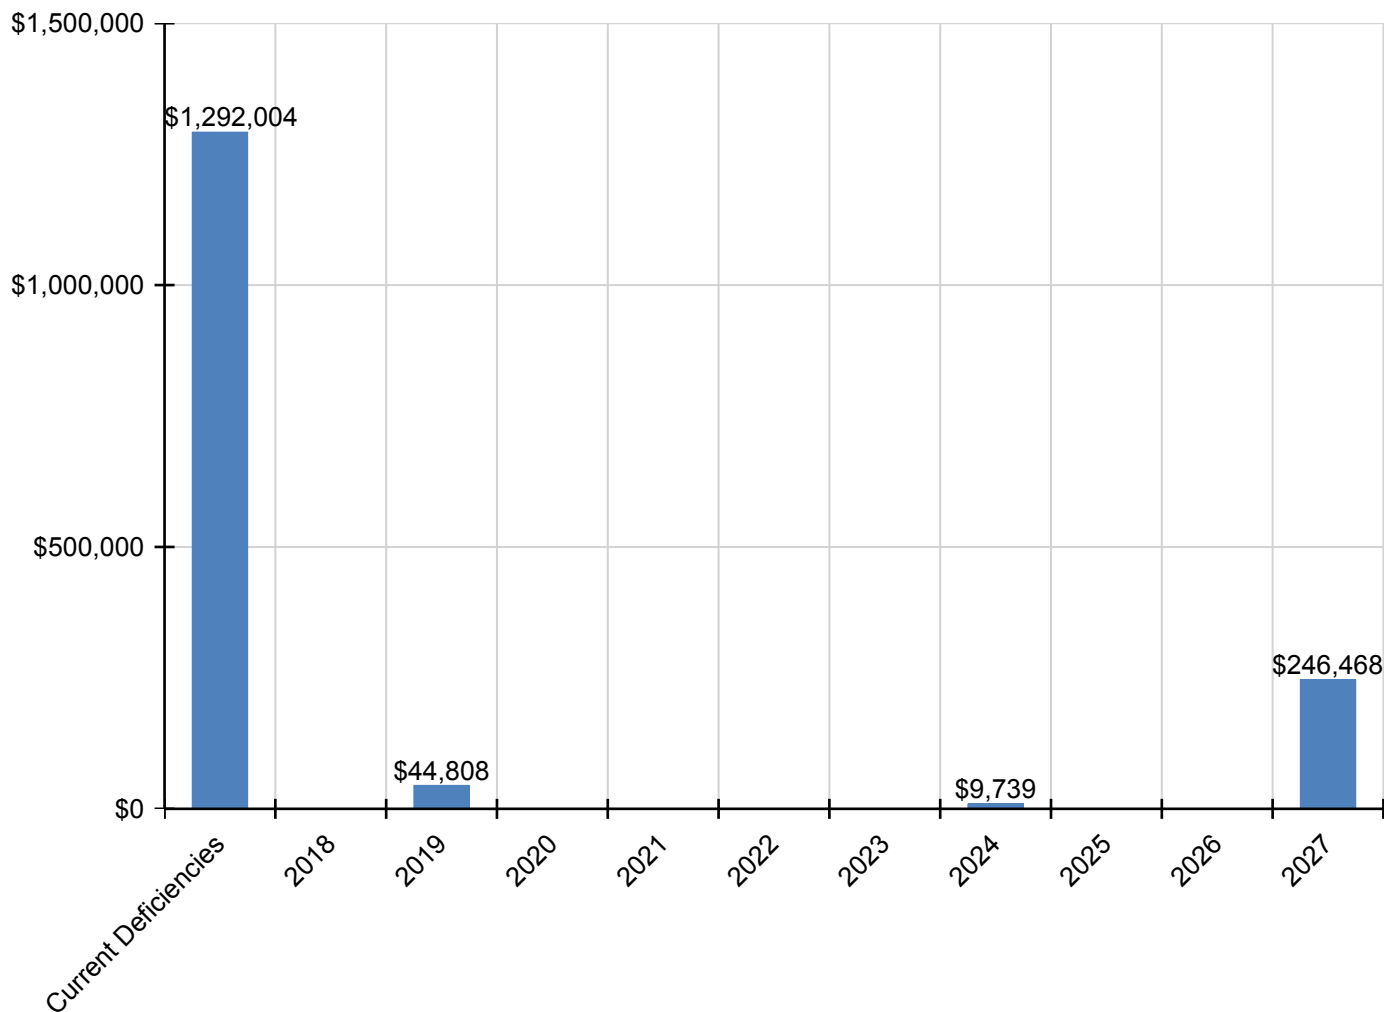
Forecasted Capital Renewal Requirement

The following chart shows the current building deficiencies and forecasting capital renewal or sustainment requirements over the next ten years.

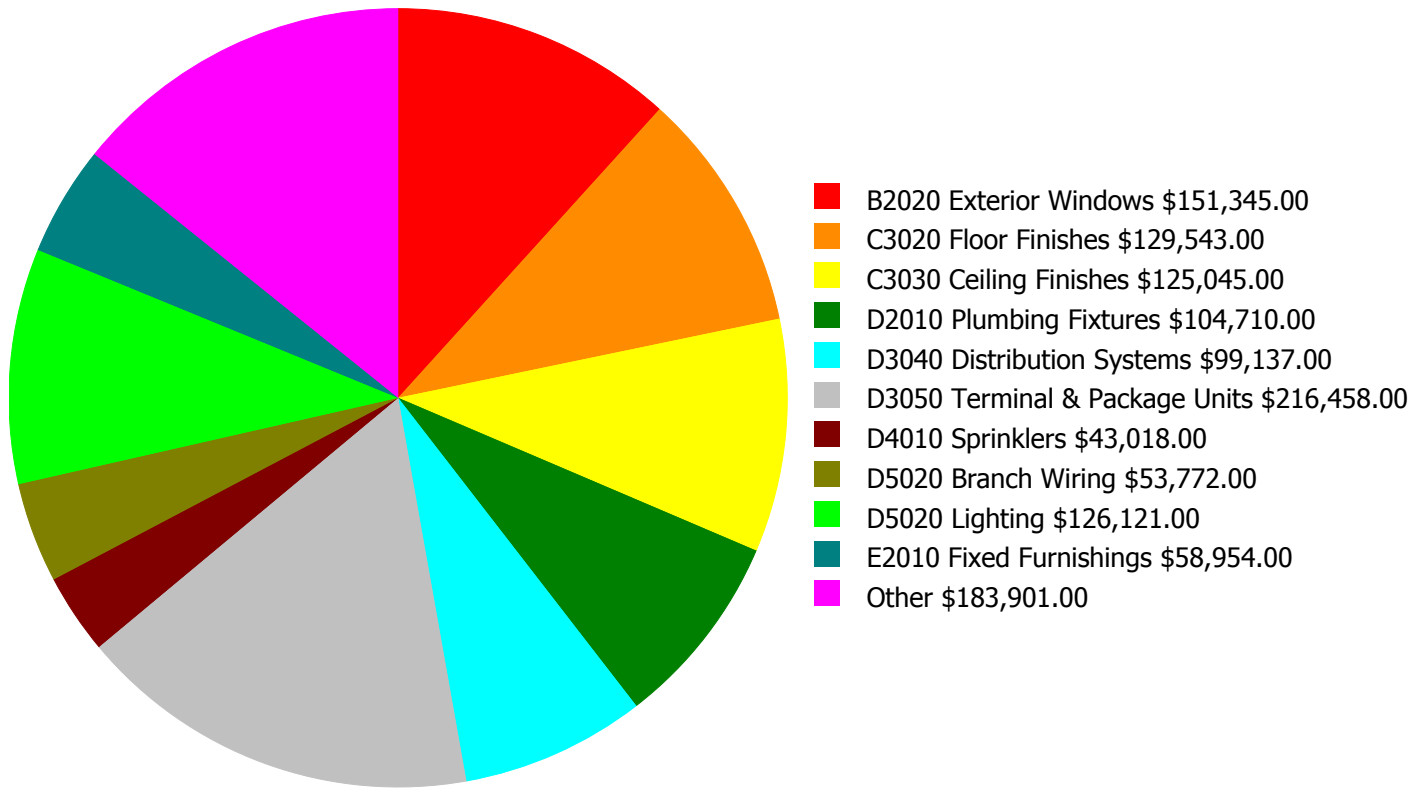
Deficiency Summary by System

Current deficiencies included assemblies that have reached or exceeded their design life or components of the assemblies that are in need of repair. Assemblies that have reached their design life are identified as current deficiencies and assigned the distress 'Beyond Useful Life'. The following chart lists all current deficiencies associated with this facility.

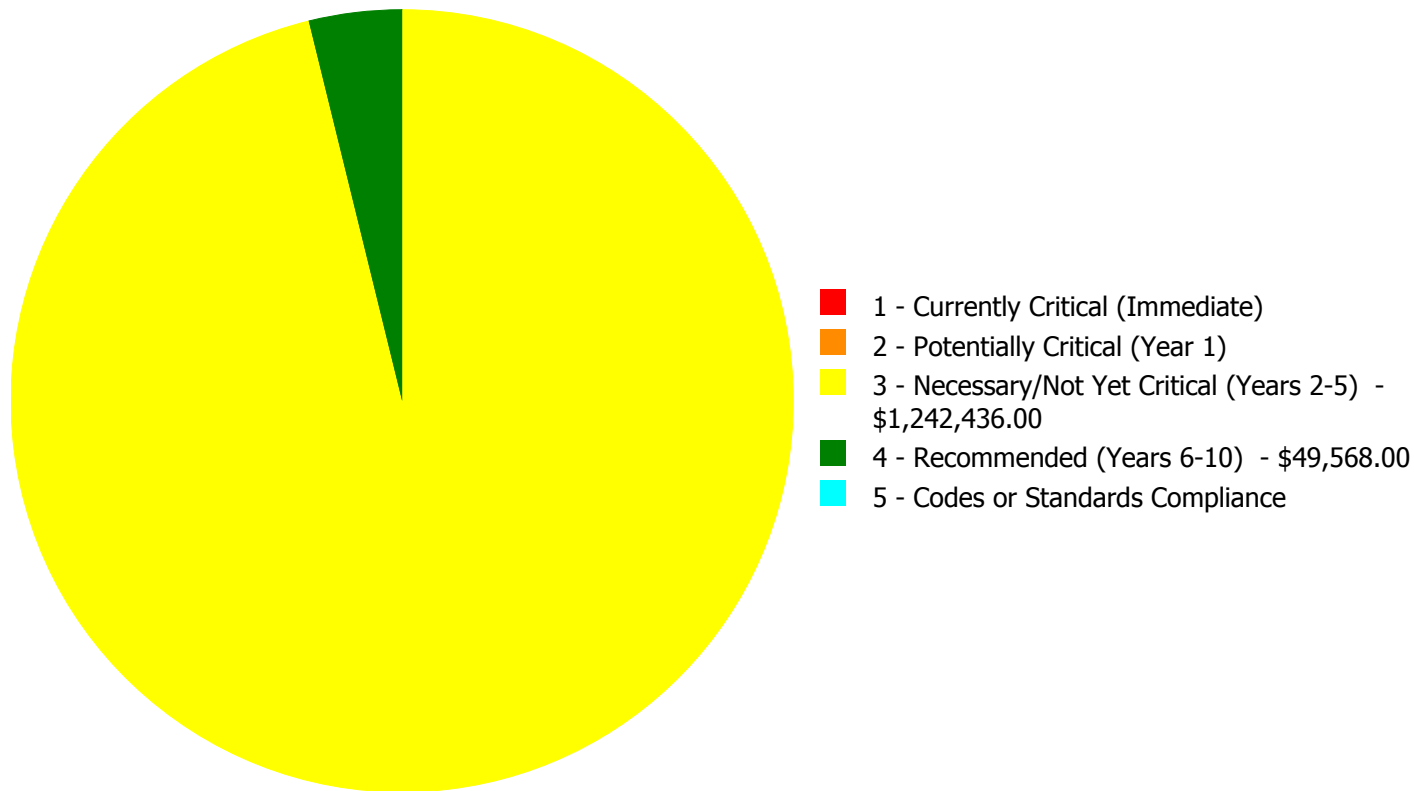
Deficiency Summary by Priority

The following chart shows the total repair costs broken down by priority. Assessors assigned deficiencies within eCOMET to one of the following priority categories:

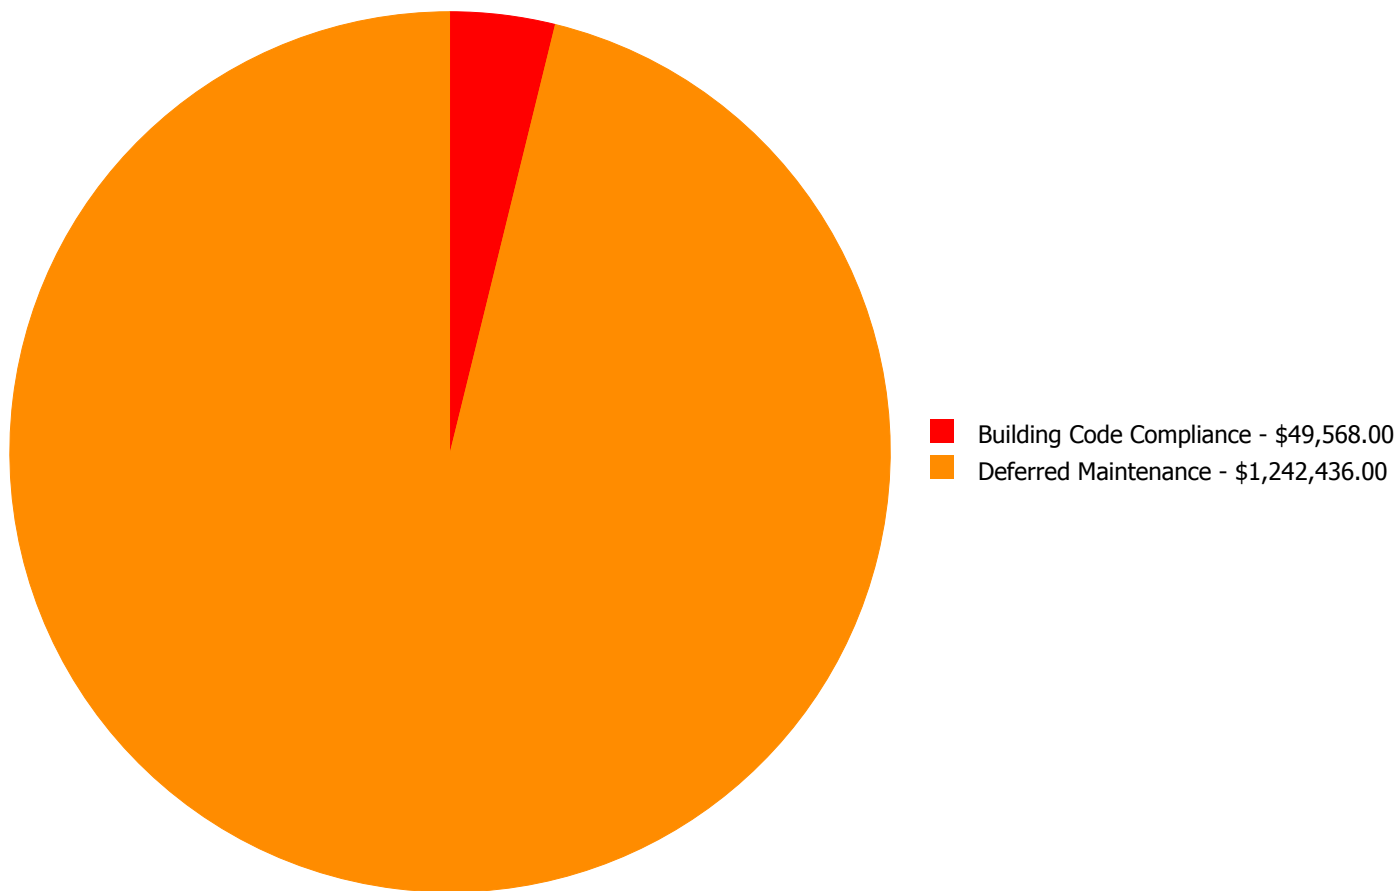
Deficiency Summary by Category

The following chart shows the total repair costs broken down by deficiency categories. Assessors assigned deficiencies to one of the following categories:

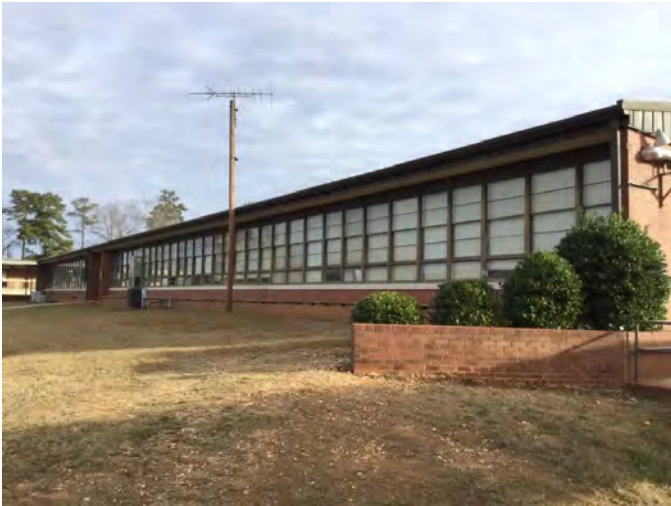
System: B2020 - Exterior Windows

Location: Exterior Walls
Distress: Beyond Service Life
Category: Deferred Maintenance
Priority: 3 - Necessary/Not Yet Critical (Years 2-5)
Correction: Renew System
Qty: 8,888.00
Unit of Measure: S.F.
Estimate: \$151,345.00
Assessor Name: Eduardo Lopez
Date Created: 01/04/2017

Notes: The exterior windows are aged, rusted, not energy efficient and should be replaced.

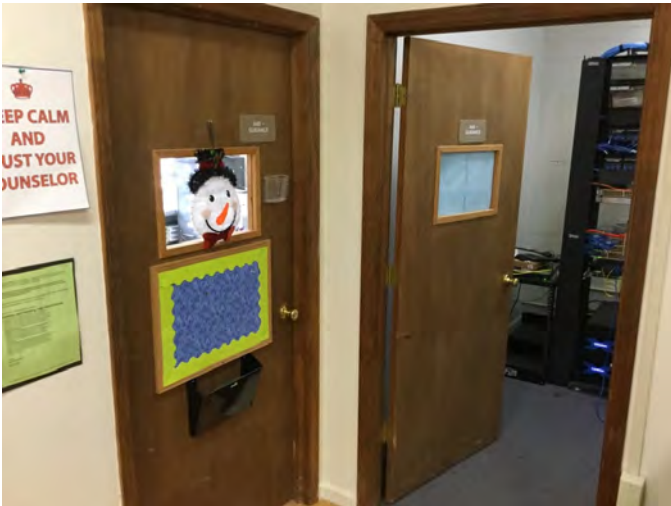
System: C1020 - Interior Doors

Location: Throughout the Building
Distress: Beyond Service Life
Category: Deferred Maintenance
Priority: 3 - Necessary/Not Yet Critical (Years 2-5)
Correction: Renew System
Qty: 8,888.00
Unit of Measure: S.F.
Estimate: \$28,939.00
Assessor Name: Eduardo Lopez
Date Created: 01/04/2017

Notes: The interior doors are aged, failing, most hardware is not ADA or code compliant and should be replaced.

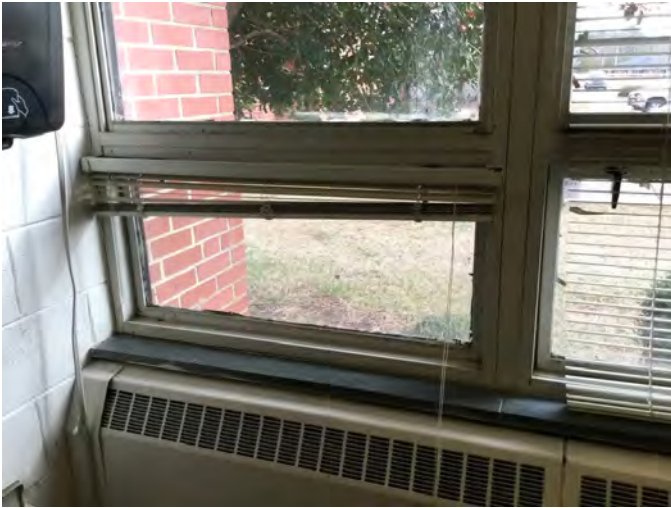
System: C1030 - Fittings

Location: Throughout the Building
Distress: Beyond Service Life
Category: Deferred Maintenance
Priority: 3 - Necessary/Not Yet Critical (Years 2-5)
Correction: Renew System
Qty: 8,888.00
Unit of Measure: S.F.
Estimate: \$17,598.00
Assessor Name: Eduardo Lopez
Date Created: 01/04/2017

Notes: The fittings throughout the building are aged, in marginal condition, handrails and room signage are not ADA compliant and should be replaced.

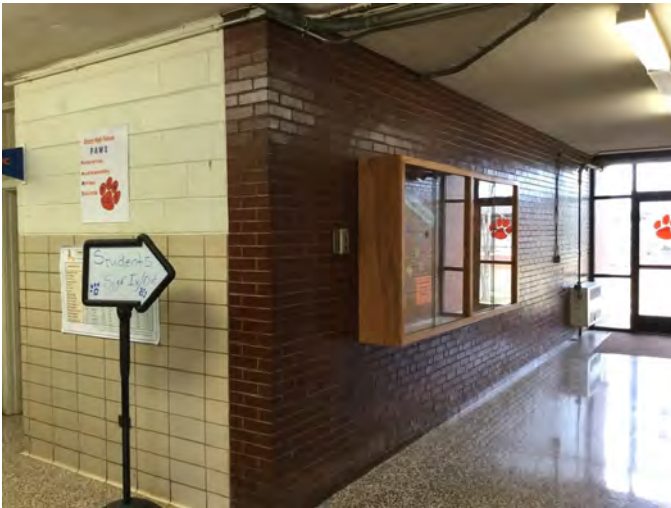
System: C3010 - Wall Finishes

Location: Throughout the Building
Distress: Beyond Service Life
Category: Deferred Maintenance
Priority: 3 - Necessary/Not Yet Critical (Years 2-5)
Correction: Renew System
Qty: 8,888.00
Unit of Measure: S.F.
Estimate: \$30,308.00
Assessor Name: Eduardo Lopez
Date Created: 01/04/2017

Notes: The wall finishes are aged, scuffed, fading, stained and should be replaced.

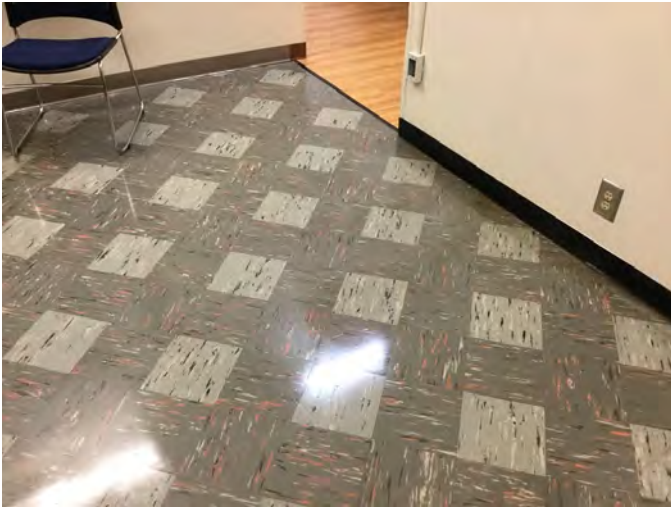
System: C3020 - Floor Finishes

Location: Throughout the Building
Distress: Beyond Service Life
Category: Deferred Maintenance
Priority: 3 - Necessary/Not Yet Critical (Years 2-5)
Correction: Renew System
Qty: 8,888.00
Unit of Measure: S.F.
Estimate: \$129,543.00
Assessor Name: Eduardo Lopez
Date Created: 01/04/2017

Notes: The original flooring is in poor conditions and should be replaced.

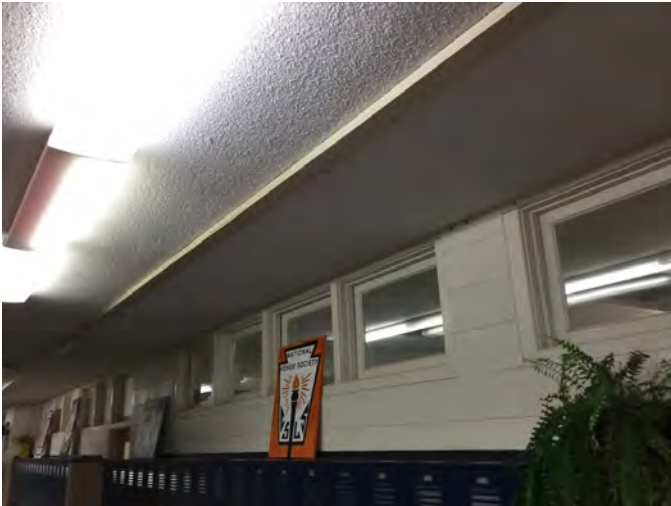
System: C3030 - Ceiling Finishes

Location: Throughout the Building
Distress: Beyond Service Life
Category: Deferred Maintenance
Priority: 3 - Necessary/Not Yet Critical (Years 2-5)
Correction: Renew System
Qty: 8,888.00
Unit of Measure: S.F.
Estimate: \$125,045.00
Assessor Name: Eduardo Lopez
Date Created: 01/04/2017

Notes: The original ceiling finishes are aged, failing and should be replaced.

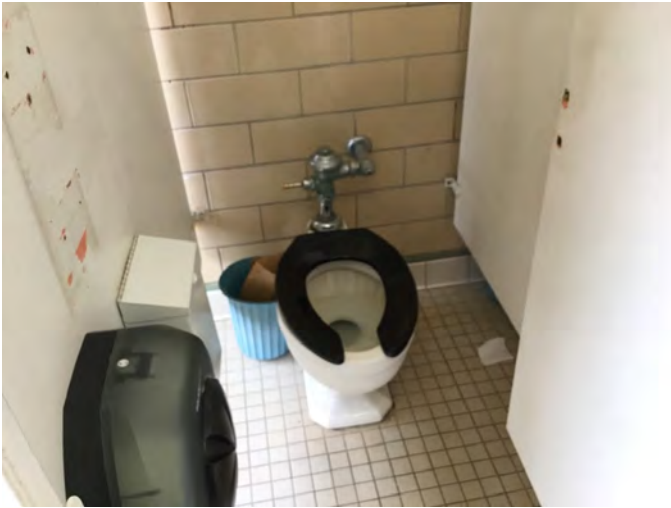
System: D2010 - Plumbing Fixtures

Location: Throughout the Building
Distress: Beyond Service Life
Category: Deferred Maintenance
Priority: 3 - Necessary/Not Yet Critical (Years 2-5)
Correction: Renew System
Qty: 8,888.00
Unit of Measure: S.F.
Estimate: \$104,710.00
Assessor Name: Eduardo Lopez
Date Created: 01/04/2017

Notes: Plumbing fixtures are in operational conditions. However, they are aged, not ADA compliant, and should be scheduled for replacement.

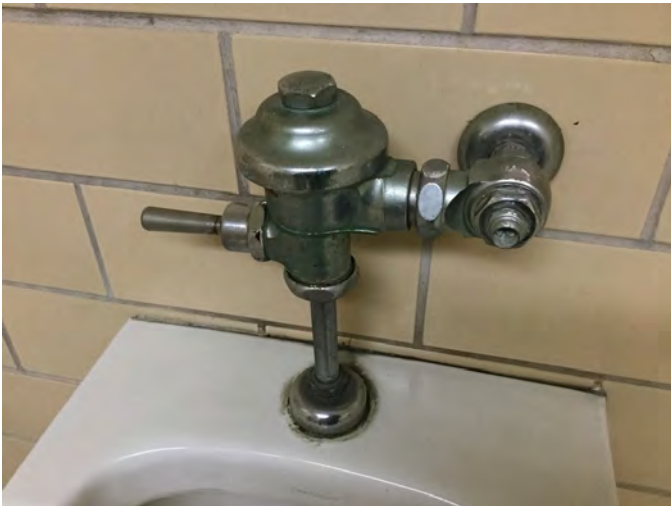
System: D2020 - Domestic Water Distribution

Location: Throughout the Building
Distress: Beyond Service Life
Category: Deferred Maintenance
Priority: 3 - Necessary/Not Yet Critical (Years 2-5)
Correction: Renew System
Qty: 8,888.00
Unit of Measure: S.F.
Estimate: \$19,456.00
Assessor Name: Eduardo Lopez
Date Created: 01/04/2017

Notes: The domestic water distribution system is aged and should be replaced.

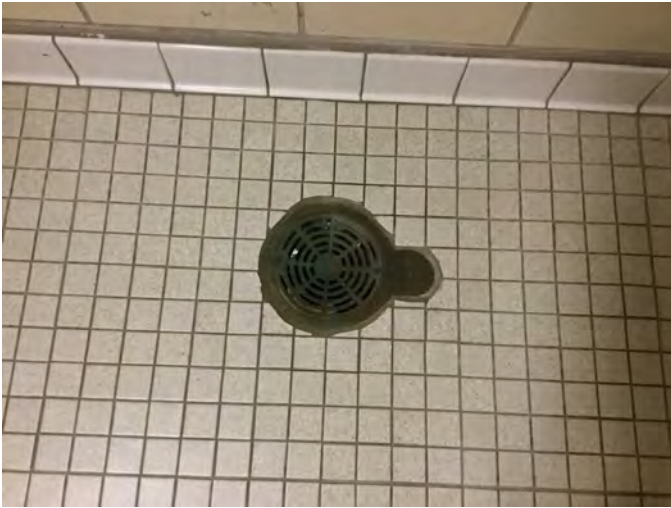
System: D2030 - Sanitary Waste

Location: Throughout the Building
Distress: Beyond Service Life
Category: Deferred Maintenance
Priority: 3 - Necessary/Not Yet Critical (Years 2-5)
Correction: Renew System
Qty: 8,888.00
Unit of Measure: S.F.
Estimate: \$30,699.00
Assessor Name: Eduardo Lopez
Date Created: 01/04/2017

Notes: The sanitary waste system is beyond its expected service life and should be replaced.

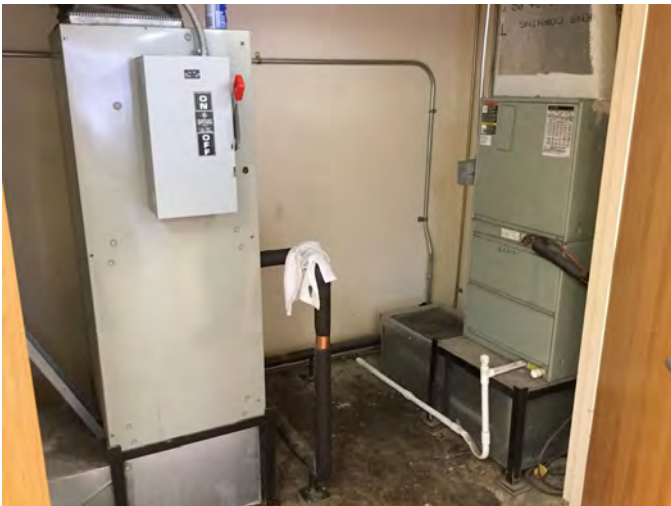
System: D3040 - Distribution Systems

Location: Throughout the Building
Distress: Beyond Service Life
Category: Deferred Maintenance
Priority: 3 - Necessary/Not Yet Critical (Years 2-5)
Correction: Renew System
Qty: 8,888.00
Unit of Measure: S.F.
Estimate: \$99,137.00
Assessor Name: Eduardo Lopez
Date Created: 01/04/2017

Notes: Distribution systems are aged, becoming logistically unsupportable, and should be replaced.

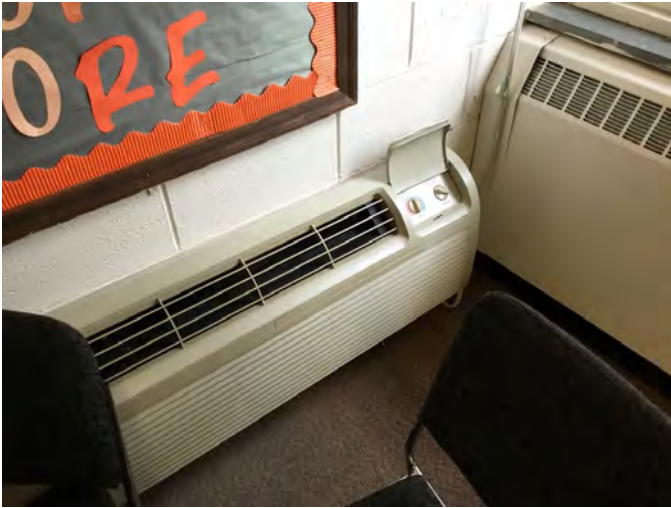
System: D3050 - Terminal & Package Units

Location: Throughout the Building
Distress: Beyond Service Life
Category: Deferred Maintenance
Priority: 3 - Necessary/Not Yet Critical (Years 2-5)
Correction: Renew System
Qty: 8,888.00
Unit of Measure: S.F.
Estimate: \$216,458.00
Assessor Name: Eduardo Lopez
Date Created: 01/04/2017

Notes: Terminal and package units are beyond their expected service life and should be scheduled for replacement.

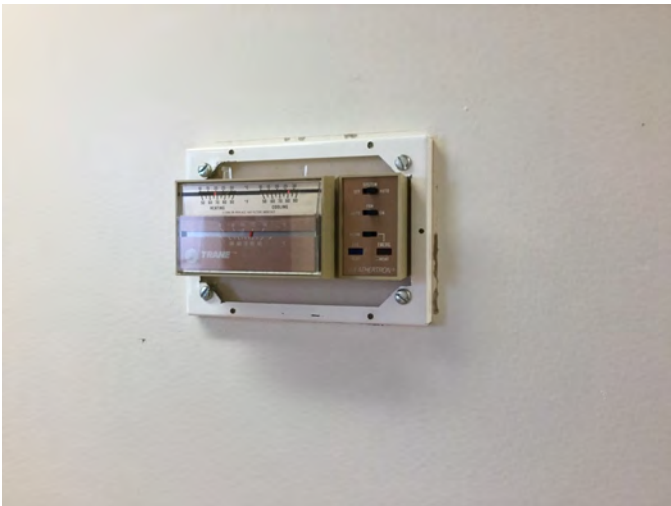
System: D3060 - Controls & Instrumentation

Location: Throughout the Building
Distress: Beyond Service Life
Category: Deferred Maintenance
Priority: 3 - Necessary/Not Yet Critical (Years 2-5)
Correction: Renew System
Qty: 8,888.00
Unit of Measure: S.F.
Estimate: \$31,384.00
Assessor Name: Eduardo Lopez
Date Created: 01/04/2017

Notes: The controls and instrumentation system is in marginal condition and should be schedule for replacement.

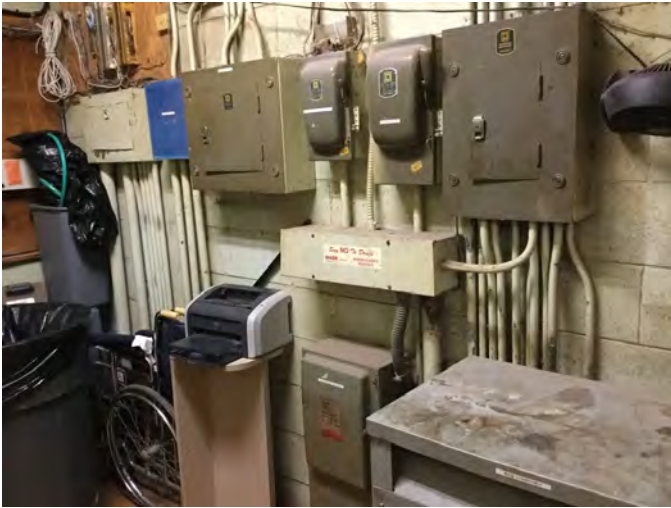
System: D5010 - Electrical Service/Distribution

Location: Throughout the Building
Distress: Beyond Service Life
Category: Deferred Maintenance
Priority: 3 - Necessary/Not Yet Critical (Years 2-5)
Correction: Renew System
Qty: 8,888.00
Unit of Measure: S.F.
Estimate: \$18,967.00
Assessor Name: Eduardo Lopez
Date Created: 01/04/2017

Notes: The original electrical service is operating but is in poor condition and should be replaced.

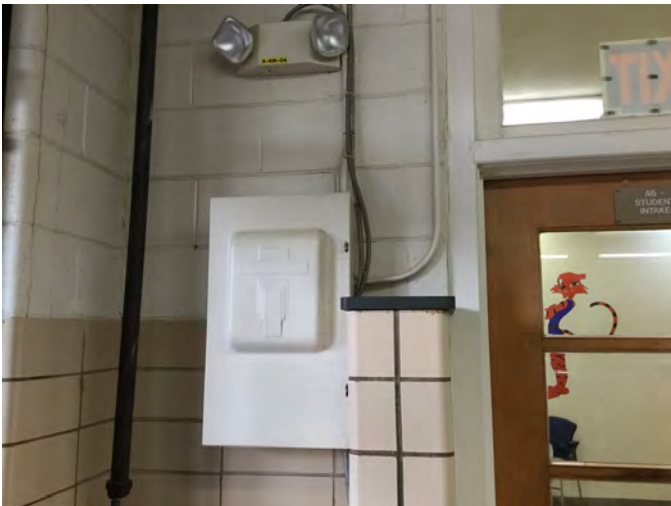
System: D5020 - Branch Wiring

Location: Throughout the Building
Distress: Beyond Service Life
Category: Deferred Maintenance
Priority: 3 - Necessary/Not Yet Critical (Years 2-5)
Correction: Renew System
Qty: 8,888.00
Unit of Measure: S.F.
Estimate: \$53,772.00
Assessor Name: Eduardo Lopez
Date Created: 01/04/2017

Notes: The original branch wiring system is operating but is aged, in marginal condition, and should be replaced.

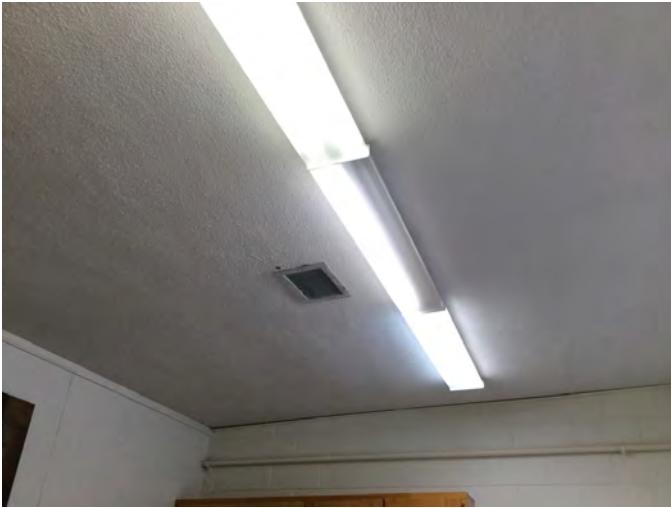
System: D5020 - Lighting

Location: Throughout the Building
Distress: Beyond Service Life
Category: Deferred Maintenance
Priority: 3 - Necessary/Not Yet Critical (Years 2-5)
Correction: Renew System
Qty: 8,888.00
Unit of Measure: S.F.
Estimate: \$126,121.00
Assessor Name: Eduardo Lopez
Date Created: 01/04/2017

Notes: The original lighting system is operating but is aged, in marginal condition, and should be replaced.

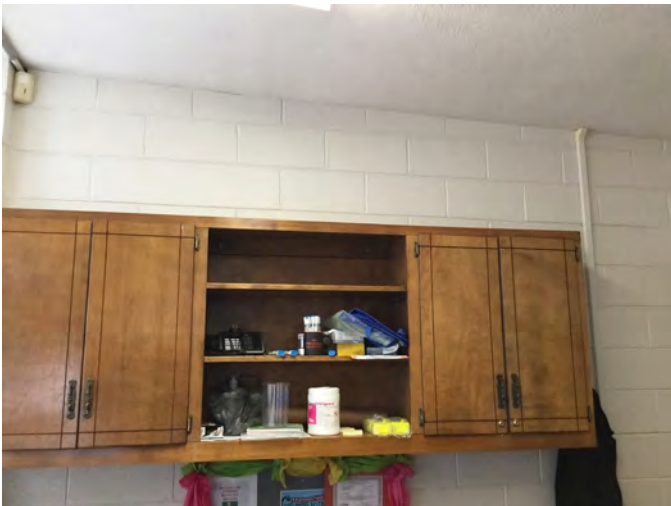
System: E2010 - Fixed Furnishings

Location: Throughout the Building
Distress: Beyond Service Life
Category: Deferred Maintenance
Priority: 3 - Necessary/Not Yet Critical (Years 2-5)
Correction: Renew System
Qty: 8,888.00
Unit of Measure: S.F.
Estimate: \$58,954.00
Assessor Name: Eduardo Lopez
Date Created: 01/04/2017

Notes: The fixed furnishings are aged, in marginal condition, and should be replaced.

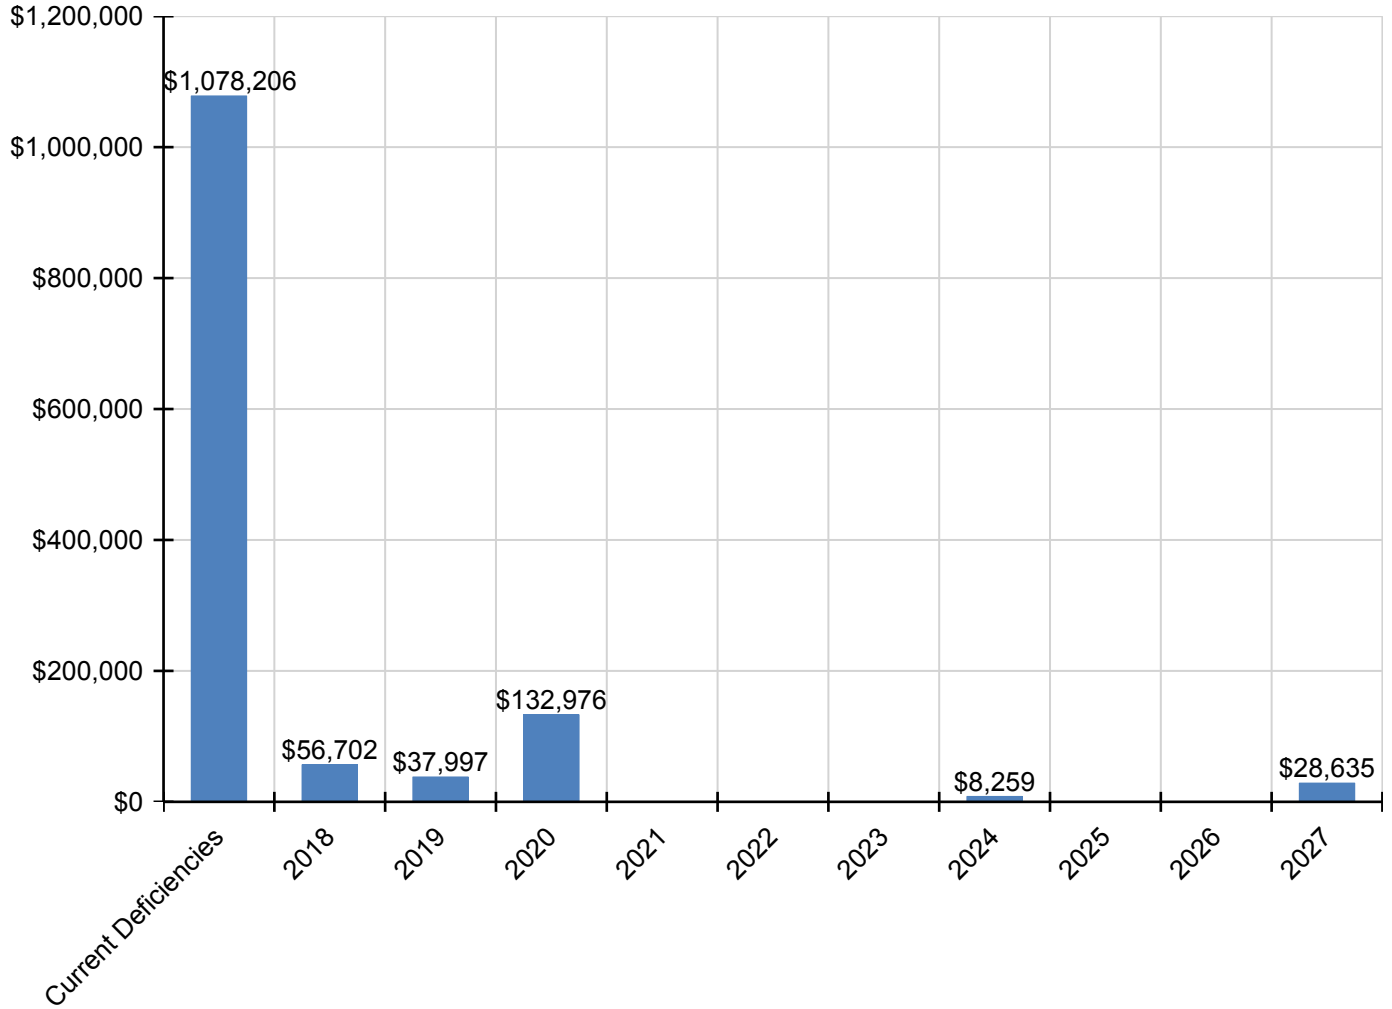
Forecasted Capital Renewal Requirement

The following chart shows the current building deficiencies and forecasting capital renewal or sustainment requirements over the next ten years.

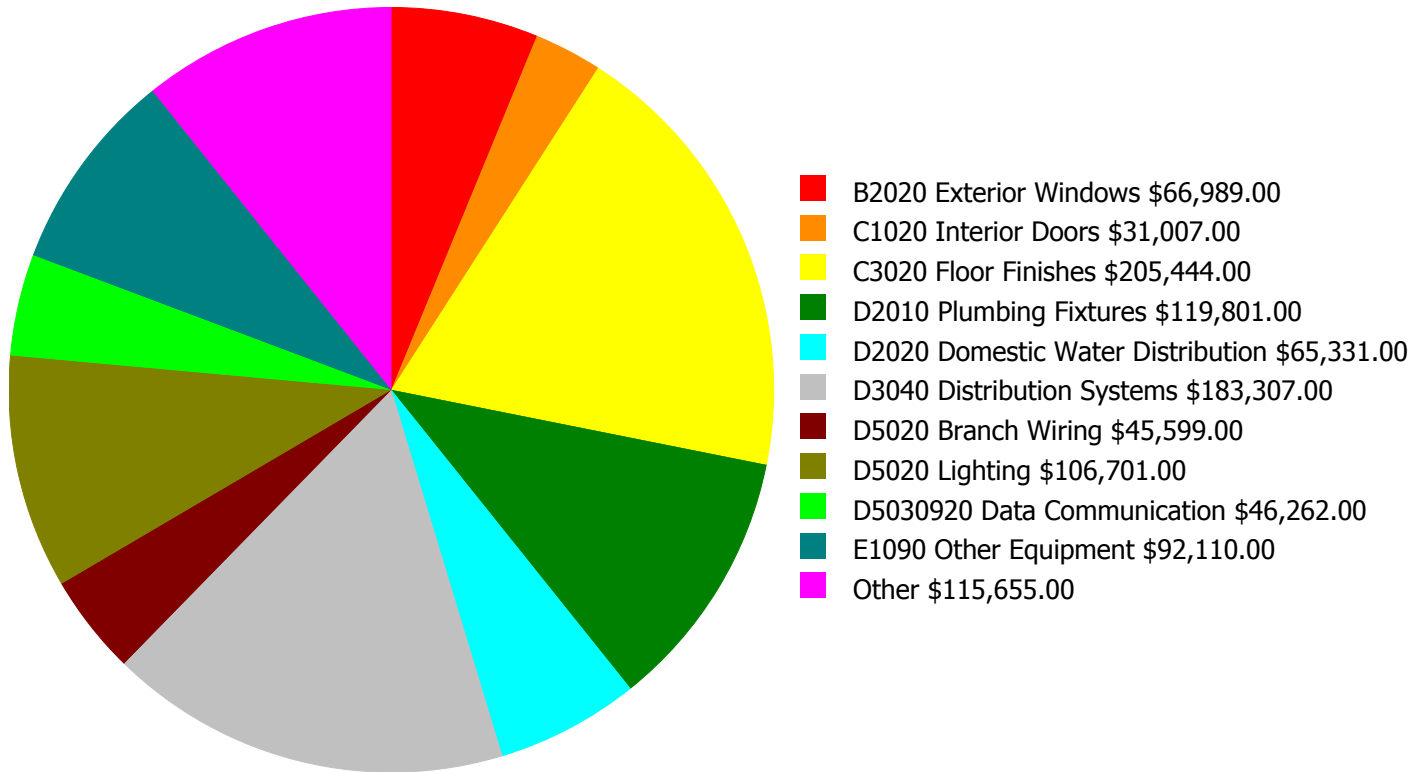
Deficiency Summary by System

Current deficiencies included assemblies that have reached or exceeded their design life or components of the assemblies that are in need of repair. Assemblies that have reached their design life are identified as current deficiencies and assigned the distress 'Beyond Useful Life'. The following chart lists all current deficiencies associated with this facility.

Budget Estimate Total: \$1,078,206.00

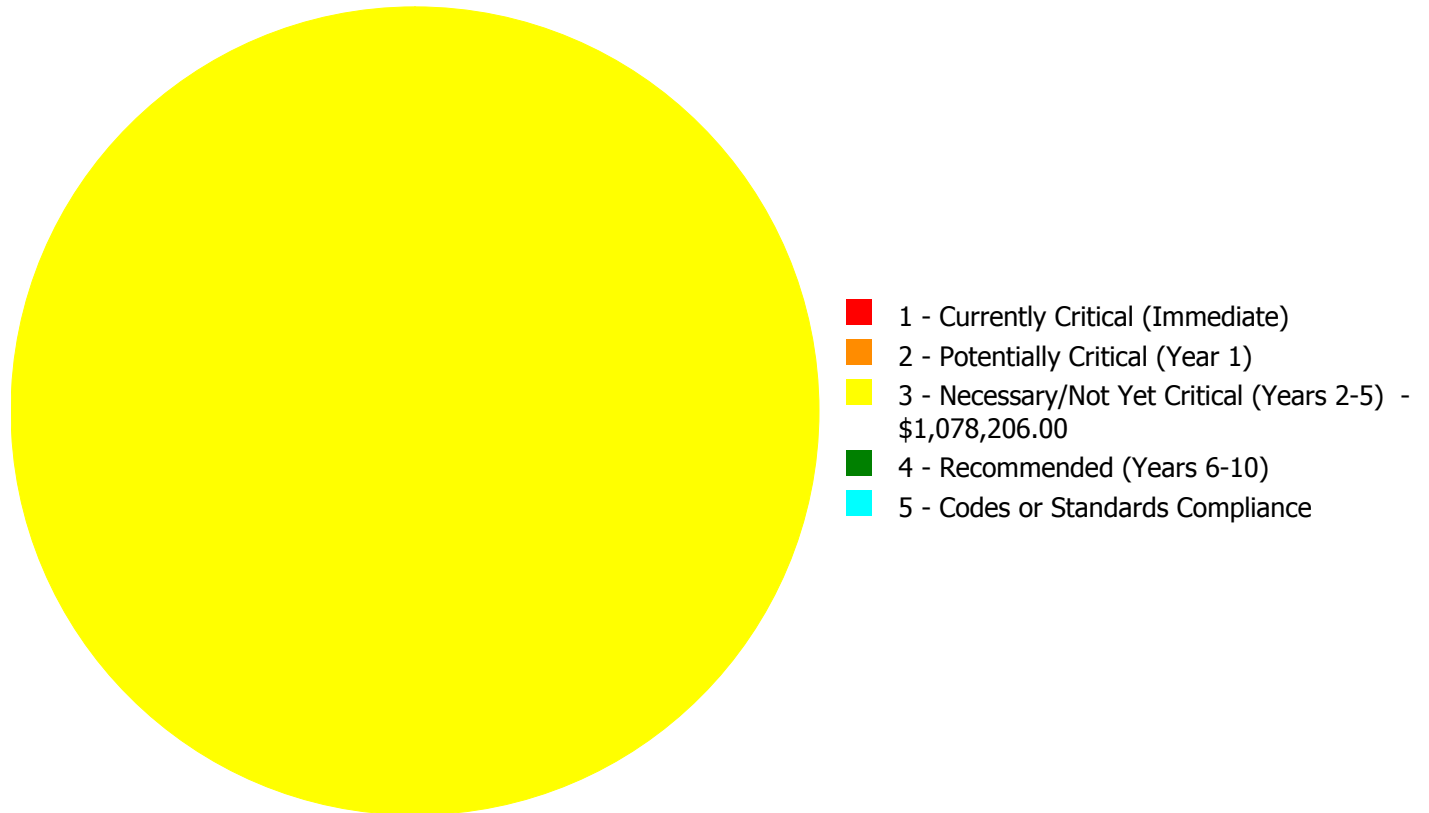
Deficiency Summary by Priority

The following chart shows the total repair costs broken down by priority. Assessors assigned deficiencies within eCOMET to one of the following priority categories:

Budget Estimate Total: \$1,078,206.00

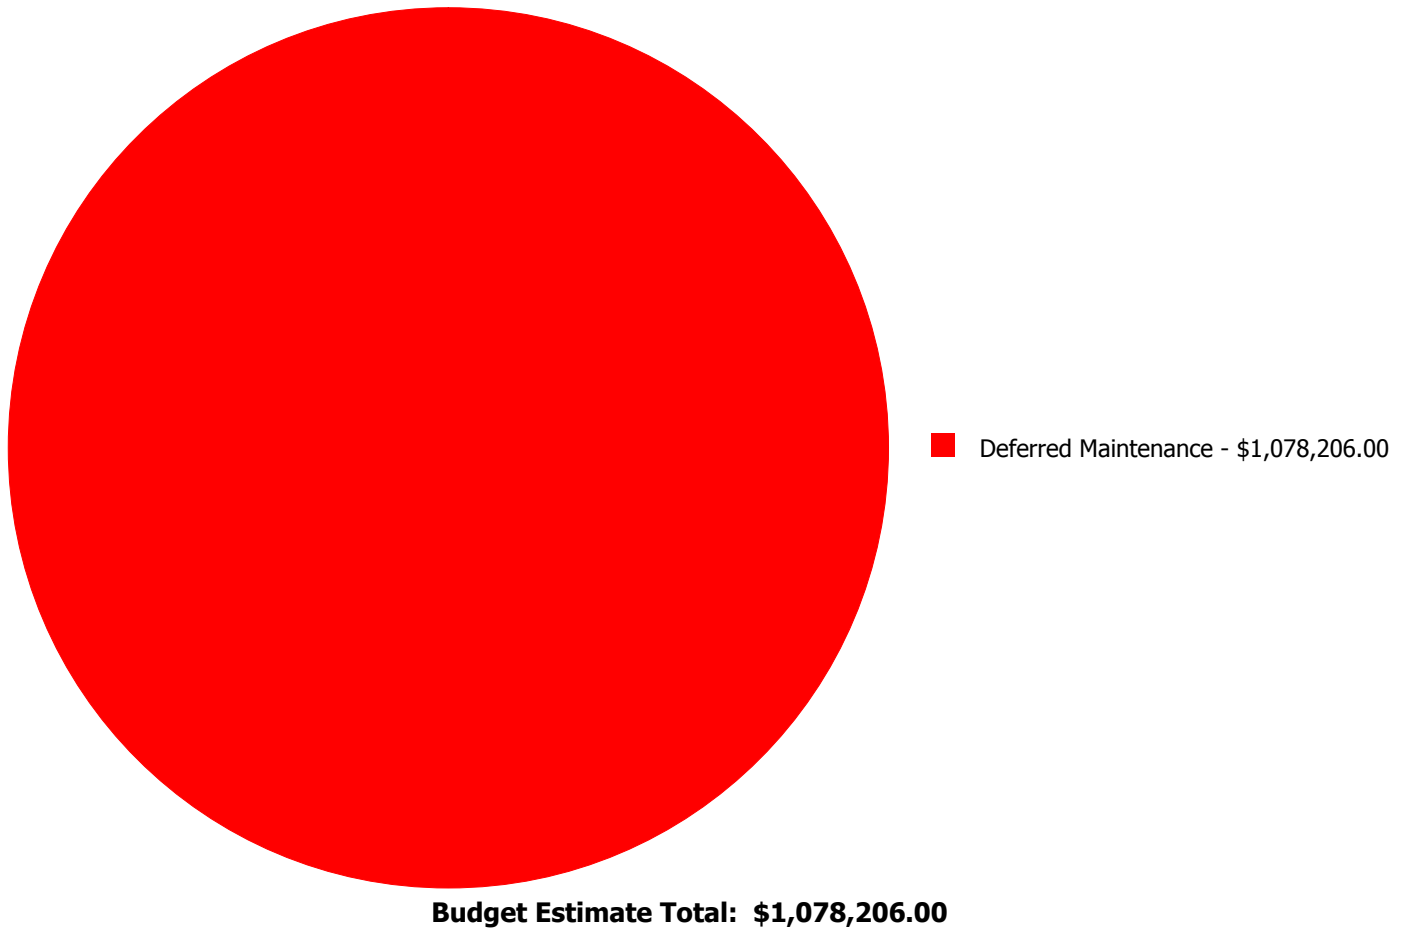
Deficiency Summary by Category

The following chart shows the total repair costs broken down by deficiency categories. Assessors assigned deficiencies to one of the following categories:

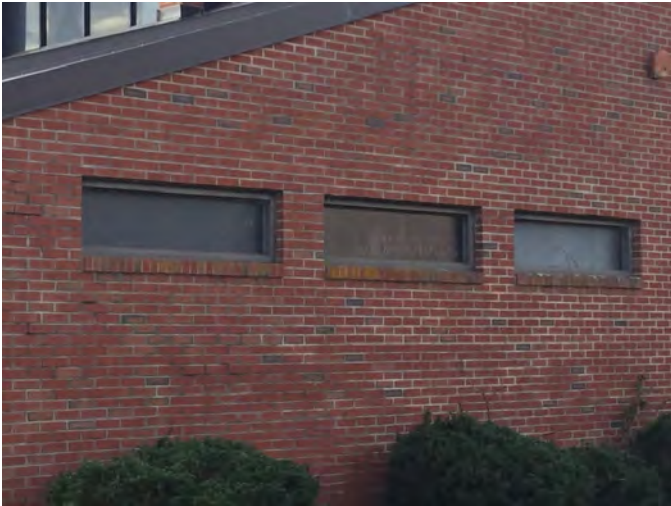
System: B2020 - Exterior Windows

Location: Exterior Walls
Distress: Beyond Service Life
Category: Deferred Maintenance
Priority: 3 - Necessary/Not Yet Critical (Years 2-5)
Correction: Renew System
Qty: 7,537.00
Unit of Measure: S.F.
Estimate: \$66,989.00
Assessor Name: Eduardo Lopez
Date Created: 02/16/2017

Notes: The exterior windows are aged, rusted, not energy efficient and should be replaced.

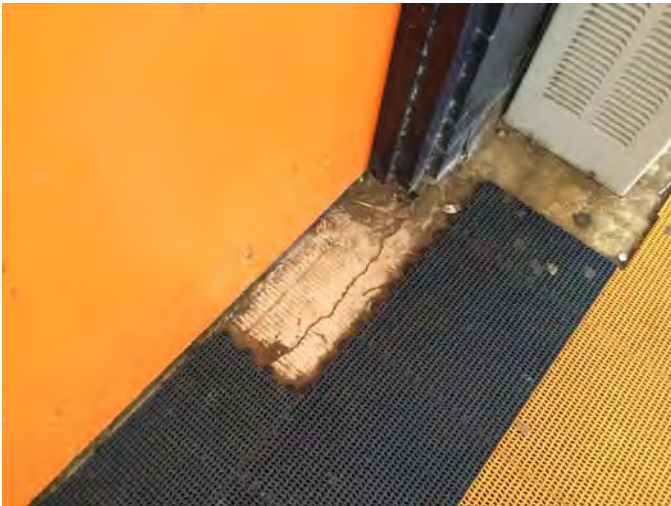
System: C1020 - Interior Doors

Location: Throughout the Building
Distress: Beyond Service Life
Category: Deferred Maintenance
Priority: 3 - Necessary/Not Yet Critical (Years 2-5)
Correction: Renew System
Qty: 7,537.00
Unit of Measure: S.F.
Estimate: \$31,007.00
Assessor Name: Eduardo Lopez
Date Created: 02/16/2017

Notes: The interior doors are aged, failing, most hardware is not ADA or code compliant and should be replaced.

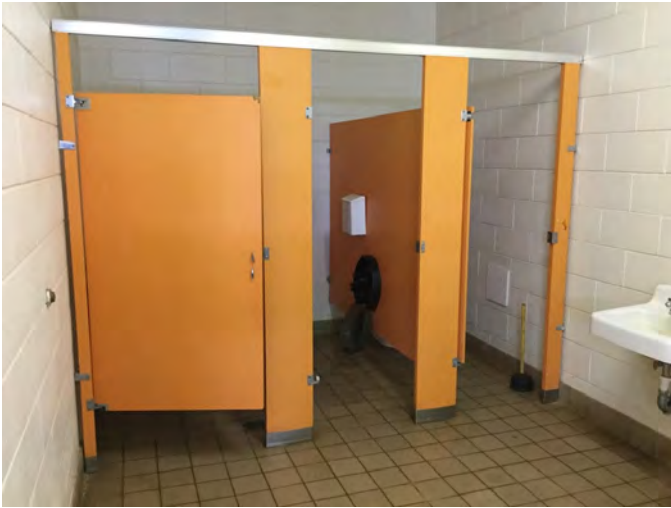
System: C1030 - Fittings

Location: Throughout the Building
Distress: Beyond Service Life
Category: Deferred Maintenance
Priority: 3 - Necessary/Not Yet Critical (Years 2-5)
Correction: Renew System
Qty: 7,537.00
Unit of Measure: S.F.
Estimate: \$14,923.00
Assessor Name: Eduardo Lopez
Date Created: 02/16/2017

Notes: The fittings throughout the building are aged, in marginal condition, handrails and room signage are not ADA compliant and should be replaced.

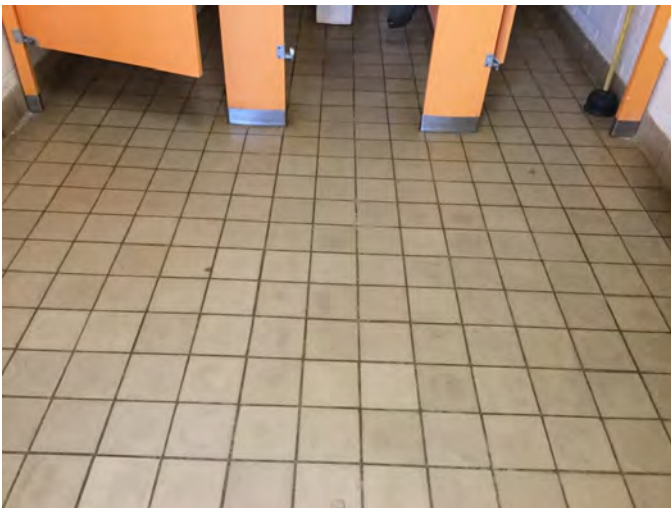
System: C3020 - Floor Finishes

Location: Throughout the Building
Distress: Beyond Service Life
Category: Deferred Maintenance
Priority: 3 - Necessary/Not Yet Critical (Years 2-5)
Correction: Renew System
Qty: 7,537.00
Unit of Measure: S.F.
Estimate: \$205,444.00
Assessor Name: Eduardo Lopez
Date Created: 02/16/2017

Notes: The original flooring is in poor conditions and should be replaced.
