NC School District/040 Anson County/High School

Anson High

Campus Assessment Report

March 10, 2017

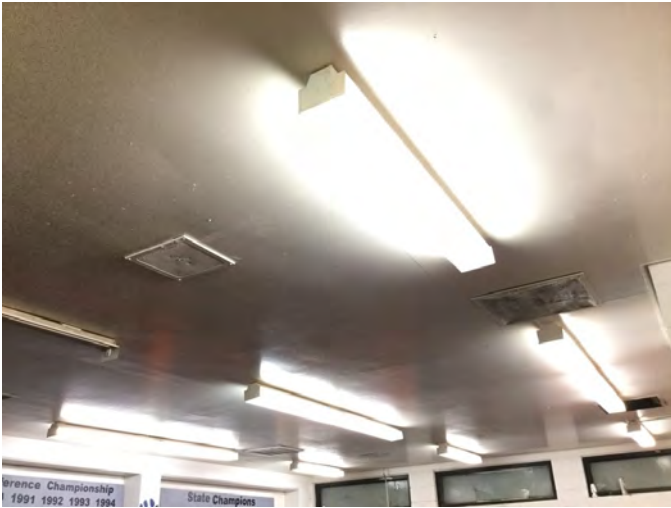
System: C3030 - Ceiling Finishes

Location: Throughout the Building
Distress: Beyond Service Life
Category: Deferred Maintenance
Priority: 3 - Necessary/Not Yet Critical (Years 2-5)
Correction: Renew System
Qty: 7,537.00
Unit of Measure: S.F.
Estimate: \$14,343.00
Assessor Name: Eduardo Lopez
Date Created: 02/16/2017

Notes: The original ceiling finishes are aged, failing and should be replaced.

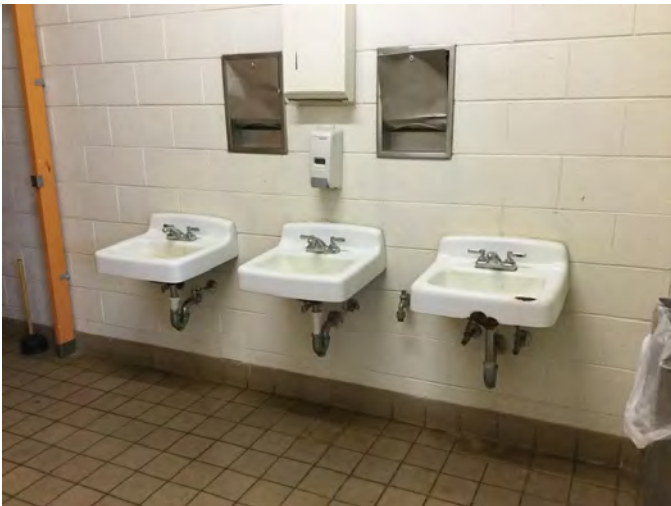
System: D2010 - Plumbing Fixtures

Location: Throughout the Building
Distress: Beyond Service Life
Category: Deferred Maintenance
Priority: 3 - Necessary/Not Yet Critical (Years 2-5)
Correction: Renew System
Qty: 7,537.00
Unit of Measure: S.F.
Estimate: \$119,801.00
Assessor Name: Eduardo Lopez
Date Created: 02/16/2017

Notes: Plumbing fixtures are in operational conditions. However, they are aged, not ADA compliant, and should be scheduled for replacement.

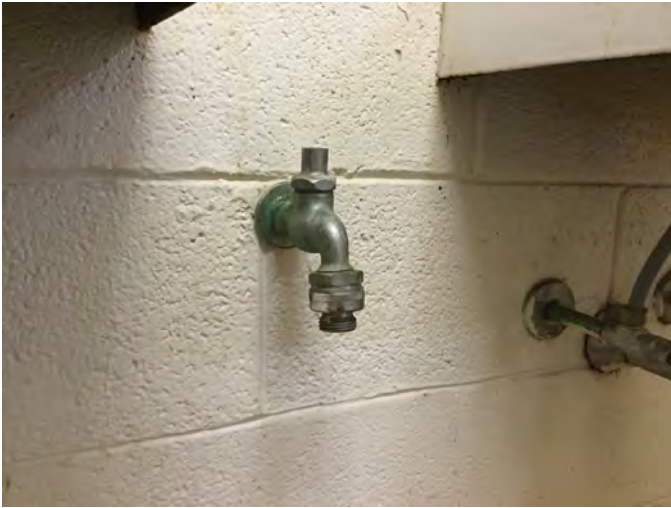
System: D2020 - Domestic Water Distribution

Location: Throughout the Building
Distress: Beyond Service Life
Category: Deferred Maintenance
Priority: 3 - Necessary/Not Yet Critical (Years 2-5)
Correction: Renew System
Qty: 7,537.00
Unit of Measure: S.F.
Estimate: \$65,331.00
Assessor Name: Eduardo Lopez
Date Created: 02/16/2017

Notes: The domestic water distribution system is aged and should be replaced.

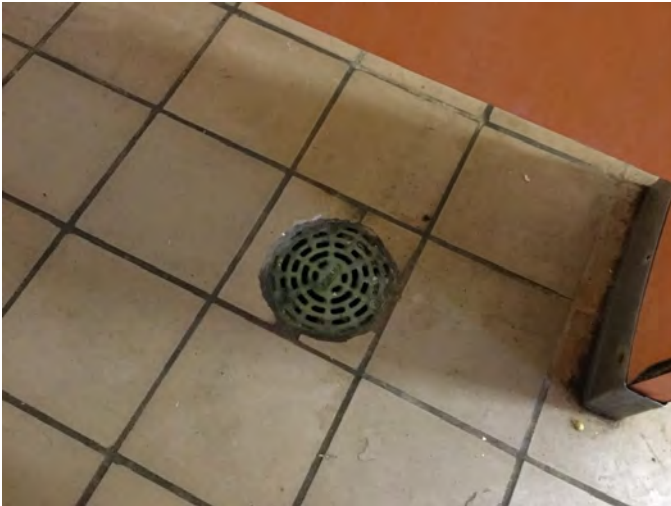
System: D2030 - Sanitary Waste

Location: Throughout the Building
Distress: Beyond Service Life
Category: Deferred Maintenance
Priority: 3 - Necessary/Not Yet Critical (Years 2-5)
Correction: Renew System
Qty: 7,537.00
Unit of Measure: S.F.
Estimate: \$25,950.00
Assessor Name: Eduardo Lopez
Date Created: 02/16/2017

Notes: The sanitary waste system is beyond its expected service life and should be replaced.

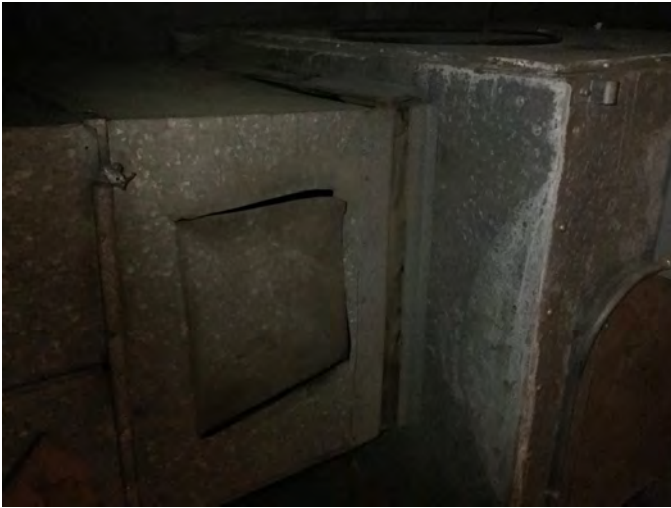
System: D3040 - Distribution Systems

Location: Throughout the Building
Distress: Beyond Service Life
Category: Deferred Maintenance
Priority: 3 - Necessary/Not Yet Critical (Years 2-5)
Correction: Renew System
Qty: 7,537.00
Unit of Measure: S.F.
Estimate: \$183,307.00
Assessor Name: Eduardo Lopez
Date Created: 02/16/2017

Notes: Distribution systems are aged, becoming logistically unsupportable, and should be replaced.

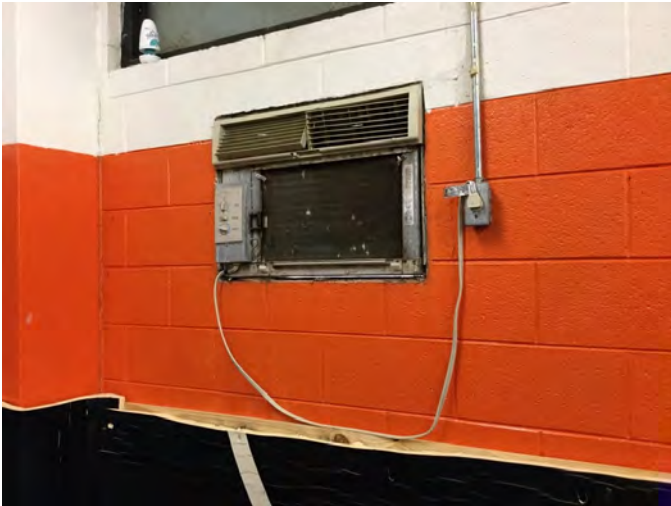
System: D3050 - Terminal & Package Units

Location: Throughout the Building
Distress: Beyond Service Life
Category: Deferred Maintenance
Priority: 3 - Necessary/Not Yet Critical (Years 2-5)
Correction: Renew System
Qty: 7,537.00
Unit of Measure: S.F.
Estimate: \$17,742.00
Assessor Name: Eduardo Lopez
Date Created: 02/16/2017

Notes: Terminal and package units are beyond their expected service life and should be scheduled for replacement.

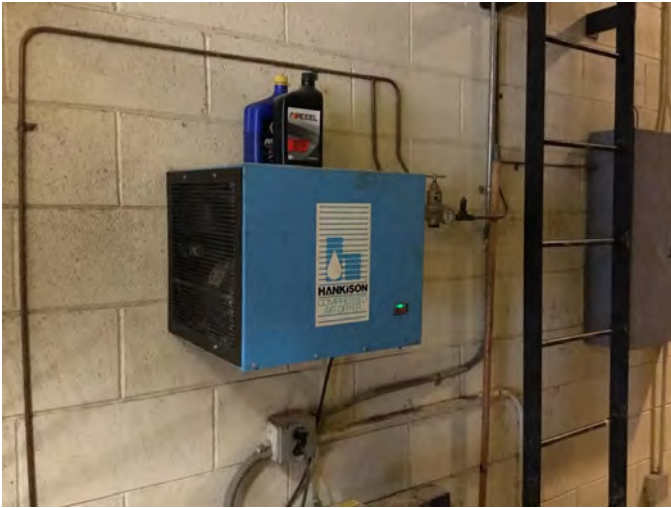
System: D3060 - Controls & Instrumentation

Location: Throughout the Building
Distress: Beyond Service Life
Category: Deferred Maintenance
Priority: 3 - Necessary/Not Yet Critical (Years 2-5)
Correction: Renew System
Qty: 7,537.00
Unit of Measure: S.F.
Estimate: \$26,613.00
Assessor Name: Eduardo Lopez
Date Created: 02/16/2017

Notes: The controls and instrumentation system is in marginal condition and should be schedule for replacement.

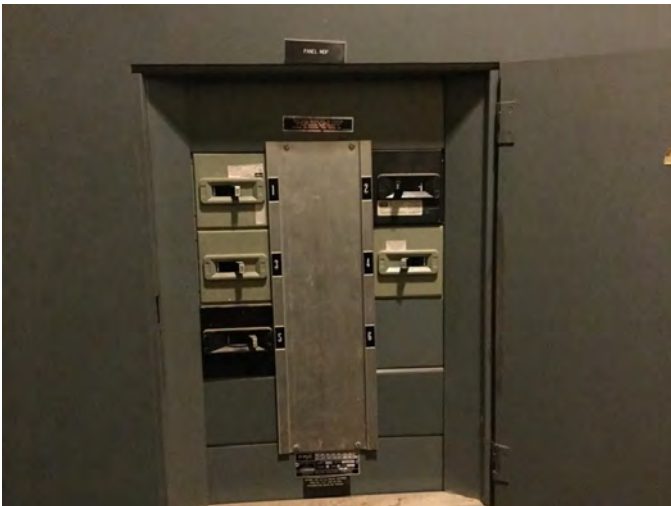
System: D5010 - Electrical Service/Distribution

Location: Throughout the Building
Distress: Beyond Service Life
Category: Deferred Maintenance
Priority: 3 - Necessary/Not Yet Critical (Years 2-5)
Correction: Renew System
Qty: 7,537.00
Unit of Measure: S.F.
Estimate: \$16,084.00
Assessor Name: Eduardo Lopez
Date Created: 02/16/2017

Notes: The original electrical service is operating but is in poor condition and should be replaced.

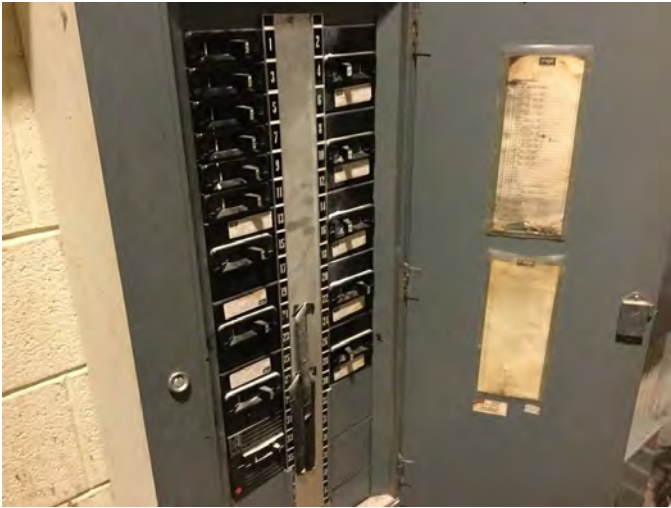
System: D5020 - Branch Wiring

Location: Throughout the Building
Distress: Beyond Service Life
Category: Deferred Maintenance
Priority: 3 - Necessary/Not Yet Critical (Years 2-5)
Correction: Renew System
Qty: 7,537.00
Unit of Measure: S.F.
Estimate: \$45,599.00
Assessor Name: Eduardo Lopez
Date Created: 02/16/2017

Notes: The original branch wiring system is operating but is aged, in marginal condition, and should be replaced.

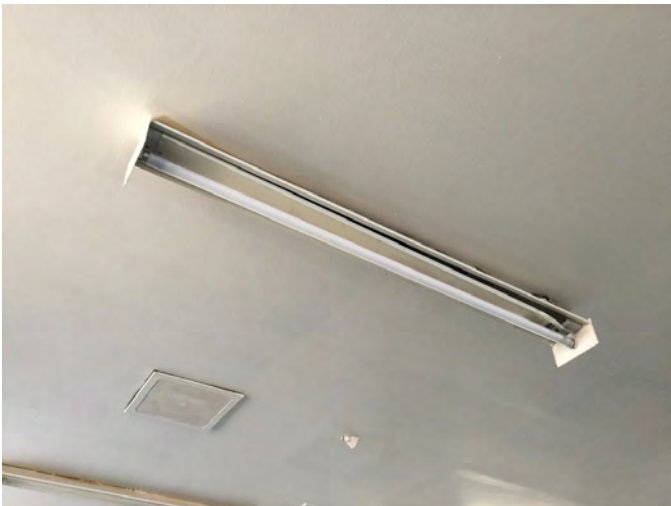
System: D5020 - Lighting

Location: Throughout the Building
Distress: Beyond Service Life
Category: Deferred Maintenance
Priority: 3 - Necessary/Not Yet Critical (Years 2-5)
Correction: Renew System
Qty: 7,537.00
Unit of Measure: S.F.
Estimate: \$106,701.00
Assessor Name: Eduardo Lopez
Date Created: 02/16/2017

Notes: The original lighting system is operating but is aged, in marginal condition, and should be replaced.

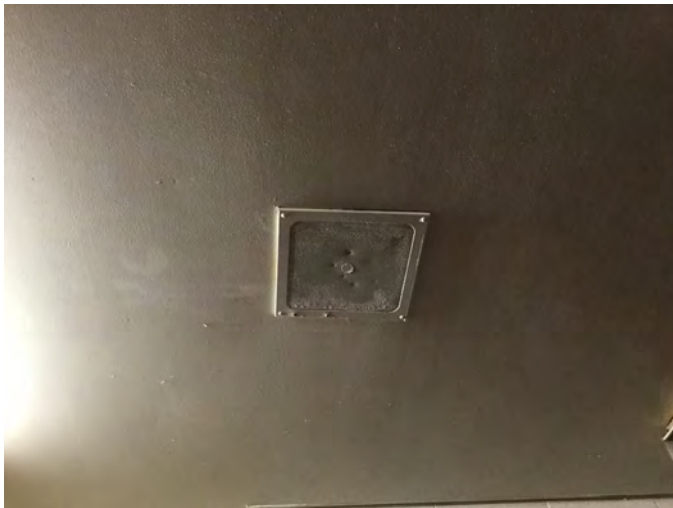
System: D5030920 - Data Communication

Location: Throughout the Building
Distress: Beyond Service Life
Category: Deferred Maintenance
Priority: 3 - Necessary/Not Yet Critical (Years 2-5)
Correction: Renew System
Qty: 7,537.00
Unit of Measure: S.F.
Estimate: \$46,262.00
Assessor Name: Eduardo Lopez
Date Created: 02/16/2017

Notes: The data communication system is beyond its expected service life and should be scheduled for replacement.

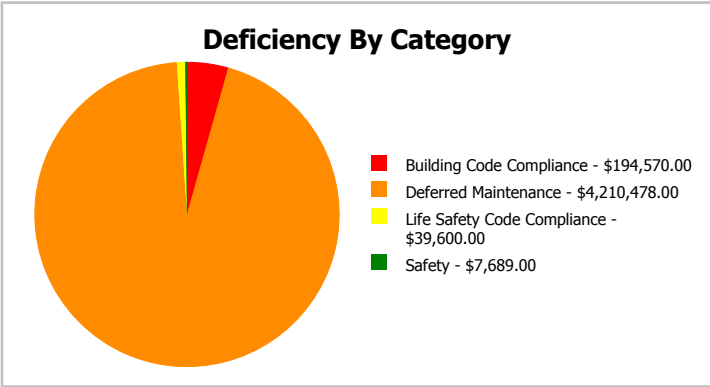
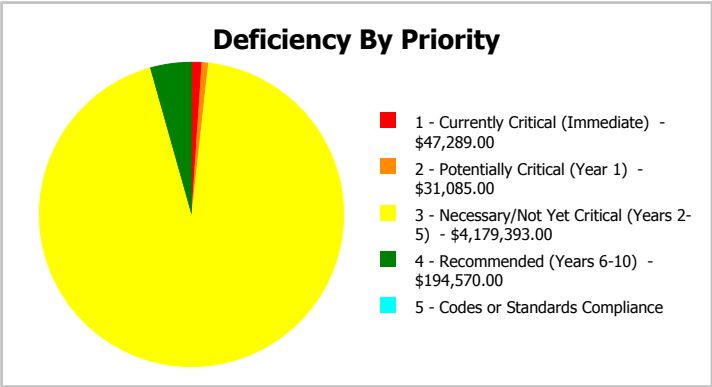
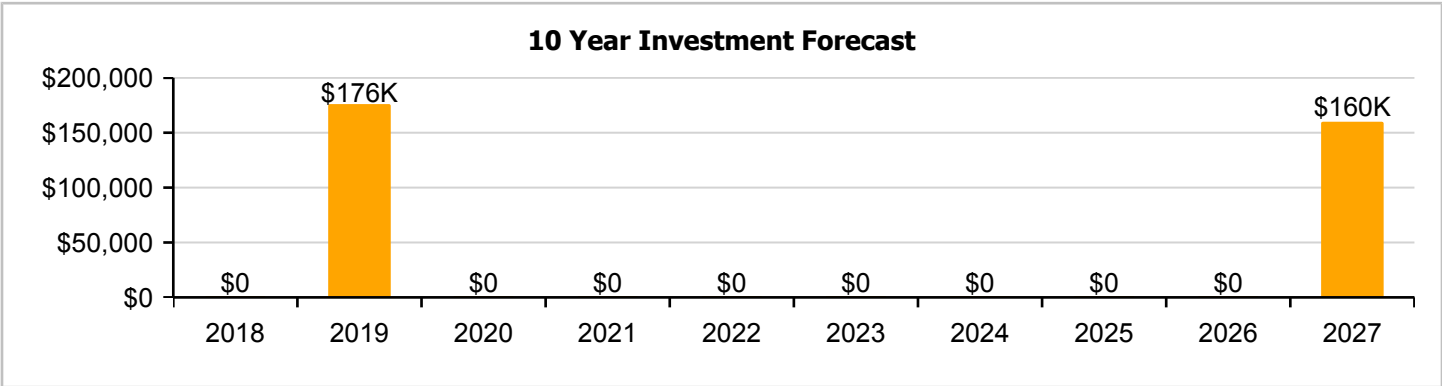
Dashboard Summary

Function:	HS -High School	Gross Area:	34,888
Year Built:	1976	Last Renovation:	
Repair Cost:	\$4,452,337	Replacement Value:	\$7,108,429
FCI:	62.63 %	RSLI%:	26.65 %

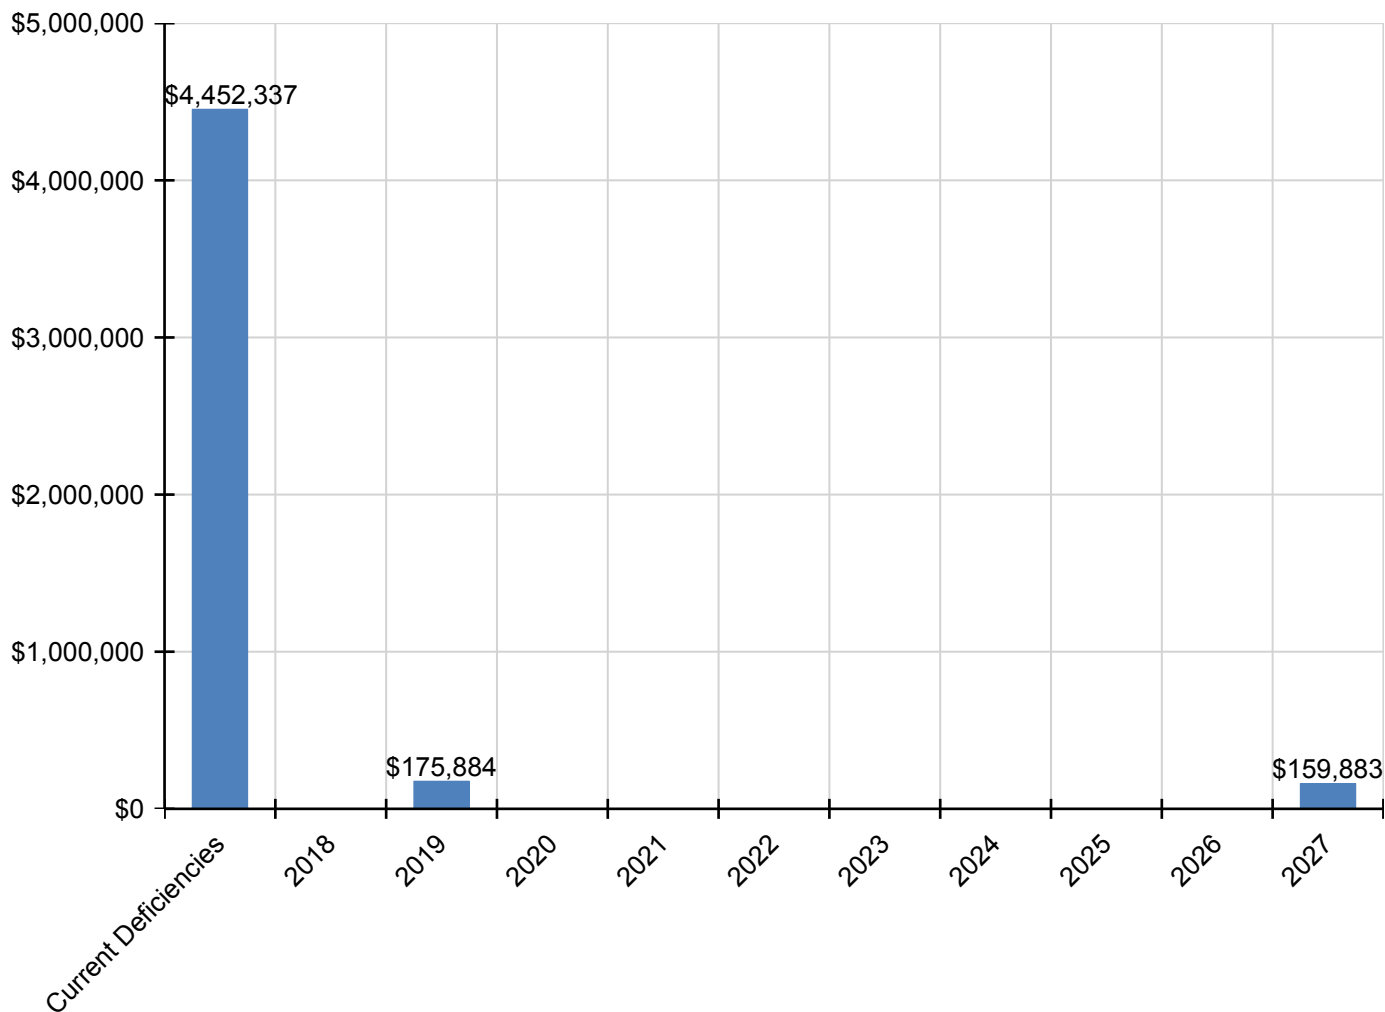
Forecasted Capital Renewal Requirement

The following chart shows the current building deficiencies and forecasting capital renewal or sustainment requirements over the next ten years.

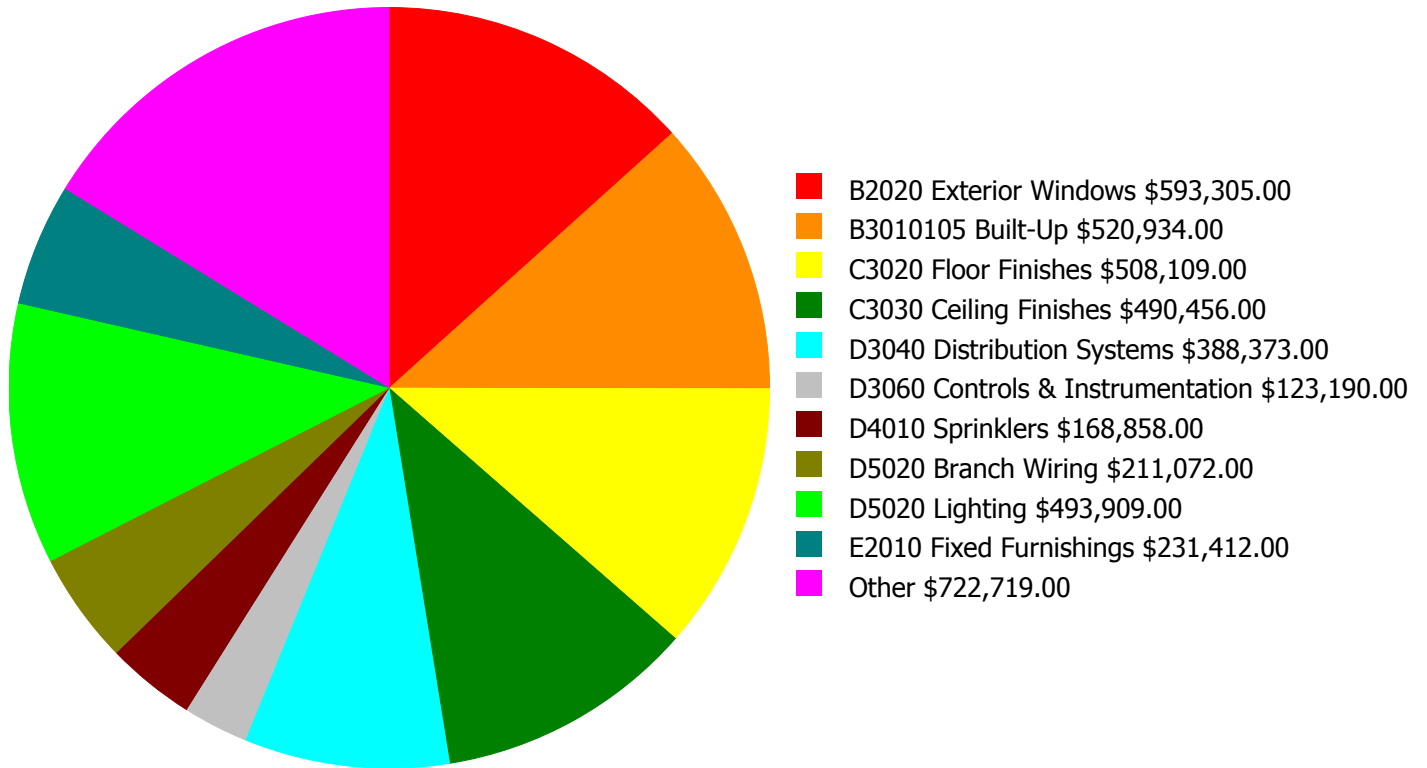
Deficiency Summary by System

Current deficiencies included assemblies that have reached or exceeded their design life or components of the assemblies that are in need of repair. Assemblies that have reached their design life are identified as current deficiencies and assigned the distress 'Beyond Useful Life'. The following chart lists all current deficiencies associated with this facility.

Budget Estimate Total: \$4,452,337.00

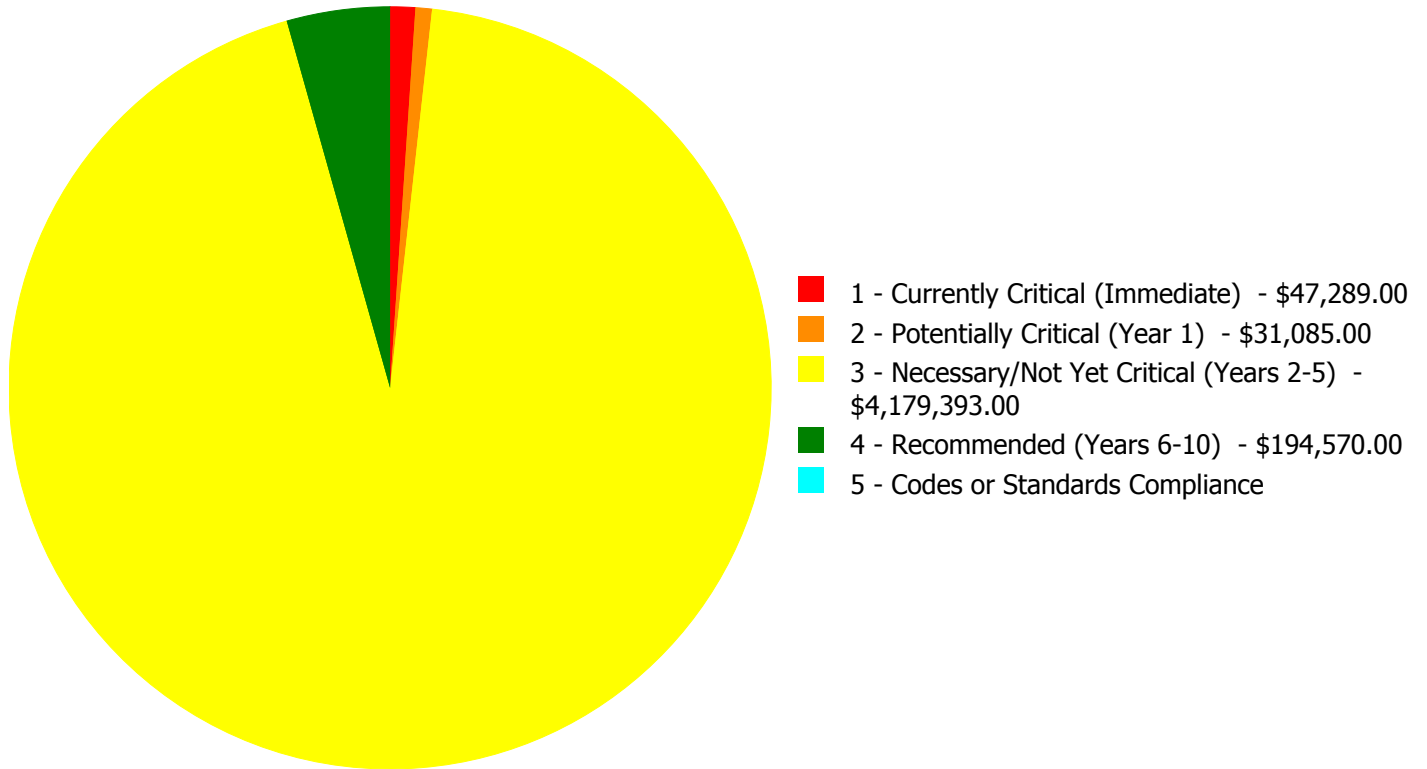
Deficiency Summary by Priority

The following chart shows the total repair costs broken down by priority. Assessors assigned deficiencies within eCOMET to one of the following priority categories:

Budget Estimate Total: \$4,452,337.00

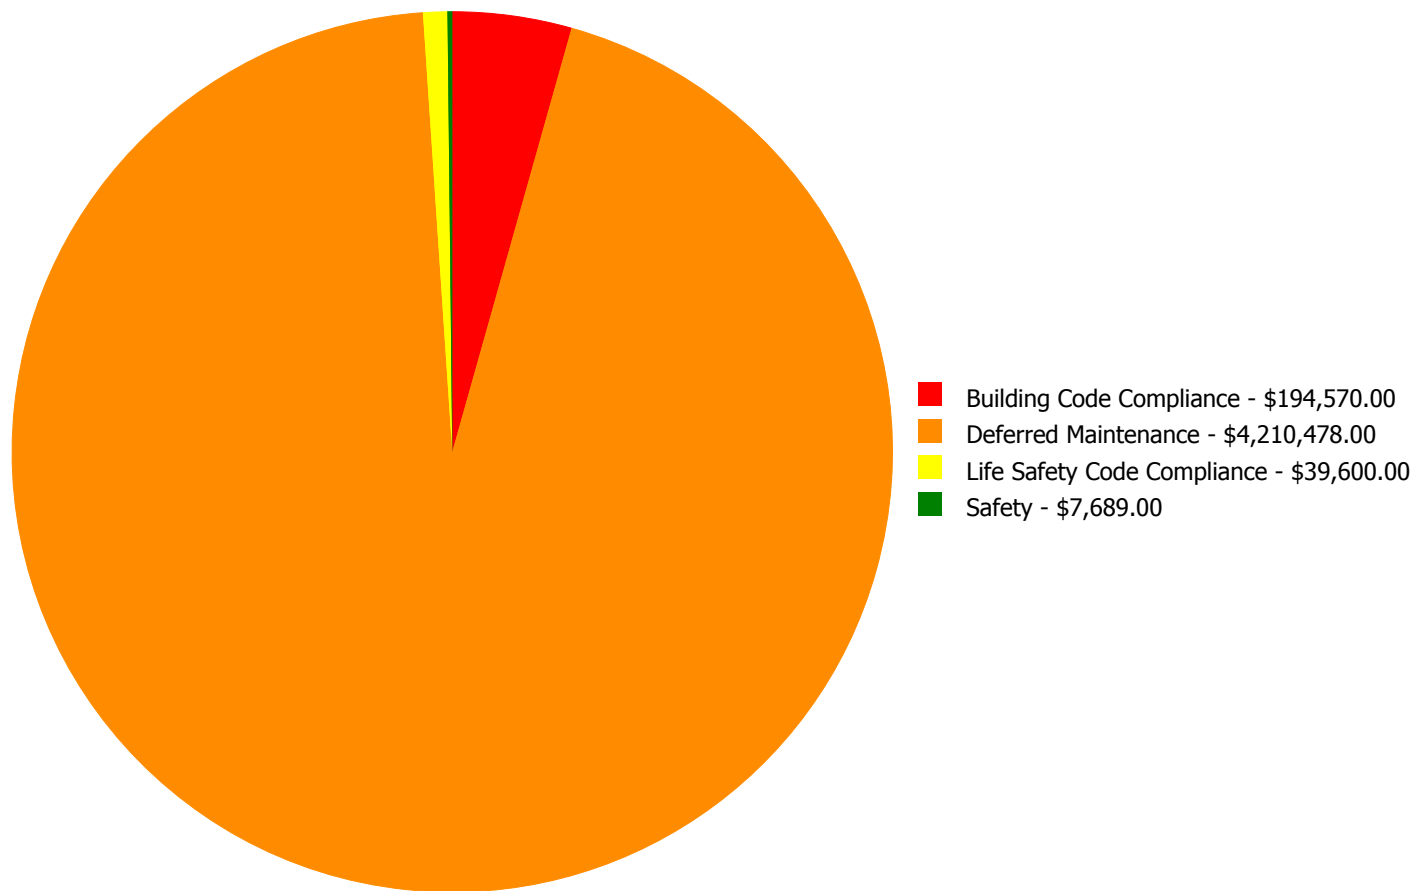
Deficiency Summary by Category

The following chart shows the total repair costs broken down by deficiency categories. Assessors assigned deficiencies to one of the following categories:

Budget Estimate Total: \$4,452,337.00

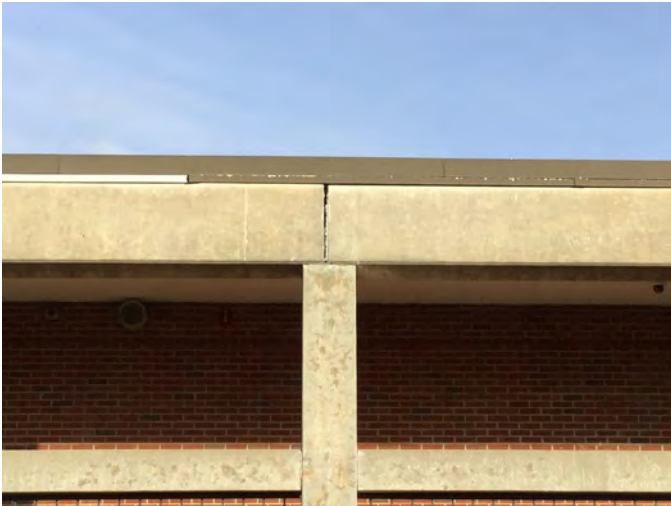
System: B2010 - Exterior Walls

Location: Exterior Columns
Distress: Failing
Category: Life Safety Code Compliance
Priority: 1 - Currently Critical (Immediate)
Correction: Engineering study-2016-08-16 18:28:55
Qty: 1.00
Unit of Measure: Ea.
Estimate: \$39,600.00
Assessor Name: Eduardo Lopez
Date Created: 02/15/2017

Notes: It was observed on the exterior columns are showing signs of failure with cracks and structural shifting/displaced throughout the building, and an engineering study is recommended to determine the cause. Pricing does not include remediation measures.

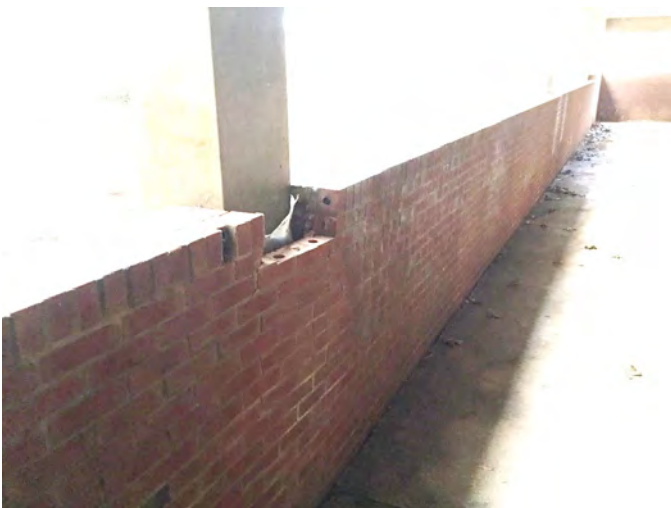
System: B2010 - Exterior Walls

Location: 1st Floor Corridor, Northeast End
Distress: Damaged
Category: Safety
Priority: 1 - Currently Critical (Immediate)
Correction: Repair clay brick wall, 1st floor
Qty: 100.00
Unit of Measure: S.F.
Estimate: \$7,689.00
Assessor Name: Eduardo Lopez
Date Created: 02/23/2017

Notes: Repair retaining wall.

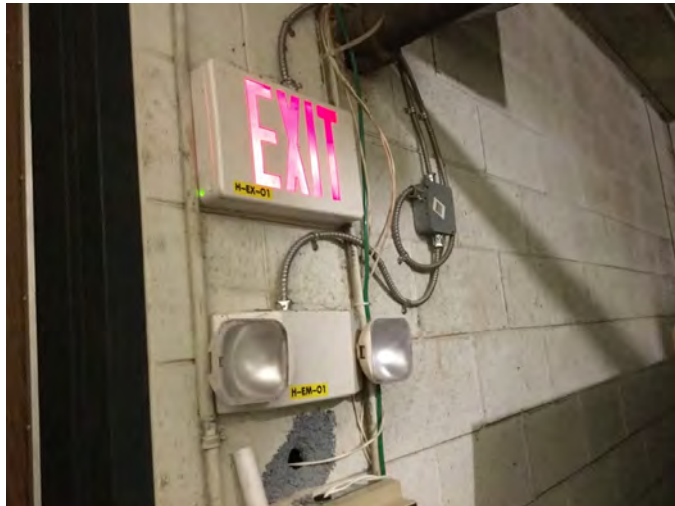
System: D5090 - Other Electrical Systems

Location: Throughout the building
Distress: Beyond Service Life
Category: Deferred Maintenance
Priority: 2 - Potentially Critical (Year 1)
Correction: Renew System
Qty: 34,888.00
Unit of Measure: S.F.
Estimate: \$31,085.00
Assessor Name: Eduardo Lopez
Date Created: 02/27/2017

Notes: System is lacking emergency exit signage at stairs and corridors.

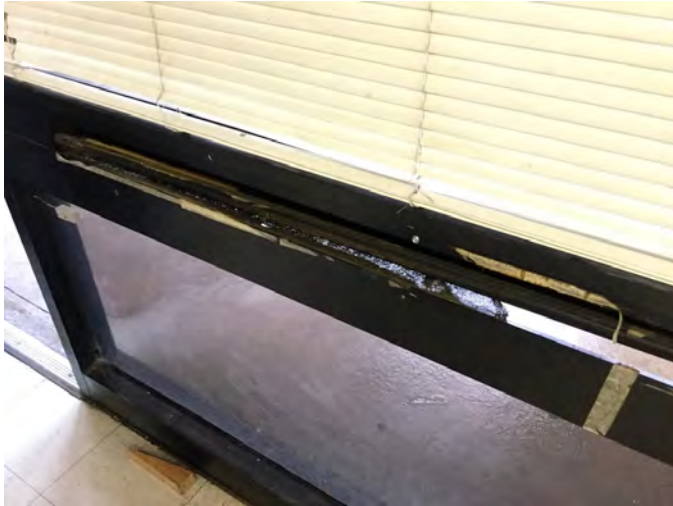
System: B2020 - Exterior Windows

Location: Exterior Walls
Distress: Beyond Service Life
Category: Deferred Maintenance
Priority: 3 - Necessary/Not Yet Critical (Years 2-5)
Correction: Renew System
Qty: 34,888.00
Unit of Measure: S.F.
Estimate: \$593,305.00
Assessor Name: Eduardo Lopez
Date Created: 01/04/2017

Notes: The exterior windows are aged, rusted, not energy efficient and should be replaced.

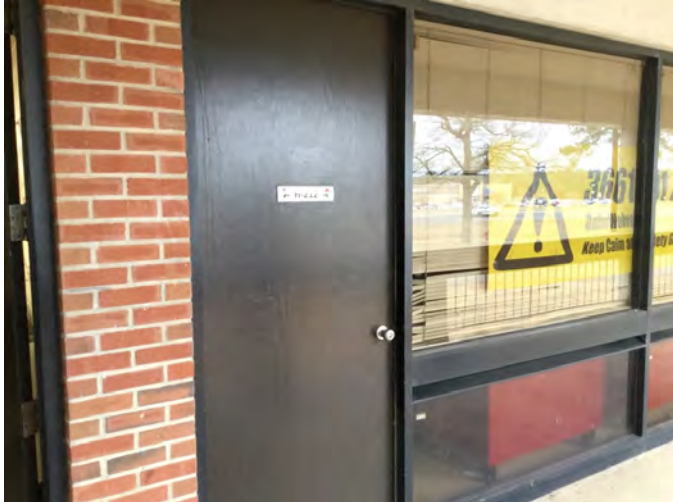
System: B2030 - Exterior Doors

Location: Exterior Walls
Distress: Beyond Service Life
Category: Deferred Maintenance
Priority: 3 - Necessary/Not Yet Critical (Years 2-5)
Correction: Renew System
Qty: 34,888.00
Unit of Measure: S.F.
Estimate: \$37,609.00
Assessor Name: Eduardo Lopez
Date Created: 01/04/2017

Notes: The exterior doors are aged, rusted and should be replaced.

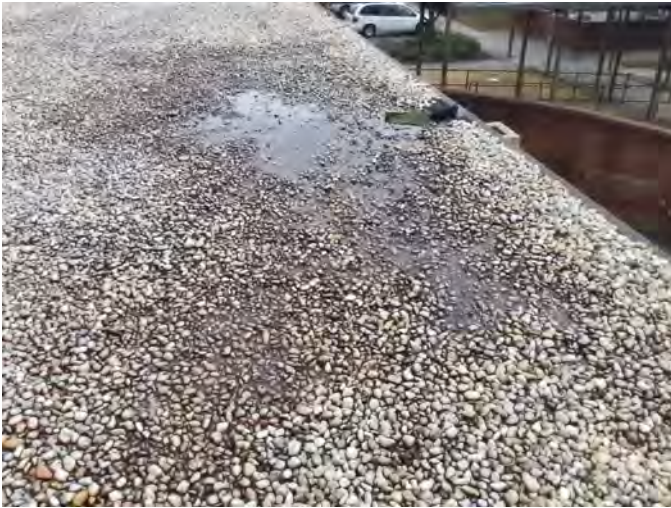
System: B3010105 - Built-Up

Location: Roof
Distress: Beyond Service Life
Category: Deferred Maintenance
Priority: 3 - Necessary/Not Yet Critical (Years 2-5)
Correction: Renew System
Qty: 34,888.00
Unit of Measure: S.F.
Estimate: \$520,934.00
Assessor Name: Eduardo Lopez
Date Created: 01/04/2017

Notes: The built-up system is beyond its expected service life and should be scheduled for replacement.

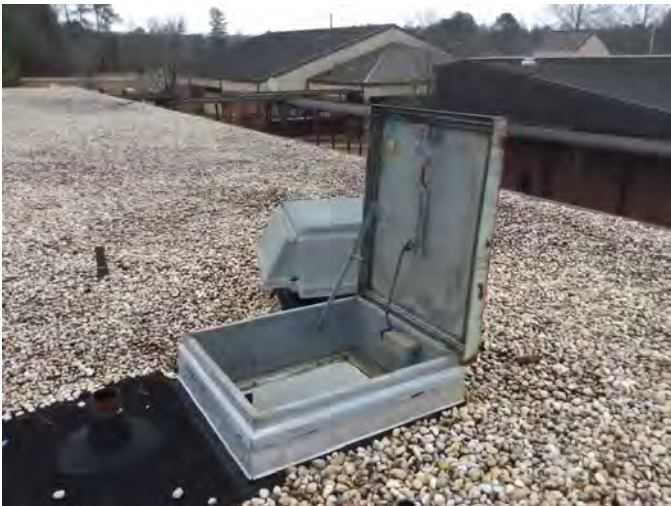
System: B3020 - Roof Openings

Location: Roof
Distress: Beyond Service Life
Category: Deferred Maintenance
Priority: 3 - Necessary/Not Yet Critical (Years 2-5)
Correction: Renew System
Qty: 34,888.00
Unit of Measure: S.F.
Estimate: \$9,594.00
Assessor Name: Eduardo Lopez
Date Created: 01/04/2017

Notes: Roof hatch does not comply with OSHA standards; roof opening protection and proper extension of fixed ladder to platform is not provided.

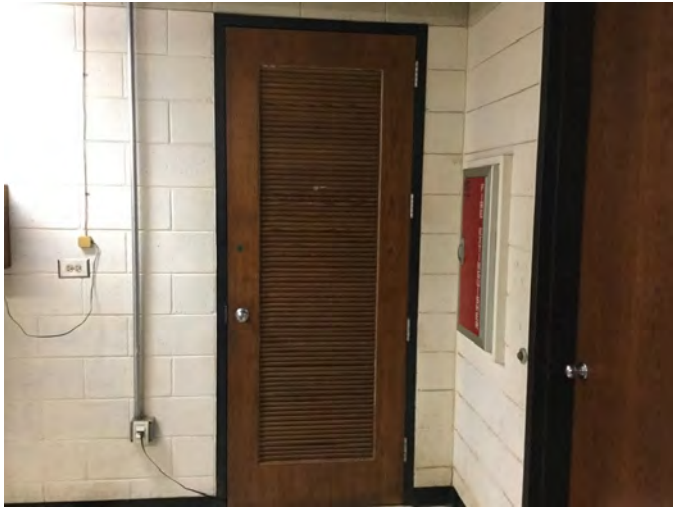
System: C1020 - Interior Doors

Location: Throughout the Building
Distress: Beyond Service Life
Category: Deferred Maintenance
Priority: 3 - Necessary/Not Yet Critical (Years 2-5)
Correction: Renew System
Qty: 34,888.00
Unit of Measure: S.F.
Estimate: \$112,828.00
Assessor Name: Eduardo Lopez
Date Created: 01/04/2017

Notes: The interior doors are aged, failing, most hardware is not ADA or code compliant and should be replaced.

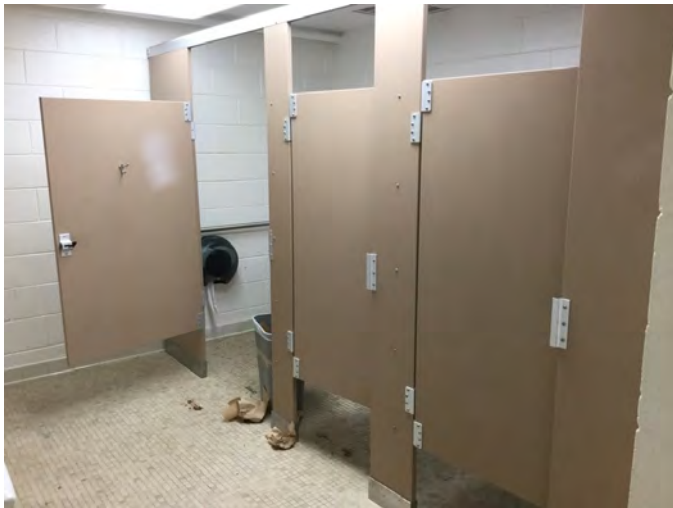
System: C1030 - Fittings

Location: Throughout the Building
Distress: Beyond Service Life
Category: Deferred Maintenance
Priority: 3 - Necessary/Not Yet Critical (Years 2-5)
Correction: Renew System
Qty: 34,888.00
Unit of Measure: S.F.
Estimate: \$69,078.00
Assessor Name: Eduardo Lopez
Date Created: 01/04/2017

Notes: The fittings throughout the building are aged, in marginal condition, handrails and room signage are not ADA compliant and should be replaced.

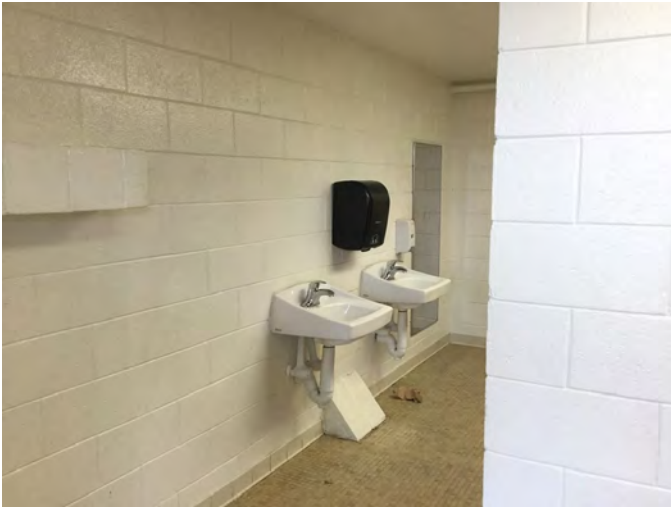
System: C3010 - Wall Finishes

Location: Throughout the Building
Distress: Beyond Service Life
Category: Deferred Maintenance
Priority: 3 - Necessary/Not Yet Critical (Years 2-5)
Correction: Renew System
Qty: 34,888.00
Unit of Measure: S.F.
Estimate: \$118,968.00
Assessor Name: Eduardo Lopez
Date Created: 01/04/2017

Notes: The wall finishes are aged, scuffed, fading, stained and should be replaced.

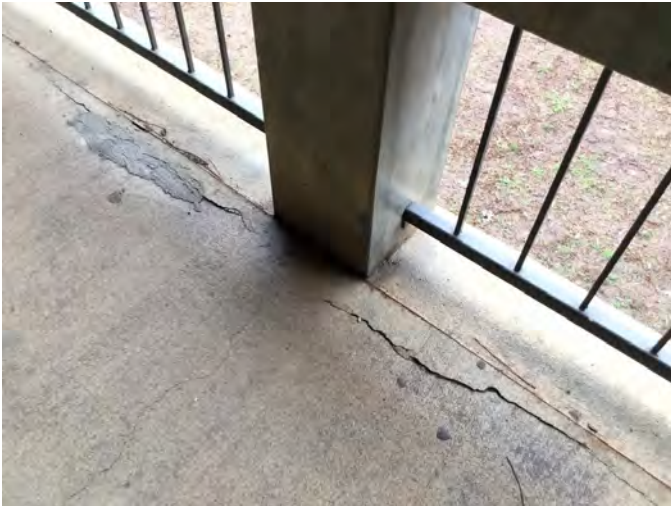
System: C3020 - Floor Finishes

Location: Throughout the Building
Distress: Beyond Service Life
Category: Deferred Maintenance
Priority: 3 - Necessary/Not Yet Critical (Years 2-5)
Correction: Renew System
Qty: 34,888.00
Unit of Measure: S.F.
Estimate: \$508,109.00
Assessor Name: Eduardo Lopez
Date Created: 01/04/2017

Notes: The original flooring is in poor conditions and should be replaced.

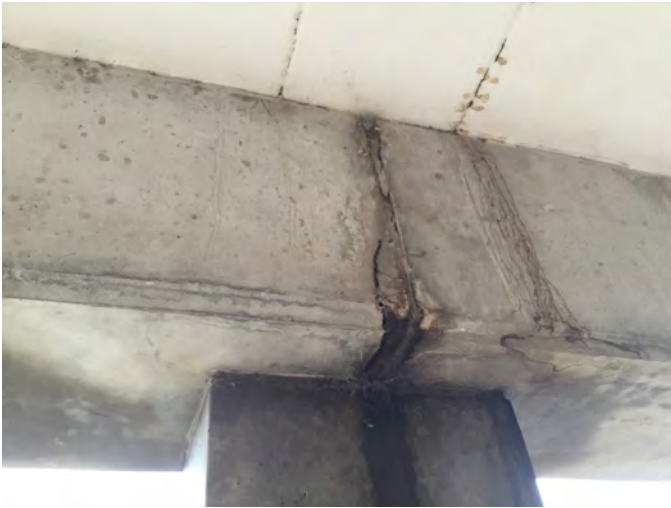
System: C3030 - Ceiling Finishes

Location: Throughout the Building
Distress: Beyond Service Life
Category: Deferred Maintenance
Priority: 3 - Necessary/Not Yet Critical (Years 2-5)
Correction: Renew System
Qty: 34,888.00
Unit of Measure: S.F.
Estimate: \$490,456.00
Assessor Name: Eduardo Lopez
Date Created: 01/04/2017

Notes: The original ceiling finishes are aged, failing and should be replaced.

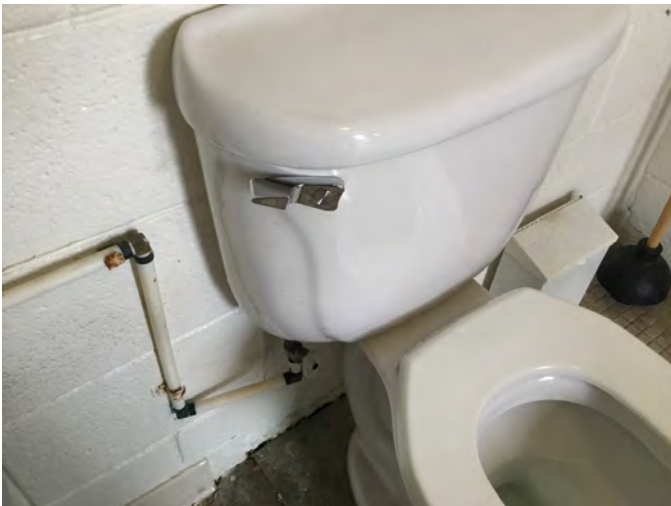
System: D2020 - Domestic Water Distribution

Location: Throughout the Building
Distress: Beyond Service Life
Category: Deferred Maintenance
Priority: 3 - Necessary/Not Yet Critical (Years 2-5)
Correction: Renew System
Qty: 34,888.00
Unit of Measure: S.F.
Estimate: \$75,986.00
Assessor Name: Eduardo Lopez
Date Created: 01/04/2017

Notes: The domestic water distribution system is aged and should be replaced.

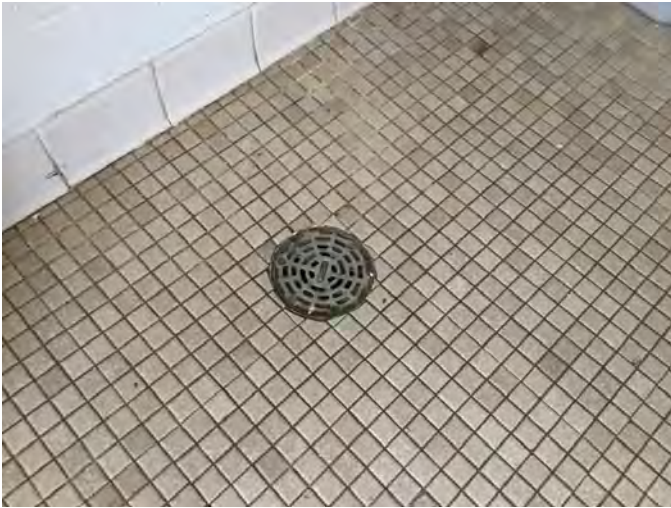
System: D2030 - Sanitary Waste

Location: Throughout the Building
Distress: Beyond Service Life
Category: Deferred Maintenance
Priority: 3 - Necessary/Not Yet Critical (Years 2-5)
Correction: Renew System
Qty: 34,888.00
Unit of Measure: S.F.
Estimate: \$120,119.00
Assessor Name: Eduardo Lopez
Date Created: 01/04/2017

Notes: The sanitary waste system is beyond its expected service life and should be replaced.

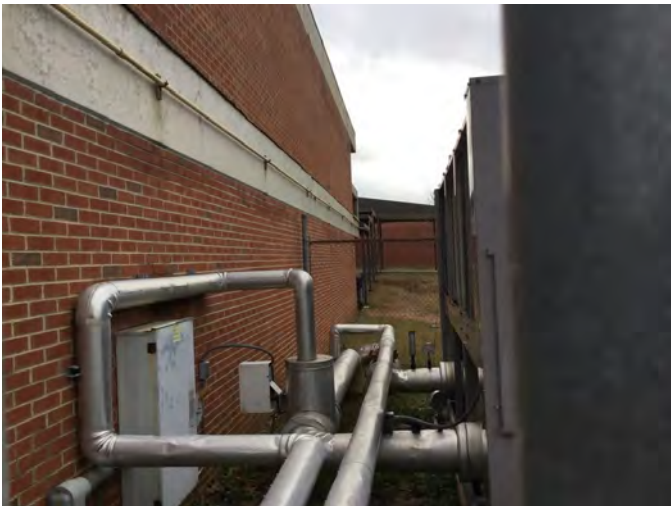
System: D3040 - Distribution Systems

Location: Throughout the Building
Distress: Beyond Service Life
Category: Deferred Maintenance
Priority: 3 - Necessary/Not Yet Critical (Years 2-5)
Correction: Renew System
Qty: 34,888.00
Unit of Measure: S.F.
Estimate: \$388,373.00
Assessor Name: Eduardo Lopez
Date Created: 01/04/2017

Notes: Distribution systems are aged, becoming logistically unsupportable, and should be replaced.

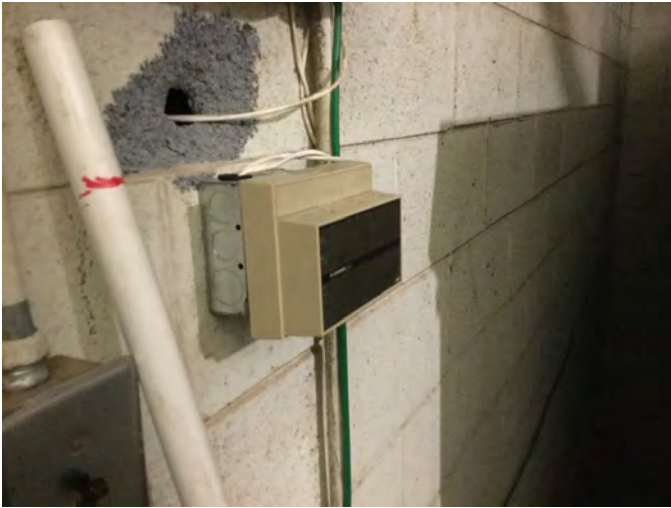
System: D3060 - Controls & Instrumentation

Location: Throughout the Building
Distress: Beyond Service Life
Category: Deferred Maintenance
Priority: 3 - Necessary/Not Yet Critical (Years 2-5)
Correction: Renew System
Qty: 34,888.00
Unit of Measure: S.F.
Estimate: \$123,190.00
Assessor Name: Eduardo Lopez
Date Created: 01/04/2017

Notes: The controls and instrumentation system is in marginal condition and should be schedule for replacement.

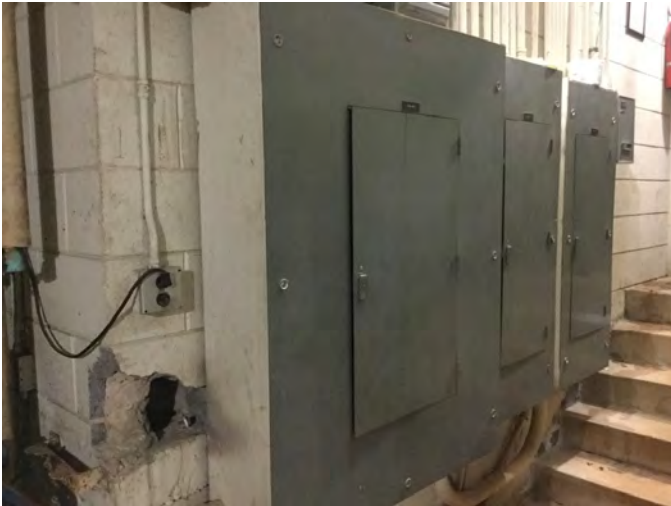
System: D5010 - Electrical Service/Distribution

Location: Throughout the Building
Distress: Beyond Service Life
Category: Deferred Maintenance
Priority: 3 - Necessary/Not Yet Critical (Years 2-5)
Correction: Renew System
Qty: 34,888.00
Unit of Measure: S.F.
Estimate: \$74,451.00
Assessor Name: Eduardo Lopez
Date Created: 01/04/2017

Notes: The original electrical service is operating but is in poor condition and should be replaced.

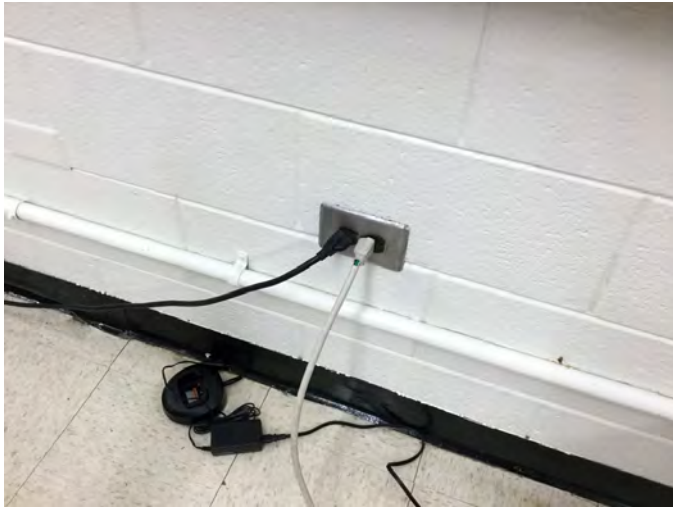
System: D5020 - Branch Wiring

Location: Throughout the Building
Distress: Beyond Service Life
Category: Deferred Maintenance
Priority: 3 - Necessary/Not Yet Critical (Years 2-5)
Correction: Renew System
Qty: 34,888.00
Unit of Measure: S.F.
Estimate: \$211,072.00
Assessor Name: Eduardo Lopez
Date Created: 01/04/2017

Notes: The original branch wiring system is operating but is aged, in marginal condition, and should be replaced.

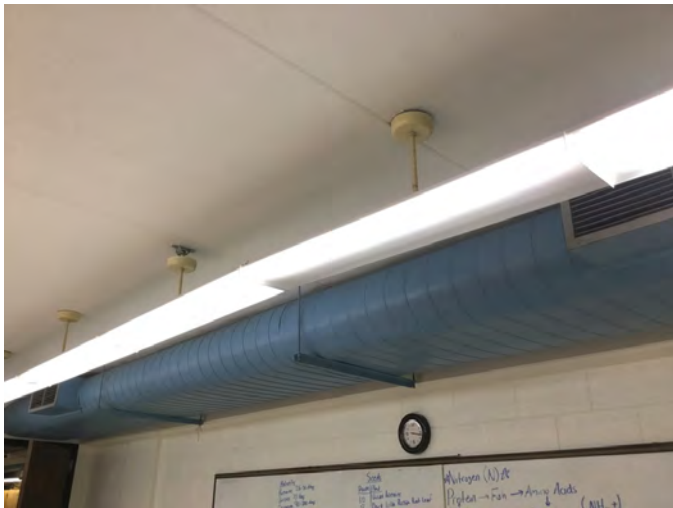
System: D5020 - Lighting

Location: Throughout the Building
Distress: Beyond Service Life
Category: Deferred Maintenance
Priority: 3 - Necessary/Not Yet Critical (Years 2-5)
Correction: Renew System
Qty: 34,888.00
Unit of Measure: S.F.
Estimate: \$493,909.00
Assessor Name: Eduardo Lopez
Date Created: 01/04/2017

Notes: The original lighting system is operating but is aged, in marginal condition, and should be replaced.

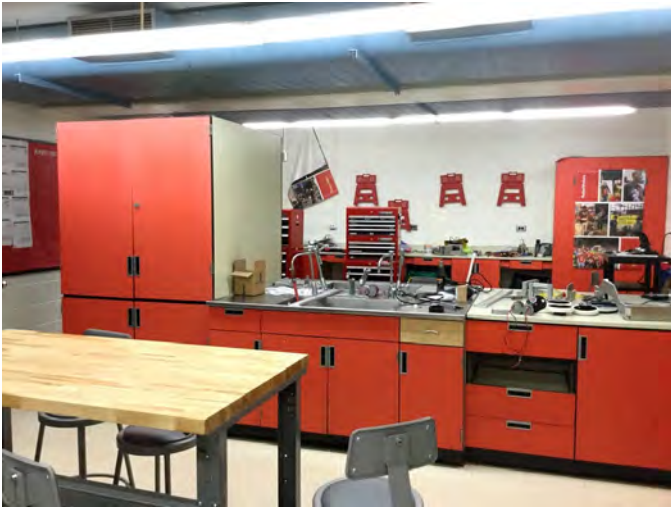
System: E2010 - Fixed Furnishings

Location: Throughout the Building
Distress: Beyond Service Life
Category: Deferred Maintenance
Priority: 3 - Necessary/Not Yet Critical (Years 2-5)
Correction: Renew System
Qty: 34,888.00
Unit of Measure: S.F.
Estimate: \$231,412.00
Assessor Name: Eduardo Lopez
Date Created: 01/04/2017

Notes: The fixed furnishings are aged, in marginal condition, and should be replaced.

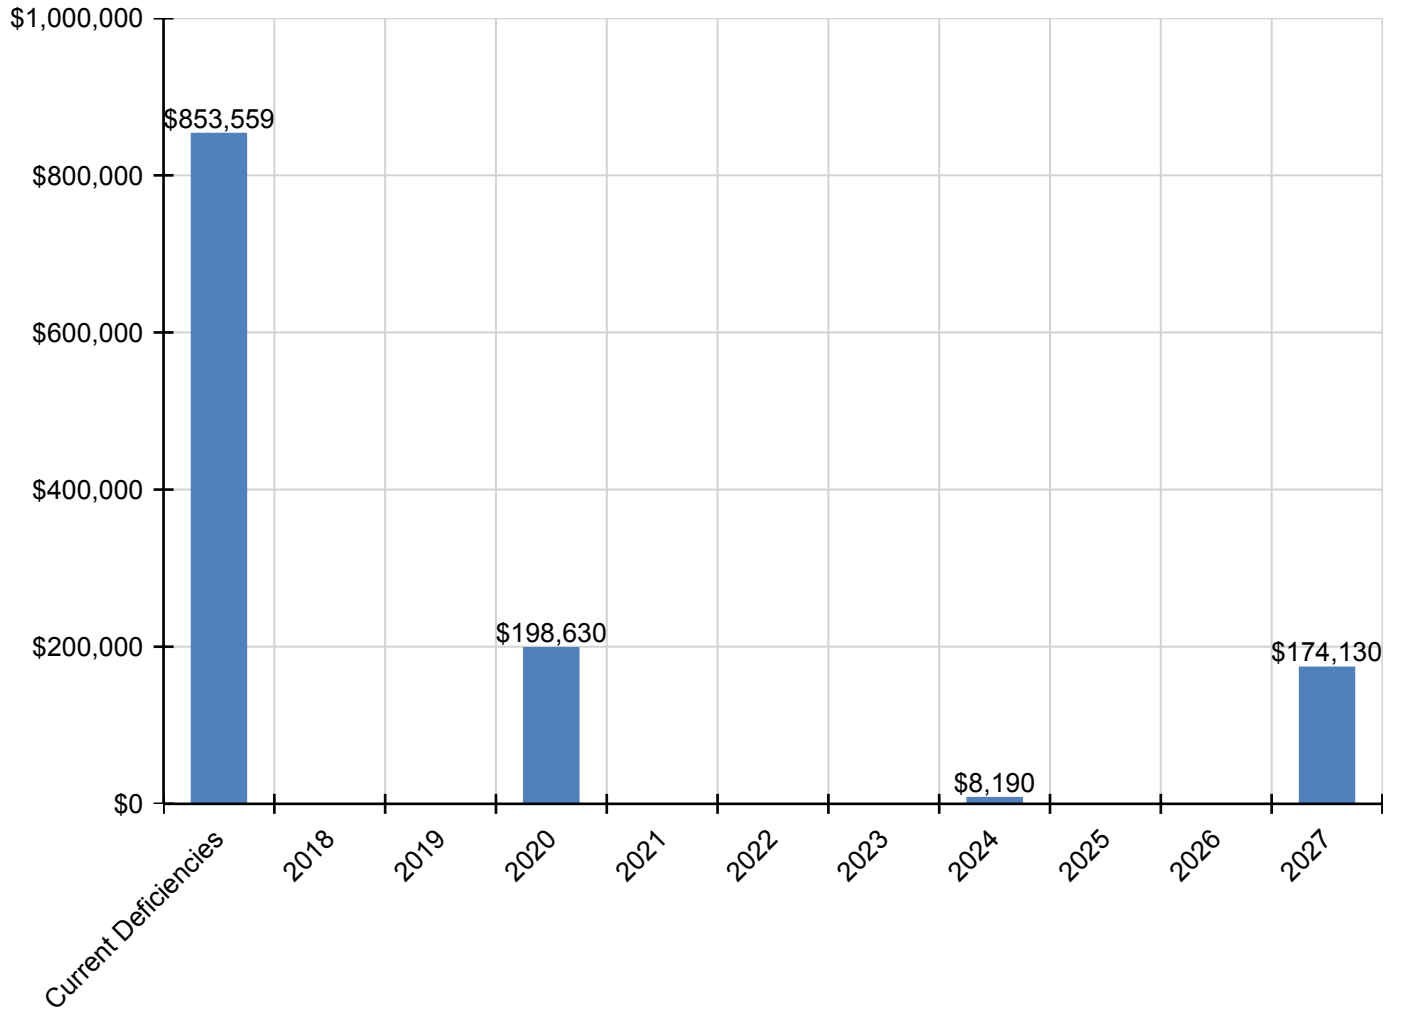
Forecasted Capital Renewal Requirement

The following chart shows the current building deficiencies and forecasting capital renewal or sustainment requirements over the next ten years.
