NC School District/040 Anson County/High School

Anson High

Campus Assessment Report

March 10, 2017

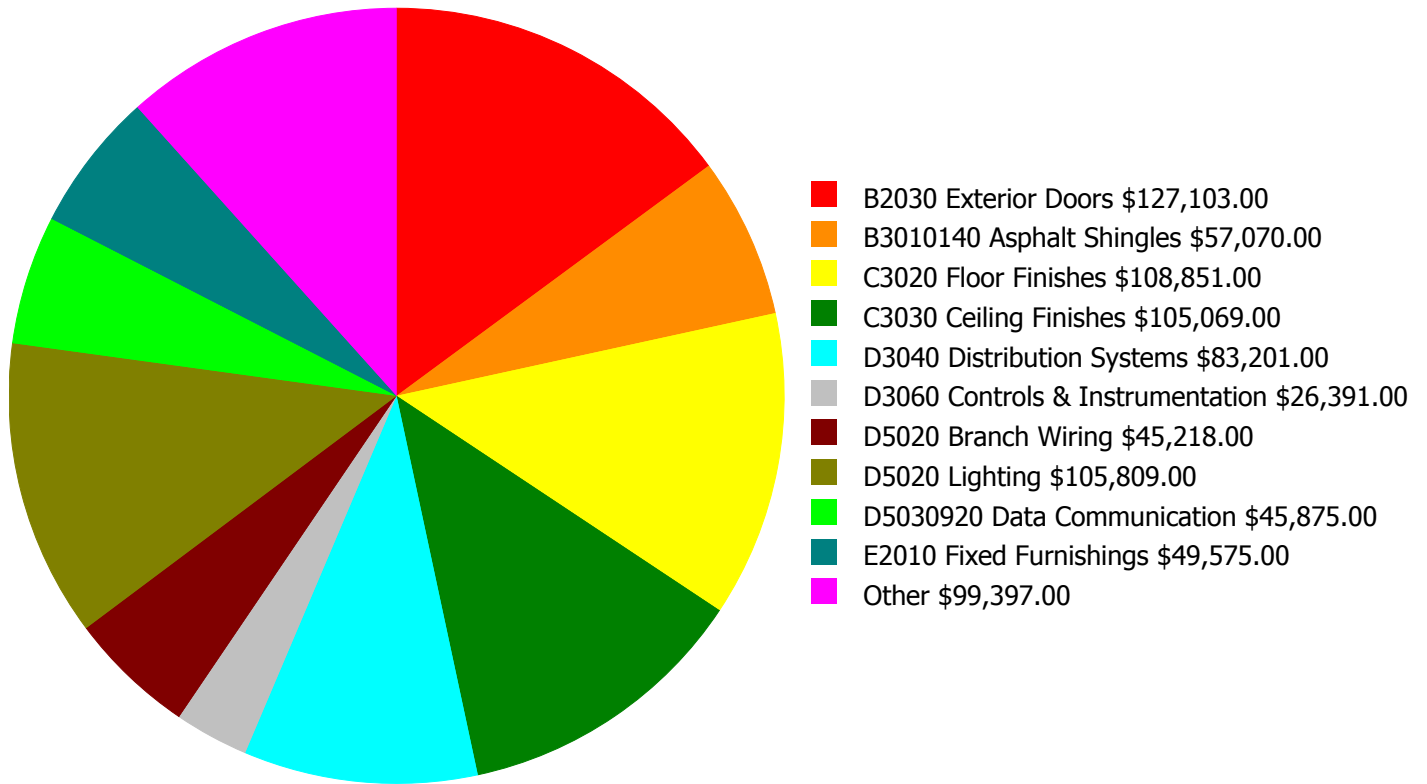
Deficiency Summary by System

Current deficiencies included assemblies that have reached or exceeded their design life or components of the assemblies that are in need of repair. Assemblies that have reached their design life are identified as current deficiencies and assigned the distress 'Beyond Useful Life'. The following chart lists all current deficiencies associated with this facility.

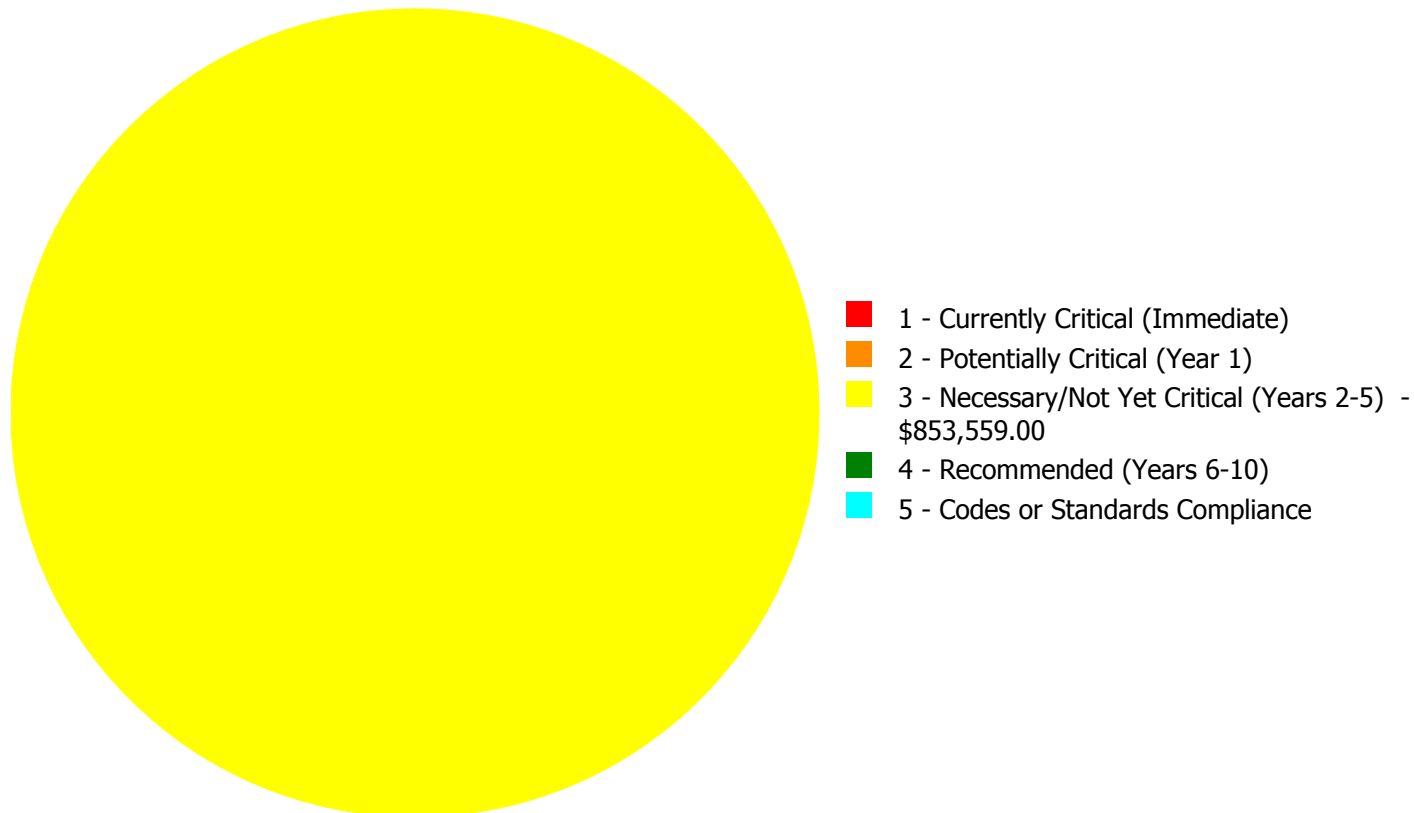
Deficiency Summary by Priority

The following chart shows the total repair costs broken down by priority. Assessors assigned deficiencies within eCOMET to one of the following priority categories:

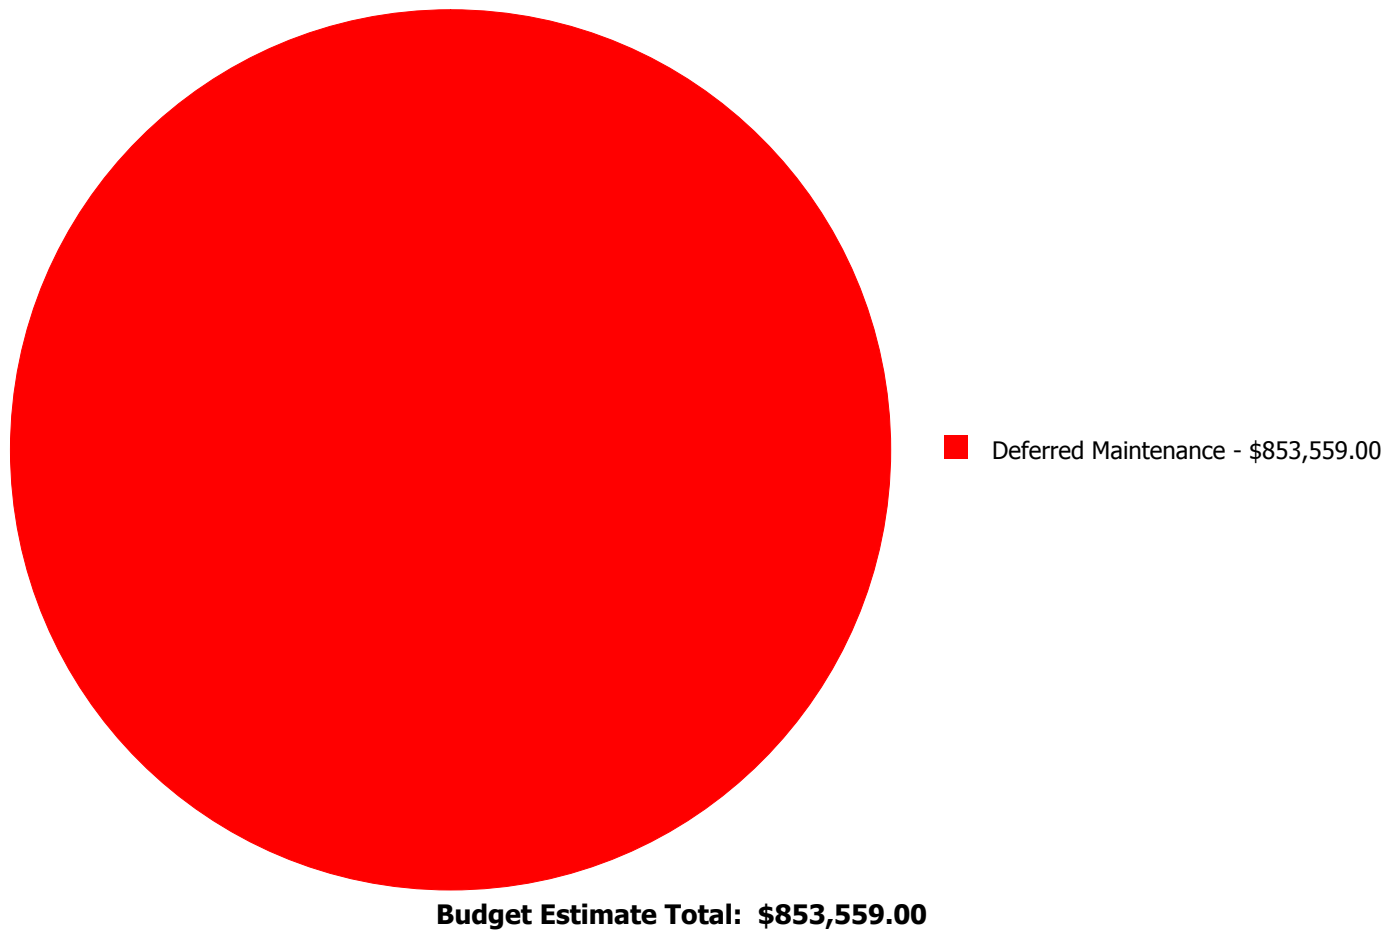
Deficiency Summary by Category

The following chart shows the total repair costs broken down by deficiency categories. Assessors assigned deficiencies to one of the following categories:

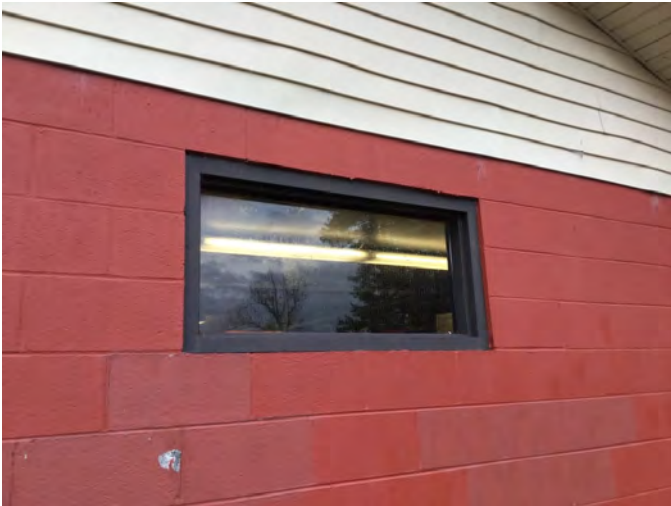
System: B2020 - Exterior Windows

Location: Exterior Walls
Distress: Beyond Service Life
Category: Deferred Maintenance
Priority: 3 - Necessary/Not Yet Critical (Years 2-5)
Correction: Renew System
Qty: 7,474.00
Unit of Measure: S.F.
Estimate: \$8,057.00
Assessor Name: Eduardo Lopez
Date Created: 01/04/2017

Notes: The exterior windows are aged, rusted, not energy efficient and should be replaced.

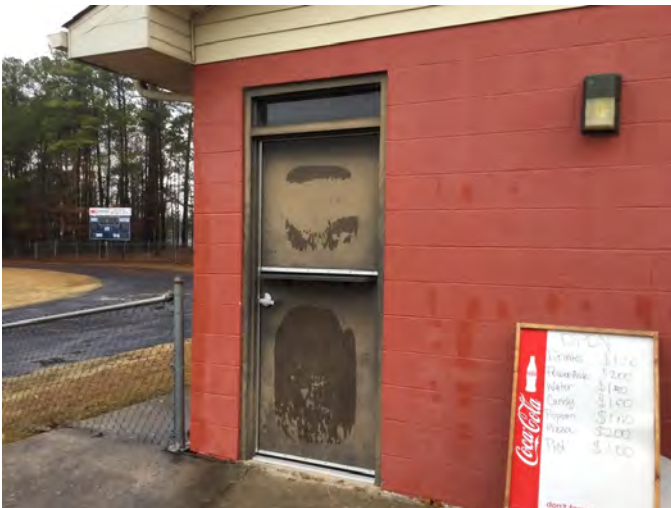
System: B2030 - Exterior Doors

Location: Exterior Walls
Distress: Beyond Service Life
Category: Deferred Maintenance
Priority: 3 - Necessary/Not Yet Critical (Years 2-5)
Correction: Renew System
Qty: 7,474.00
Unit of Measure: S.F.
Estimate: \$127,103.00
Assessor Name: Eduardo Lopez
Date Created: 01/04/2017

Notes: The exterior doors are aged, rusted and should be replaced.

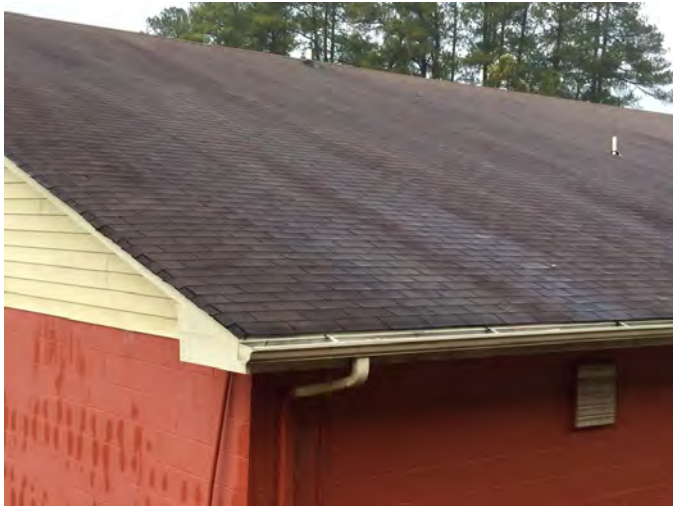
System: B3010140 - Asphalt Shingles

Location: Roof
Distress: Beyond Service Life
Category: Deferred Maintenance
Priority: 3 - Necessary/Not Yet Critical (Years 2-5)
Correction: Renew System
Qty: 7,474.00
Unit of Measure: S.F.
Estimate: \$57,070.00
Assessor Name: Eduardo Lopez
Date Created: 01/04/2017

Notes: The asphalt shingles system is beyond its expected service life and should be scheduled for replacement.

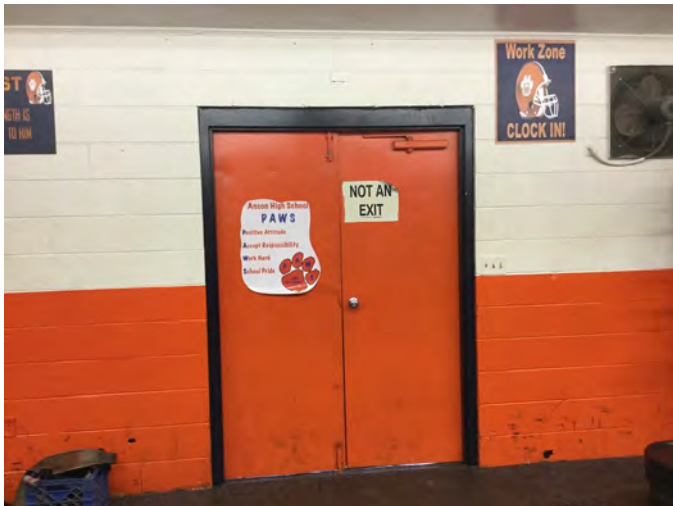
System: C1020 - Interior Doors

Location: Throughout the Building
Distress: Beyond Service Life
Category: Deferred Maintenance
Priority: 3 - Necessary/Not Yet Critical (Years 2-5)
Correction: Renew System
Qty: 7,474.00
Unit of Measure: S.F.
Estimate: \$24,171.00
Assessor Name: Eduardo Lopez
Date Created: 01/04/2017

Notes: The interior doors are aged, failing, most hardware is not ADA or code compliant and should be replaced.

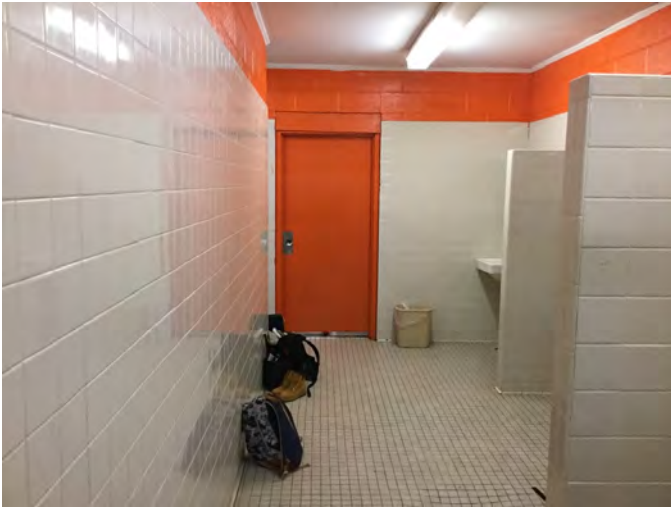
System: C3010 - Wall Finishes

Location: Throughout the Building
Distress: Beyond Service Life
Category: Deferred Maintenance
Priority: 3 - Necessary/Not Yet Critical (Years 2-5)
Correction: Renew System
Qty: 7,474.00
Unit of Measure: S.F.
Estimate: \$25,486.00
Assessor Name: Eduardo Lopez
Date Created: 01/04/2017

Notes: The wall finishes are aged, scuffed, fading, stained and should be replaced.

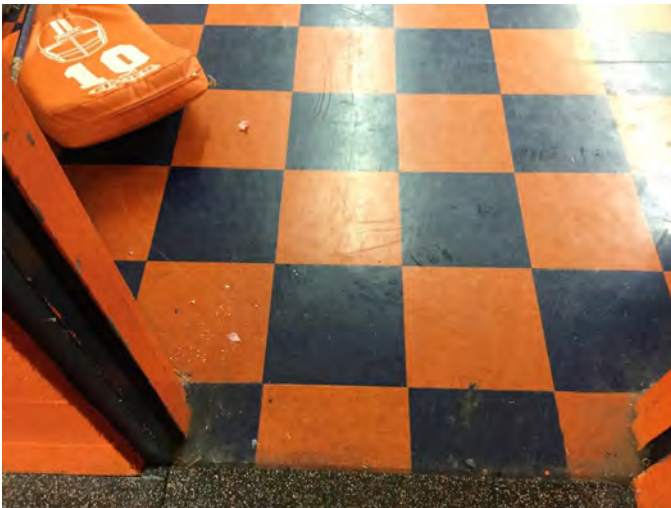
System: C3020 - Floor Finishes

Location: Throughout the Building
Distress: Beyond Service Life
Category: Deferred Maintenance
Priority: 3 - Necessary/Not Yet Critical (Years 2-5)
Correction: Renew System
Qty: 7,474.00
Unit of Measure: S.F.
Estimate: \$108,851.00
Assessor Name: Eduardo Lopez
Date Created: 01/04/2017

Notes: The original flooring is in poor conditions and should be replaced.

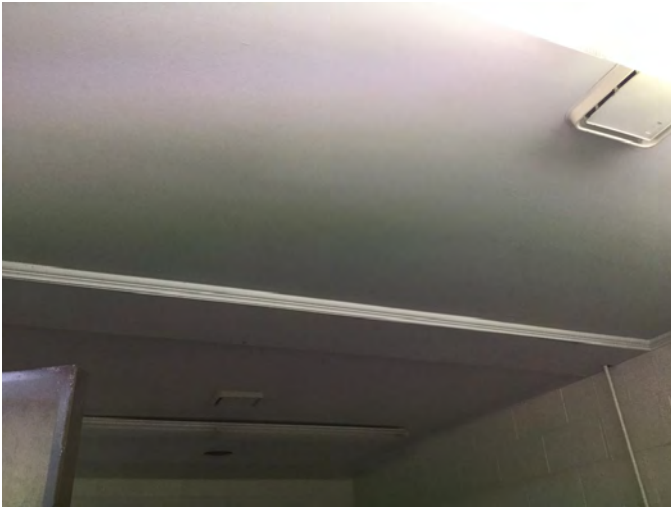
System: C3030 - Ceiling Finishes

Location: Throughout the Building
Distress: Beyond Service Life
Category: Deferred Maintenance
Priority: 3 - Necessary/Not Yet Critical (Years 2-5)
Correction: Renew System
Qty: 7,474.00
Unit of Measure: S.F.
Estimate: \$105,069.00
Assessor Name: Eduardo Lopez
Date Created: 01/04/2017

Notes: The original ceiling finishes are aged, failing and should be replaced.

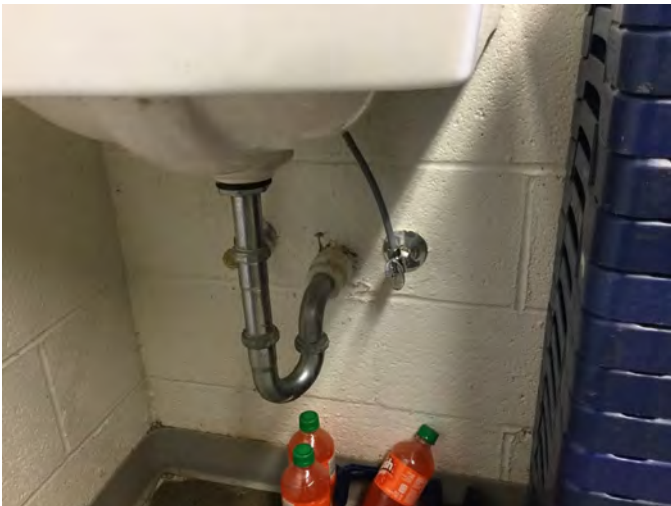
System: D2030 - Sanitary Waste

Location: Throughout the Building
Distress: Beyond Service Life
Category: Deferred Maintenance
Priority: 3 - Necessary/Not Yet Critical (Years 2-5)
Correction: Renew System
Qty: 7,474.00
Unit of Measure: S.F.
Estimate: \$25,733.00
Assessor Name: Eduardo Lopez
Date Created: 01/04/2017

Notes: The sanitary waste system is beyond its expected service life and should be replaced.

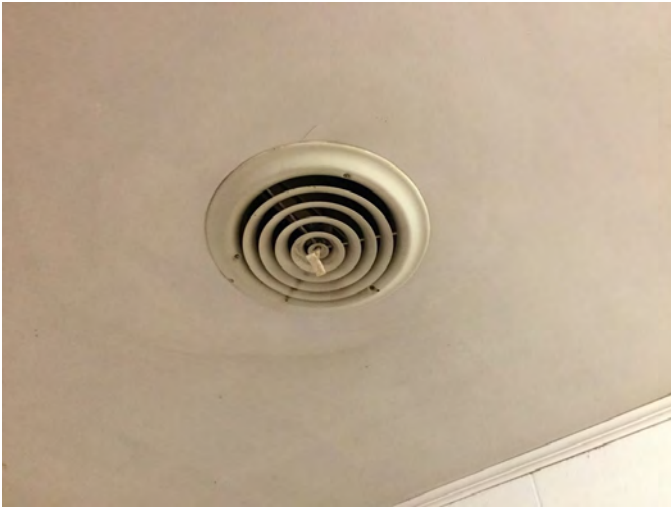
System: D3040 - Distribution Systems

Location: Throughout the Building
Distress: Beyond Service Life
Category: Deferred Maintenance
Priority: 3 - Necessary/Not Yet Critical (Years 2-5)
Correction: Renew System
Qty: 7,474.00
Unit of Measure: S.F.
Estimate: \$83,201.00
Assessor Name: Eduardo Lopez
Date Created: 01/04/2017

Notes: Distribution systems are aged, becoming logistically unsupportable, and should be replaced.

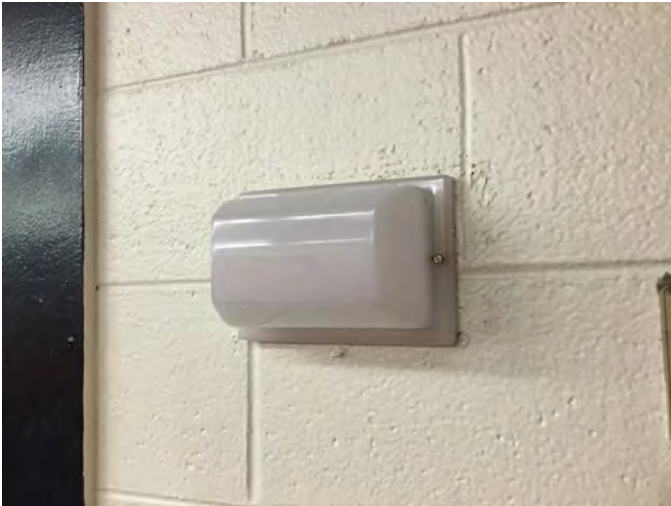
System: D3060 - Controls & Instrumentation

Location: Throughout the Building
Distress: Beyond Service Life
Category: Deferred Maintenance
Priority: 3 - Necessary/Not Yet Critical (Years 2-5)
Correction: Renew System
Qty: 7,474.00
Unit of Measure: S.F.
Estimate: \$26,391.00
Assessor Name: Eduardo Lopez
Date Created: 01/04/2017

Notes: The controls and instrumentation system is in marginal condition and should be schedule for replacement.

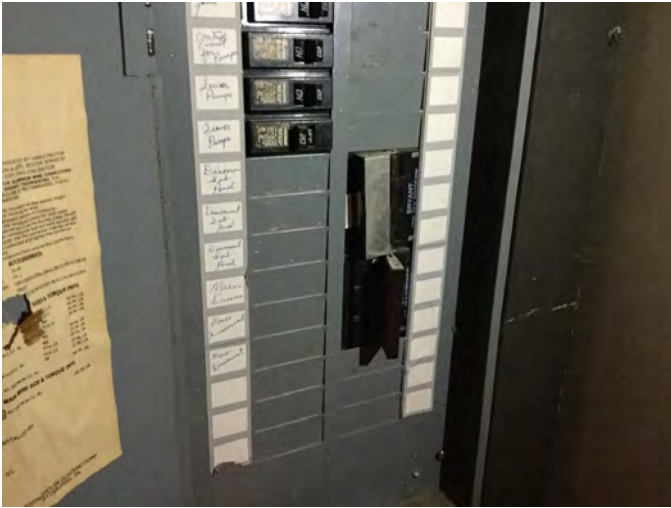
System: D5010 - Electrical Service/Distribution

Location: Throughout the Building
Distress: Beyond Service Life
Category: Deferred Maintenance
Priority: 3 - Necessary/Not Yet Critical (Years 2-5)
Correction: Renew System
Qty: 7,474.00
Unit of Measure: S.F.
Estimate: \$15,950.00
Assessor Name: Eduardo Lopez
Date Created: 01/04/2017

Notes: The original electrical service is operating but is in poor condition and should be replaced.

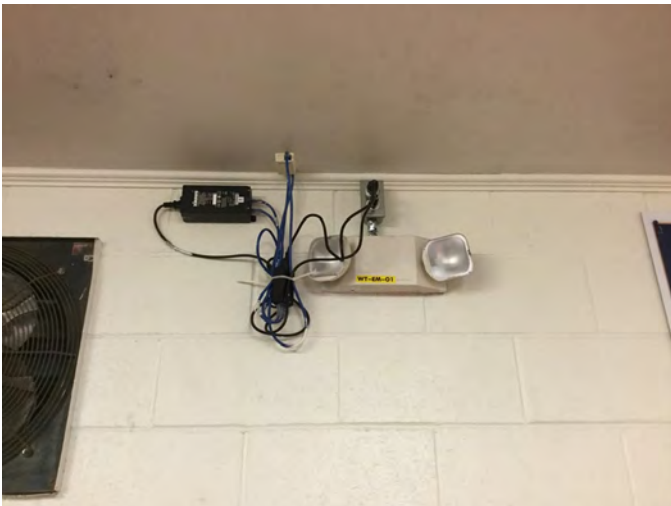
System: D5020 - Branch Wiring

Location: Throughout the Building
Distress: Beyond Service Life
Category: Deferred Maintenance
Priority: 3 - Necessary/Not Yet Critical (Years 2-5)
Correction: Renew System
Qty: 7,474.00
Unit of Measure: S.F.
Estimate: \$45,218.00
Assessor Name: Eduardo Lopez
Date Created: 01/04/2017

Notes: The original branch wiring system is operating but is aged, in marginal condition, and should be replaced.

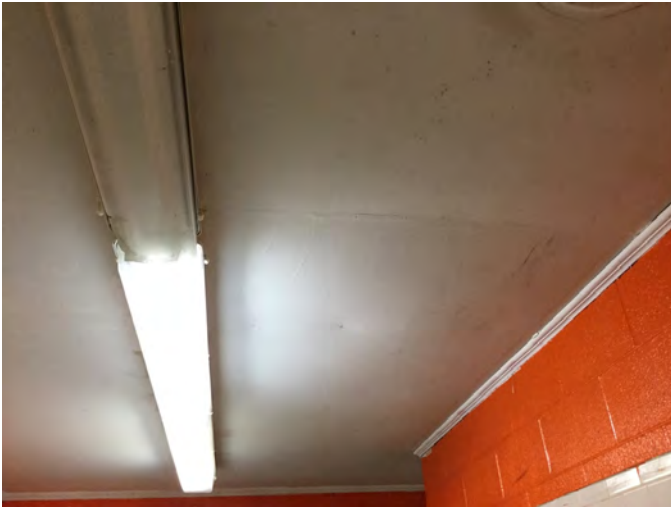
System: D5020 - Lighting

Location: Throughout the Building
Distress: Beyond Service Life
Category: Deferred Maintenance
Priority: 3 - Necessary/Not Yet Critical (Years 2-5)
Correction: Renew System
Qty: 7,474.00
Unit of Measure: S.F.
Estimate: \$105,809.00
Assessor Name: Eduardo Lopez
Date Created: 01/04/2017

Notes: The original lighting system is operating but is aged, in marginal condition, and should be replaced.

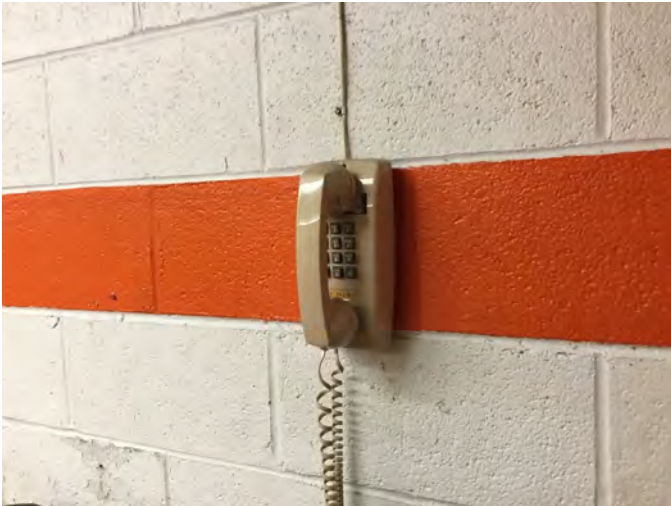
System: D5030920 - Data Communication

Location: Throughout the Building
Distress: Beyond Service Life
Category: Deferred Maintenance
Priority: 3 - Necessary/Not Yet Critical (Years 2-5)
Correction: Renew System
Qty: 7,474.00
Unit of Measure: S.F.
Estimate: \$45,875.00
Assessor Name: Eduardo Lopez
Date Created: 01/04/2017

Notes: The phone system is beyond its expected service life and should be scheduled for replacement.

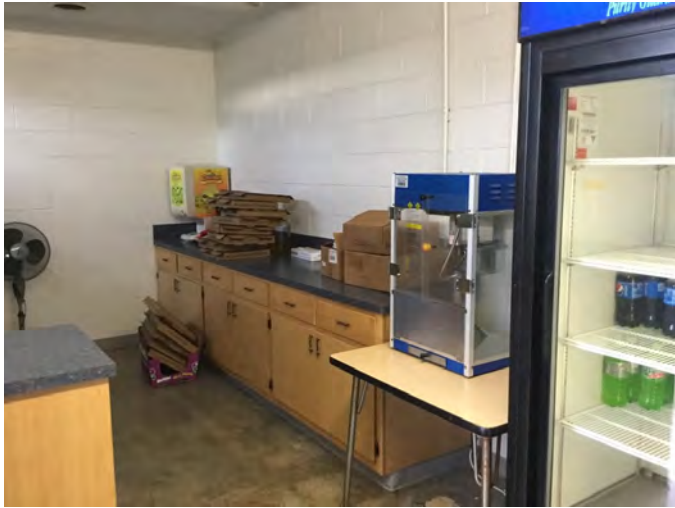
System: E2010 - Fixed Furnishings

Location: Throughout the Building
Distress: Beyond Service Life
Category: Deferred Maintenance
Priority: 3 - Necessary/Not Yet Critical (Years 2-5)
Correction: Renew System
Qty: 7,474.00
Unit of Measure: S.F.
Estimate: \$49,575.00
Assessor Name: Eduardo Lopez
Date Created: 02/15/2017

Notes: The fixed furnishings are aged, in marginal condition, and should be replaced.

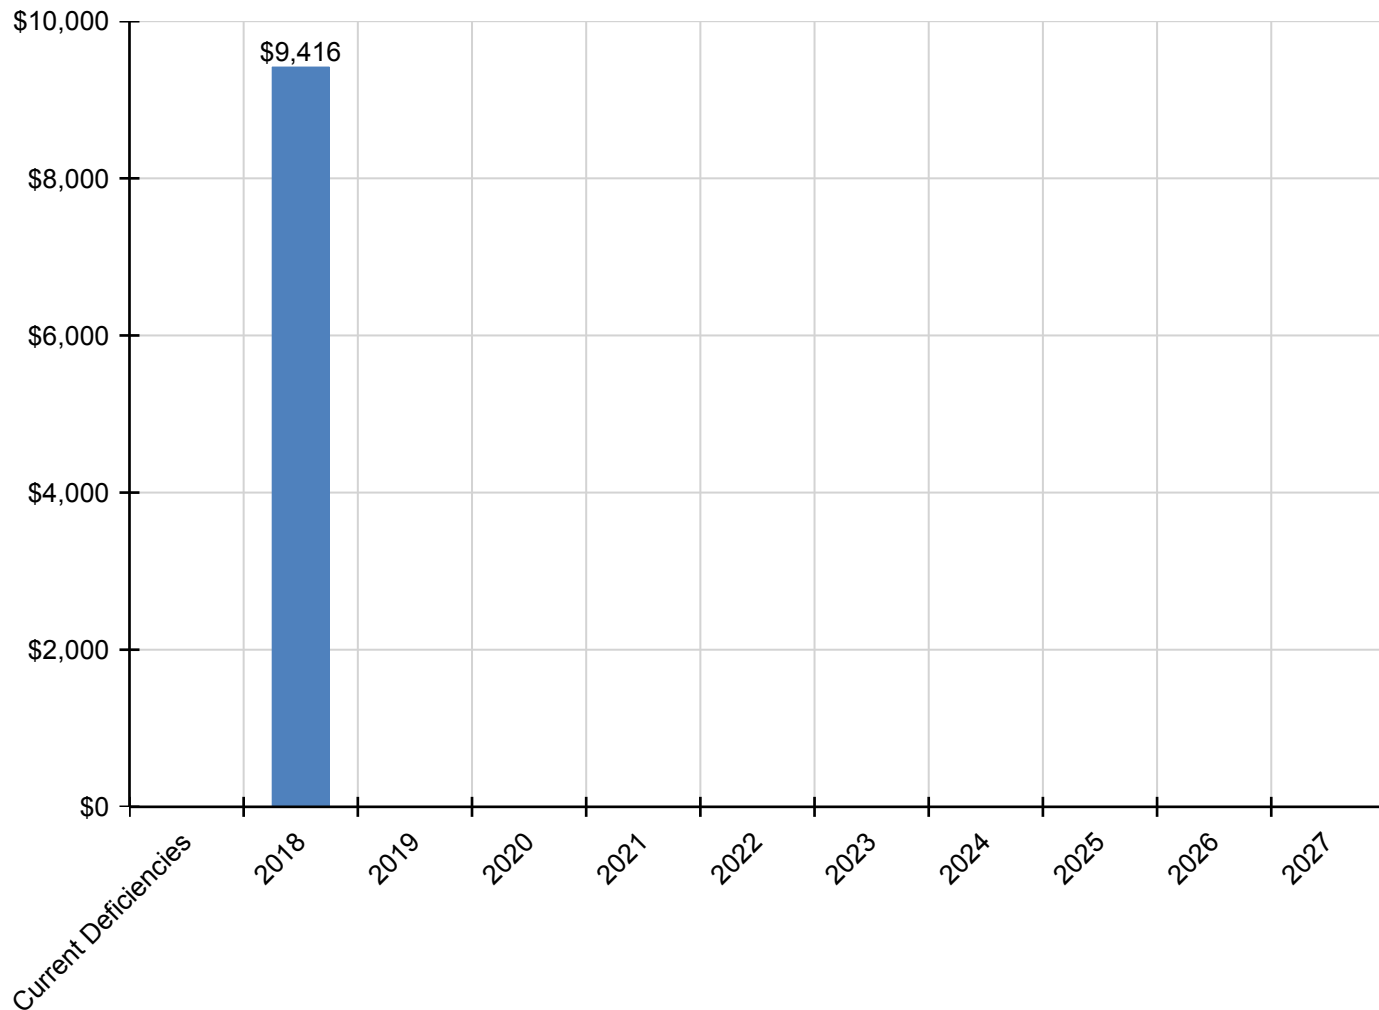
Forecasted Capital Renewal Requirement

The following chart shows the current building deficiencies and forecasting capital renewal or sustainment requirements over the next ten years.

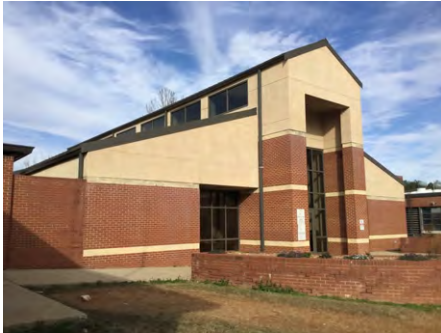
1). South Elevation - Feb 16, 2017

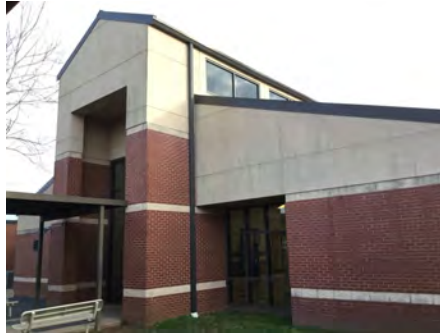
2). North Elevation - Feb 16, 2017

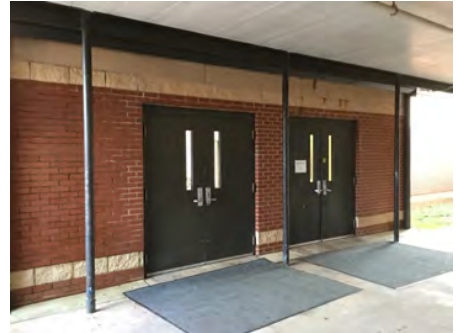
3). West Elevation - Feb 16, 2017

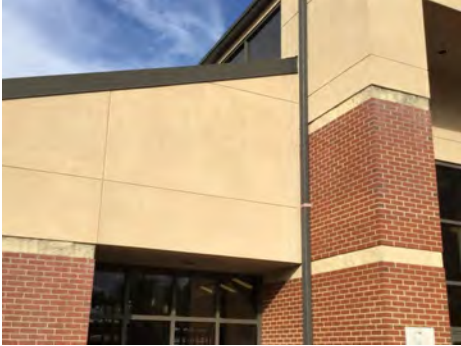
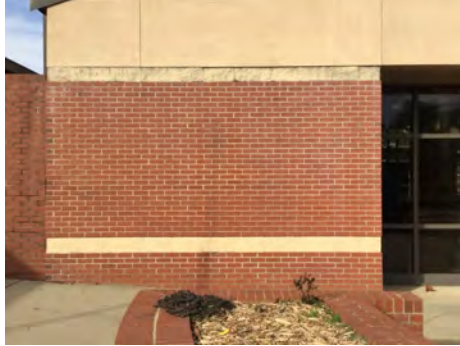
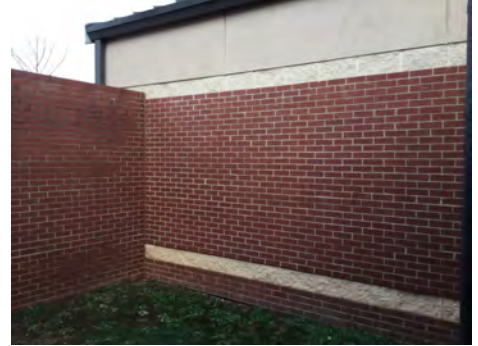
System: B2010 - Exterior Walls

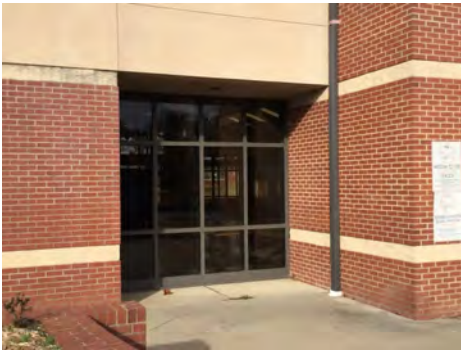
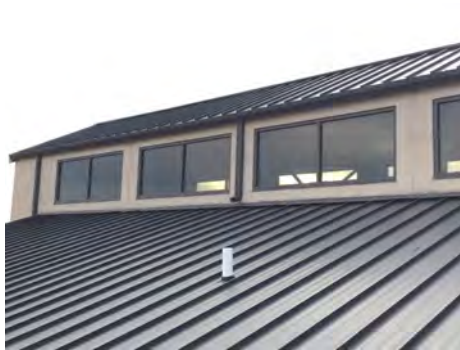
System: B2020 - Exterior Windows

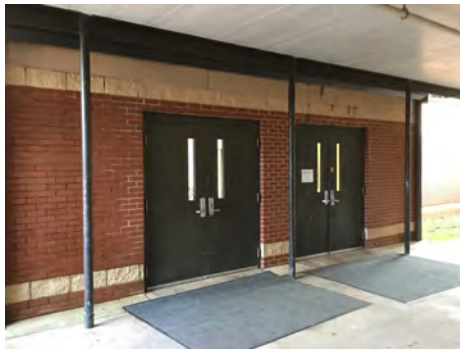
System: B2030 - Exterior Doors

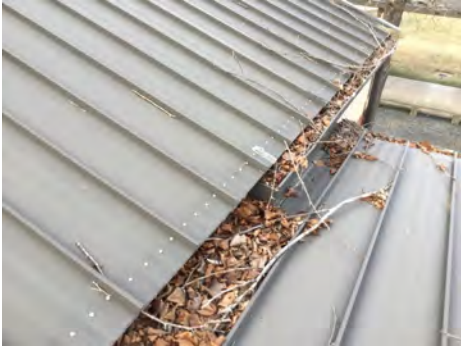
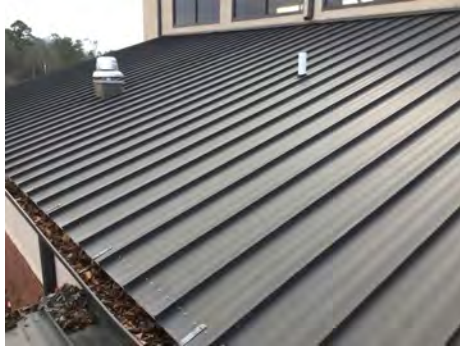
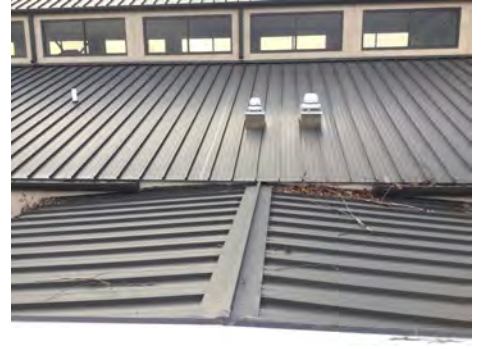
System: B3010130 - Preformed Metal Roofing

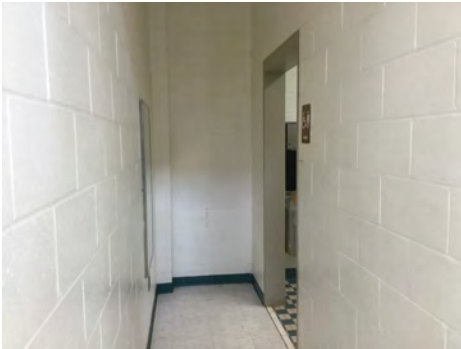
System: C1010 - Partitions

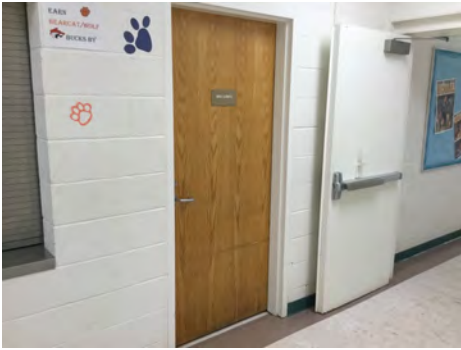
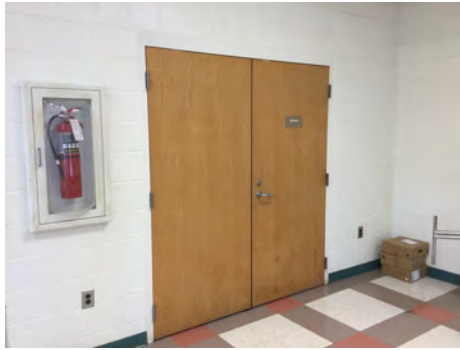
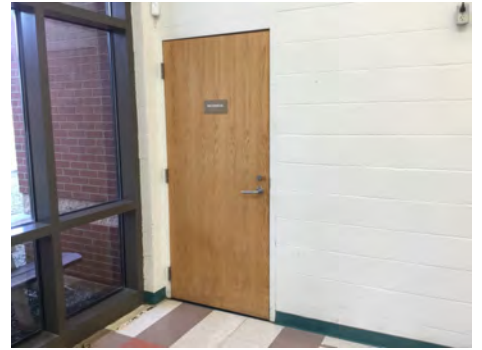
System: C1020 - Interior Doors

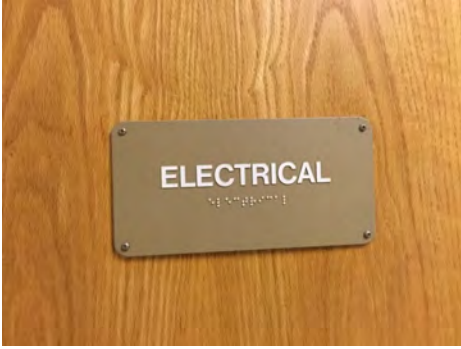
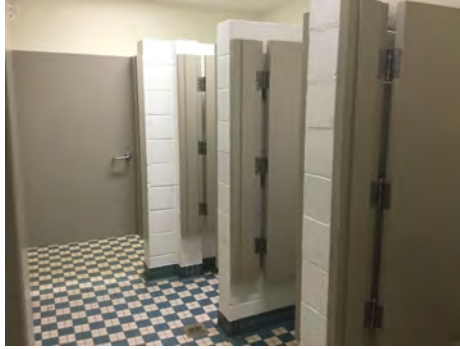
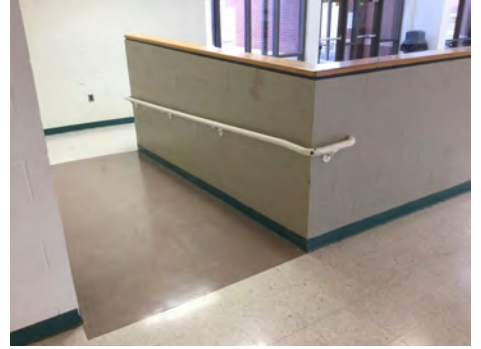
System: C1030 - Fittings

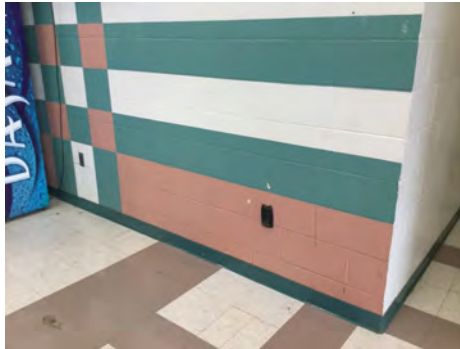
System: C3010 - Wall Finishes

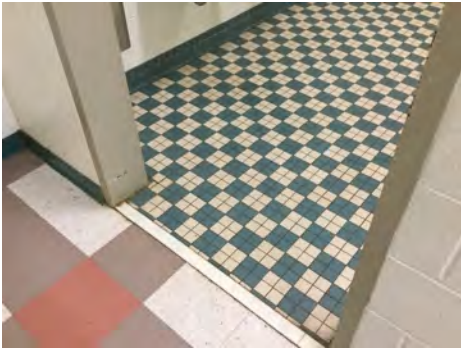
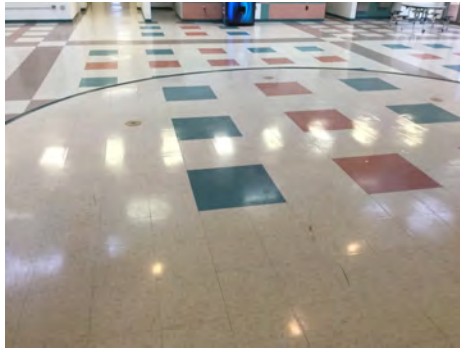
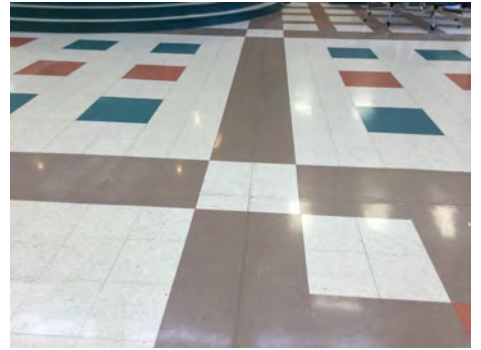
System: C3020 - Floor Finishes

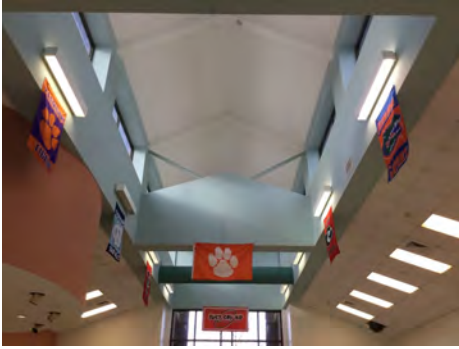
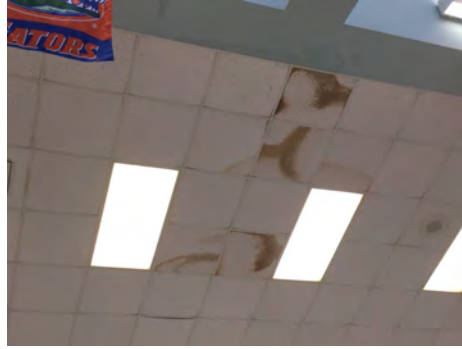
System: C3030 - Ceiling Finishes

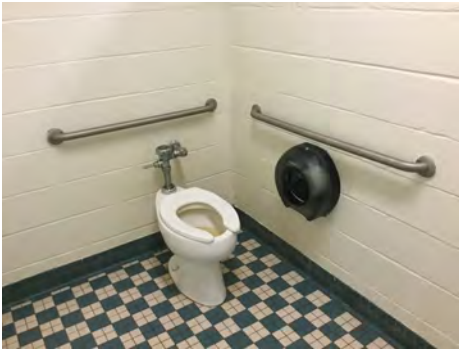
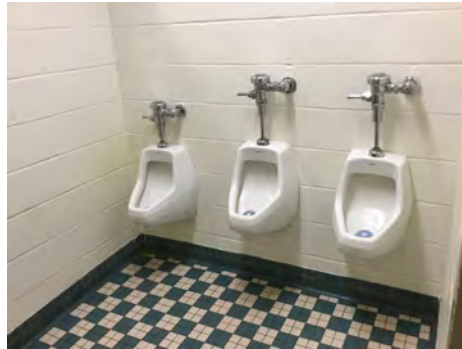
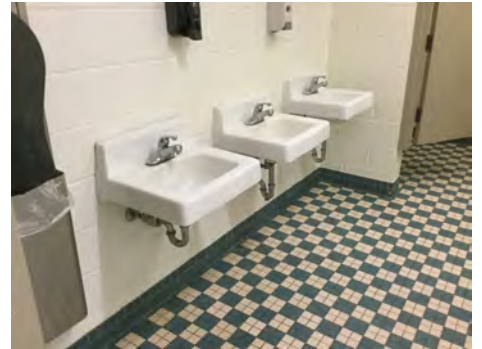
System: D2010 - Plumbing Fixtures

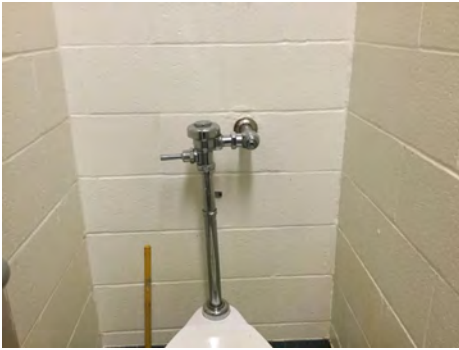
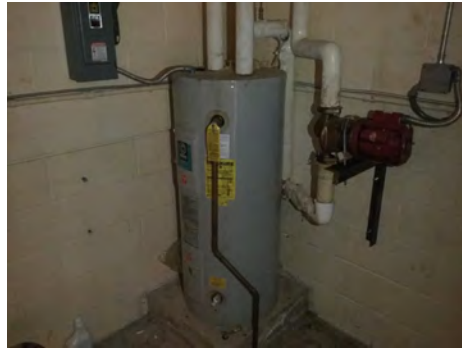
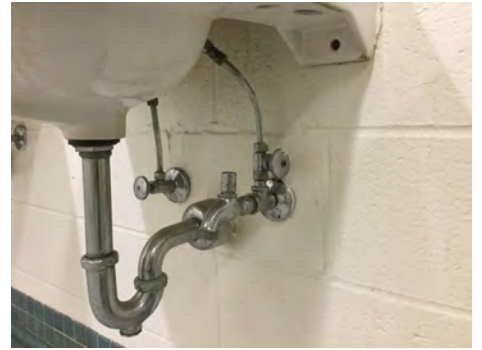
System: D2020 - Domestic Water Distribution

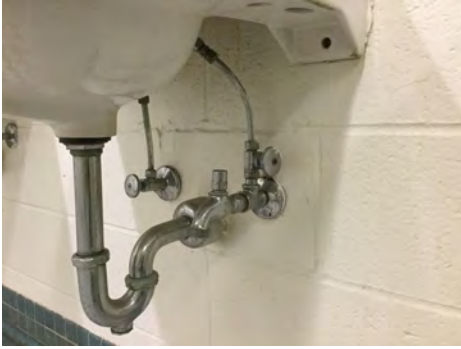
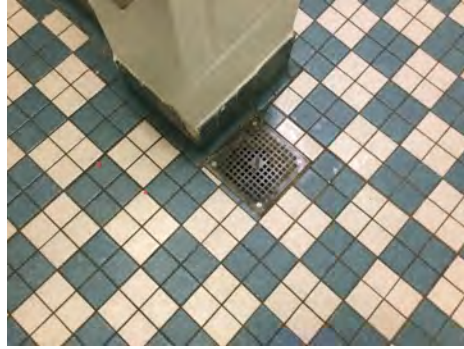
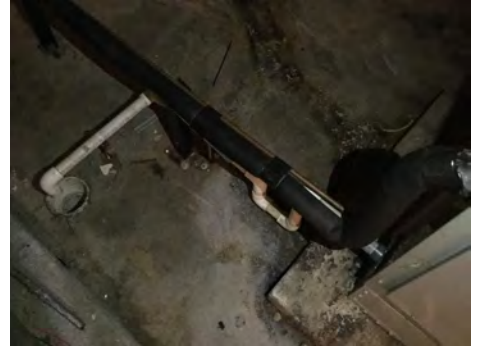
System: D2030 - Sanitary Waste

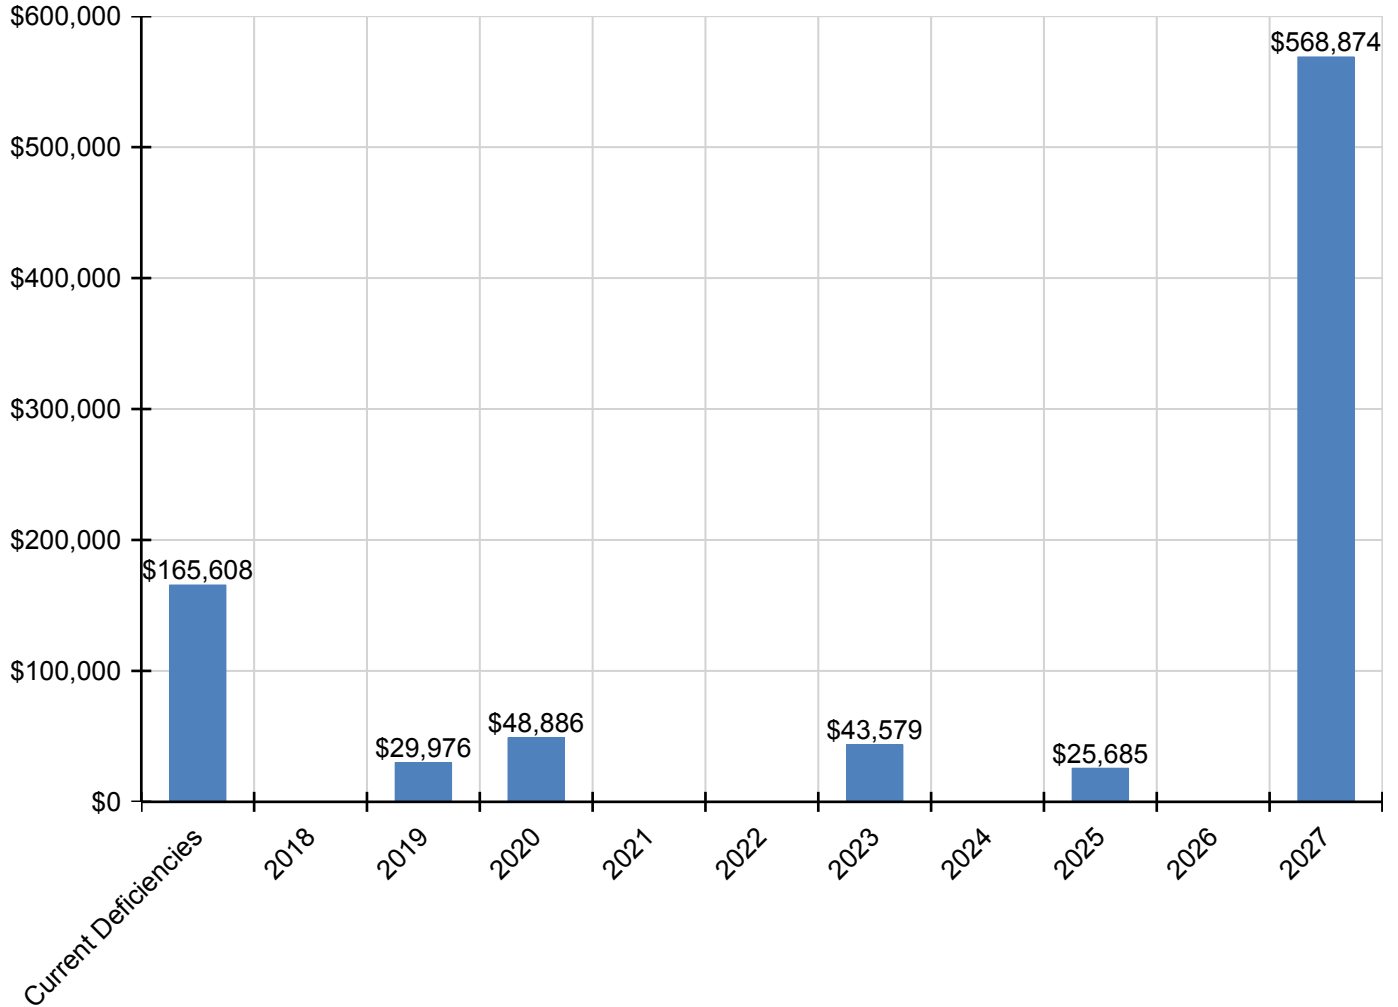
Forecasted Capital Renewal Requirement

The following chart shows the current building deficiencies and forecasting capital renewal or sustainment requirements over the next ten years.

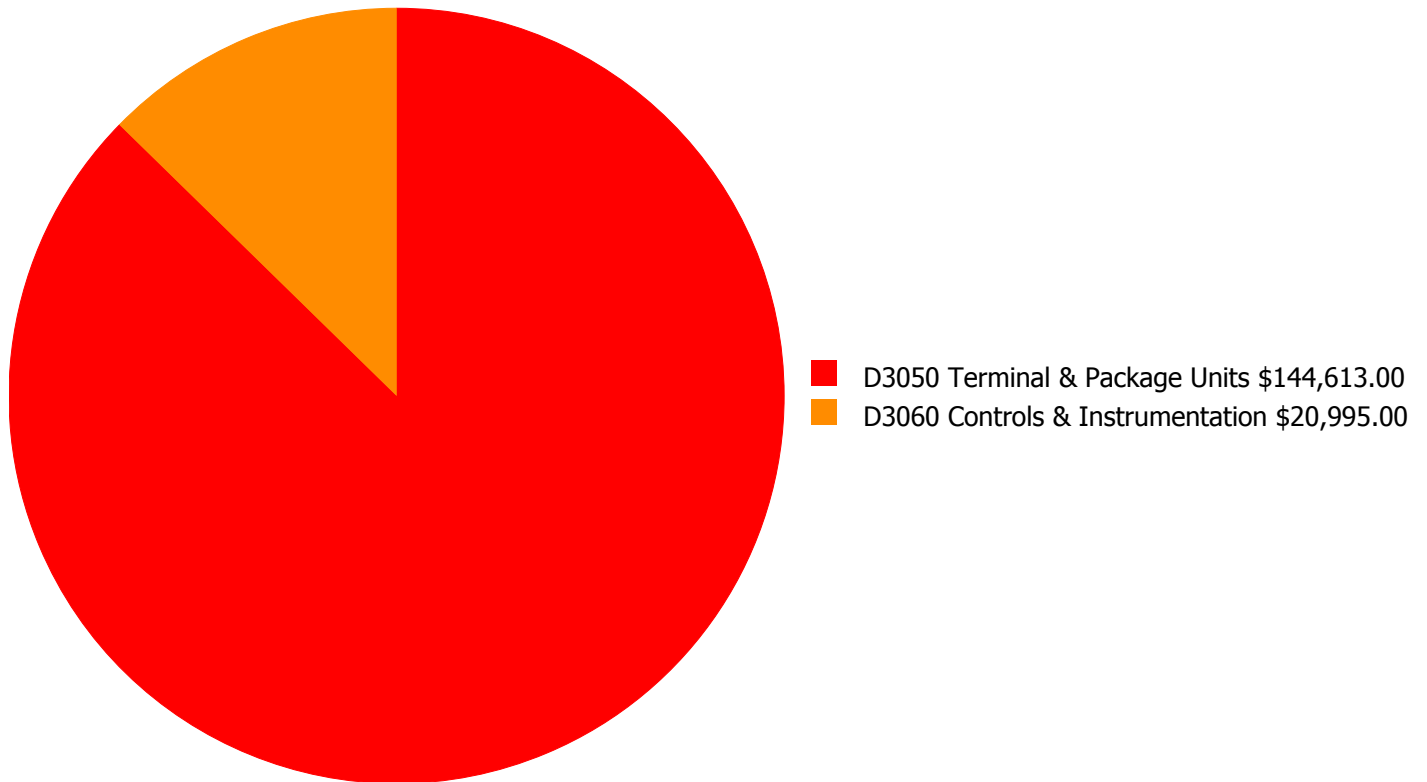
Deficiency Summary by System

Current deficiencies included assemblies that have reached or exceeded their design life or components of the assemblies that are in need of repair. Assemblies that have reached their design life are identified as current deficiencies and assigned the distress 'Beyond Useful Life'. The following chart lists all current deficiencies associated with this facility.

Budget Estimate Total: \$165,608.00

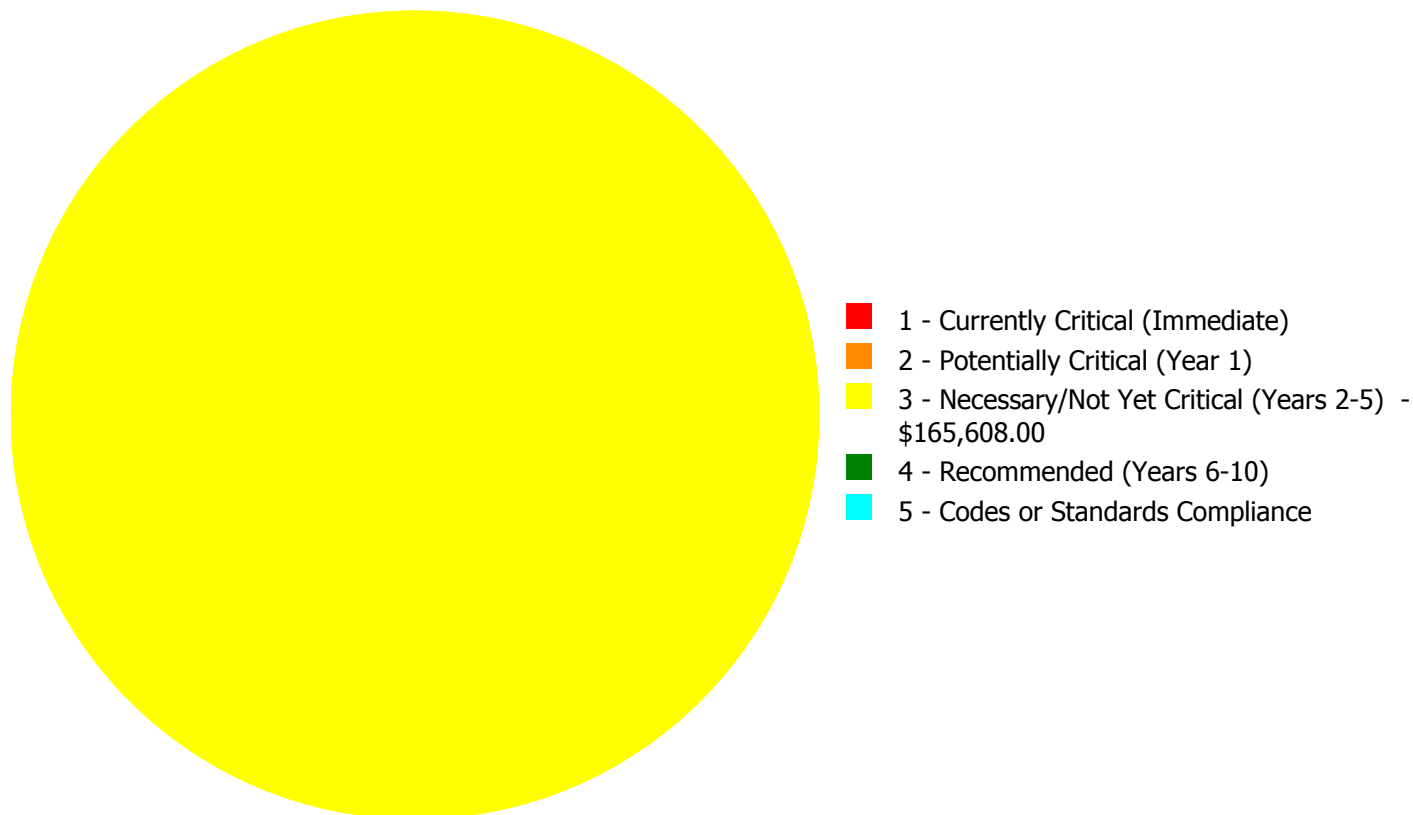
Deficiency Summary by Priority

The following chart shows the total repair costs broken down by priority. Assessors assigned deficiencies within eCOMET to one of the following priority categories:

Budget Estimate Total: \$165,608.00

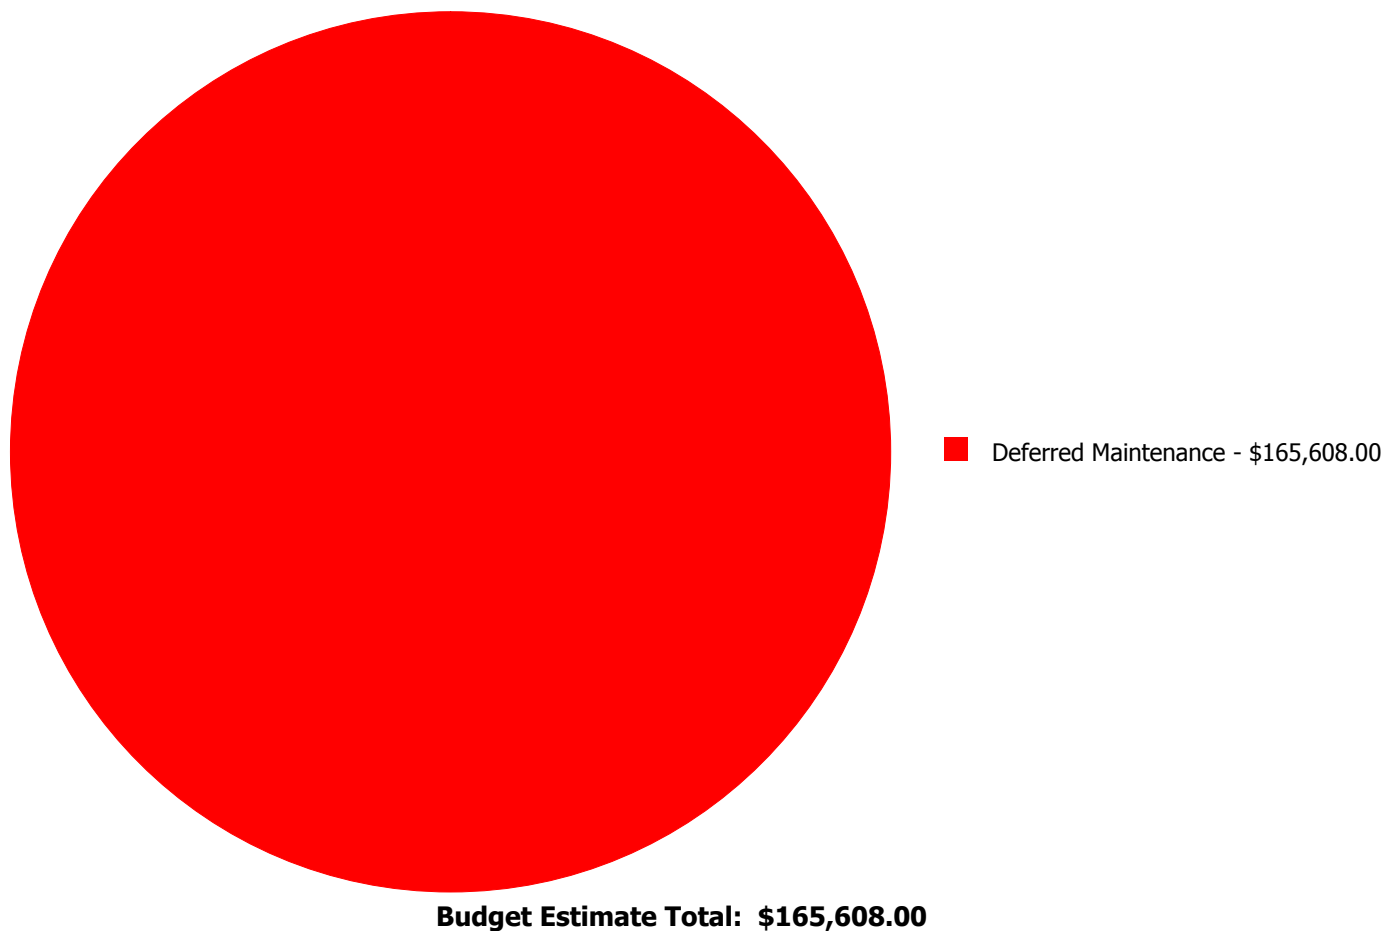
Deficiency Summary by Category

The following chart shows the total repair costs broken down by deficiency categories. Assessors assigned deficiencies to one of the following categories:
