NC School District/040 Anson County/High School

Anson High

Campus Assessment Report

March 10, 2017

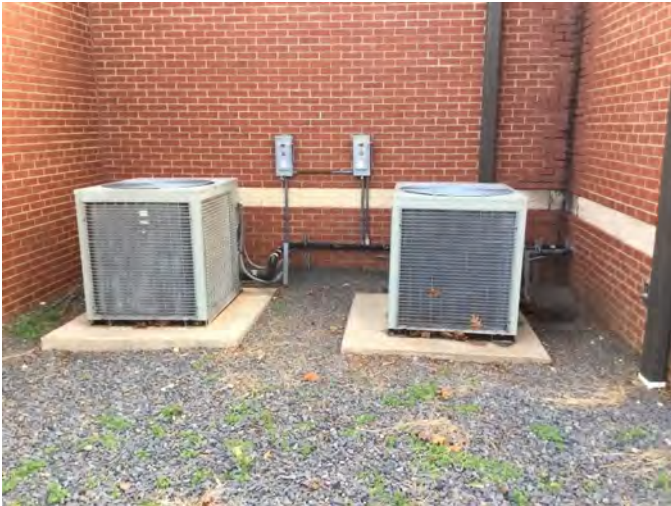
System: D3050 - Terminal & Package Units

Location: Throughout the Building
Distress: Beyond Service Life
Category: Deferred Maintenance
Priority: 3 - Necessary/Not Yet Critical (Years 2-5)
Correction: Renew System
Qty: 5,946.00
Unit of Measure: S.F.
Estimate: \$144,613.00
Assessor Name: Eduardo Lopez
Date Created: 02/16/2017

Notes: Terminal and package units are beyond their expected service life and should be scheduled for replacement.

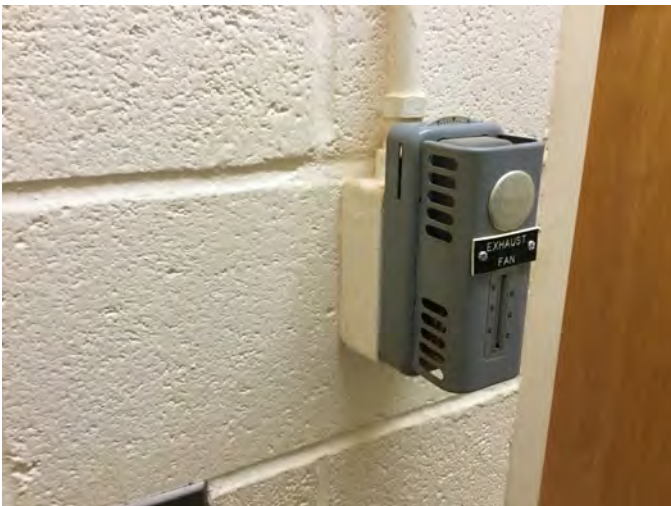
System: D3060 - Controls & Instrumentation

Location: Throughout the Building
Distress: Beyond Service Life
Category: Deferred Maintenance
Priority: 3 - Necessary/Not Yet Critical (Years 2-5)
Correction: Renew System
Qty: 5,946.00
Unit of Measure: S.F.
Estimate: \$20,995.00
Assessor Name: Eduardo Lopez
Date Created: 02/16/2017

Notes: The controls and instrumentation system is in marginal condition and should be schedule for replacement.

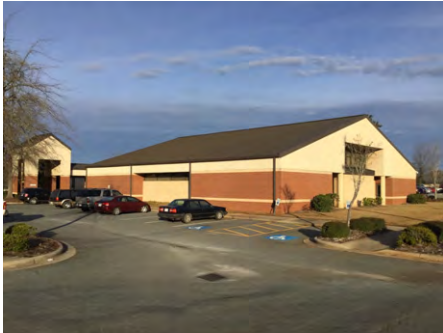
1). Southeast Elevation - Feb 12, 2017

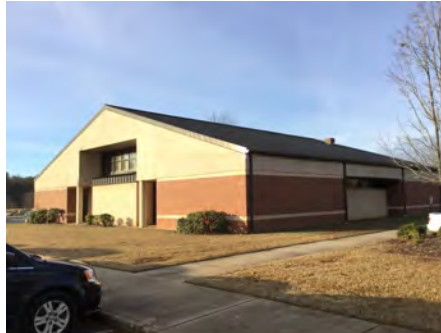
2). Northeast Elevation - Feb 12, 2017

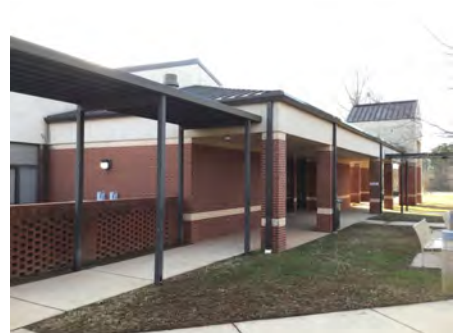
3). West Elevation - Feb 12, 2017

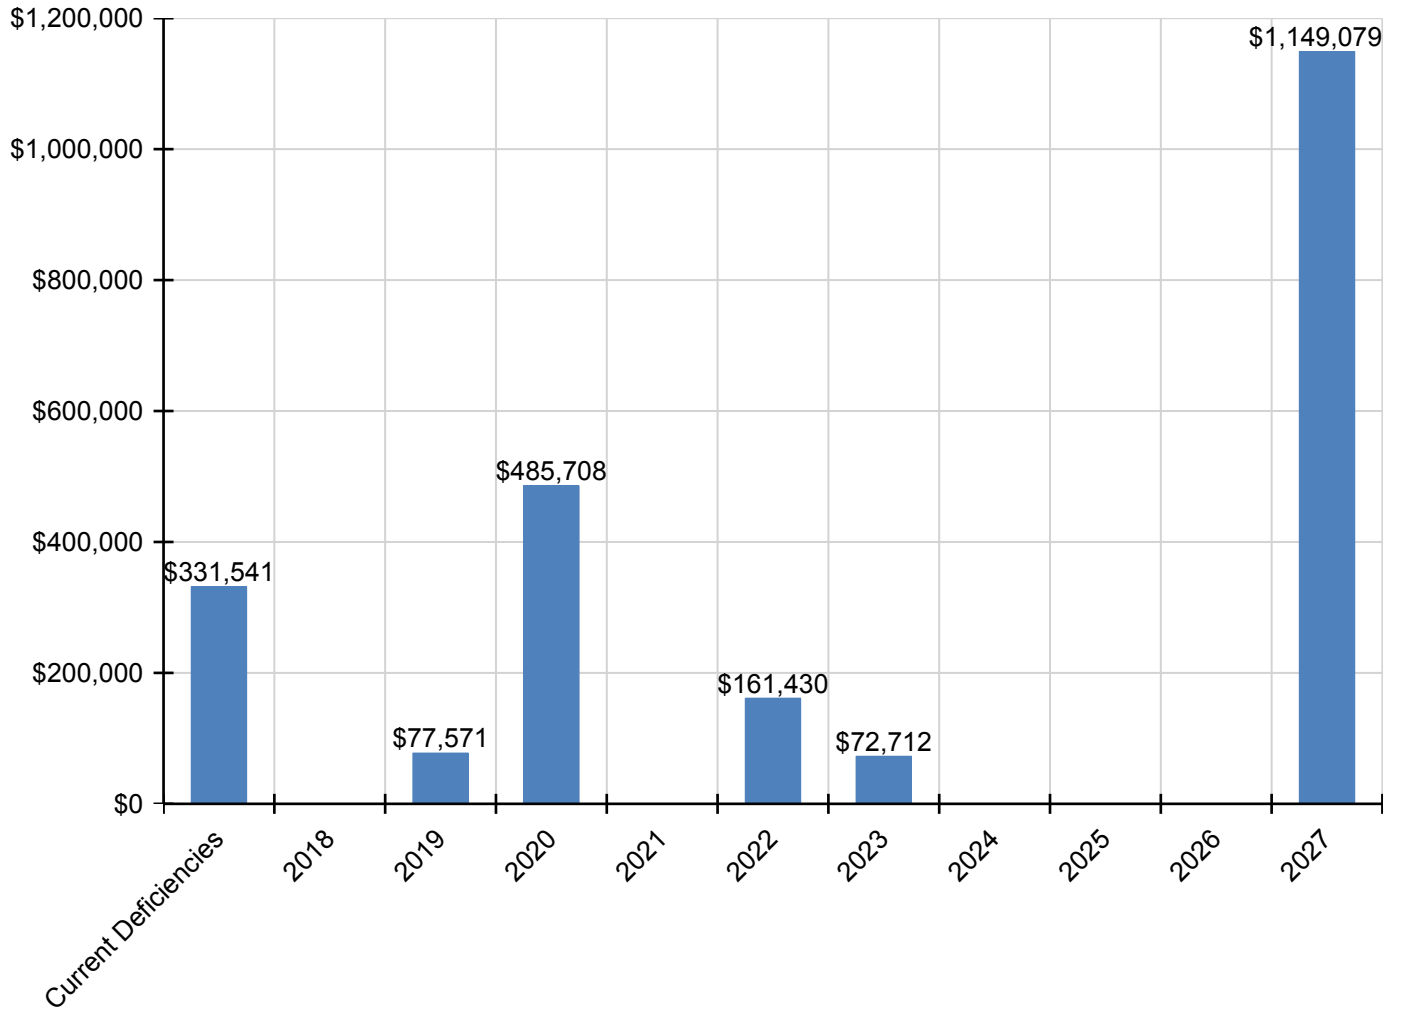
Forecasted Capital Renewal Requirement

The following chart shows the current building deficiencies and forecasting capital renewal or sustainment requirements over the next ten years.

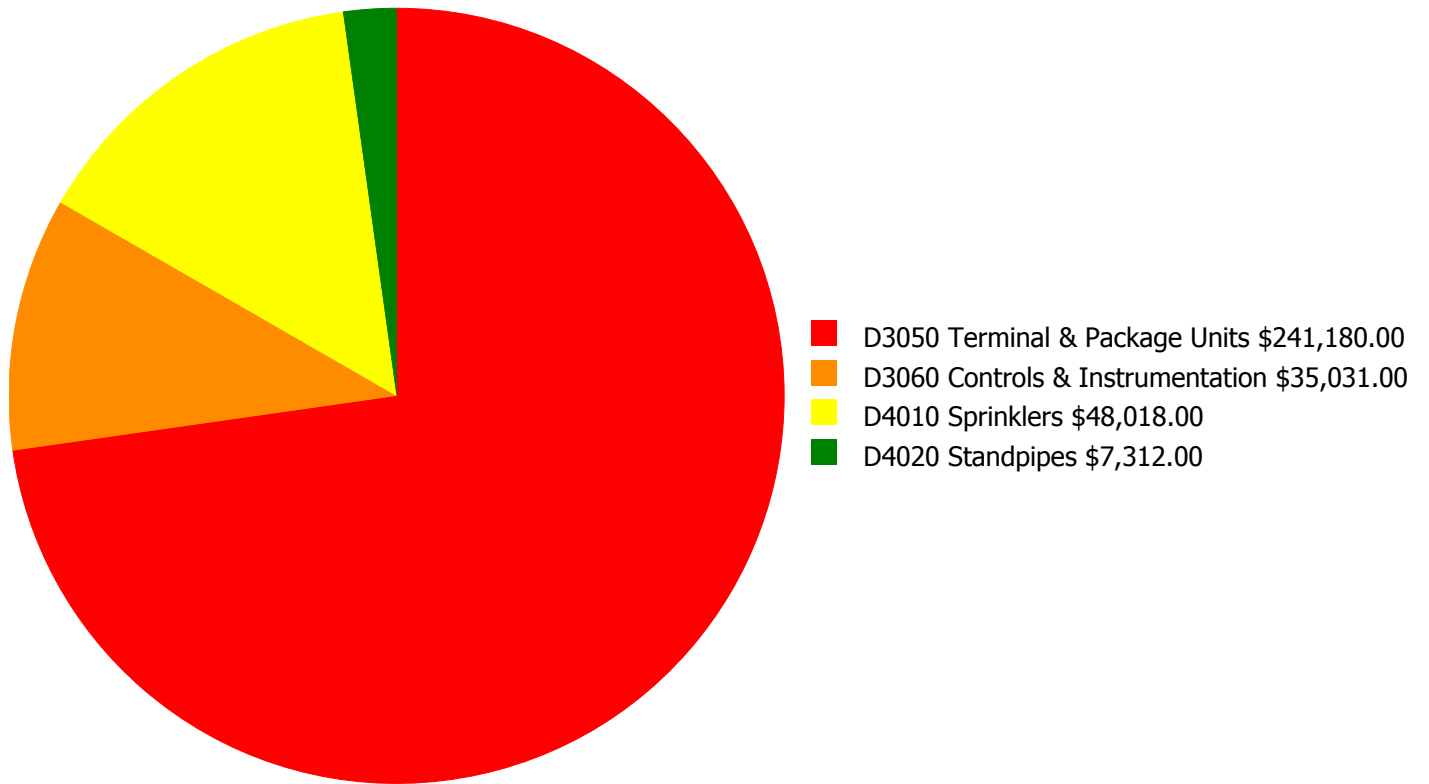
Deficiency Summary by System

Current deficiencies included assemblies that have reached or exceeded their design life or components of the assemblies that are in need of repair. Assemblies that have reached their design life are identified as current deficiencies and assigned the distress 'Beyond Useful Life'. The following chart lists all current deficiencies associated with this facility.

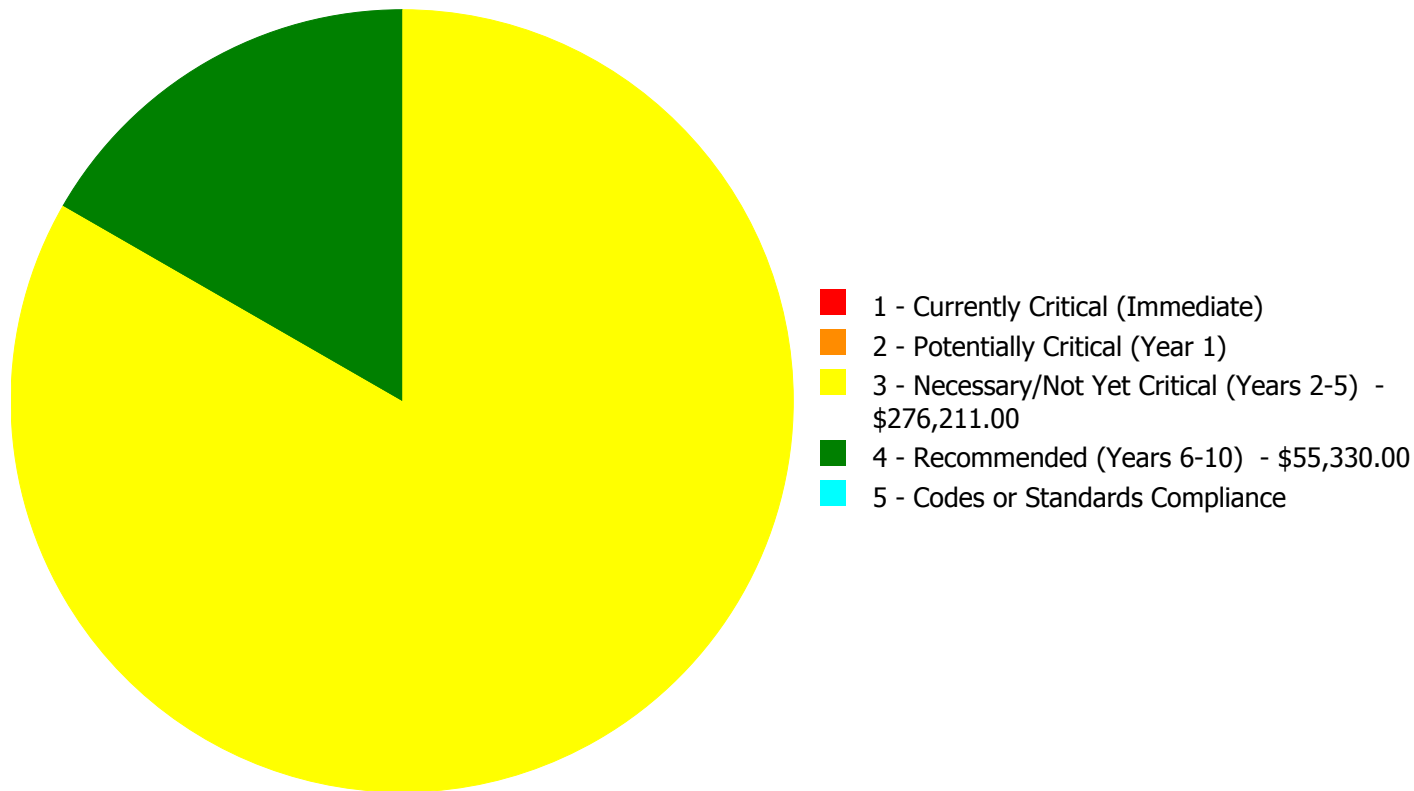
Deficiency Summary by Priority

The following chart shows the total repair costs broken down by priority. Assessors assigned deficiencies within eCOMET to one of the following priority categories:

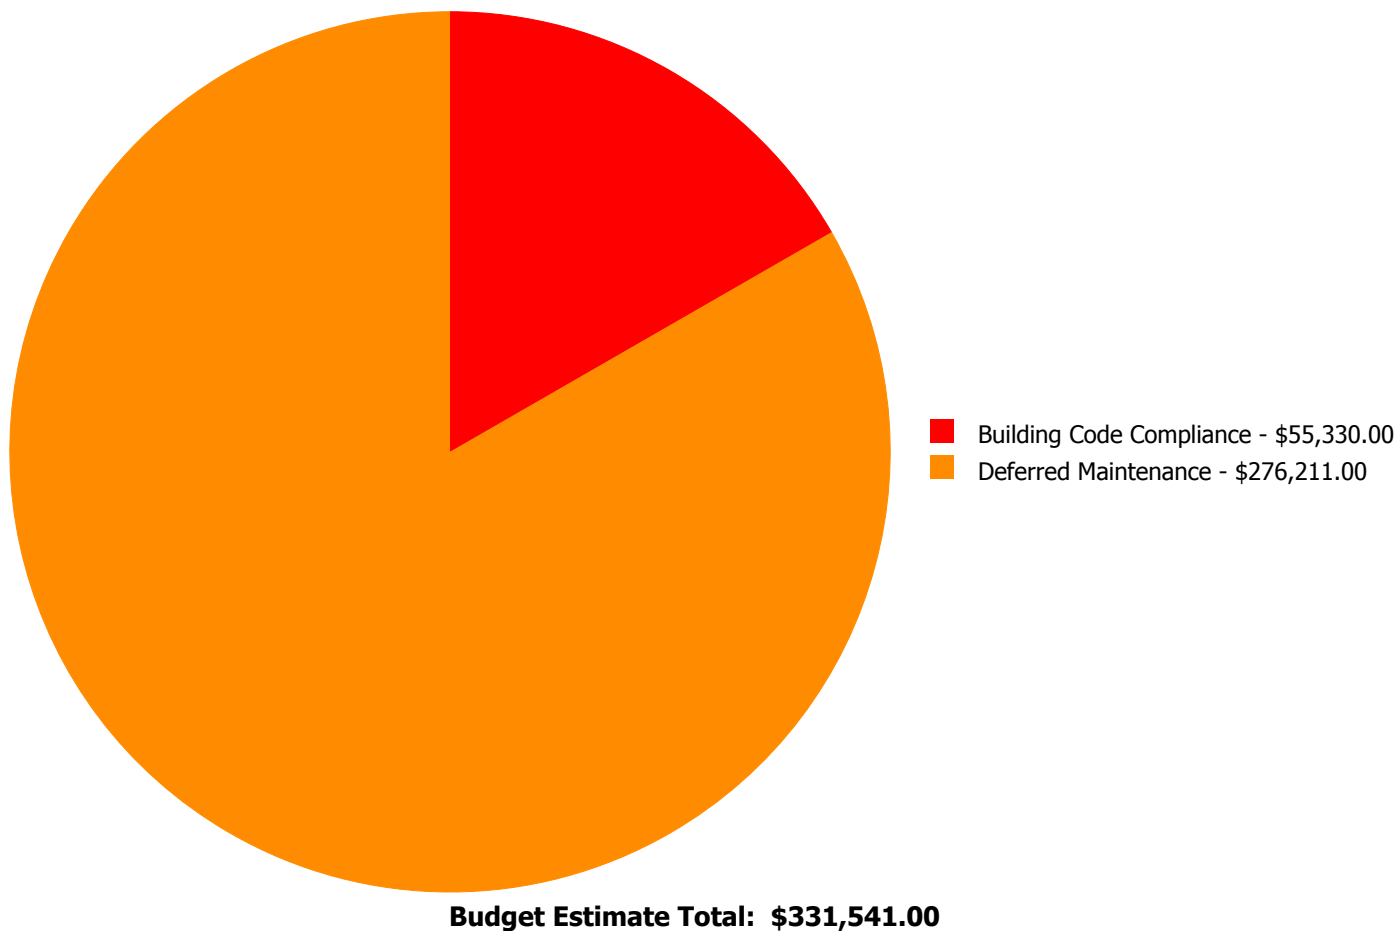
Deficiency Summary by Category

The following chart shows the total repair costs broken down by deficiency categories. Assessors assigned deficiencies to one of the following categories:

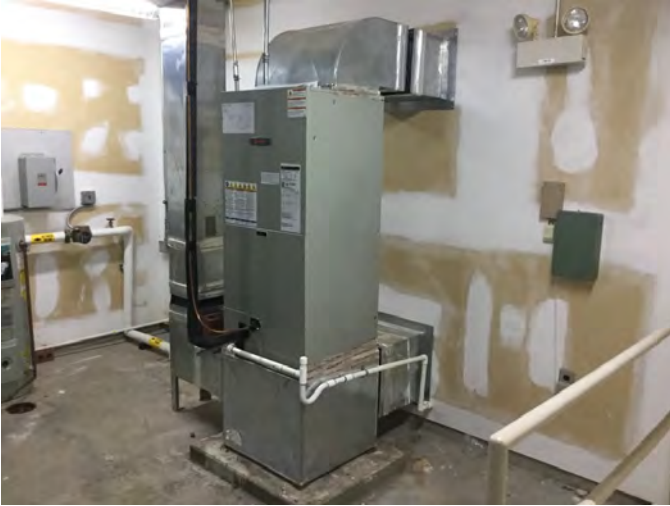
System: D3050 - Terminal & Package Units

Location: Throughout the Building
Distress: Beyond Service Life
Category: Deferred Maintenance
Priority: 3 - Necessary/Not Yet Critical (Years 2-5)
Correction: Renew System
Qty: 9,921.00
Unit of Measure: S.F.
Estimate: \$241,180.00
Assessor Name: Eduardo Lopez
Date Created: 01/04/2017

Notes: Terminal and package units are beyond their expected service life and should be scheduled for replacement.

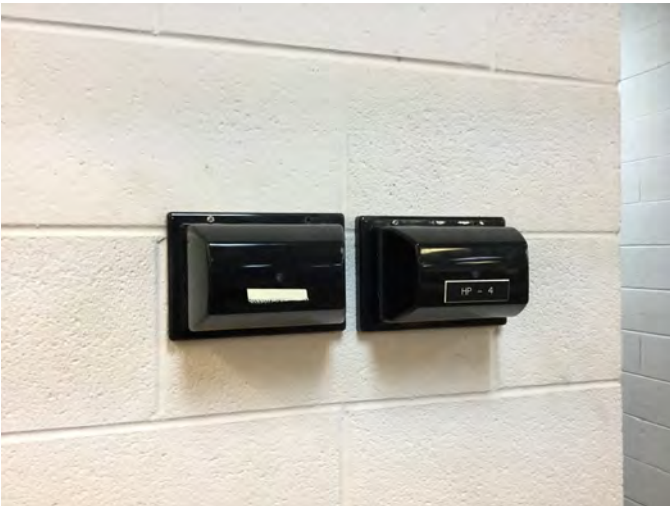
System: D3060 - Controls & Instrumentation

Location: Throughout the Building
Distress: Beyond Service Life
Category: Deferred Maintenance
Priority: 3 - Necessary/Not Yet Critical (Years 2-5)
Correction: Renew System
Qty: 9,921.00
Unit of Measure: S.F.
Estimate: \$35,031.00
Assessor Name: Eduardo Lopez
Date Created: 01/04/2017

Notes: The controls and instrumentation system is in marginal condition and should be schedule for replacement.

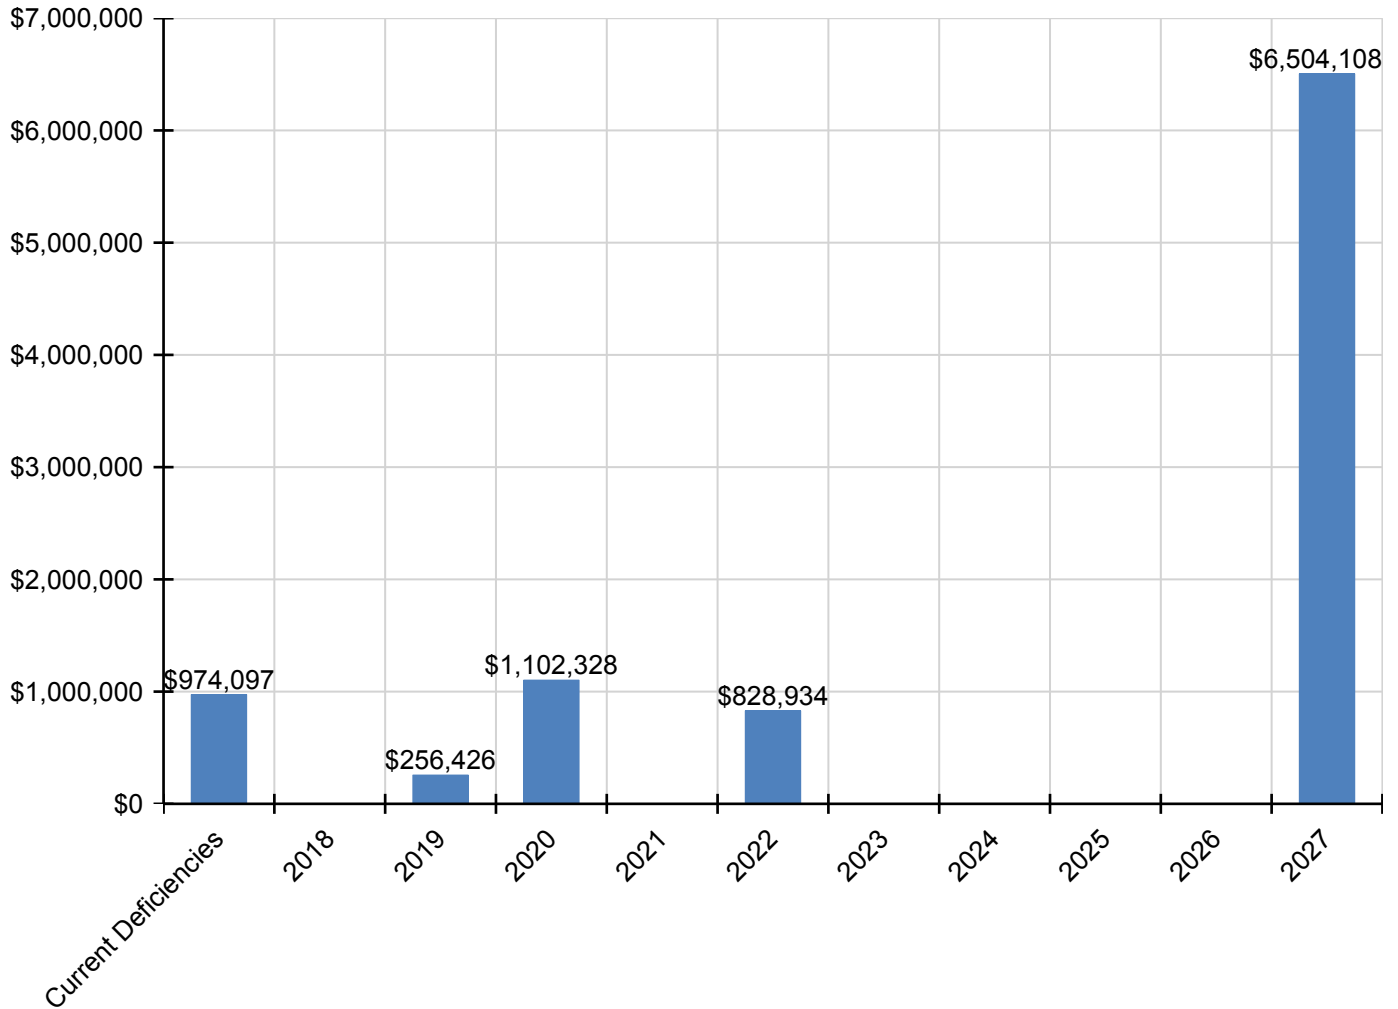
Forecasted Capital Renewal Requirement

The following chart shows the current building deficiencies and forecasting capital renewal or sustainment requirements over the next ten years.

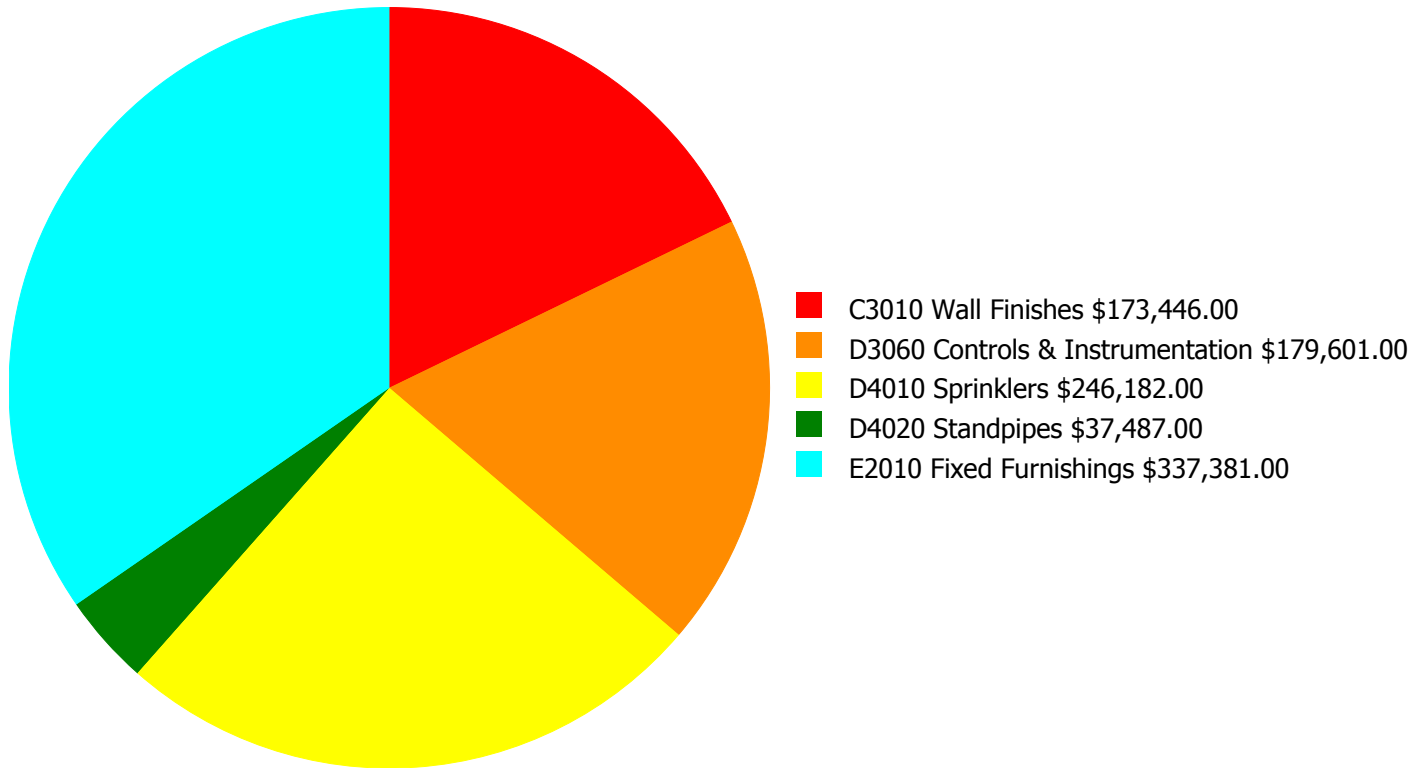
Deficiency Summary by System

Current deficiencies included assemblies that have reached or exceeded their design life or components of the assemblies that are in need of repair. Assemblies that have reached their design life are identified as current deficiencies and assigned the distress 'Beyond Useful Life'. The following chart lists all current deficiencies associated with this facility.

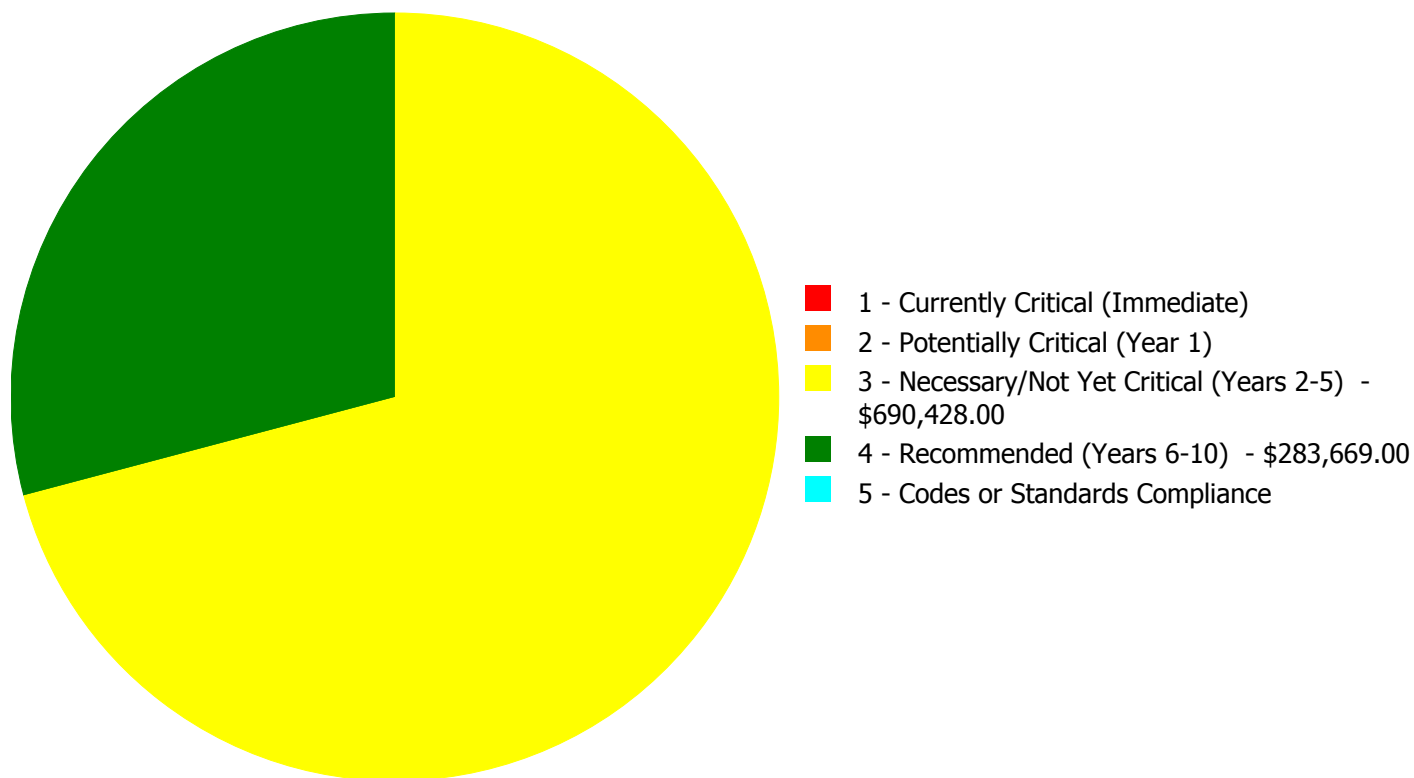
Deficiency Summary by Priority

The following chart shows the total repair costs broken down by priority. Assessors assigned deficiencies within eCOMET to one of the following priority categories:

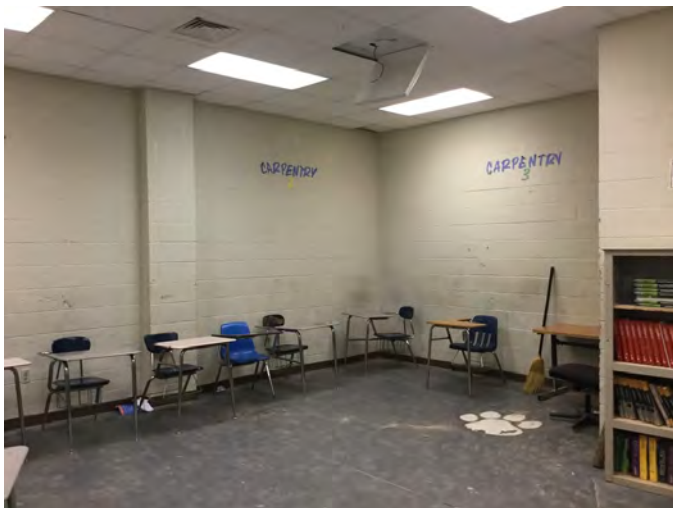
System: C3010 - Wall Finishes

Location: Throughout the Building
Distress: Beyond Service Life
Category: Deferred Maintenance
Priority: 3 - Necessary/Not Yet Critical (Years 2-5)
Correction: Renew System
Qty: 50,864.00
Unit of Measure: S.F.
Estimate: \$173,446.00
Assessor Name: Eduardo Lopez
Date Created: 01/04/2017

Notes: The wall finishes are aged, scuffed, fading, stained and should be replaced.

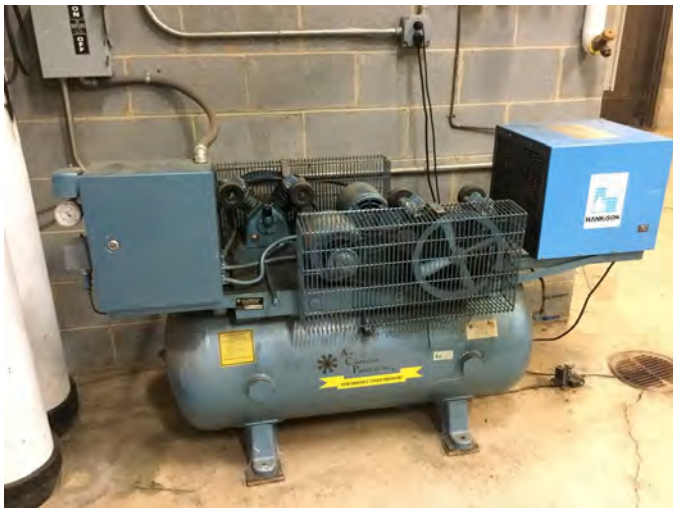
System: D3060 - Controls & Instrumentation

Location: Throughout the Building
Distress: Beyond Service Life
Category: Deferred Maintenance
Priority: 3 - Necessary/Not Yet Critical (Years 2-5)
Correction: Renew System
Qty: 50,864.00
Unit of Measure: S.F.
Estimate: \$179,601.00
Assessor Name: Eduardo Lopez
Date Created: 01/04/2017

Notes: The controls and instrumentation system is in marginal condition and should be schedule for replacement.

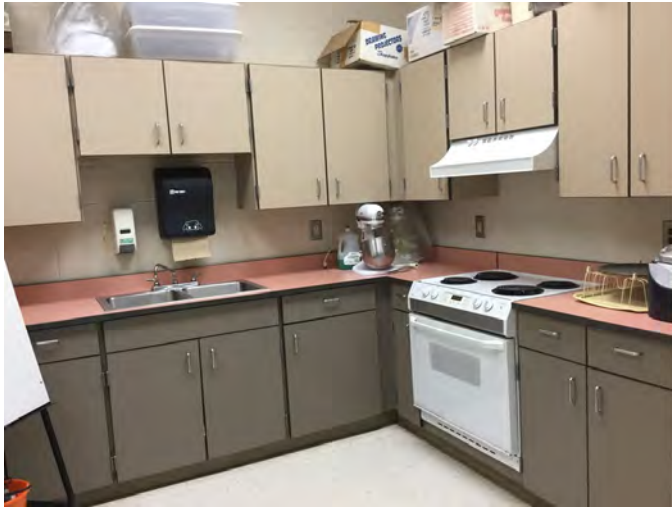
System: E2010 - Fixed Furnishings

Location: Throughout the Building
Distress: Beyond Service Life
Category: Deferred Maintenance
Priority: 3 - Necessary/Not Yet Critical (Years 2-5)
Correction: Renew System
Qty: 50,864.00
Unit of Measure: S.F.
Estimate: \$337,381.00
Assessor Name: Eduardo Lopez
Date Created: 01/04/2017

Notes: The fixed furnishings are aged, in marginal condition, and should be replaced.

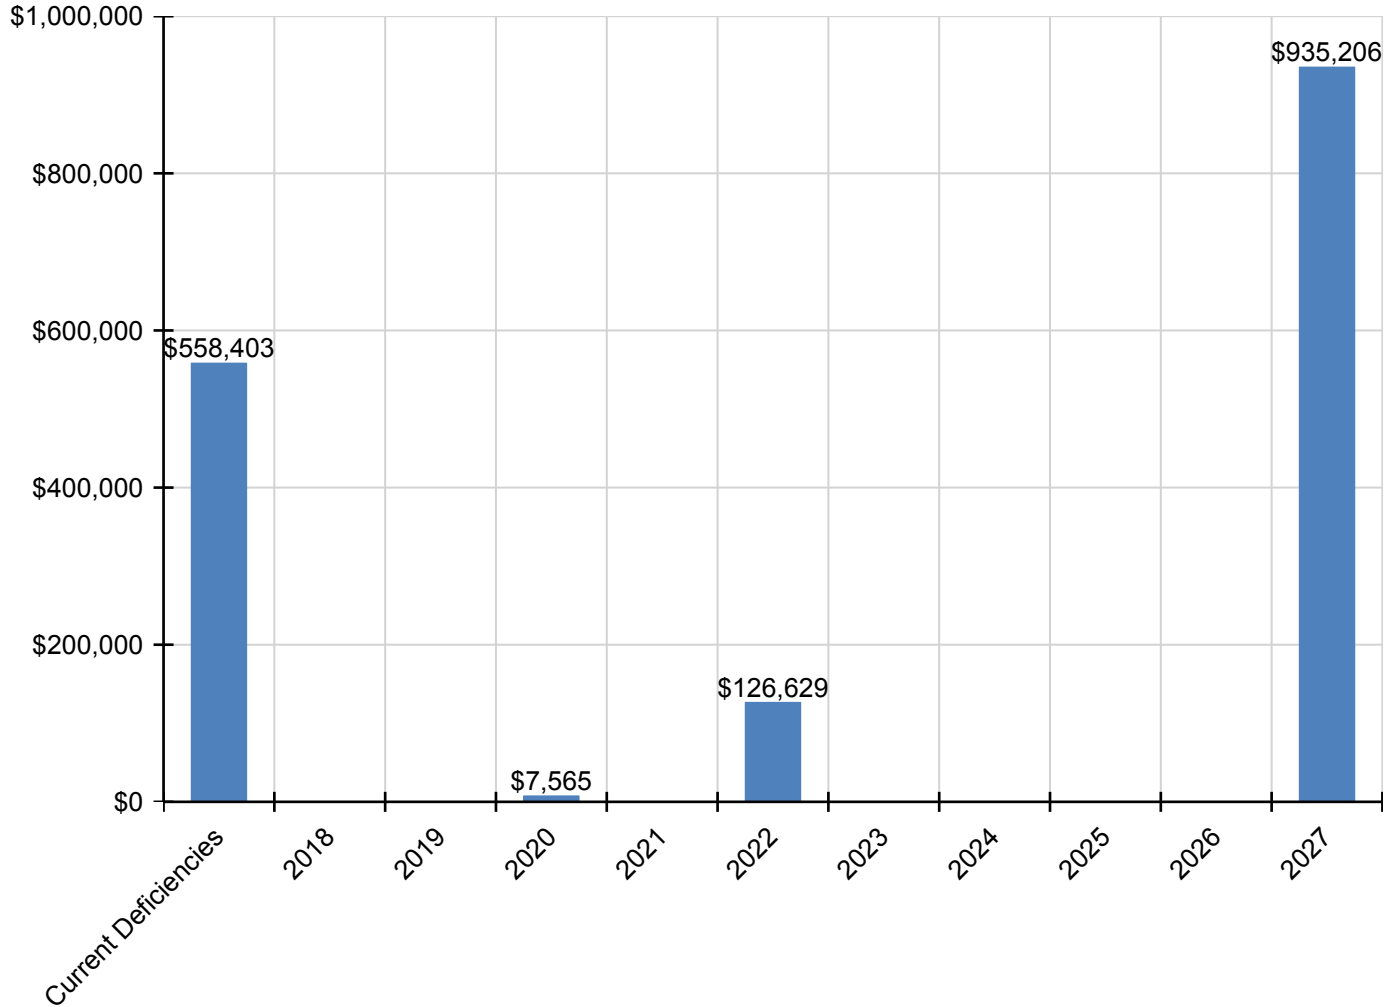
Forecasted Capital Renewal Requirement

The following chart shows the current building deficiencies and forecasting capital renewal or sustainment requirements over the next ten years.

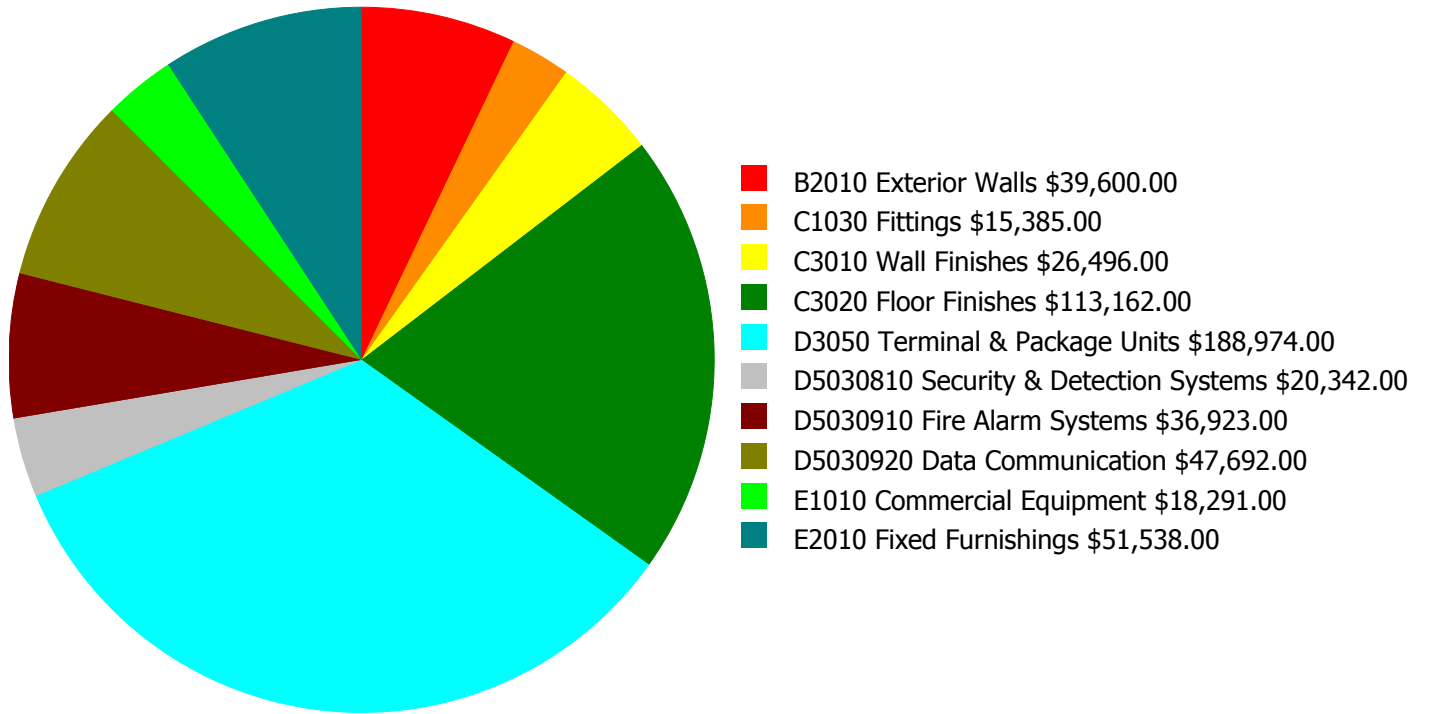
Deficiency Summary by System

Current deficiencies included assemblies that have reached or exceeded their design life or components of the assemblies that are in need of repair. Assemblies that have reached their design life are identified as current deficiencies and assigned the distress 'Beyond Useful Life'. The following chart lists all current deficiencies associated with this facility.

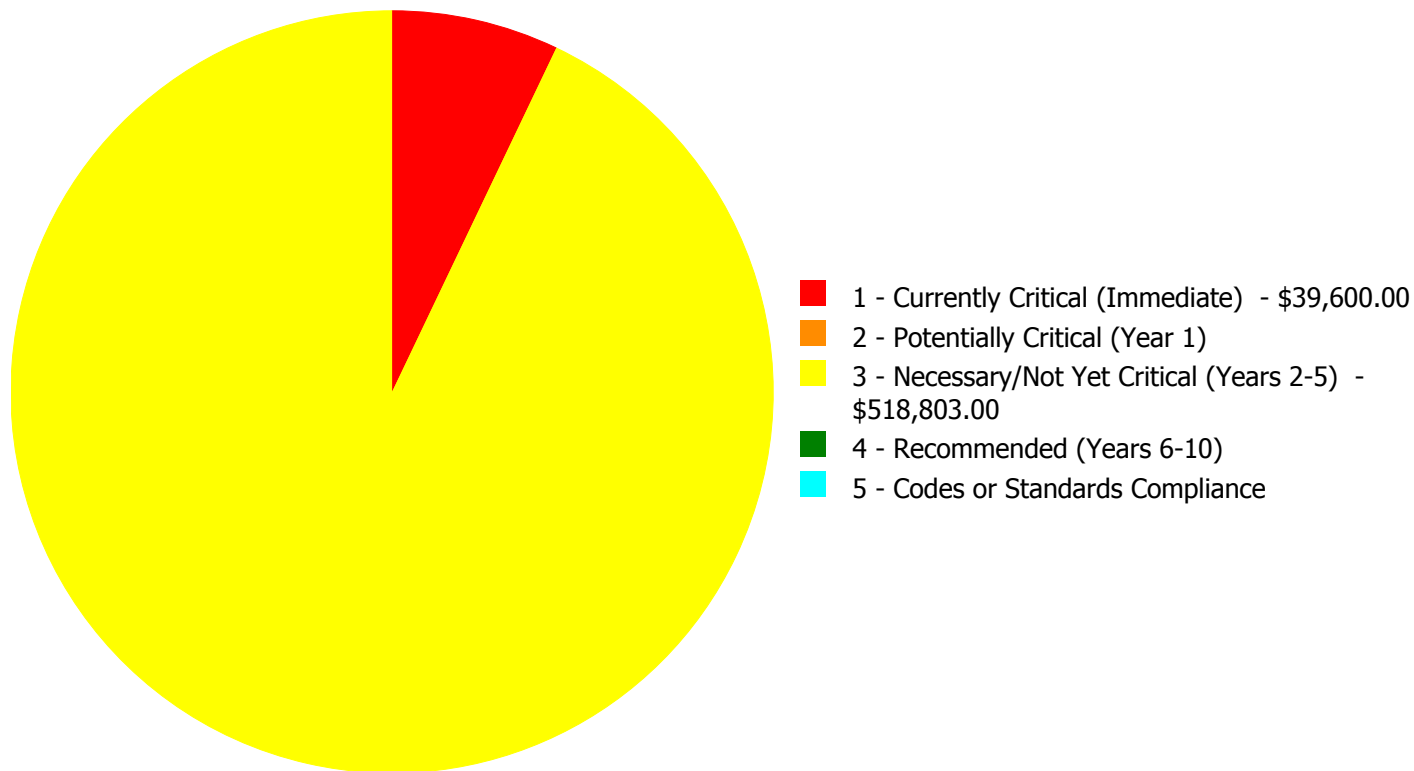
Deficiency Summary by Priority

The following chart shows the total repair costs broken down by priority. Assessors assigned deficiencies within eCOMET to one of the following priority categories:

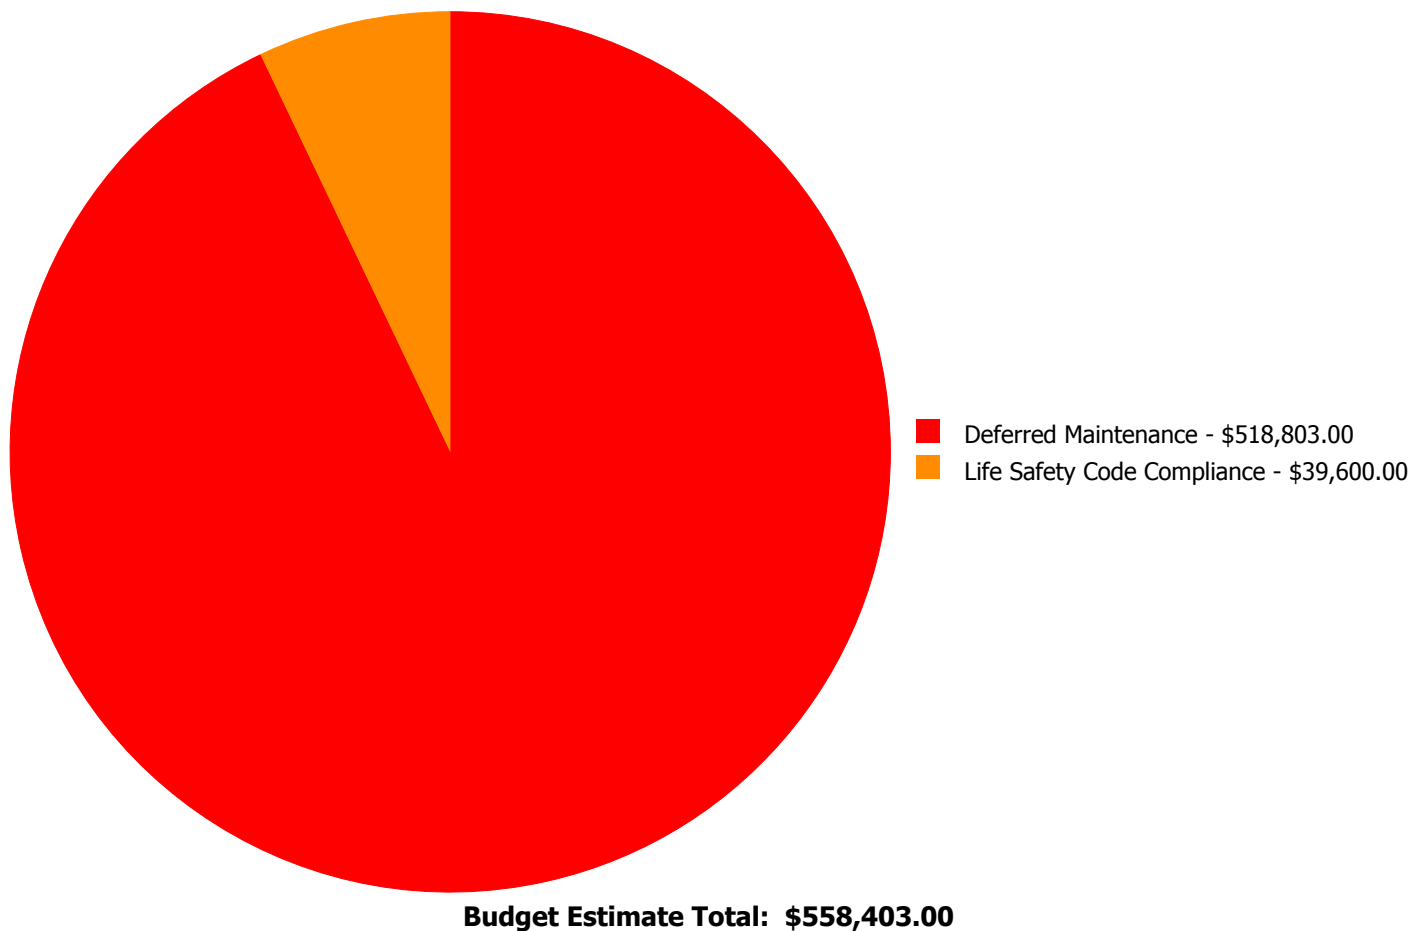
Deficiency Summary by Category

The following chart shows the total repair costs broken down by deficiency categories. Assessors assigned deficiencies to one of the following categories:

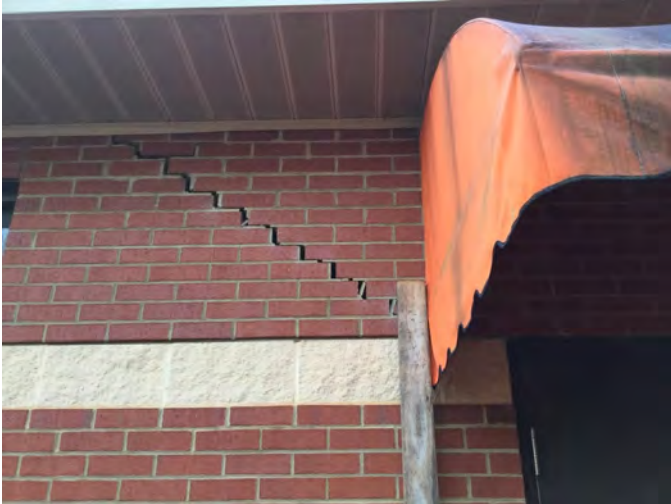
System: B2010 - Exterior Walls

Location: West End
Distress: Failing
Category: Life Safety Code Compliance
Priority: 1 - Currently Critical (Immediate)
Correction: Engineering study-2016-08-16 18:28:55
Qty: 1.00
Unit of Measure: Ea.
Estimate: \$39,600.00
Assessor Name: Eduardo Lopez
Date Created: 02/15/2017

Notes: It was observed on the exterior walls and slab are showing signs of failure with cracks and foundation settlement issues at the west end of the building, and an engineering study is recommended to determine the cause. Pricing does not include remediation measures.

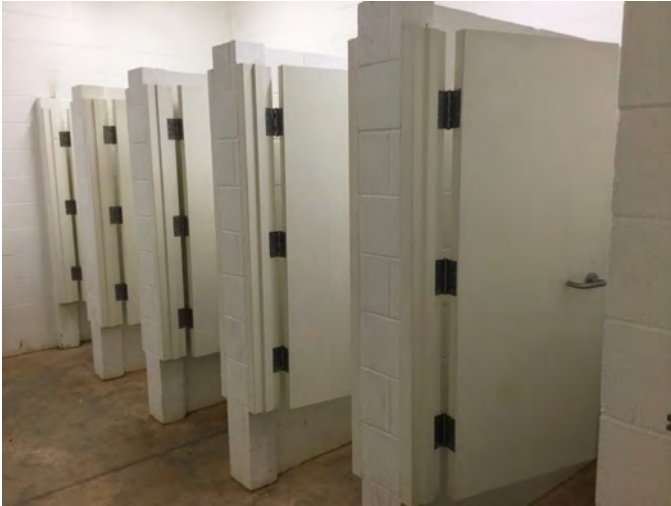
System: C1030 - Fittings

Location: Throughout the Building
Distress: Beyond Service Life
Category: Deferred Maintenance
Priority: 3 - Necessary/Not Yet Critical (Years 2-5)
Correction: Renew System
Qty: 7,770.00
Unit of Measure: S.F.
Estimate: \$15,385.00
Assessor Name: Eduardo Lopez
Date Created: 01/04/2017

Notes: The fittings throughout the building are aged, in marginal condition, handrails and room signage are not ADA compliant and should be replaced.

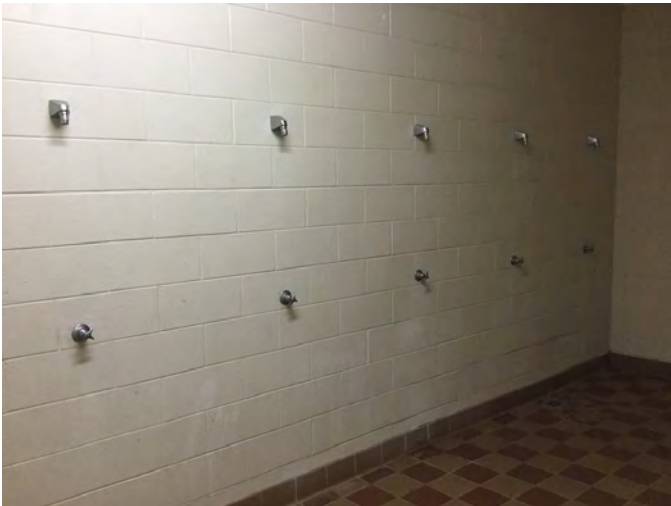
System: C3010 - Wall Finishes

Location: Throughout the Building
Distress: Beyond Service Life
Category: Deferred Maintenance
Priority: 3 - Necessary/Not Yet Critical (Years 2-5)
Correction: Renew System
Qty: 7,770.00
Unit of Measure: S.F.
Estimate: \$26,496.00
Assessor Name: Eduardo Lopez
Date Created: 01/04/2017

Notes: The wall finishes are aged, scuffed, fading, stained and should be replaced.

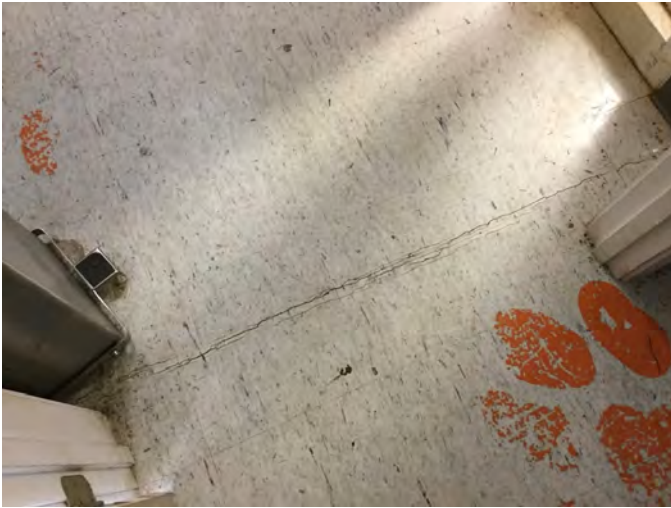
System: C3020 - Floor Finishes

Location: Throughout the Building
Distress: Beyond Service Life
Category: Deferred Maintenance
Priority: 3 - Necessary/Not Yet Critical (Years 2-5)
Correction: Renew System
Qty: 7,770.00
Unit of Measure: S.F.
Estimate: \$113,162.00
Assessor Name: Eduardo Lopez
Date Created: 01/04/2017

Notes: The original flooring is in poor conditions and should be replaced.

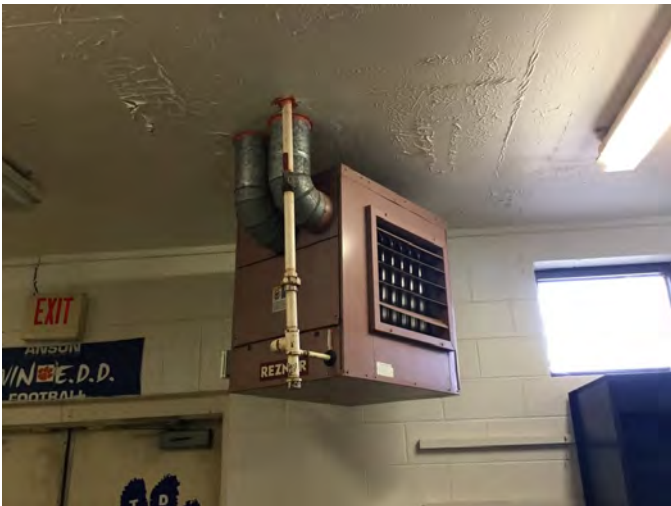
System: D3050 - Terminal & Package Units

Location: Throughout the Building
Distress: Beyond Service Life
Category: Deferred Maintenance
Priority: 3 - Necessary/Not Yet Critical (Years 2-5)
Correction: Renew System
Qty: 7,770.00
Unit of Measure: S.F.
Estimate: \$188,974.00
Assessor Name: Eduardo Lopez
Date Created: 01/04/2017

Notes: Terminal and package units are beyond their expected service life and should be scheduled for replacement.

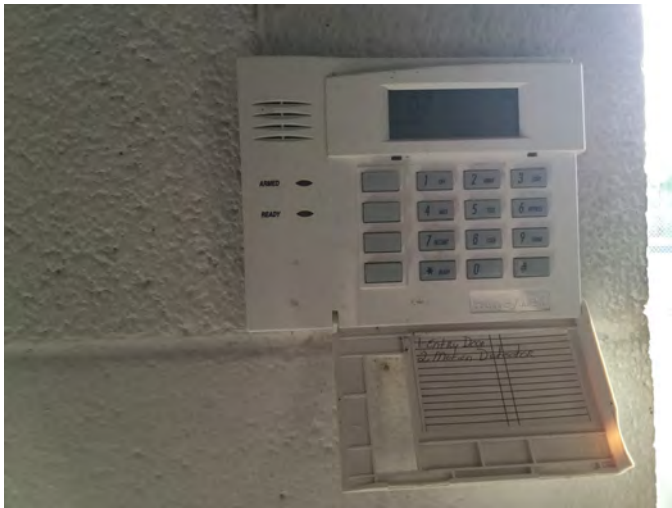
System: D5030810 - Security & Detection Systems

Location: Throughout the Building
Distress: Beyond Service Life
Category: Deferred Maintenance
Priority: 3 - Necessary/Not Yet Critical (Years 2-5)
Correction: Renew System
Qty: 7,770.00
Unit of Measure: S.F.
Estimate: \$20,342.00
Assessor Name: Eduardo Lopez
Date Created: 01/04/2017

Notes: The security and detection system is beyond its expected service life and should be scheduled for replacement.

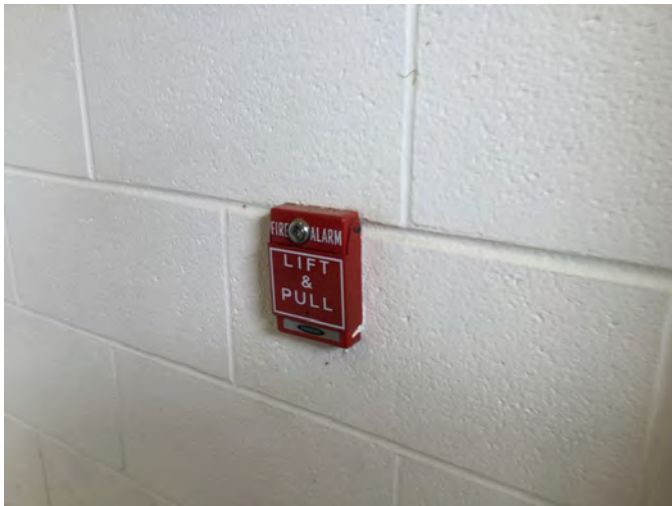
System: D5030910 - Fire Alarm Systems

Location: Throughout the Building
Distress: Beyond Service Life
Category: Deferred Maintenance
Priority: 3 - Necessary/Not Yet Critical (Years 2-5)
Correction: Renew System
Qty: 7,770.00
Unit of Measure: S.F.
Estimate: \$36,923.00
Assessor Name: Eduardo Lopez
Date Created: 01/04/2017

Notes: The fire alarm system is beyond its expected service life and should be scheduled for replacement.

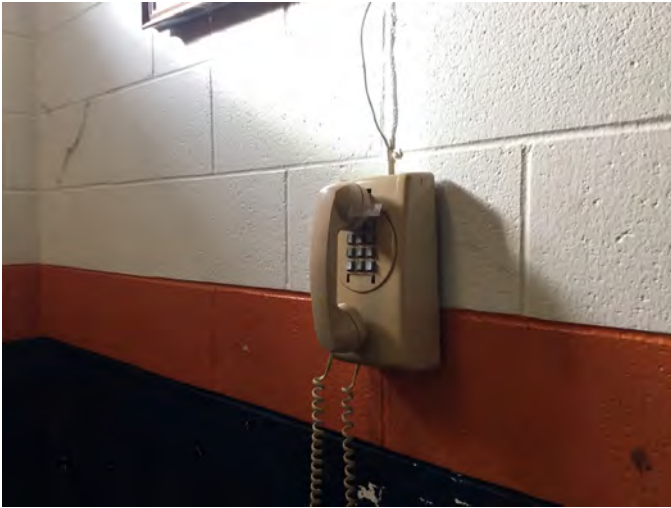
System: D5030920 - Data Communication

Location: Throughout the Building
Distress: Beyond Service Life
Category: Deferred Maintenance
Priority: 3 - Necessary/Not Yet Critical (Years 2-5)
Correction: Renew System
Qty: 7,770.00
Unit of Measure: S.F.
Estimate: \$47,692.00
Assessor Name: Eduardo Lopez
Date Created: 01/04/2017

Notes: The data communication system is beyond its expected service life and should be scheduled for replacement.

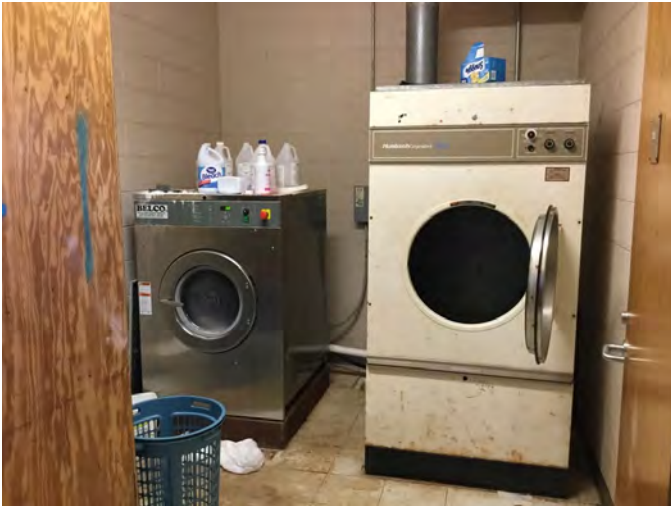
System: E1010 - Commercial Equipment

Location: Laundry Room
Distress: Beyond Service Life
Category: Deferred Maintenance
Priority: 3 - Necessary/Not Yet Critical (Years 2-5)
Correction: Renew System
Qty: 7,770.00
Unit of Measure: S.F.
Estimate: \$18,291.00
Assessor Name: Eduardo Lopez
Date Created: 02/15/2017

Notes: The commercial equipment is in deteriorating conditions and should be replaced.

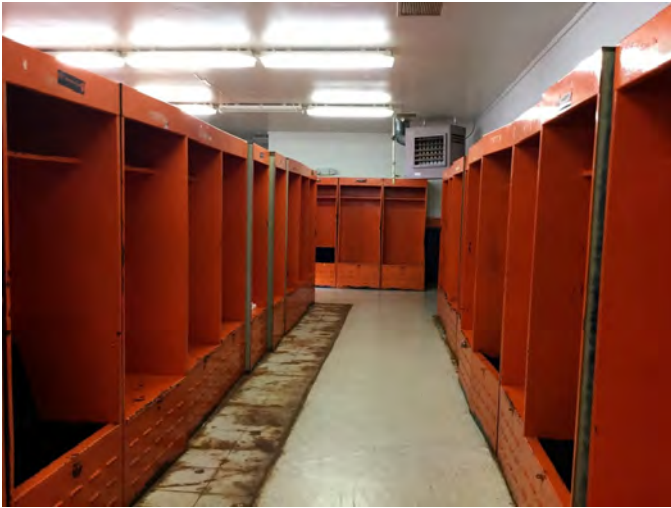
System: E2010 - Fixed Furnishings

Location: Throughout the Building
Distress: Beyond Service Life
Category: Deferred Maintenance
Priority: 3 - Necessary/Not Yet Critical (Years 2-5)
Correction: Renew System
Qty: 7,770.00
Unit of Measure: S.F.
Estimate: \$51,538.00
Assessor Name: Eduardo Lopez
Date Created: 01/04/2017

Notes: The fixed furnishings are aged, in marginal condition, and should be replaced.
