NC School District/040 Anson County/High School

Anson High

Campus Assessment Report

March 10, 2017

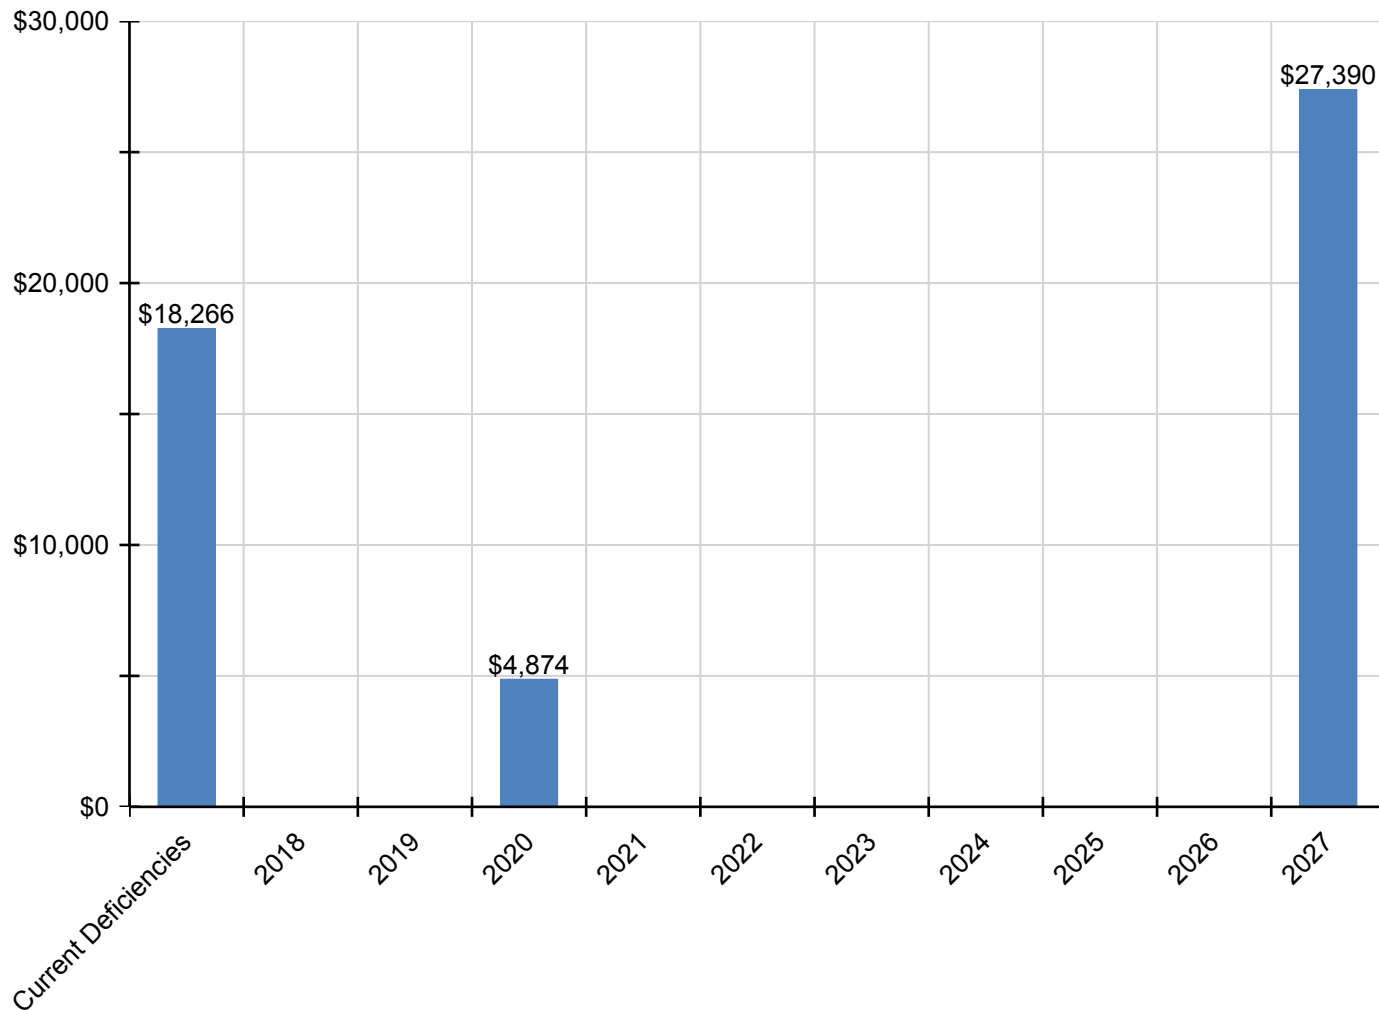
Forecasted Capital Renewal Requirement

The following chart shows the current building deficiencies and forecasting capital renewal or sustainment requirements over the next ten years.

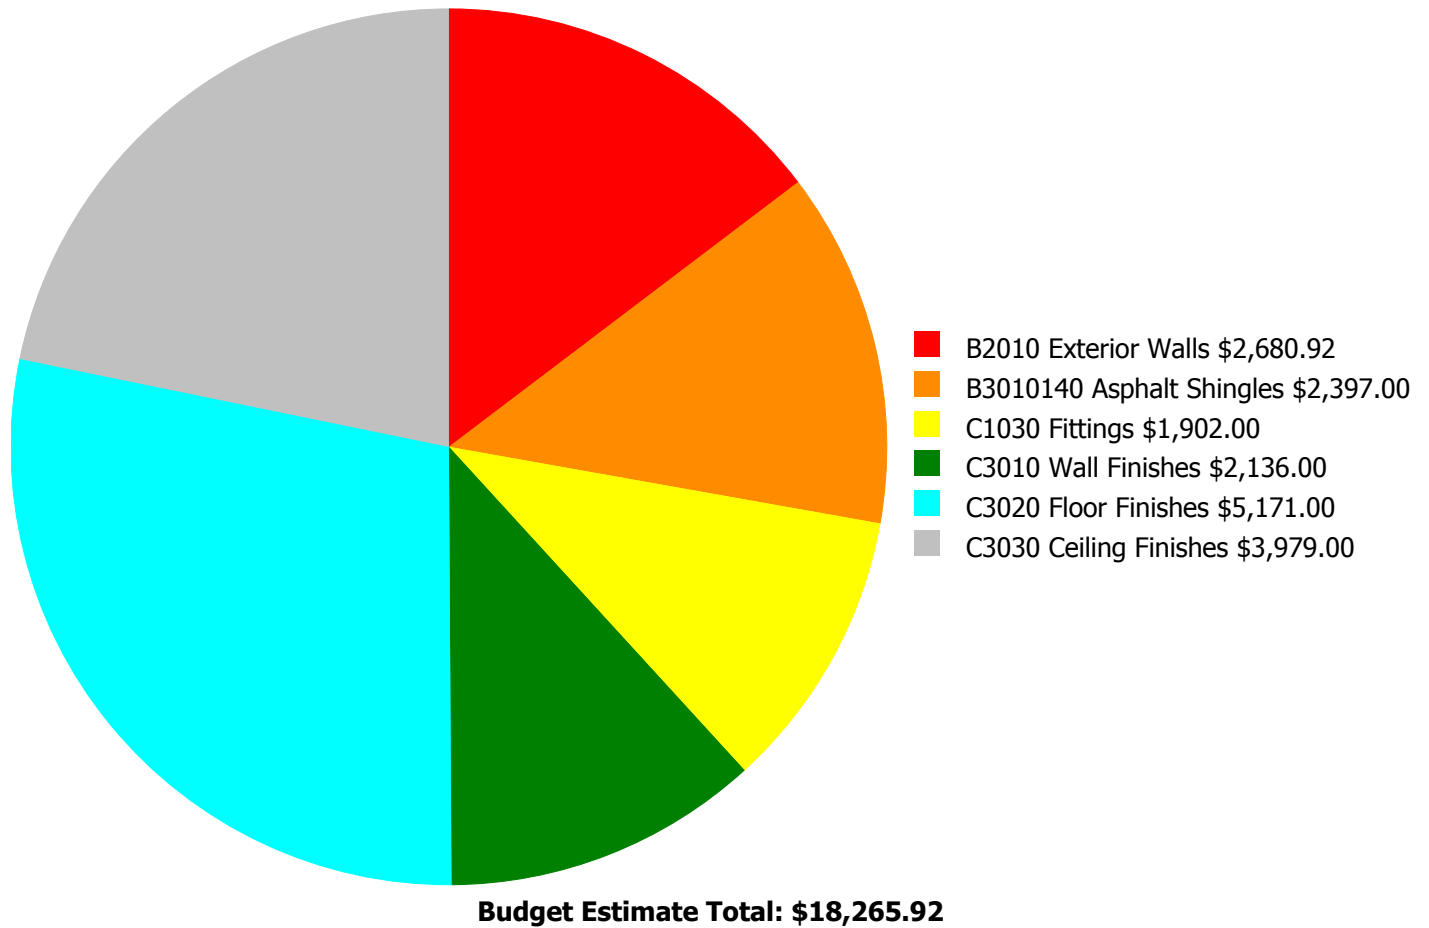
Deficiency Summary by System

Current deficiencies included assemblies that have reached or exceeded their design life or components of the assemblies that are in need of repair. Assemblies that have reached their design life are identified as current deficiencies and assigned the distress 'Beyond Useful Life'. The following chart lists all current deficiencies associated with this facility.

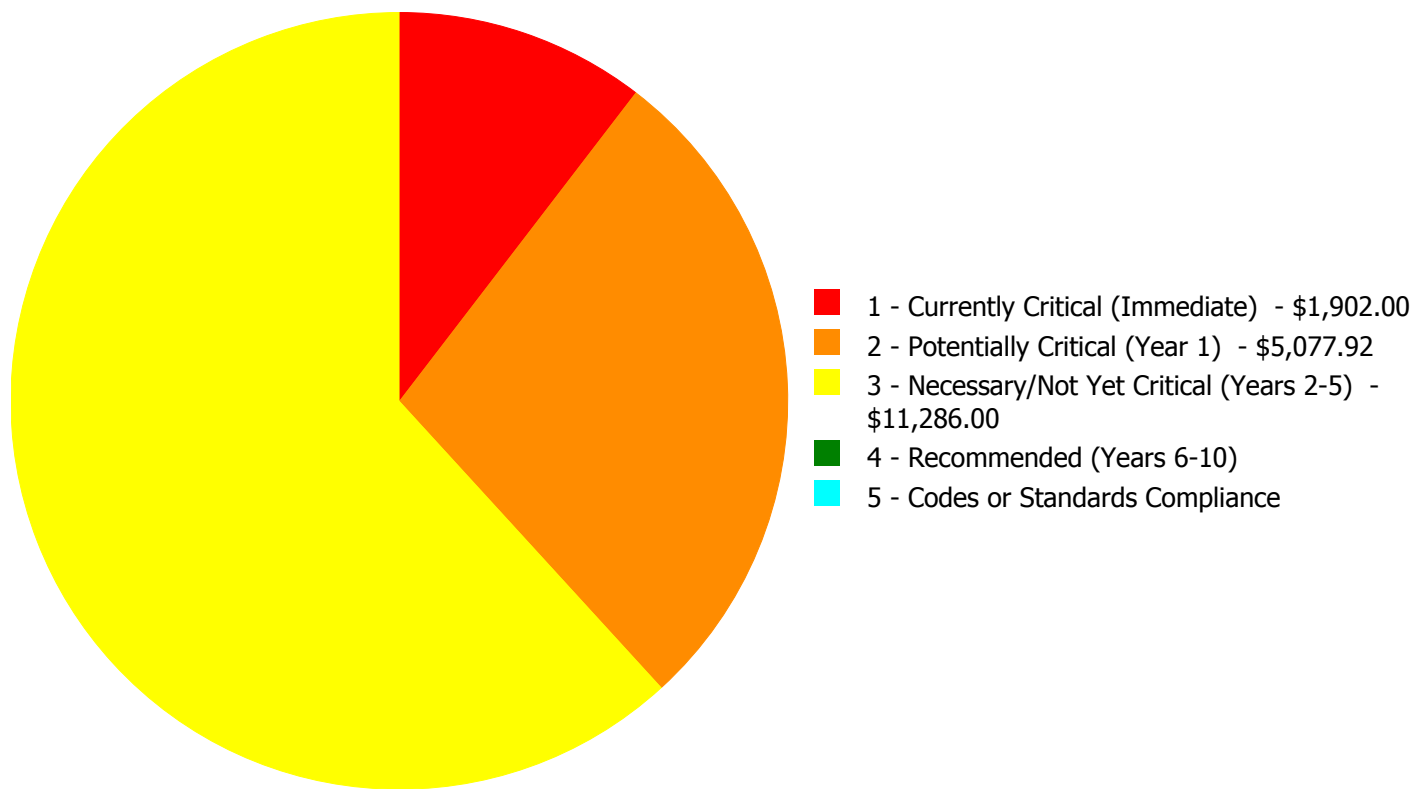
Deficiency Summary by Priority

The following chart shows the total repair costs broken down by priority. Assessors assigned deficiencies within eCOMET to one of the following priority categories:

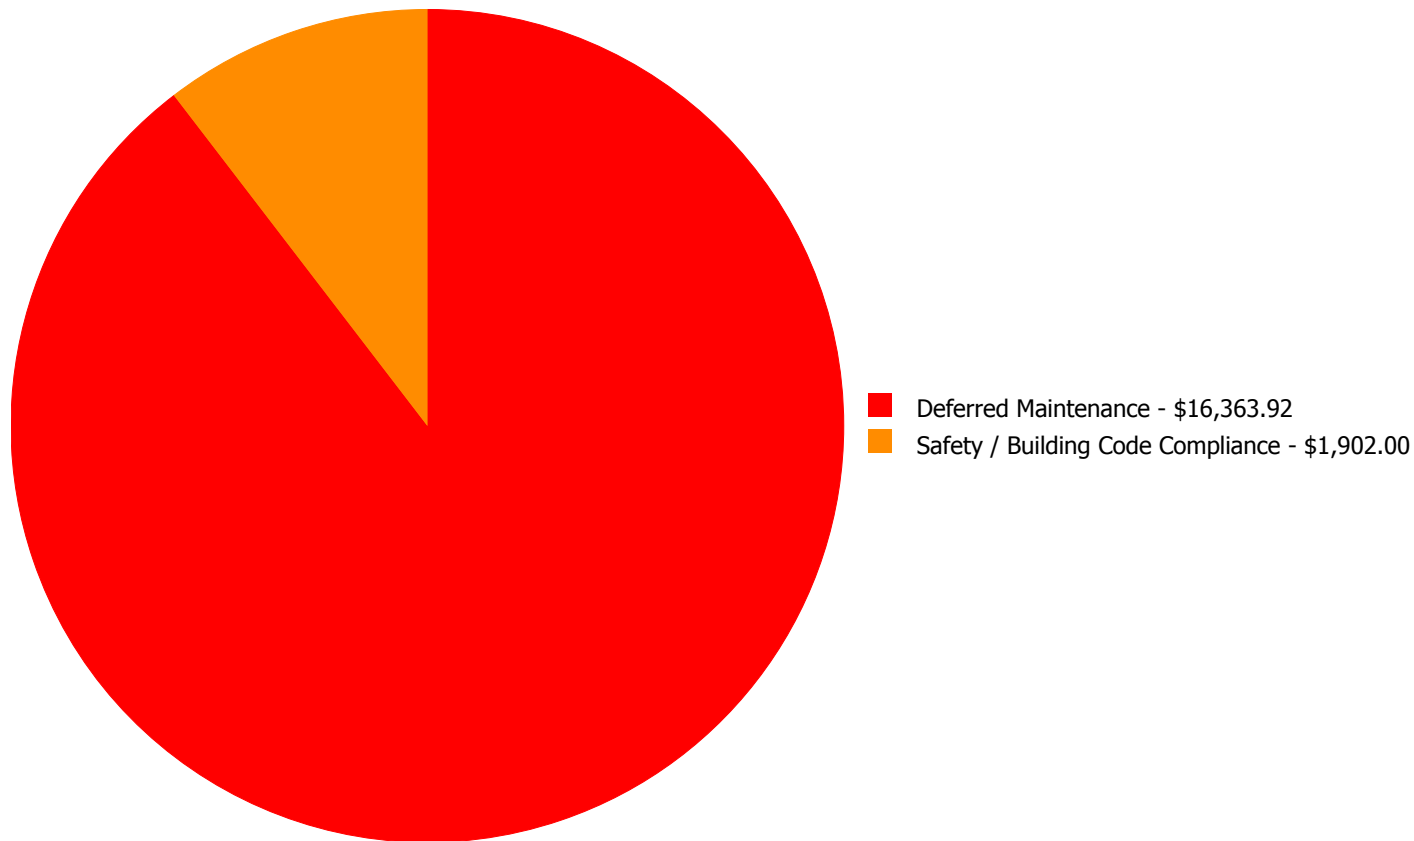
Deficiency Summary by Category

The following chart shows the total repair costs broken down by deficiency categories. Assessors assigned deficiencies to one of the following categories:

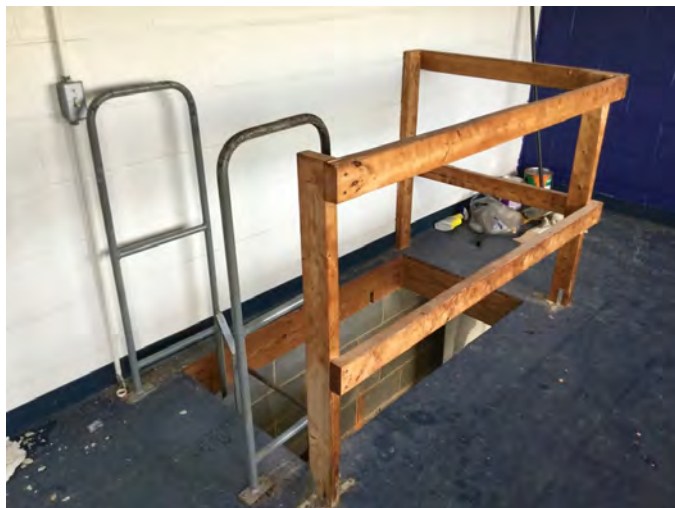
System: C1030 - Fittings

Location: 2nd Floor
Distress: Inadequate
Category: Safety / Building Code Compliance
Priority: 1 - Currently Critical (Immediate)
Correction: Renew System
Qty: 380.00
Unit of Measure: S.F.
Estimate: \$1,902.00
Assessor Name: Eduardo Lopez
Date Created: 02/15/2017

Notes: The handrail is not code compliant and should be replaced.

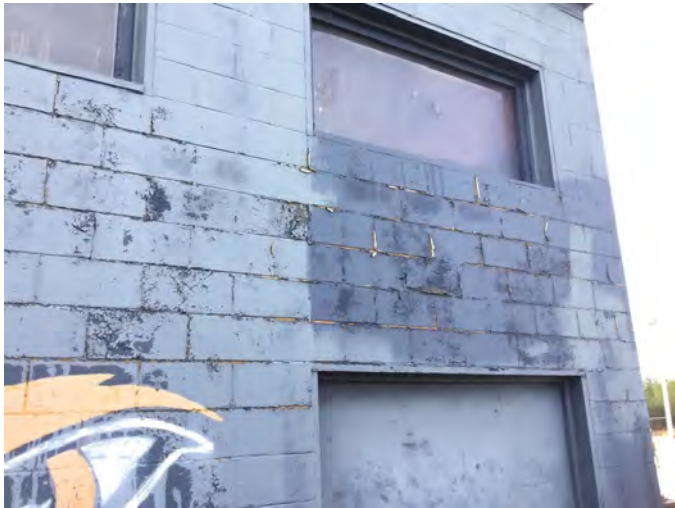
System: B2010 - Exterior Walls

Location: Exterior Walls
Distress: Damaged
Category: Deferred Maintenance
Priority: 2 - Potentially Critical (Year 1)
Correction: Spray refinish exterior walls
Qty: 1,000.00
Unit of Measure: S.F.
Estimate: \$2,680.92
Assessor Name: Eduardo Lopez
Date Created: 02/15/2017

Notes: The exterior wall paint is damaged, fading, stained, and should be re-painted.

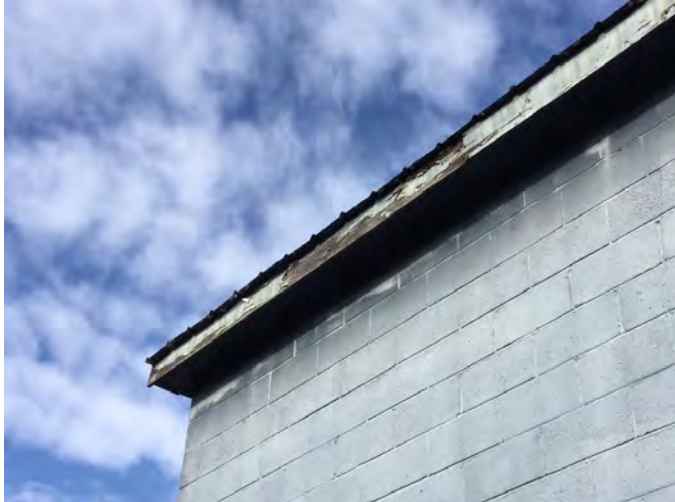
System: B3010140 - Asphalt Shingles

Location: Roof
Distress: Beyond Service Life
Category: Deferred Maintenance
Priority: 2 - Potentially Critical (Year 1)
Correction: Renew System
Qty: 380.00
Unit of Measure: S.F.
Estimate: \$2,397.00
Assessor Name: Eduardo Lopez
Date Created: 02/15/2017

Notes: The asphalt shingles roof covering is in deteriorating conditions with water leaks, and should be replaced.

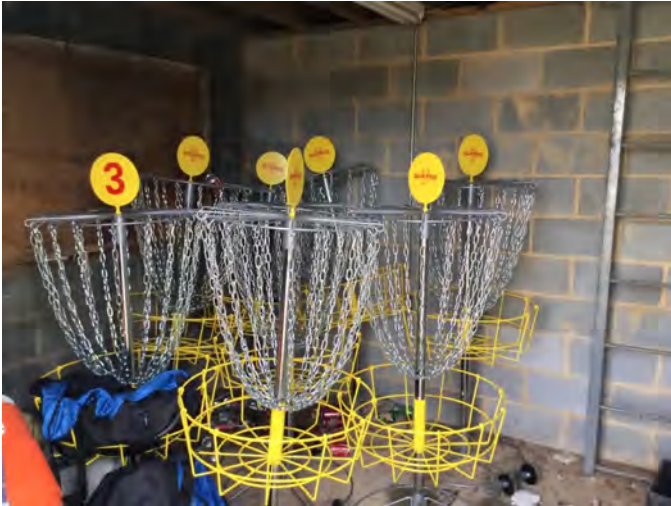
System: C3010 - Wall Finishes

Location: Throughout the Building
Distress: Beyond Service Life
Category: Deferred Maintenance
Priority: 3 - Necessary/Not Yet Critical (Years 2-5)
Correction: Renew System
Qty: 380.00
Unit of Measure: S.F.
Estimate: \$2,136.00
Assessor Name: Eduardo Lopez
Date Created: 02/15/2017

Notes: The wall finishes are aged, scuffed, fading, stained and should be replaced.

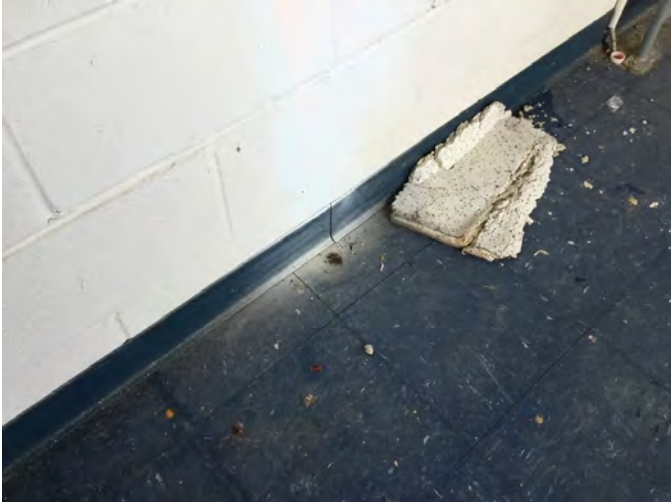
System: C3020 - Floor Finishes

Location: Throughout the Building
Distress: Beyond Service Life
Category: Deferred Maintenance
Priority: 3 - Necessary/Not Yet Critical (Years 2-5)
Correction: Renew System
Qty: 380.00
Unit of Measure: S.F.
Estimate: \$5,171.00
Assessor Name: Eduardo Lopez
Date Created: 02/15/2017

Notes: The original flooring is in poor conditions and should be replaced.

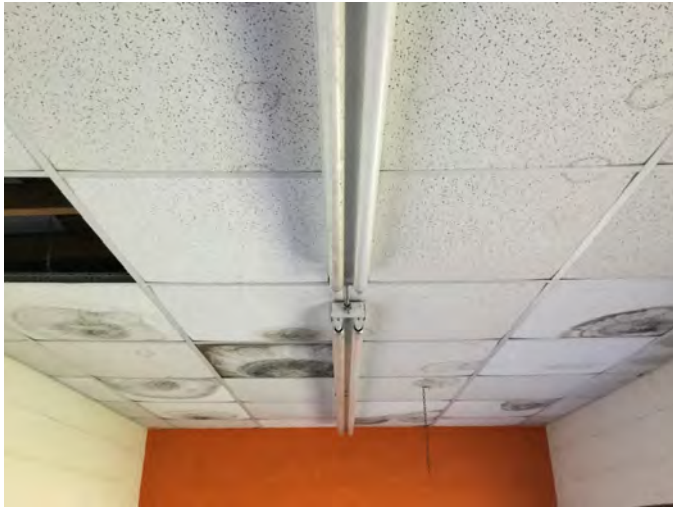
System: C3030 - Ceiling Finishes

Location: Throughout the Building
Distress: Beyond Service Life
Category: Deferred Maintenance
Priority: 3 - Necessary/Not Yet Critical (Years 2-5)
Correction: Renew System
Qty: 380.00
Unit of Measure: S.F.
Estimate: \$3,979.00
Assessor Name: Eduardo Lopez
Date Created: 02/15/2017

Notes: The original ceiling finishes are aged, failing and should be replaced.

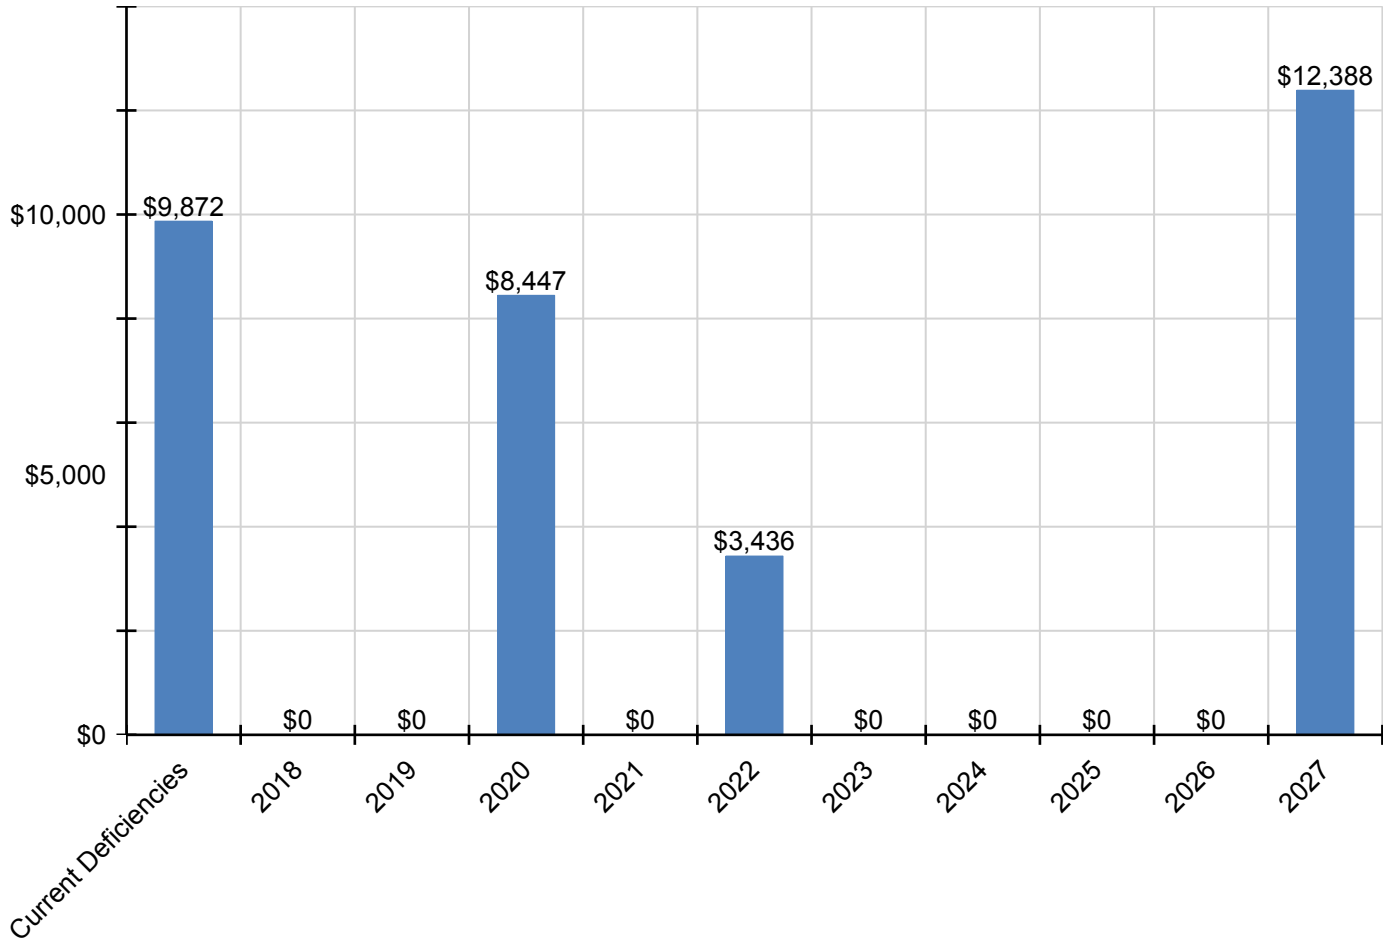
Forecasted Capital Renewal Requirement

The following chart shows the current building deficiencies and forecasting capital renewal or sustainment requirements over the next ten years.

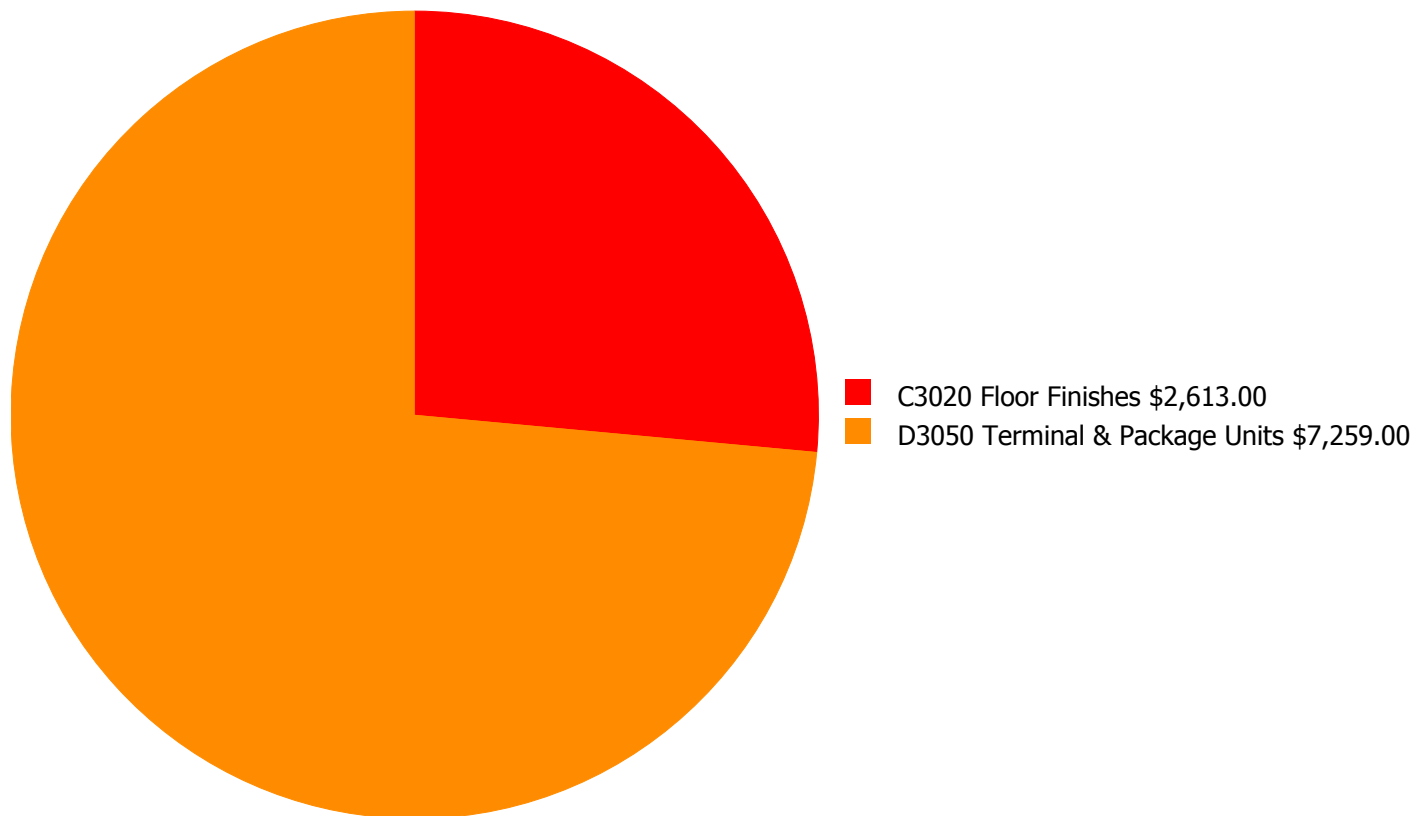
Deficiency Summary by System

Current deficiencies included assemblies that have reached or exceeded their design life or components of the assemblies that are in need of repair. Assemblies that have reached their design life are identified as current deficiencies and assigned the distress 'Beyond Useful Life'. The following chart lists all current deficiencies associated with this facility.

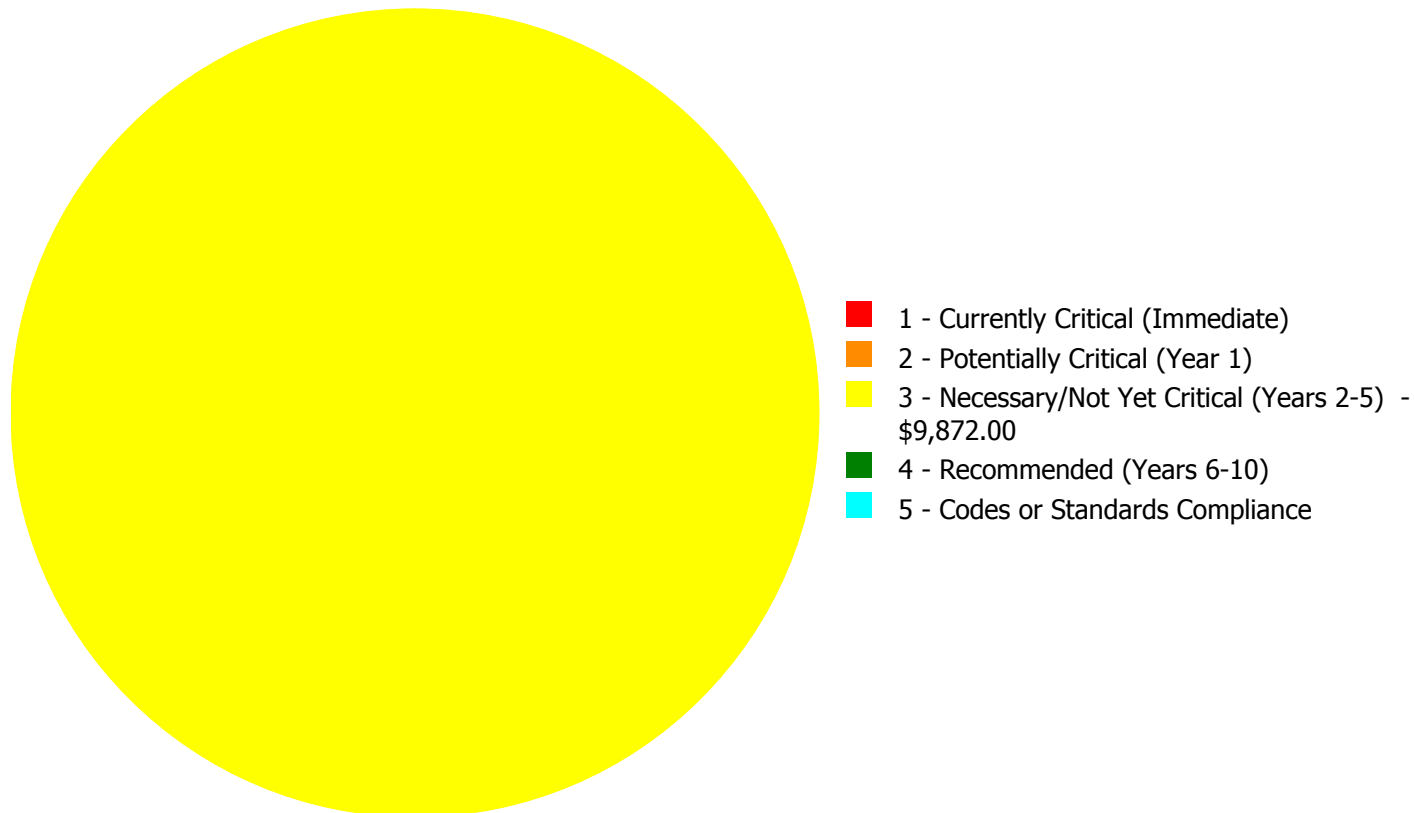
Deficiency Summary by Priority

The following chart shows the total repair costs broken down by priority. Assessors assigned deficiencies within eCOMET to one of the following priority categories:

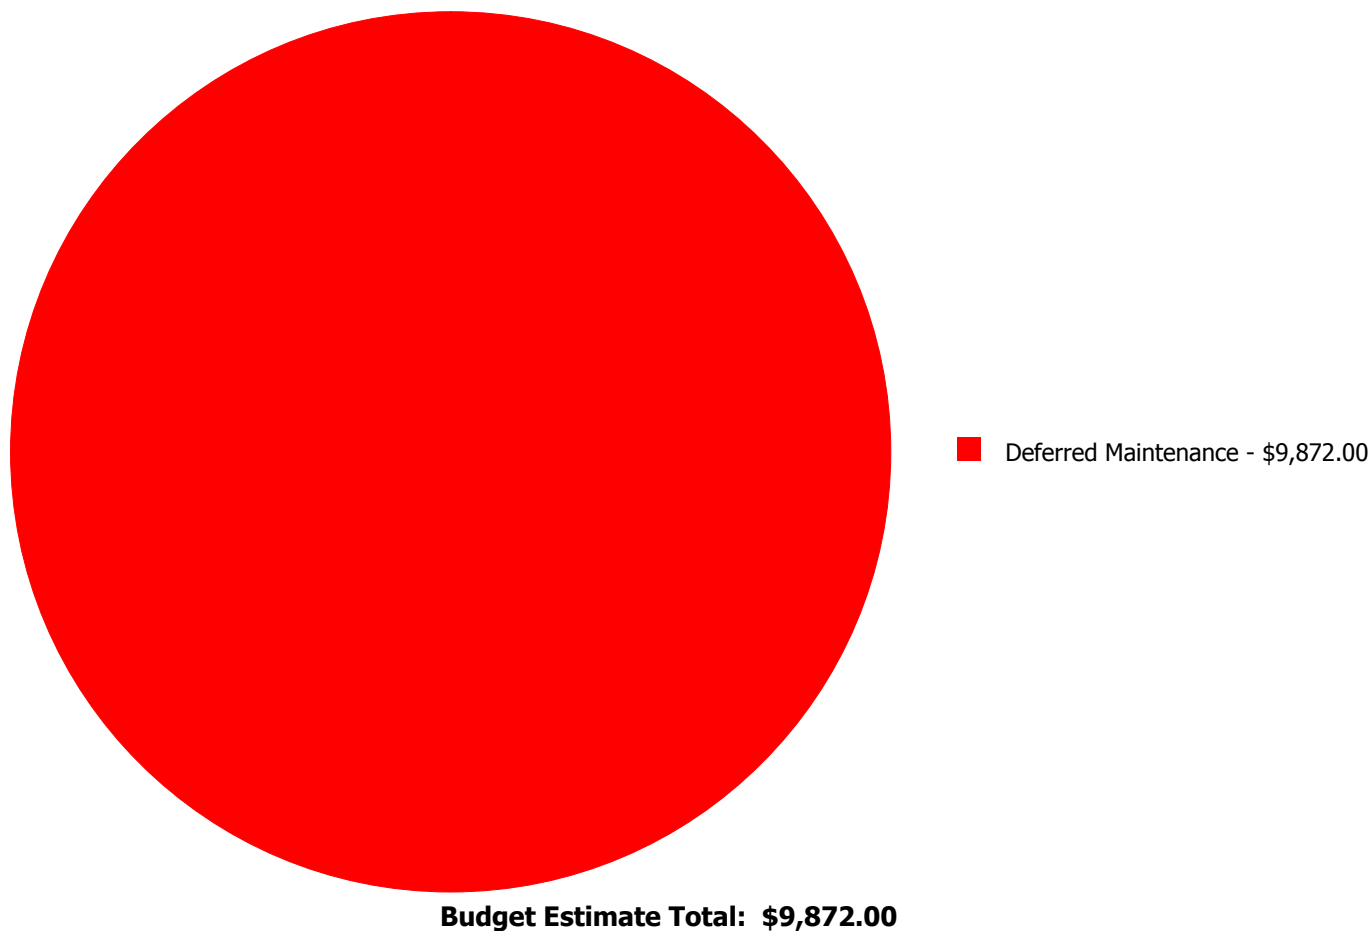
Deficiency Summary by Category

The following chart shows the total repair costs broken down by deficiency categories. Assessors assigned deficiencies to one of the following categories:

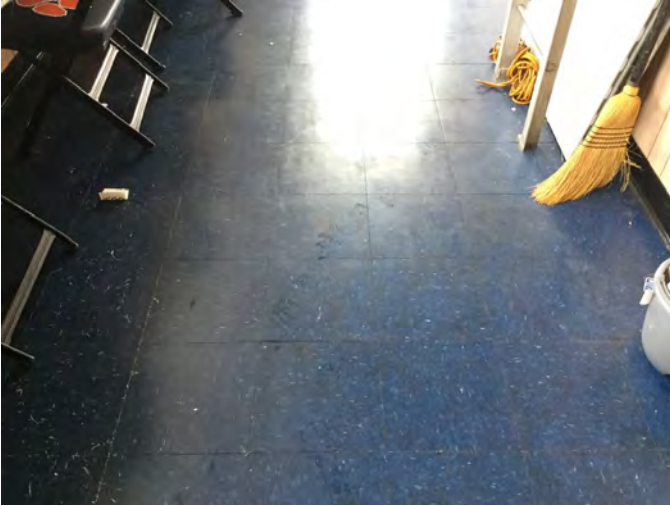
System: C3020 - Floor Finishes

Location: Throughout the Building
Distress: Beyond Service Life
Category: Deferred Maintenance
Priority: 3 - Necessary/Not Yet Critical (Years 2-5)
Correction: Renew System
Qty: 192.00
Unit of Measure: S.F.
Estimate: \$2,613.00
Assessor Name: Eduardo Lopez
Date Created: 01/04/2017

Notes: The original flooring is in poor conditions and should be replaced.

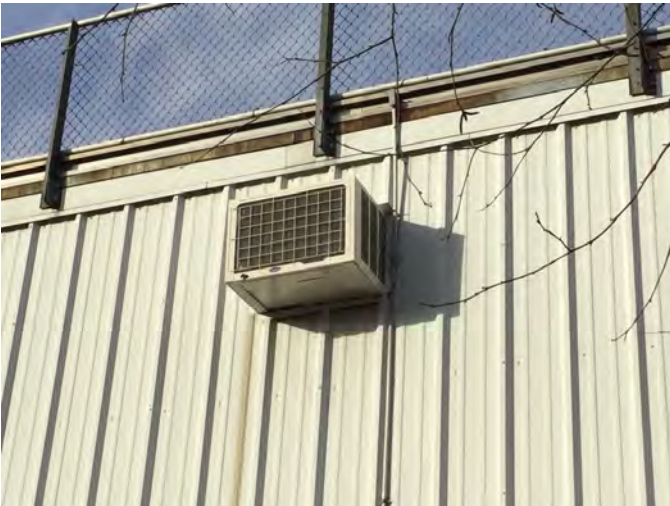
System: D3050 - Terminal & Package Units

Location: Throughout the Building
Distress: Beyond Service Life
Category: Deferred Maintenance
Priority: 3 - Necessary/Not Yet Critical (Years 2-5)
Correction: Renew System
Qty: 192.00
Unit of Measure: S.F.
Estimate: \$7,259.00
Assessor Name: Eduardo Lopez
Date Created: 01/04/2017

Notes: Terminal and package units are beyond their expected service life and should be scheduled for replacement.

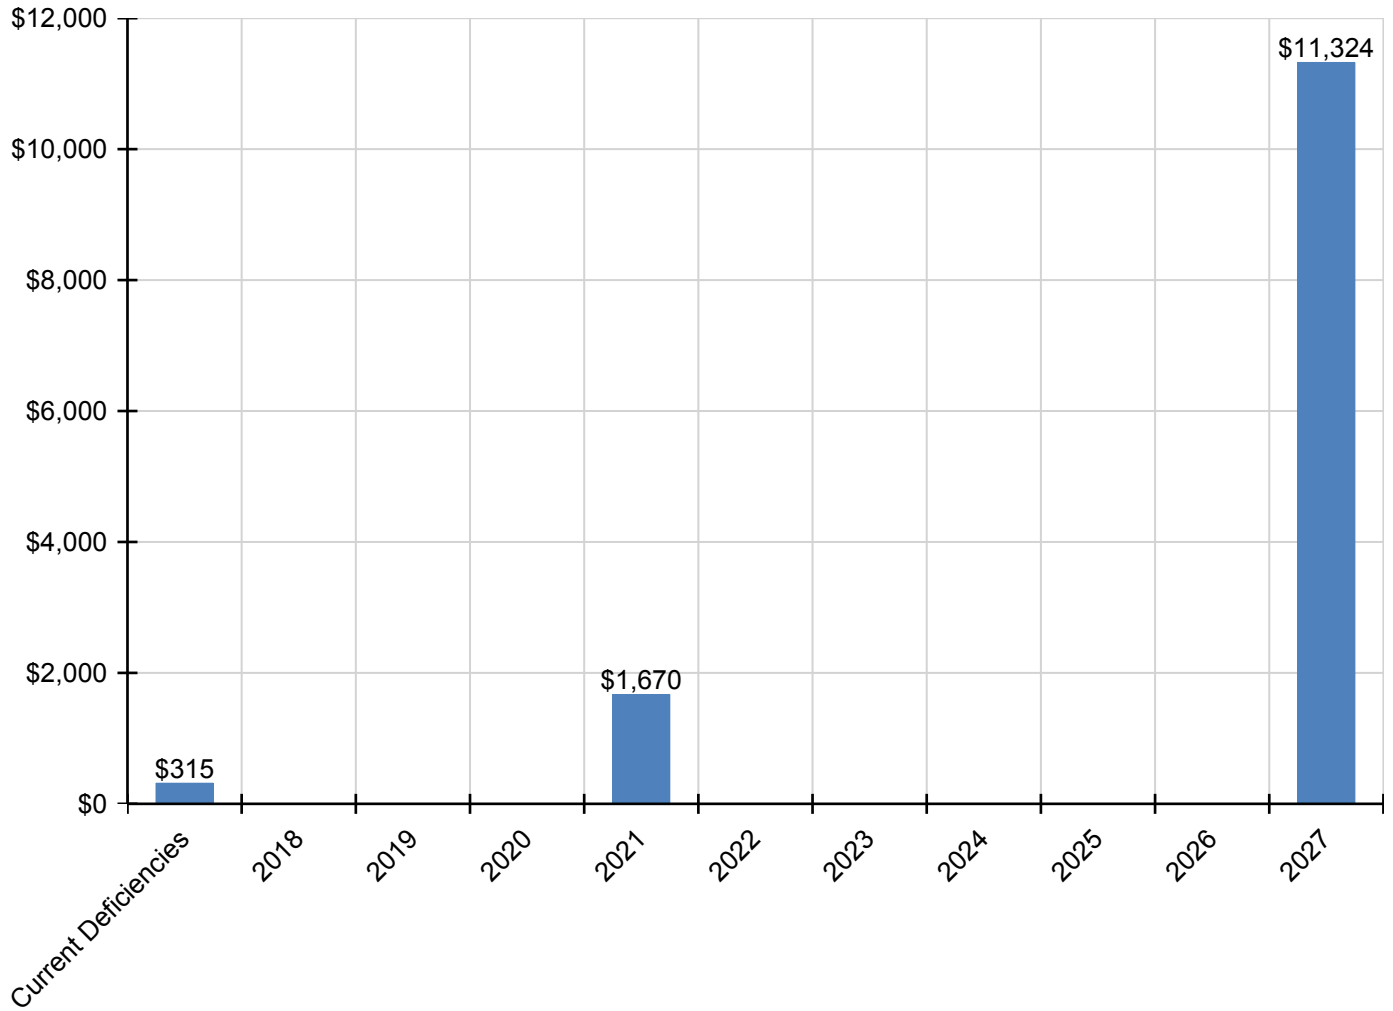
Forecasted Capital Renewal Requirement

The following chart shows the current building deficiencies and forecasting capital renewal or sustainment requirements over the next ten years.

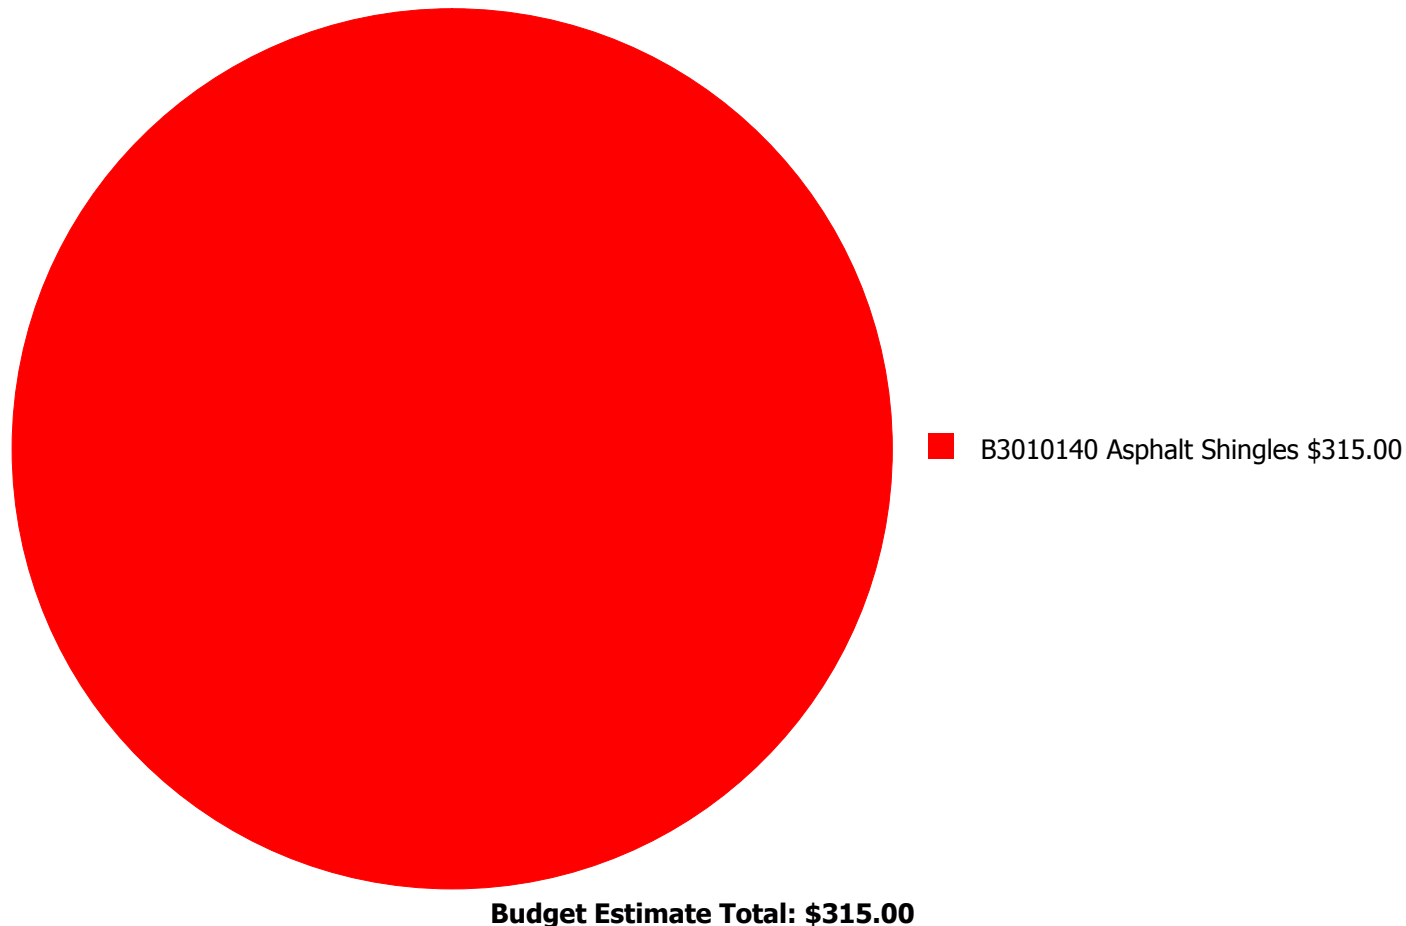
Deficiency Summary by System

Current deficiencies included assemblies that have reached or exceeded their design life or components of the assemblies that are in need of repair. Assemblies that have reached their design life are identified as current deficiencies and assigned the distress 'Beyond Useful Life'. The following chart lists all current deficiencies associated with this facility.

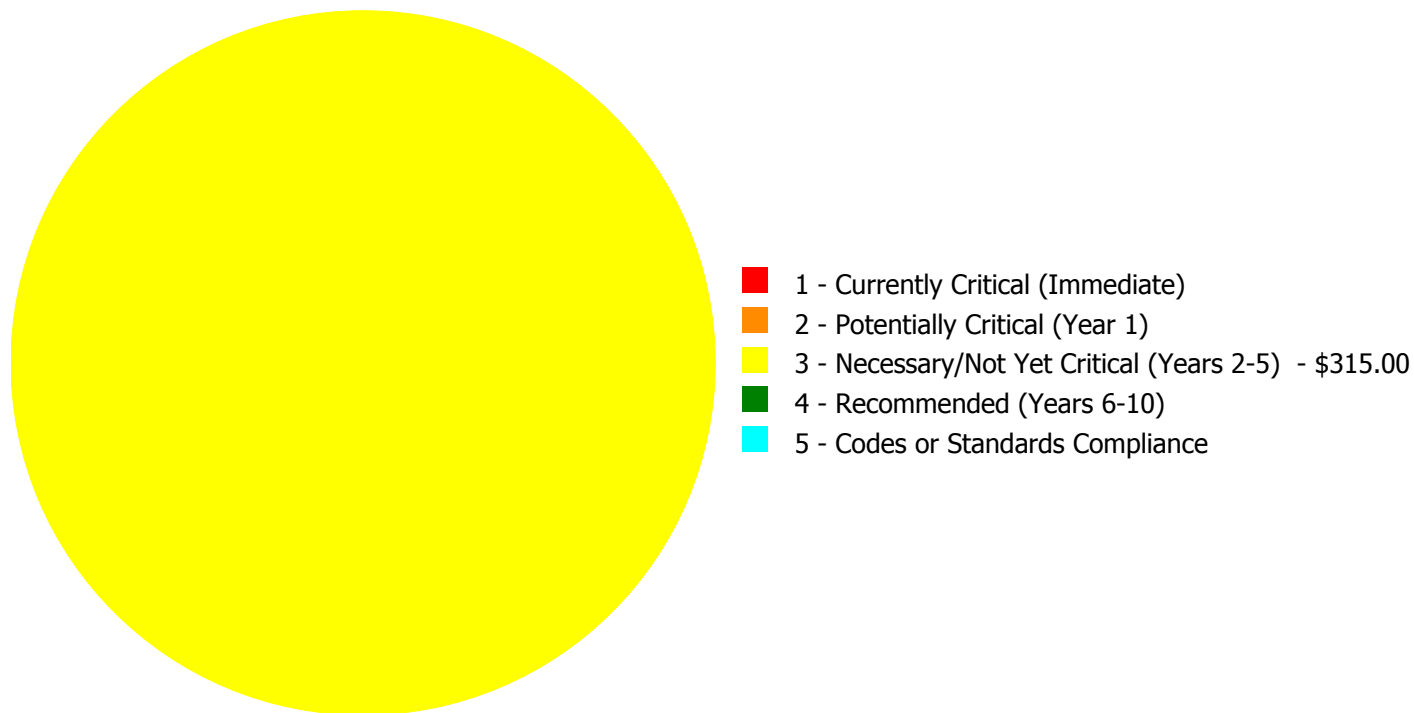
Deficiency Summary by Priority

The following chart shows the total repair costs broken down by priority. Assessors assigned deficiencies within eCOMET to one of the following priority categories:

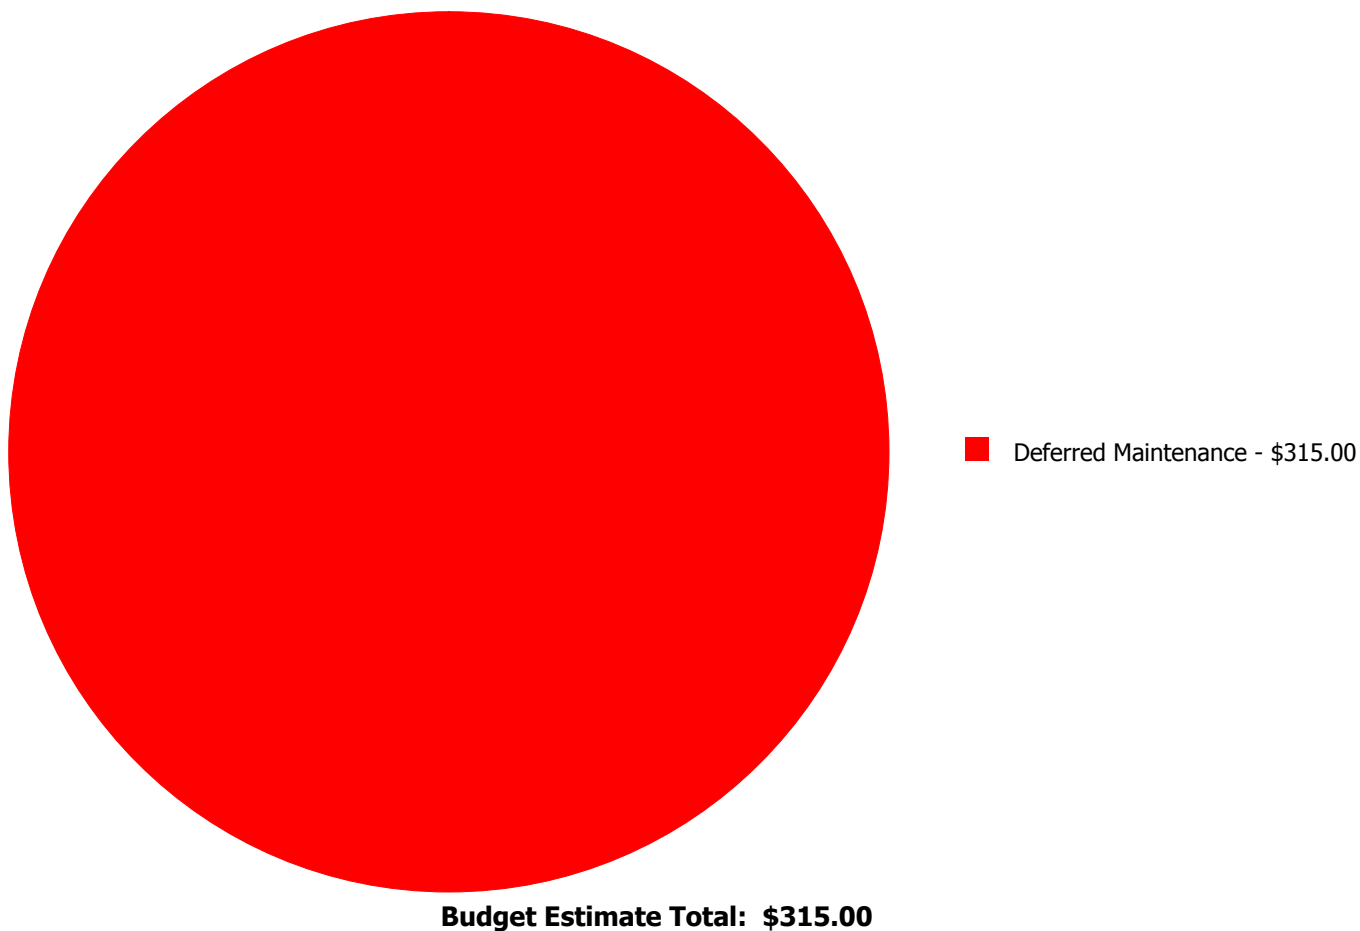
Deficiency Summary by Category

The following chart shows the total repair costs broken down by deficiency categories. Assessors assigned deficiencies to one of the following categories:

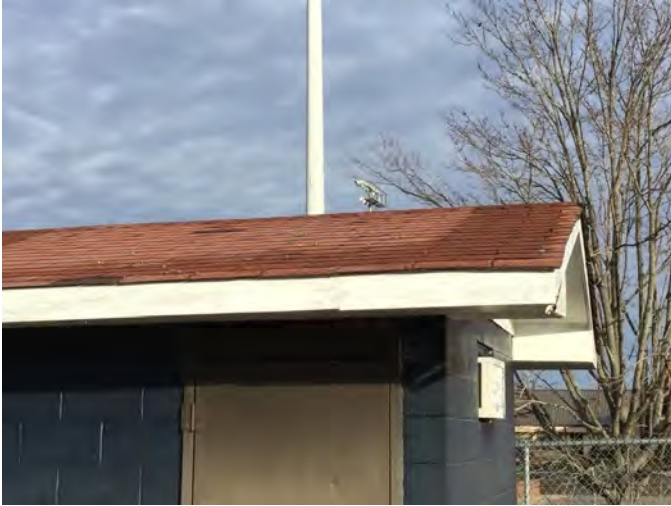
System: B3010140 - Asphalt Shingles

Location: Roof
Distress: Beyond Service Life
Category: Deferred Maintenance
Priority: 3 - Necessary/Not Yet Critical (Years 2-5)
Correction: Renew System
Qty: 50.00
Unit of Measure: S.F.
Estimate: \$315.00
Assessor Name: Terence Davis
Date Created: 01/04/2017

Notes: The asphalt shingles are aged and should be scheduled for replacement.

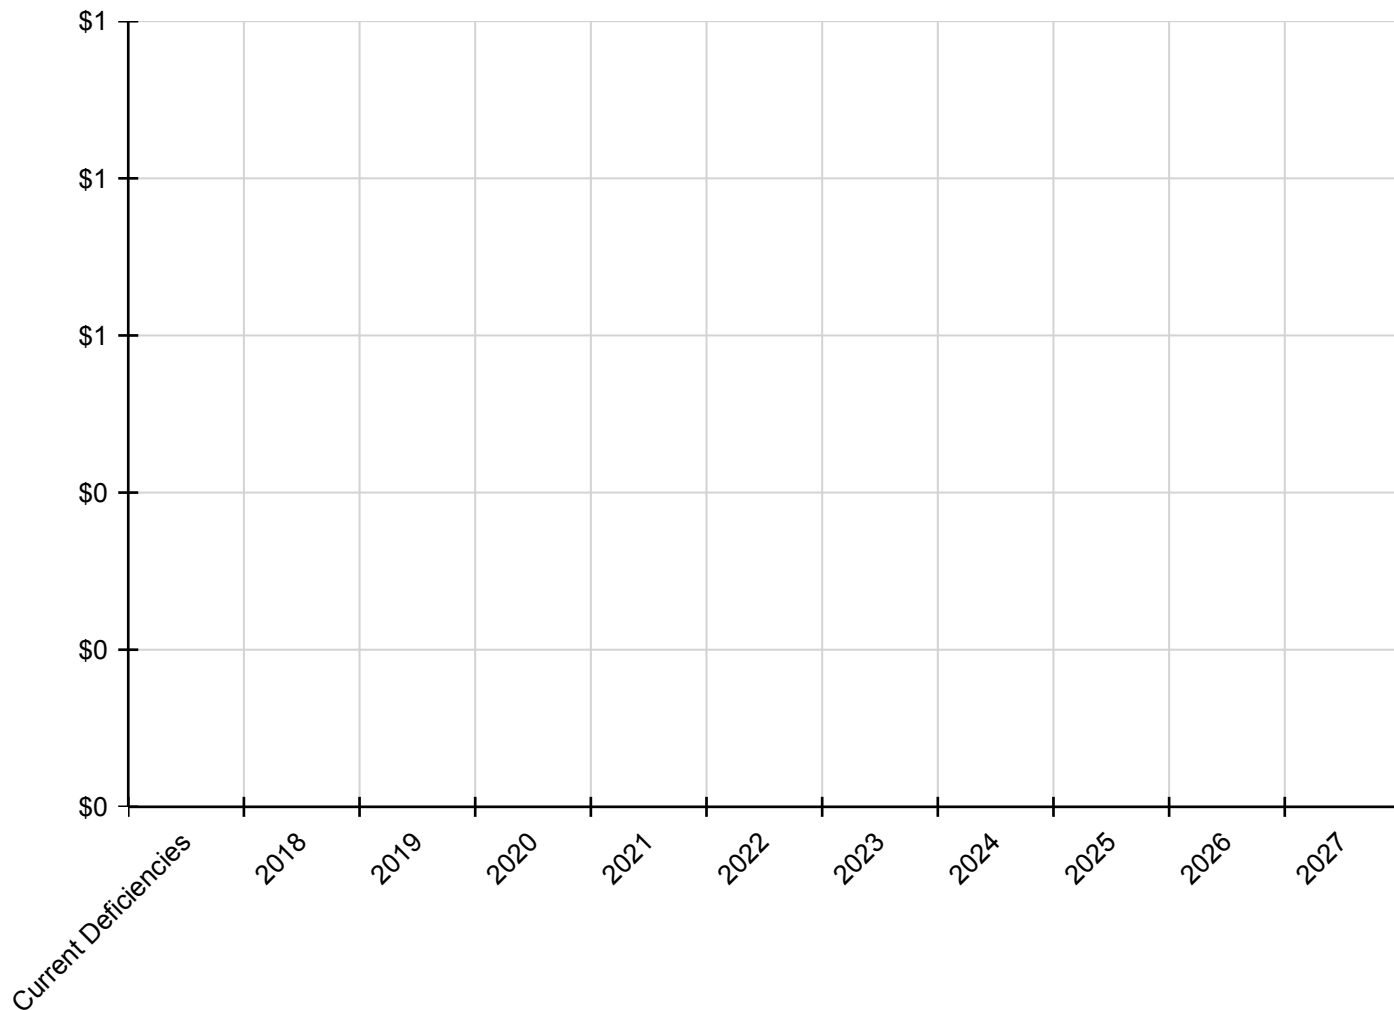
Forecasted Capital Renewal Requirement

The following chart shows the current building deficiencies and forecasting capital renewal or sustainment requirements over the next ten years.

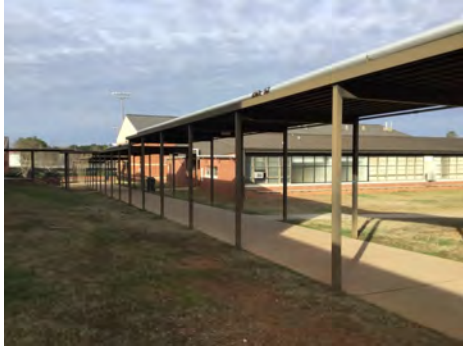
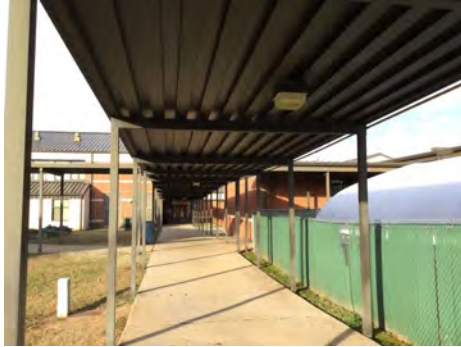
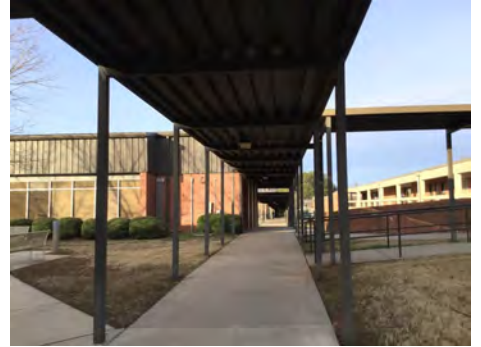
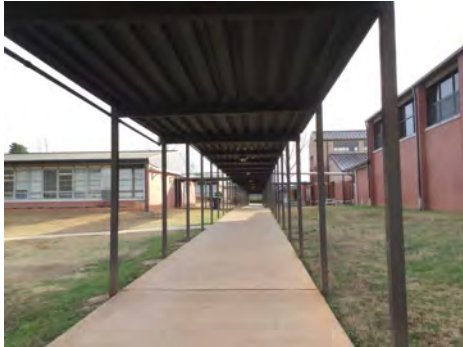
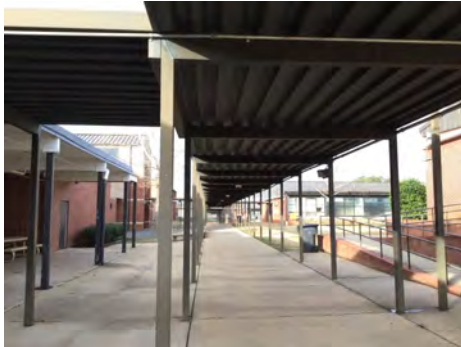
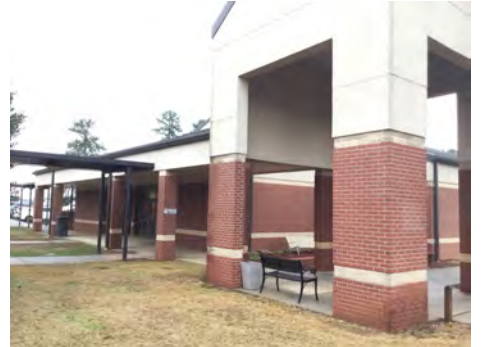
System: G2040950 - Covered Walkways

Note: covered walkway 1960 10,560 SF and 2002 1,299 SF total 11760 SF

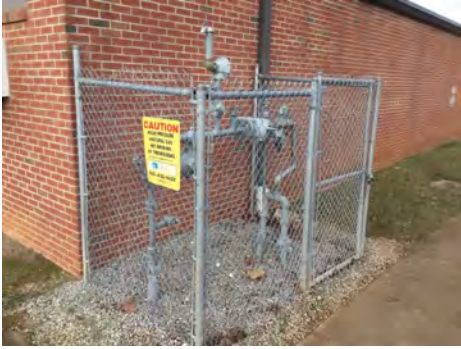
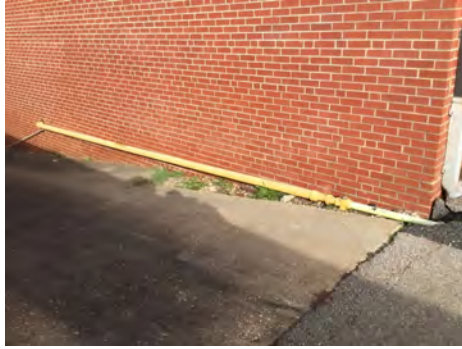
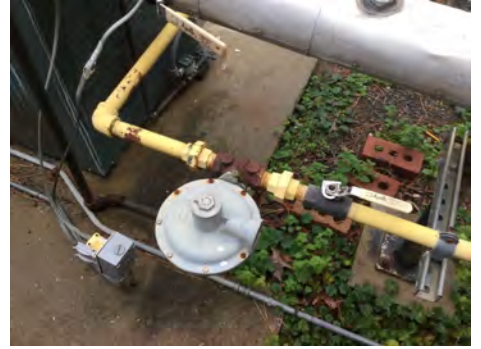
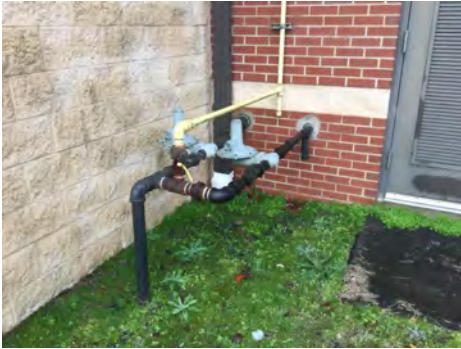
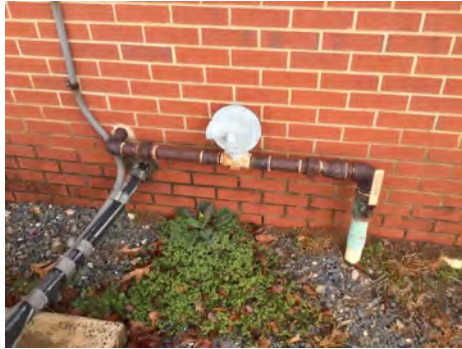
System: G3060 - Fuel Distribution

Note: Supplies Building E, H, K and W
