NC School District/040 Anson County/High School

Anson High

Campus Assessment Report

March 10, 2017

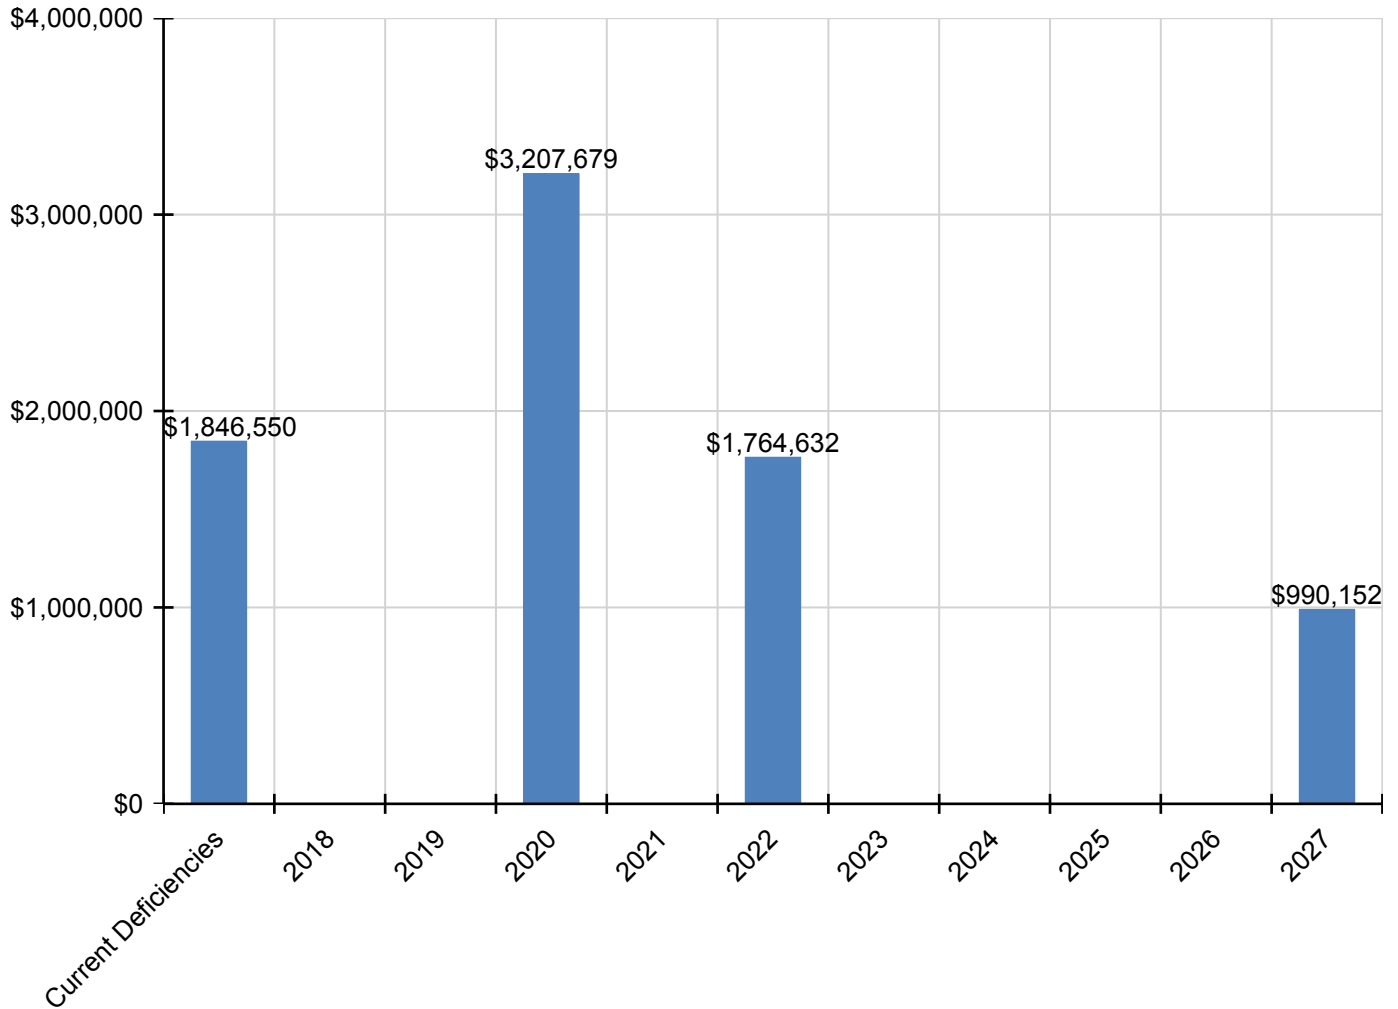
Forecasted Capital Renewal Requirement

The following chart shows the current building deficiencies and forecasting capital renewal or sustainment requirements over the next ten years.

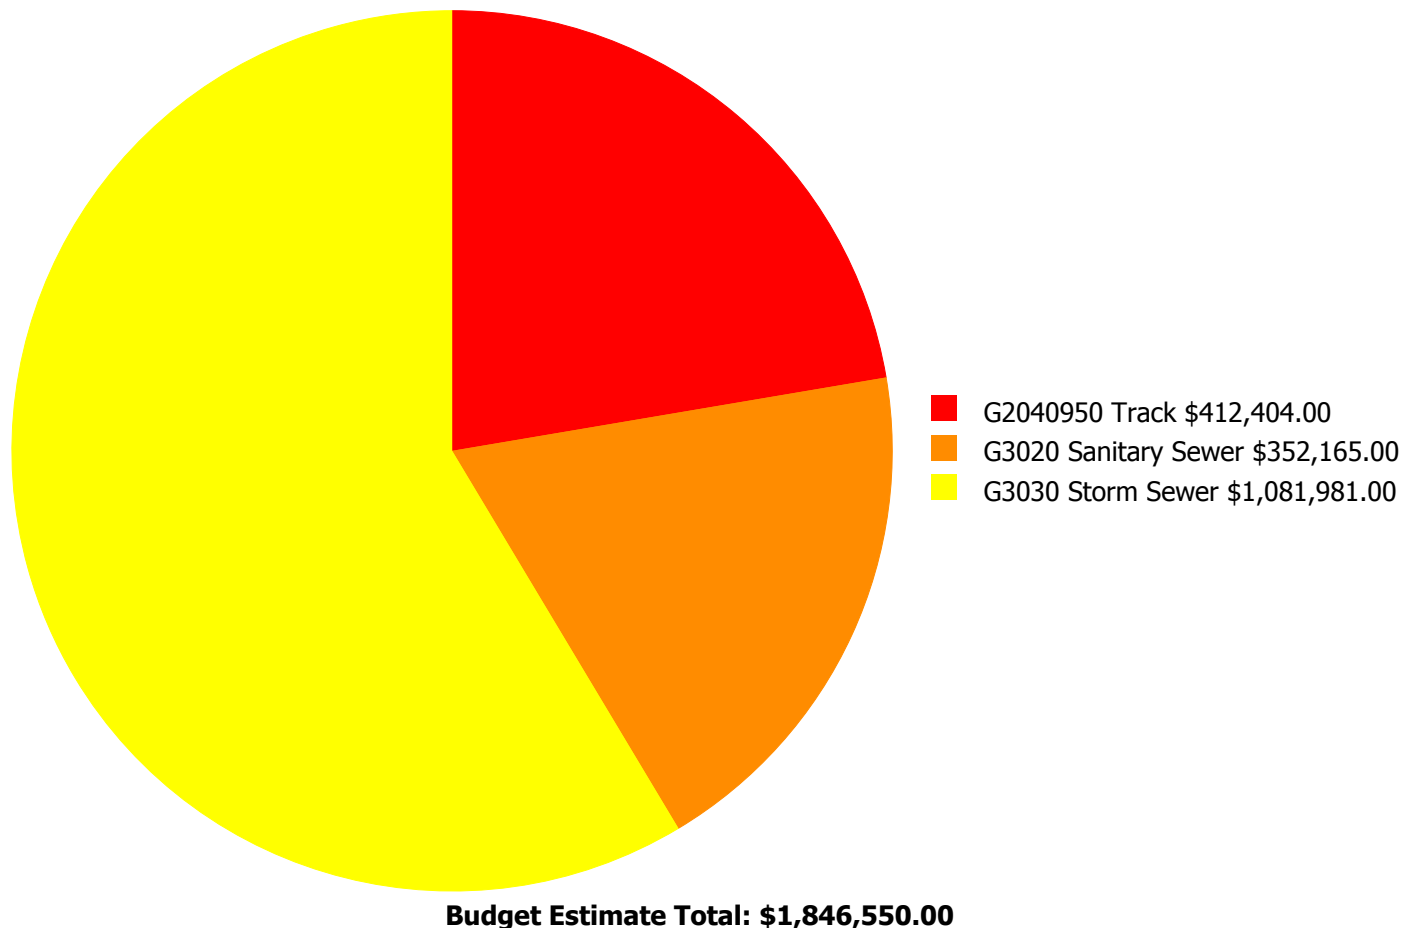
Deficiency Summary by System

Current deficiencies included assemblies that have reached or exceeded their design life or components of the assemblies that are in need of repair. Assemblies that have reached their design life are identified as current deficiencies and assigned the distress 'Beyond Useful Life'. The following chart lists all current deficiencies associated with this facility.

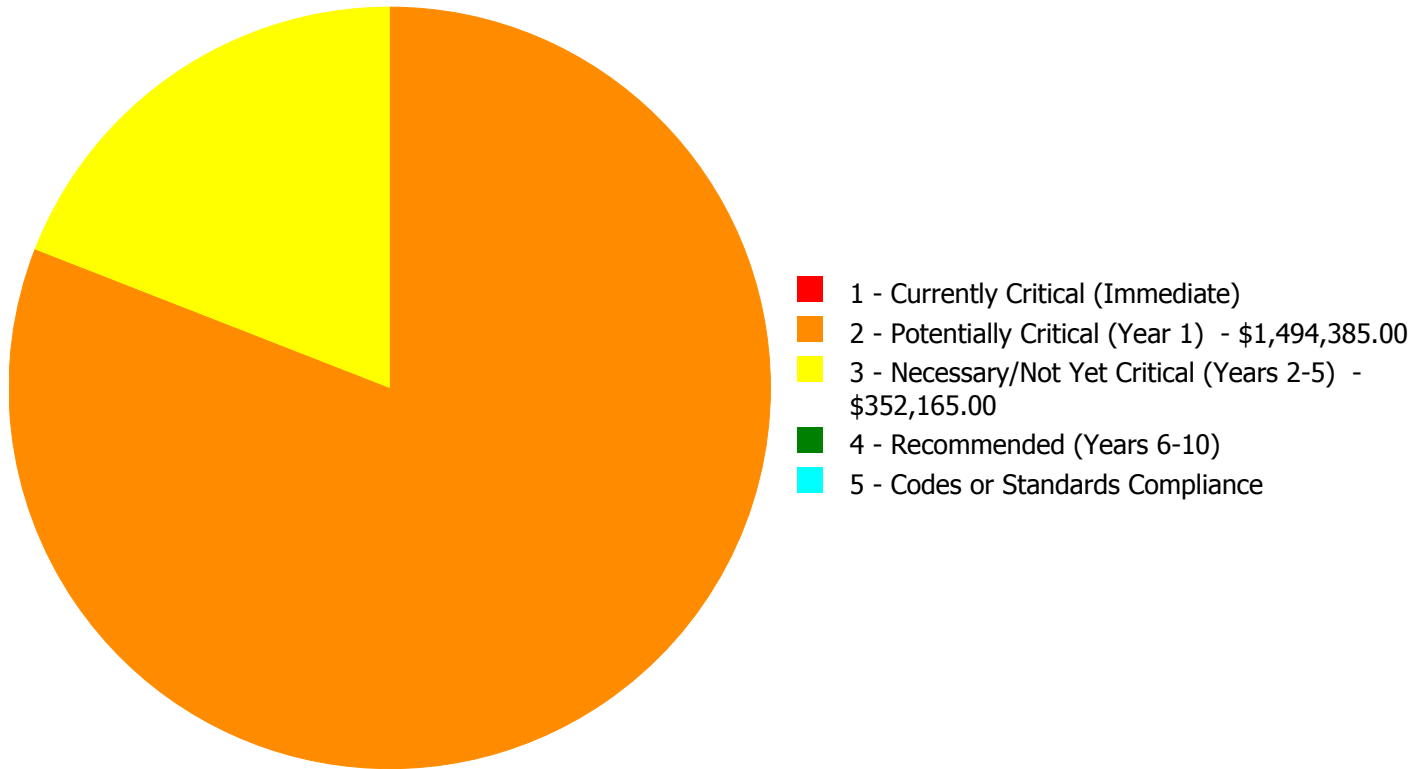
Deficiency Summary by Priority

The following chart shows the total repair costs broken down by priority. Assessors assigned deficiencies within eCOMET to one of the following priority categories:

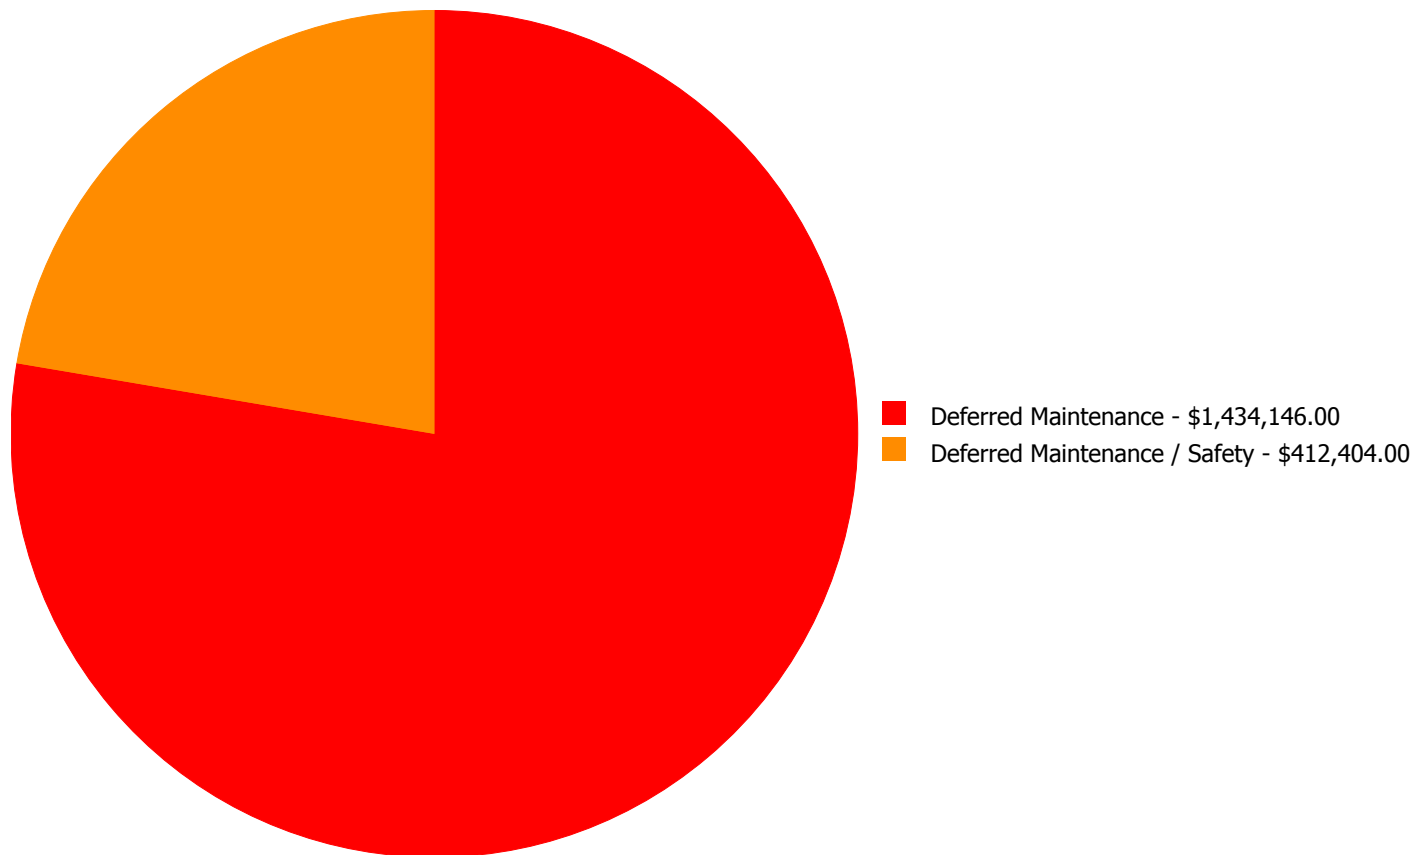
Deficiency Summary by Category

The following chart shows the total repair costs broken down by deficiency categories. Assessors assigned deficiencies to one of the following categories:

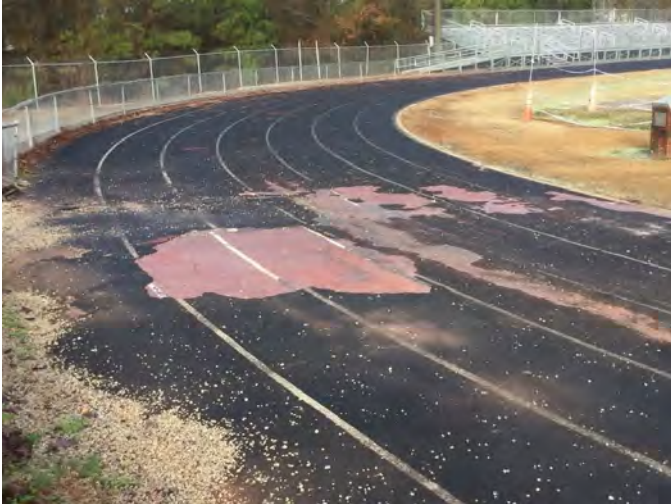
System: G2040950 - Track

Location: Site
Distress: Beyond Service Life
Category: Deferred Maintenance / Safety
Priority: 2 - Potentially Critical (Year 1)
Correction: Renew System
Qty: 210,625.00
Unit of Measure: S.F.
Estimate: \$412,404.00
Assessor Name: Eduardo Lopez
Date Created: 01/04/2017

Notes: The track is in deteriorating condition with many trip hazards and should be replaced.

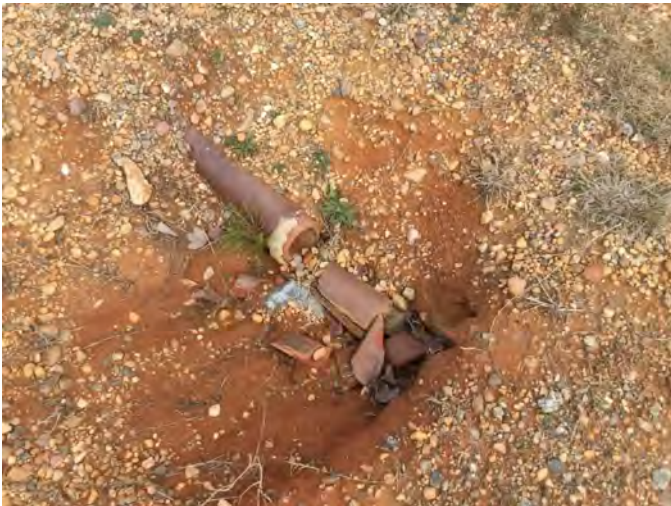
System: G3030 - Storm Sewer

Location: Site
Distress: Beyond Service Life
Category: Deferred Maintenance
Priority: 2 - Potentially Critical (Year 1)
Correction: Renew System
Qty: 210,625.00
Unit of Measure: S.F.
Estimate: \$1,081,981.00
Assessor Name: Eduardo Lopez
Date Created: 02/17/2017

Notes: The storm sewer system is damaged in different locations and should be scheduled for replacement.

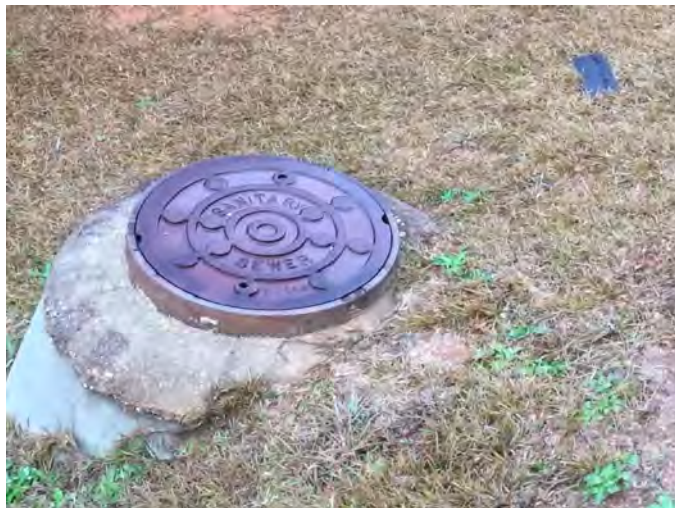
System: G3020 - Sanitary Sewer

Location: Site
Distress: Beyond Service Life
Category: Deferred Maintenance
Priority: 3 - Necessary/Not Yet Critical (Years 2-5)
Correction: Renew System
Qty: 210,625.00
Unit of Measure: S.F.
Estimate: \$352,165.00
Assessor Name: Eduardo Lopez
Date Created: 02/17/2017

Notes: The sanitary sewer system is beyond its expected service life and should be scheduled for replacement.
