NC School District/830 Scotland County/High School

Scotland High

Campus Assessment Report

March 11, 2017

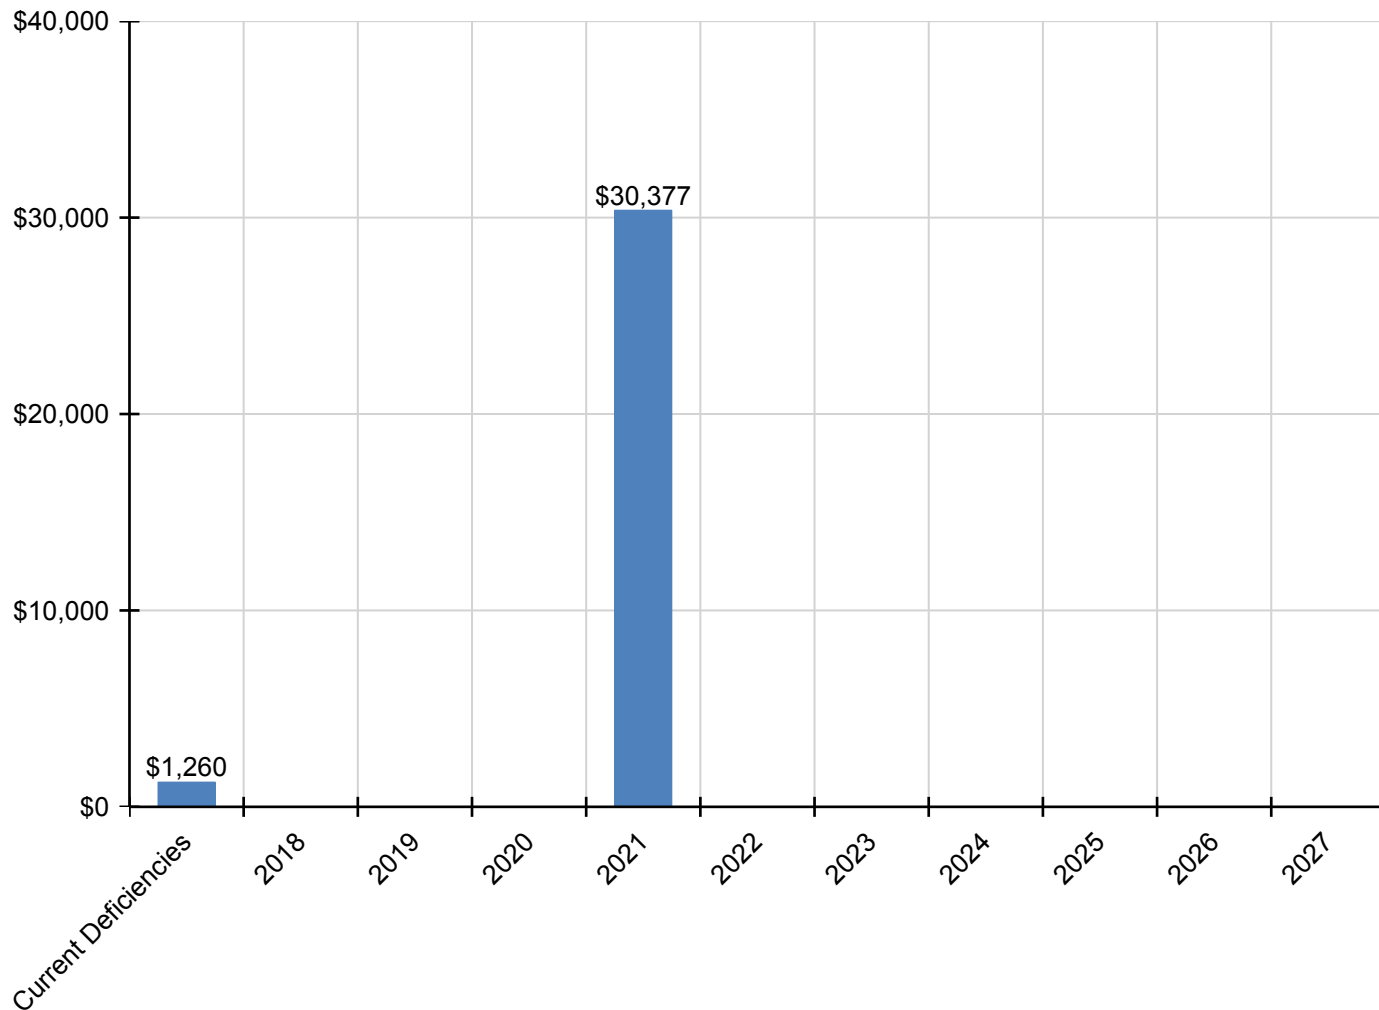
Forecasted Capital Renewal Requirement

The following chart shows the current building deficiencies and forecasting capital renewal or sustainment requirements over the next ten years.

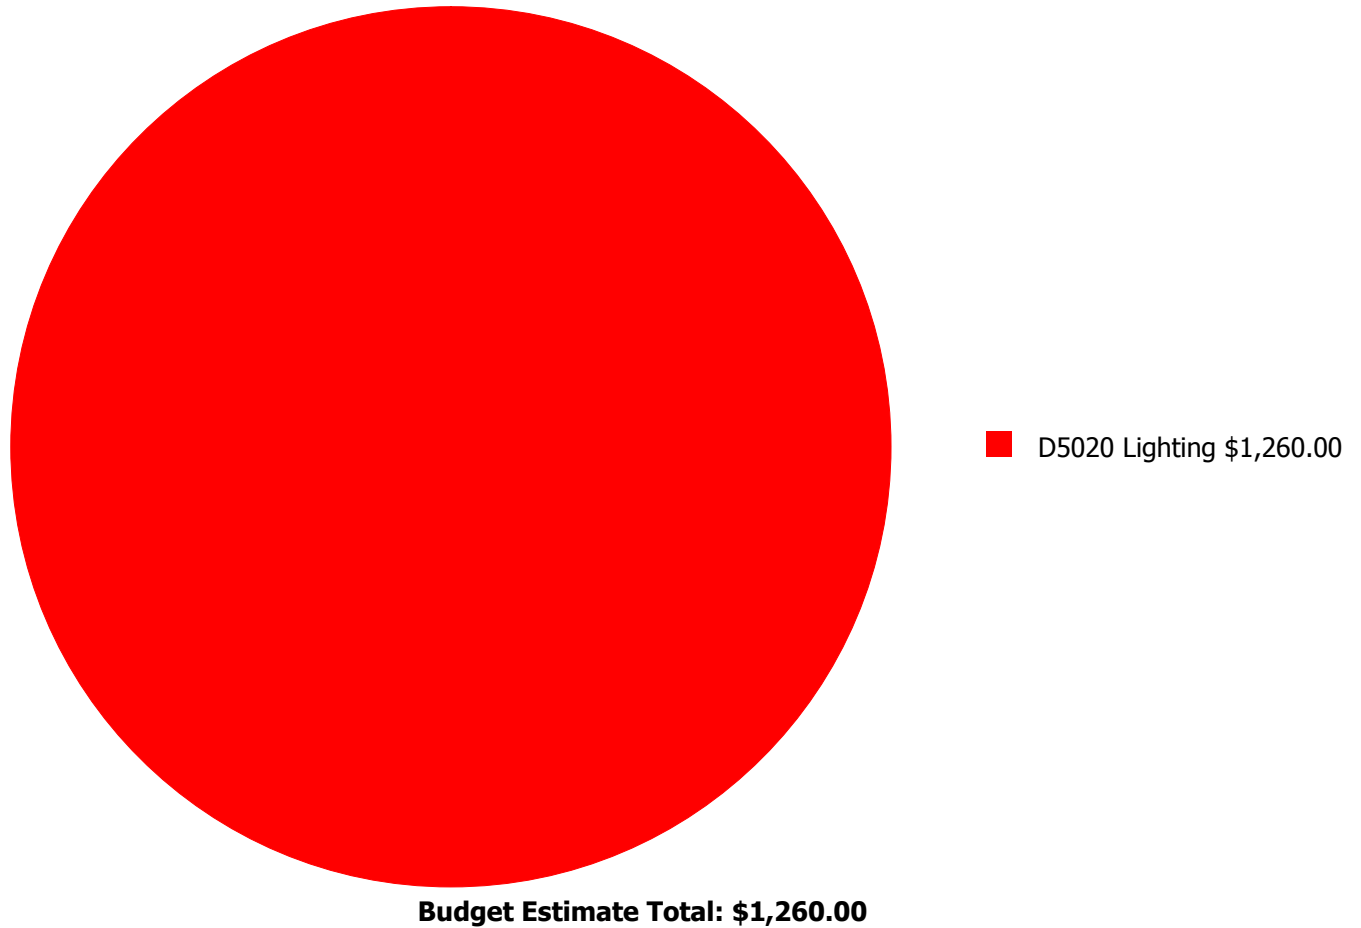
Deficiency Summary by System

Current deficiencies included assemblies that have reached or exceeded their design life or components of the assemblies that are in need of repair. Assemblies that have reached their design life are identified as current deficiencies and assigned the distress 'Beyond Useful Life'. The following chart lists all current deficiencies associated with this facility.

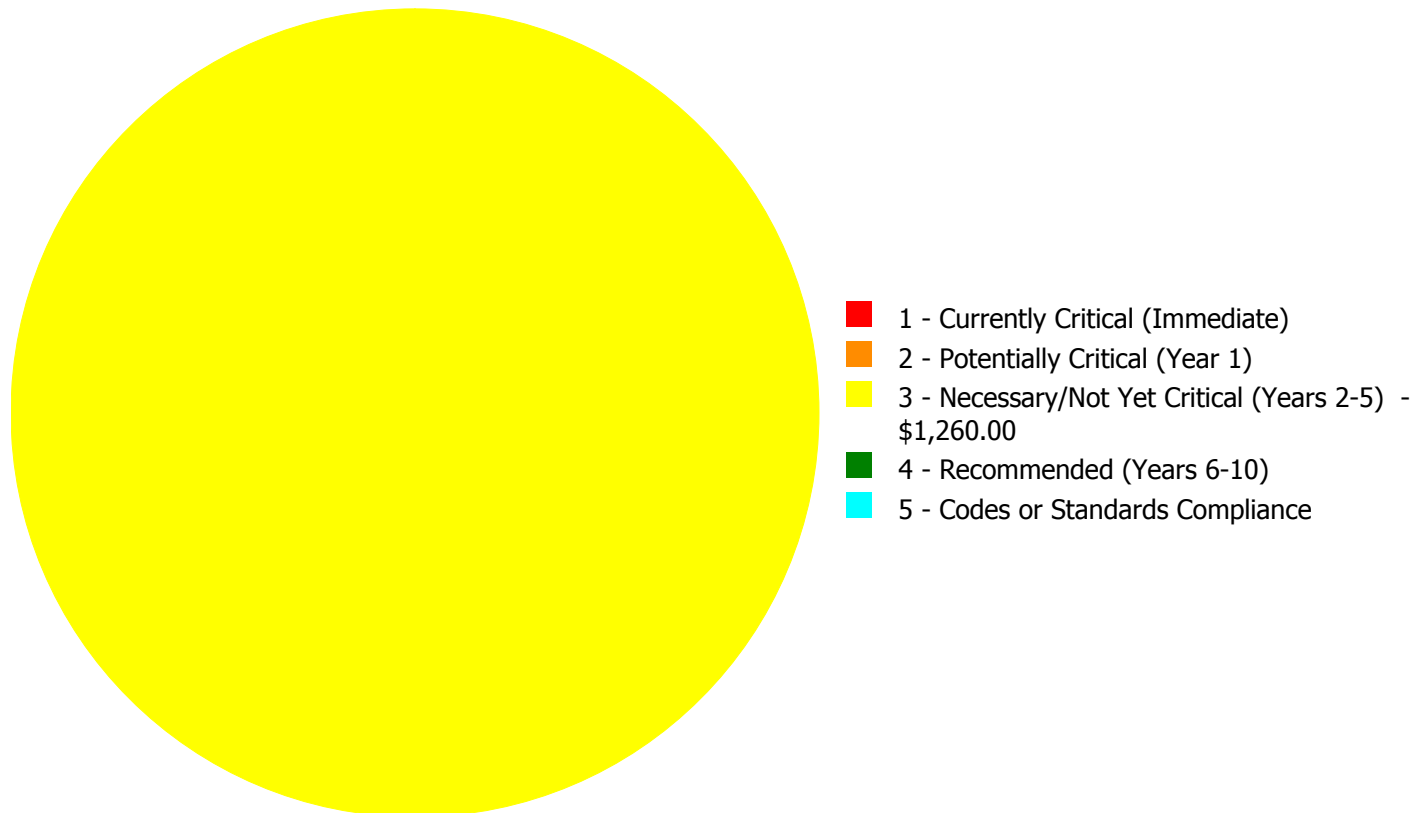
Deficiency Summary by Priority

The following chart shows the total repair costs broken down by priority. Assessors assigned deficiencies within eCOMET to one of the following priority categories:

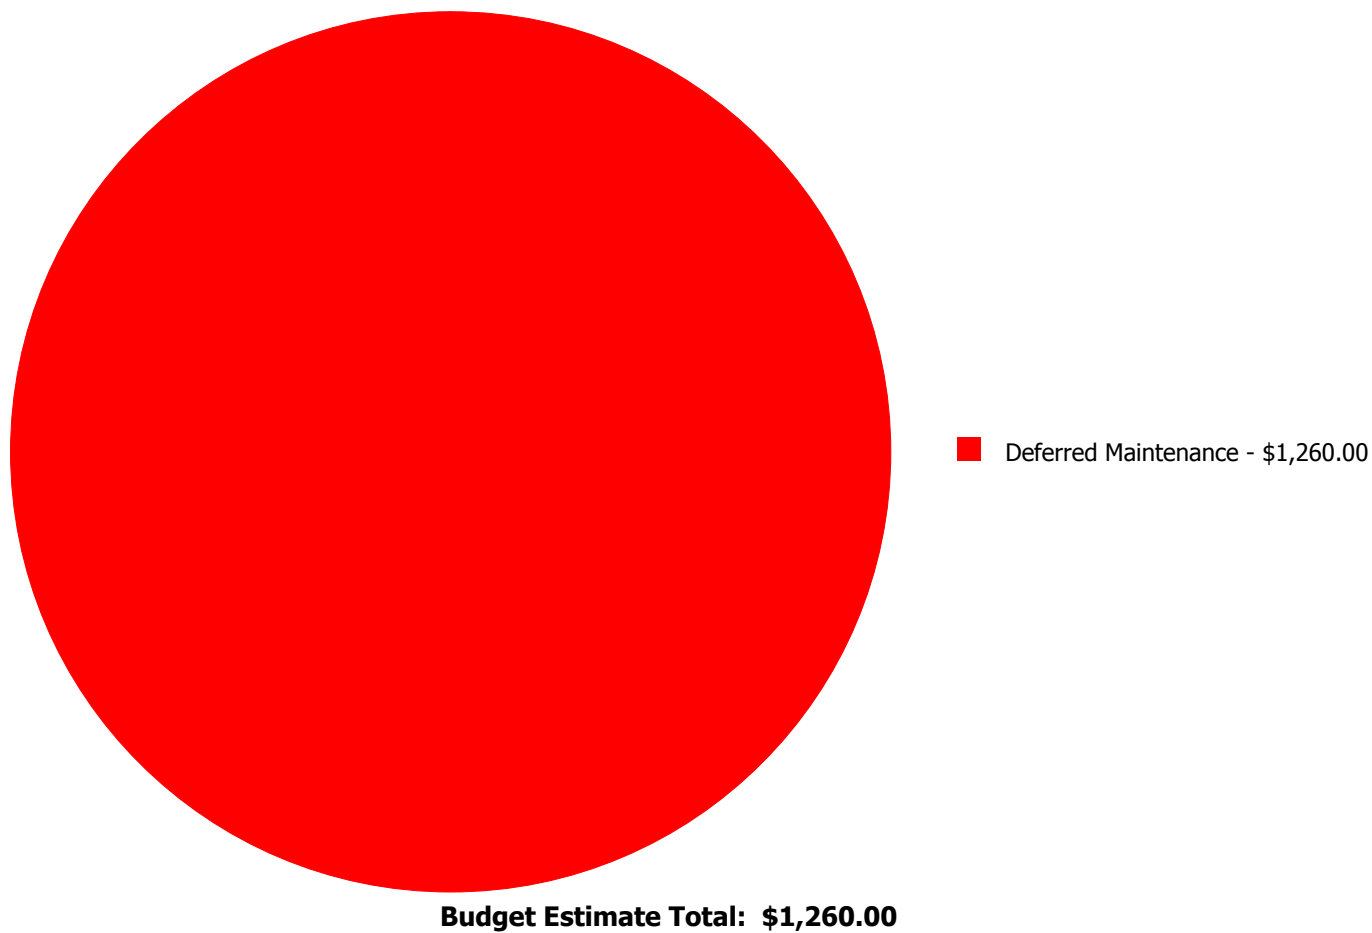
Deficiency Summary by Category

The following chart shows the total repair costs broken down by deficiency categories. Assessors assigned deficiencies to one of the following categories:

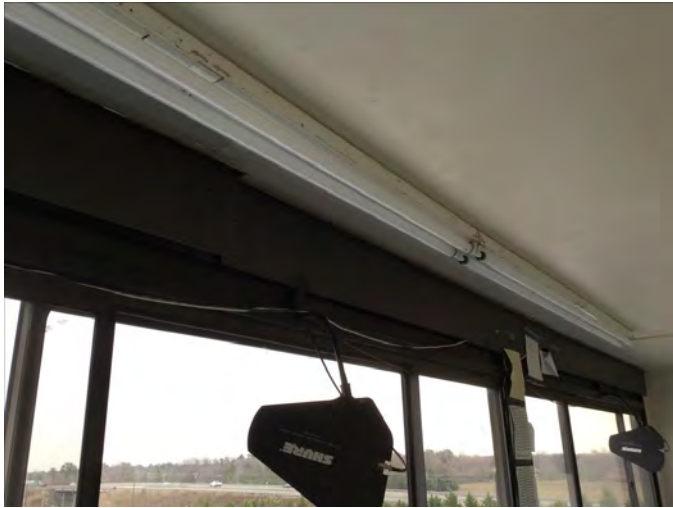
System: D5020 - Lighting

Location: Throughout Building
Distress: Beyond Service Life
Category: Deferred Maintenance
Priority: 3 - Necessary/Not Yet Critical (Years 2-5)
Correction: Renew System
Qty: 320.00
Unit of Measure: S.F.
Estimate: \$1,260.00
Assessor Name: Eduardo Lopez
Date Created: 01/10/2017

Notes: The lighting system is beyond its service life and should be replaced.

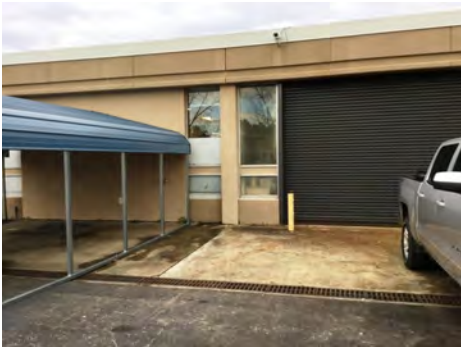
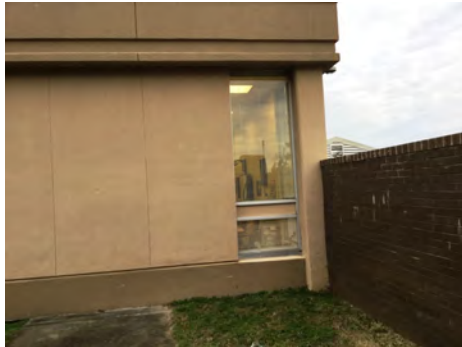
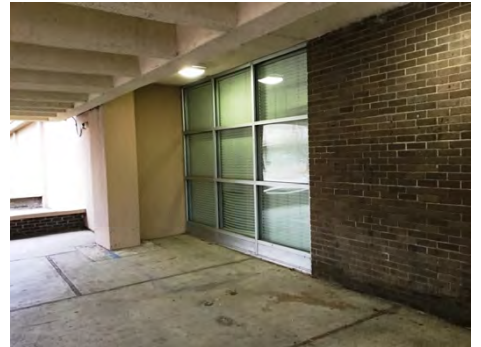
System: B2020 - Exterior Windows

Note: The exterior windows are beyond their service life and should be replaced.

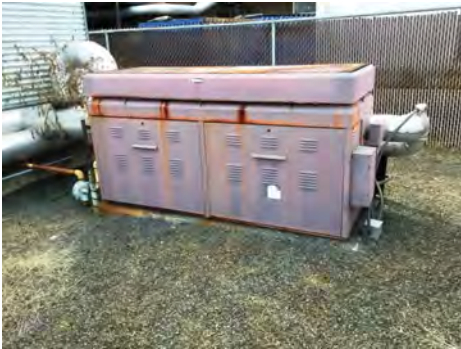
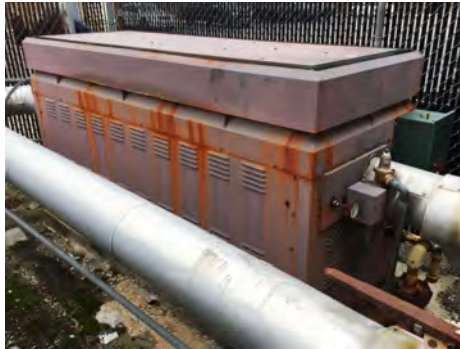
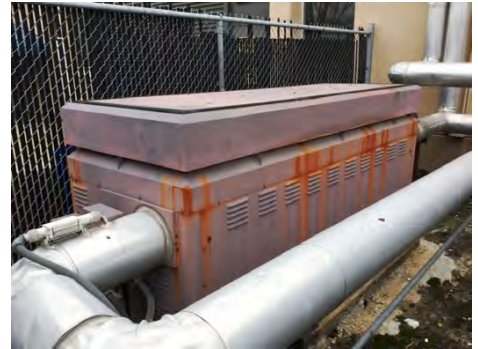
System: D3020 - Heat Generating Systems

Note: The heat generating systems are beyond their service life and should be replaced.

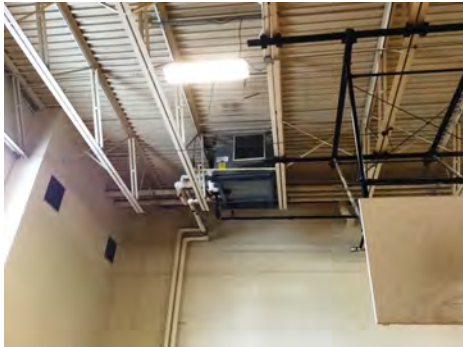
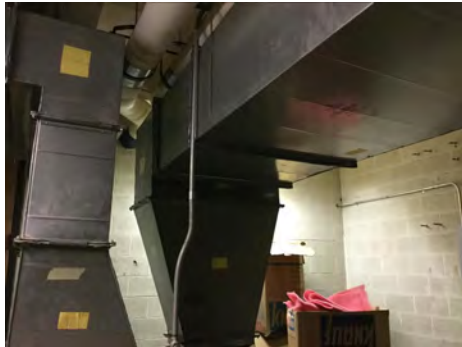
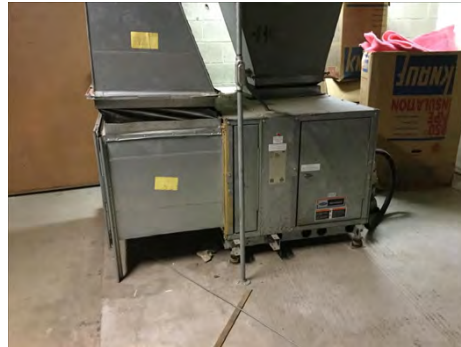
System: D3040 - Distribution Systems

Note: The distribution system is beyond its service life and should be replaced.

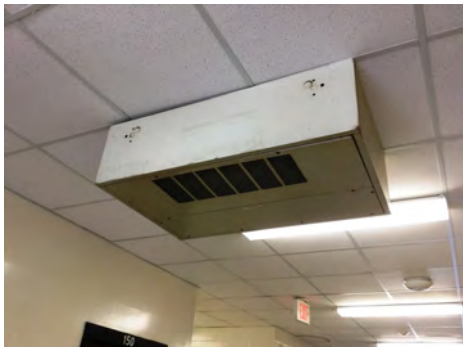
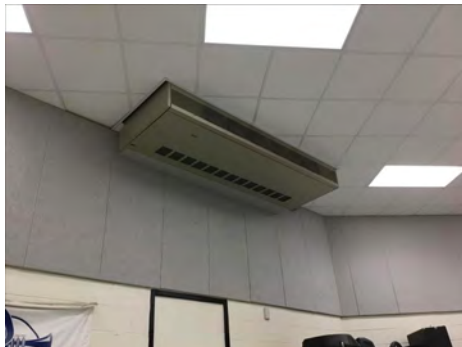
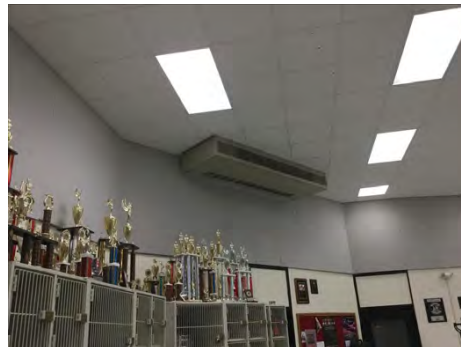
System: D3050 - Terminal & Package Units

Note: The terminal and package units are beyond their service life and should be replaced.

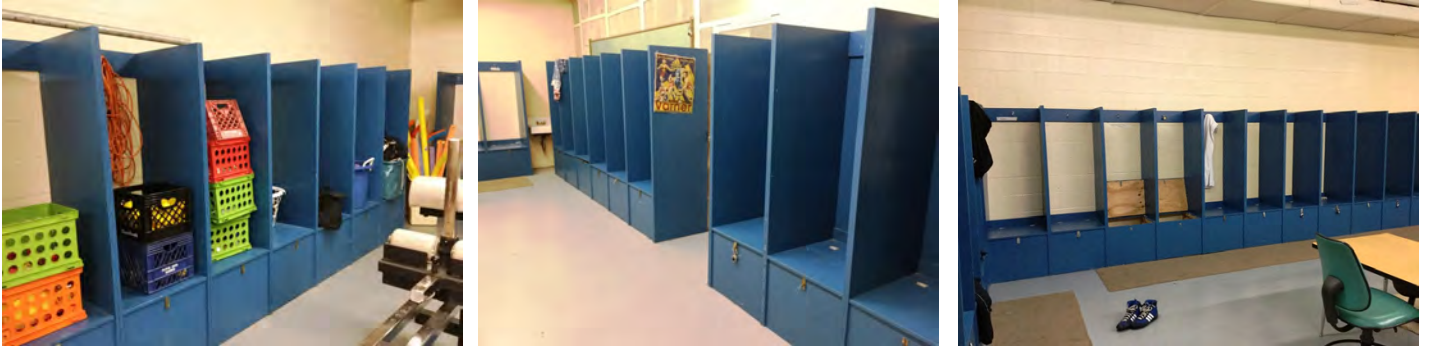
System: E2010 - Fixed Furnishings

Note: The fixed furnishings are beyond their service life and should be replaced.

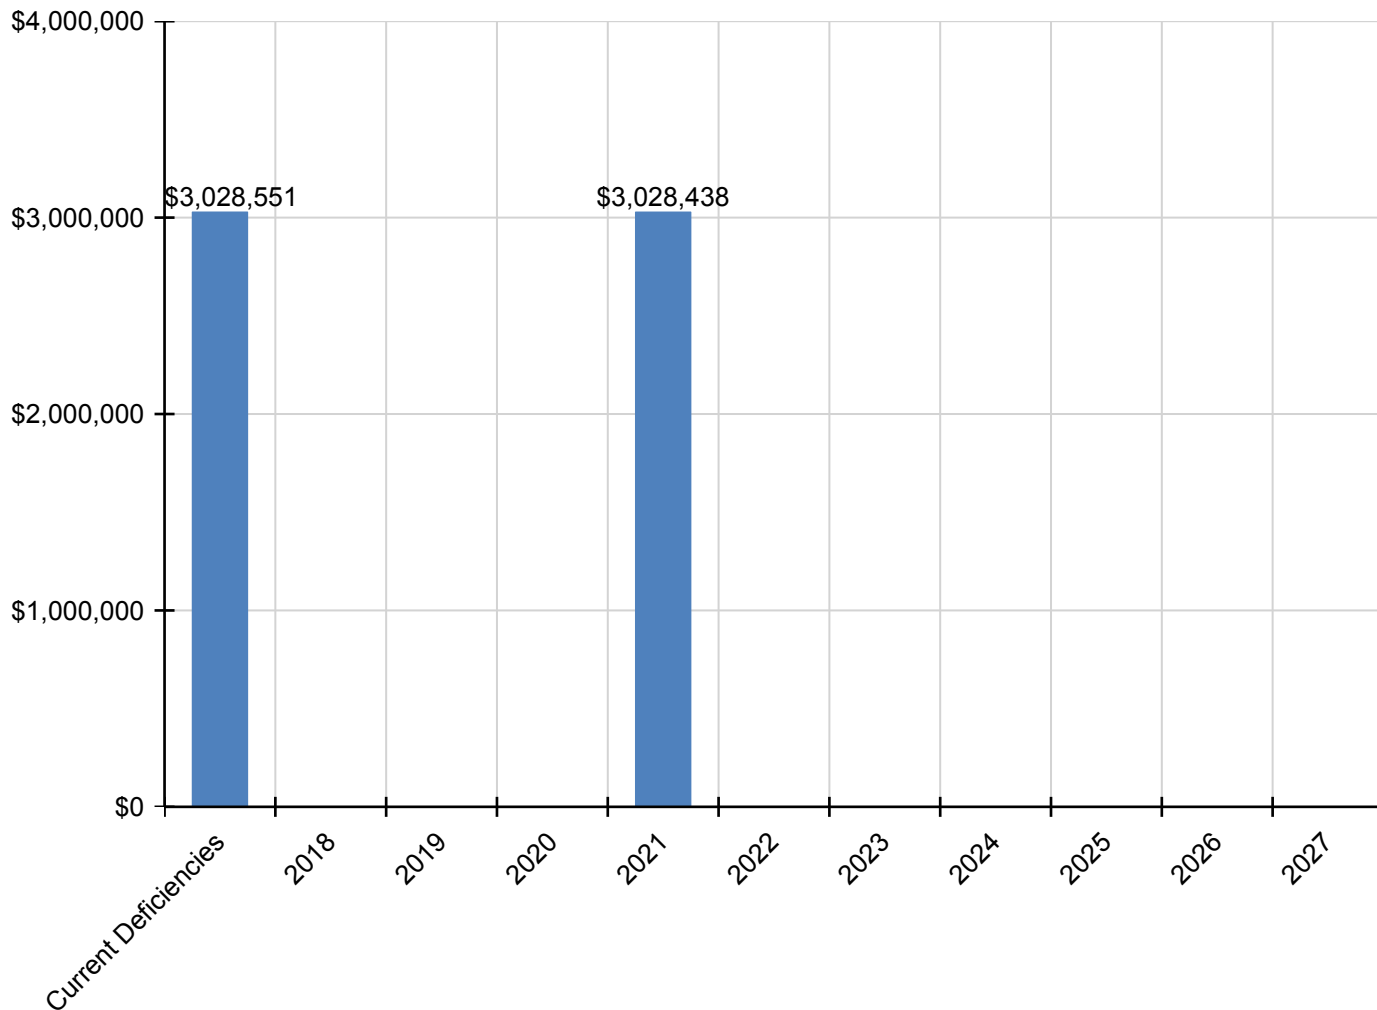
Forecasted Capital Renewal Requirement

The following chart shows the current building deficiencies and forecasting capital renewal or sustainment requirements over the next ten years.

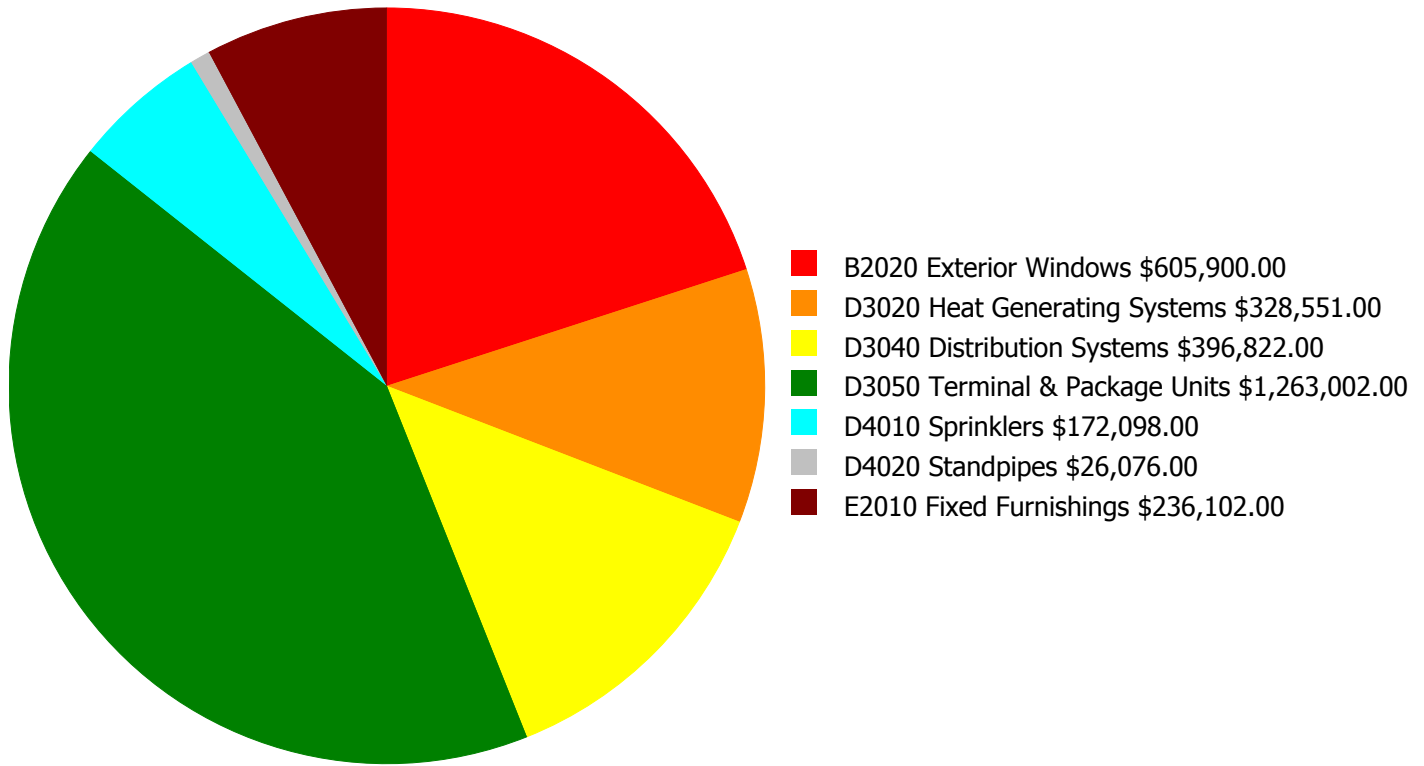
Deficiency Summary by System

Current deficiencies included assemblies that have reached or exceeded their design life or components of the assemblies that are in need of repair. Assemblies that have reached their design life are identified as current deficiencies and assigned the distress 'Beyond Useful Life'. The following chart lists all current deficiencies associated with this facility.

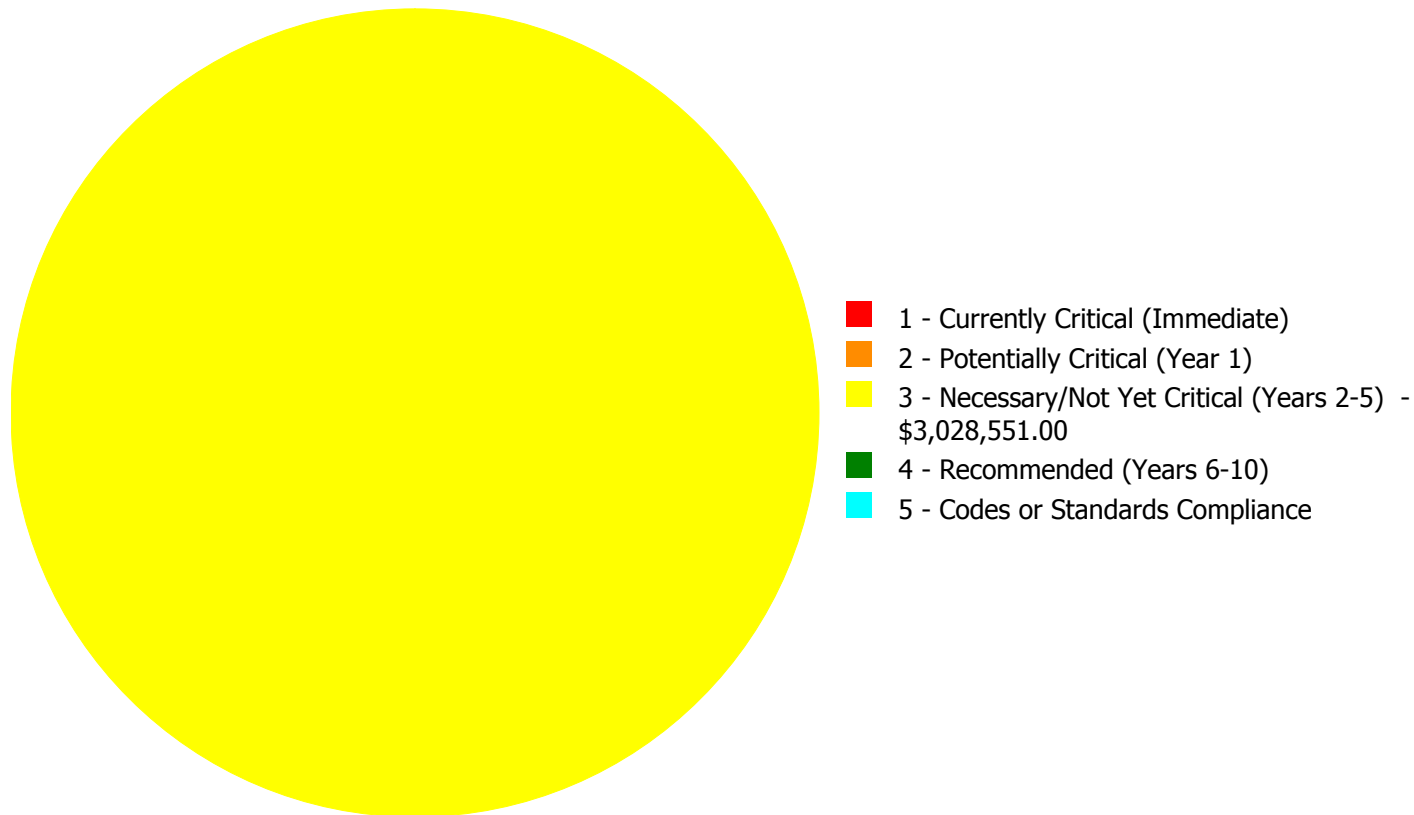
Deficiency Summary by Priority

The following chart shows the total repair costs broken down by priority. Assessors assigned deficiencies within eCOMET to one of the following priority categories:

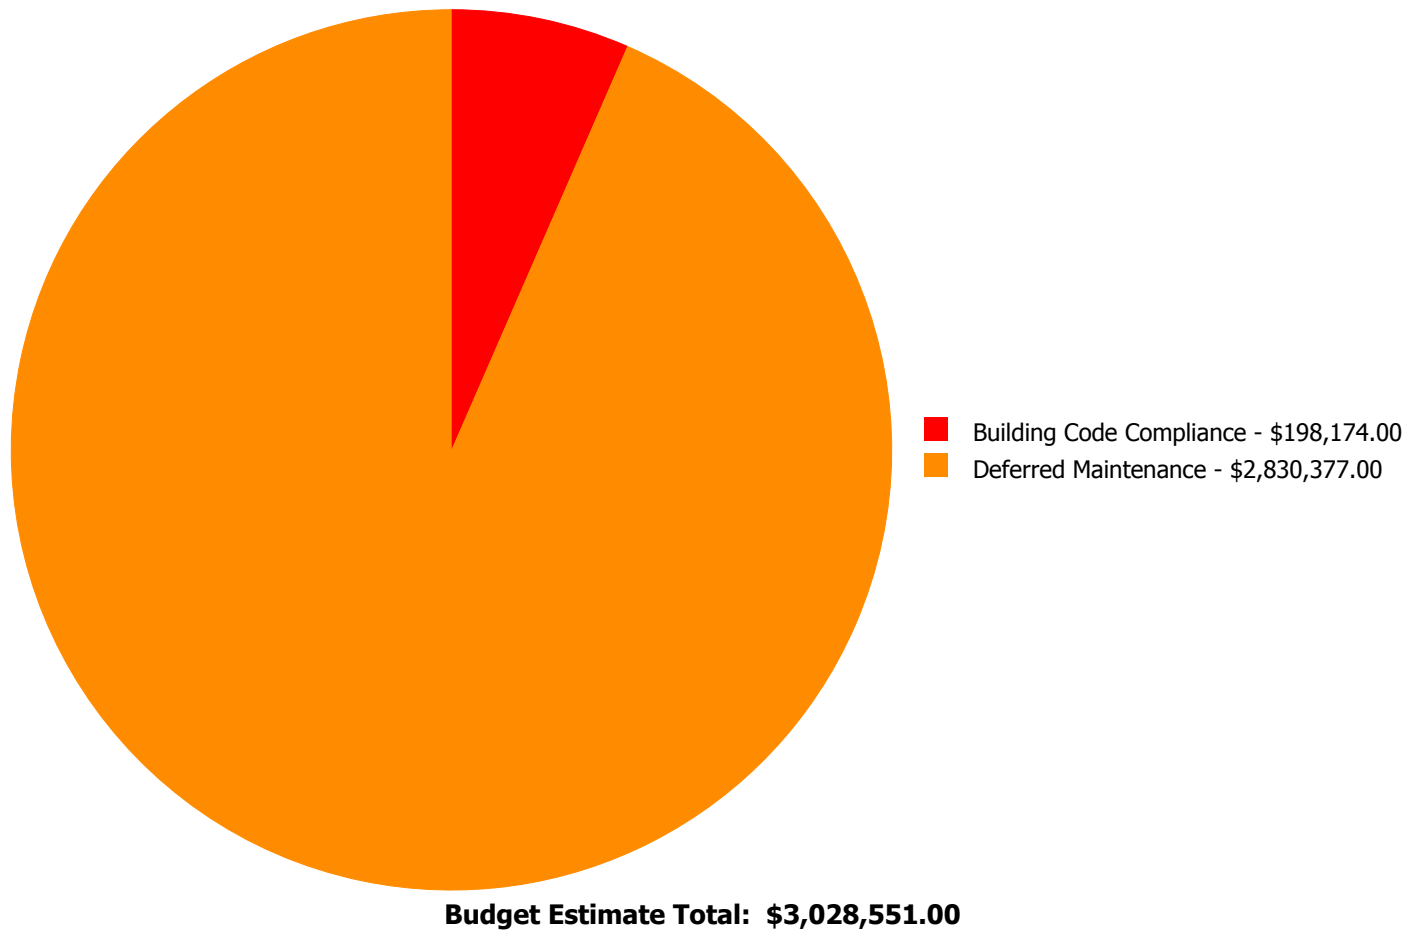
Deficiency Summary by Category

The following chart shows the total repair costs broken down by deficiency categories. Assessors assigned deficiencies to one of the following categories:

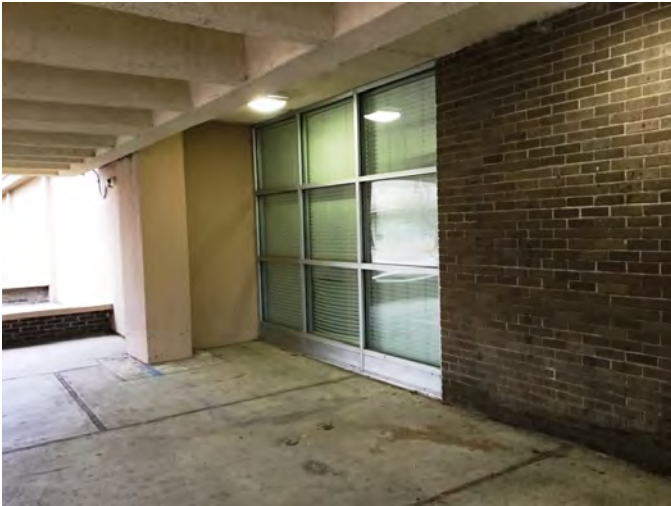
System: B2020 - Exterior Windows

Location: Exterior Walls
Distress: Beyond Service Life
Category: Deferred Maintenance
Priority: 3 - Necessary/Not Yet Critical (Years 2-5)
Correction: Renew System
Qty: 43,100.00
Unit of Measure: S.F.
Estimate: \$605,900.00
Assessor Name: Eduardo Lopez
Date Created: 02/13/2017

Notes: The exterior windows are beyond their service life and should be replaced.

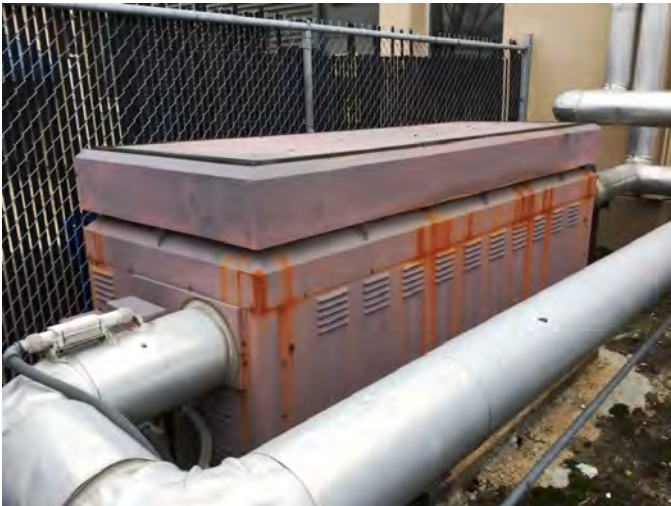
System: D3020 - Heat Generating Systems

Location: Throughout Building
Distress: Beyond Service Life
Category: Deferred Maintenance
Priority: 3 - Necessary/Not Yet Critical (Years 2-5)
Correction: Renew System
Qty: 43,100.00
Unit of Measure: S.F.
Estimate: \$328,551.00
Assessor Name: Eduardo Lopez
Date Created: 02/13/2017

Notes: The heat generating systems are beyond their service life and should be replaced.

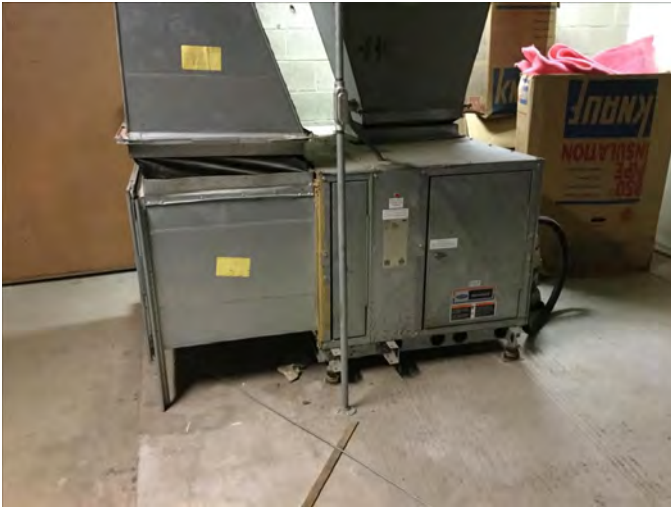
System: D3040 - Distribution Systems

Location: Throughout Building
Distress: Beyond Service Life
Category: Deferred Maintenance
Priority: 3 - Necessary/Not Yet Critical (Years 2-5)
Correction: Renew System
Qty: 43,100.00
Unit of Measure: S.F.
Estimate: \$396,822.00
Assessor Name: Eduardo Lopez
Date Created: 02/13/2017

Notes: The distribution system is beyond its service life and should be replaced.

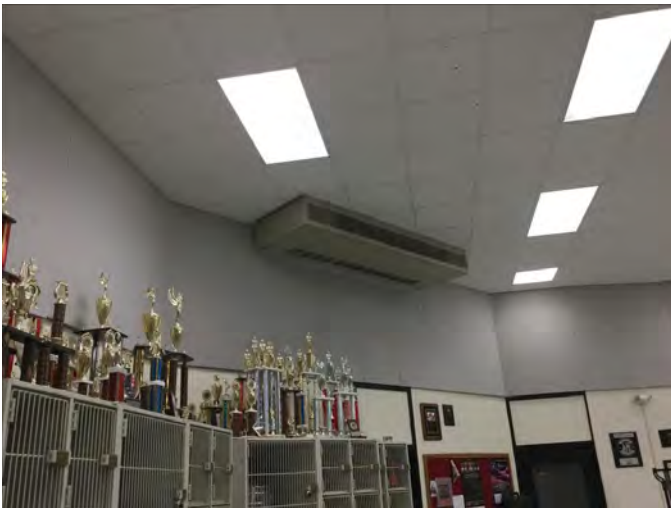
System: D3050 - Terminal & Package Units

Location: Throughout Building
Distress: Beyond Service Life
Category: Deferred Maintenance
Priority: 3 - Necessary/Not Yet Critical (Years 2-5)
Correction: Renew System
Qty: 43,100.00
Unit of Measure: S.F.
Estimate: \$1,263,002.00
Assessor Name: Eduardo Lopez
Date Created: 02/13/2017

Notes: The terminal and package units are beyond their service life and should be replaced.

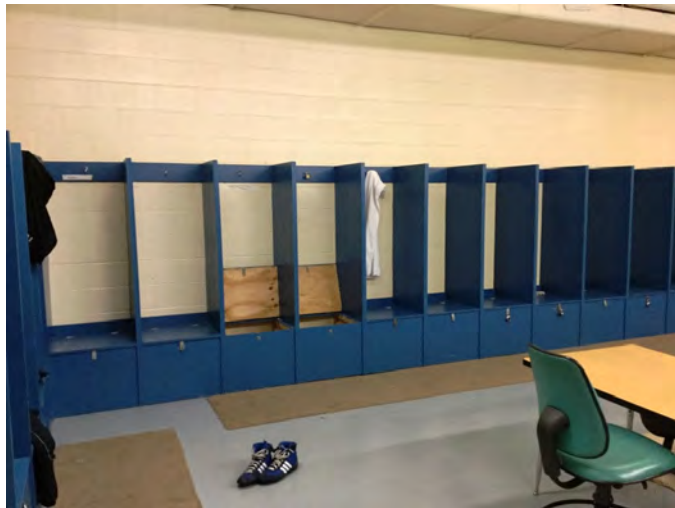
System: E2010 - Fixed Furnishings

Location: Throughout Building
Distress: Beyond Service Life
Category: Deferred Maintenance
Priority: 3 - Necessary/Not Yet Critical (Years 2-5)
Correction: Renew System
Qty: 43,100.00
Unit of Measure: S.F.
Estimate: \$236,102.00
Assessor Name: Eduardo Lopez
Date Created: 02/13/2017

Notes: The fixed furnishings are beyond their service life and should be replaced.

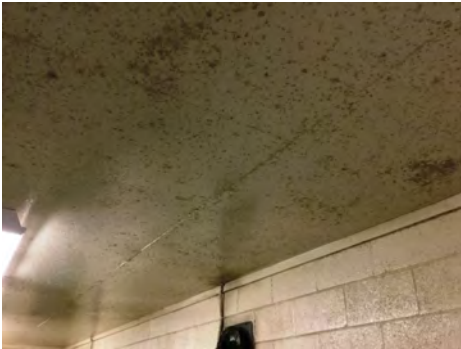
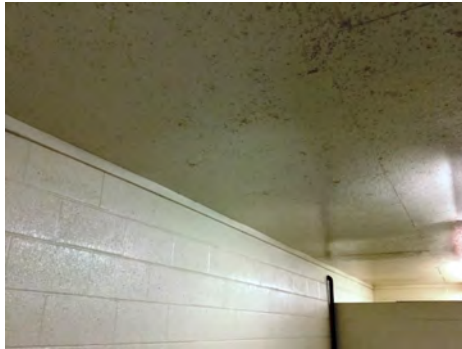
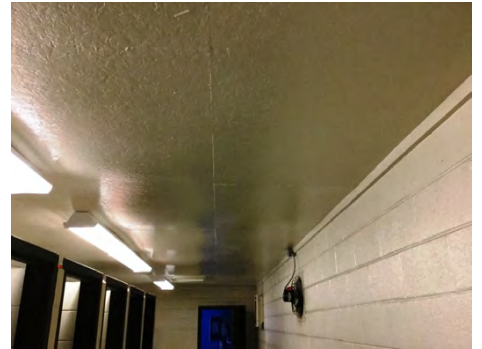
System: C3030 - Ceiling Finishes

Note: The ceiling finishes are beyond their service life and should be replaced.

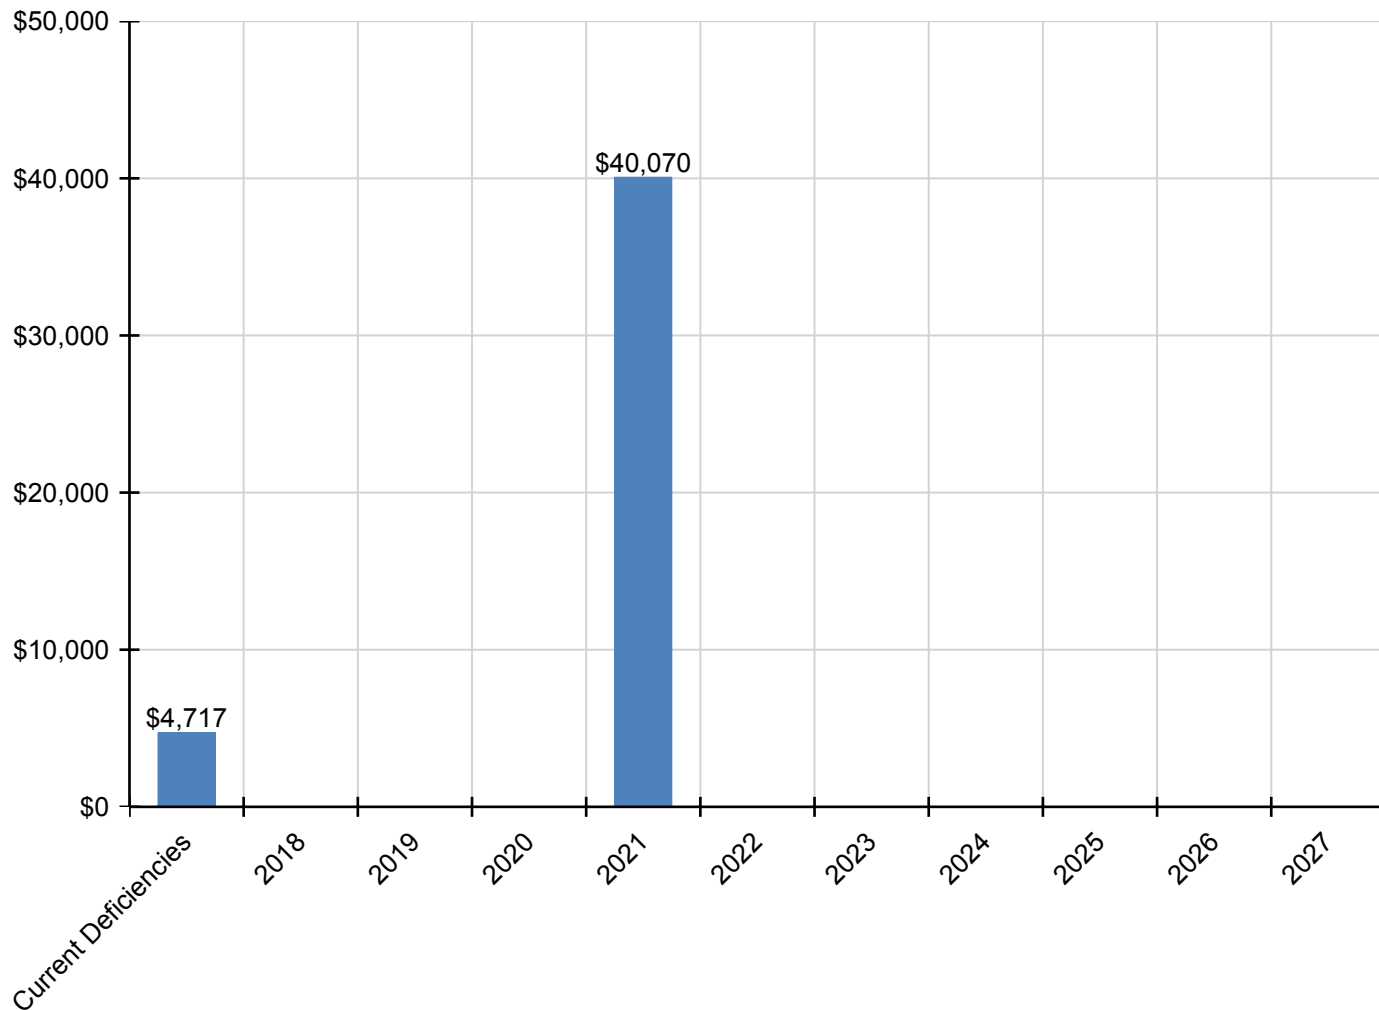
Forecasted Capital Renewal Requirement

The following chart shows the current building deficiencies and forecasting capital renewal or sustainment requirements over the next ten years.

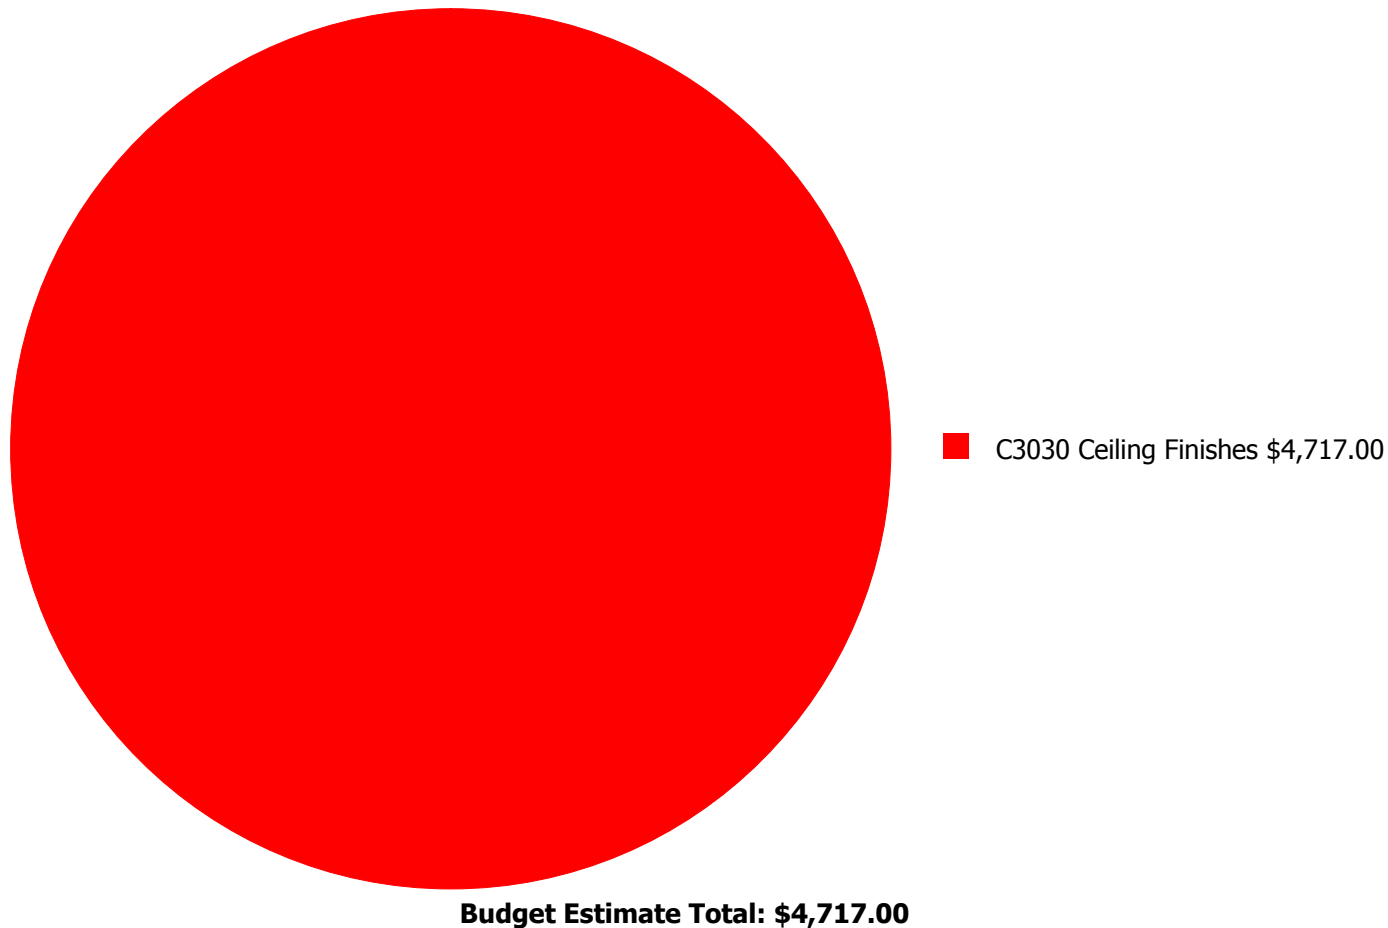
Deficiency Summary by System

Current deficiencies included assemblies that have reached or exceeded their design life or components of the assemblies that are in need of repair. Assemblies that have reached their design life are identified as current deficiencies and assigned the distress 'Beyond Useful Life'. The following chart lists all current deficiencies associated with this facility.

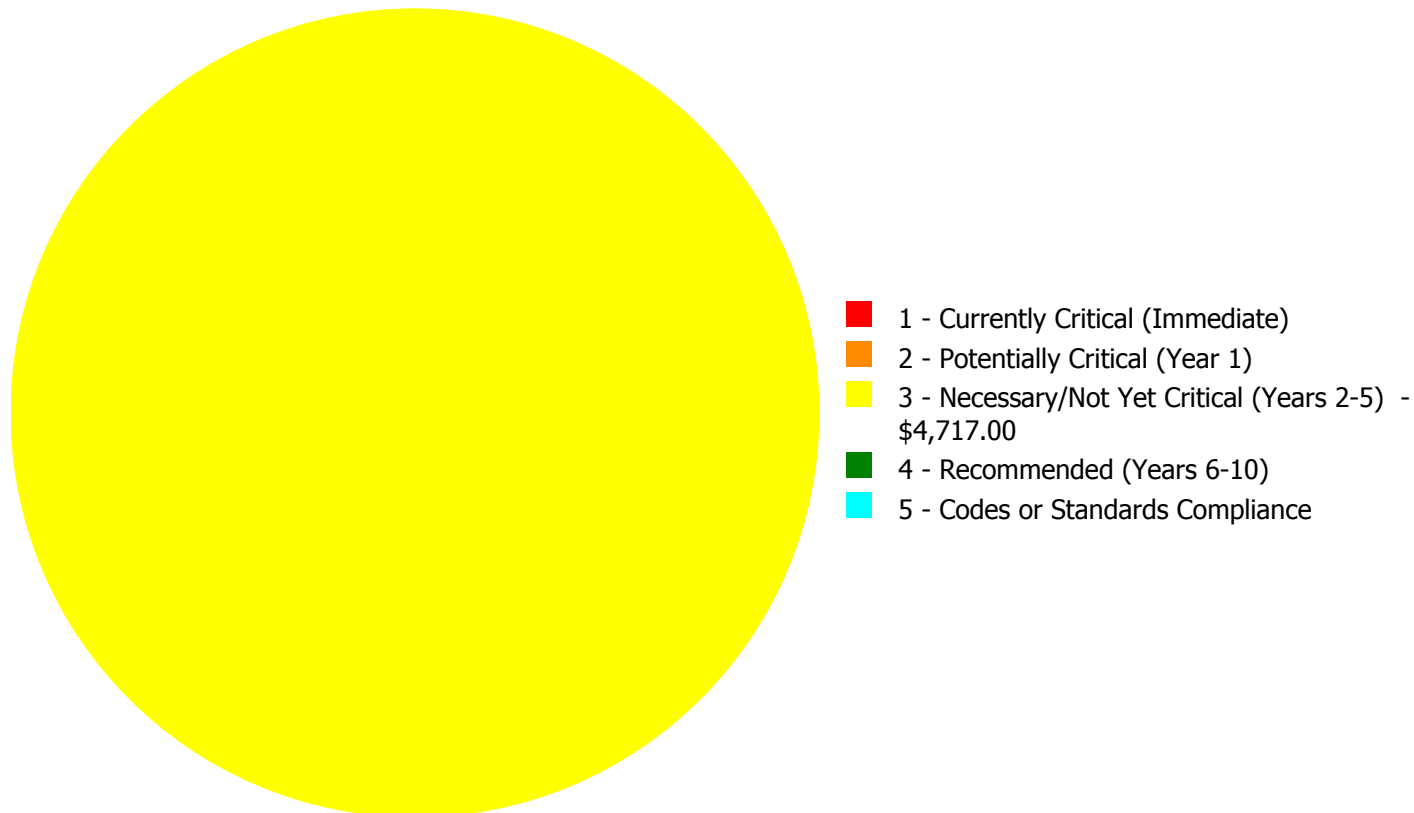
Deficiency Summary by Priority

The following chart shows the total repair costs broken down by priority. Assessors assigned deficiencies within eCOMET to one of the following priority categories:

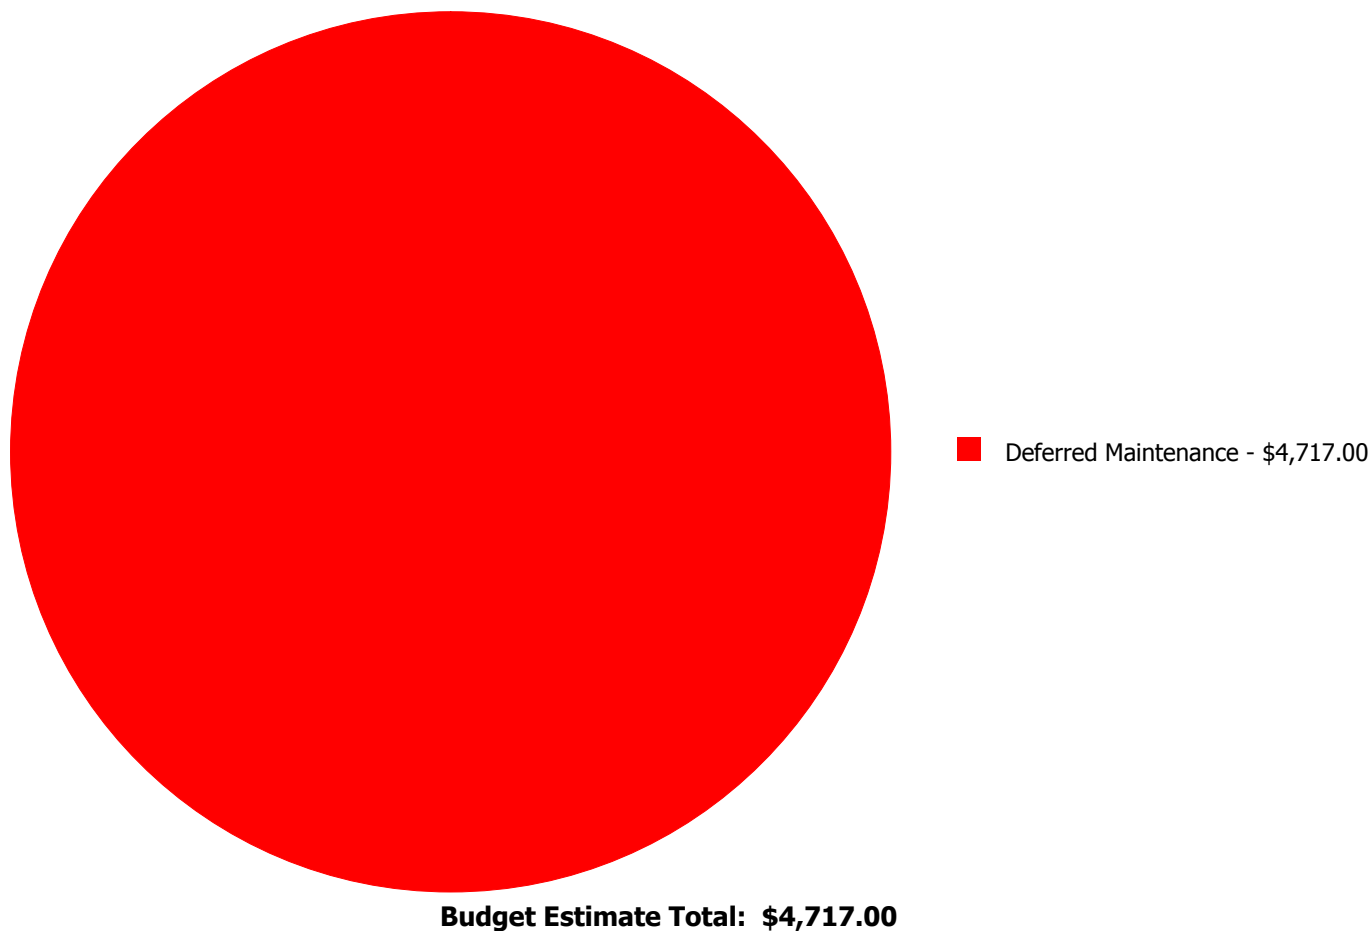
Deficiency Summary by Category

The following chart shows the total repair costs broken down by deficiency categories. Assessors assigned deficiencies to one of the following categories:

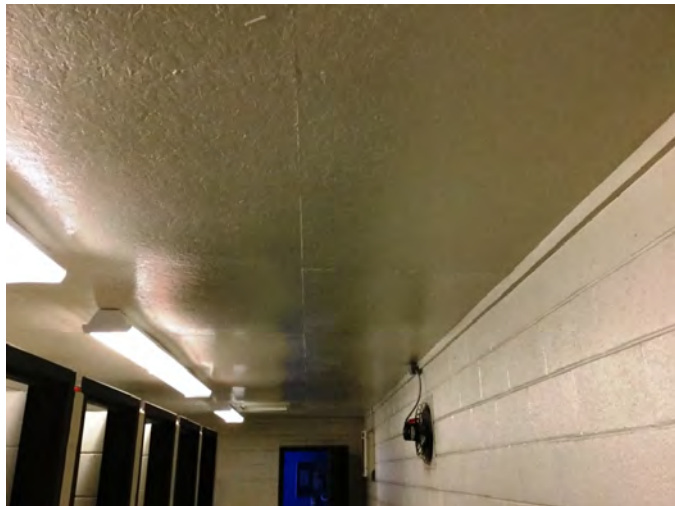
System: C3030 - Ceiling Finishes

Location: Throughout Building
Distress: Beyond Service Life
Category: Deferred Maintenance
Priority: 3 - Necessary/Not Yet Critical (Years 2-5)
Correction: Renew System
Qty: 450.00
Unit of Measure: S.F.
Estimate: \$4,717.00
Assessor Name: Eduardo Lopez
Date Created: 01/10/2017

Notes: The ceiling finishes are beyond their service life and should be replaced.

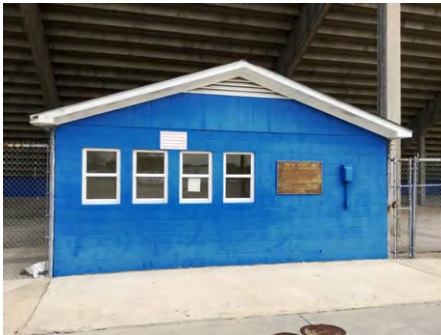
1). South Elevation - Jan 10, 2017

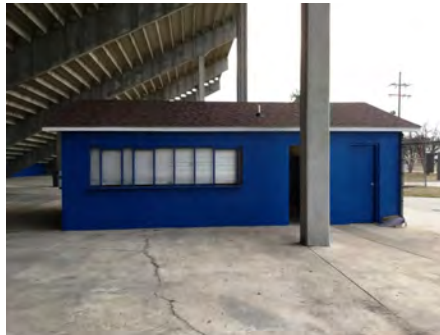
2). West Elevation - Jan 10, 2017

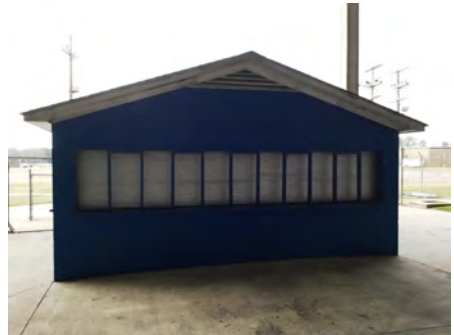
3). North Elevation - Jan 10, 2017

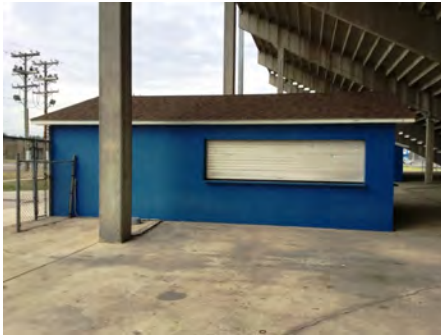
4). East Elevation - Jan 10, 2017
