NC School District/830 Scotland County/High School

Scotland High

Campus Assessment Report

March 11, 2017

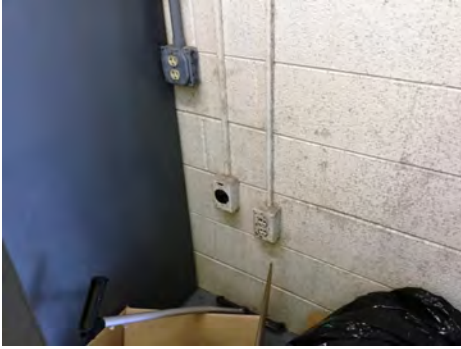
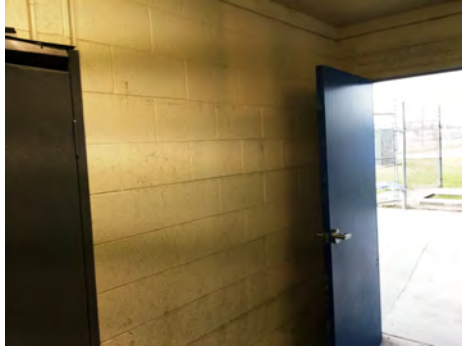
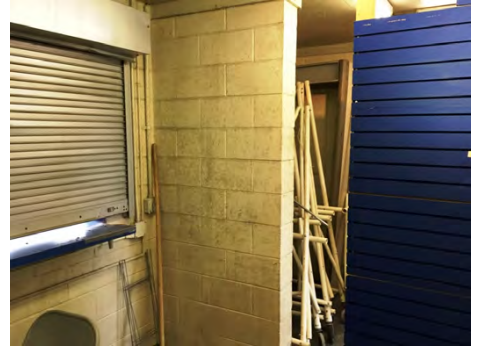
System: C3010 - Wall Finishes

Note: The wall finishes are beyond their service life and should be replaced.

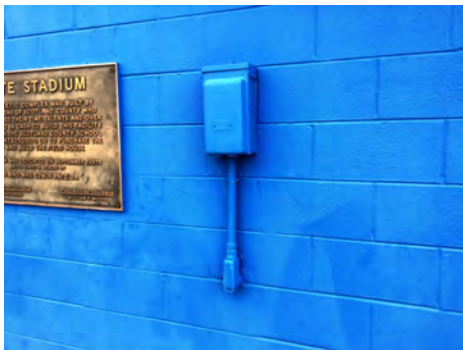
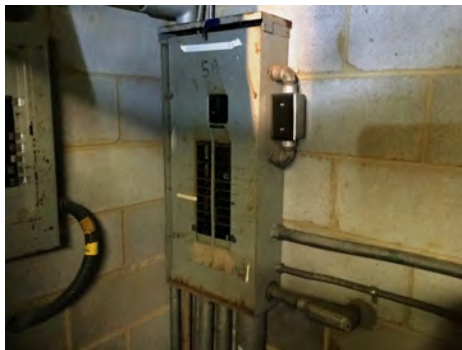
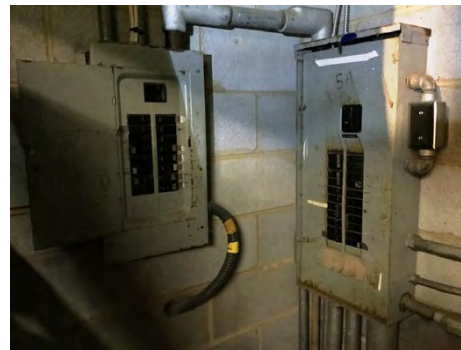
System: D5010 - Electrical Service/Distribution

Note: The electrical service distribution is beyond its service life and should be replaced.

Notes: The electrical service distribution is beyond its service life and should be replaced.

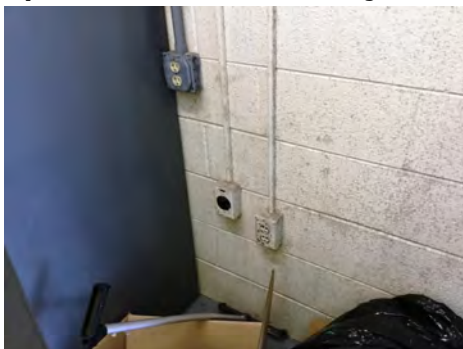
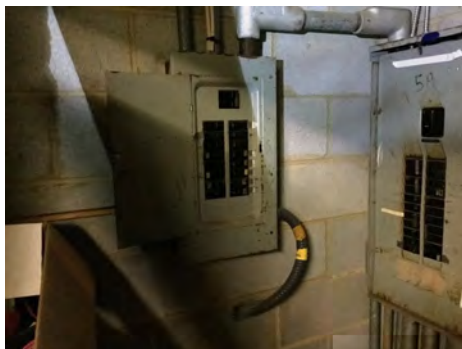
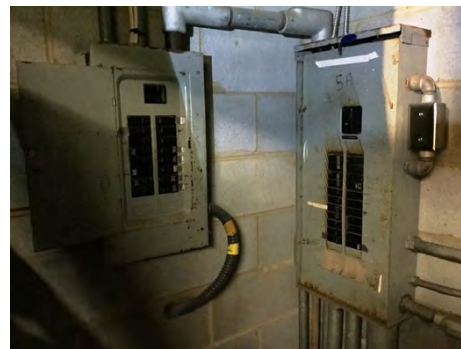
System: D5020 - Branch Wiring

Note: The branch wiring is beyond its service life and should be replaced.

Notes: The branch wiring is beyond its service life and should be replaced.

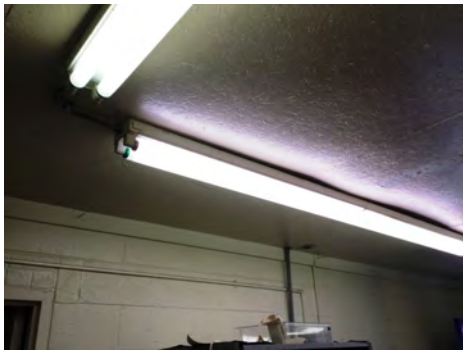
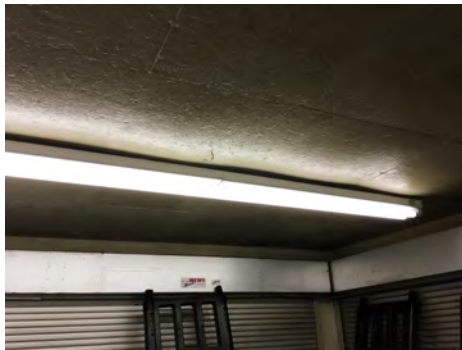
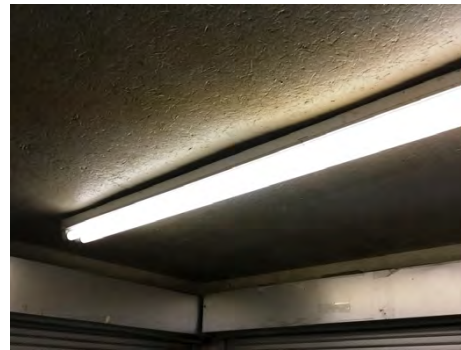
System: D5020 - Lighting

Note: The lighting system is beyond its service life and should be replaced.

Notes: The lighting system is beyond its service life and should be replaced.

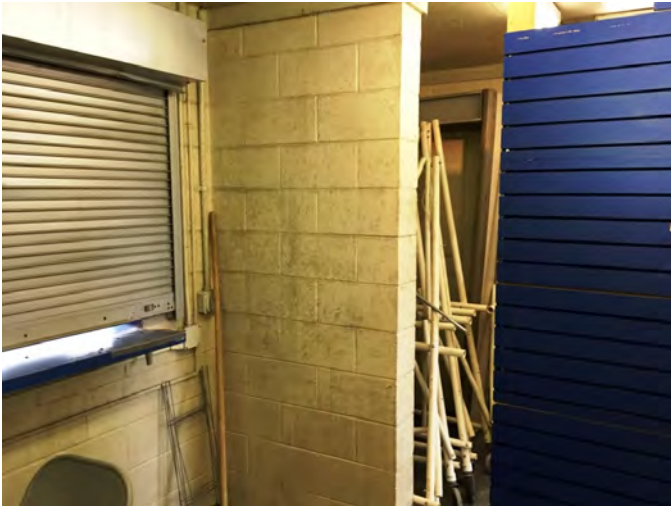
System: C3010 - Wall Finishes

Location: Throughout Building
Distress: Beyond Service Life
Category: Deferred Maintenance
Priority: 3 - Necessary/Not Yet Critical (Years 2-5)
Correction: Renew System
Qty: 460.00
Unit of Measure: S.F.
Estimate: \$2,586.00
Assessor Name: Terence Davis
Date Created: 01/10/2017

Notes: The wall finishes are beyond its service life and should be replaced.

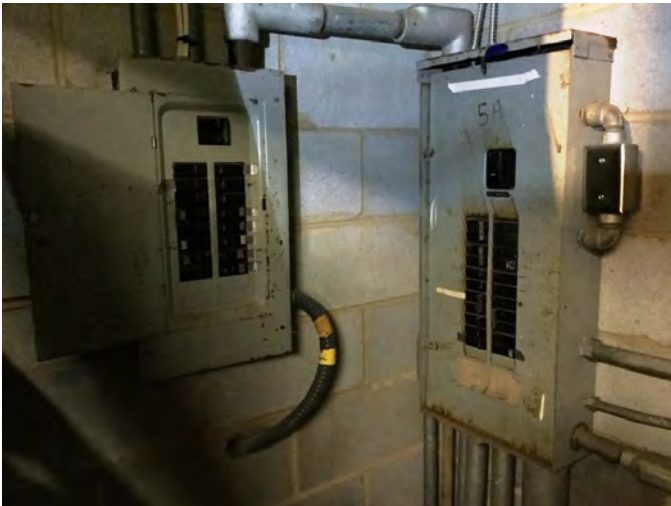
System: D5010 - Electrical Service/Distribution

Location: Throughout Building
Distress: Beyond Service Life
Category: Deferred Maintenance
Priority: 3 - Necessary/Not Yet Critical (Years 2-5)
Correction: Renew System
Qty: 460.00
Unit of Measure: S.F.
Estimate: \$1,564.00
Assessor Name: Terence Davis
Date Created: 01/10/2017

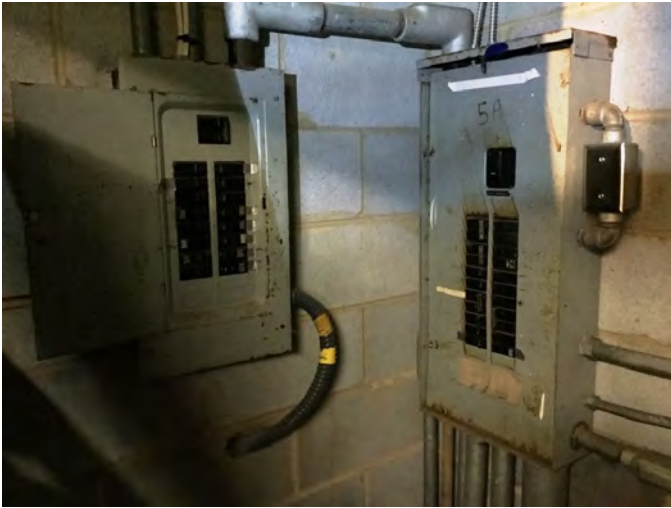
System: D5020 - Branch Wiring

Location: Throughout Building
Distress: Beyond Service Life
Category: Deferred Maintenance
Priority: 3 - Necessary/Not Yet Critical (Years 2-5)
Correction: Renew System
Qty: 460.00
Unit of Measure: S.F.
Estimate: \$1,811.00
Assessor Name: Terence Davis
Date Created: 01/10/2017

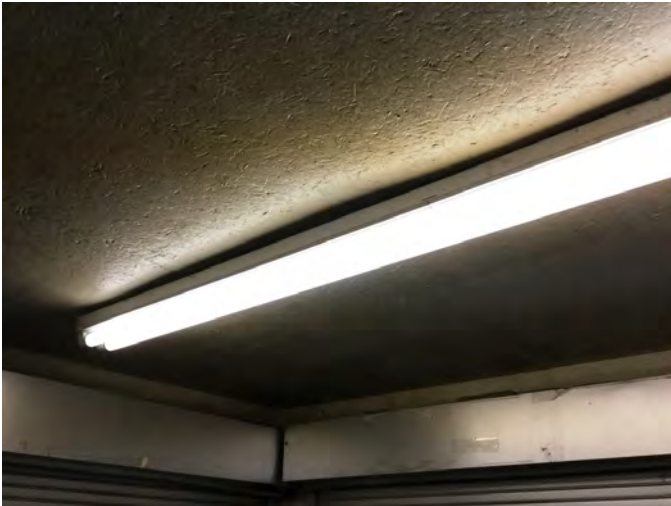
System: D5020 - Lighting

Location: Throughout Building
Distress: Beyond Service Life
Category: Deferred Maintenance
Priority: 3 - Necessary/Not Yet Critical (Years 2-5)
Correction: Renew System
Qty: 460.00
Unit of Measure: S.F.
Estimate: \$4,847.00
Assessor Name: Terence Davis
Date Created: 01/10/2017

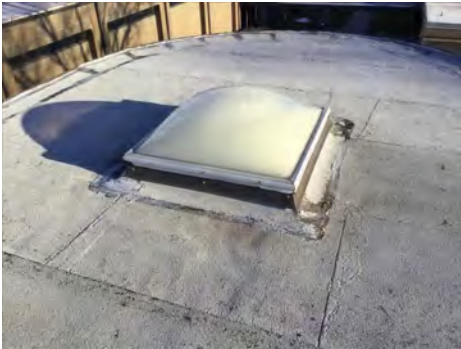
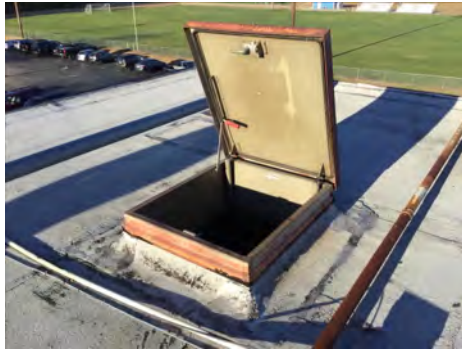
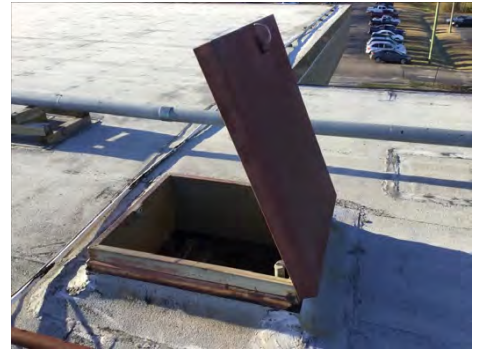
System: B3020 - Roof Openings

Note: The roof openings are beyond their service life and should be replaced.

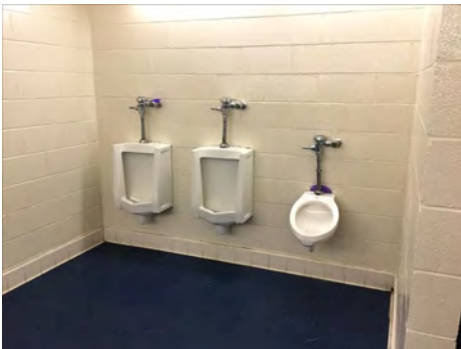
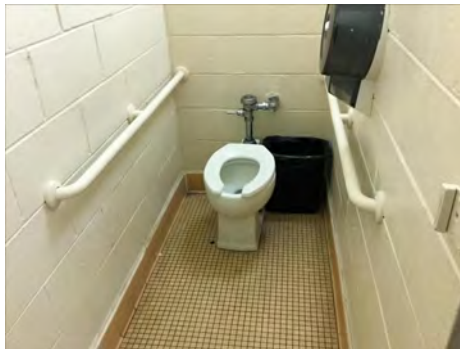
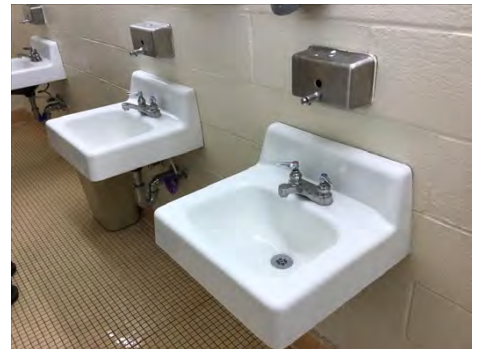
System: D2010 - Plumbing Fixtures

Note: The plumbing fixtures are beyond their service life and should be replaced.

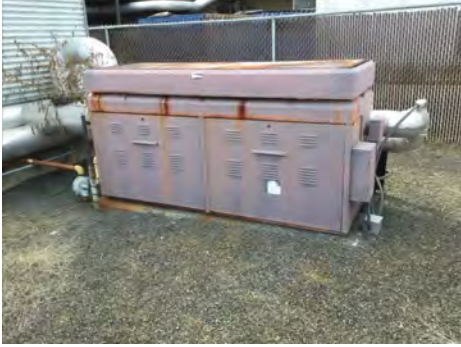
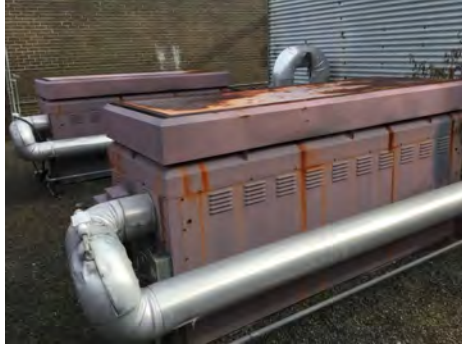
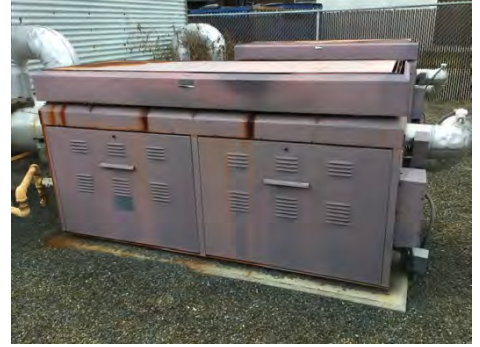
System: D3020 - Heat Generating Systems

Note: The heat generating systems are beyond their service life and should be replaced.

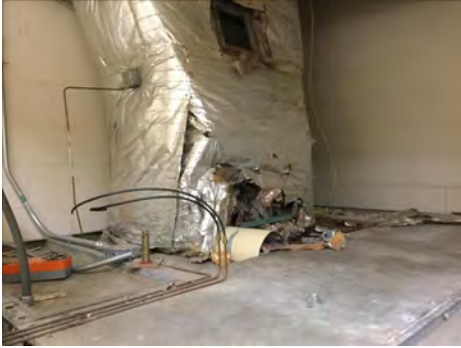
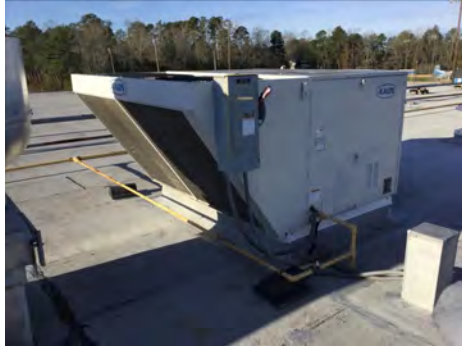
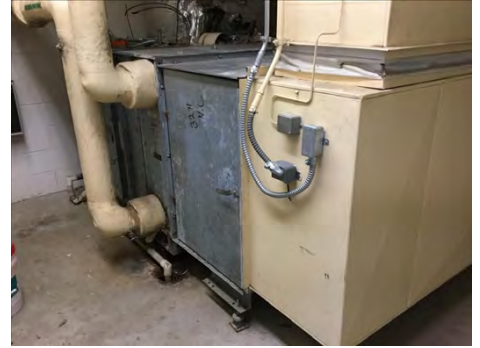
System: D3040 - Distribution Systems

Note: The distribution system is beyond its service life and should be replaced.

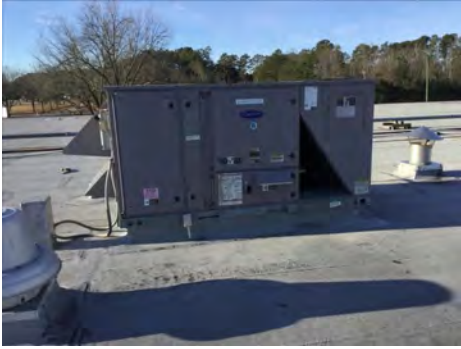
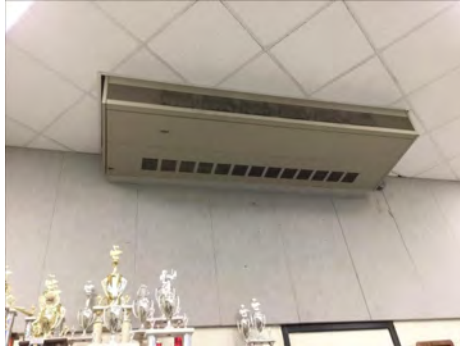
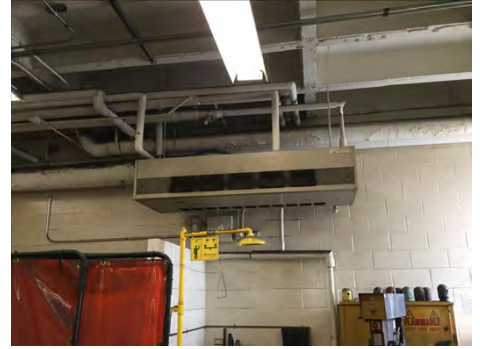
System: D3050 - Terminal & Package Units

Note: The terminal and package units are beyond their service life and should be replaced.

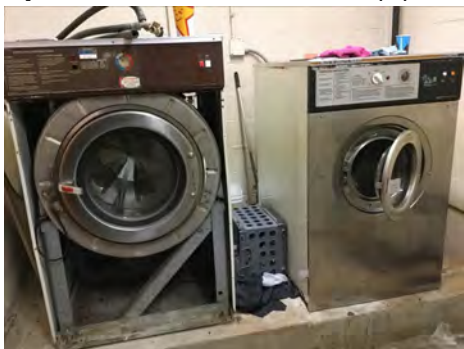
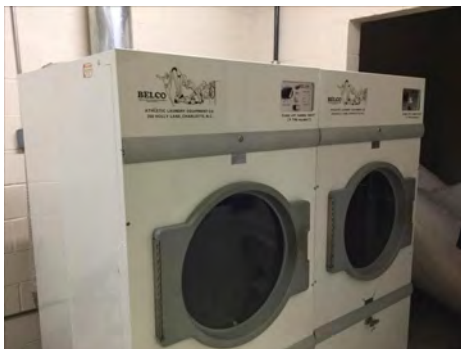
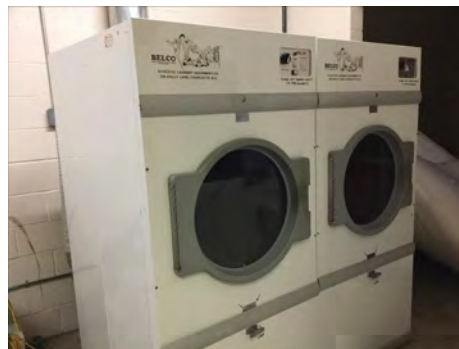
System: E1010 - Commercial Equipment

Note: The commercial equipment is beyond its service life and should be replaced.

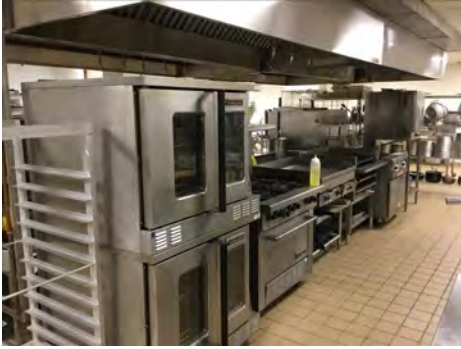
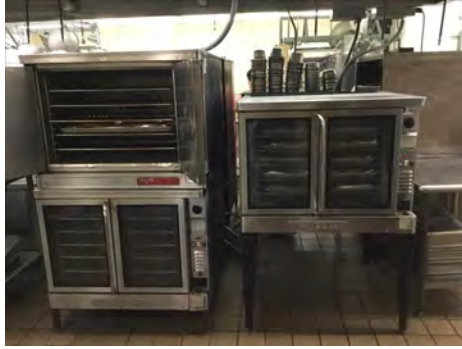
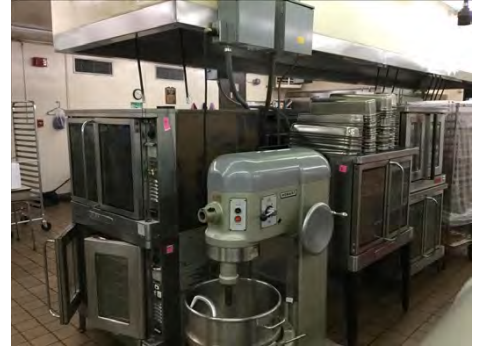
System: E1090 - Other Equipment

Note: The kitchen equipment is beyond its service life and should be replaced.

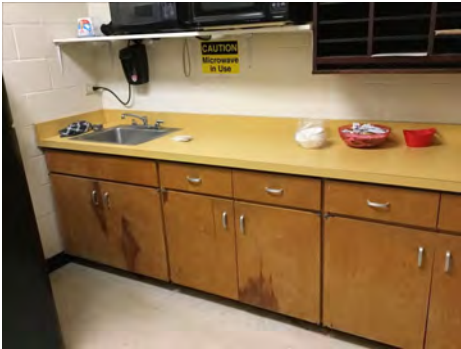
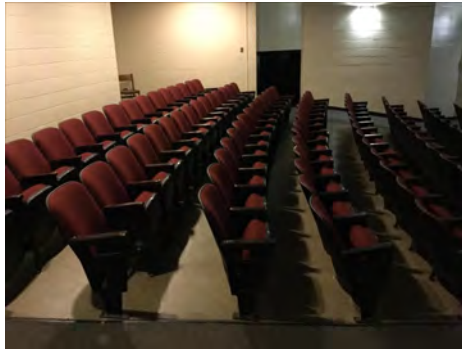
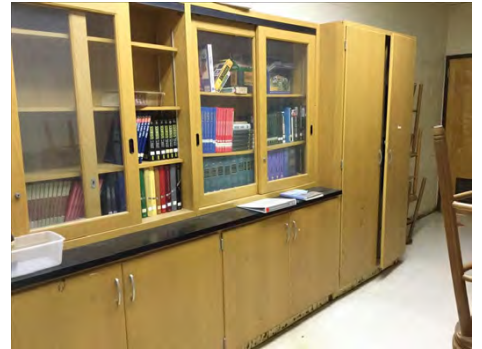
System: E2010 - Fixed Furnishings

Note: The fixed furnishings are beyond their service life and should be replaced.

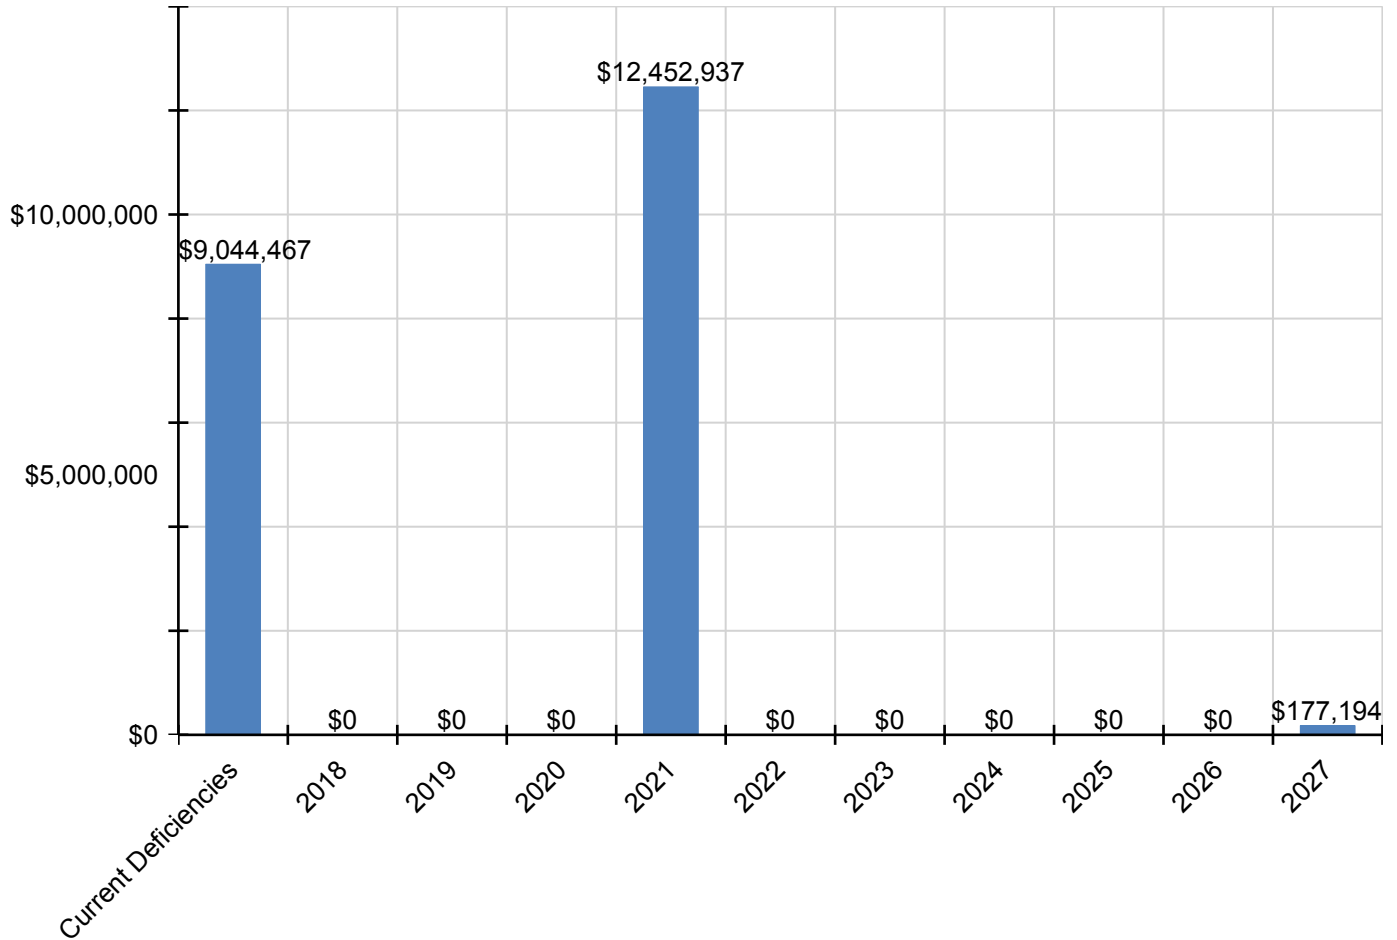
Forecasted Capital Renewal Requirement

The following chart shows the current building deficiencies and forecasting capital renewal or sustainment requirements over the next ten years.

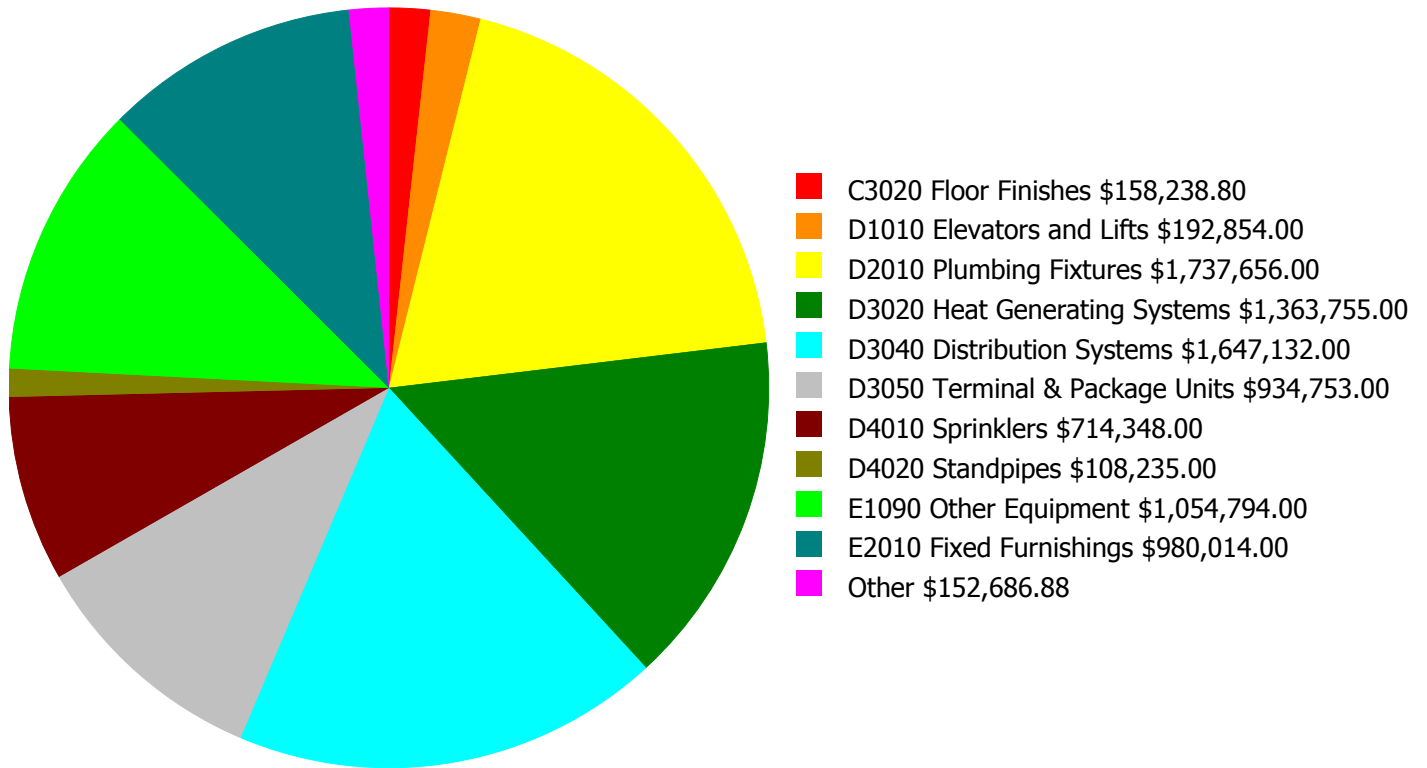
Deficiency Summary by System

Current deficiencies included assemblies that have reached or exceeded their design life or components of the assemblies that are in need of repair. Assemblies that have reached their design life are identified as current deficiencies and assigned the distress 'Beyond Useful Life'. The following chart lists all current deficiencies associated with this facility.

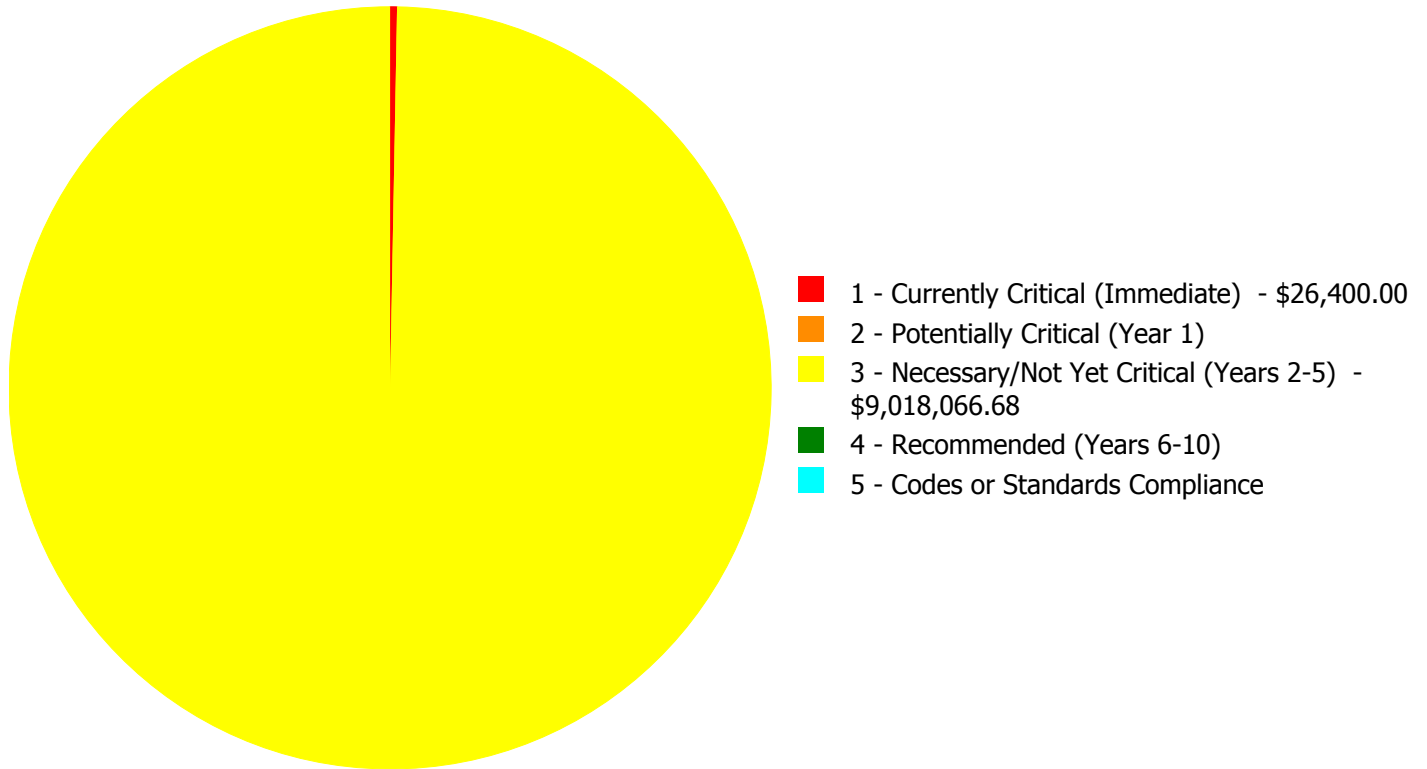
Deficiency Summary by Priority

The following chart shows the total repair costs broken down by priority. Assessors assigned deficiencies within eCOMET to one of the following priority categories:

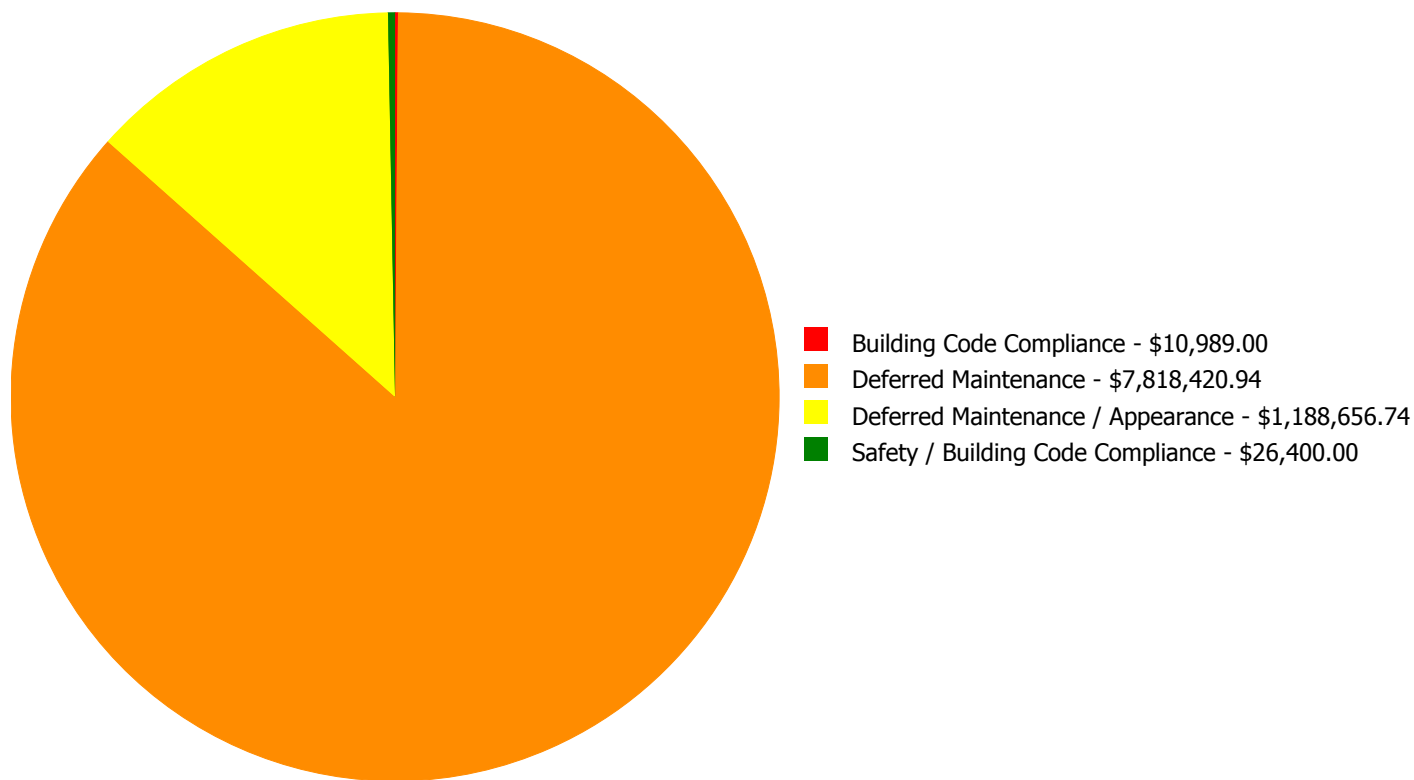
Deficiency Summary by Category

The following chart shows the total repair costs broken down by deficiency categories. Assessors assigned deficiencies to one of the following categories:

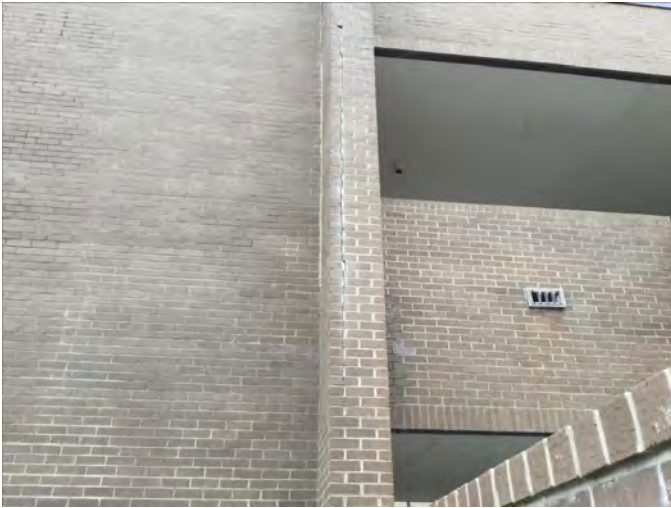
System: B2010 - Exterior Walls

Location: Exterior Walls
Distress: Damaged
Category: Safety / Building Code Compliance
Priority: 1 - Currently Critical (Immediate)
Correction: Engineering Study-2016-11-15 17:41:59
Qty: 1.00
Unit of Measure: Ea.
Estimate: \$13,200.00
Assessor Name: Terence Davis
Date Created: 01/06/2017

Notes: There are visible cracks on the exterior walls and it should be studied by a professional engineer.

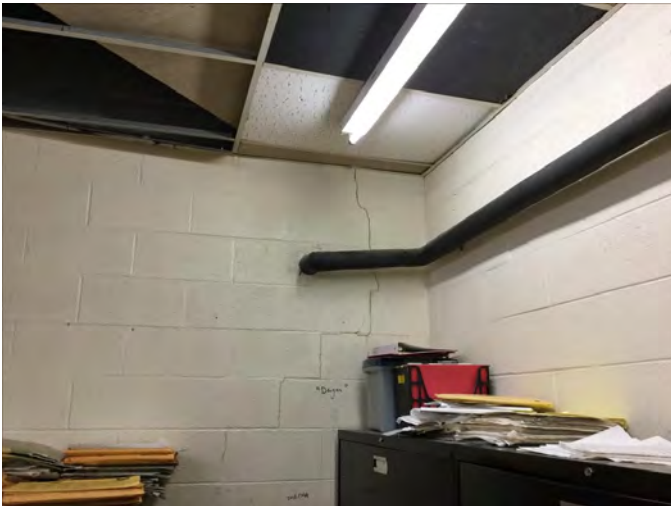
System: C1010 - Partitions

Location: Media Center
Distress: Failing
Category: Safety / Building Code Compliance
Priority: 1 - Currently Critical (Immediate)
Correction: Engineering Study
Qty: 1.00
Unit of Measure: Ea.
Estimate: \$13,200.00
Assessor Name: Terence Davis
Date Created: 01/06/2017

Notes: There are visible cracks on the partition wall and should be studied by a professional engineer.

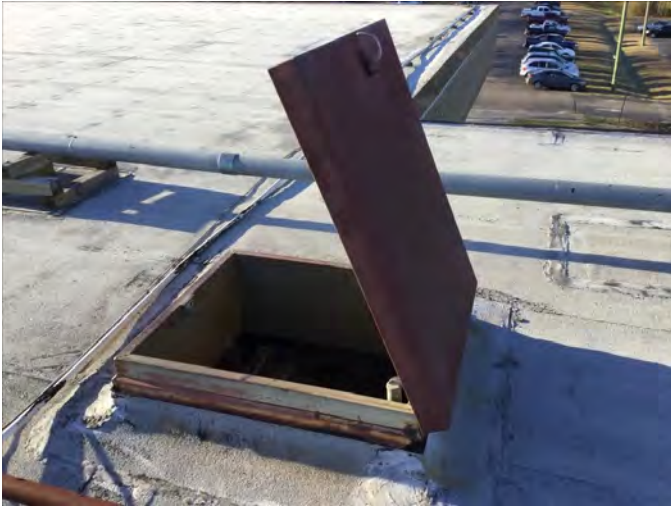
System: B3020 - Roof Openings

Location: Roof
Distress: Beyond Service Life
Category: Deferred Maintenance
Priority: 3 - Necessary/Not Yet Critical (Years 2-5)
Correction: Renew System
Qty: 178,900.00
Unit of Measure: S.F.
Estimate: \$41,326.00
Assessor Name: Terence Davis
Date Created: 12/30/2016

Notes: The roof openings are beyond their service life and should be replaced by OSHA complaint access.

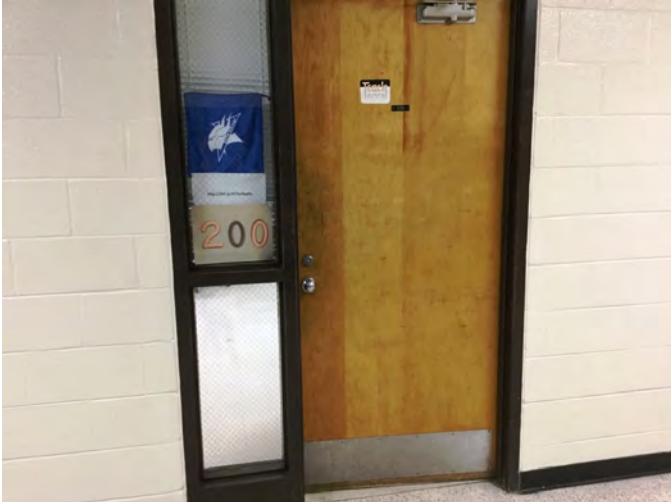
System: C1030 - Fittings

Location: Throughout Building
Distress: Inadequate
Category: Building Code Compliance
Priority: 3 - Necessary/Not Yet Critical (Years 2-5)
Correction: Replace signage and toilet partitions
Qty: 150.00
Unit of Measure: Ea.
Estimate: \$10,989.00
Assessor Name: Terence Davis
Date Created: 02/14/2017

Notes: The signage is not ADA compliant and should be replaced.

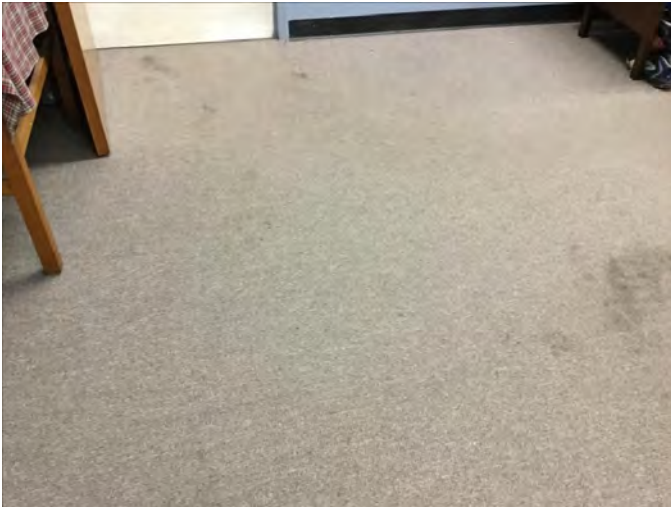
System: C3020 - Floor Finishes

Location: Throughout building
Distress: Beyond Service Life
Category: Deferred Maintenance / Appearance
Priority: 3 - Necessary/Not Yet Critical (Years 2-5)
Correction: Replace carpet
Qty: 1,851.11
Unit of Measure: S.Y.
Estimate: \$158,238.80
Assessor Name: Terence Davis
Date Created: 01/06/2017

Notes: The carpet is beyond its service life and should be replaced.

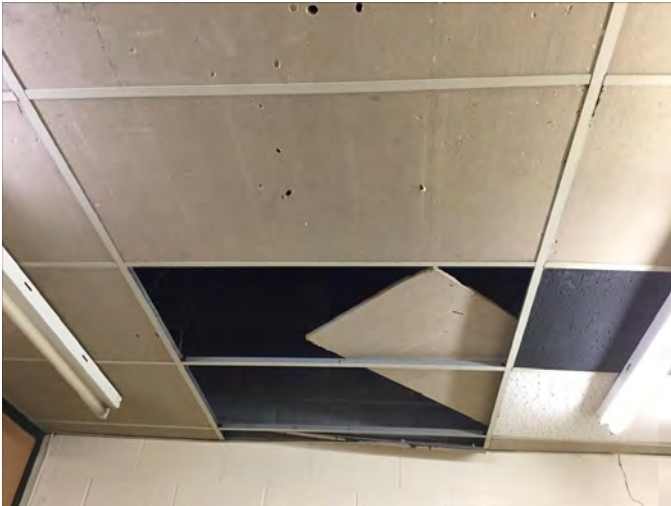
System: C3030 - Ceiling Finishes

Location: Throughout building
Distress: Beyond Service Life
Category: Deferred Maintenance / Appearance
Priority: 3 - Necessary/Not Yet Critical (Years 2-5)
Correction: Acoustic tile repairs - (2% of ceilings)
Qty: 47.20
Unit of Measure: C.S.F.
Estimate: \$50,403.94
Assessor Name: Terence Davis
Date Created: 01/06/2017

Notes: The acoustical ceiling tiles are beyond their service life and should be replaced.

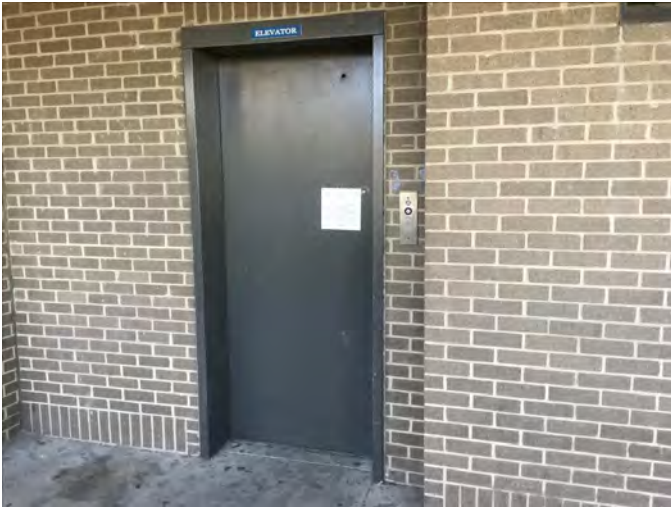
System: D1010 - Elevators and Lifts

Location: Throughout Building
Distress: Beyond Service Life
Category: Deferred Maintenance
Priority: 3 - Necessary/Not Yet Critical (Years 2-5)
Correction: Renew System
Qty: 178,900.00
Unit of Measure: S.F.
Estimate: \$192,854.00
Assessor Name: Terence Davis
Date Created: 12/30/2016

Notes: The elevators and lifts are beyond their service life and should be replaced.

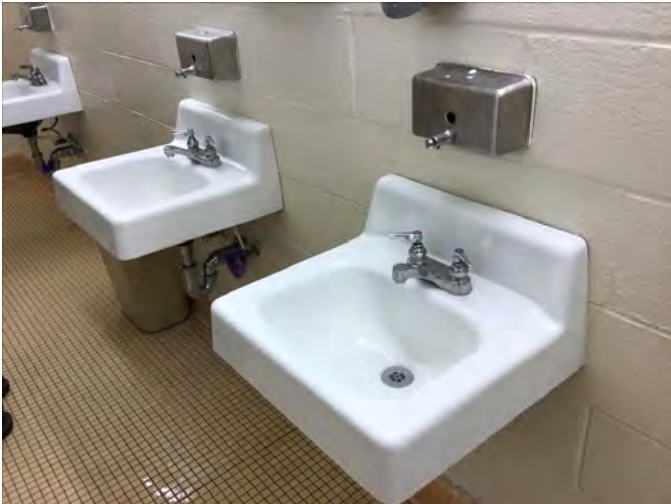
System: D2010 - Plumbing Fixtures

Location: Throughout Building
Distress: Beyond Service Life
Category: Deferred Maintenance
Priority: 3 - Necessary/Not Yet Critical (Years 2-5)
Correction: Renew System
Qty: 178,900.00
Unit of Measure: S.F.
Estimate: \$1,737,656.00
Assessor Name: Terence Davis
Date Created: 12/30/2016

Notes: The plumbing fixtures are beyond their service life and should be replaced.

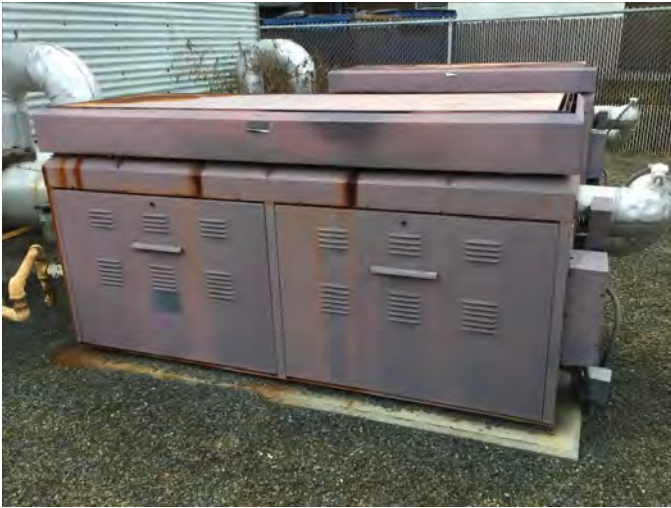
System: D3020 - Heat Generating Systems

Location: Throughout Building
Distress: Beyond Service Life
Category: Deferred Maintenance
Priority: 3 - Necessary/Not Yet Critical (Years 2-5)
Correction: Renew System
Qty: 178,900.00
Unit of Measure: S.F.
Estimate: \$1,363,755.00
Assessor Name: Terence Davis
Date Created: 12/30/2016

Notes: The heat generating systems are beyond their service life and should be replaced.

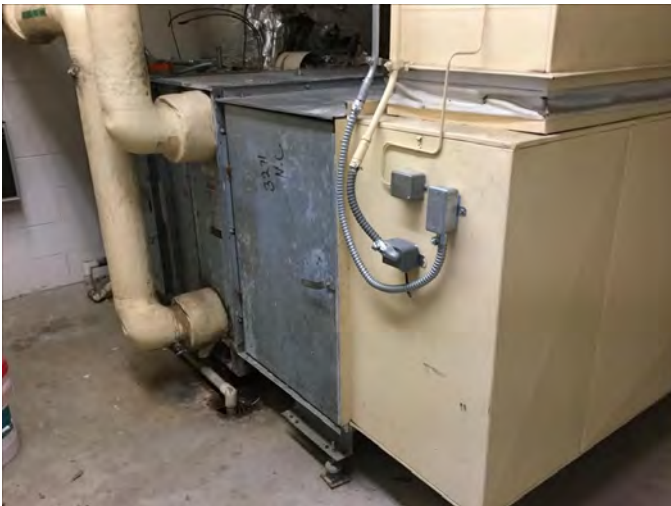
System: D3040 - Distribution Systems

Location: Throughout Building
Distress: Beyond Service Life
Category: Deferred Maintenance
Priority: 3 - Necessary/Not Yet Critical (Years 2-5)
Correction: Renew System
Qty: 178,900.00
Unit of Measure: S.F.
Estimate: \$1,647,132.00
Assessor Name: Terence Davis
Date Created: 12/30/2016

Notes: The distribution system is beyond its service life and should be replaced.

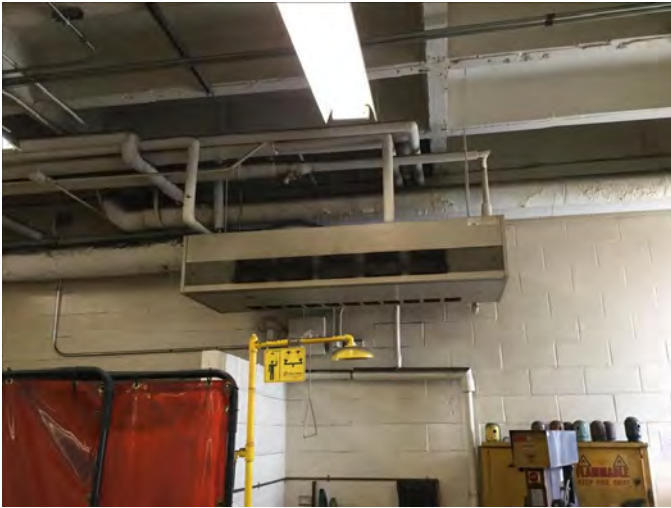
System: D3050 - Terminal & Package Units

Location: Throughout Building
Distress: Beyond Service Life
Category: Deferred Maintenance
Priority: 3 - Necessary/Not Yet Critical (Years 2-5)
Correction: Renew System
Qty: 178,900.00
Unit of Measure: S.F.
Estimate: \$934,753.00
Assessor Name: Terence Davis
Date Created: 12/30/2016

Notes: The terminal and package units are beyond their service life and should be replaced.

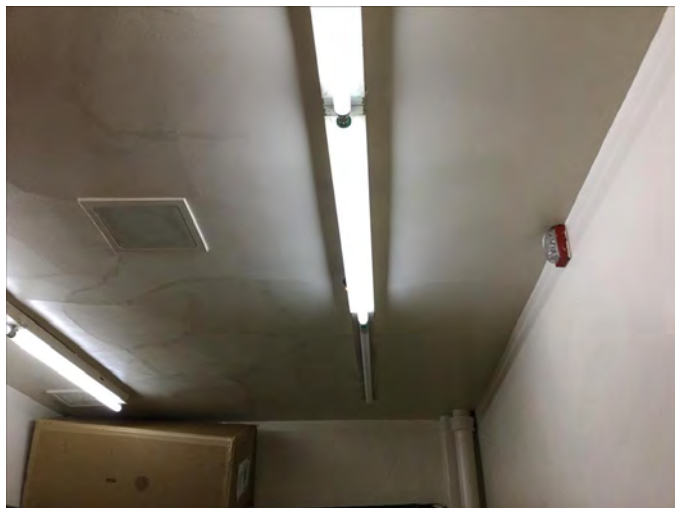
System: D5020 - Lighting

Location: Throughout building
Distress: Beyond Service Life
Category: Deferred Maintenance
Priority: 3 - Necessary/Not Yet Critical (Years 2-5)
Correction: Replace fluorescent fixture, lay-in, recess mtd, 2' x 4', two 40 W
Qty: 75.00
Unit of Measure: Ea.
Estimate: \$23,567.94
Assessor Name: Terence Davis
Date Created: 01/06/2017

Notes: The lighting fixtures are beyond their service life and should be replaced.

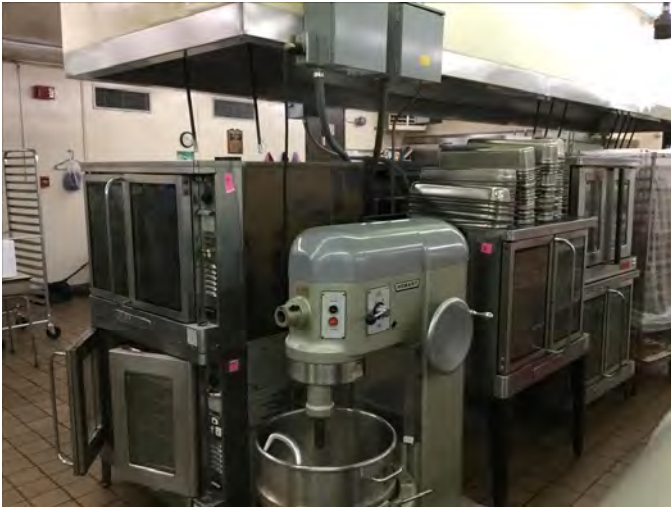
System: E1090 - Other Equipment

Location: Cafeteria and Home Economics Classrooms
Distress: Beyond Service Life
Category: Deferred Maintenance
Priority: 3 - Necessary/Not Yet Critical (Years 2-5)
Correction: Renew System
Qty: 178,900.00
Unit of Measure: S.F.
Estimate: \$1,054,794.00
Assessor Name: Terence Davis
Date Created: 12/30/2016

Notes: The kitchen equipment is beyond its service life and should be replaced.

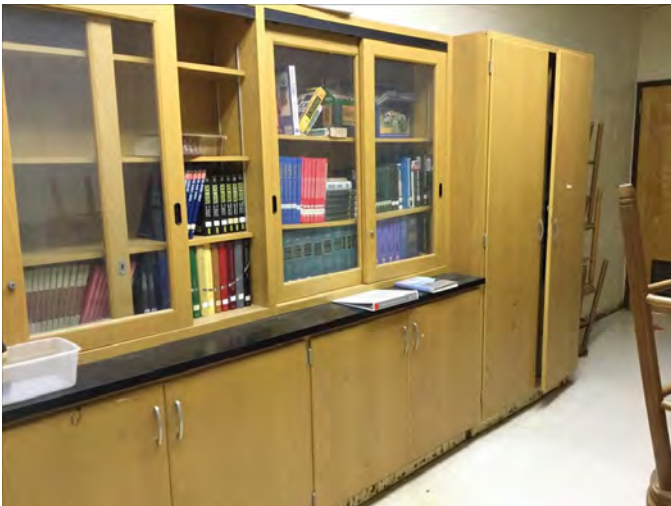
System: E2010 - Fixed Furnishings

Location: Throughout Building
Distress: Beyond Service Life
Category: Deferred Maintenance / Appearance
Priority: 3 - Necessary/Not Yet Critical (Years 2-5)
Correction: Renew System
Qty: 178,900.00
Unit of Measure: S.F.
Estimate: \$980,014.00
Assessor Name: Terence Davis
Date Created: 12/30/2016

Notes: The fixed furnishings are beyond their service life and should be replaced.

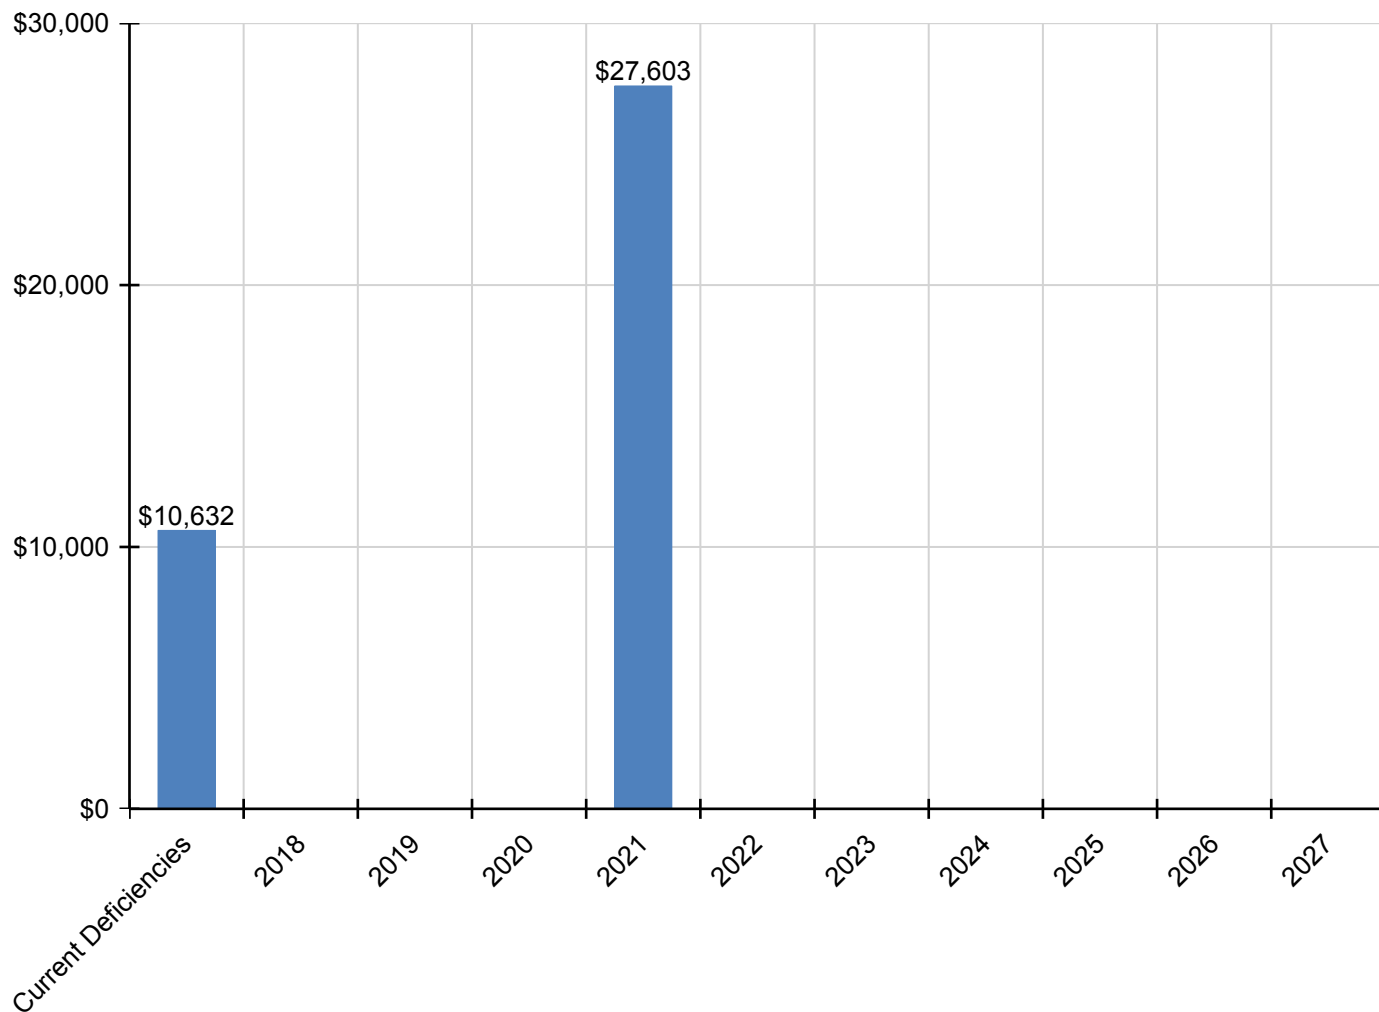
Forecasted Capital Renewal Requirement

The following chart shows the current building deficiencies and forecasting capital renewal or sustainment requirements over the next ten years.

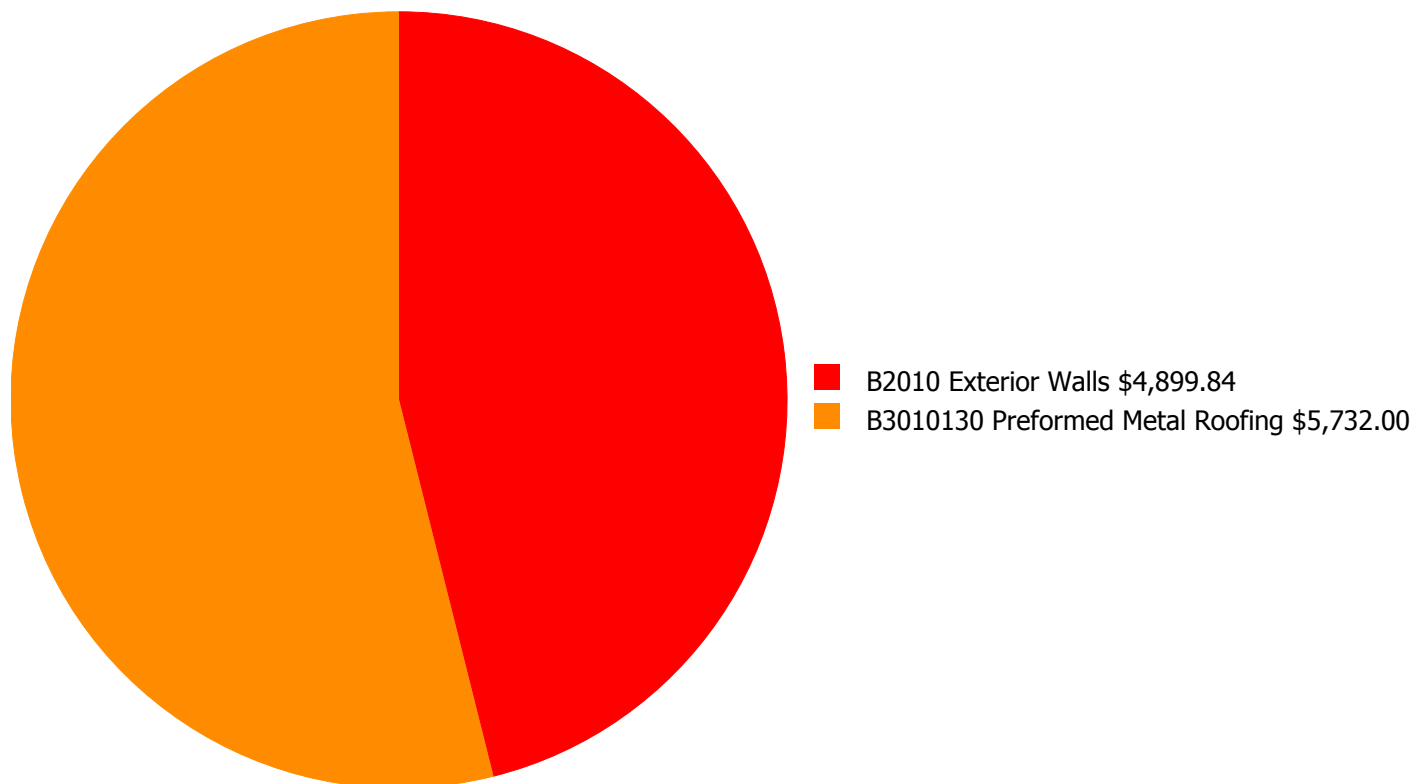
Deficiency Summary by System

Current deficiencies included assemblies that have reached or exceeded their design life or components of the assemblies that are in need of repair. Assemblies that have reached their design life are identified as current deficiencies and assigned the distress 'Beyond Useful Life'. The following chart lists all current deficiencies associated with this facility.
