NC School District/830 Scotland County/High School

Scotland High

Campus Assessment Report

March 11, 2017

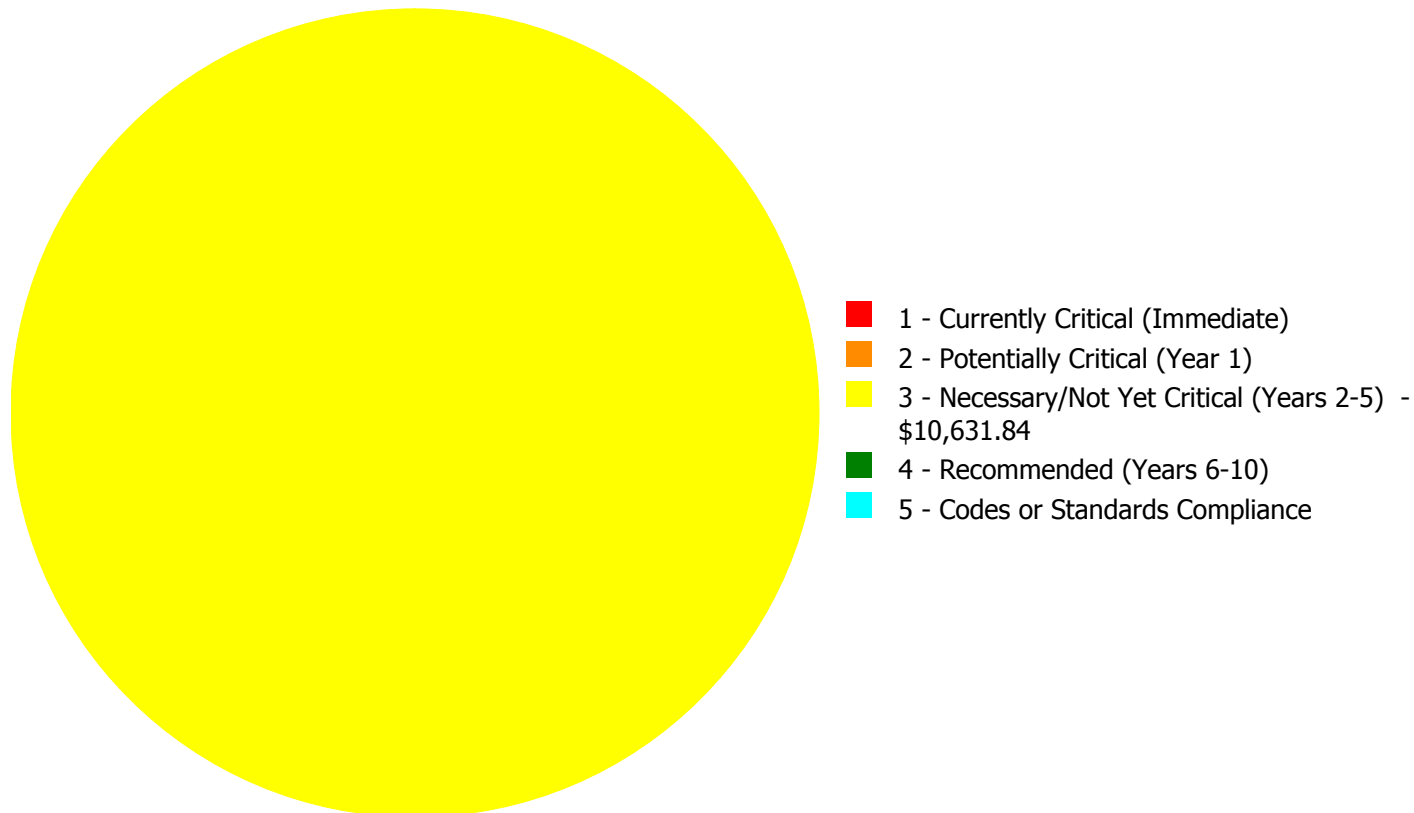
Deficiency Summary by Priority

The following chart shows the total repair costs broken down by priority. Assessors assigned deficiencies within eCOMET to one of the following priority categories:

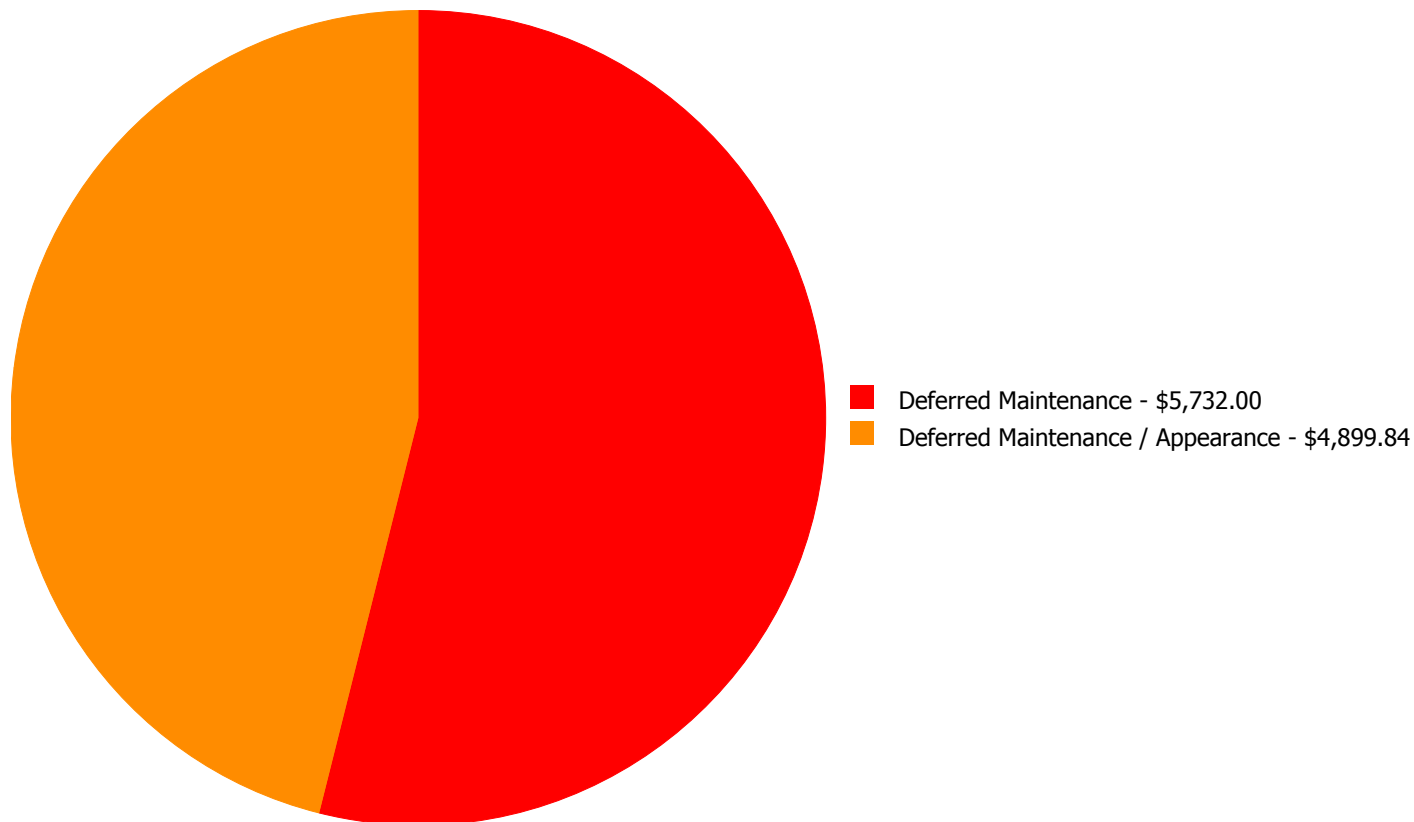
Deficiency Summary by Category

The following chart shows the total repair costs broken down by deficiency categories. Assessors assigned deficiencies to one of the following categories:

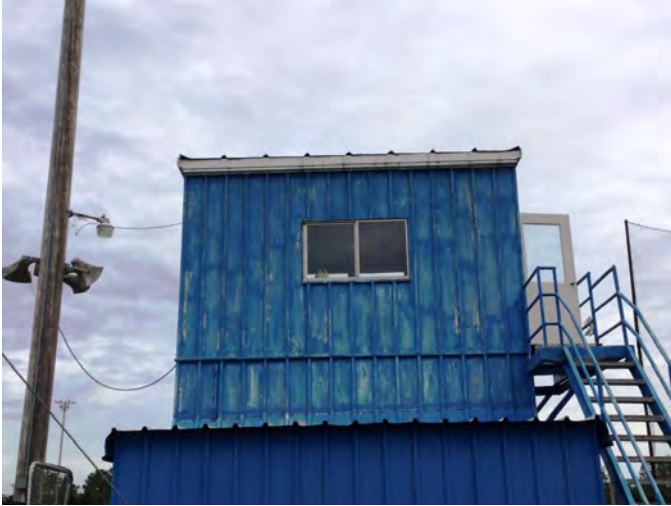
System: B2010 - Exterior Walls

Location: Exterior Walls
Distress: Beyond Service Life
Category: Deferred Maintenance / Appearance
Priority: 3 - Necessary/Not Yet Critical (Years 2-5)
Correction: Refinish aluminum siding, 2nd floor
Qty: 12.80
Unit of Measure: C.S.F.
Estimate: \$4,899.84
Assessor Name: Eduardo Lopez
Date Created: 01/11/2017

Notes: The exterior wall finish is in poor condition and should be replaced.

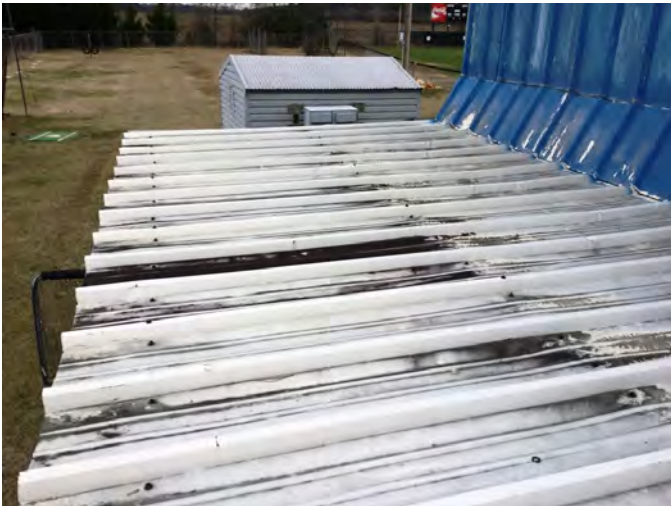
System: B3010130 - Preformed Metal Roofing

Location: Roof
Distress: Beyond Service Life
Category: Deferred Maintenance
Priority: 3 - Necessary/Not Yet Critical (Years 2-5)
Correction: Renew System
Qty: 430.00
Unit of Measure: S.F.
Estimate: \$5,732.00
Assessor Name: Eduardo Lopez
Date Created: 01/11/2017

Notes: The roof is beyond its service life and should be replaced.

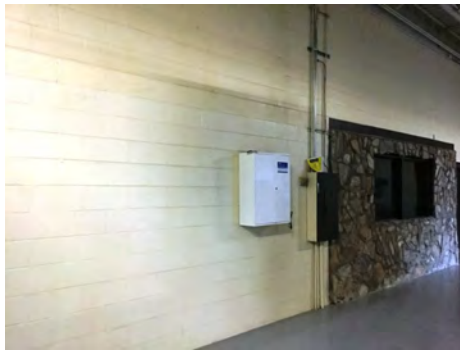
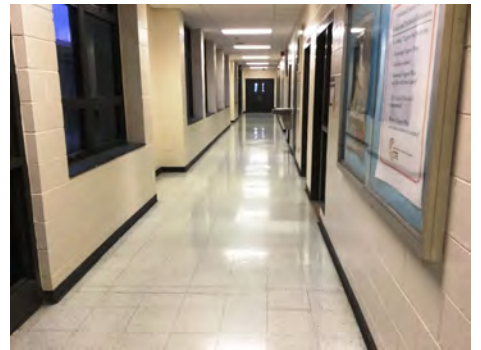
System: C1010 - Partitions

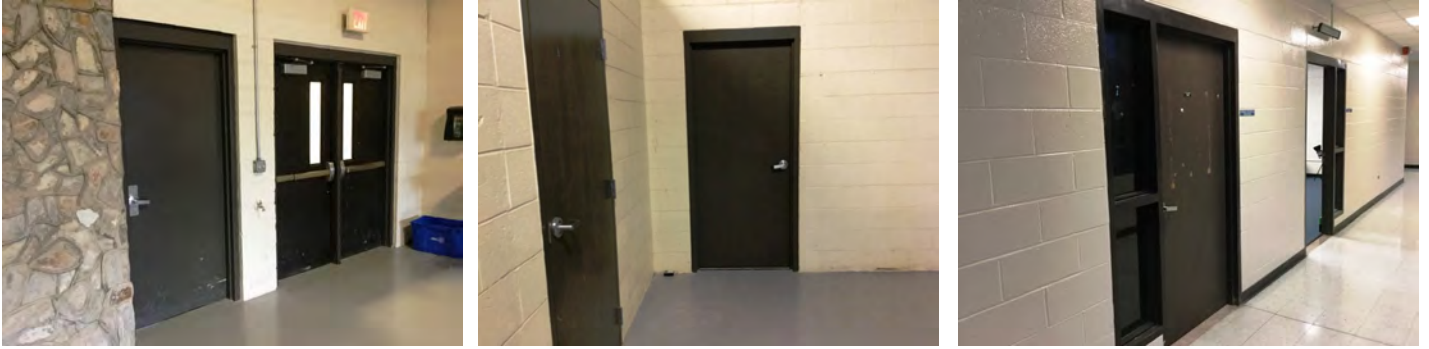
System: C1020 - Interior Doors

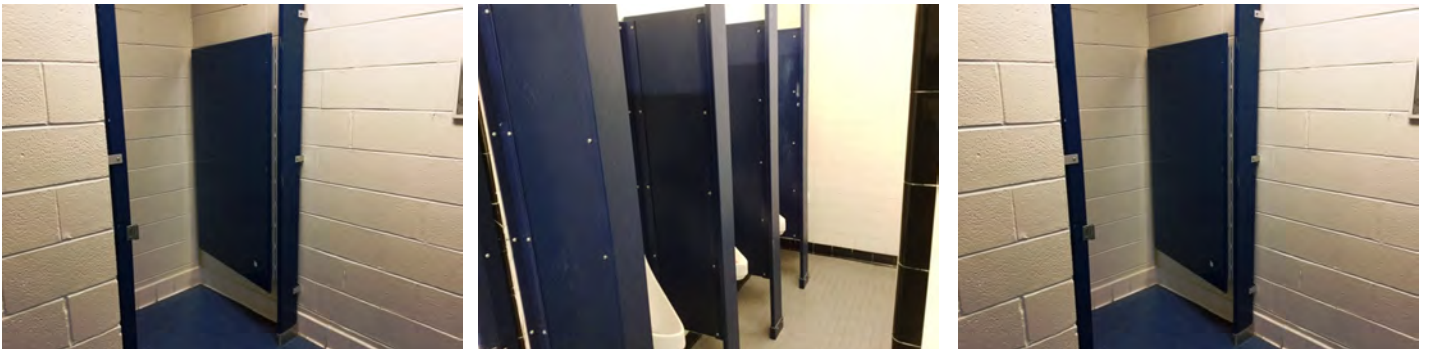
System: C1030 - Fittings

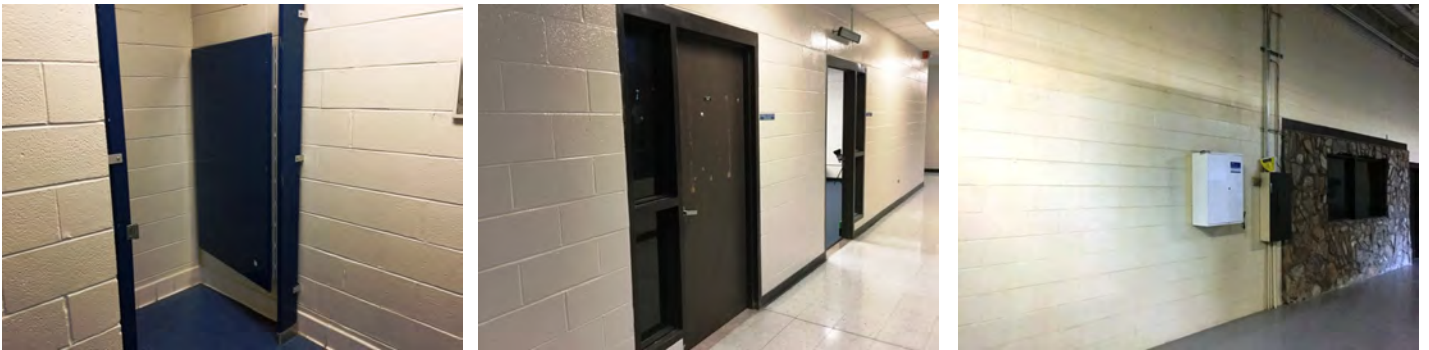
System: C3010 - Wall Finishes

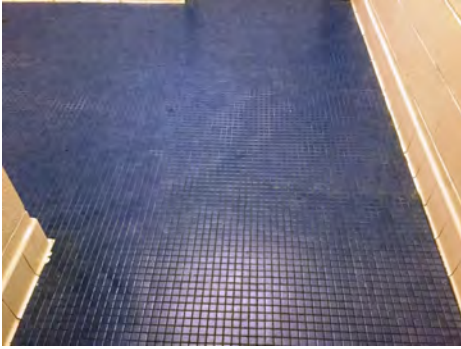
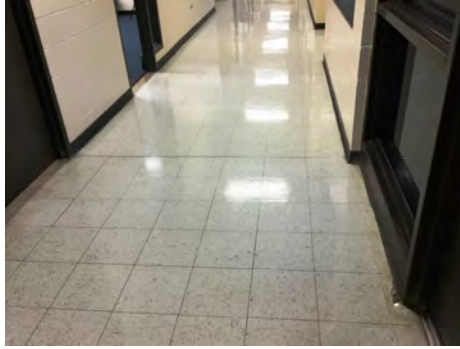
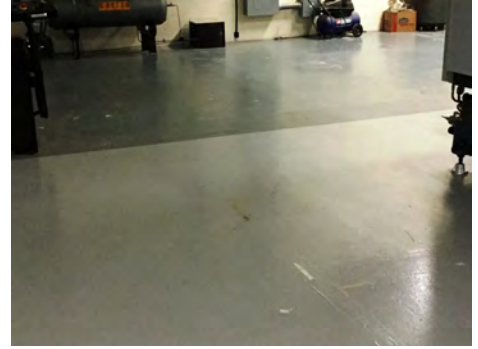
System: C3020 - Floor Finishes

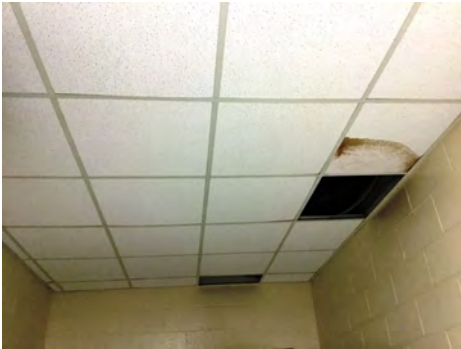
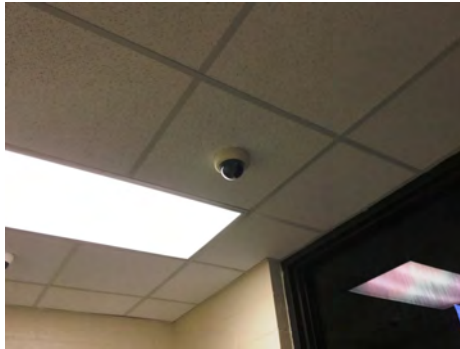
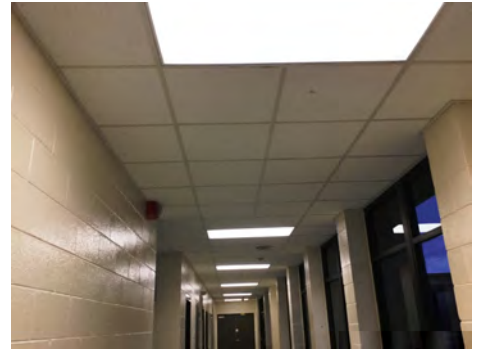
System: C3030 - Ceiling Finishes

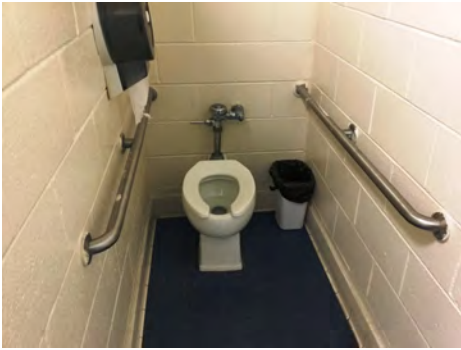
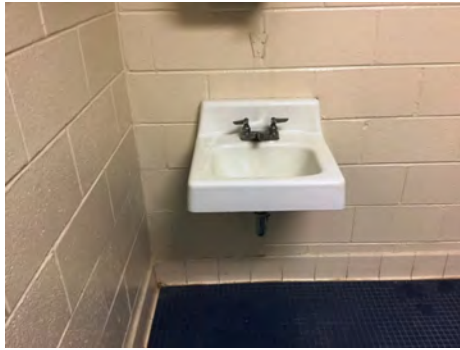
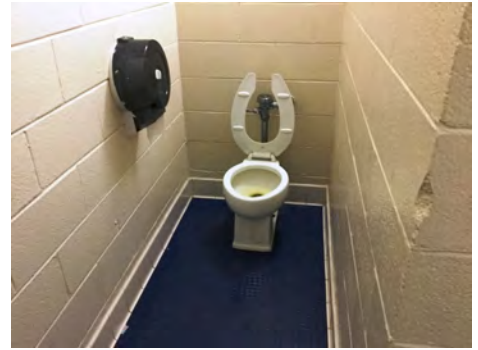
System: D2010 - Plumbing Fixtures

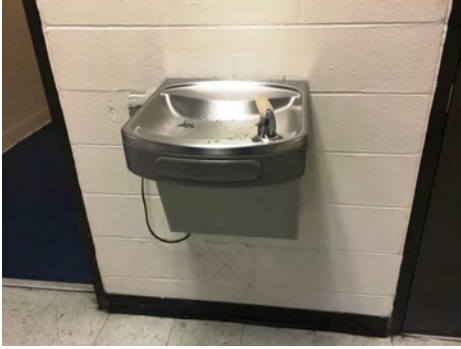
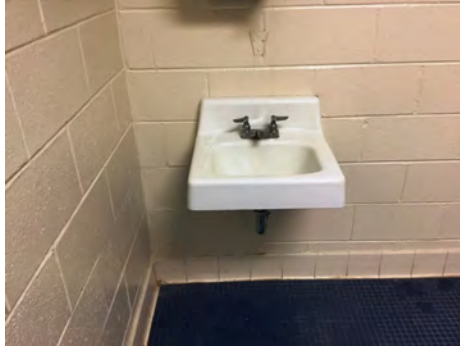
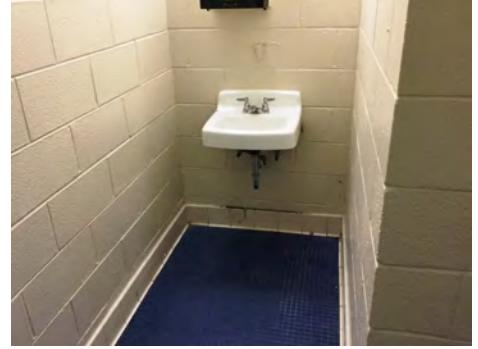
System: D2020 - Domestic Water Distribution

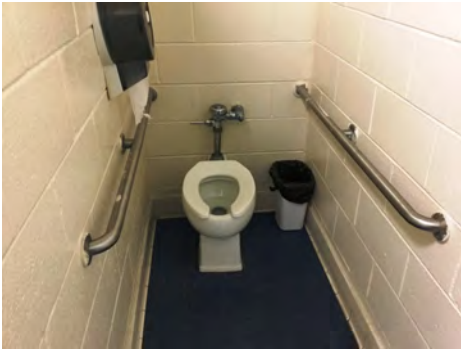
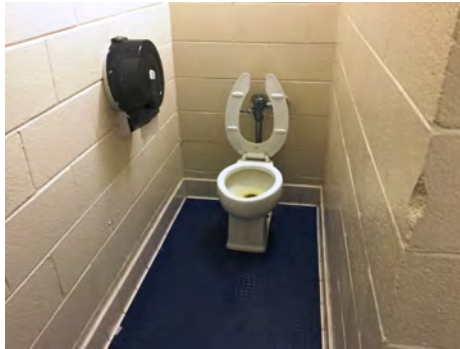
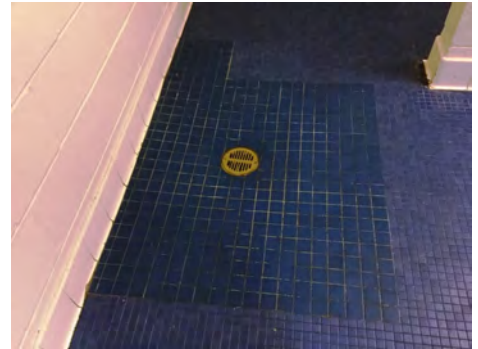
System: D2030 - Sanitary Waste

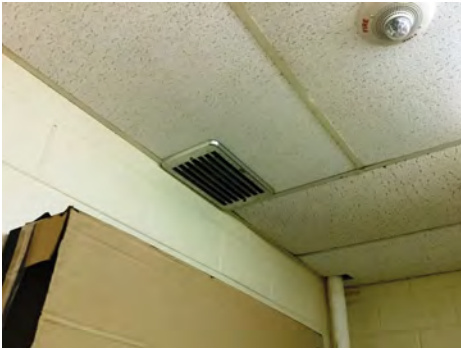
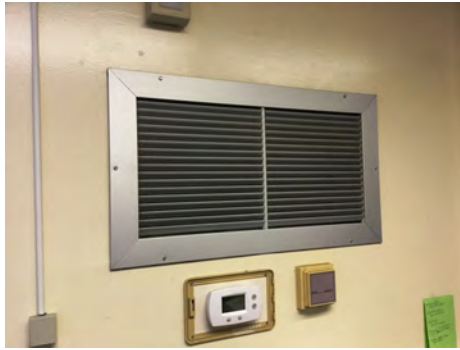
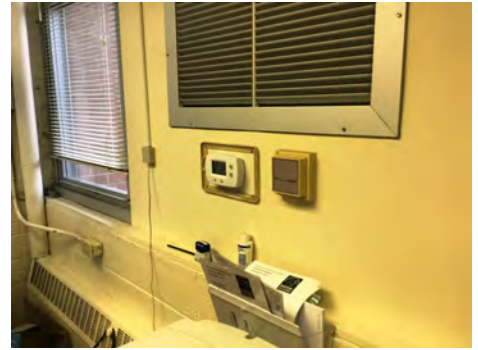
System: D3040 - Distribution Systems

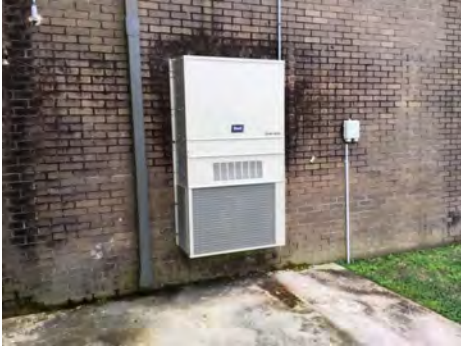
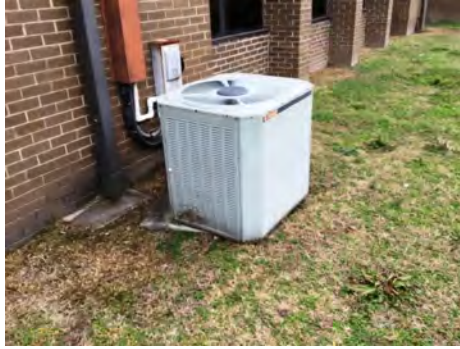
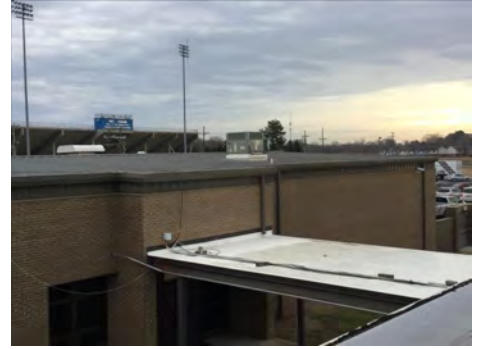
System: D3050 - Terminal & Package Units

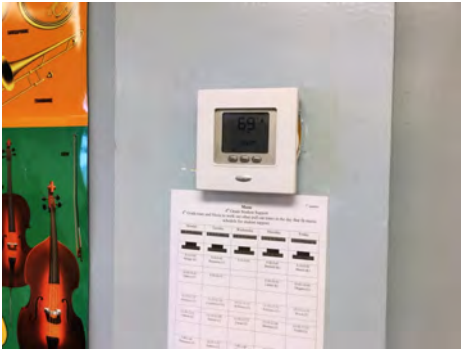
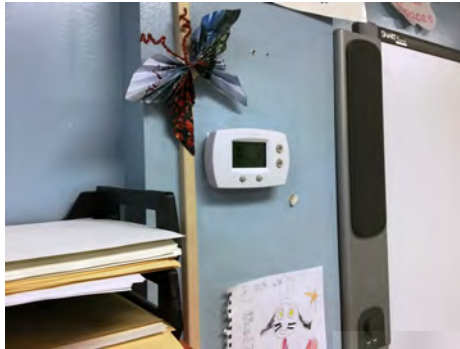
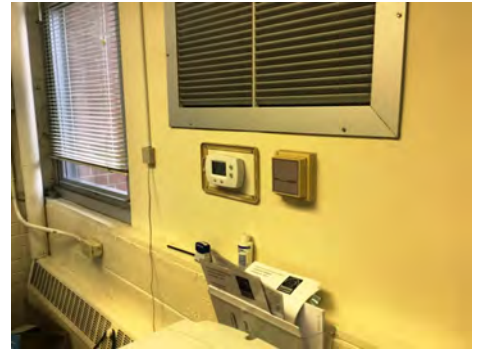
System: D3060 - Controls & Instrumentation

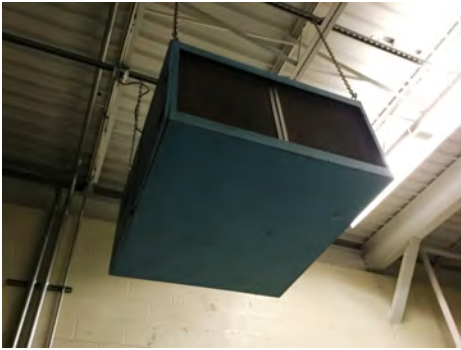
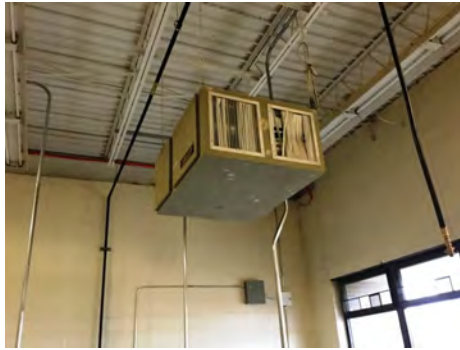
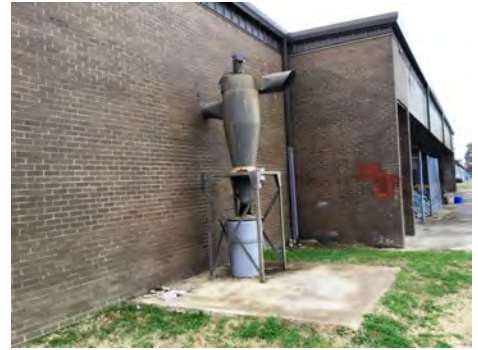
System: D3090 - Other HVAC Systems/Equip

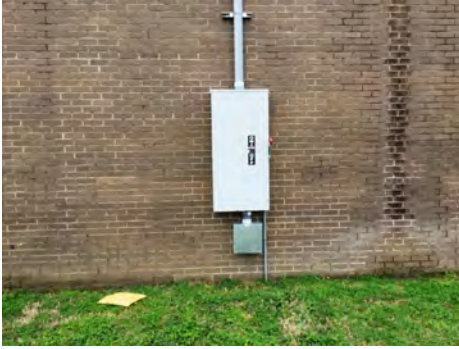
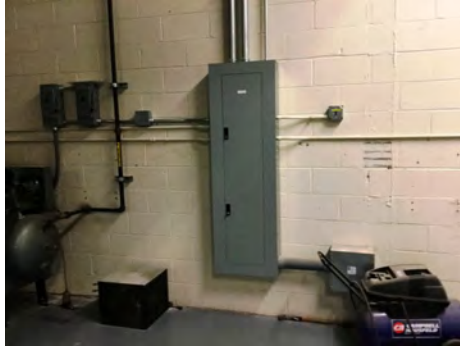
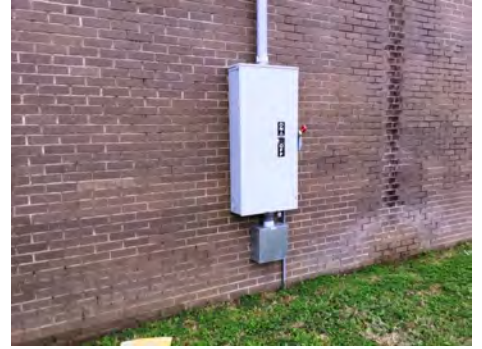
System: D5010 - Electrical Service/Distribution

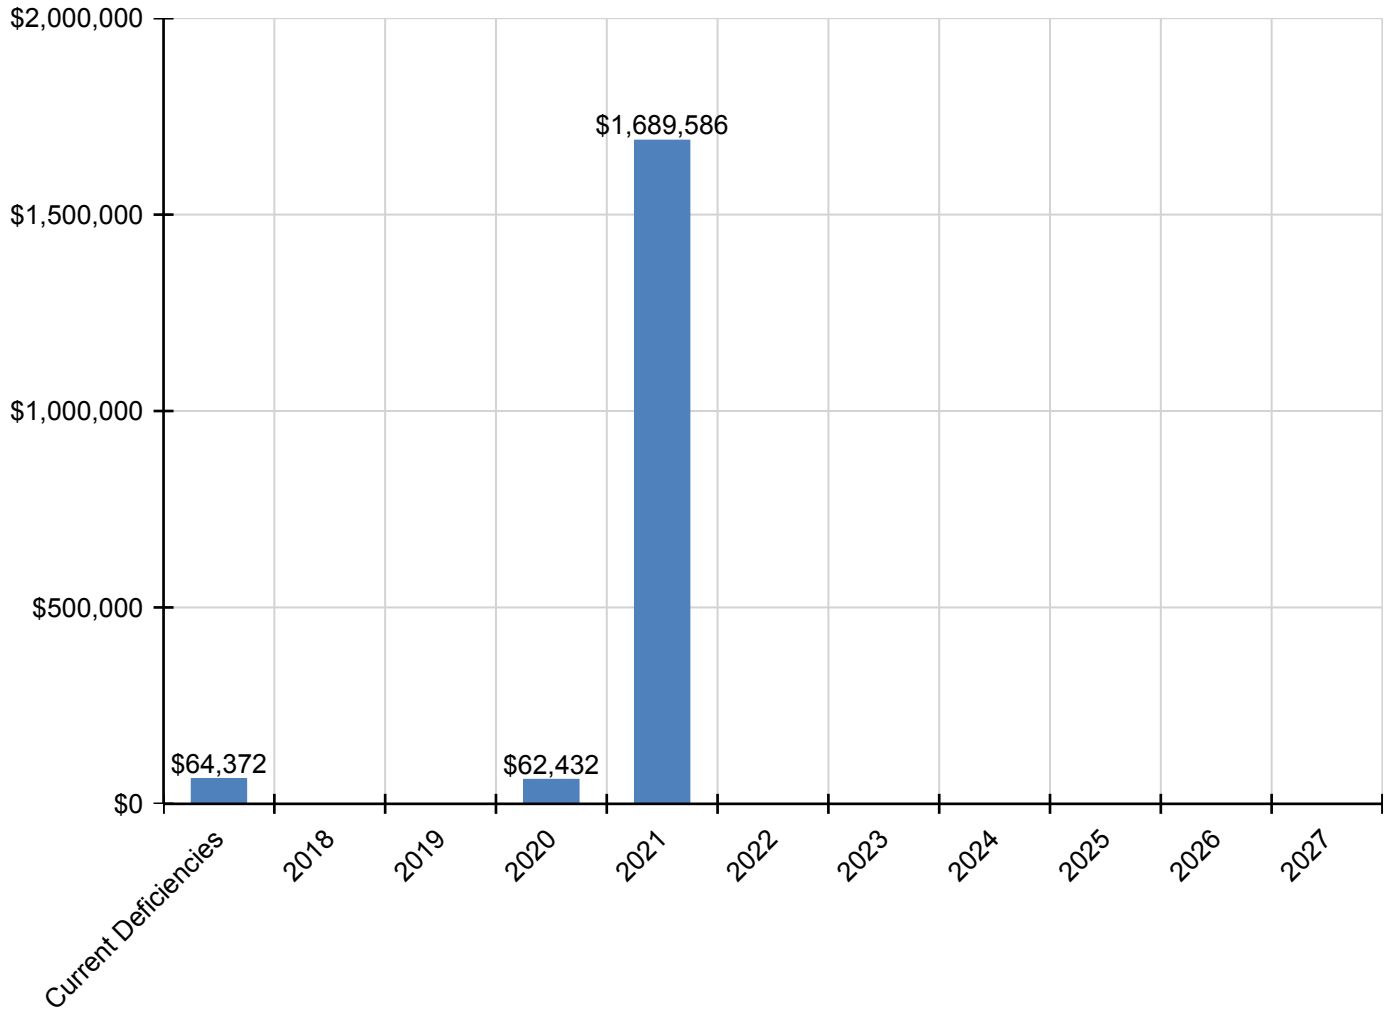
Forecasted Capital Renewal Requirement

The following chart shows the current building deficiencies and forecasting capital renewal or sustainment requirements over the next ten years.

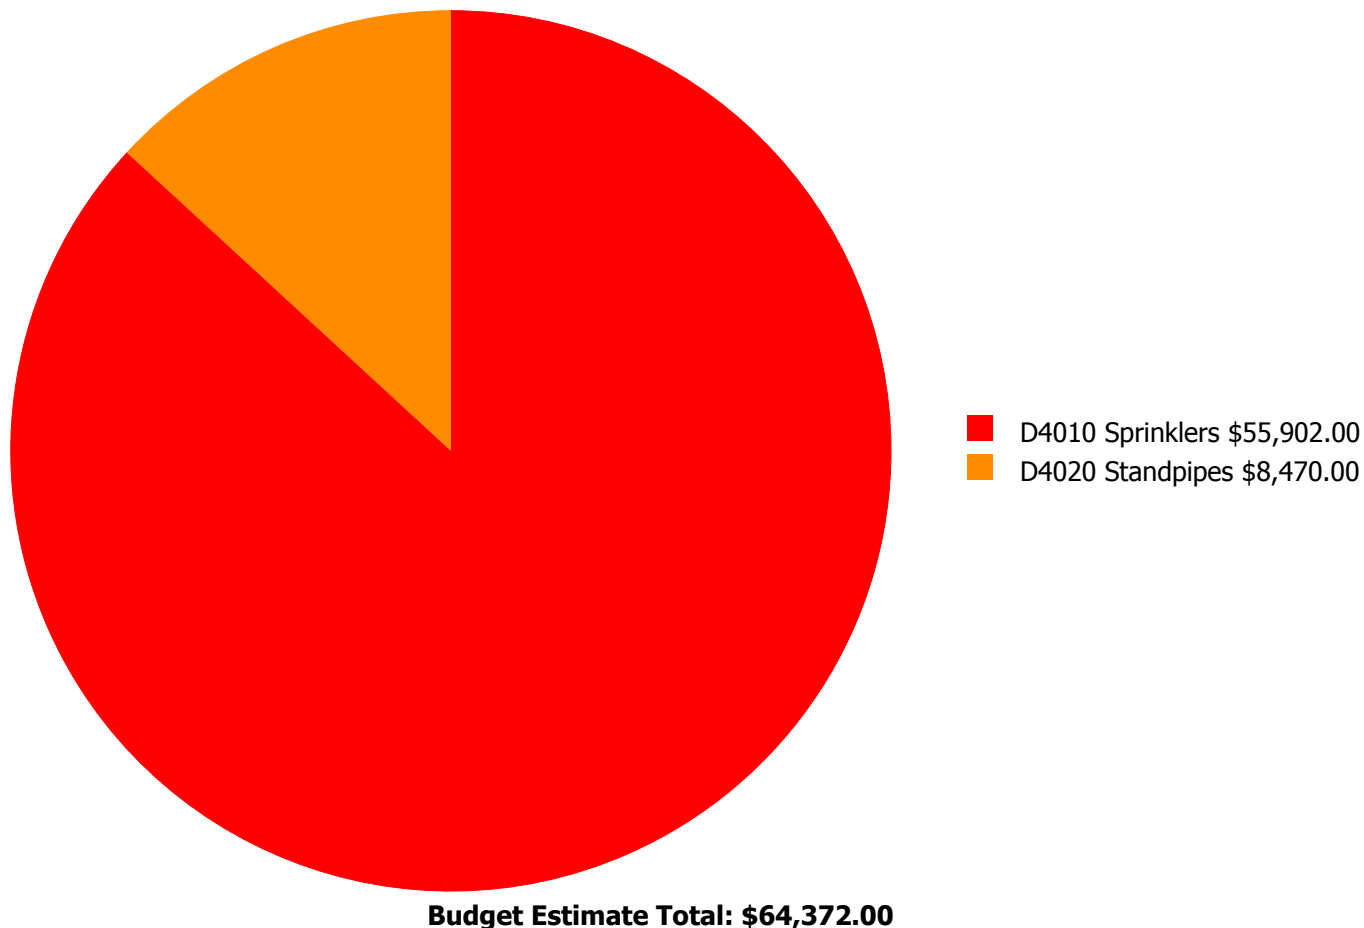
Deficiency Summary by System

Current deficiencies included assemblies that have reached or exceeded their design life or components of the assemblies that are in need of repair. Assemblies that have reached their design life are identified as current deficiencies and assigned the distress 'Beyond Useful Life'. The following chart lists all current deficiencies associated with this facility.

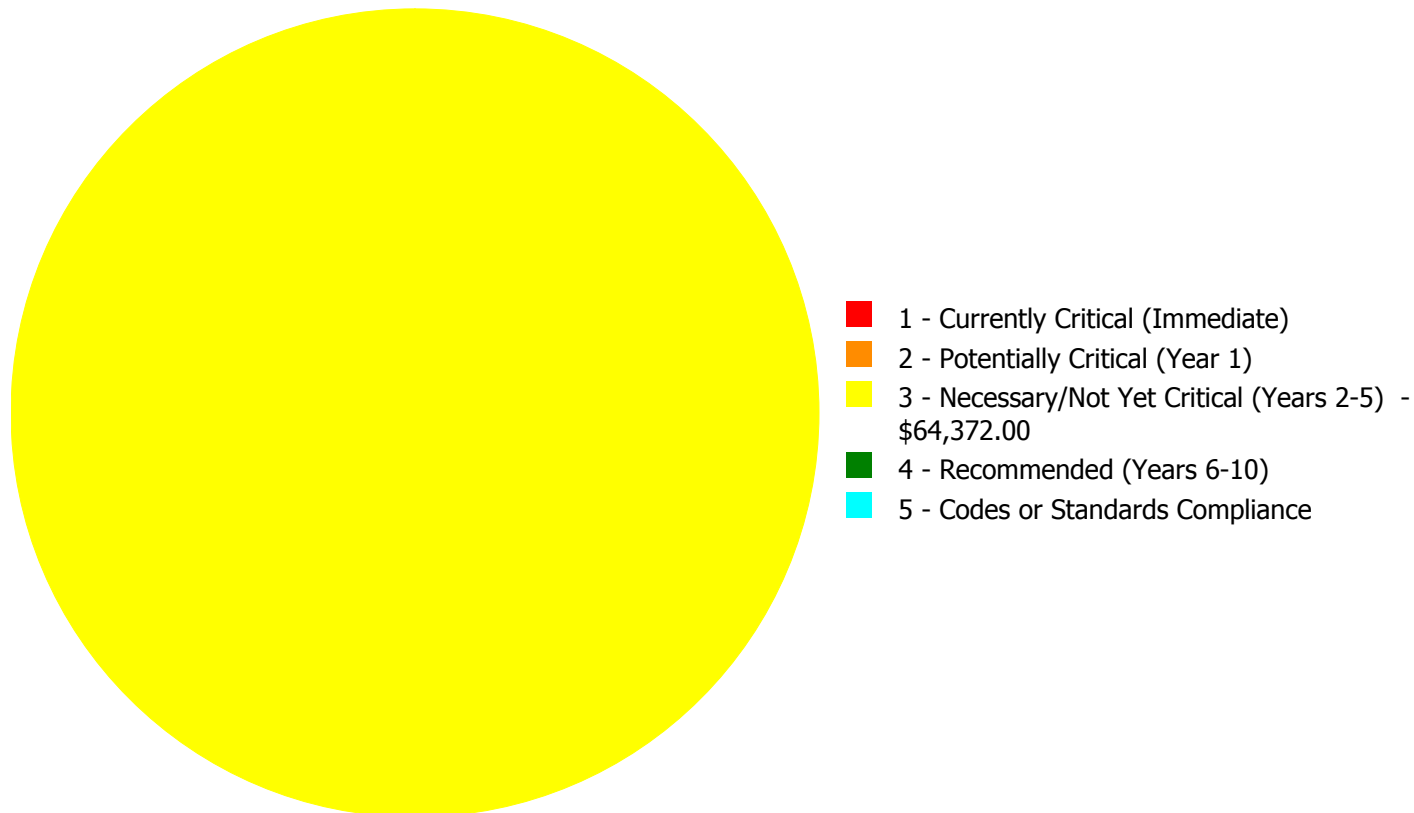
Deficiency Summary by Priority

The following chart shows the total repair costs broken down by priority. Assessors assigned deficiencies within eCOMET to one of the following priority categories:

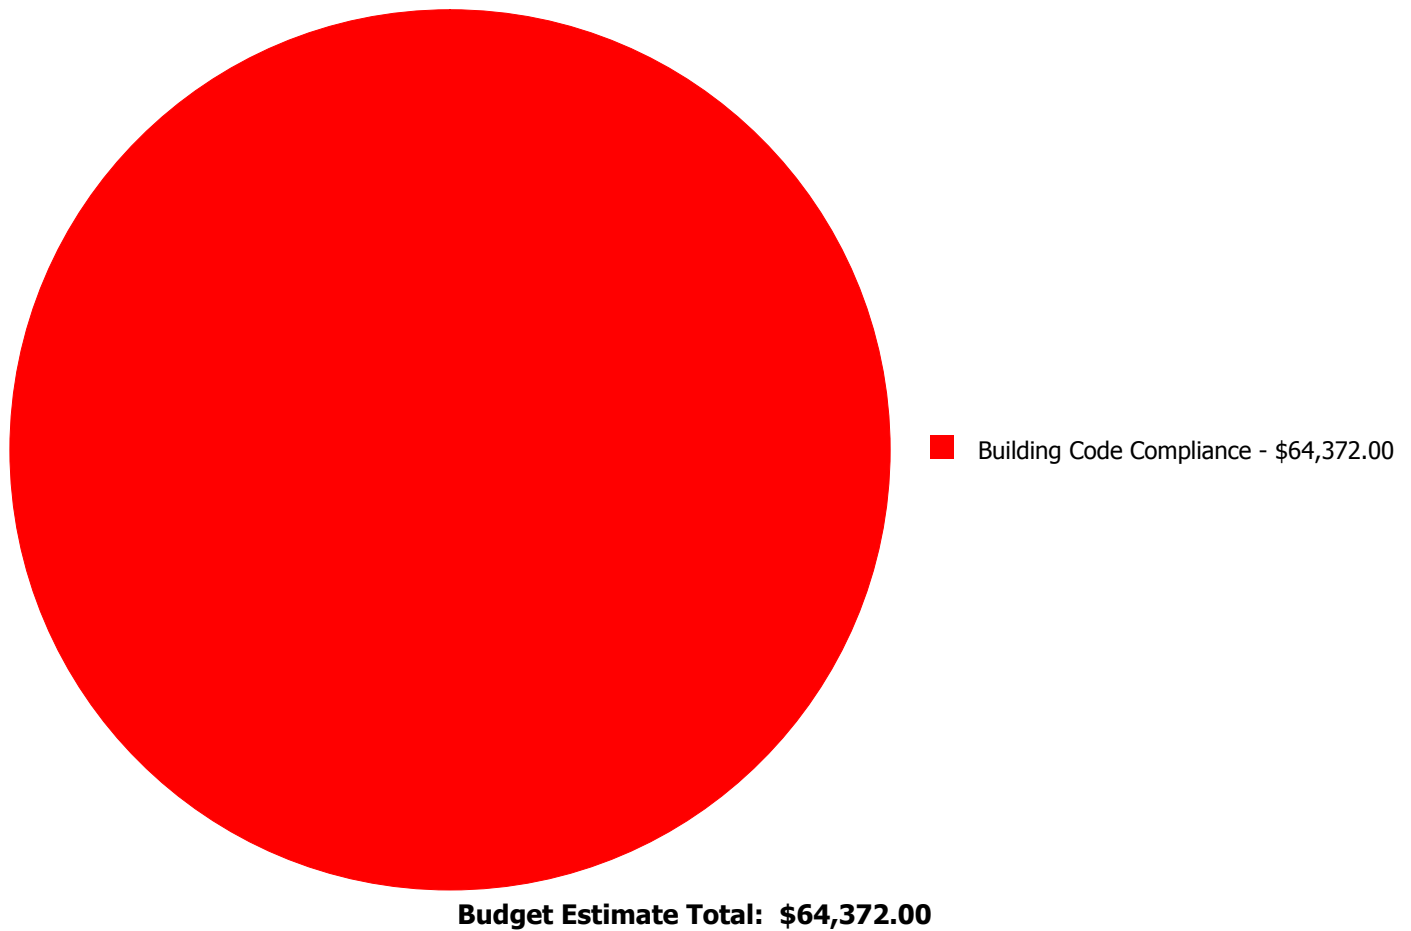
Deficiency Summary by Category

The following chart shows the total repair costs broken down by deficiency categories. Assessors assigned deficiencies to one of the following categories:

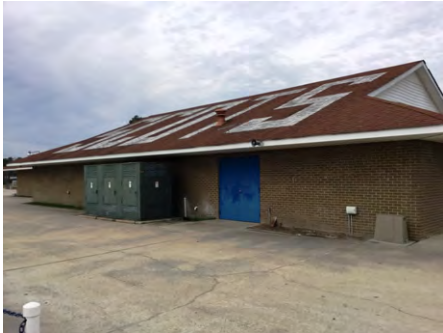
1). East Elevation - Jan 11, 2017

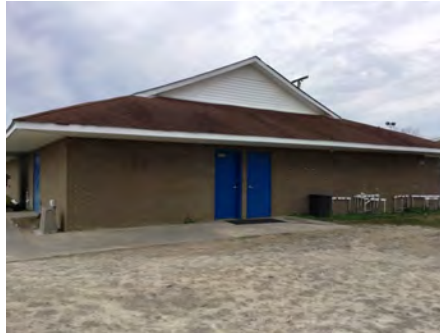
2). North Elevation - Jan 11, 2017

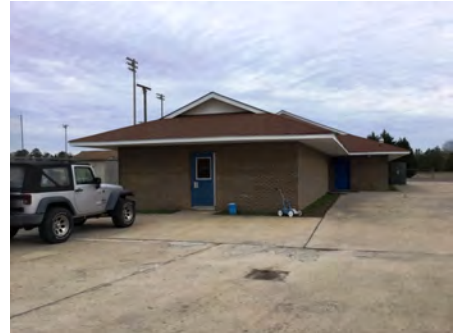
3). West Elevation - Jan 11, 2017

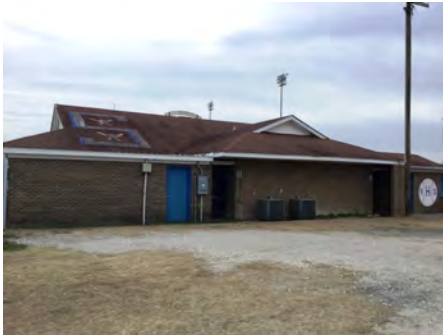
4). South Elevation - Jan 11, 2017

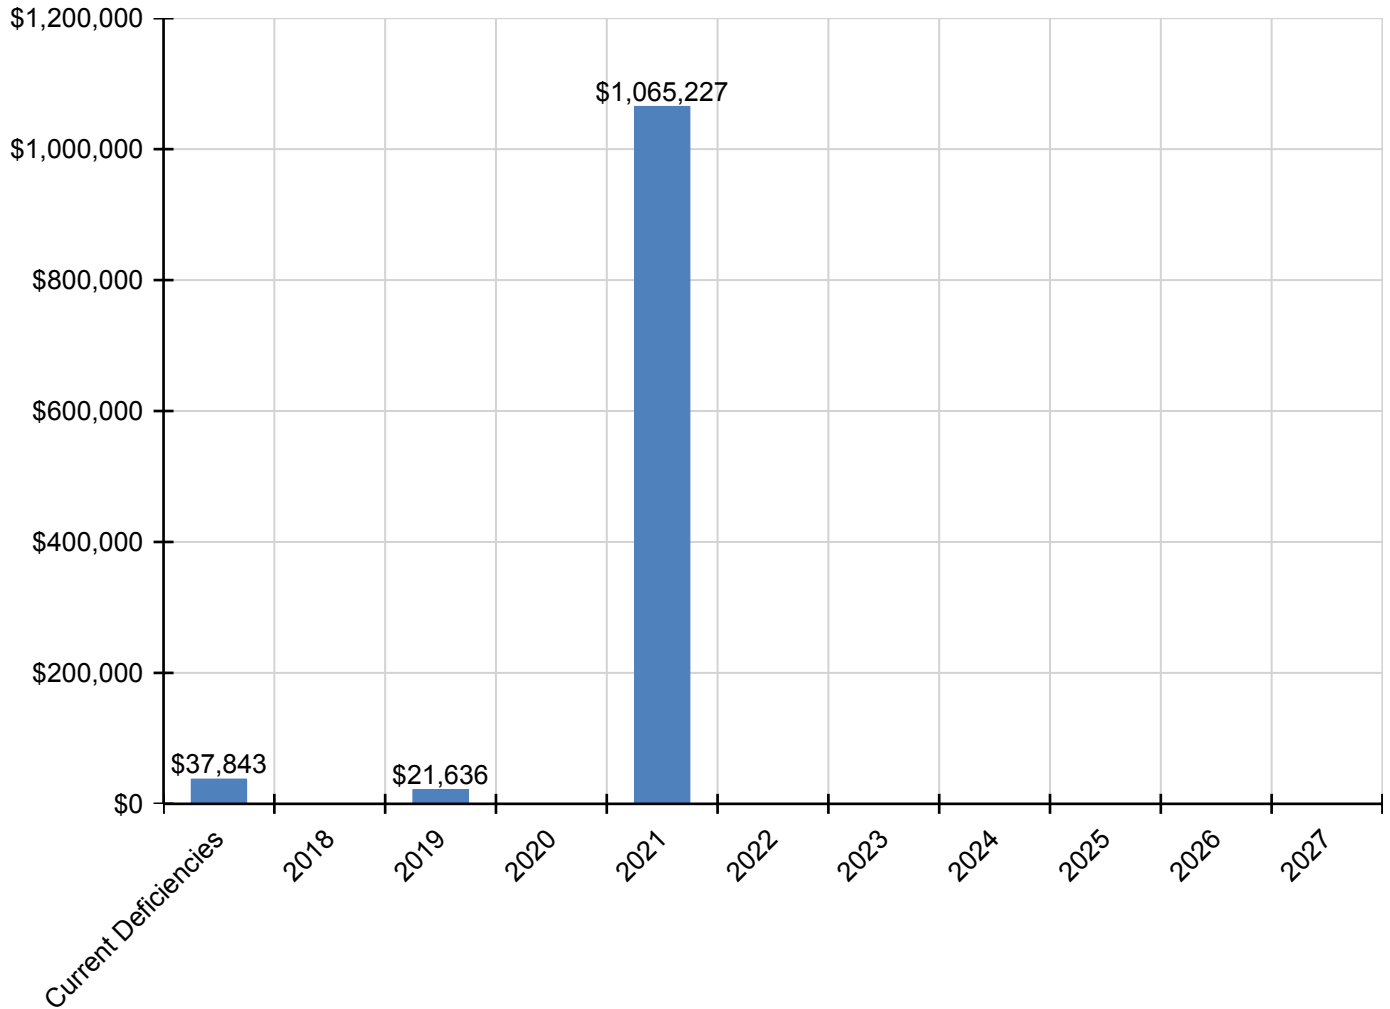
Forecasted Capital Renewal Requirement

The following chart shows the current building deficiencies and forecasting capital renewal or sustainment requirements over the next ten years.

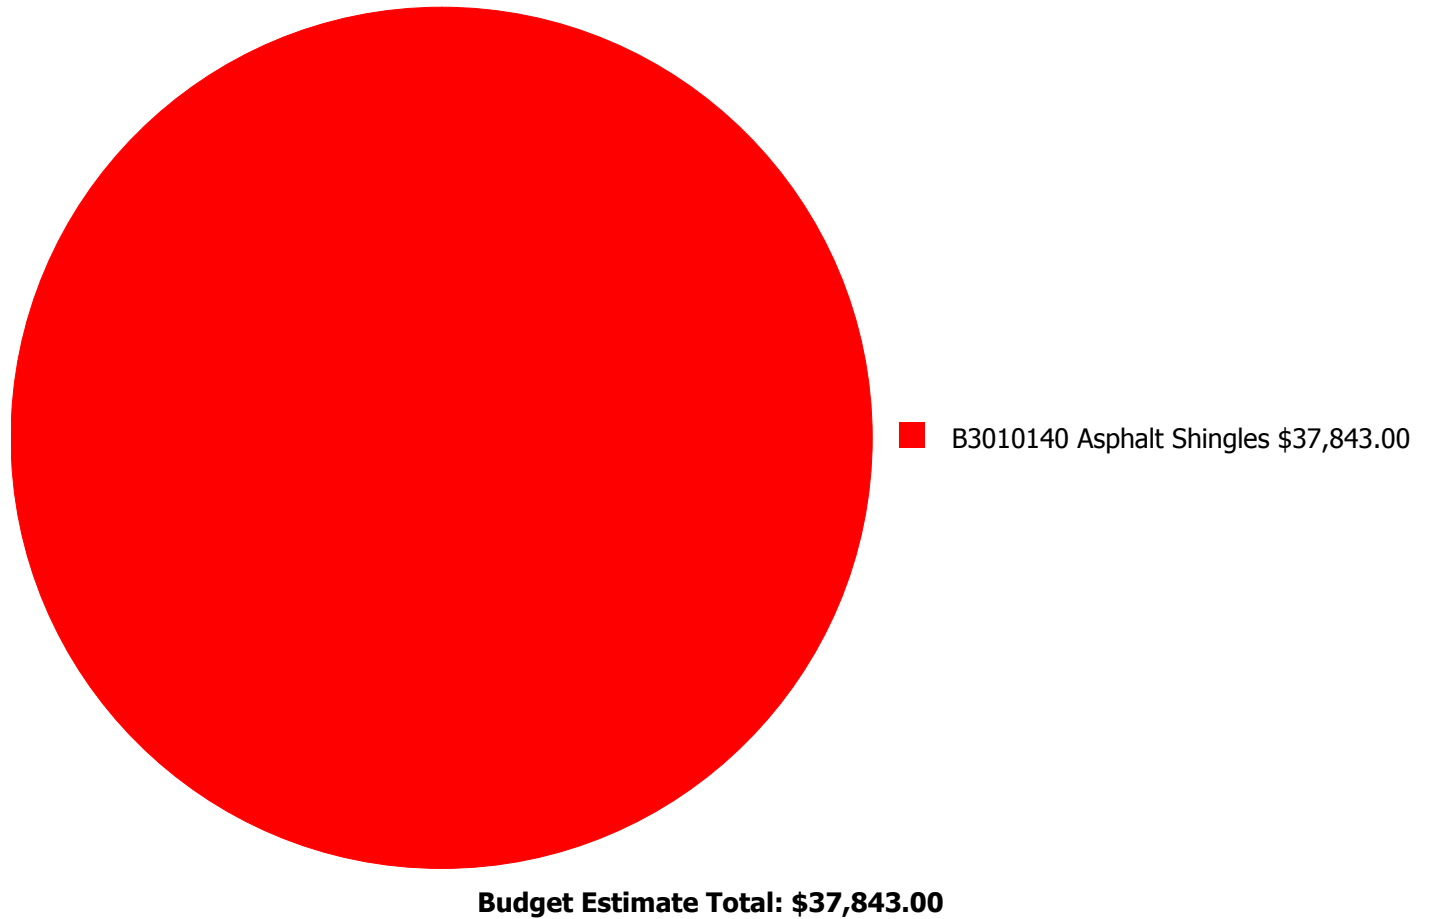
Deficiency Summary by System

Current deficiencies included assemblies that have reached or exceeded their design life or components of the assemblies that are in need of repair. Assemblies that have reached their design life are identified as current deficiencies and assigned the distress 'Beyond Useful Life'. The following chart lists all current deficiencies associated with this facility.

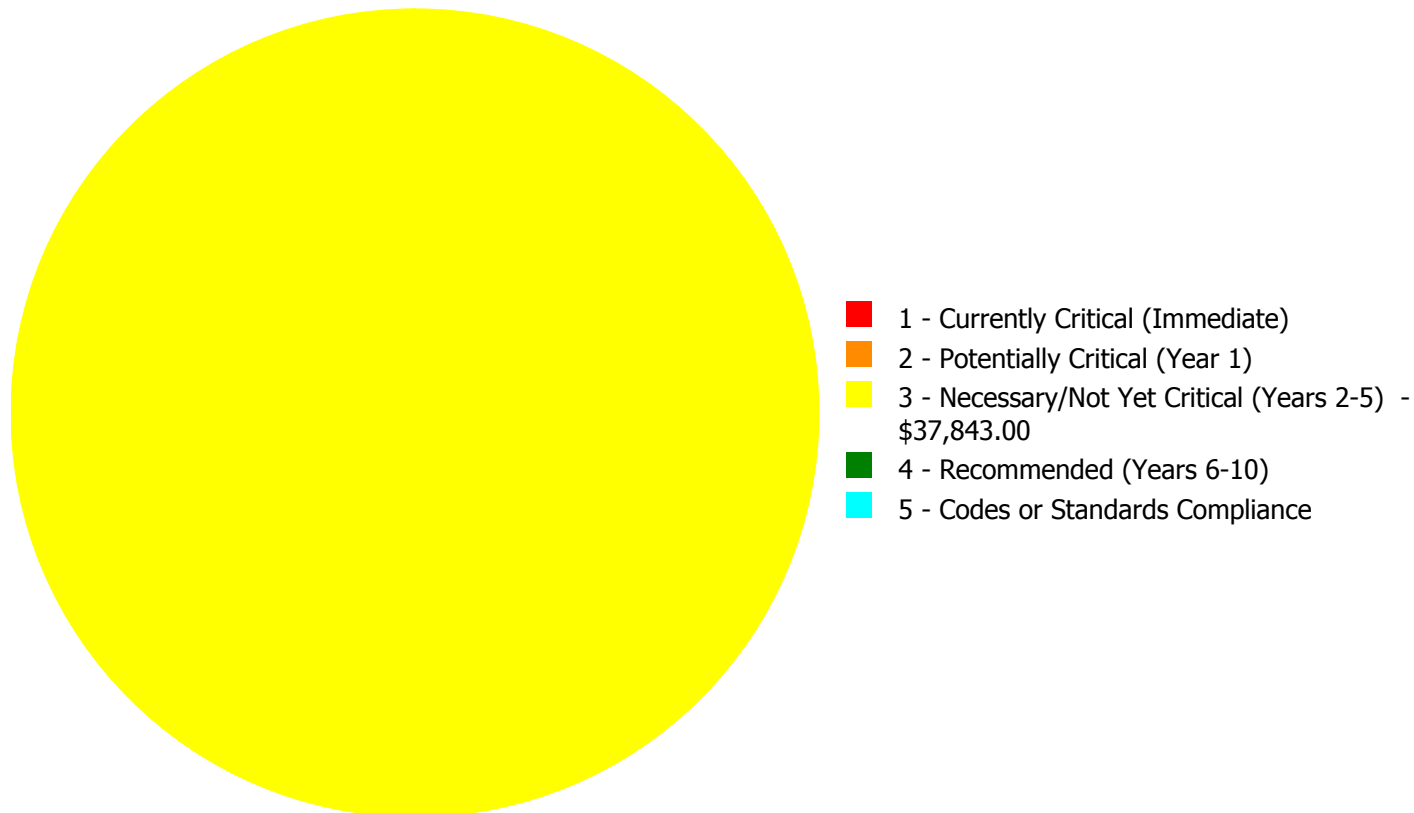
Deficiency Summary by Priority

The following chart shows the total repair costs broken down by priority. Assessors assigned deficiencies within eCOMET to one of the following priority categories:

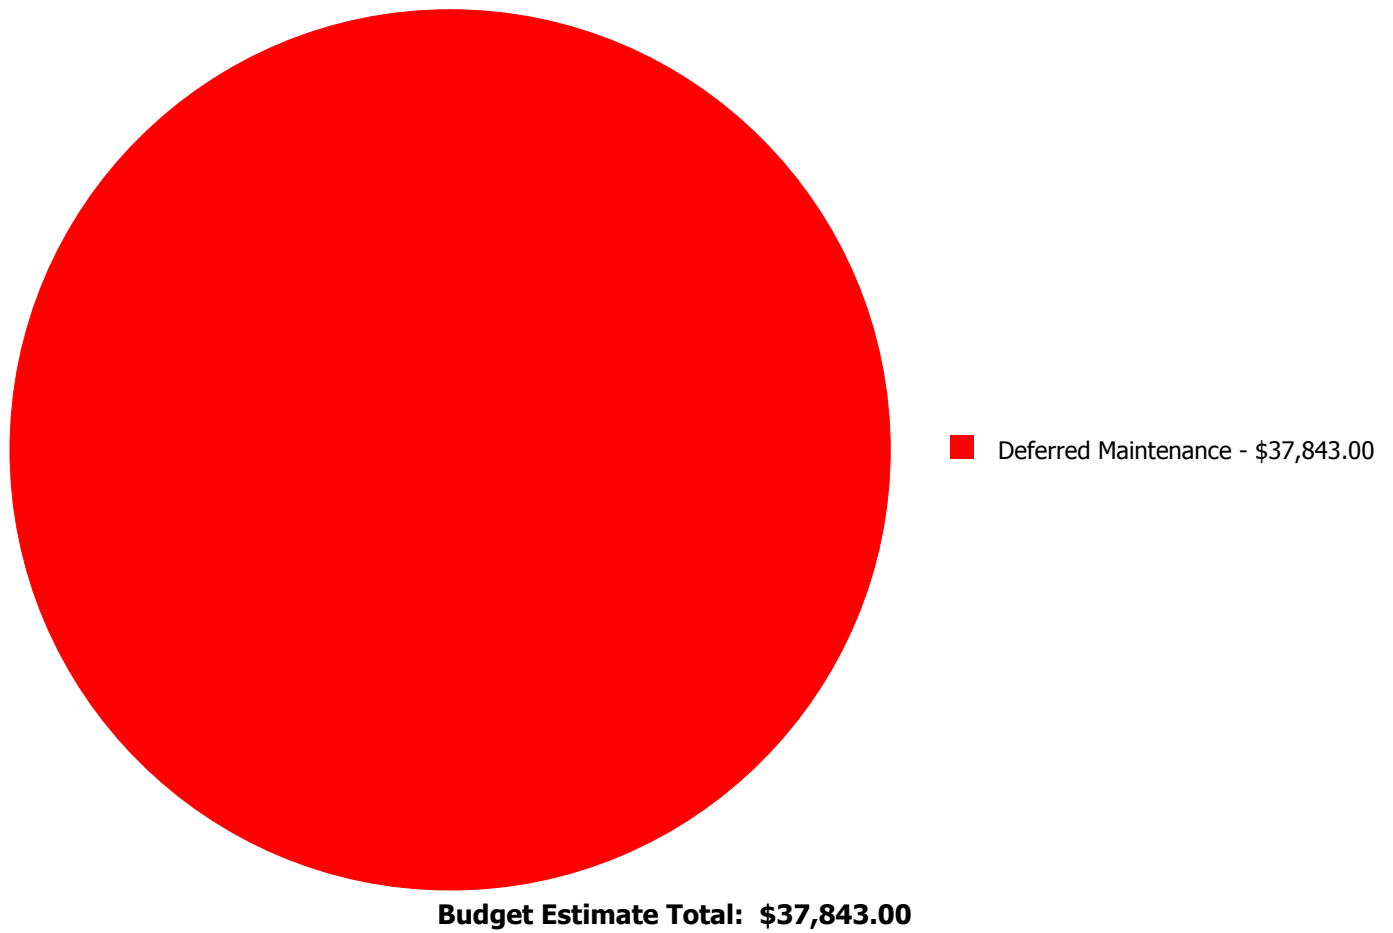
Deficiency Summary by Category

The following chart shows the total repair costs broken down by deficiency categories. Assessors assigned deficiencies to one of the following categories:

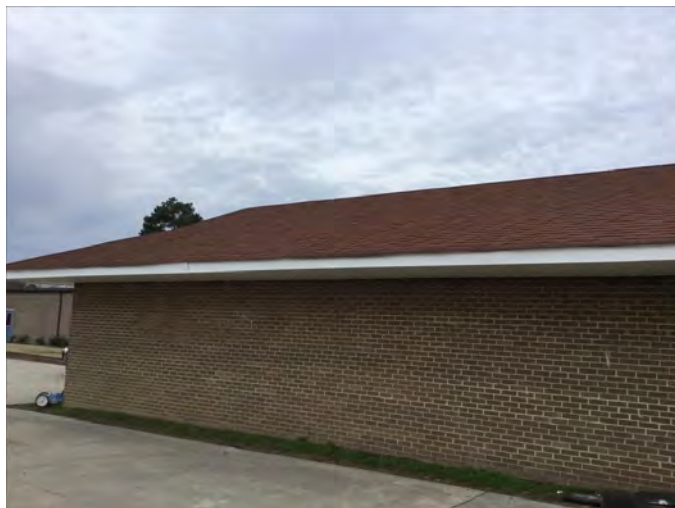
System: B3010140 - Asphalt Shingles

Location: Roof
Distress: Beyond Service Life
Category: Deferred Maintenance
Priority: 3 - Necessary/Not Yet Critical (Years 2-5)
Correction: Renew System
Qty: 6,000.00
Unit of Measure: S.F.
Estimate: \$37,843.00
Assessor Name: Eduardo Lopez
Date Created: 01/11/2017

Notes: The roof is beyond its service life and should be replaced.

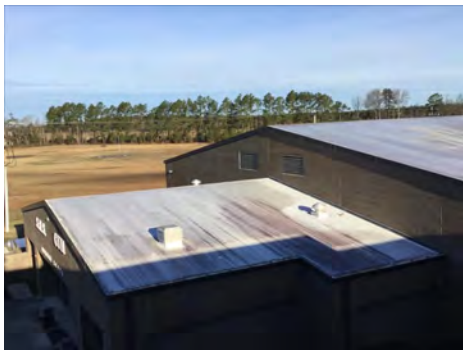
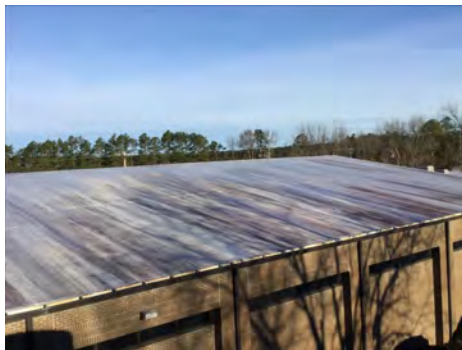
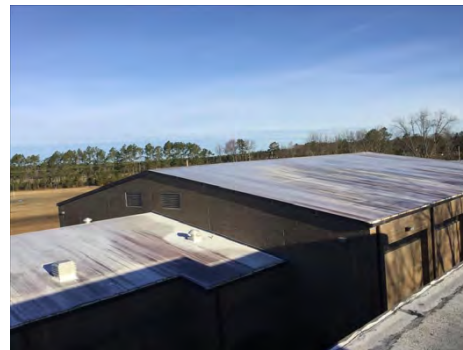
System: B3010120 - Single Ply Membrane

Note: The roof is beyond its service life and should be replaced.

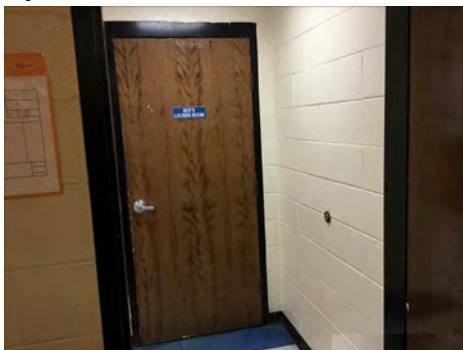
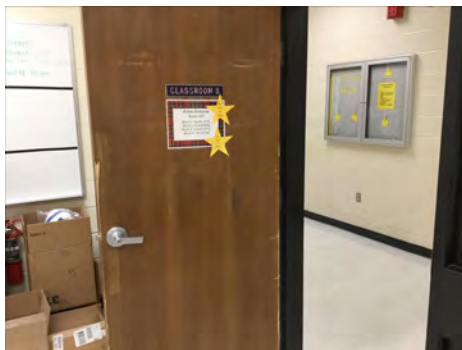
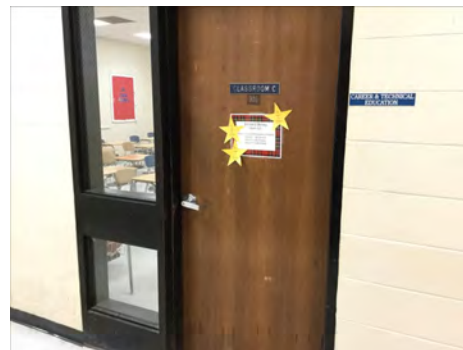
System: C1020 - Interior Doors

Note: The doors are in poor condition and should be replaced.
