NC School District/830 Scotland County/High School

Scotland High

Campus Assessment Report

March 11, 2017

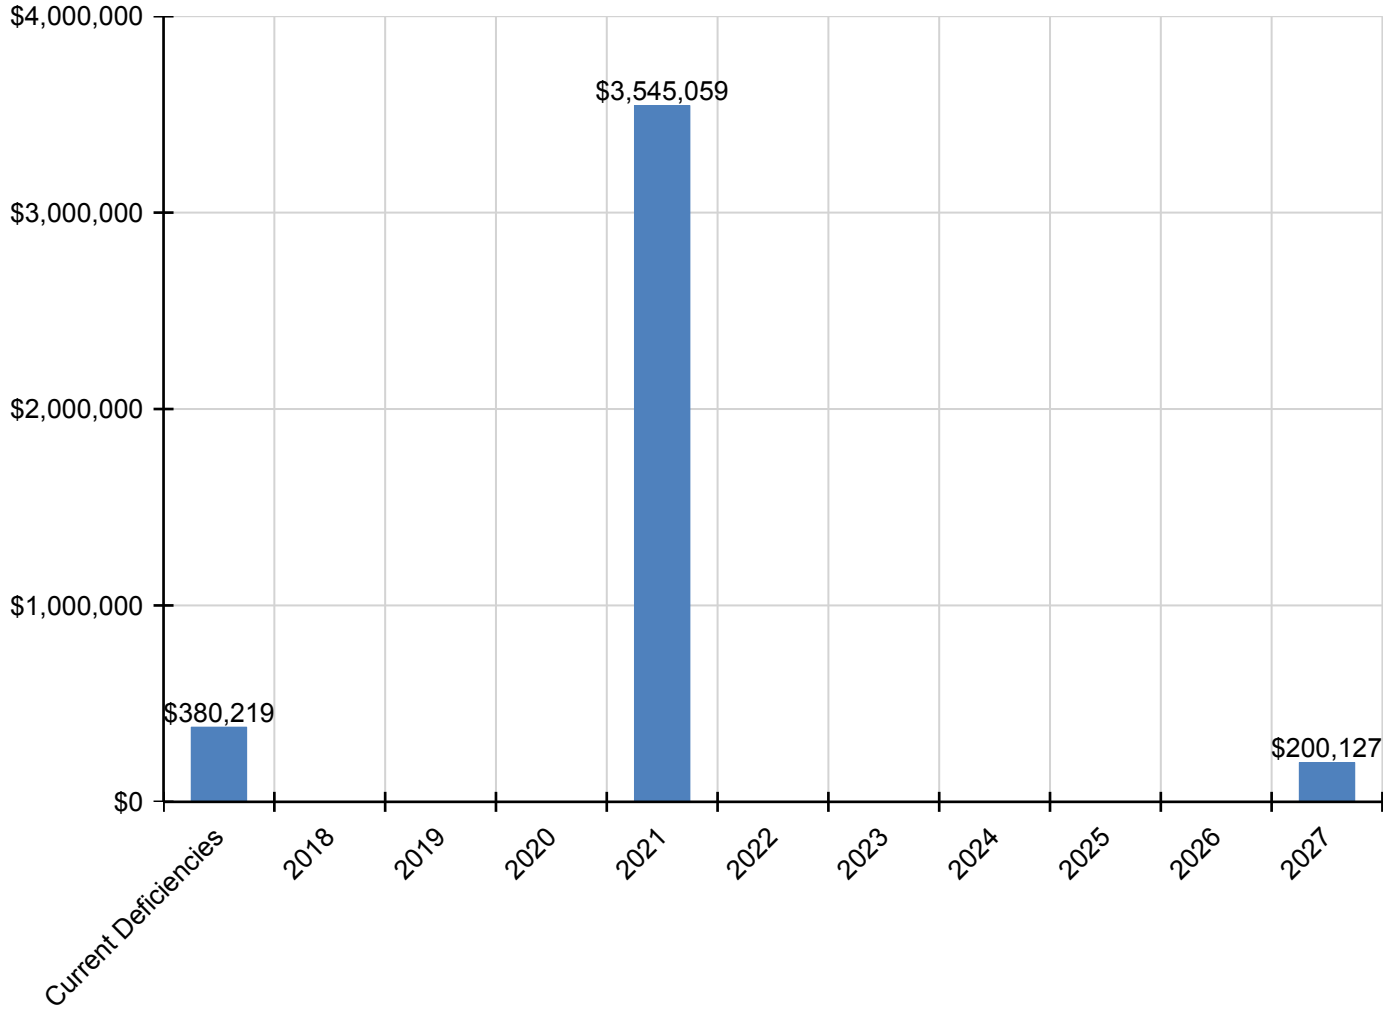
Forecasted Capital Renewal Requirement

The following chart shows the current building deficiencies and forecasting capital renewal or sustainment requirements over the next ten years.

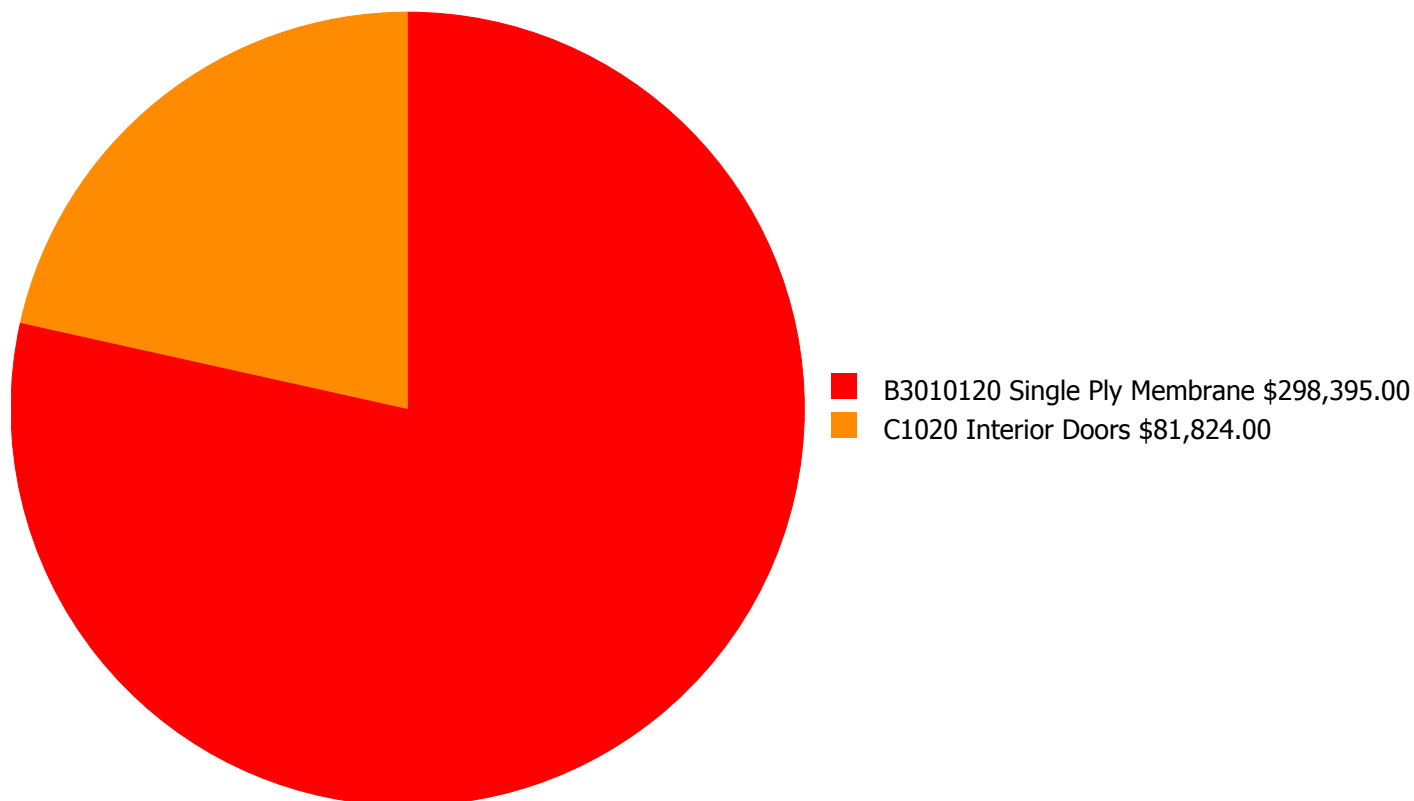
Deficiency Summary by System

Current deficiencies included assemblies that have reached or exceeded their design life or components of the assemblies that are in need of repair. Assemblies that have reached their design life are identified as current deficiencies and assigned the distress 'Beyond Useful Life'. The following chart lists all current deficiencies associated with this facility.

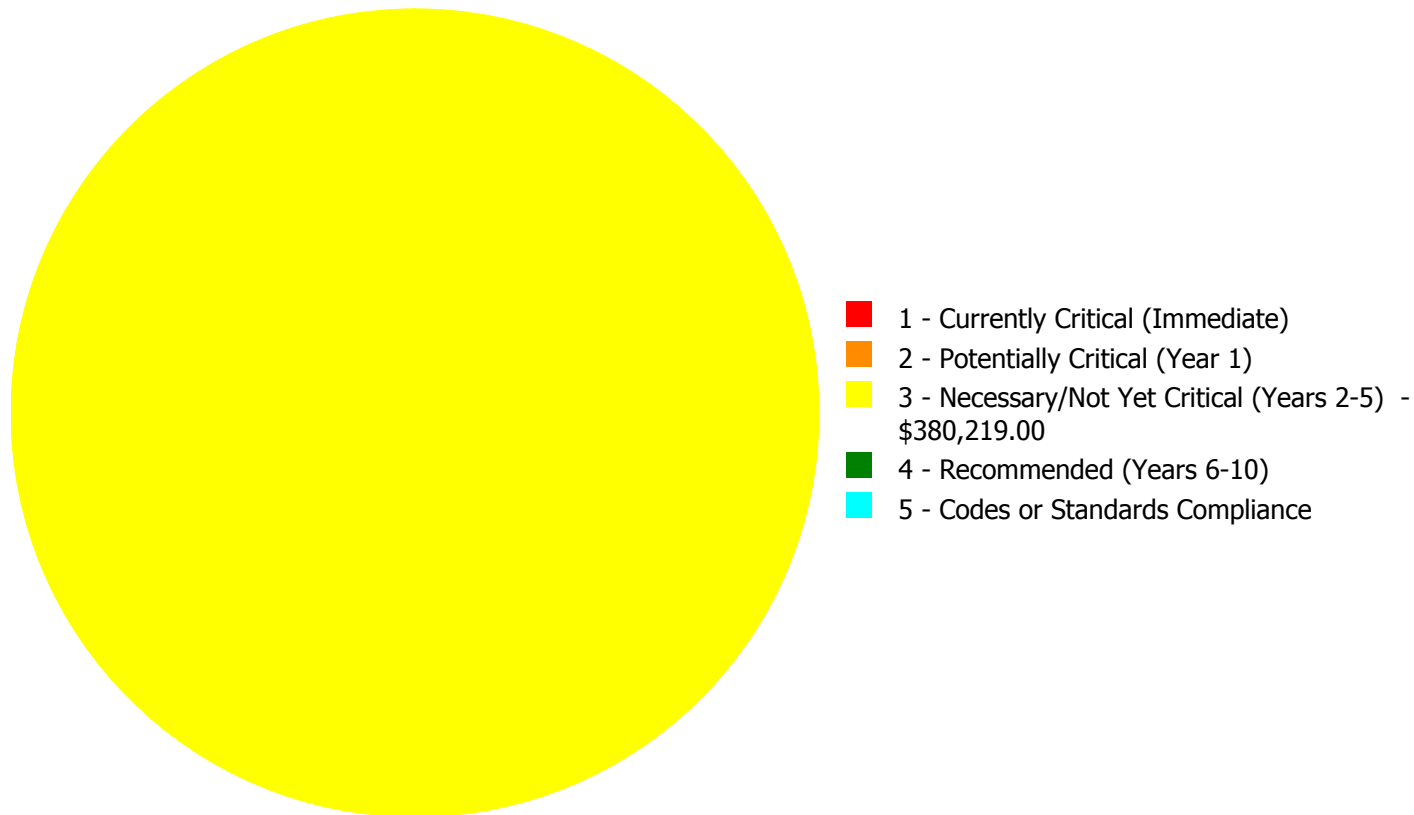
Deficiency Summary by Priority

The following chart shows the total repair costs broken down by priority. Assessors assigned deficiencies within eCOMET to one of the following priority categories:

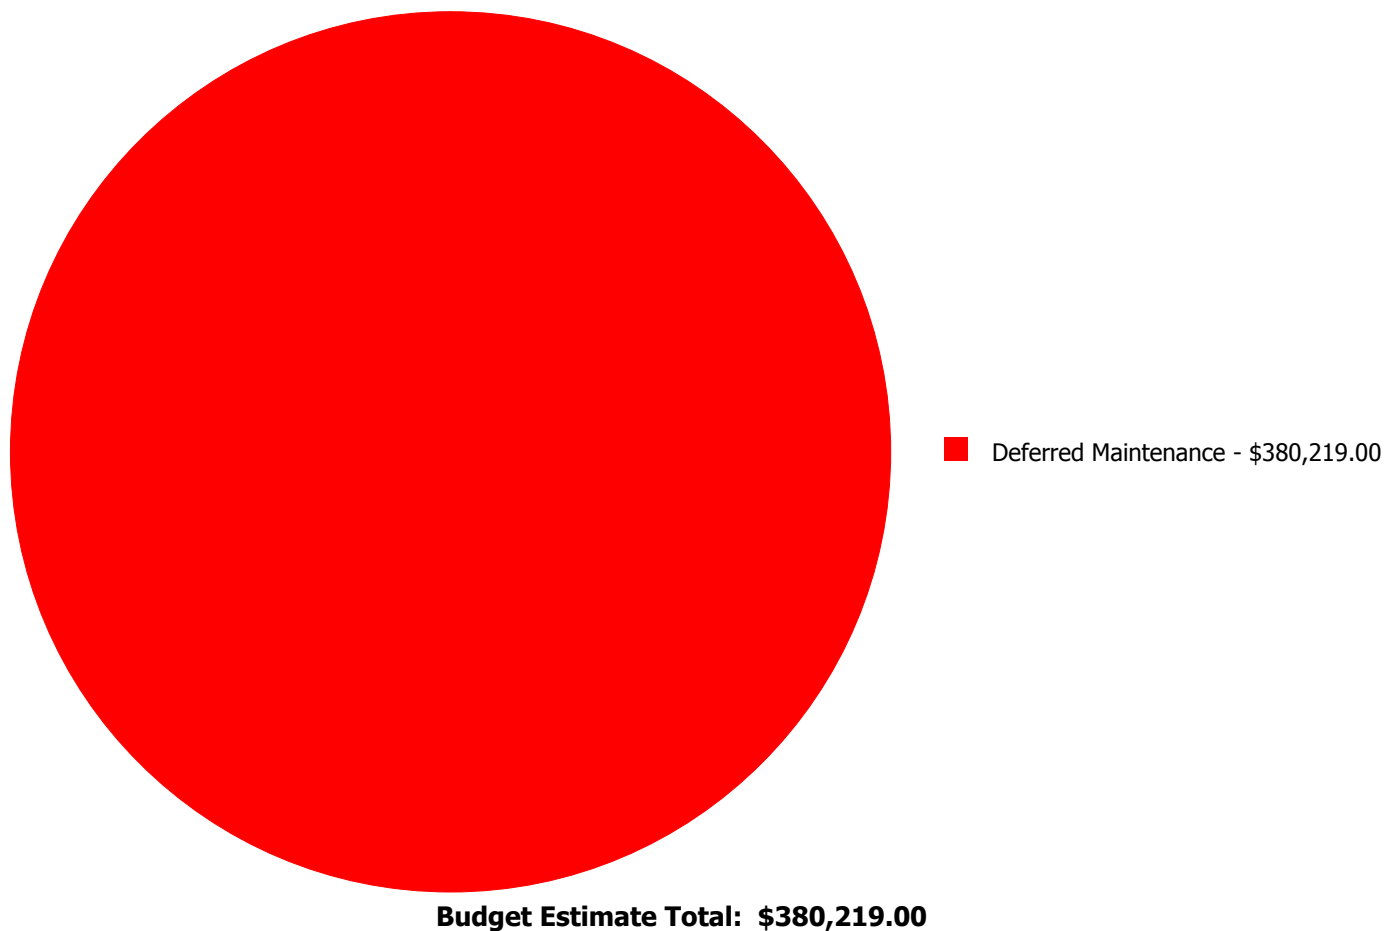
Deficiency Summary by Category

The following chart shows the total repair costs broken down by deficiency categories. Assessors assigned deficiencies to one of the following categories:

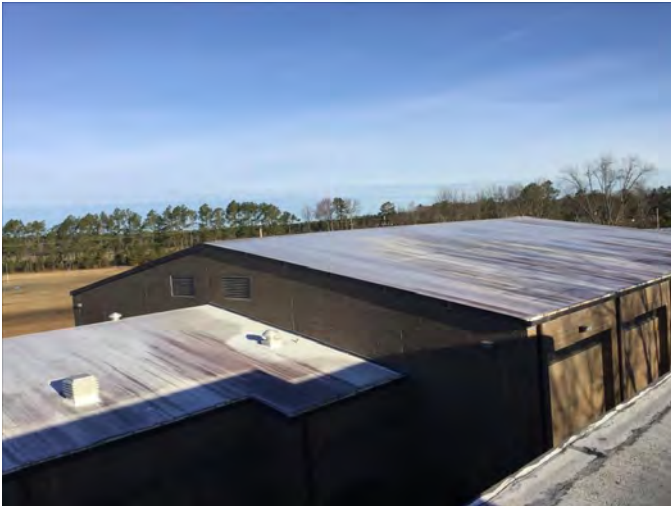
System: B3010120 - Single Ply Membrane

Location: Roof
Distress: Beyond Service Life
Category: Deferred Maintenance
Priority: 3 - Necessary/Not Yet Critical (Years 2-5)
Correction: Renew System
Qty: 28,500.00
Unit of Measure: S.F.
Estimate: \$298,395.00
Assessor Name: Terence Davis
Date Created: 01/05/2017

Notes: The roof is beyond its service life and should be replaced.

Note: The roof is beyond its service life and should be replaced.

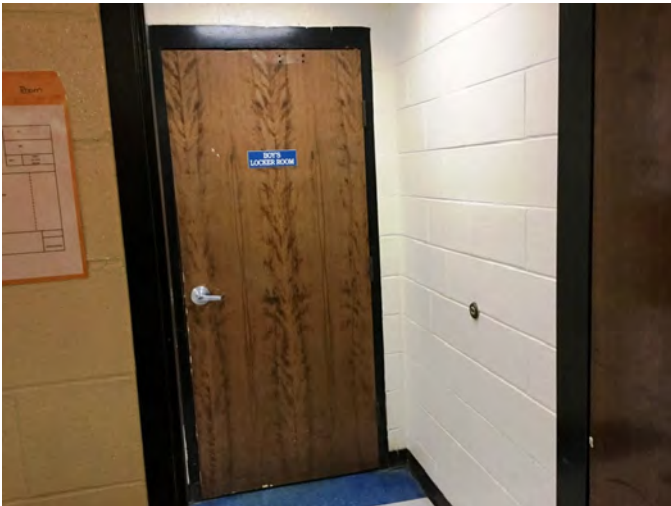
System: C1020 - Interior Doors

Location: Throughout Building
Distress: Damaged
Category: Deferred Maintenance
Priority: 3 - Necessary/Not Yet Critical (Years 2-5)
Correction: Renew System
Qty: 28,500.00
Unit of Measure: S.F.
Estimate: \$81,824.00
Assessor Name: Terence Davis
Date Created: 01/06/2017

Notes: The doors are in poor condition and should be replaced.

Note: The doors are in poor condition and should be replaced.

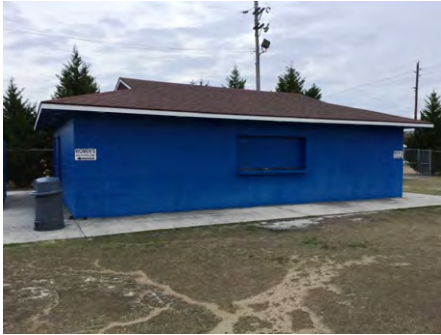
1). South Elevation - Jan 11, 2017

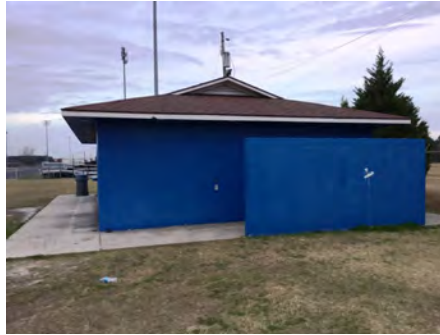
2). East Elevation - Jan 11, 2017

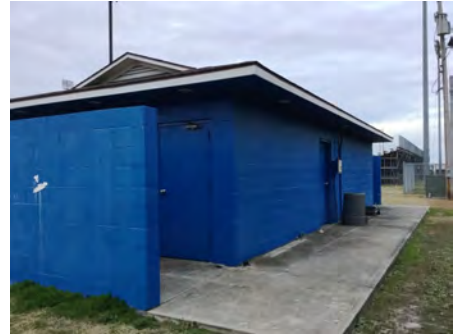
3). Northeast Elevation - Jan 11, 2017

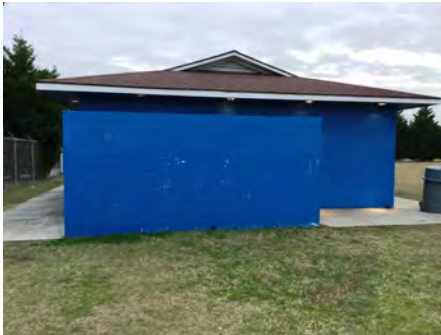
4). West Elevation - Jan 11, 2017

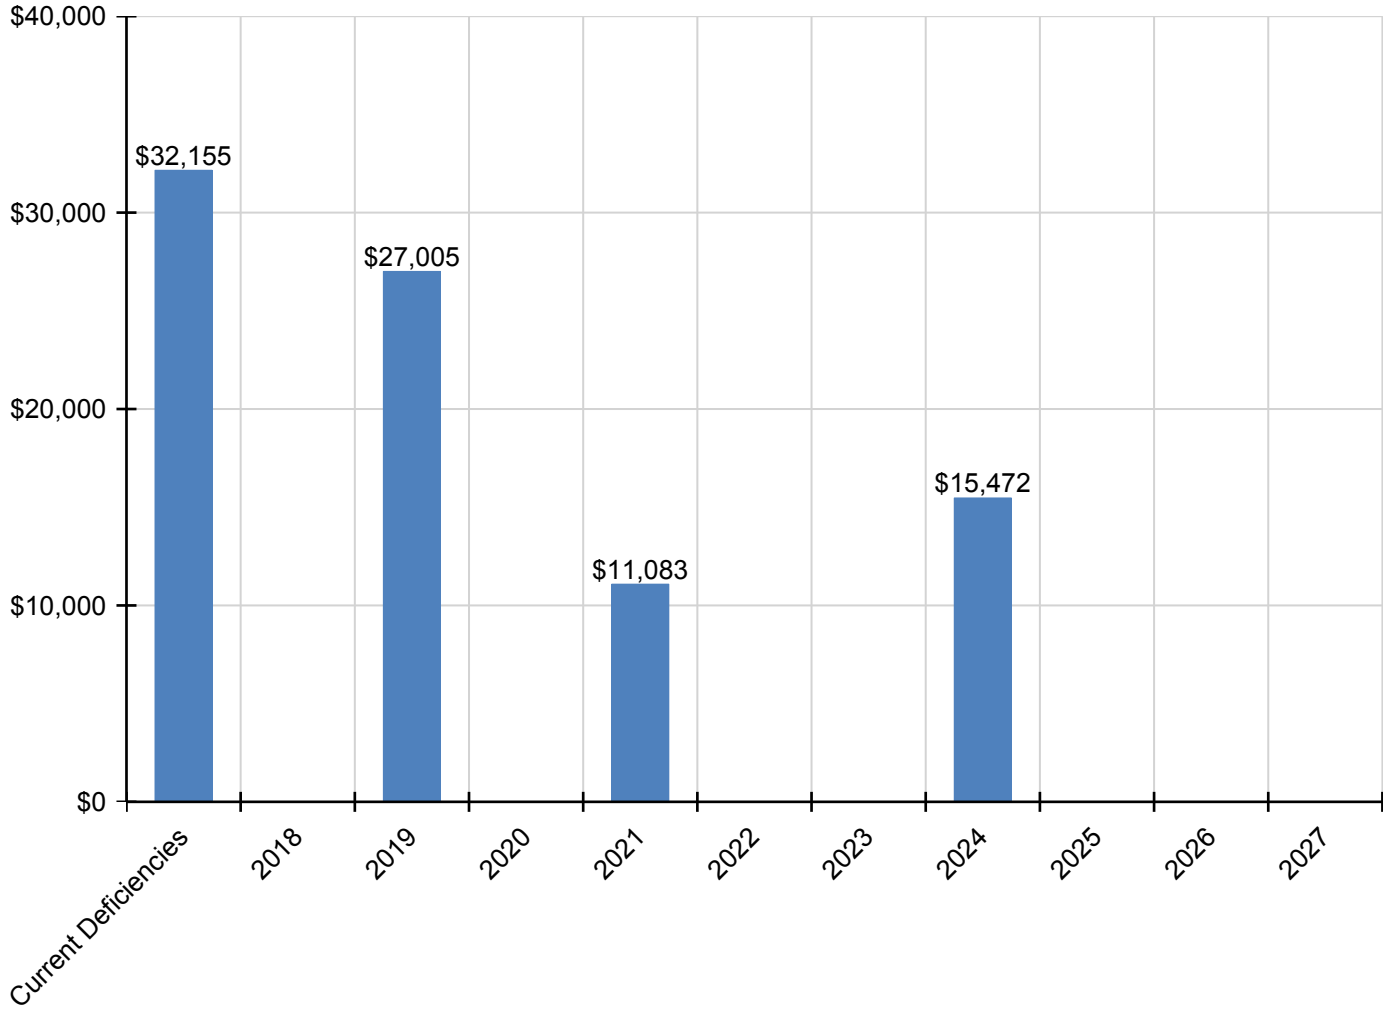
Forecasted Capital Renewal Requirement

The following chart shows the current building deficiencies and forecasting capital renewal or sustainment requirements over the next ten years.

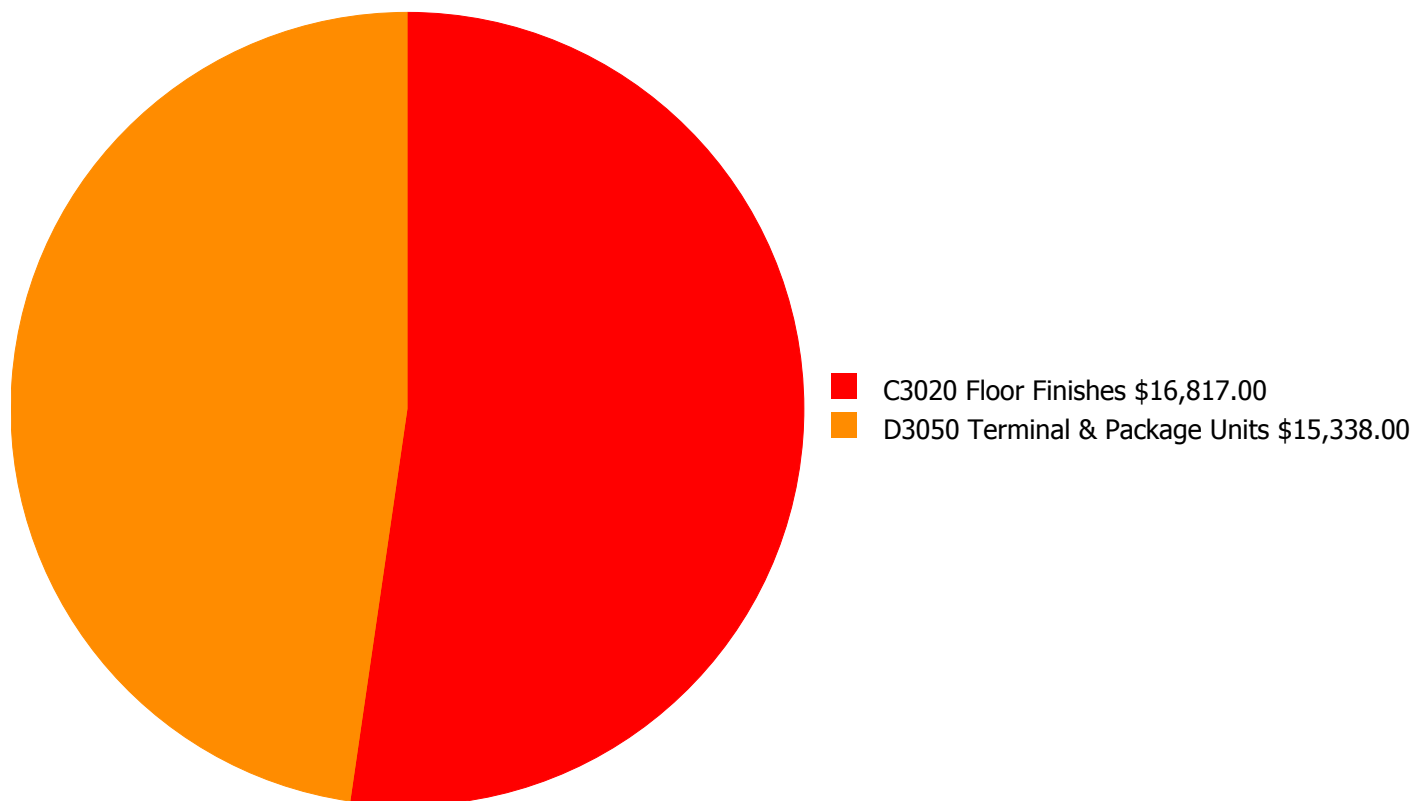
Deficiency Summary by System

Current deficiencies included assemblies that have reached or exceeded their design life or components of the assemblies that are in need of repair. Assemblies that have reached their design life are identified as current deficiencies and assigned the distress 'Beyond Useful Life'. The following chart lists all current deficiencies associated with this facility.

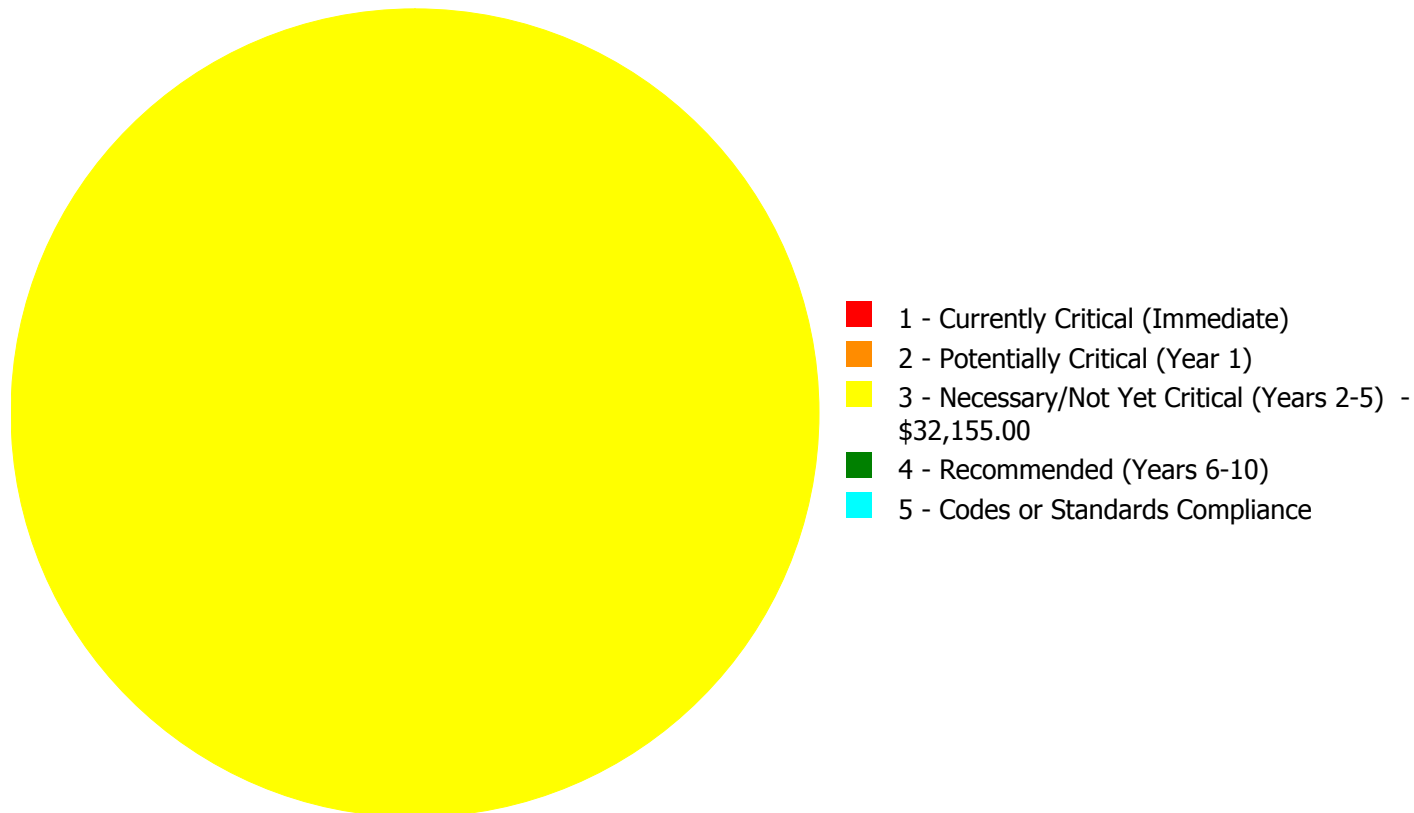
Deficiency Summary by Priority

The following chart shows the total repair costs broken down by priority. Assessors assigned deficiencies within eCOMET to one of the following priority categories:

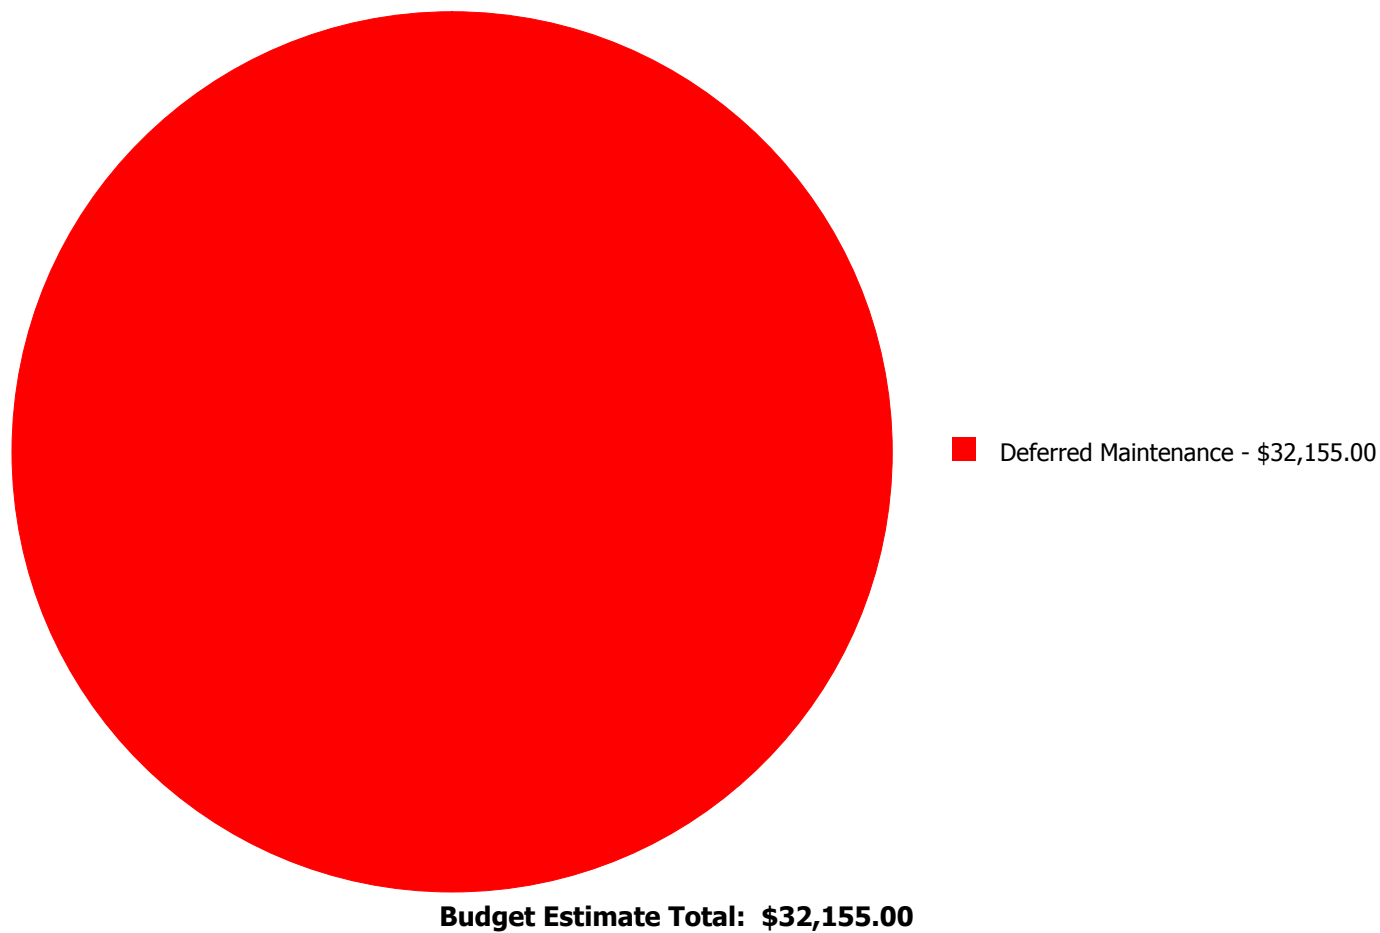
Deficiency Summary by Category

The following chart shows the total repair costs broken down by deficiency categories. Assessors assigned deficiencies to one of the following categories:

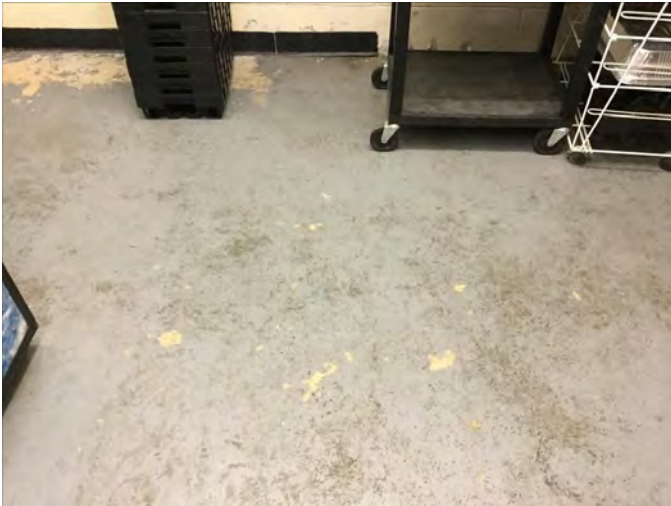
System: C3020 - Floor Finishes

Location: Throughout Building
Distress: Beyond Service Life
Category: Deferred Maintenance
Priority: 3 - Necessary/Not Yet Critical (Years 2-5)
Correction: Renew System
Qty: 1,200.00
Unit of Measure: S.F.
Estimate: \$16,817.00
Assessor Name: Eduardo Lopez
Date Created: 01/11/2017

Notes: The floor finishes are beyond their service life and should be replaced.

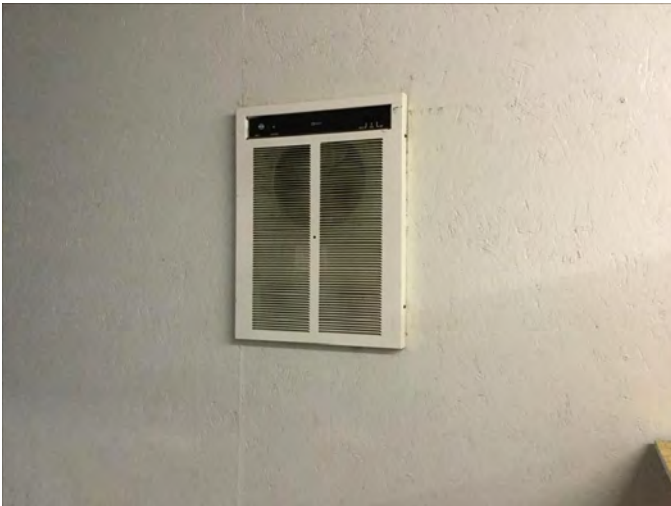
System: D3050 - Terminal & Package Units

Location: Throughout Building
Distress: Beyond Service Life
Category: Deferred Maintenance
Priority: 3 - Necessary/Not Yet Critical (Years 2-5)
Correction: Renew System
Qty: 1,200.00
Unit of Measure: S.F.
Estimate: \$15,338.00
Assessor Name: Eduardo Lopez
Date Created: 01/11/2017

Notes: The terminal and package units are beyond their service life and should be replaced.

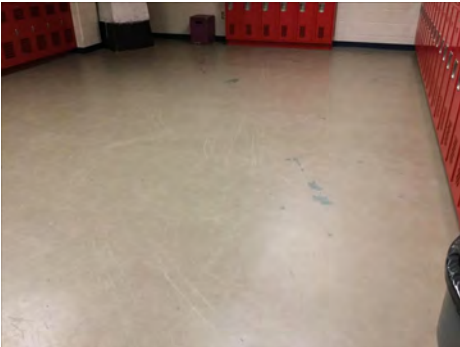
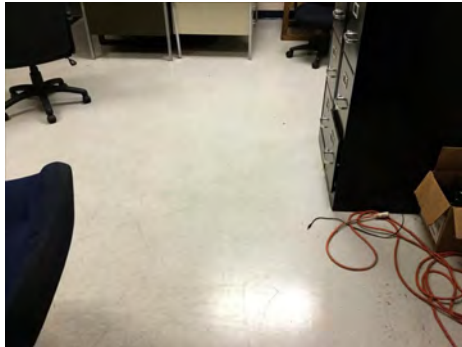
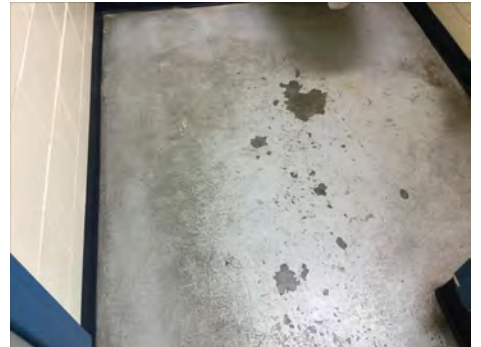
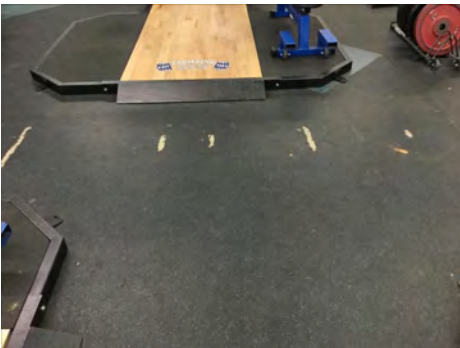
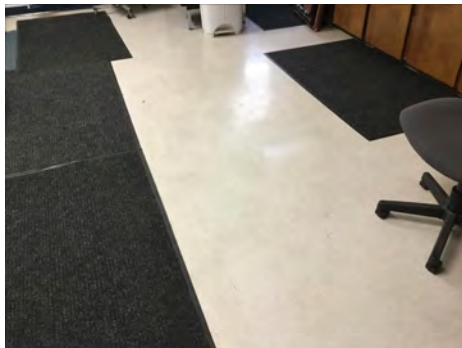
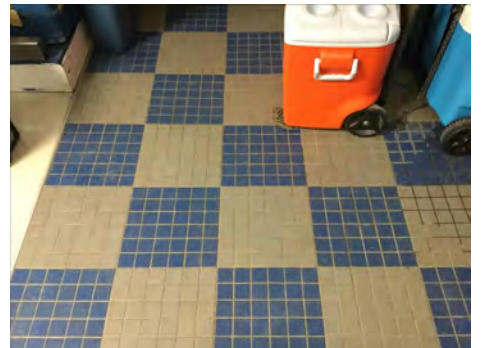
System: C3020 - Floor Finishes

Note: The epoxy in the boys restroom is in poor condition and should be replaced.

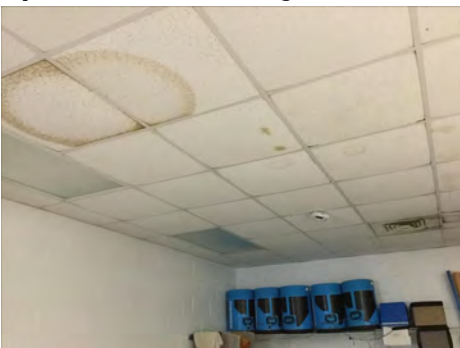
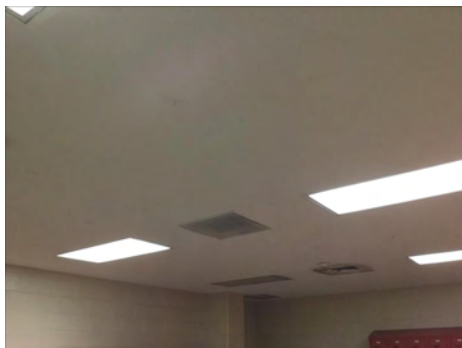
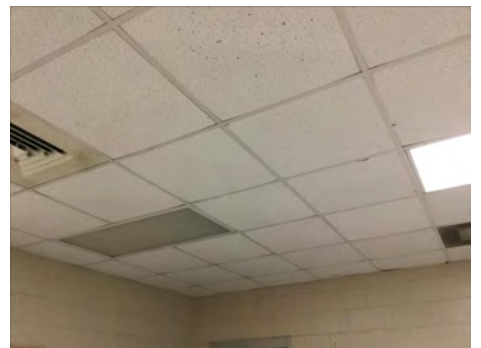
System: C3030 - Ceiling Finishes

Note: The acoustical ceiling tiles are beyond their service life and should be replaced.

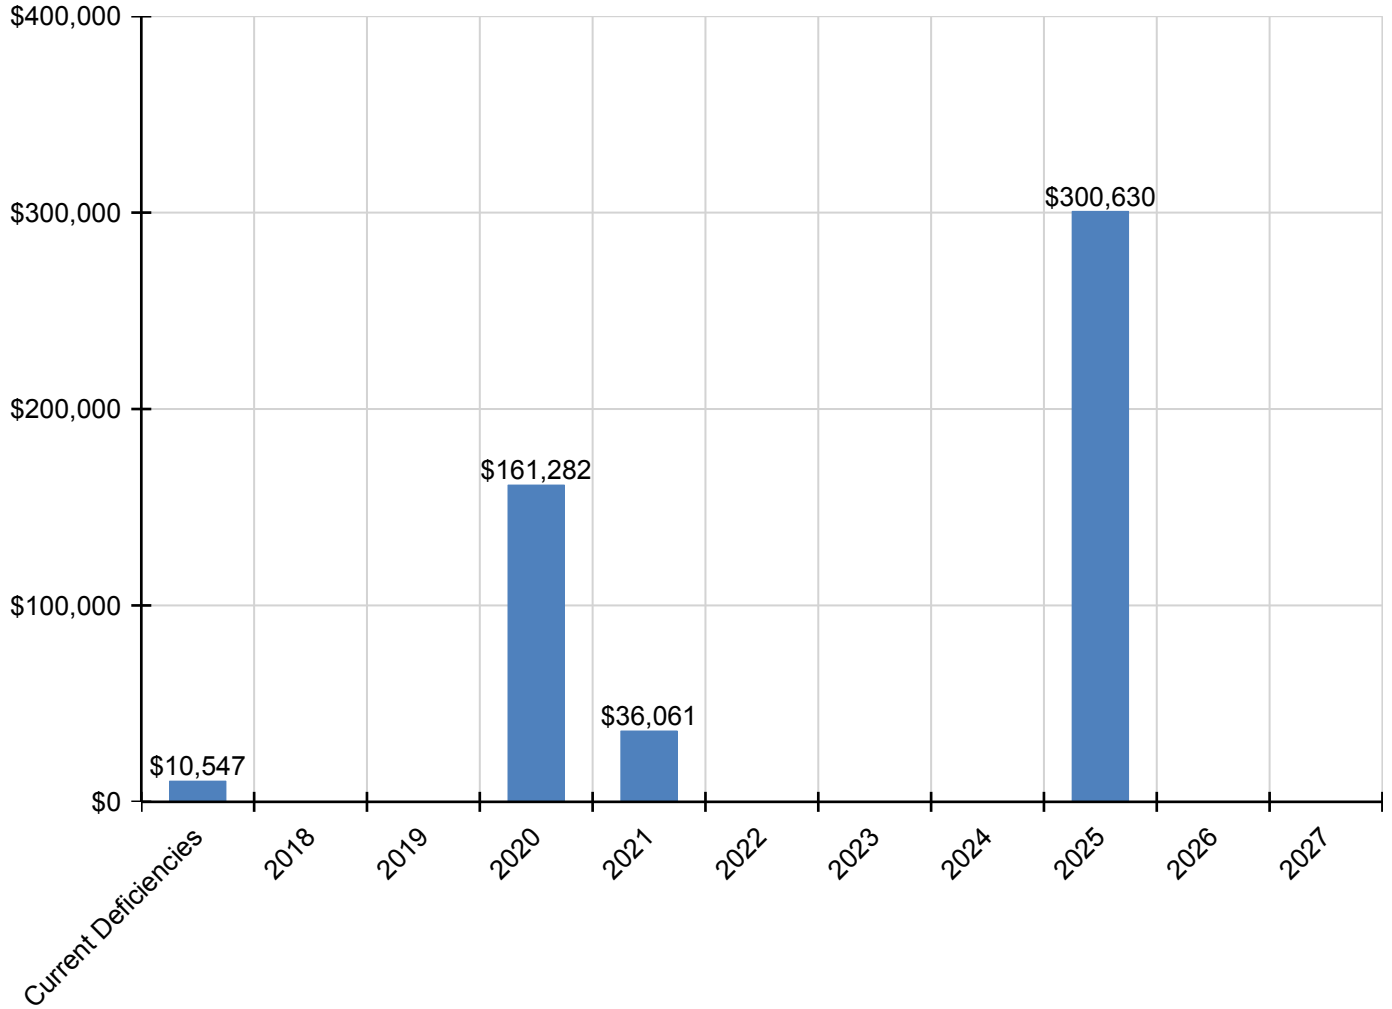
Forecasted Capital Renewal Requirement

The following chart shows the current building deficiencies and forecasting capital renewal or sustainment requirements over the next ten years.

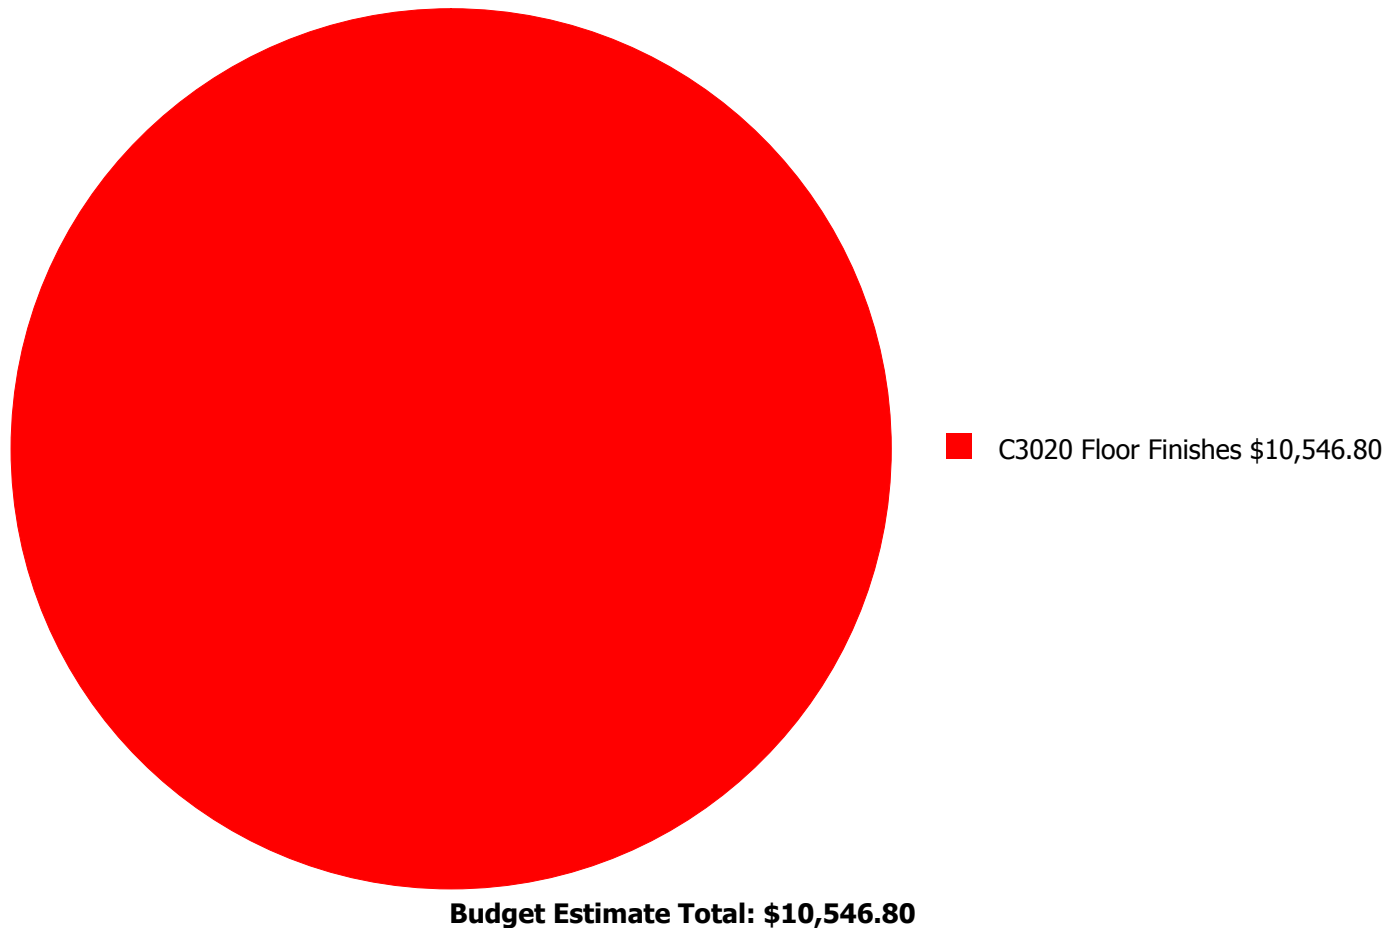
Deficiency Summary by System

Current deficiencies included assemblies that have reached or exceeded their design life or components of the assemblies that are in need of repair. Assemblies that have reached their design life are identified as current deficiencies and assigned the distress 'Beyond Useful Life'. The following chart lists all current deficiencies associated with this facility.

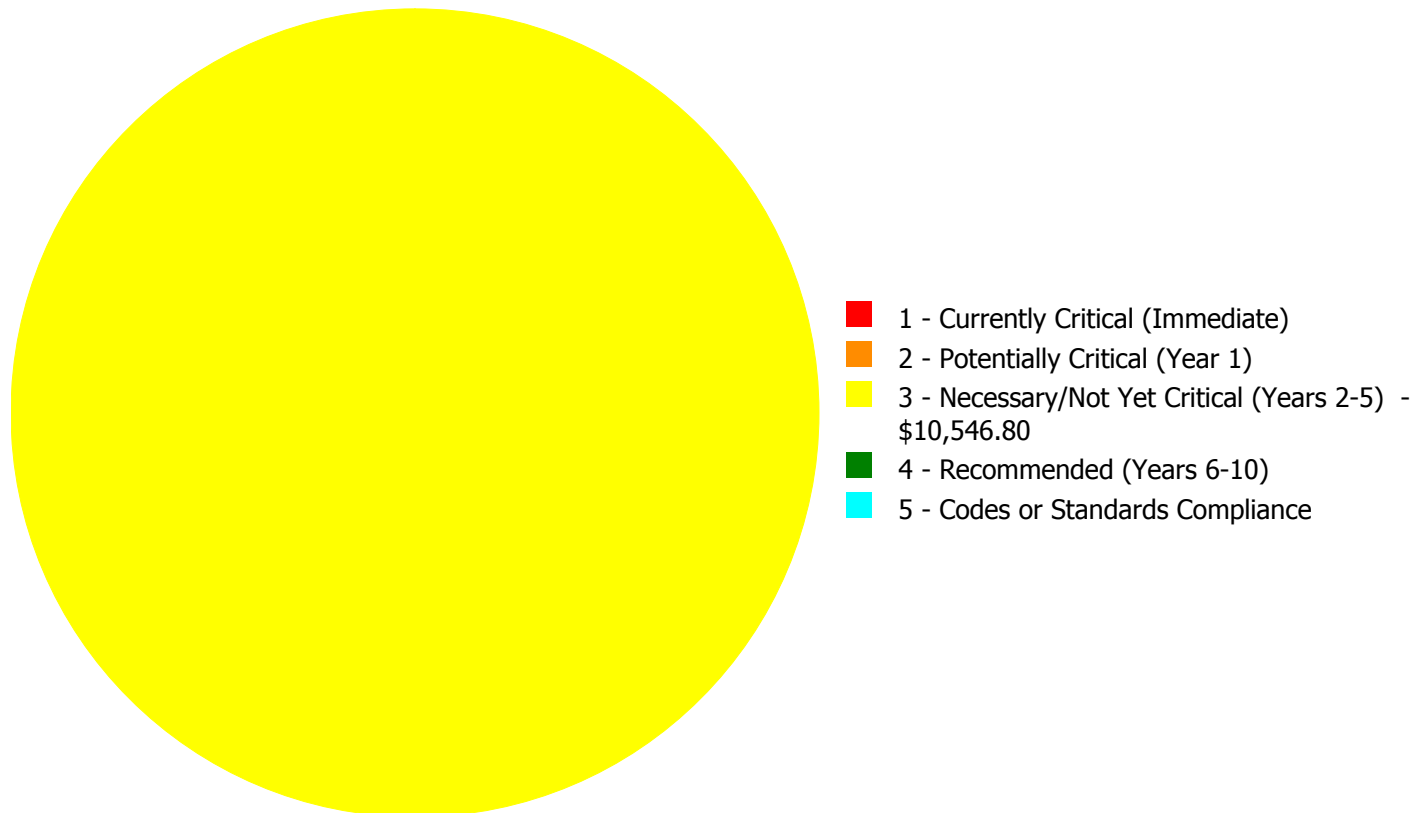
Deficiency Summary by Priority

The following chart shows the total repair costs broken down by priority. Assessors assigned deficiencies within eCOMET to one of the following priority categories:

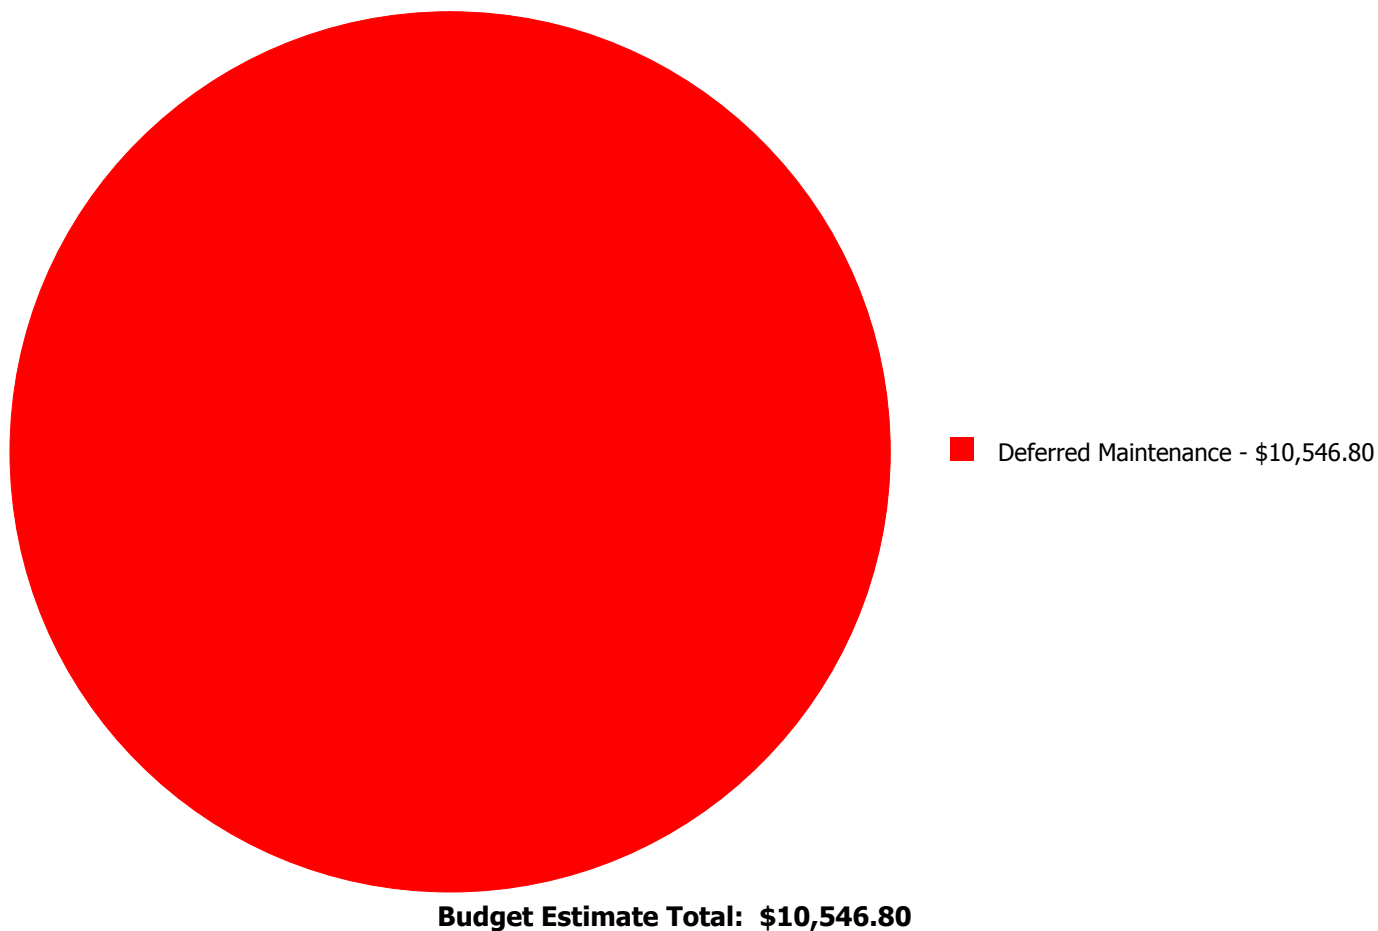
Deficiency Summary by Category

The following chart shows the total repair costs broken down by deficiency categories. Assessors assigned deficiencies to one of the following categories:

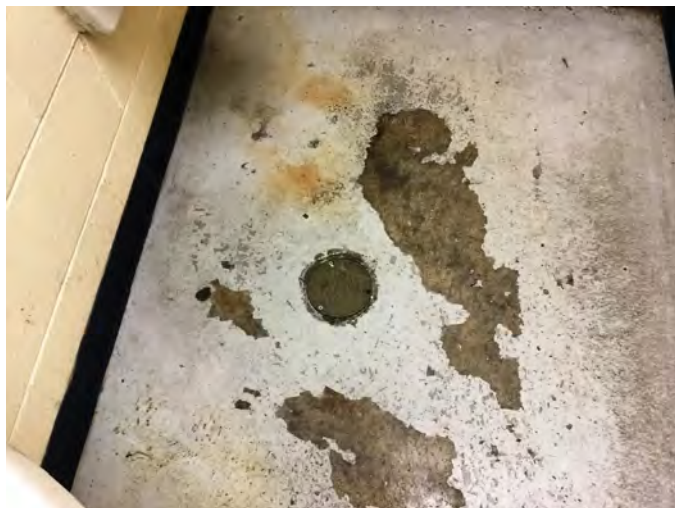
System: C3020 - Floor Finishes

Location: Mens Restroom
Distress: Damaged
Category: Deferred Maintenance
Priority: 3 - Necessary/Not Yet Critical (Years 2-5)
Correction: Replace epoxy flooring
Qty: 5.00
Unit of Measure: C.S.F.
Estimate: \$10,546.80
Assessor Name: Eduardo Lopez
Date Created: 01/11/2017

Notes: The epoxy flooring in the restroom area is in poor condition and should be replaced.

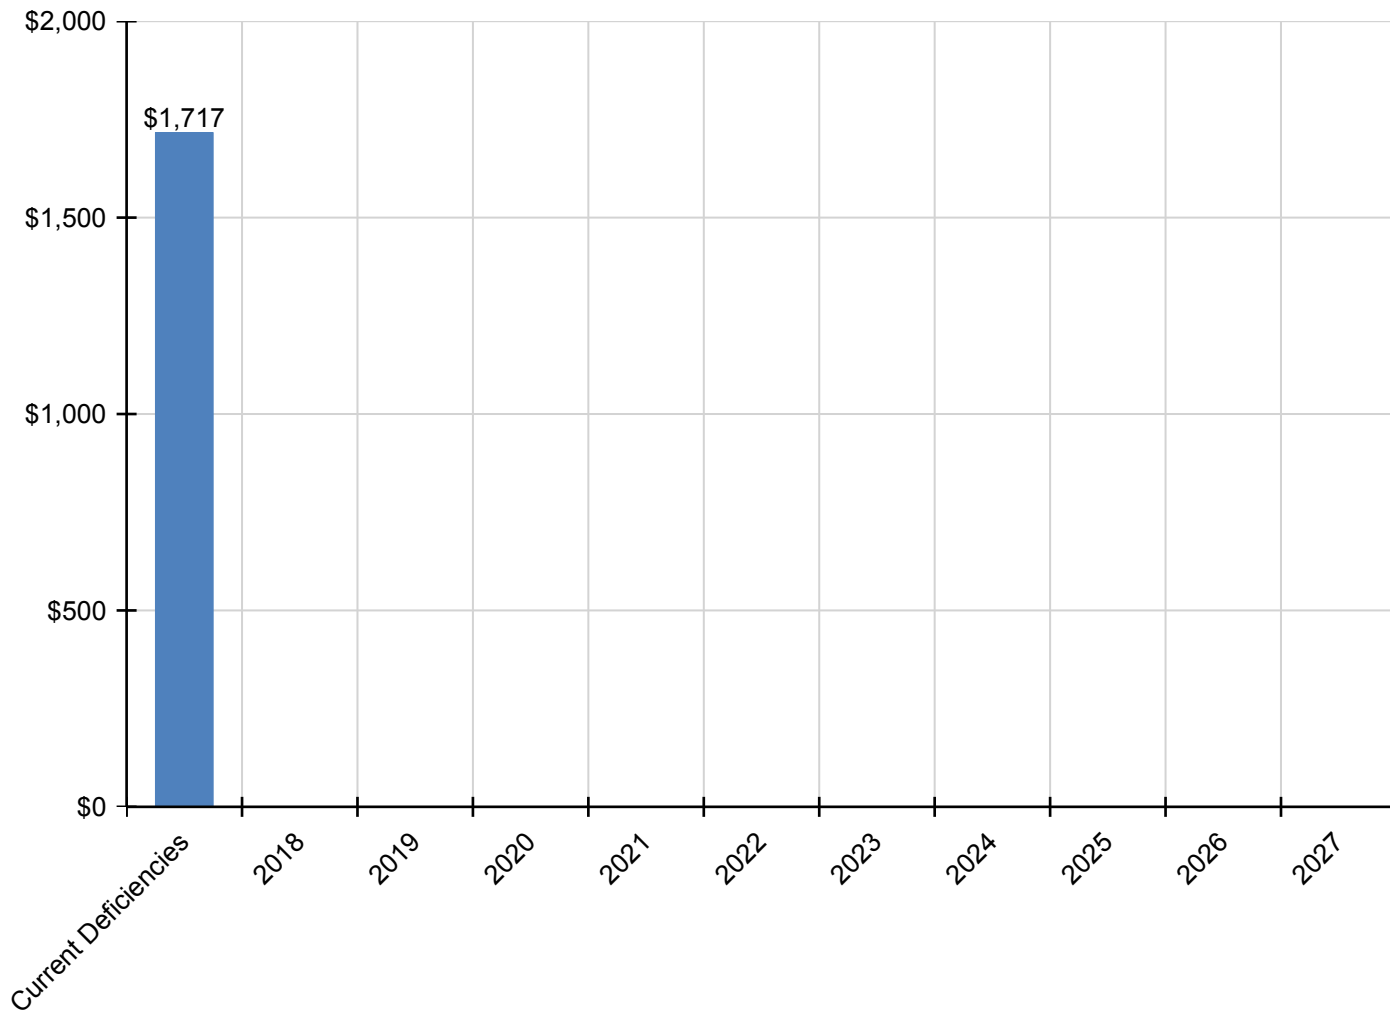
Forecasted Capital Renewal Requirement

The following chart shows the current building deficiencies and forecasting capital renewal or sustainment requirements over the next ten years.

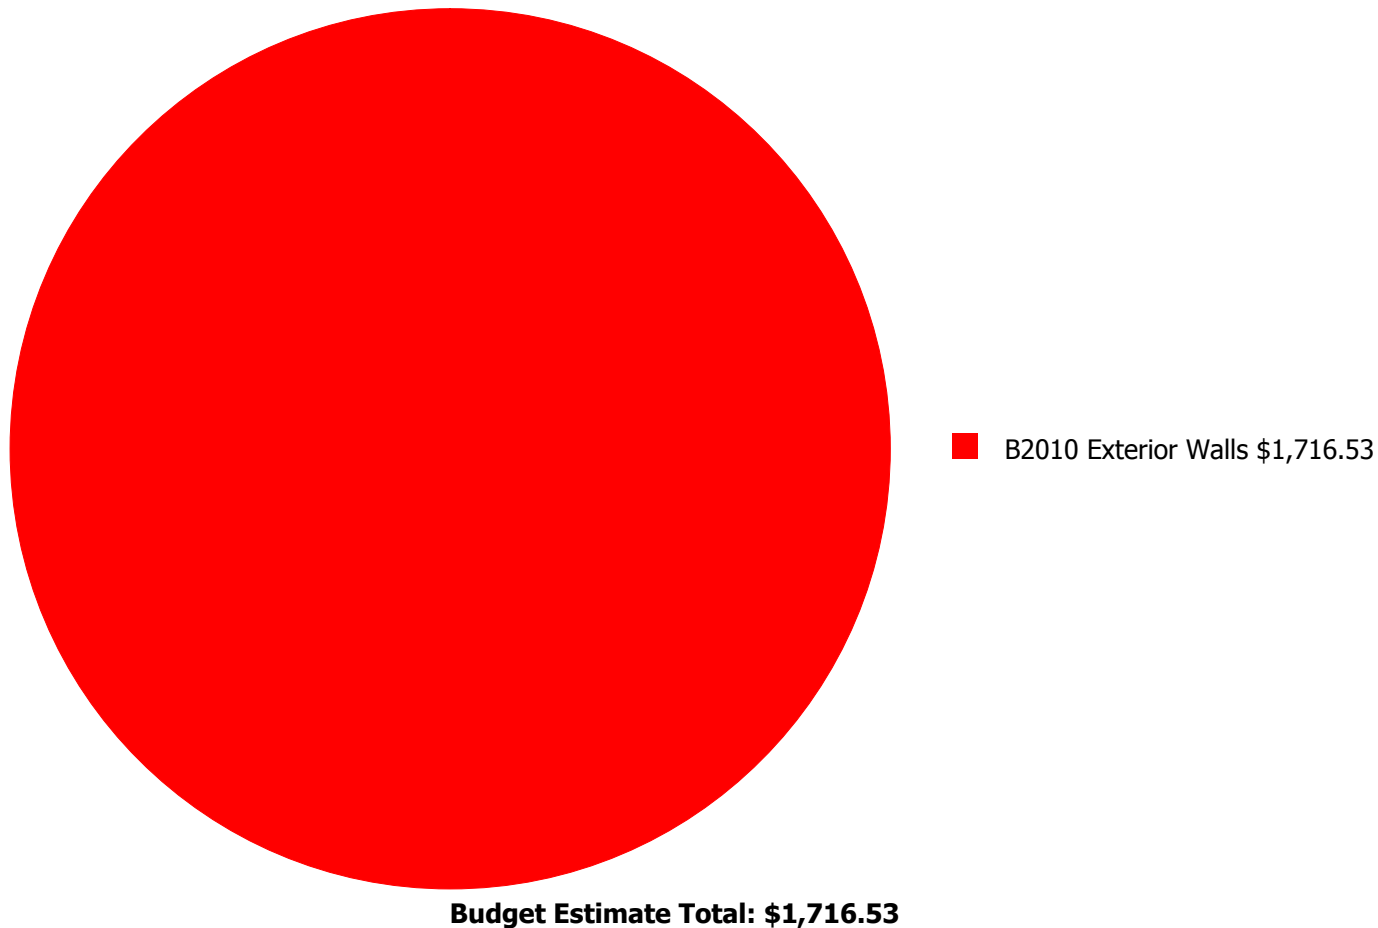
Deficiency Summary by System

Current deficiencies included assemblies that have reached or exceeded their design life or components of the assemblies that are in need of repair. Assemblies that have reached their design life are identified as current deficiencies and assigned the distress 'Beyond Useful Life'. The following chart lists all current deficiencies associated with this facility.
