NC School District/830 Scotland County/High School

Scotland High

Campus Assessment Report

March 11, 2017

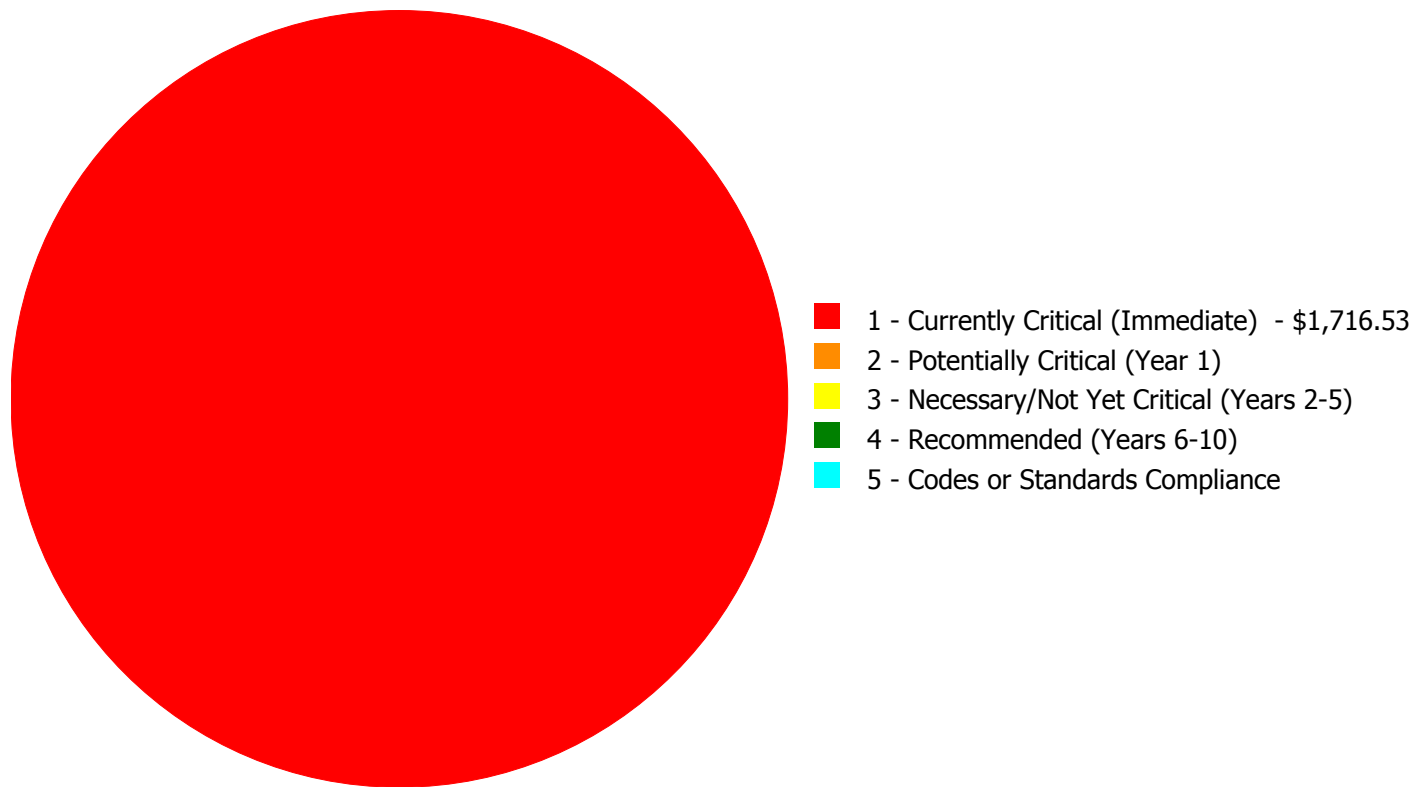
Deficiency Summary by Priority

The following chart shows the total repair costs broken down by priority. Assessors assigned deficiencies within eCOMET to one of the following priority categories:

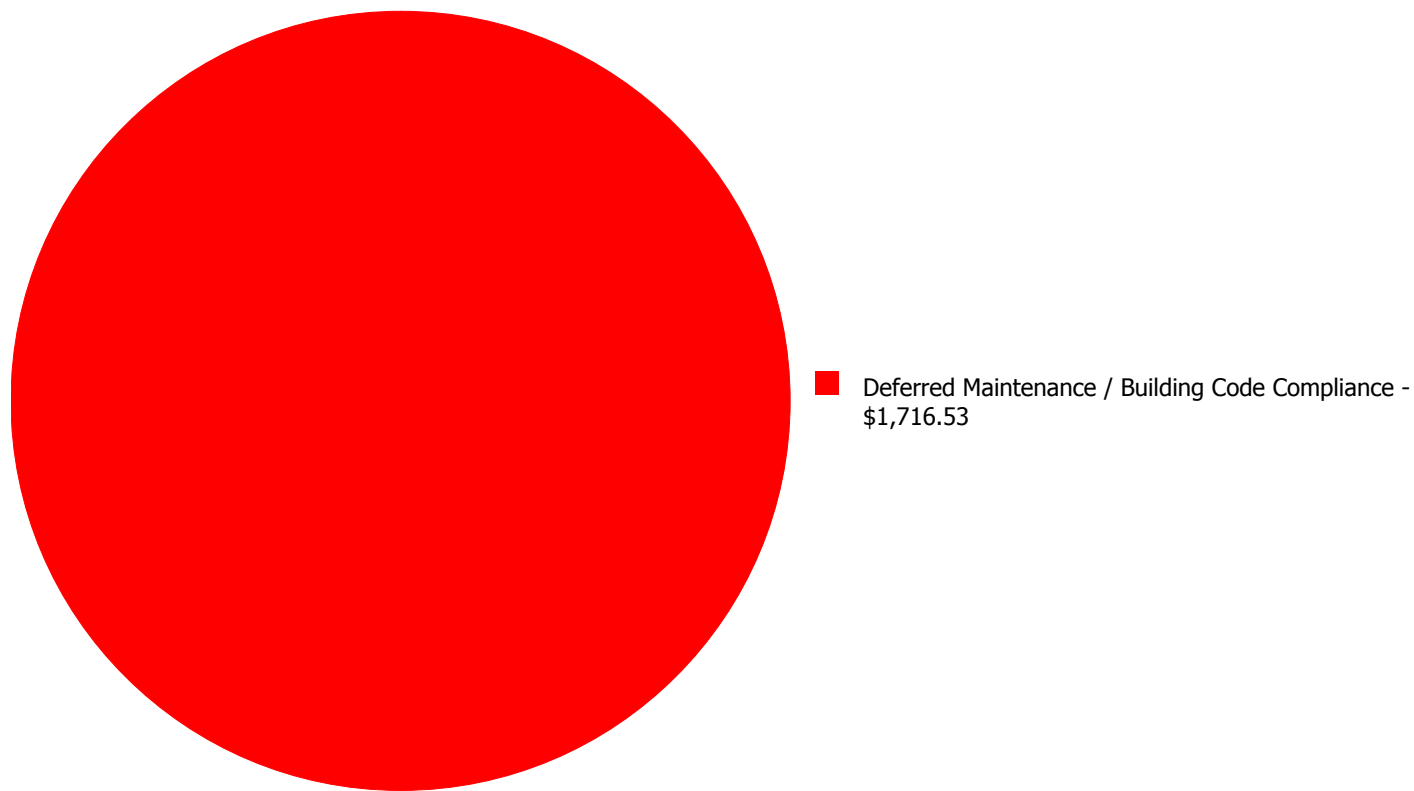
Deficiency Summary by Category

The following chart shows the total repair costs broken down by deficiency categories. Assessors assigned deficiencies to one of the following categories:

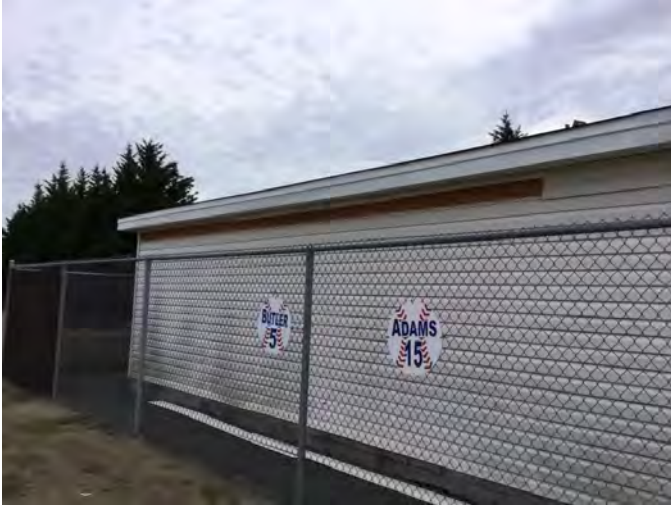
System: B2010 - Exterior Walls

Location: Exterior Walls
Distress: Damaged
Category: Deferred Maintenance / Building Code Compliance
Priority: 1 - Currently Critical (Immediate)
Correction: Replace hardboard panels, 1st floor
Qty: 2.00
Unit of Measure: C.S.F.
Estimate: \$1,716.53
Assessor Name: Eduardo Lopez
Date Created: 01/12/2017

Notes: The exterior siding is falling off and it is in poor condition and it should be replaced.

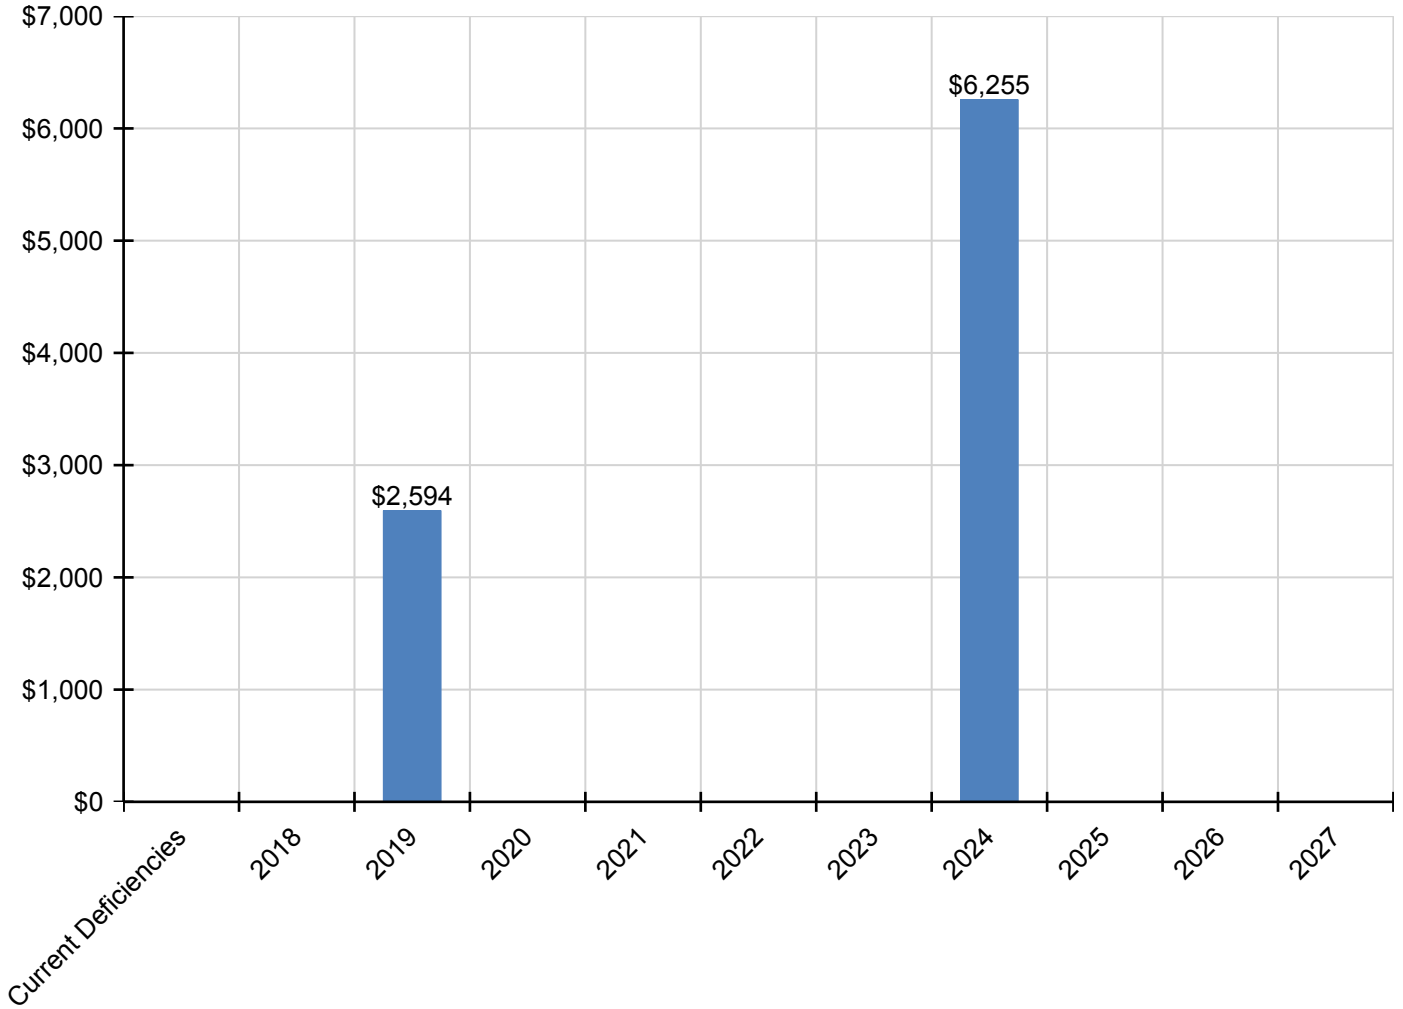
Forecasted Capital Renewal Requirement

The following chart shows the current building deficiencies and forecasting capital renewal or sustainment requirements over the next ten years.

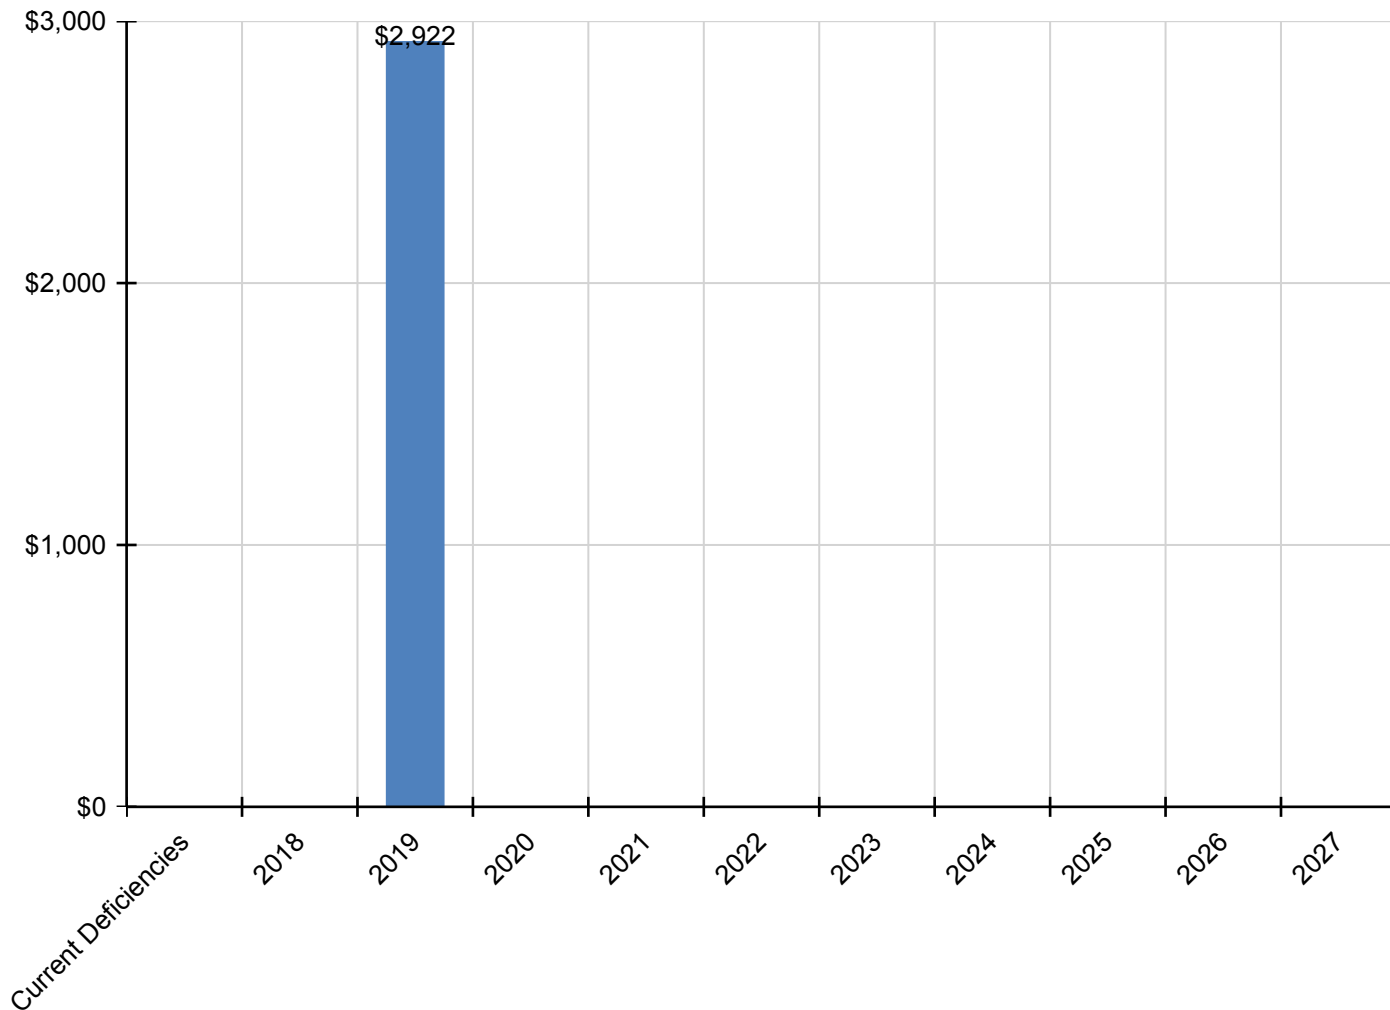
Forecasted Capital Renewal Requirement

The following chart shows the current building deficiencies and forecasting capital renewal or sustainment requirements over the next ten years.

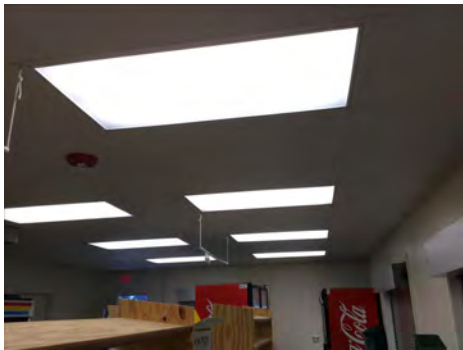
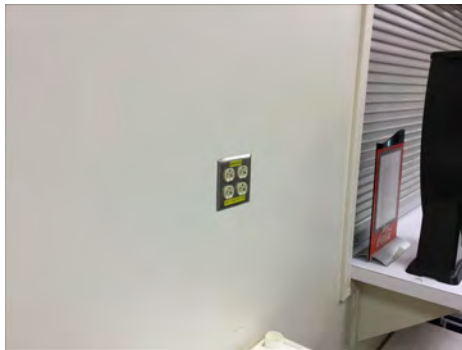
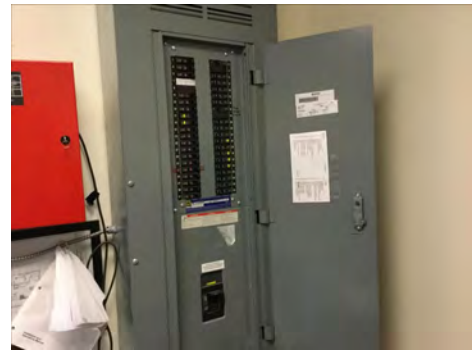
System: D5020 - Branch Wiring

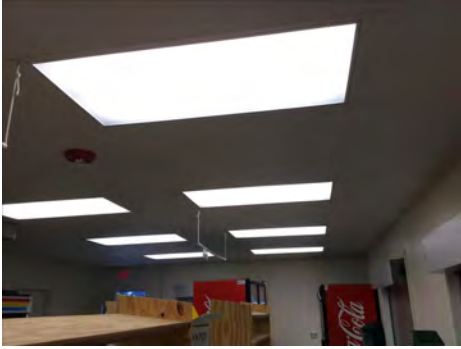
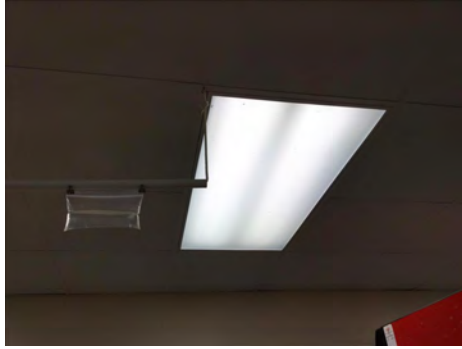
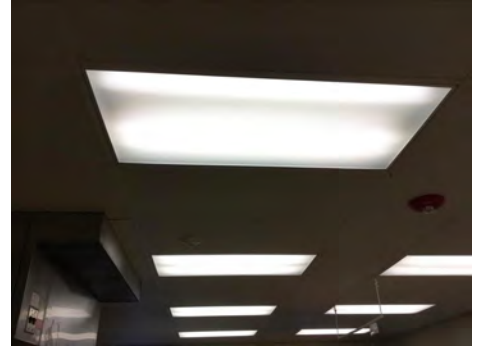
System: D5020 - Lighting

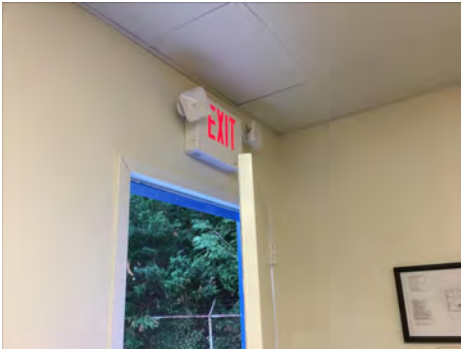
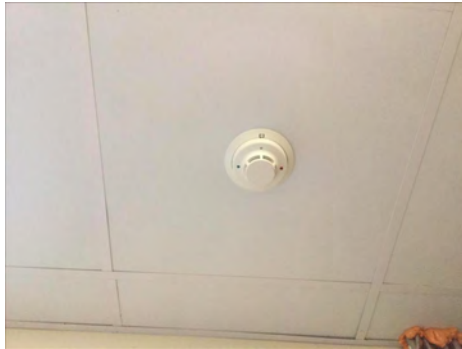
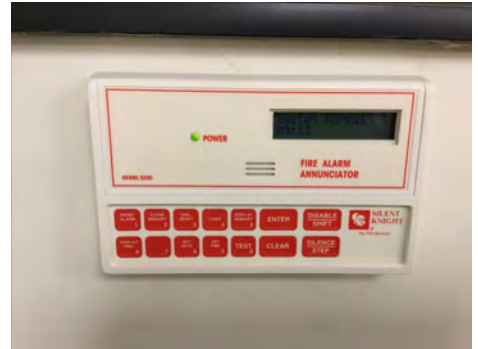
System: D5030810 - Security & Detection Systems

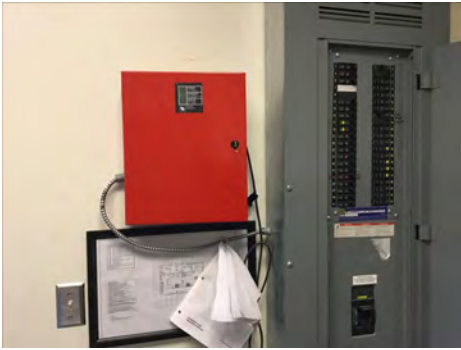
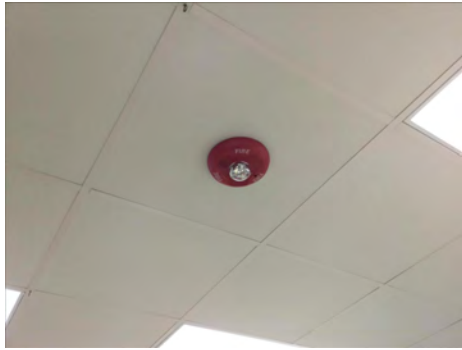
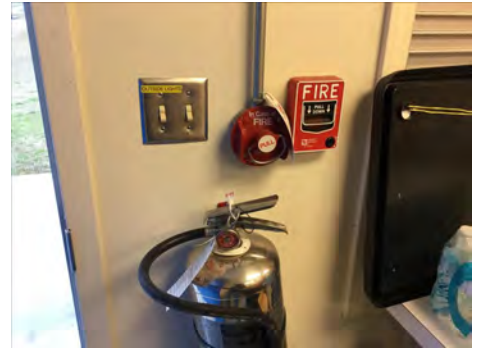
System: D5030910 - Fire Alarm Systems

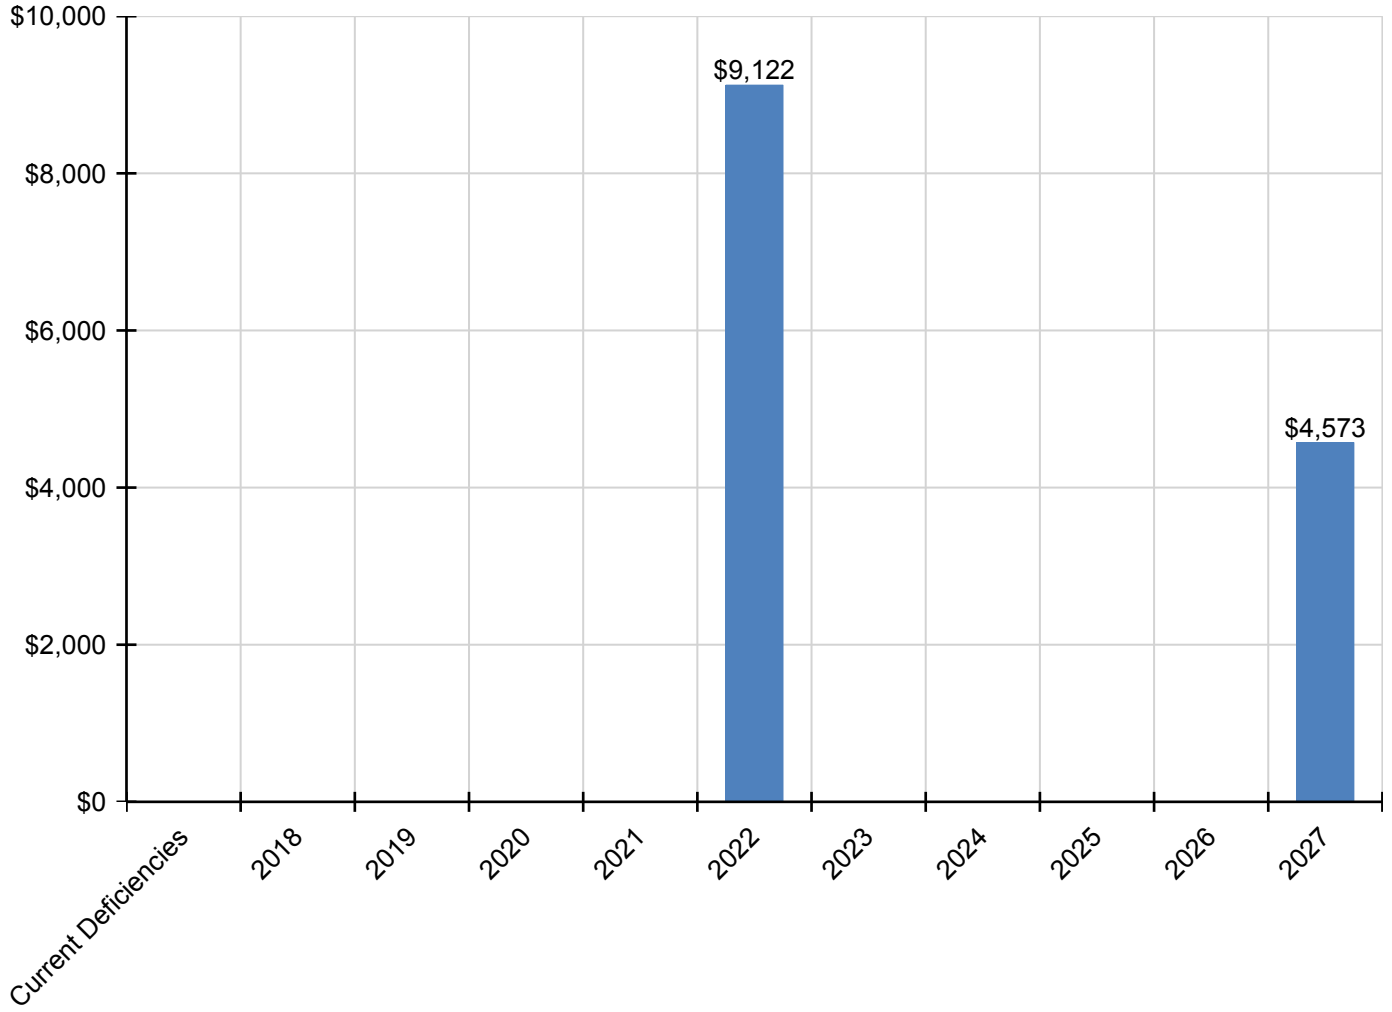
Forecasted Capital Renewal Requirement

The following chart shows the current building deficiencies and forecasting capital renewal or sustainment requirements over the next ten years.

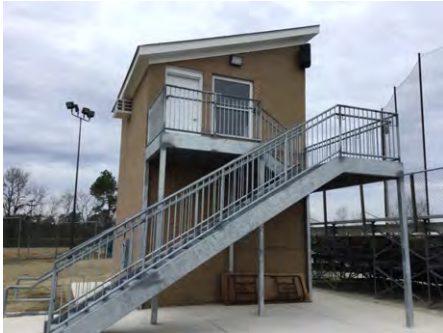
1). Northeast Elevation - Jan 12, 2017

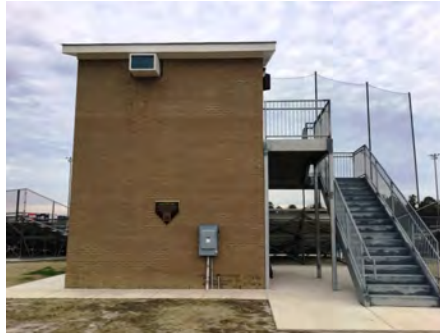
2). Southeast Elevation - Jan 12, 2017

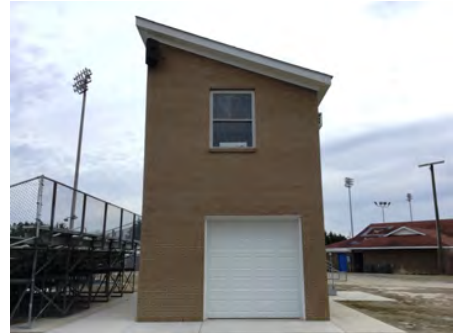
3). Southwest Elevation - Jan 12, 2017

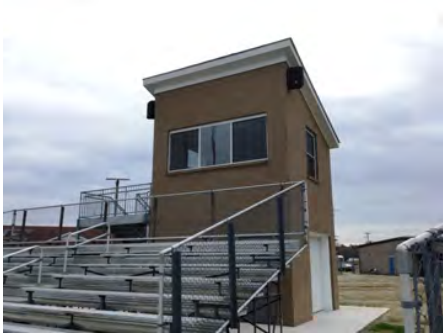
4). Northwest Elevation - Jan 12, 2017

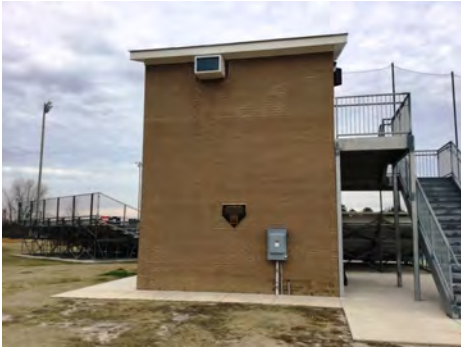
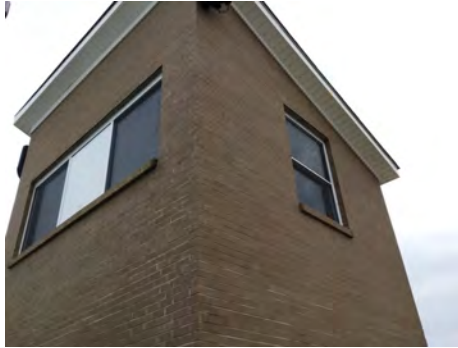
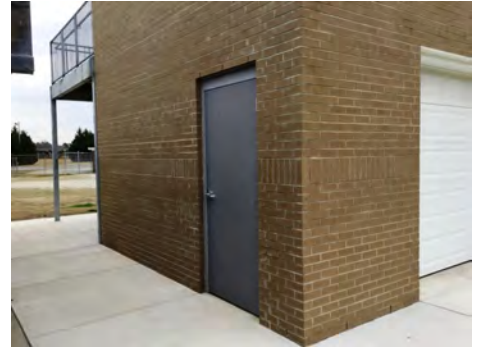
System: B2010 - Exterior Walls

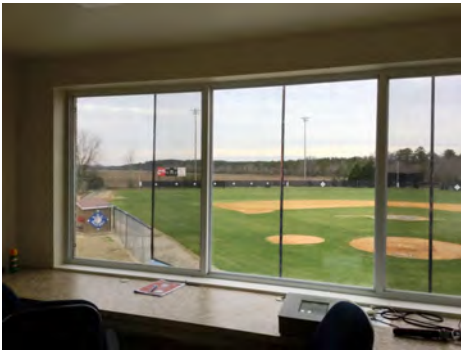
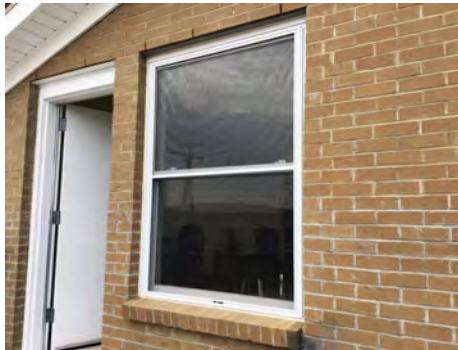
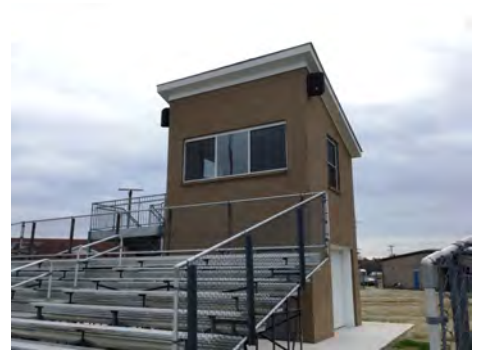
System: B2020 - Exterior Windows

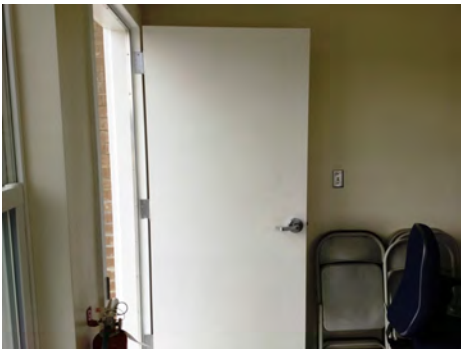
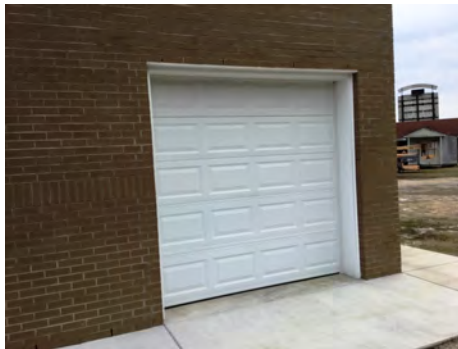
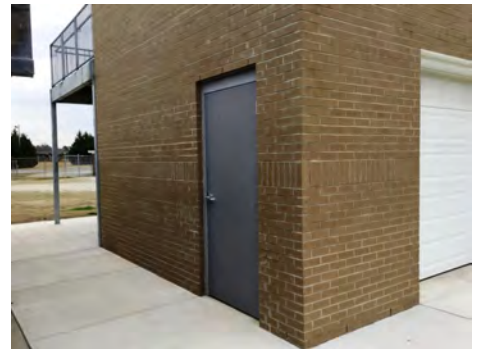
System: B2030 - Exterior Doors

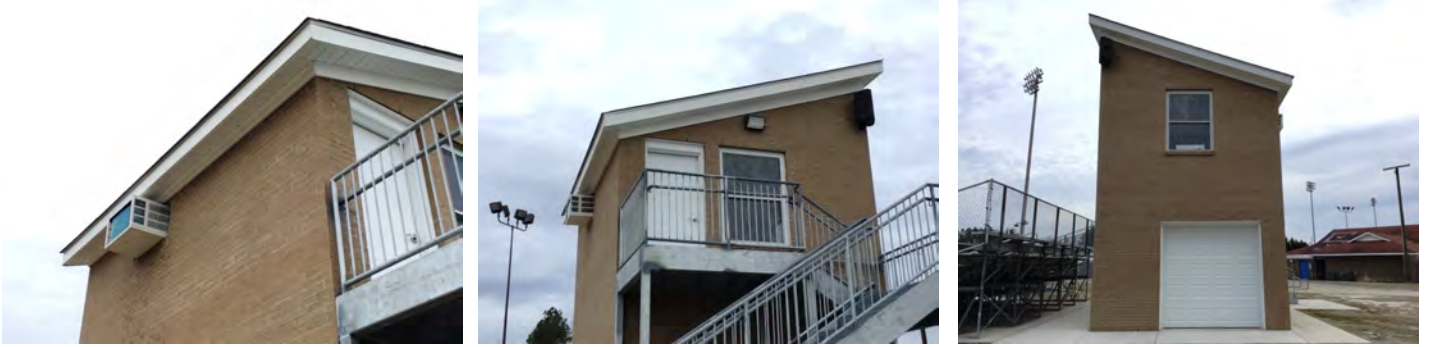
System: B3010140 - Asphalt Shingles

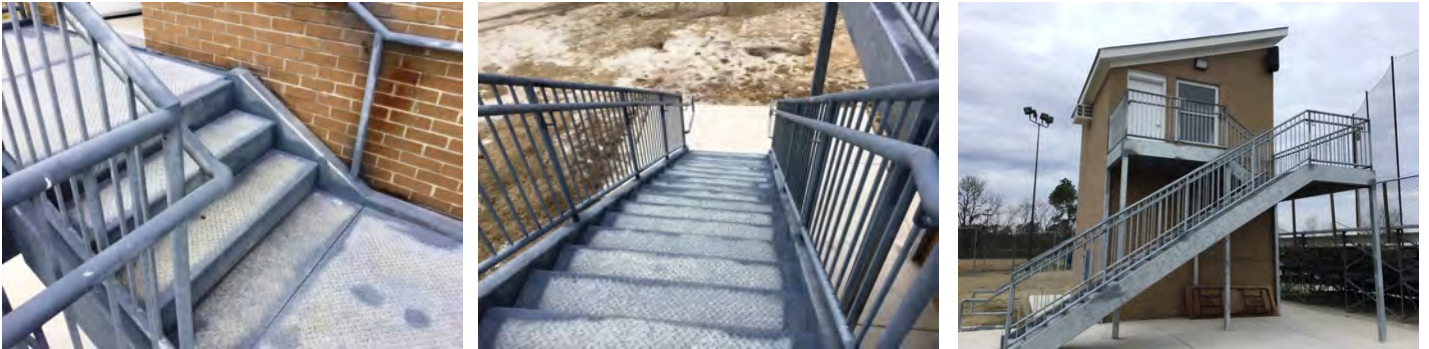
System: C2010 - Stair Construction

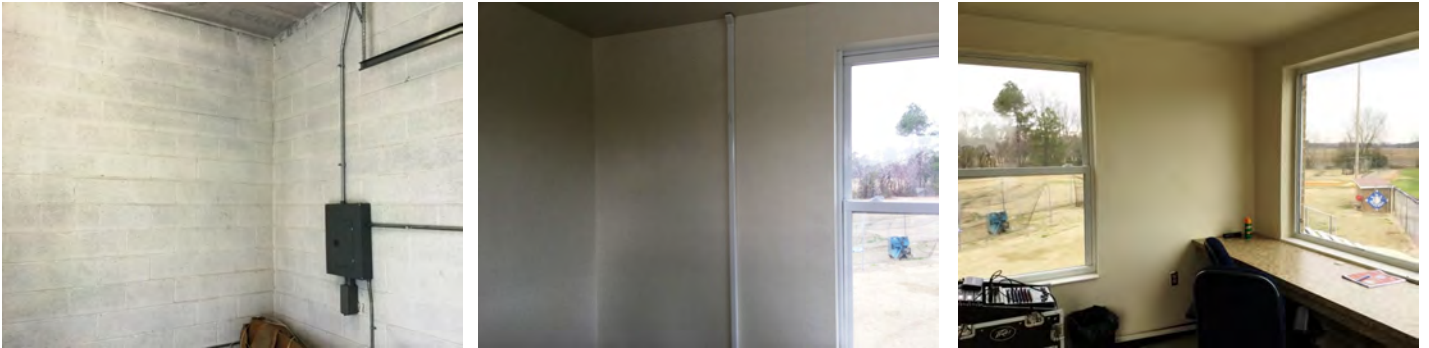
System: C3010 - Wall Finishes

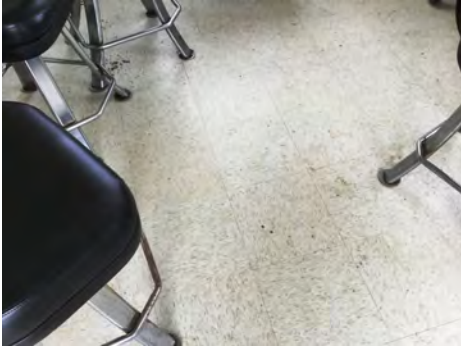
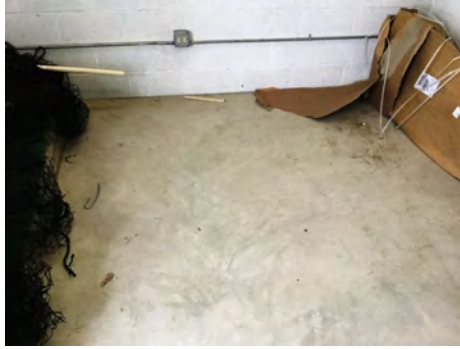
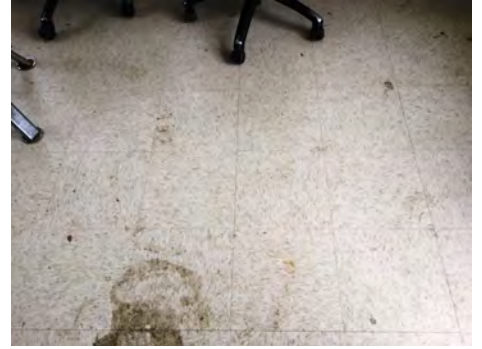
System: C3020 - Floor Finishes

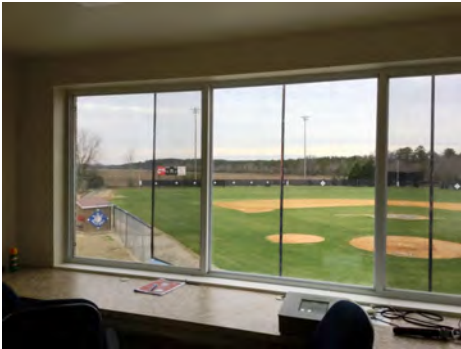
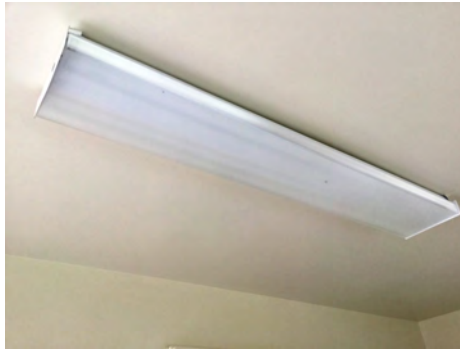
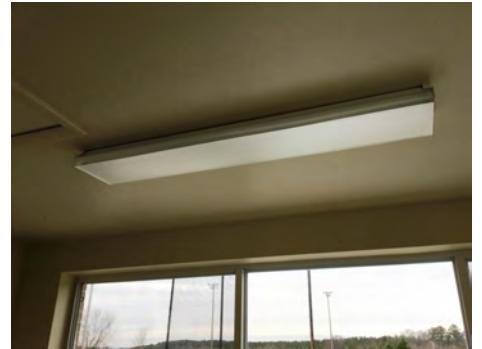
System: C3030 - Ceiling Finishes

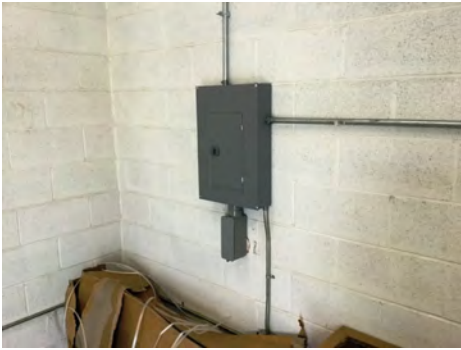
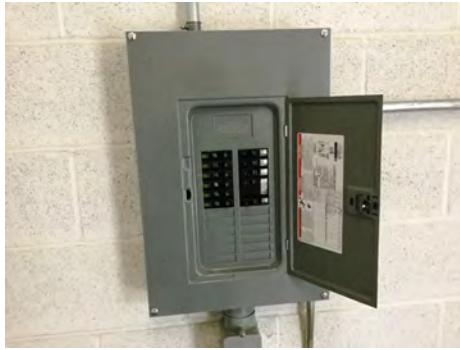
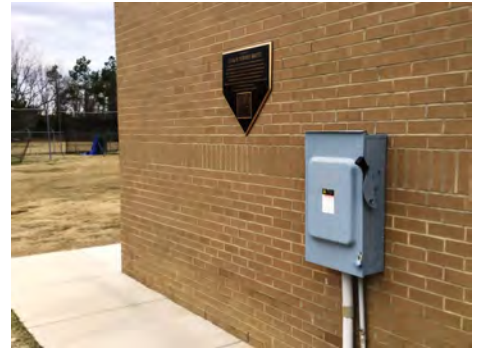
System: D5010 - Electrical Service/Distribution

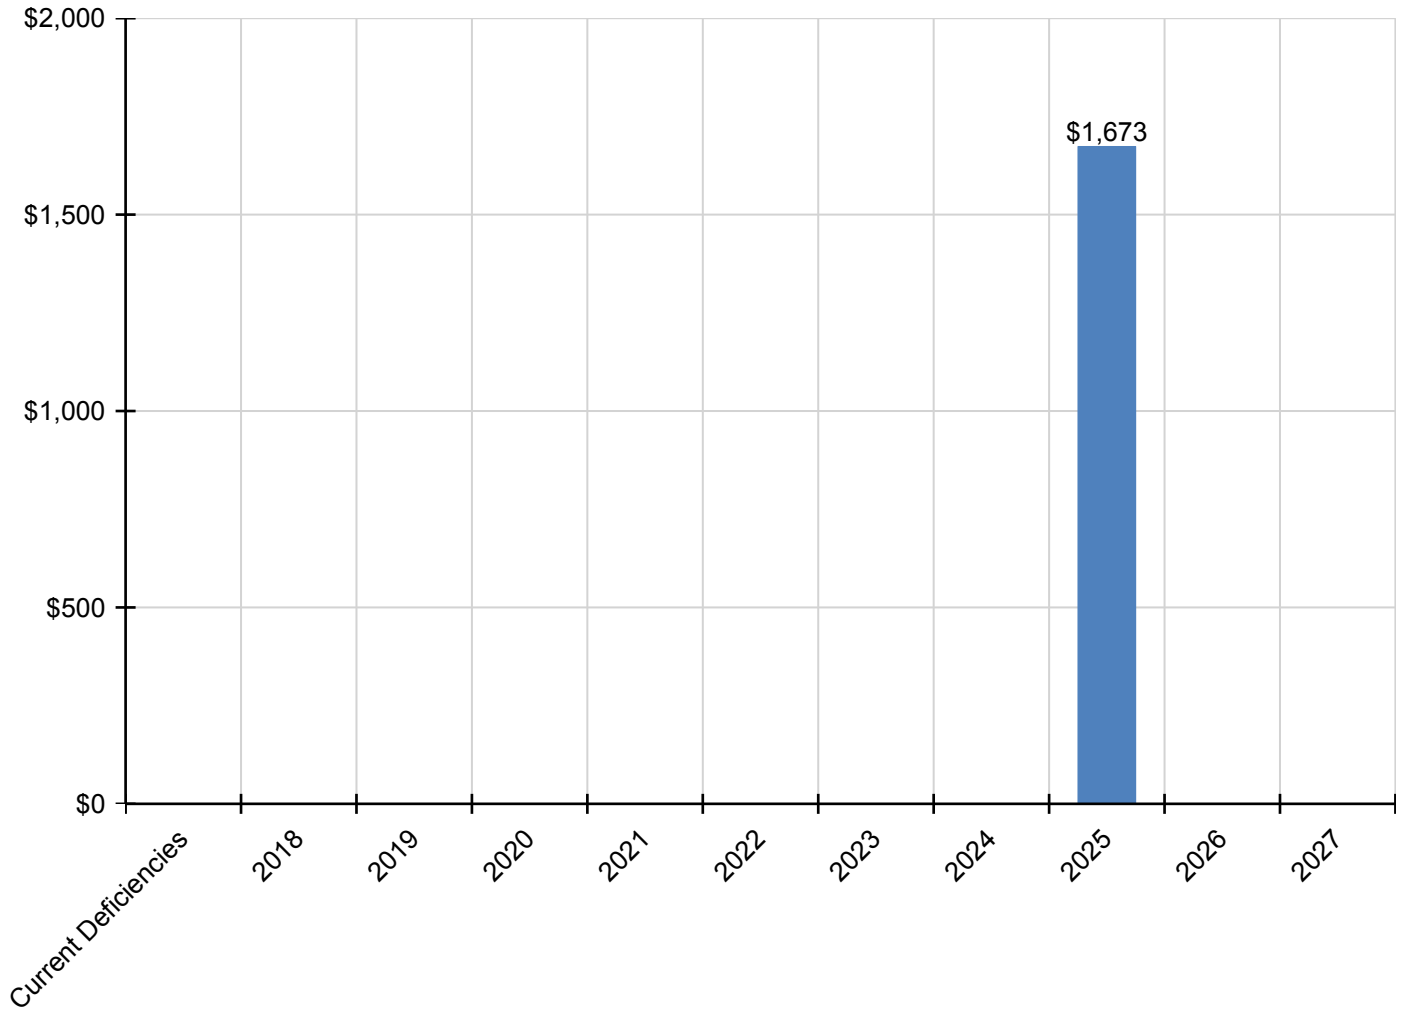
Forecasted Capital Renewal Requirement

The following chart shows the current building deficiencies and forecasting capital renewal or sustainment requirements over the next ten years.

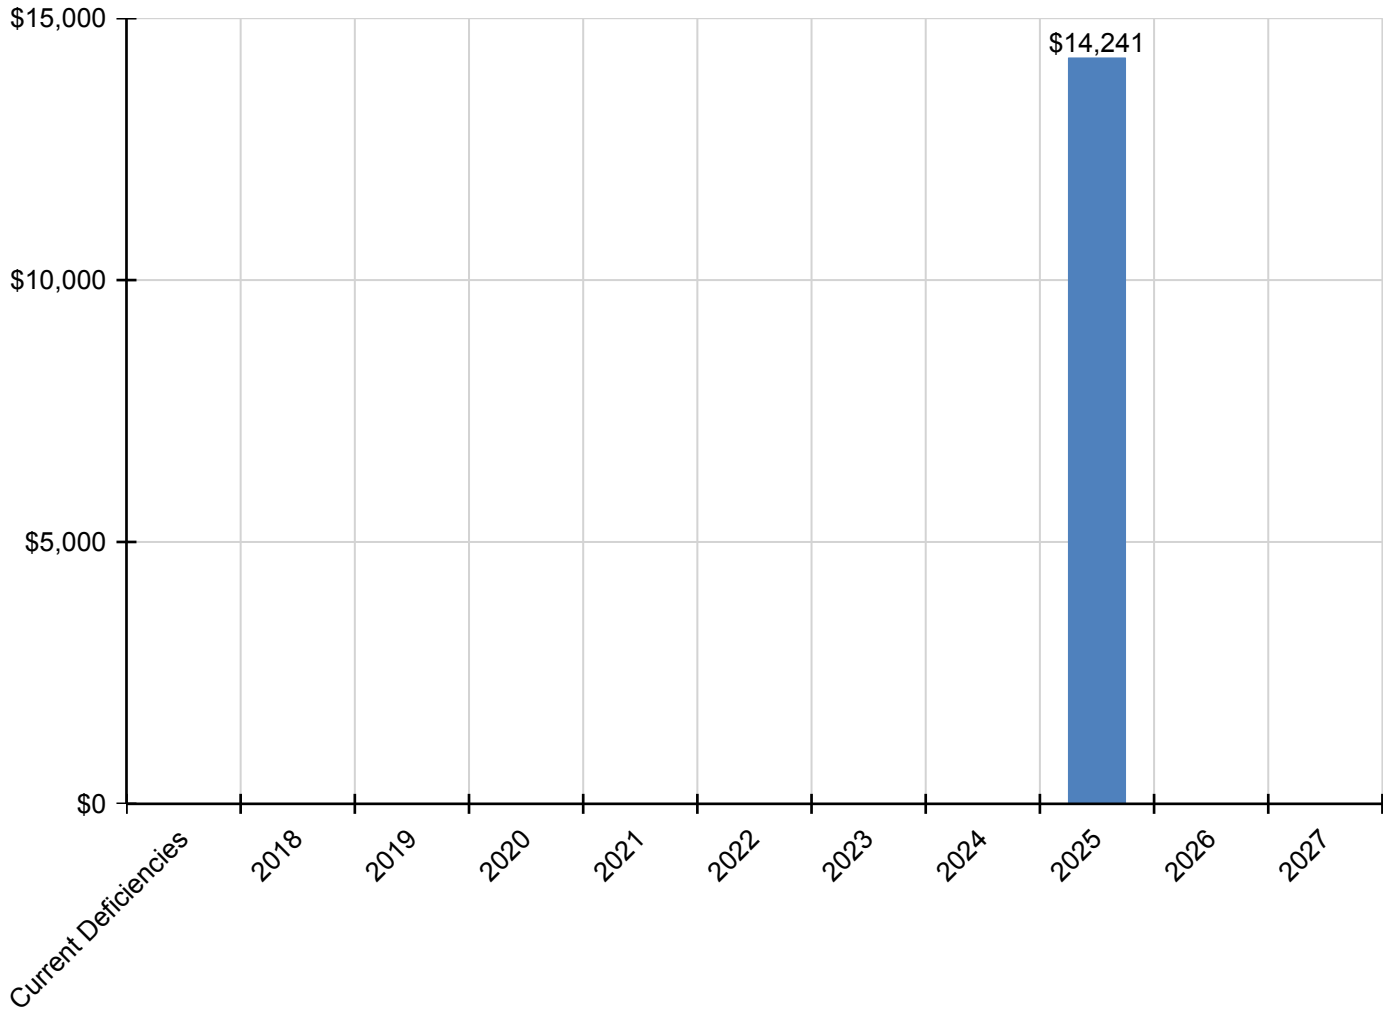
Forecasted Capital Renewal Requirement

The following chart shows the current building deficiencies and forecasting capital renewal or sustainment requirements over the next ten years.

eCOMET forecasts future Capital Renewal projects for expiring systems based on the Calculated Next Renewal year found in the system listing. There is a 3% yearly inflation factor applied to the system costs expiring in the future. The table below reflects Capital Renewal projects over the next 10 years. Note: Blank cells (or \$0) indicate no systems are scheduled for renewal in that year.

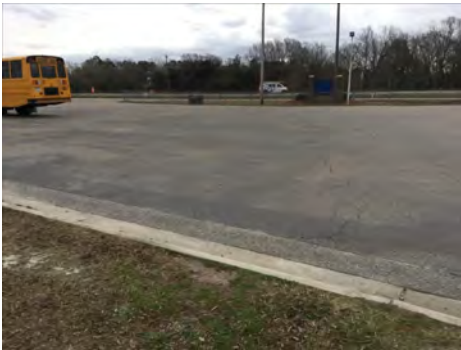
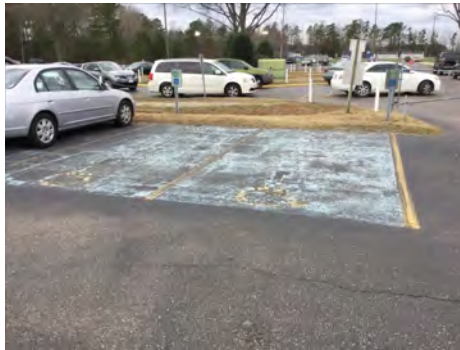
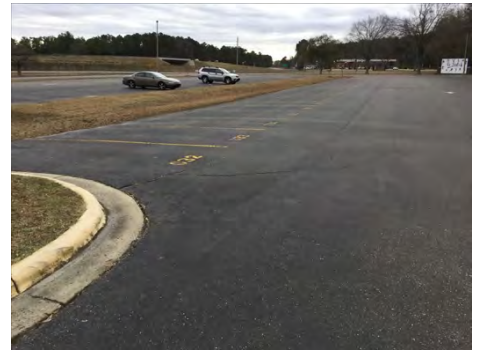
System: G2020 - Parking Lots

Note: The parking lot is beyond its service life and should be resealed, restriped and recoated.

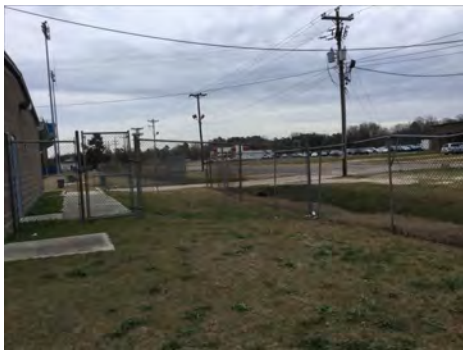
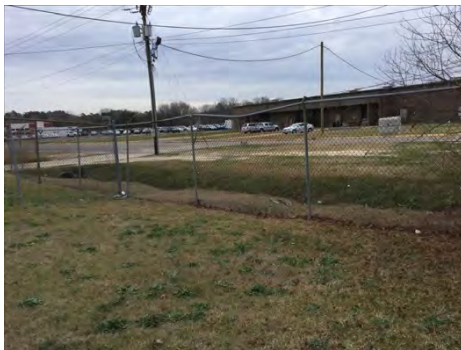
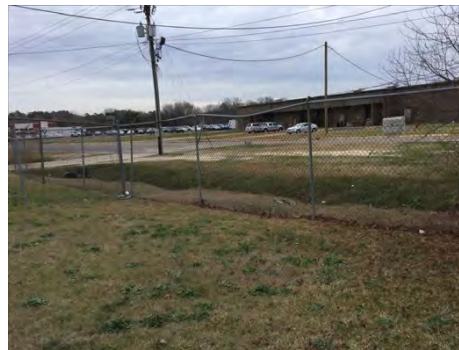
System: G2040105 - Fence & Guardrails

Note: The fences and guardrail are rusted and beyond their service life and should be replaced.

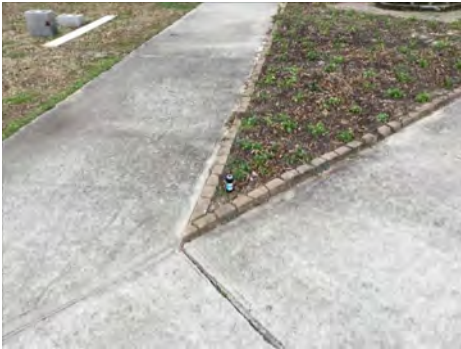
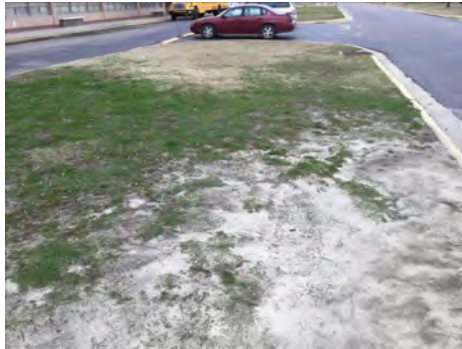
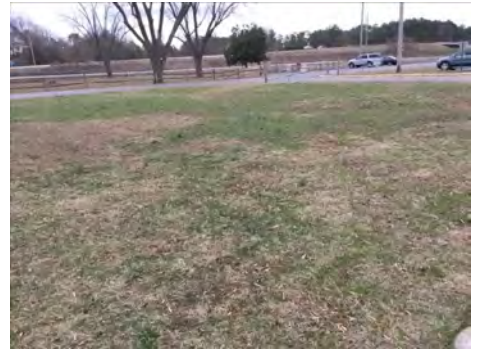
System: G2050 - Landscaping

Note: The landscaping is beyond its service life and should be replaced.

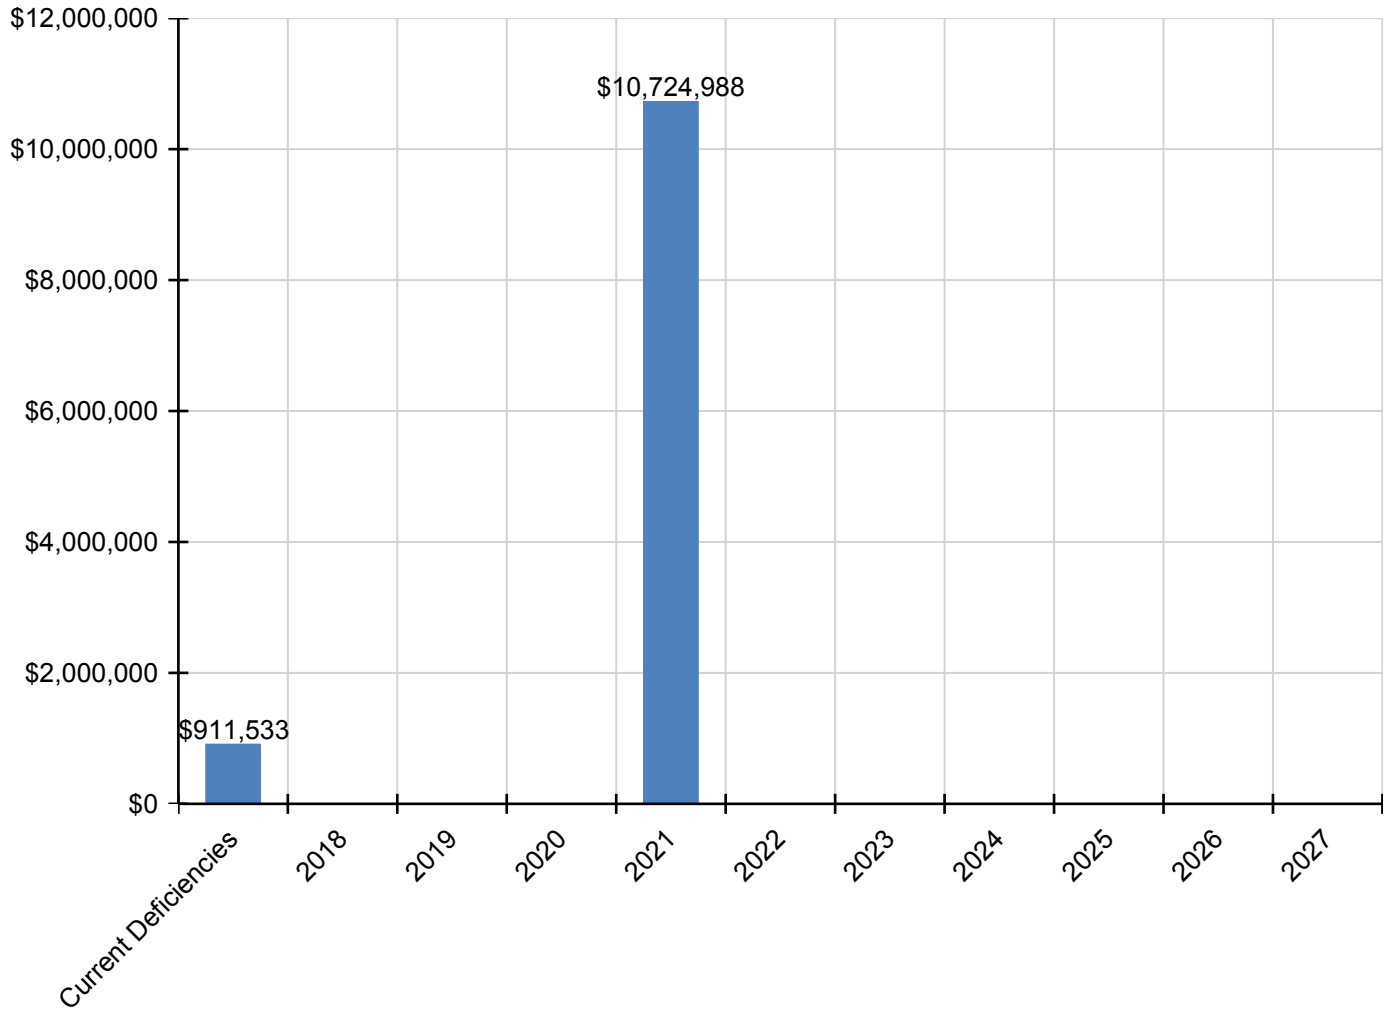
Forecasted Capital Renewal Requirement

The following chart shows the current building deficiencies and forecasting capital renewal or sustainment requirements over the next ten years.

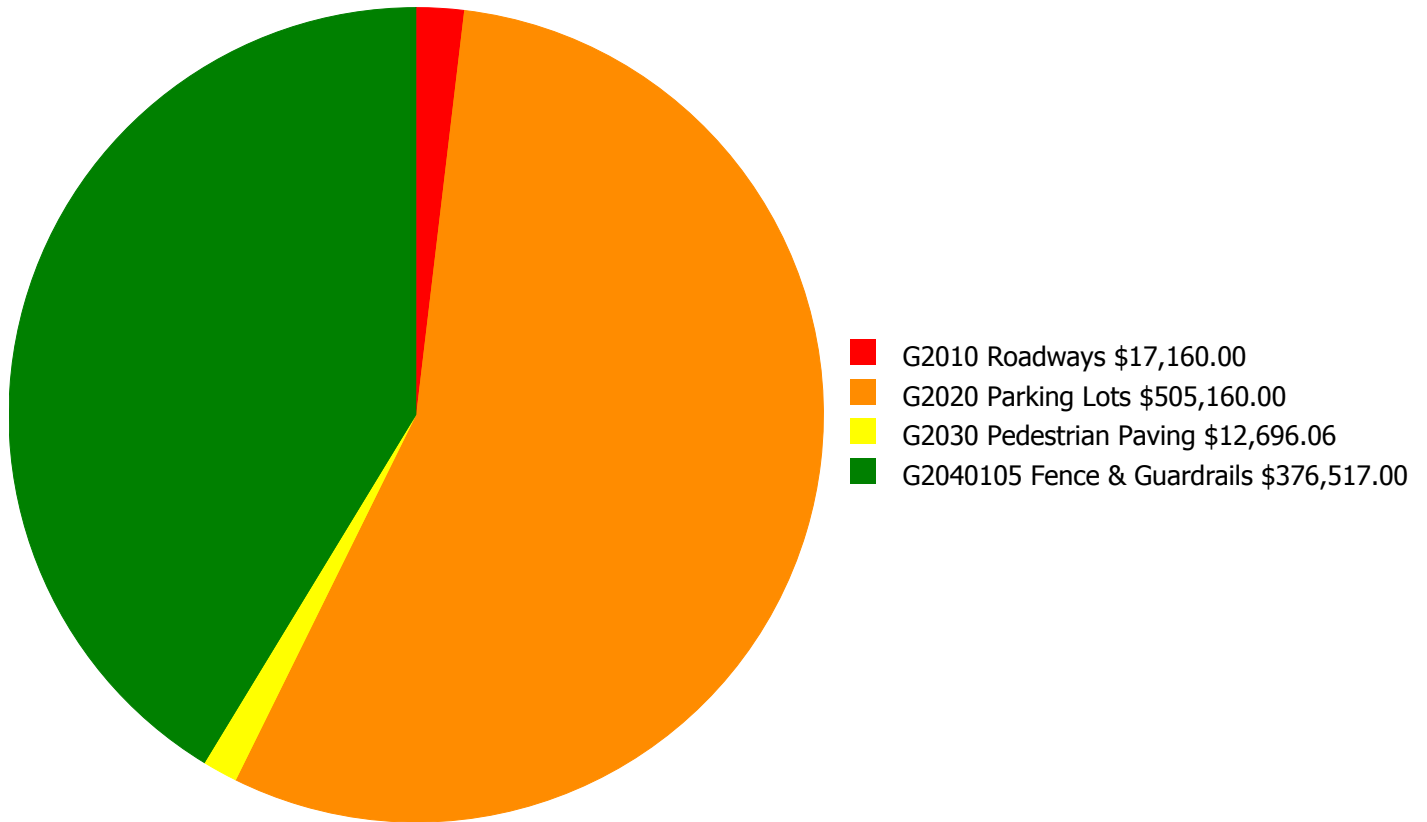
Deficiency Summary by System

Current deficiencies included assemblies that have reached or exceeded their design life or components of the assemblies that are in need of repair. Assemblies that have reached their design life are identified as current deficiencies and assigned the distress 'Beyond Useful Life'. The following chart lists all current deficiencies associated with this facility.

Budget Estimate Total: \$911,533.06

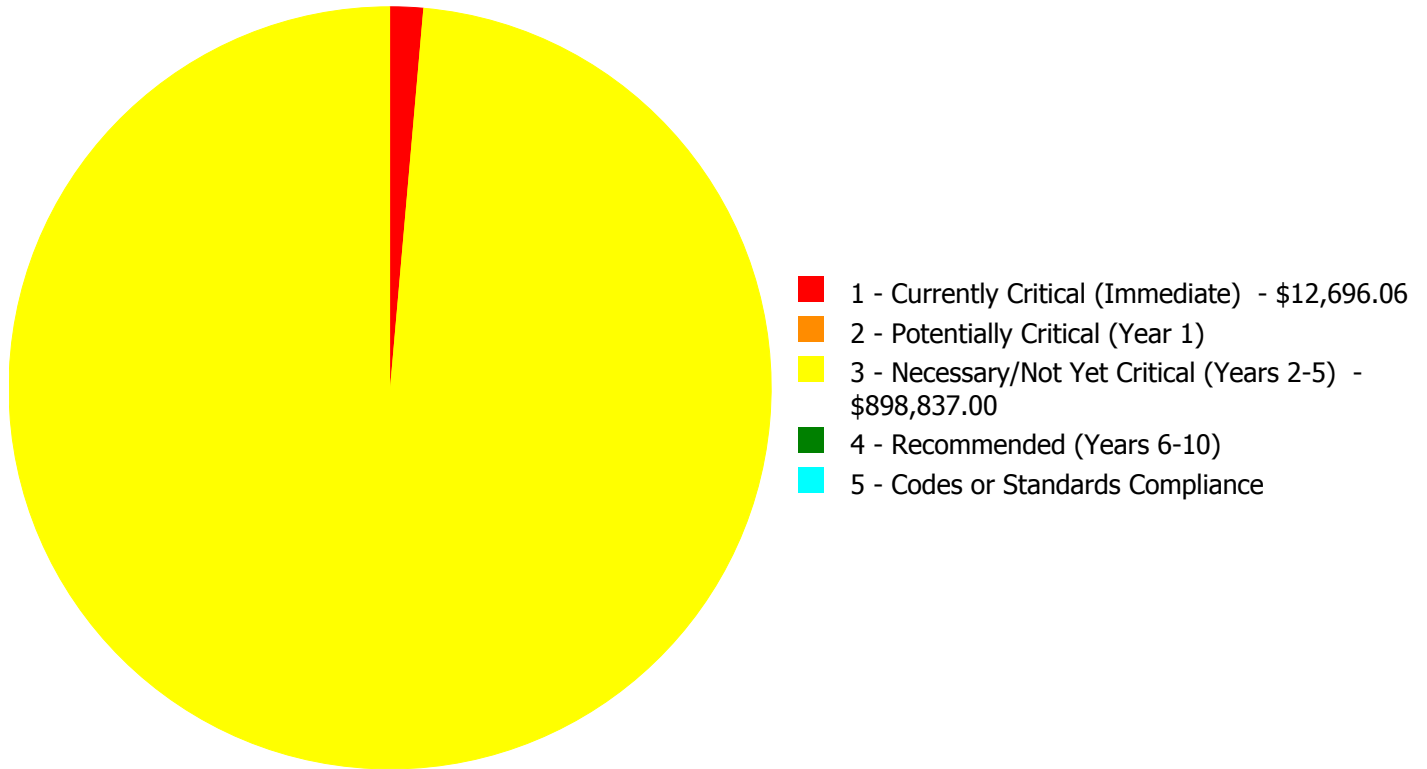
Deficiency Summary by Priority

The following chart shows the total repair costs broken down by priority. Assessors assigned deficiencies within eCOMET to one of the following priority categories:

Budget Estimate Total: \$911,533.06
