NC School District/830 Scotland County/High School

Scotland High

Campus Assessment Report

March 11, 2017

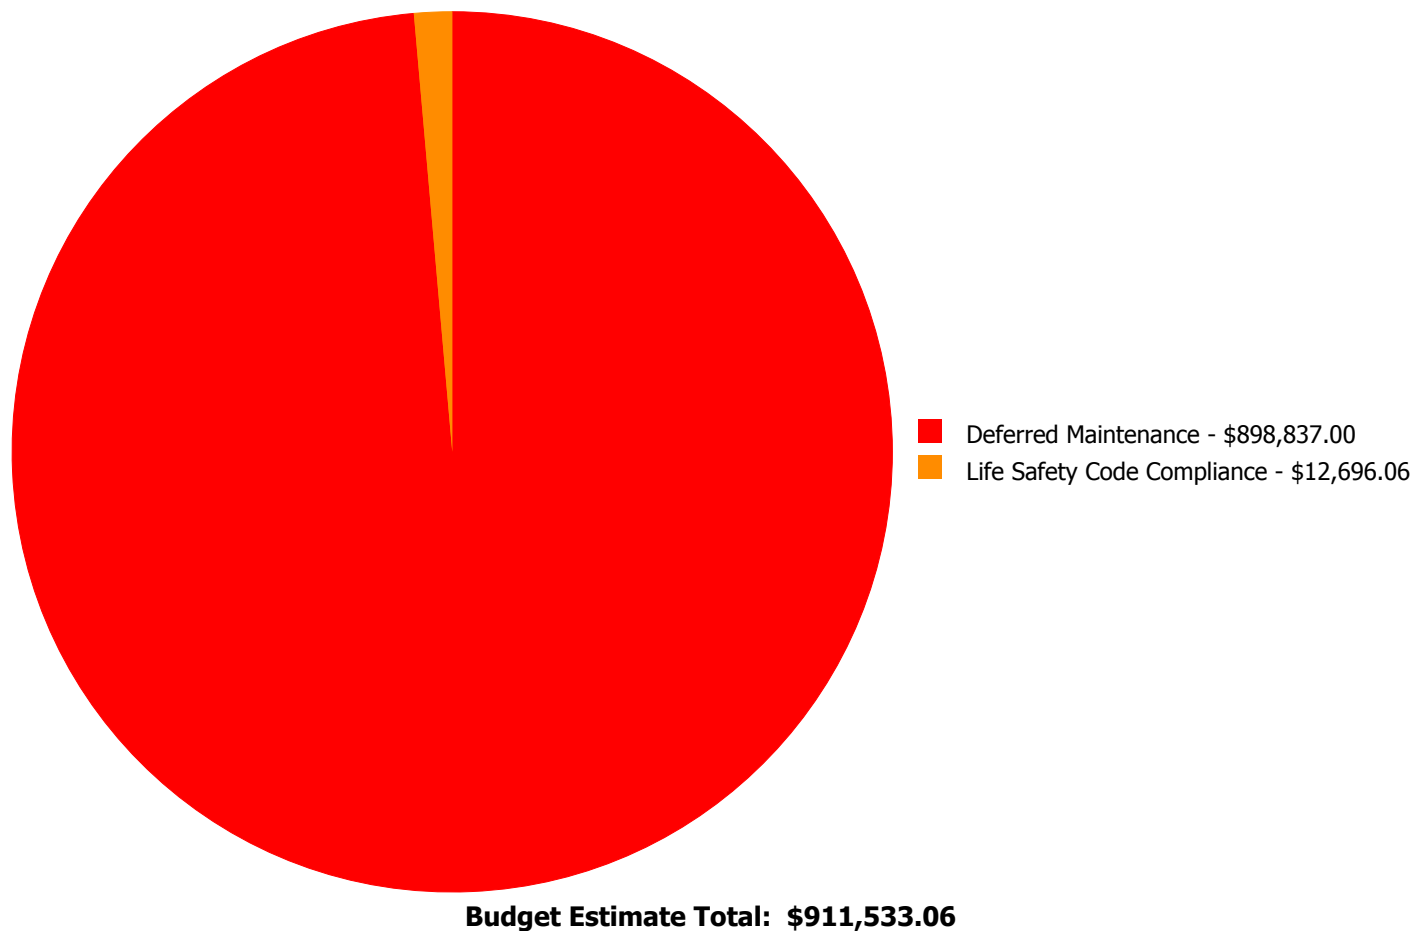
Deficiency Summary by Category

The following chart shows the total repair costs broken down by deficiency categories. Assessors assigned deficiencies to one of the following categories:

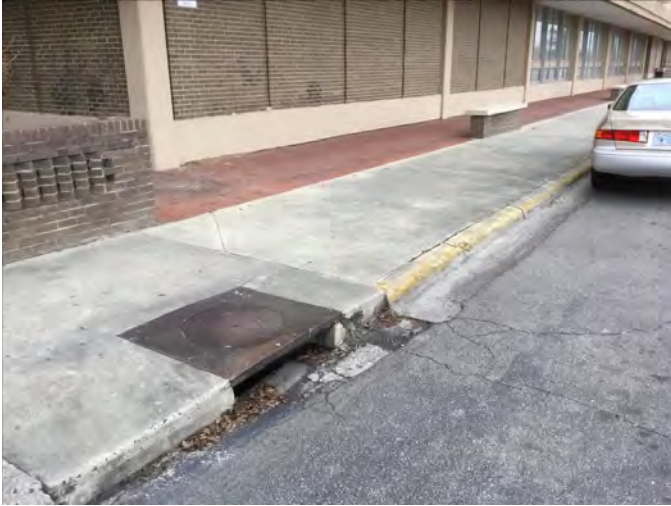
System: G2030 - Pedestrian Paving

Location: Site
Distress: Failing
Category: Life Safety Code Compliance
Priority: 1 - Currently Critical (Immediate)
Correction: Remove and replace concrete sidewalk, 4' wide
Qty: 250.00
Unit of Measure: L.F.
Estimate: \$12,696.06
Assessor Name: Somnath Das
Date Created: 01/09/2017

Notes: The pedestrian paving is undulating and has become a tripping hazard, the pedestrian paving should be replaced.

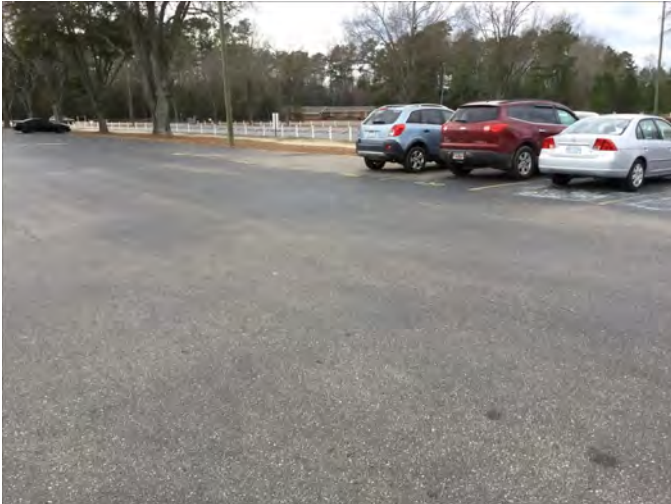
System: G2010 - Roadways

Location: Site
Distress: Failing
Category: Deferred Maintenance
Priority: 3 - Necessary/Not Yet Critical (Years 2-5)
Correction: Resurface the roadway
Qty: 100.00
Unit of Measure: L.F.
Estimate: \$17,160.00
Assessor Name: Somnath Das
Date Created: 01/09/2017

Notes: The roadways have cracks and it should be resealed and recoated.

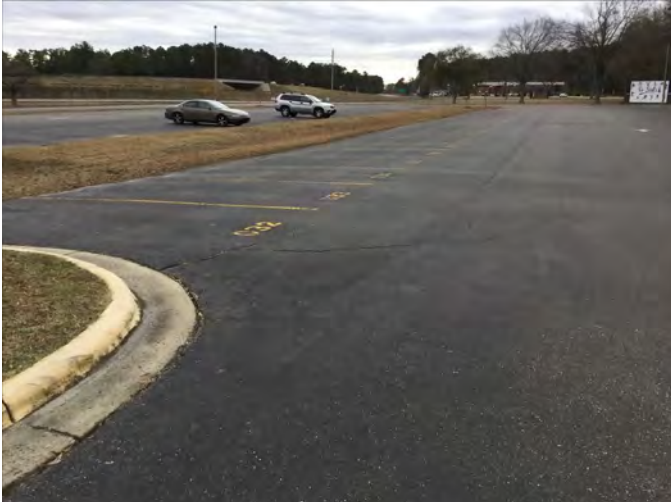
System: G2020 - Parking Lots

Location: Site
Distress: Beyond Service Life
Category: Deferred Maintenance
Priority: 3 - Necessary/Not Yet Critical (Years 2-5)
Correction: Renew System
Qty: 285,240.00
Unit of Measure: S.F.
Estimate: \$505,160.00
Assessor Name: Somnath Das
Date Created: 12/30/2016

Notes: The parking lot is beyond its service life and should be resealed, restriped and recoated.

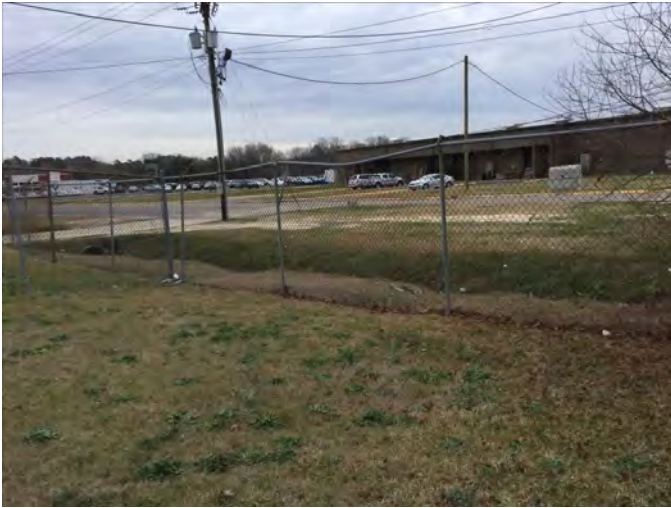
System: G2040105 - Fence & Guardrails

Location: Site
Distress: Beyond Service Life
Category: Deferred Maintenance
Priority: 3 - Necessary/Not Yet Critical (Years 2-5)
Correction: Renew System
Qty: 285,240.00
Unit of Measure: S.F.
Estimate: \$376,517.00
Assessor Name: Somnath Das
Date Created: 12/30/2016

Notes: The fences and guardrail are rusted and beyond their service life and should be replaced.

Note: The fences and guardrail are rusted and beyond their service life and should be replaced.
