NC School District/220 Clay County/Elementary School

# Hayesville Elementary

## Campus Assessment Report

March 13, 2017

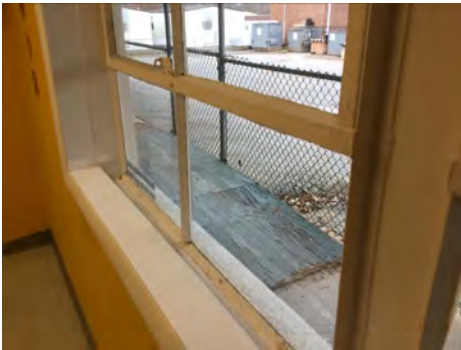
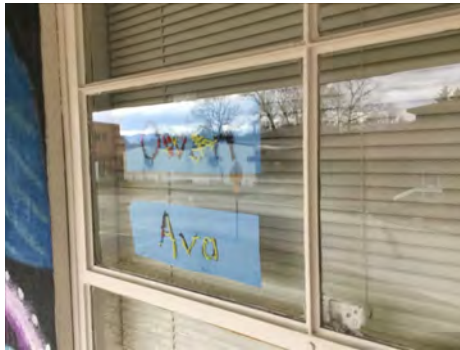
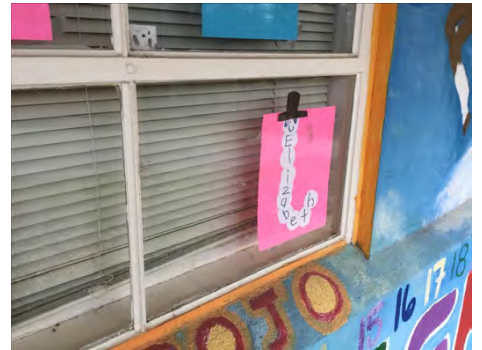
**System:** B2020 - Exterior Windows

**Notes:** The original metal frame, single pane, operable windows are aged, worn, inefficient and should be replaced.

**Location:** Exterior  
**Distress:** Failing  
**Category:** Deferred Maintenance  
**Priority:** 3 - Necessary/Not Yet Critical (Years 2-5)  
**Correction:** Renew System  
**Qty:** 23,963.00  
**Unit of Measure:** S.F.  
**Estimate:** \$252,259.00  
**Assessor Name:** Eduardo Lopez  
**Date Created:** 02/09/2017

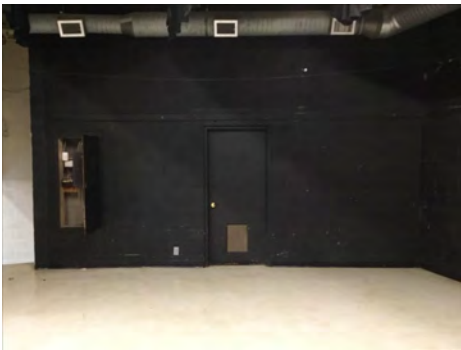
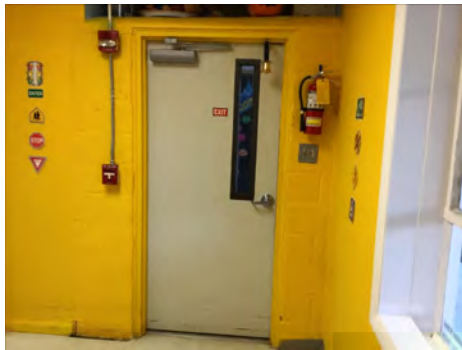
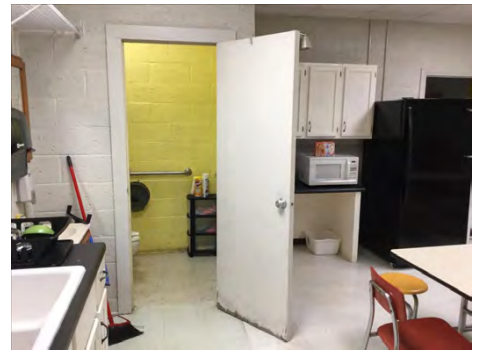
**System:** C1020 - Interior Doors

**Notes:** The interior doors are aged, frames are rusting and damaged, and the hardware is not ADA compliant and should be replaced.

**Location:** Classroom Restrooms  
**Distress:** Damaged  
**Category:** Deferred Maintenance / Accessibility Code Compliance  
**Priority:** 3 - Necessary/Not Yet Critical (Years 2-5)  
**Correction:** Renew System  
**Qty:** 23,963.00  
**Unit of Measure:** S.F.  
**Estimate:** \$68,271.00  
**Assessor Name:** Eduardo Lopez  
**Date Created:** 02/09/2017

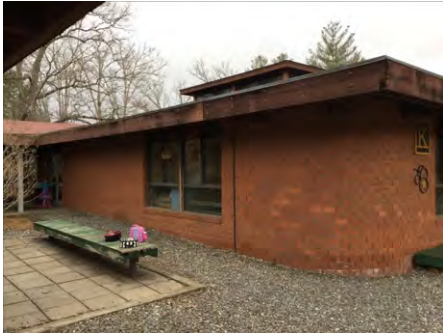
1). East Elevation - Jan 23, 2017

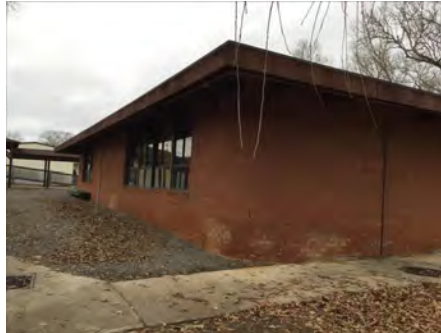
2). South Elevation - Jan 23, 2017

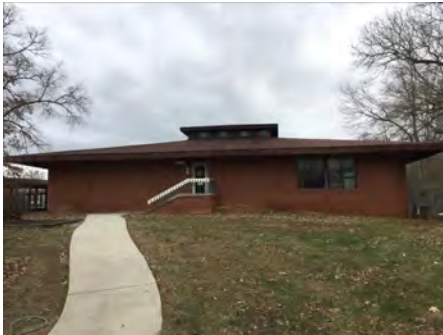
4). West Elevation - Jan 23, 2017
