NC School District/430 Harnett County/Middle School

Harnett Central Middle

Campus Assessment Report

March 11, 2017

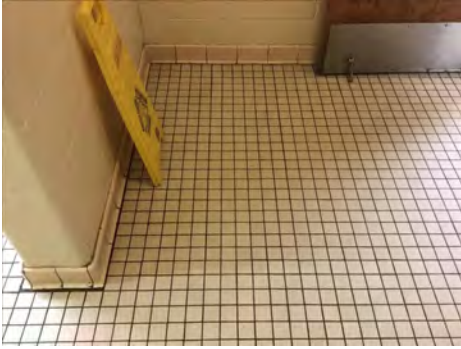
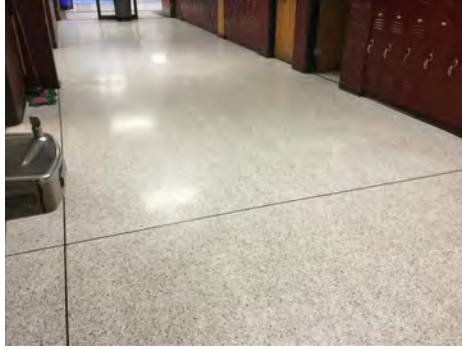
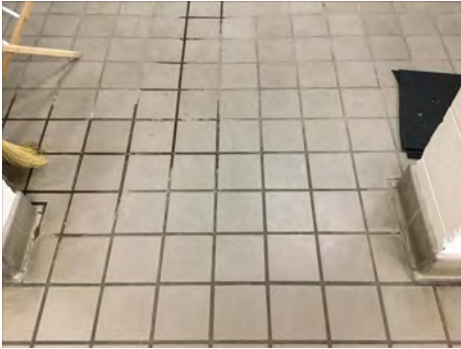
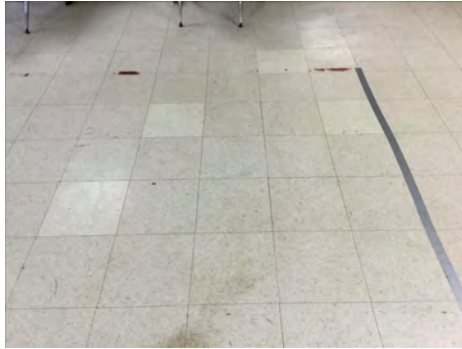
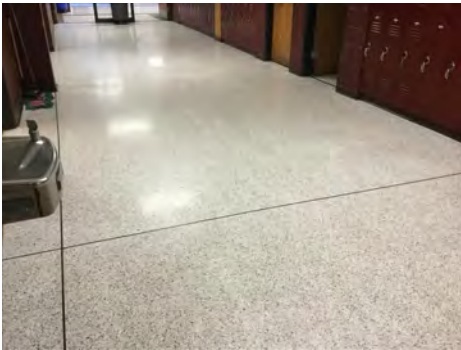
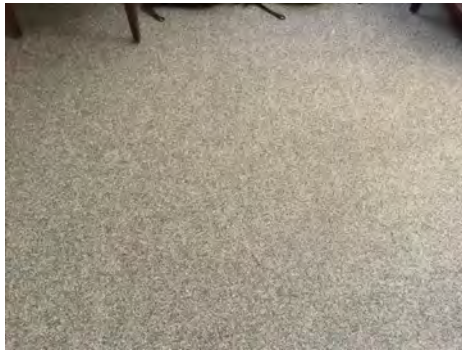
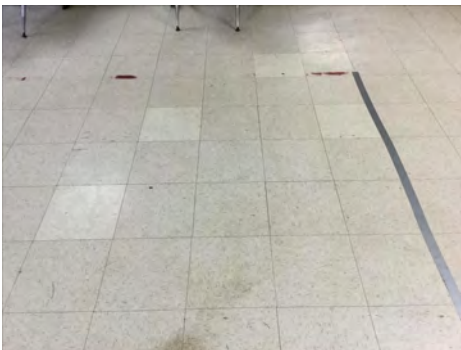
System: C3020 - Floor Finishes

Note: VCT and carpet is original and needs to be replaced.

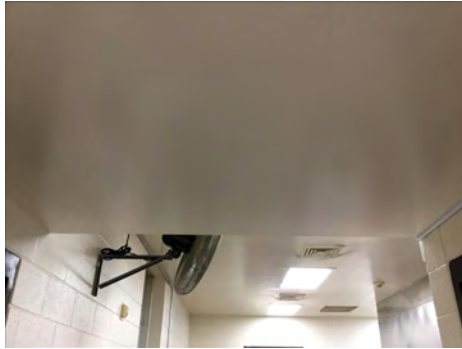
System: C3030 - Ceiling Finishes

Note: ACT Tiles needs to be replaced

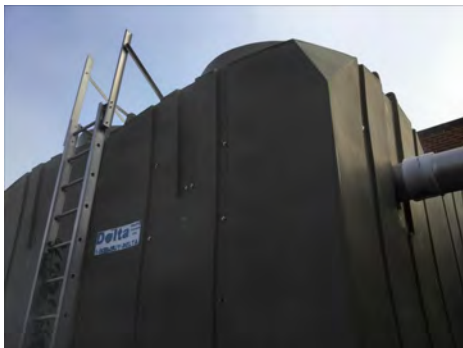
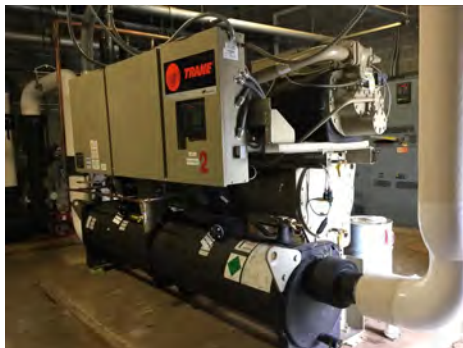
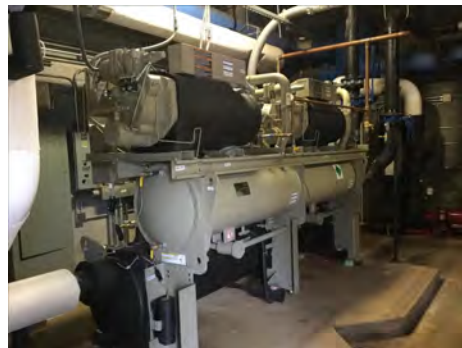
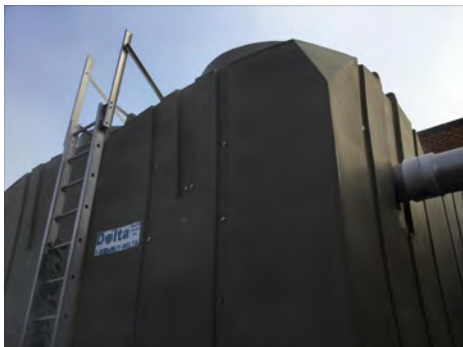
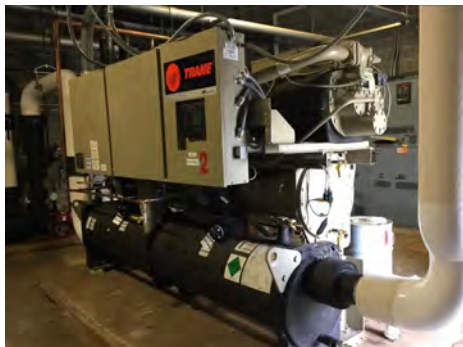
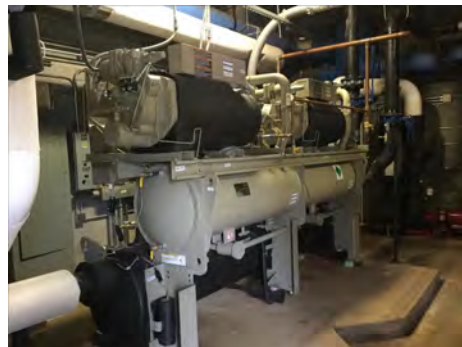
System: D3030 - Cooling Generating Systems

Note: Chillers in 2016 and cooling towers were installed in 2002

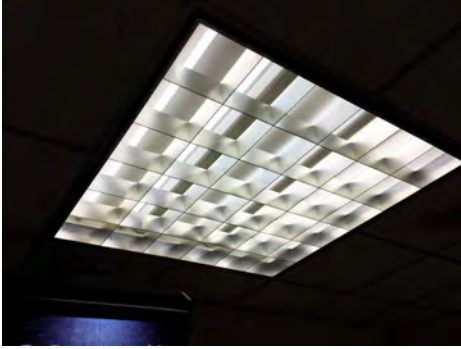
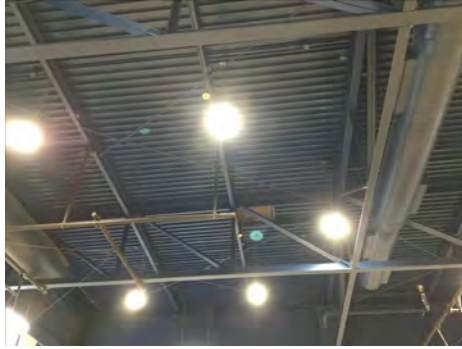
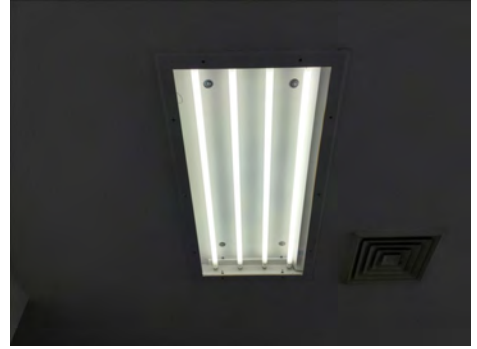
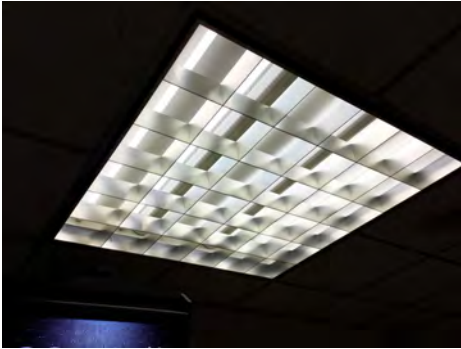
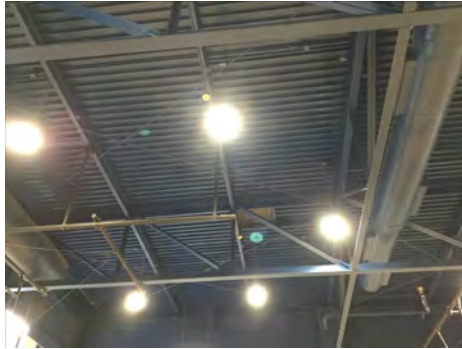
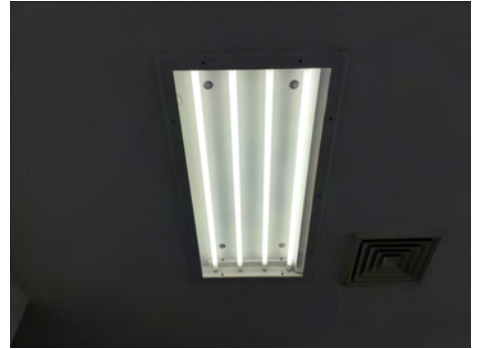
System: D5020 - Lighting

Note: Lights are changed to T8's and now they are being upgraded to LED's.

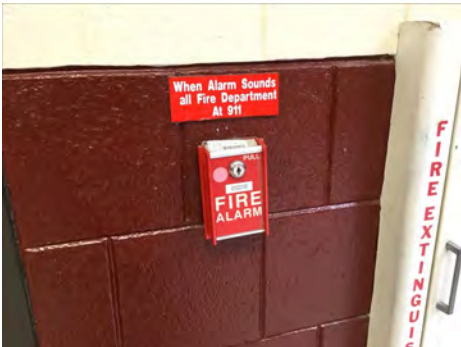
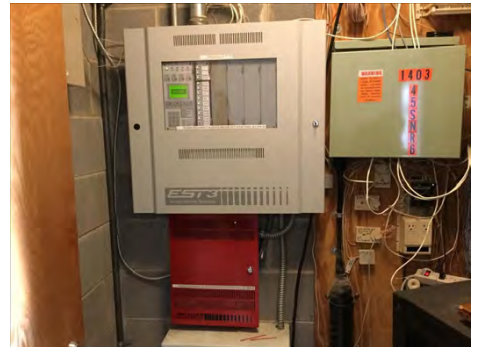
System: D5030910 - Fire Alarm Systems

Notes: The fire alarm system is beyond its service life and should be replaced.

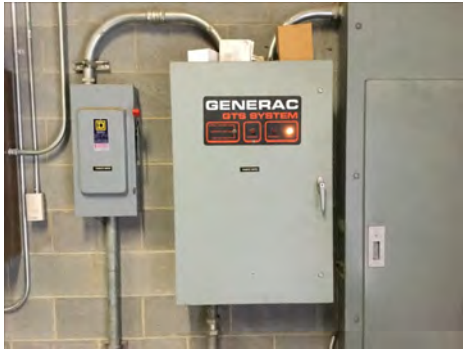
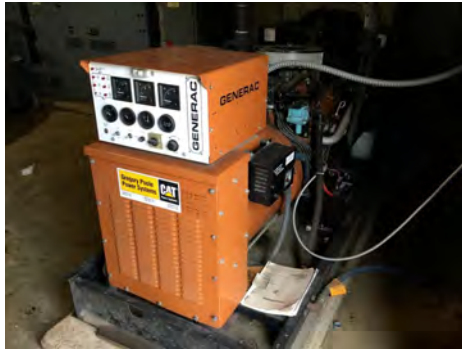
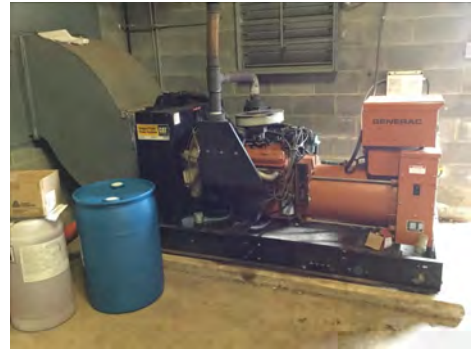
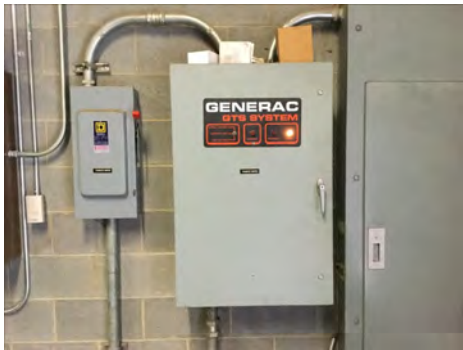
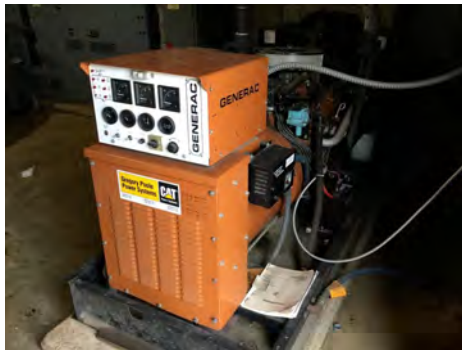
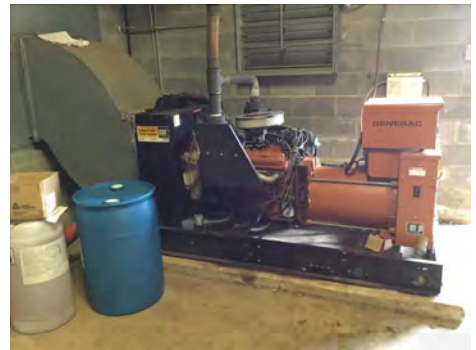
System: D5090 - Other Electrical Systems

Note: Propane powered

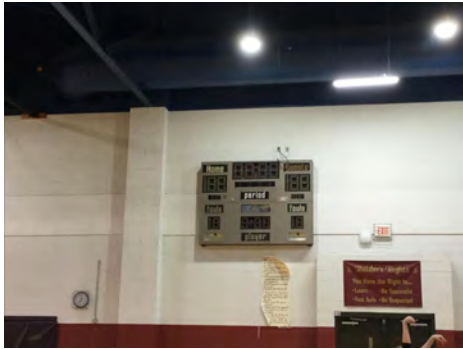
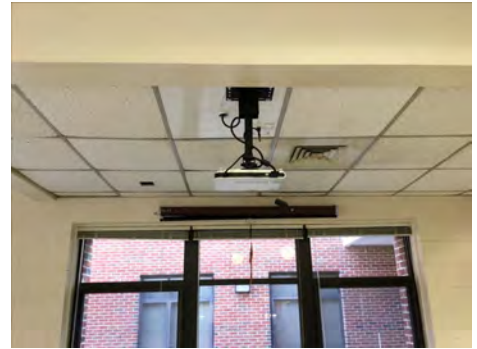
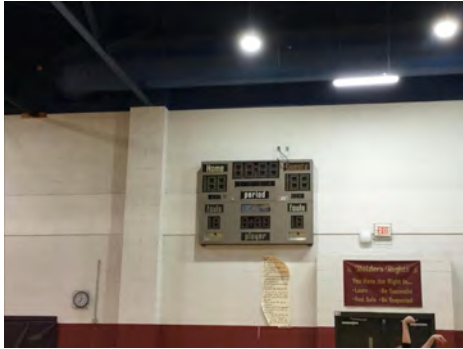
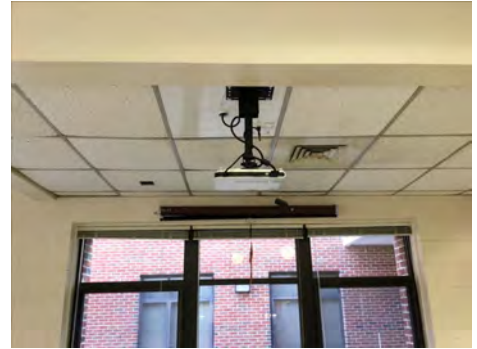
System: E1020 - Institutional Equipment

Note: New projectors, but the sports equipment is original.

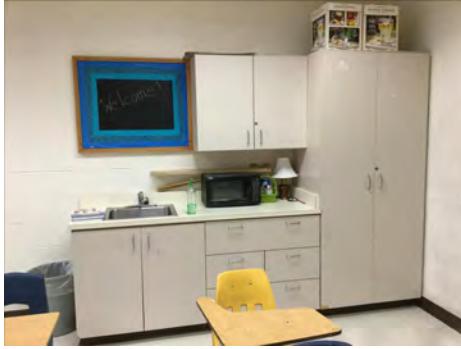
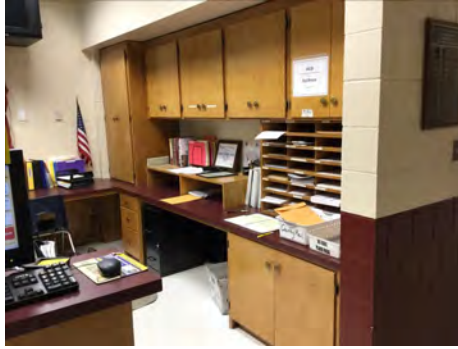
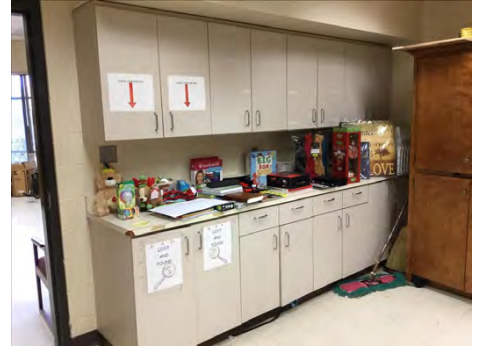
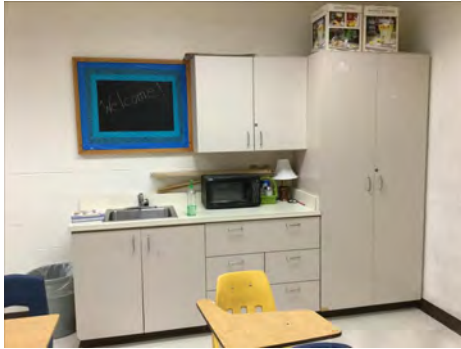
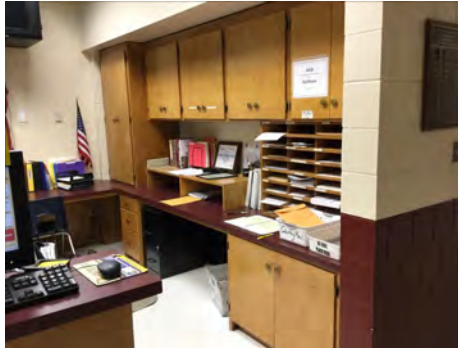
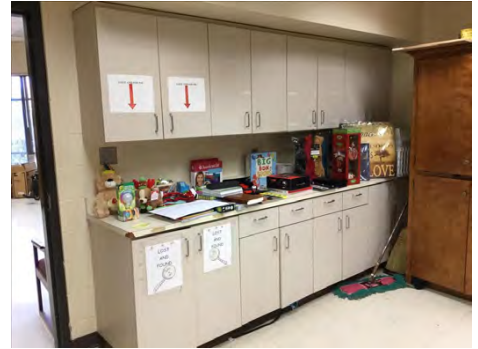
System: E2010 - Fixed Furnishings

Notes: The fixed furnishing is beyond service life and should be replaced.

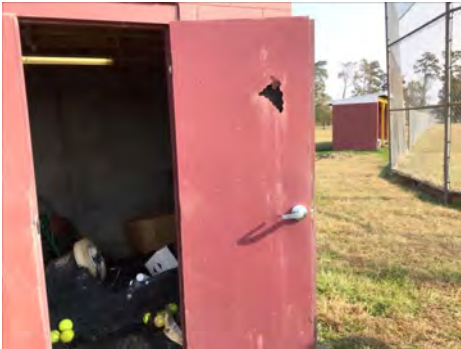
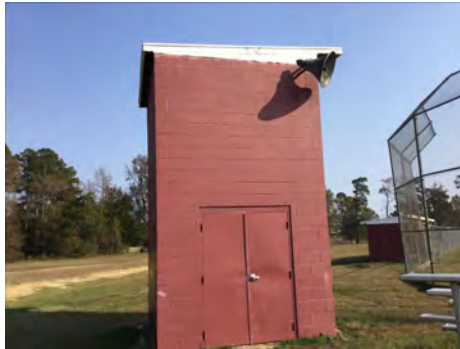
System: B2030 - Exterior Doors

Location: Exterior of the building
Distress: Damaged
Category: Deferred Maintenance / Building Code Compliance
Priority: 3 - Necessary/Not Yet Critical (Years 2-5)
Correction: Renew System
Qty: 200.00
Unit of Measure: S.F.
Estimate: \$1,905.00
Assessor Name: Eduardo Lopez
Date Created: 11/16/2016

Notes: The exterior door is rusted and damaged and should be replaced.

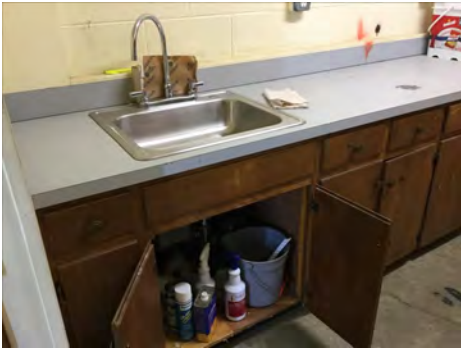
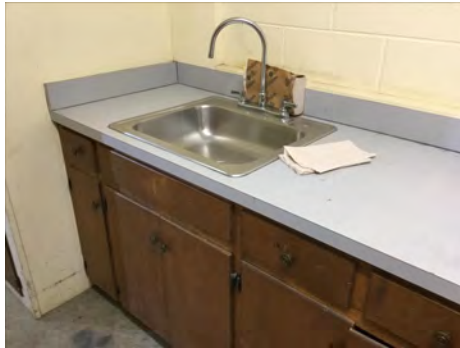
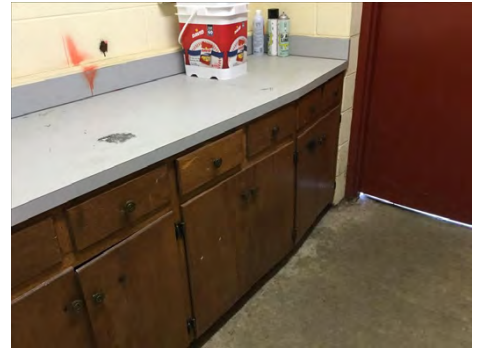
System: E2010 - Fixed Furnishings

Notes: The fixed furnishing is beyond its service life and should be replaced.
