NC School District/430 Harnett County/Middle School

# Western Harnett Middle

## Campus Assessment Report

March 11, 2017

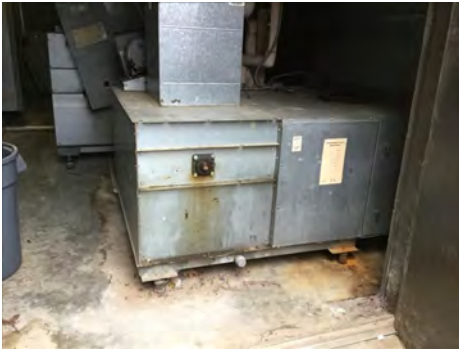
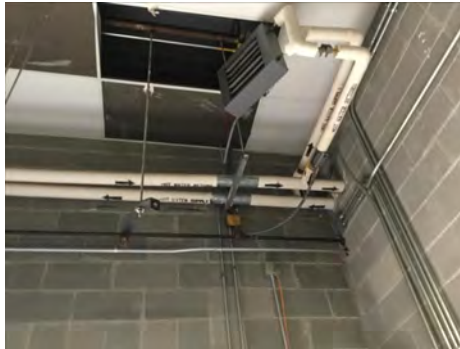
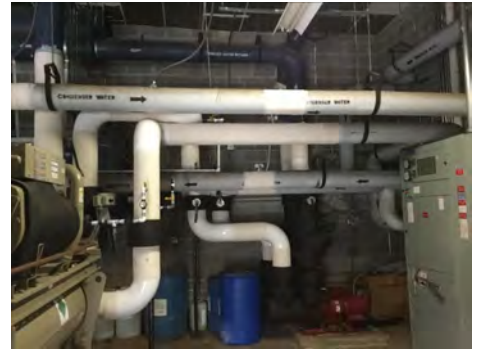
**System:** D3040 - Distribution Systems

**Note:** Air Handlers are 1990

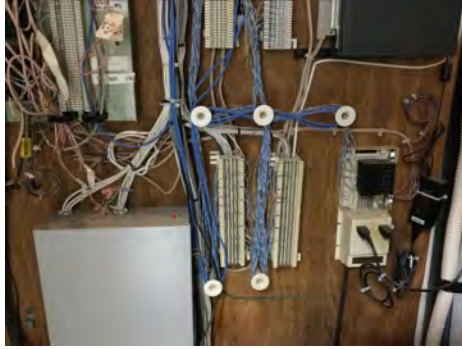
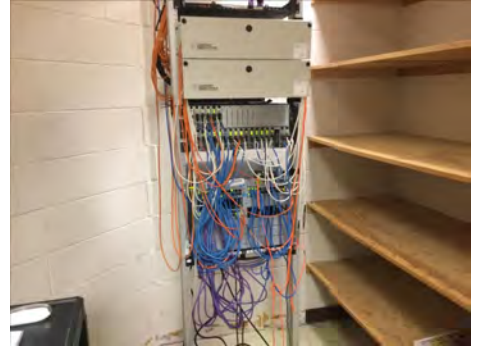
**System:** D5030920 - Data Communication

**Note:** The PA system does not work
