NC School District/830 Scotland County/Elementary School

I E Johnson Elementary

Campus Assessment Report

March 11, 2017

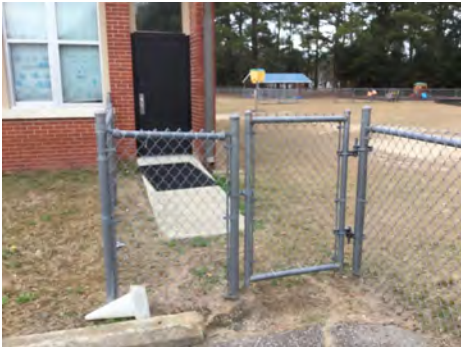
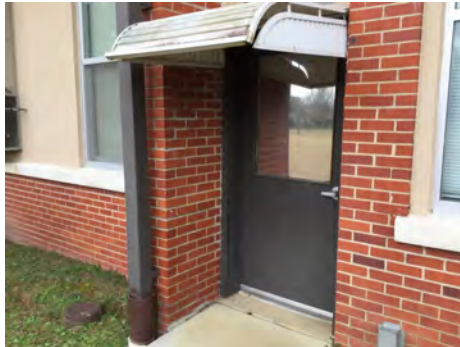
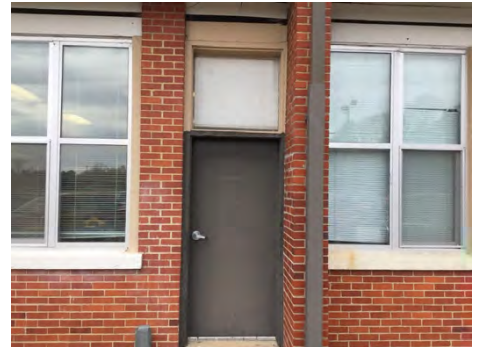
System: B2030 - Exterior Doors

Notes: The original metal exterior doors are aged, rusted, damaged and should be replaced with energy efficient doors

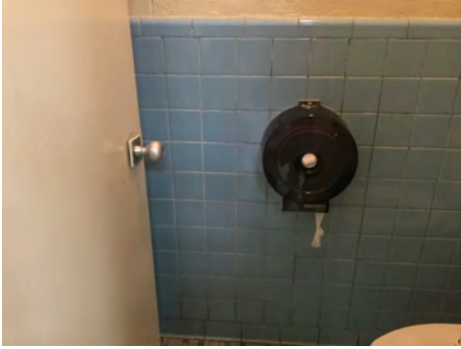
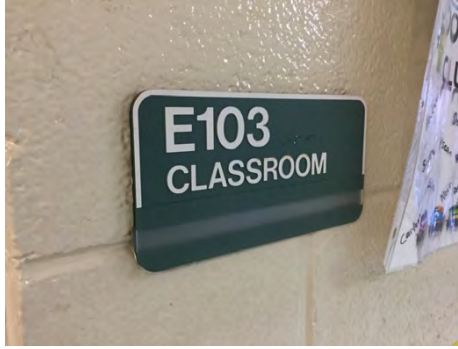
System: C1030 - Fittings

Notes: The bathroom fittings and toilet partitions are aged, worn, damaged and should be replaced. The original fittings are aged, and should be replaced. The room signs are inadequate, do not comply with present requirements and is recommended to replace them.

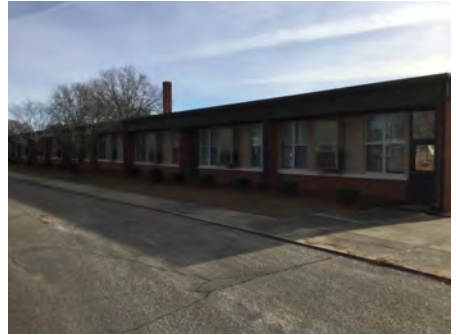
3). Southeast Elevation - Jan 10, 2017

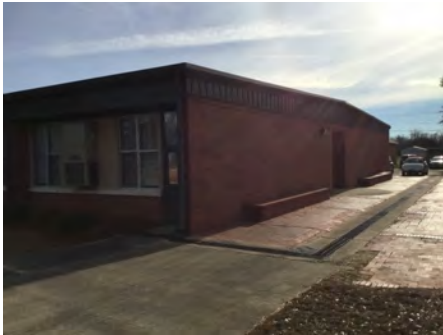
4). Southwest Elevation - Jan 10, 2017

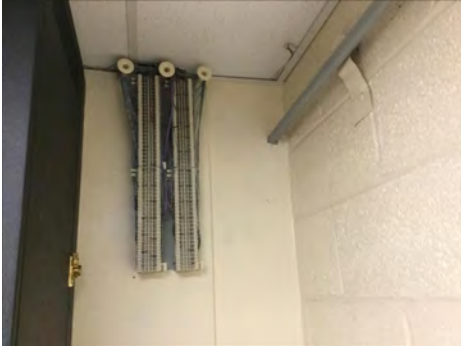
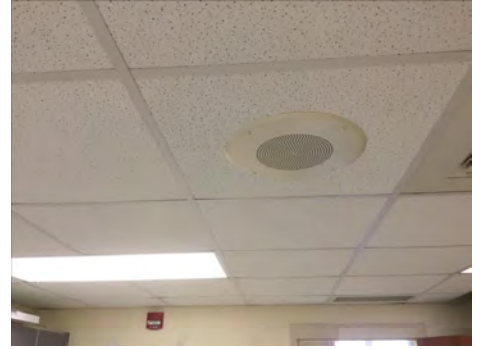
System: D5030920 - Data Communication

Note: Telephone and PA systems are separate.

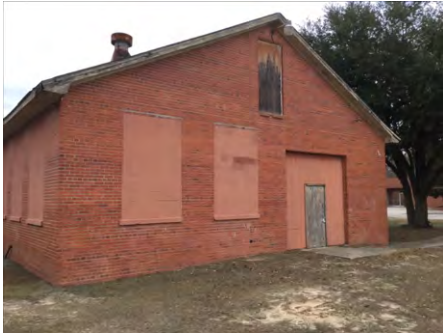
1). South Elevation - Feb 21, 2017

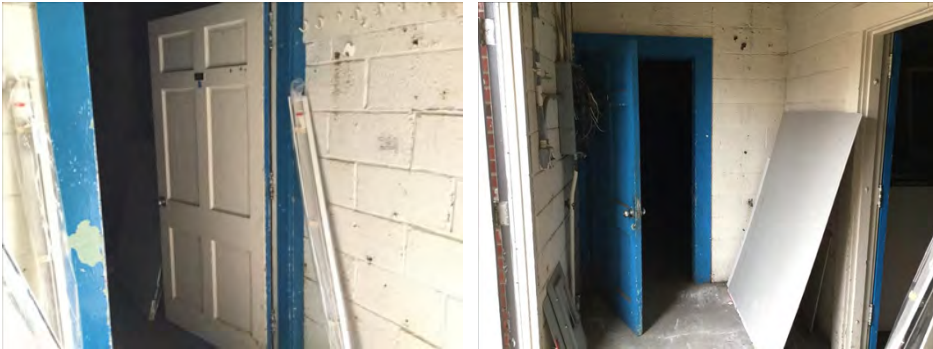
System: C1020 - Interior Doors

Notes: The original wood interior doors are aged, worn and should be replaced.

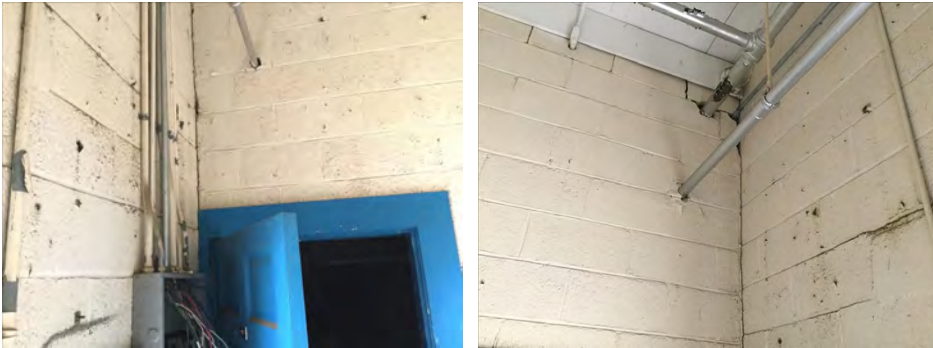
System: C3010 - Wall Finishes

Notes: The original painted wall finish is aged, chipped, stained and should be replaced.

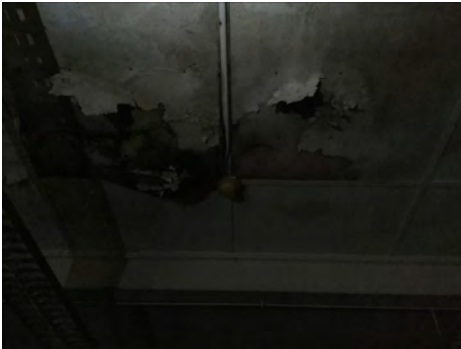
System: C3030 - Ceiling Finishes

Notes: The original ceiling finish is aged, chipped, stained and should be replaced.

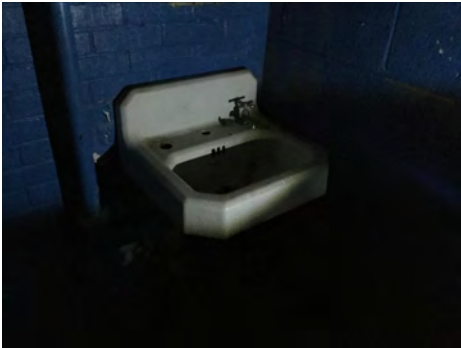
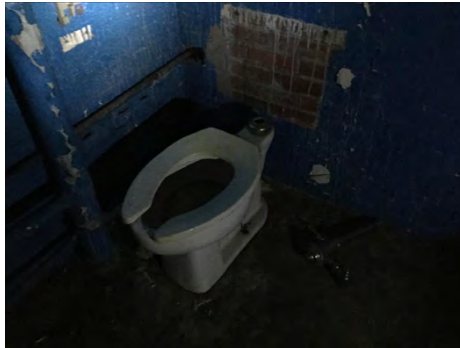
System: D2010 - Plumbing Fixtures

Notes: The original plumbing fixtures are aged, chipped, stained, showing signs of failure and should be replaced.

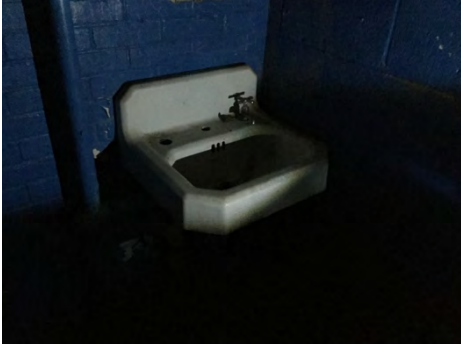
System: D2020 - Domestic Water Distribution

Notes: The original copper water distribution system is aged, corroded, has reported leaks and should be replaced.

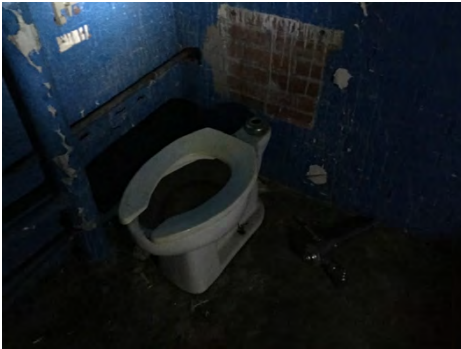
System: D2030 - Sanitary Waste

Notes: The original sanitary waste system is operating but is in poor condition and should be replaced.

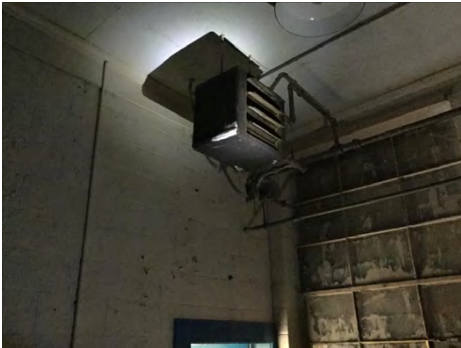
System: D3040 - Distribution Systems

Notes: The original distribution system is operating but is in poor condition and should be replaced.

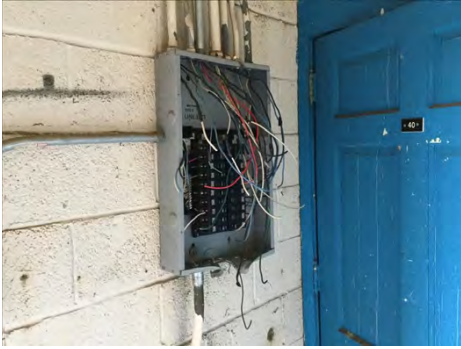
System: D5010 - Electrical Service/Distribution

Notes: The original distribution wiring system is damaged, in poor condition and should be replaced.

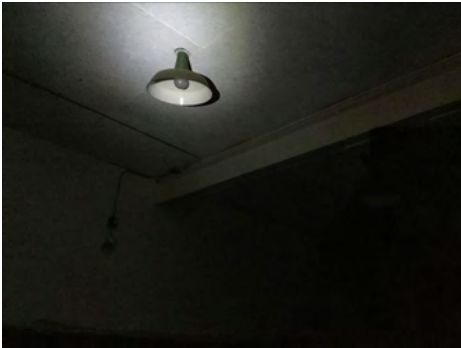
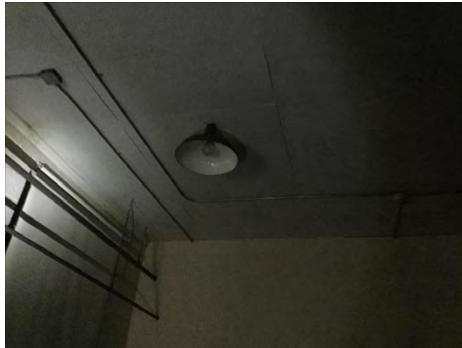
System: D5020 - Lighting

Notes: The original lighting system is operating properly but is aged, inefficient, in poor condition and should be replaced with an energy efficient system.

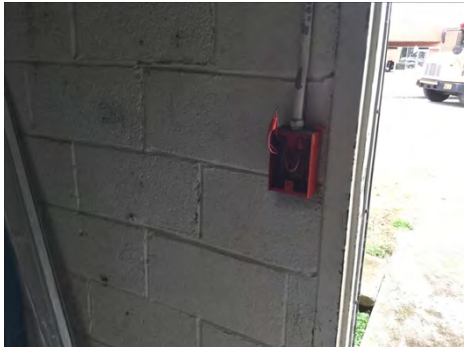
System: D5030910 - Fire Alarm Systems

Notes: The original fire alarm system is aged and should be replaced.
