NC School District/830 Scotland County/Elementary School

South Scotland Elementary

Campus Assessment Report

March 11, 2017

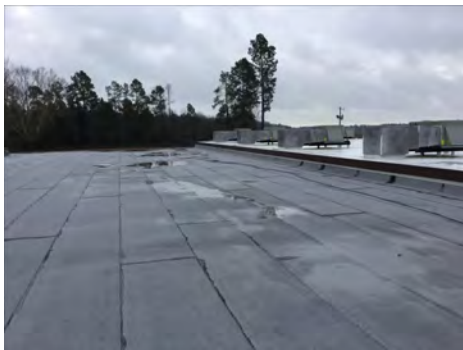
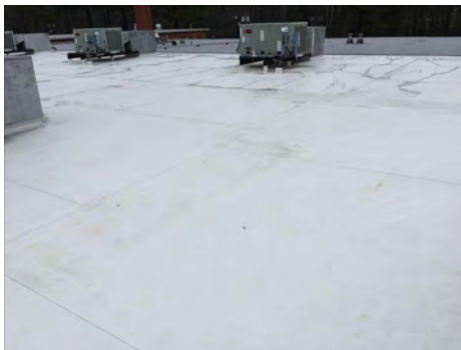
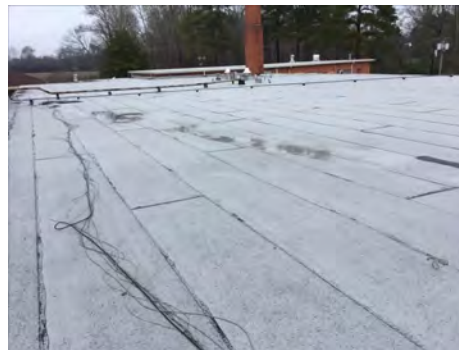
System: B3010120 - Single Ply Membrane

Note: The TPO was installed in 2015

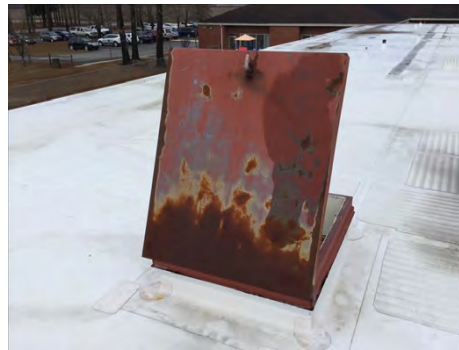
System: B3020 - Roof Openings

Note: The roof opening is beyond its service life and should be replaced with an OSHA compliant access hatch.

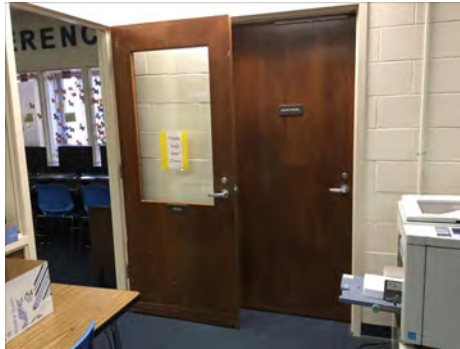
System: C1020 - Interior Doors

Note: The interior doors are beyond their service life and should be replaced.

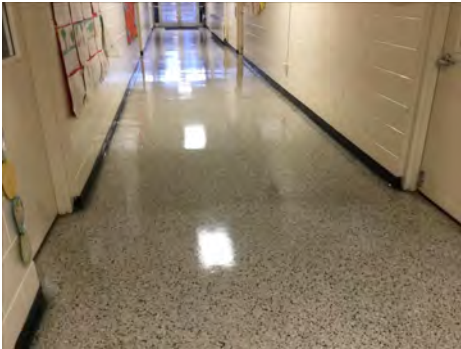
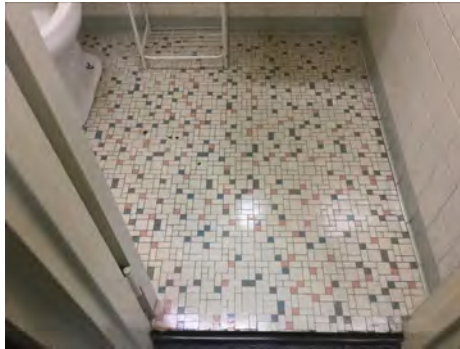
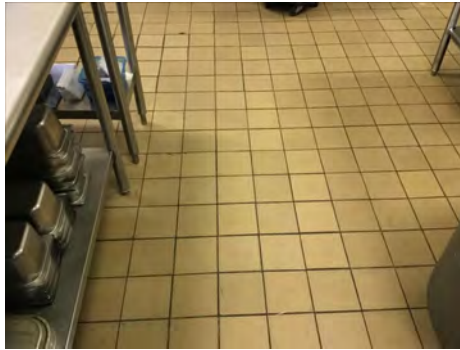
System: C3020 - Floor Finishes

Note: The carpet is beyond its service life and should be replaced.

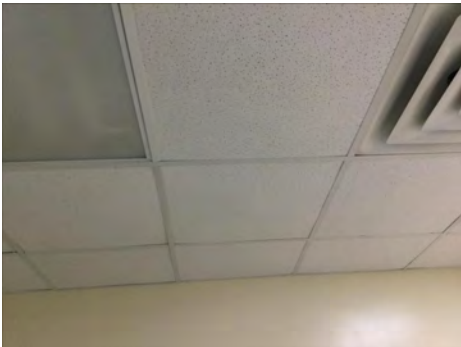
System: C3030 - Ceiling Finishes

Note: The acoustical ceiling tiles are beyond their service life and should be replaced.

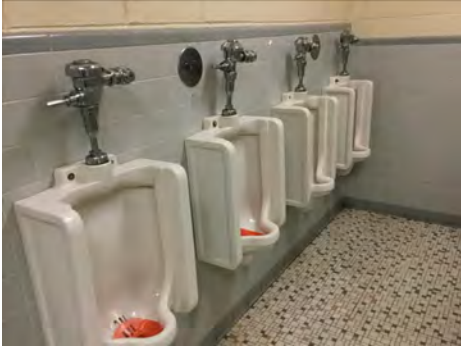
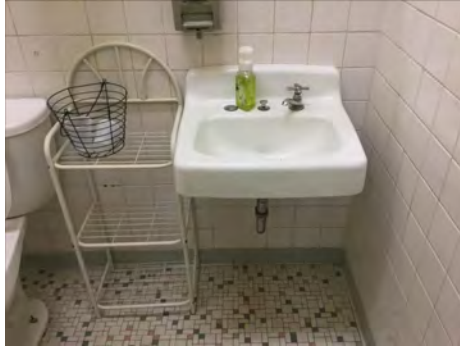
System: D2010 - Plumbing Fixtures

Note: The plumbing fixtures are beyond their service life and should be replaced.

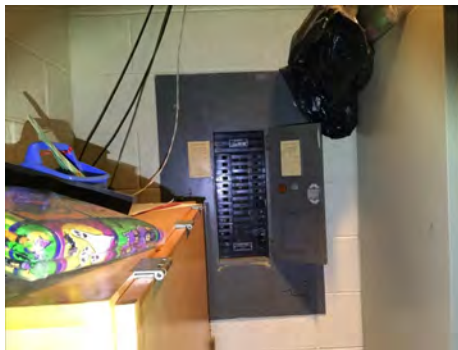
System: D5020 - Branch Wiring

Note: The branch wiring system is beyond its service life and should be replaced.

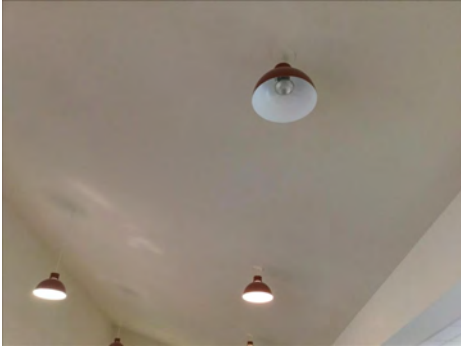
System: D5020 - Lighting

Note: The lights are primarily T-12's and are beyond their service life and they get replaced by T-8's as per needs basis.

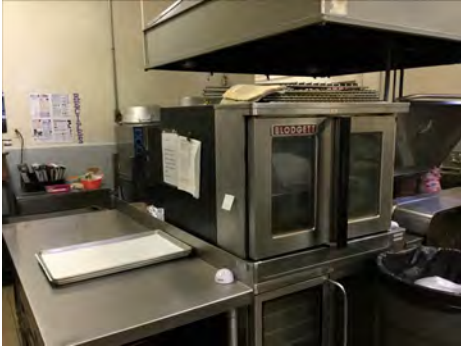
System: E1090 - Other Equipment

Note: The kitchen equipment is beyond its service life and should be replaced.

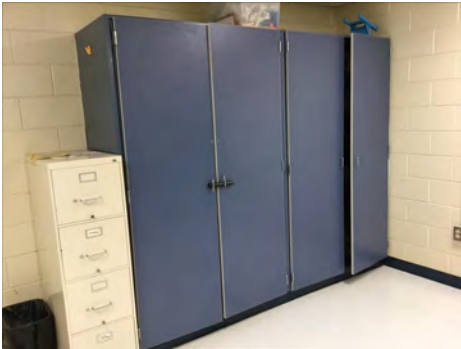
System: E2010 - Fixed Furnishings

Note: The fixed furnishings are beyond their service life and should be replaced.

Notes: The fixed furnishings are beyond their service life and should be replaced.

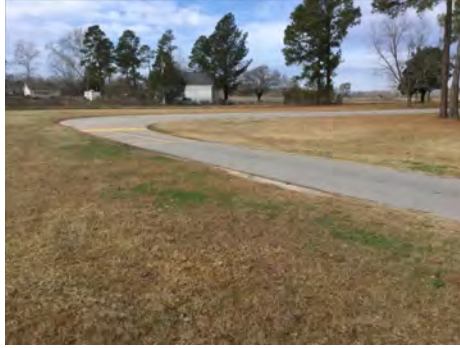
System: G2010 - Roadways

Note: The roads need to be resealed.

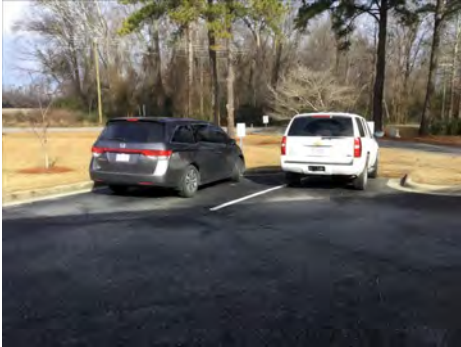
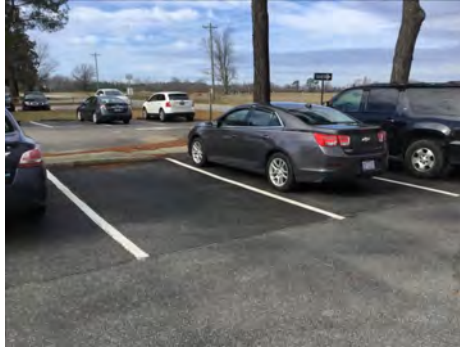
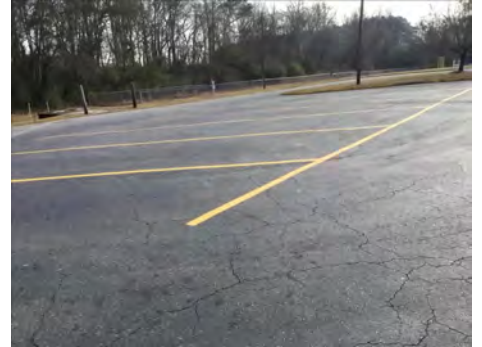
System: G2020 - Parking Lots

Note: The parking striping was done in 2014.

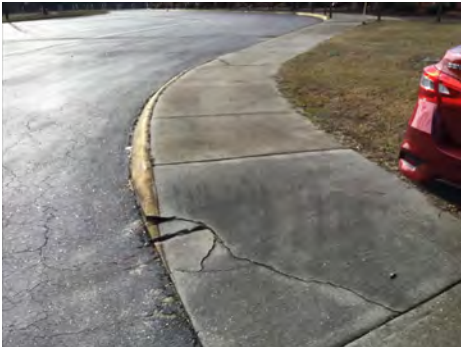
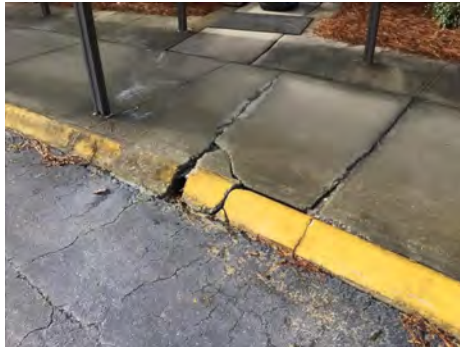
System: G2030 - Pedestrian Paving

Note: The pedestrian paving is cracked and beyond its service life and should be replaced.
