NC School District/995 Yancey County/High School

Mountain Heritage High

Campus Assessment Report

March 12, 2017

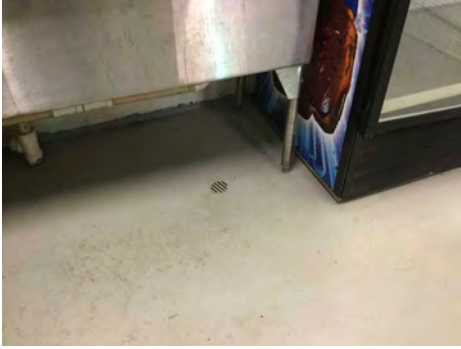
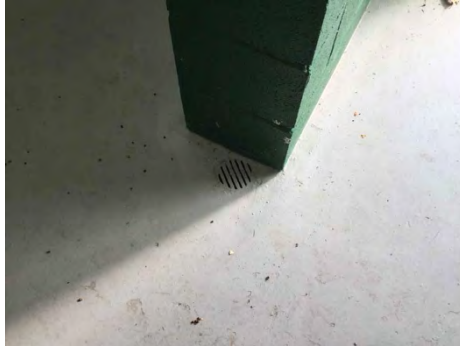
System: D2030 - Sanitary Waste

Notes: The sanitary waste system is aged, has reported periodic failures, and should be replaced.

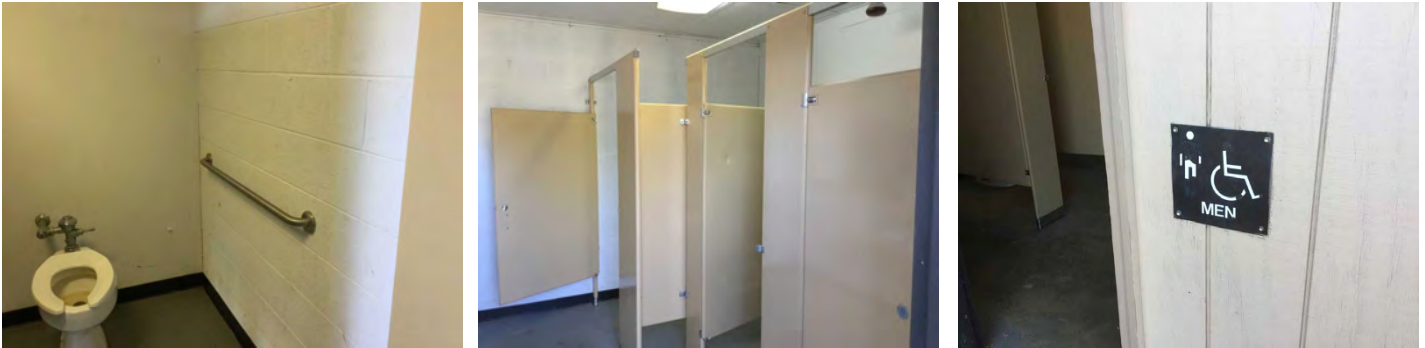
System: C1030 - Fittings

Notes: The fittings throughout the building are aged, in marginal condition, and should be replaced.

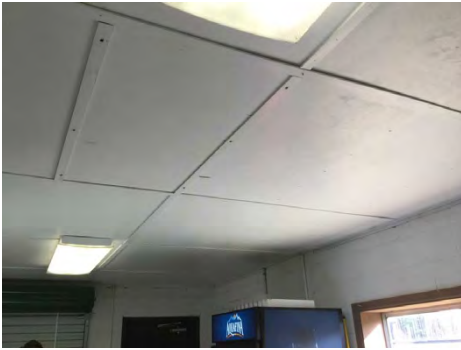
System: C3030 - Ceiling Finishes

Notes: The original ceiling finishes are aged, failing and should be replaced.
