NC School District/995 Yancey County/Middle School

East Yancey Middle

Campus Assessment Report

March 11, 2017

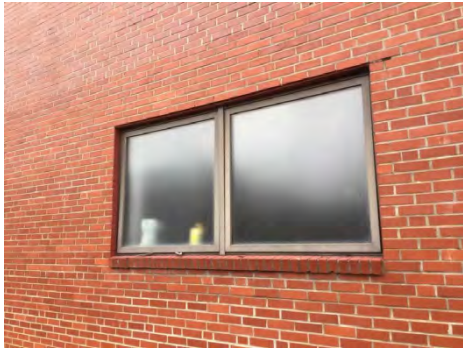
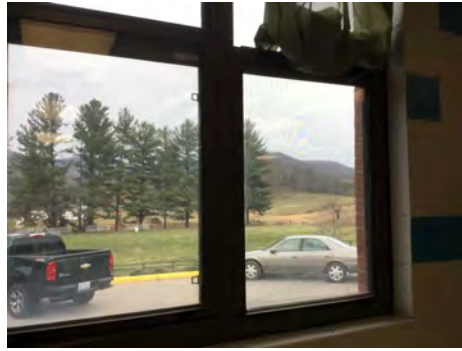
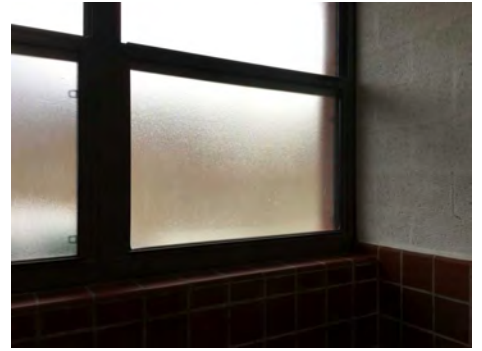
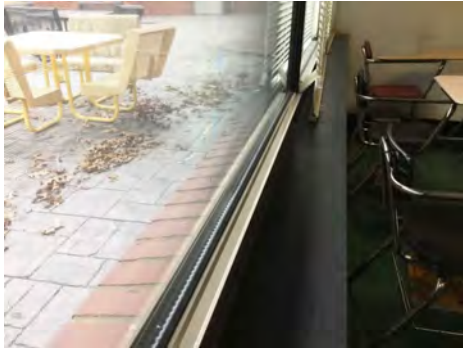
System: B2020 - Exterior Windows

Notes: The aluminum frame, operable, single pane windows are aged, rusted, not energy efficient, and should be replaced.

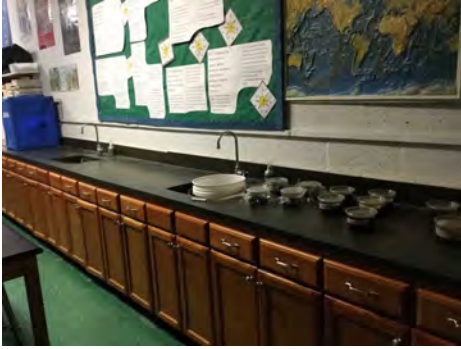
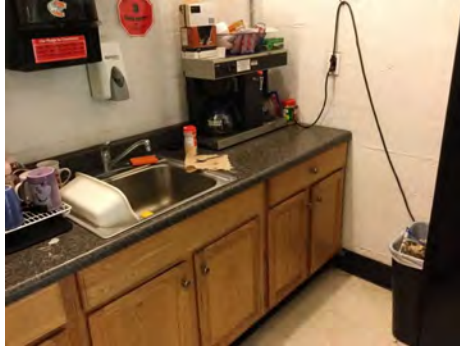
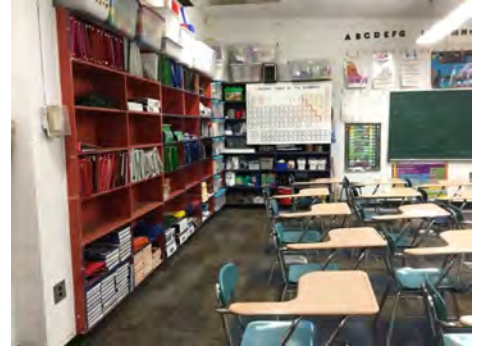
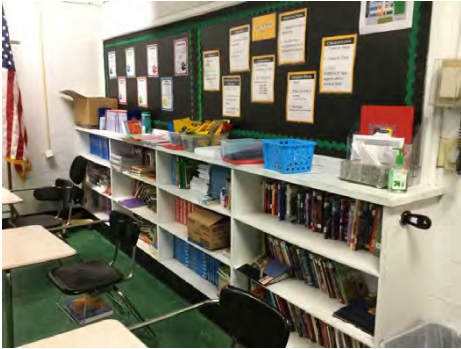
System: E2010 - Fixed Furnishings

Notes: The fixed furnishings are aged, in marginal condition, and should be replaced.

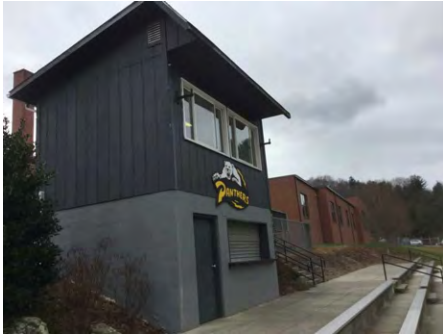
1). North Elevation - Feb 02, 2017

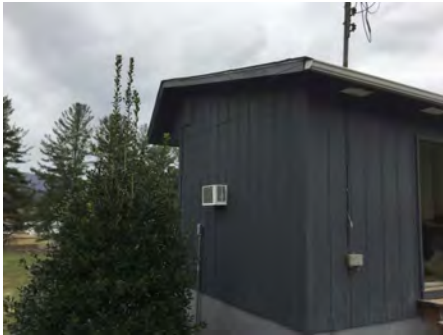
4). West Elevation - Feb 02, 2017

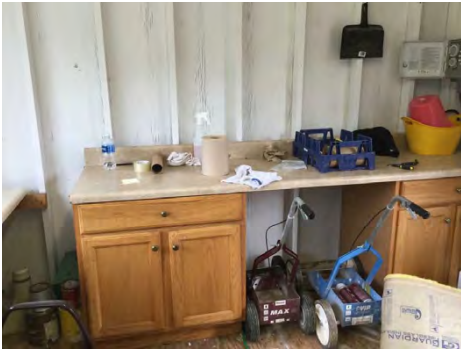
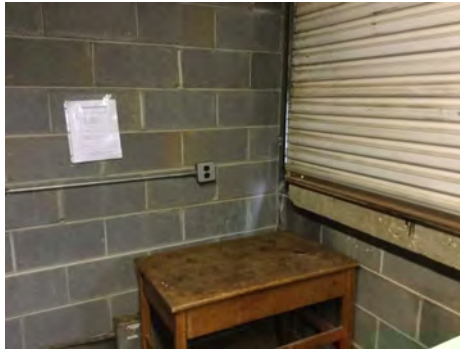
System: C3010 - Wall Finishes

Notes: The wall paint is damaged, fading, stained, and should be re-painted.

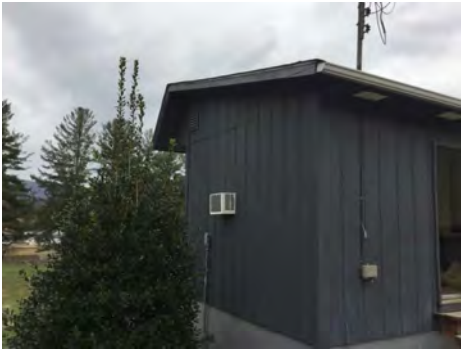
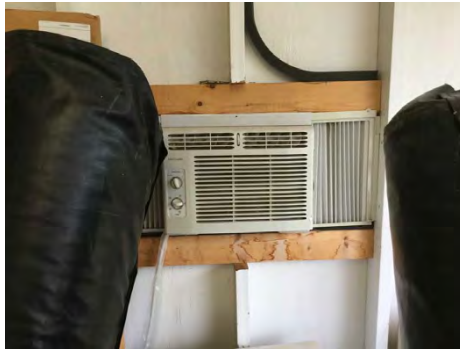
System: D3050 - Terminal & Package Units

Notes: The wall mounted DX condensers are aged, rusted, not energy efficient, and should be replaced.

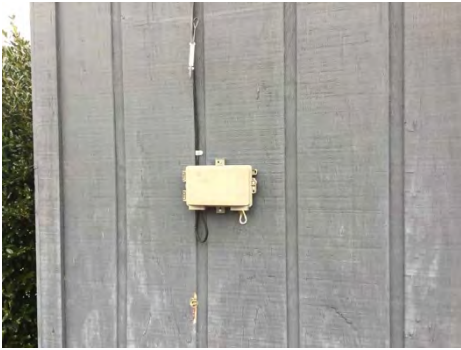
System: D5030920 - Data Communication

Notes: The data communication system is failing and should be replaced.
